New Jersey Beach Profile Network

Cape May County

Great Egg Harbor Inlet
to Stow Creek

NJBPN Profile #'s
225 - 100

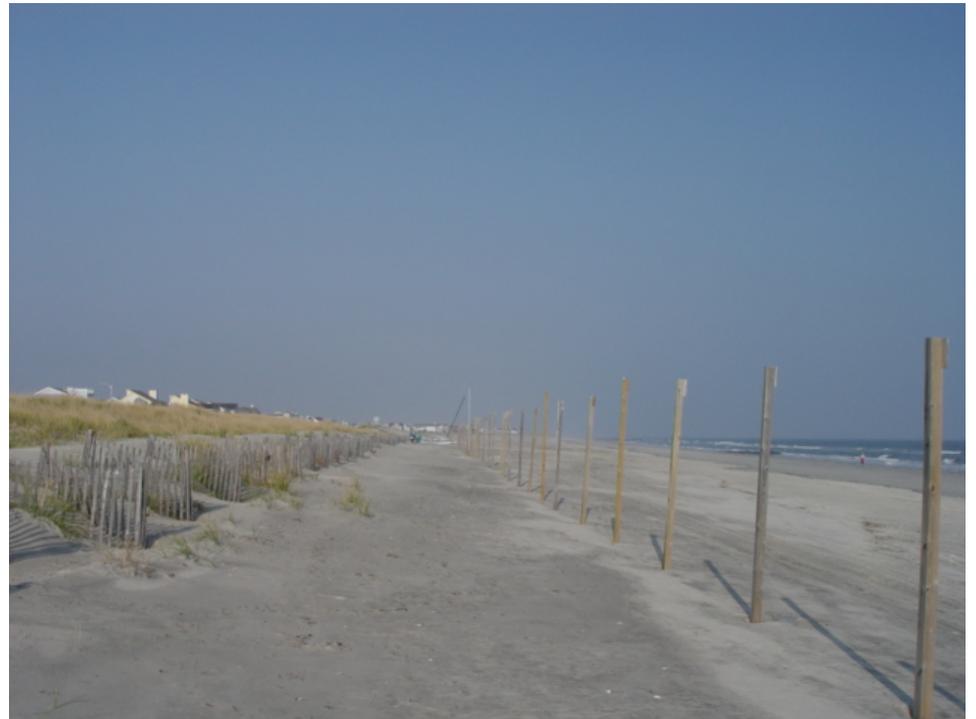
Figure 280. This view taken November 14, 2007, shows the toe of the dune and the row of poles put into the sand to tether the catamarans used each summer by Stone Harbor residents. The beach lost 46.25 yds³/ft., while the shoreline retreated 57 feet over the 18-month interval.

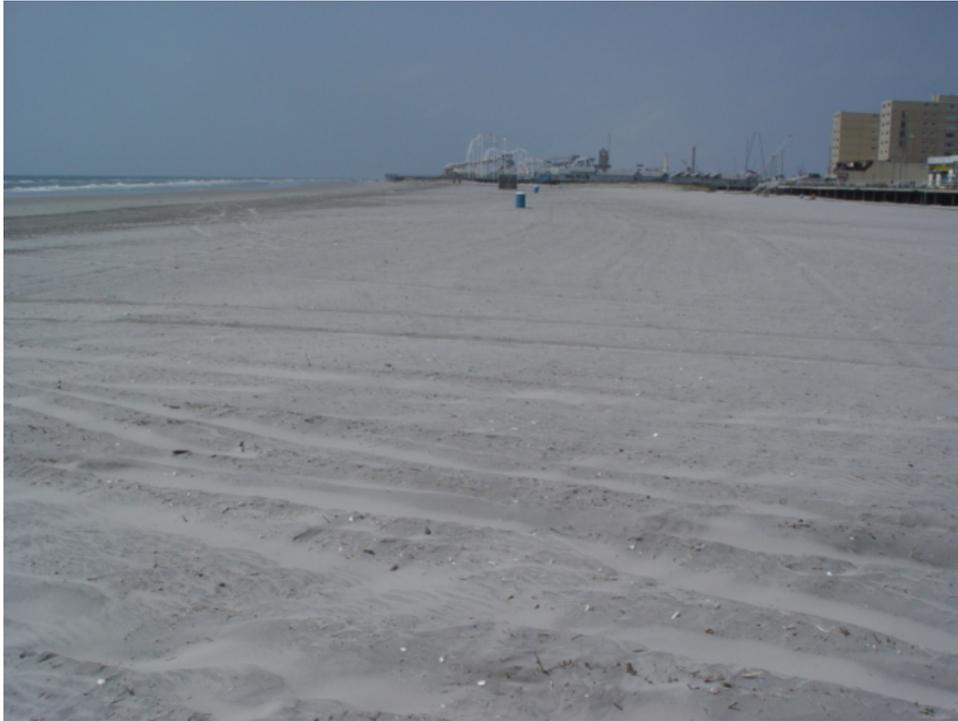
Figure 283. Loss rates reversed at North Wildwood following the largest loss ever measured at a New Jersey beach in the history of the project (1055 feet of retreat in the shoreline from 1998 to 2005). The beach gained sand in each survey since the 30th survey in the spring of 2005. The left picture was taken May 11, 2006.

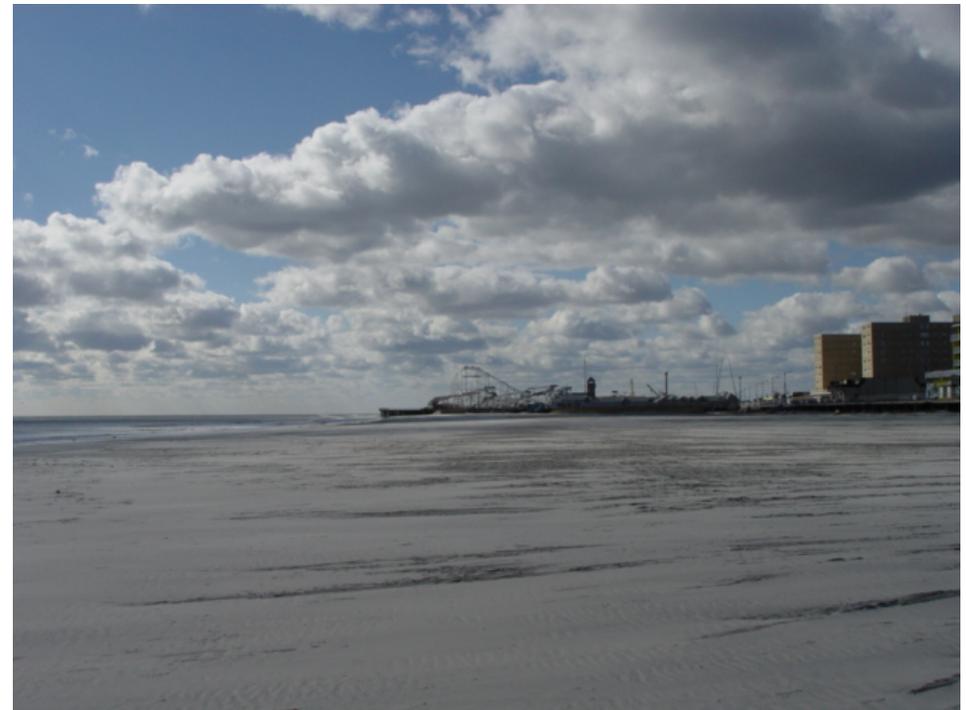
Figure 284. The photograph to the right was taken November 16, 2007 and shows the broad, flat beach leading to the recreational piers in both North Wildwood and Wildwood. This 18-month interval saw a 20.93 yds³/ft. gain in sand volume with a 54-foot shoreline advance. This annual gain is about 5% of the sand loss documented at this location.

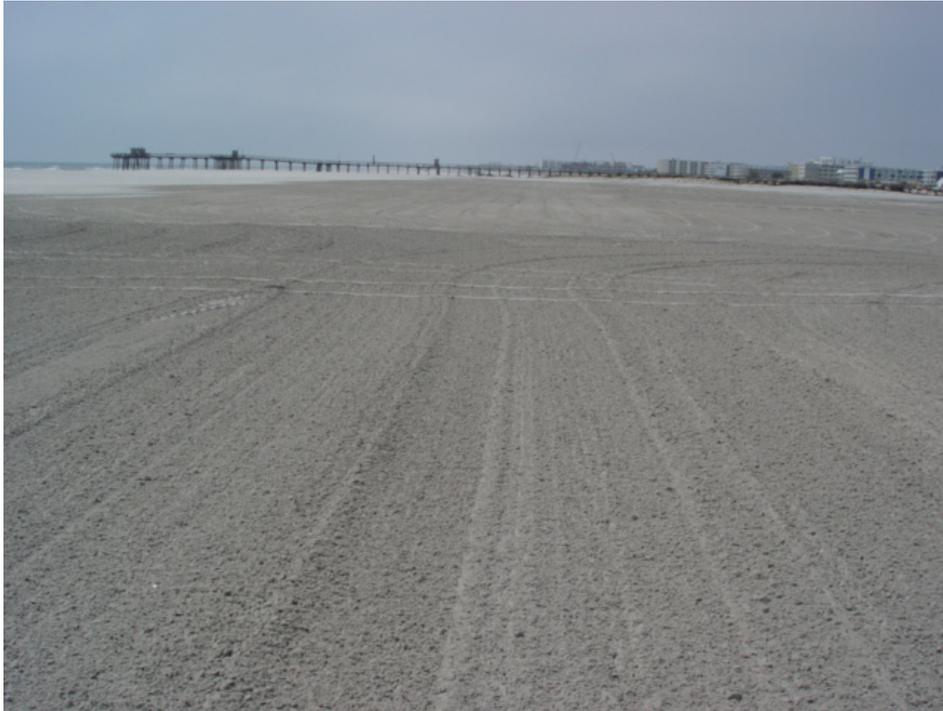
Figure 286. In May of 2006 the beach in Wildwood was graded smooth for the coming tourist season. The vast width of this shoreline has been the subject of many stories over the years. Many folks feel that all the sand lost from every other New Jersey beach comes somehow, to Wildwood. This dramatic accretion has its roots in the early 20th Century with three major events. 1.) The US Navy commissioned the construction of a 3,000-foot long pair of inlet jetties at Cold Springs Inlet south of this location in 1906-11. 2.) In 1922 access causeway construction from “Three-Mile” Island to “Two-Mile Island caused the closure of Turtle Gut Inlet making this one barrier segment. All the ebb-tidal delta sand immediately moved onto the beach. 3.) The oceanfront property had already been sold by 1920 and existing and subsequent owners have successfully resisted allowing new construction seaward as the shoreline accreted.

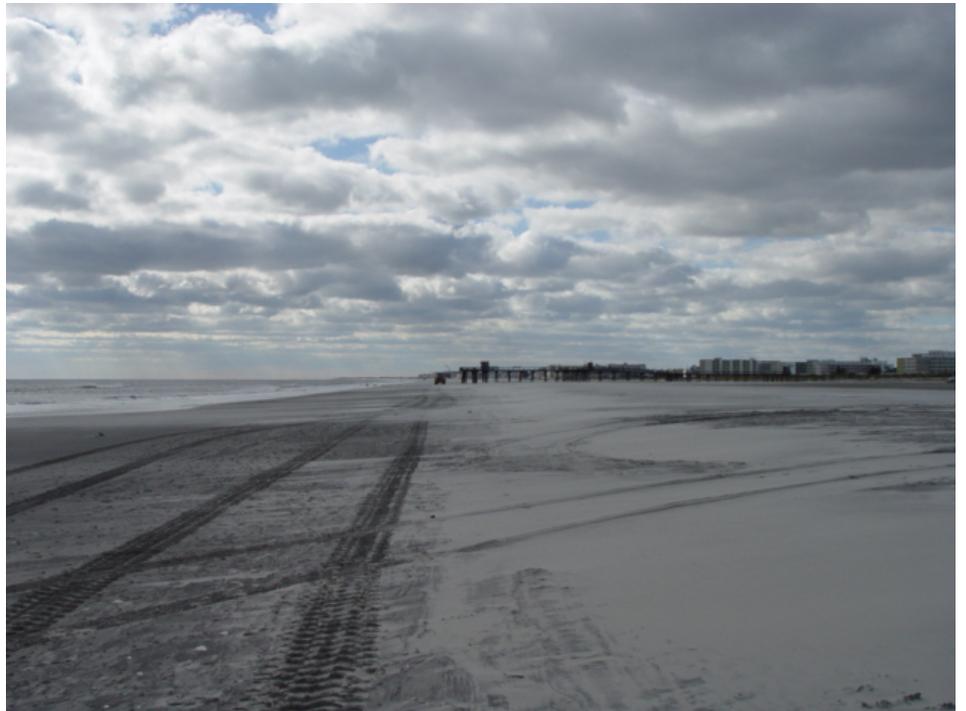
Figure 287. This view taken November 16, 2007, shows the same view to the south 18 months later. This beach has continued to advance over the past 10 years, this time, due to changes in the tidal channel location in Hereford Inlet. These changes forced massive erosion in North Wildwood with half the lost sand moving into Hereford Inlet as a giant spit, and the other half moving south along the beach advancing this shoreline by 72 feet in 18 months. The sand volume increased by 37.45 yds³/ft.

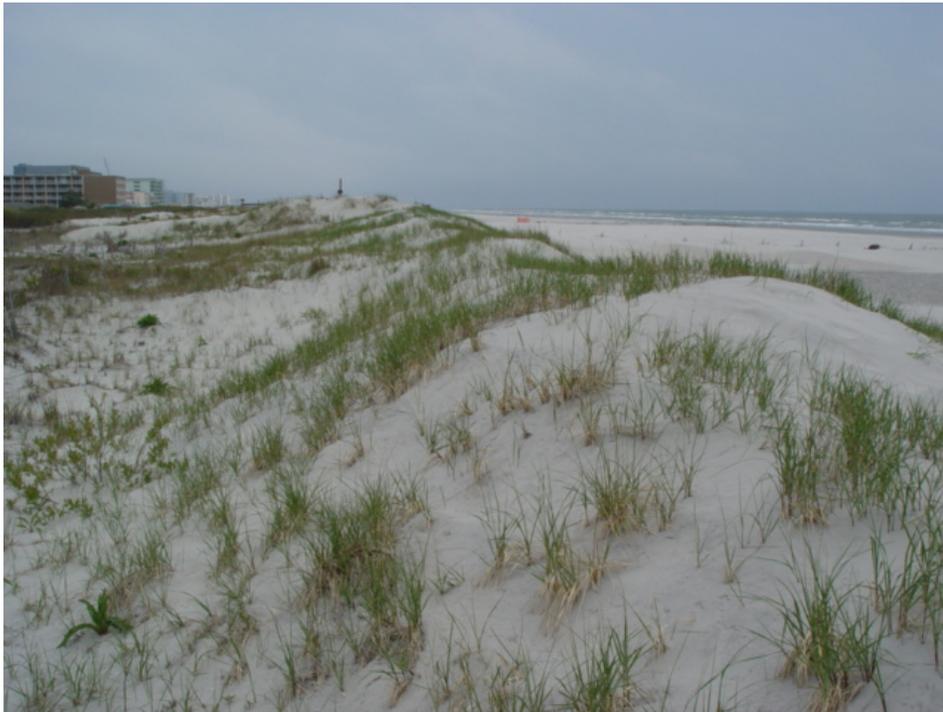
Figure 289. This view to the northeast shows the dunes that have developed at this site since this project began. Sand appears to add to the volume between every survey adding to the bulk and volume of these features. Initially there was no dune system present seaward of the developed property bulkheads. The picture was taken May 11, 2006.

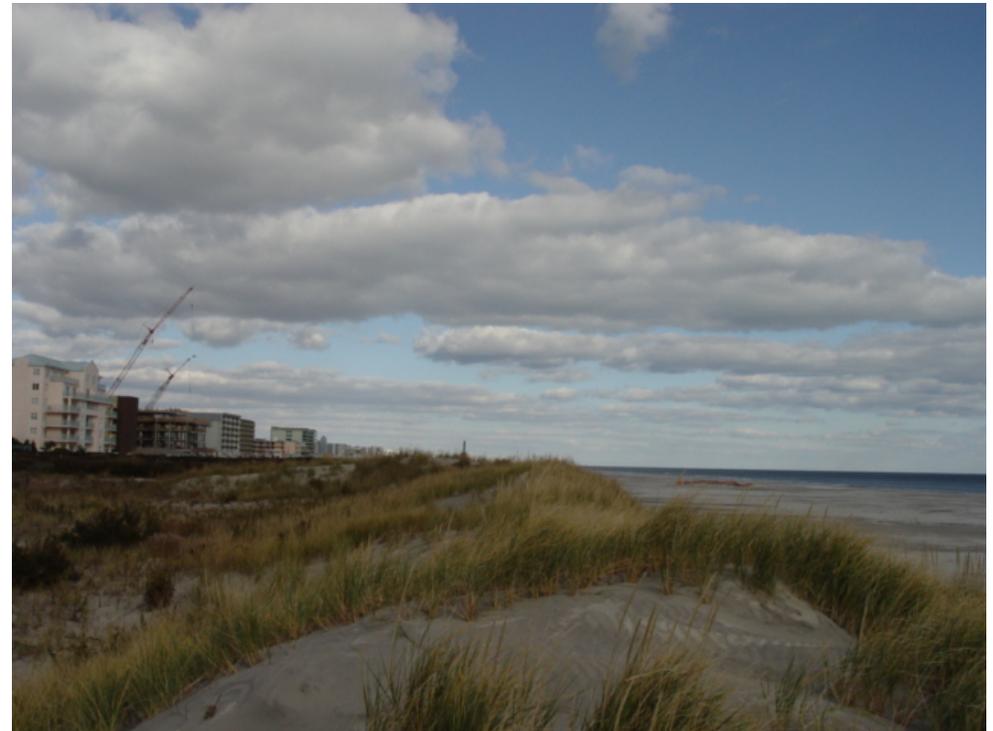
Figure 290. By the fall of 2007, grass growth had added to the dunes and their height and width. Significant re-development has occurred in the interim as well. This beach gained 28.12 yds³/ft., and the shoreline advanced 41 feet. These gains are most likely attributable to the sand loss at the north end of this barrier island. This picture was taken November 21, 2007

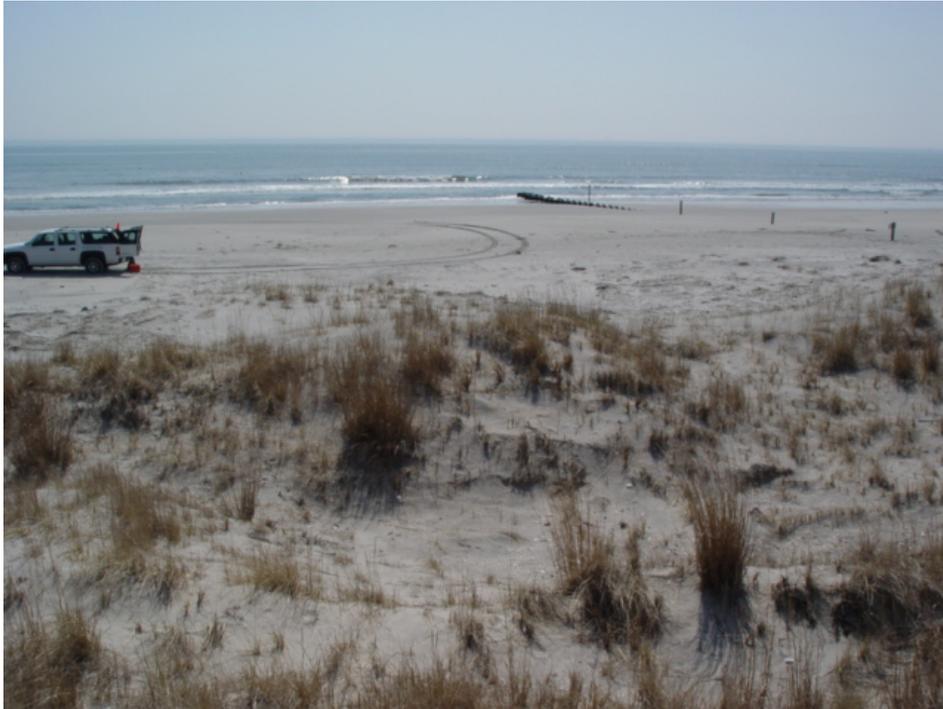
Figure 292. Looking east from the dune crest, the natural area south of development was once in the hands of the military. Now part of the Cape May National Wildlife Refuge, this is a valuable asset saved from condominiums. The timber groin is an old structure.

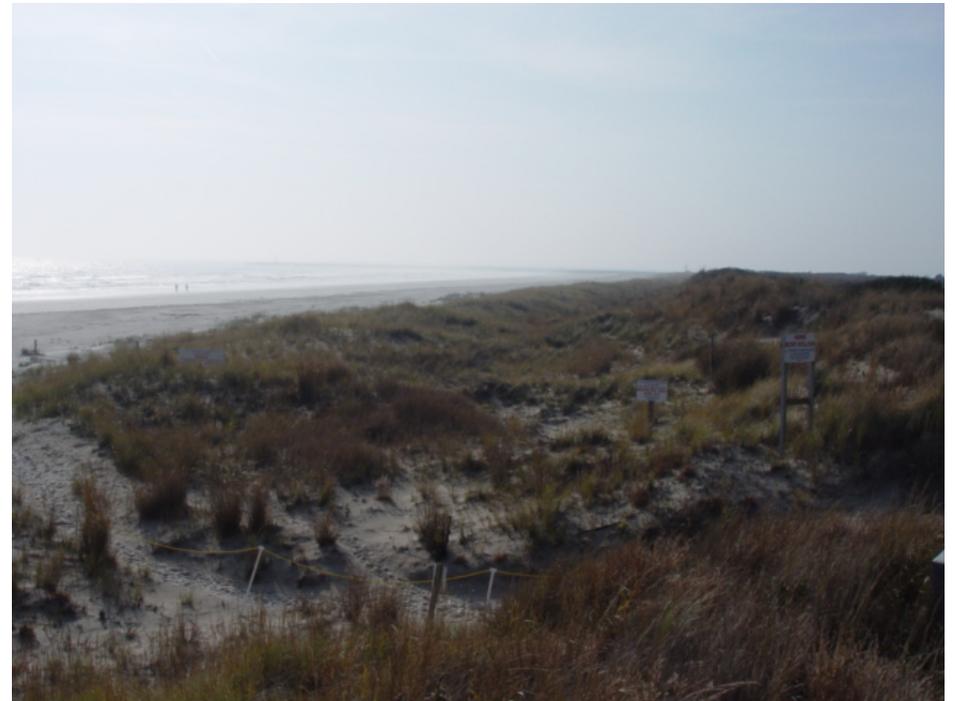
Figure 293. This view taken November 21, 2007, shows the extent of the dune system and the native vegetation across this wide area. The beach gained 5.76 yds³/ft., and the shoreline advanced 14 feet over the past 18 months. The dense vegetation prevents sand from reaching inland beyond the small fore dunes that are developing at their seaward limit.

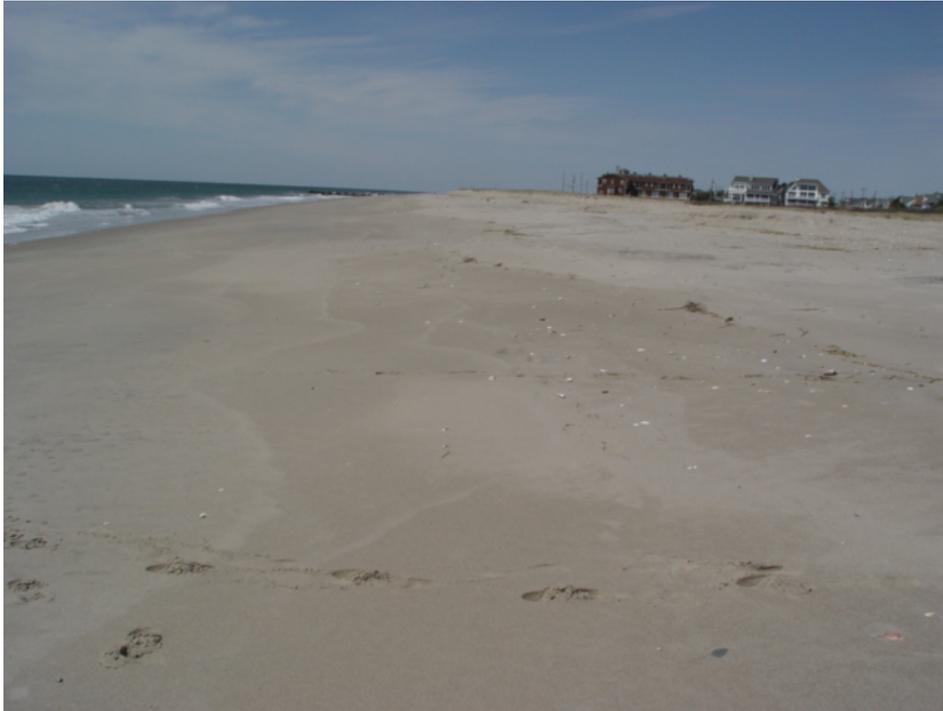
Figure 295. This view south in April 26, 2006 shows the extent of the beach and berm between this recreational facility and the Cape May City development to the south. Sand has been added seven times since 1989 when the first modern large-scale Federal beach nourishment project commenced.

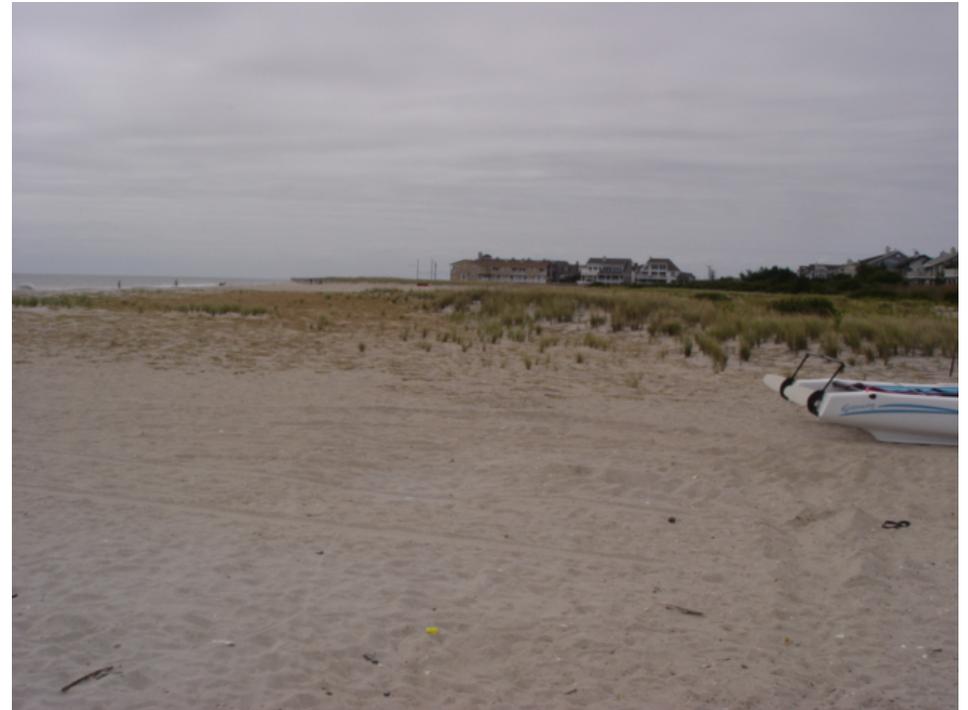
Figure 296. The vegetation is beginning to colonize the wide berm following beach restoration. High level recreational activity prevents it from growing in front of the profile site at the beach club. The sand volume increased by 16.92 yds³/ft., while the shoreline advanced 22 feet. Initially not a stable nourished beach in the early 1990's, the site has become very stable as the shoreline south was built seaward to support this width.

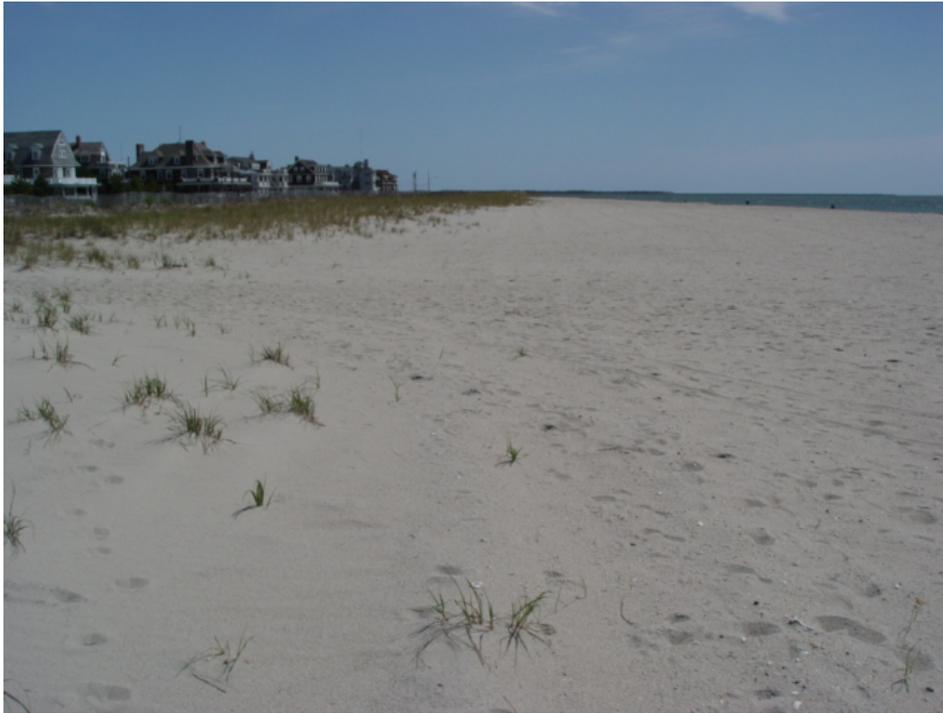
Figure 298. Baltimore Avenue had no dry beach in 1986 and very little recreational use was made of the shoreline here. There was a rock seawall at the road's edge and high tide was at the rocks all the time. Following the initial sand placement in 1990, the beach became a resource once again. This photograph was taken on April 26, 2006 looking north along the toe of the dune.

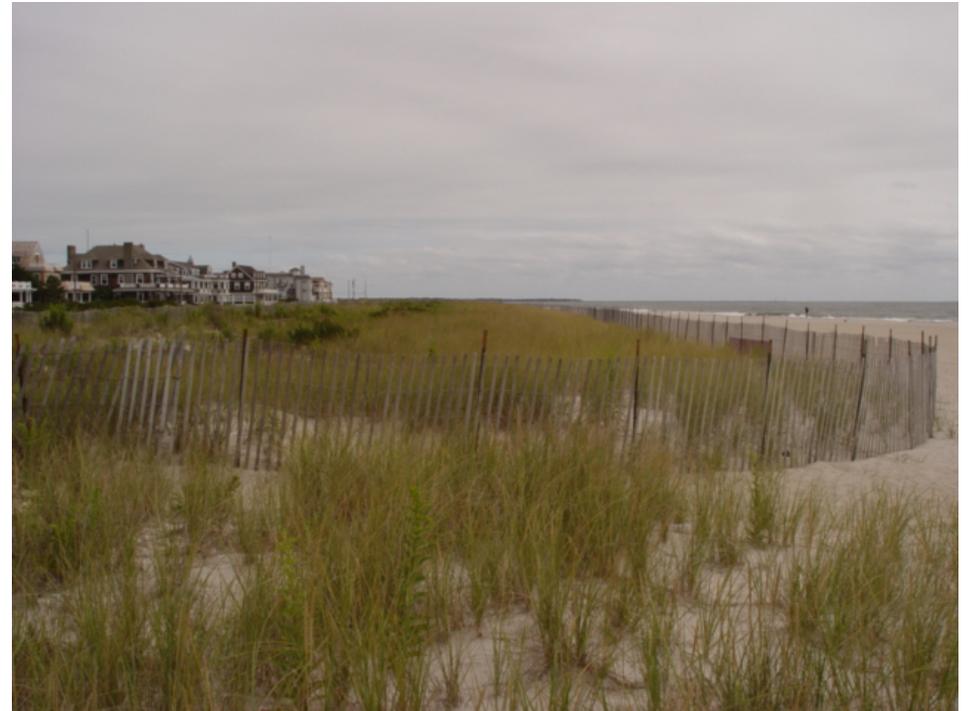
Figure 299. This view taken September 18, 2007, shows the substantial dunes between the rock revetment and the berm. 20 years ago this photo spot would have been in 5 feet of water or more at low tide. This beach gained 8.55 yds³/ft., and the shoreline advanced 7 feet over the study interval.

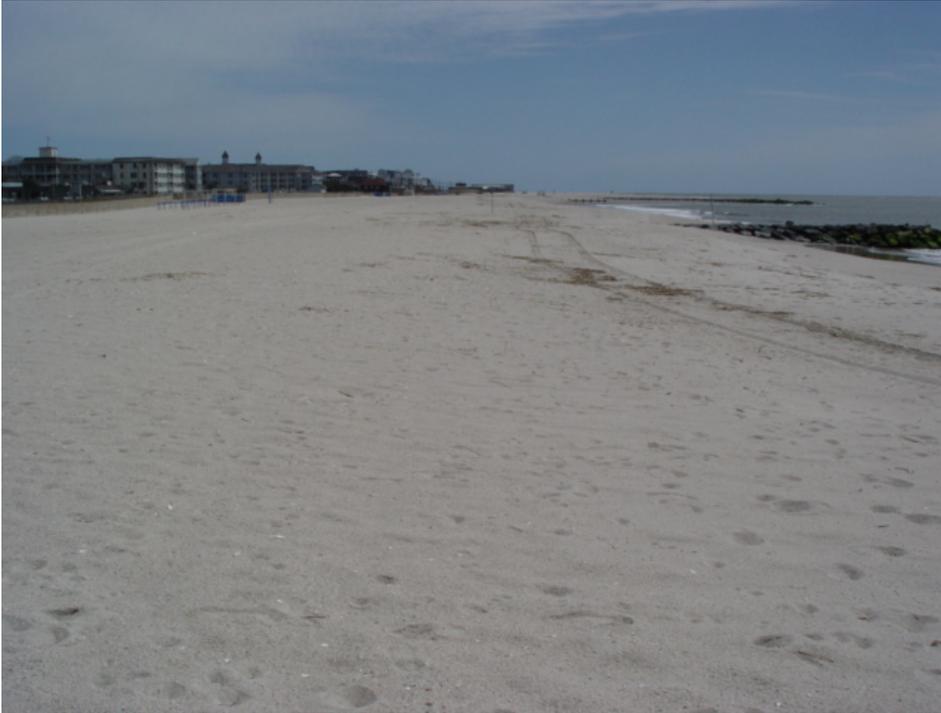
Figure 301. This is the primary recreational beach for Cape May City. Sand was sufficient for tourists at this location prior to the Federal project, but the available space was not sufficient for a summer weekend. Today the beach is wide, stable and grows as maintenance occurs. This view on April 26, 2006 shows the groins exposed as sand was being lost, but the general trend is highly positive compared to pre-project conditions.

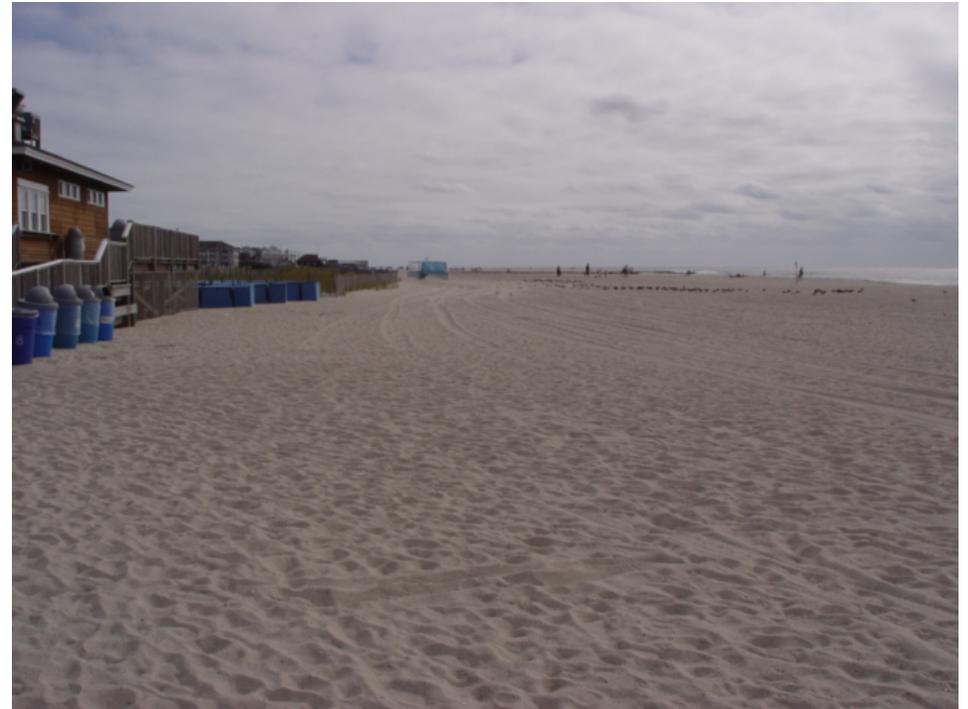
Figure 302. The photograph to the right was taken September 18, 2007 and shows the new restroom facility built at the boardwalk several years ago. The dune extends north and south of this facility along the boardwalk located on the rock revetment. The width of this beach is evident in this shot and it grew wider by 30 feet and gained an additional 18.77 yds³/ft. of new sand by September 2007.

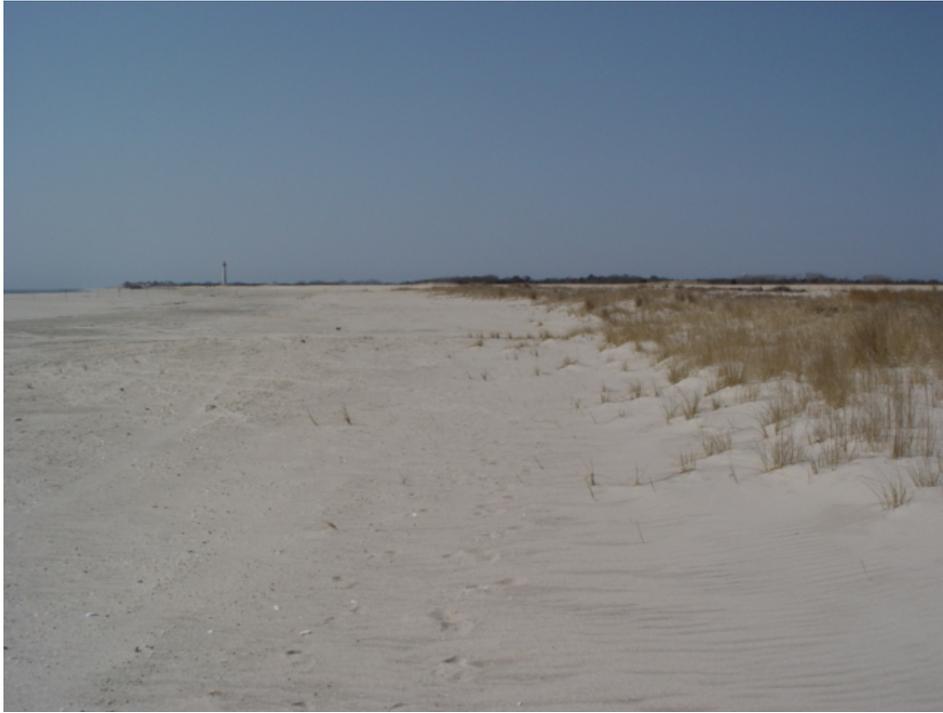
Figure 304. Beach nourishment has unintended consequences when sand moves beyond the project extents. In this case the nature conservancy land has received hundreds of thousands of cubic yards of sand shed from the Cape May City project beaches. Prior to the project the beach lay directly at the toe of the tall landward dune (rebuilt by the State in 1985). The next 20 years saw advance after advance until the present shoreline lies over 600 feet seaward of that original position. This view taken March 29, 2006 shows the toe of the vegetated dunes and the beach seaward of them looking south toward the Cape May lighthouse in the distance.

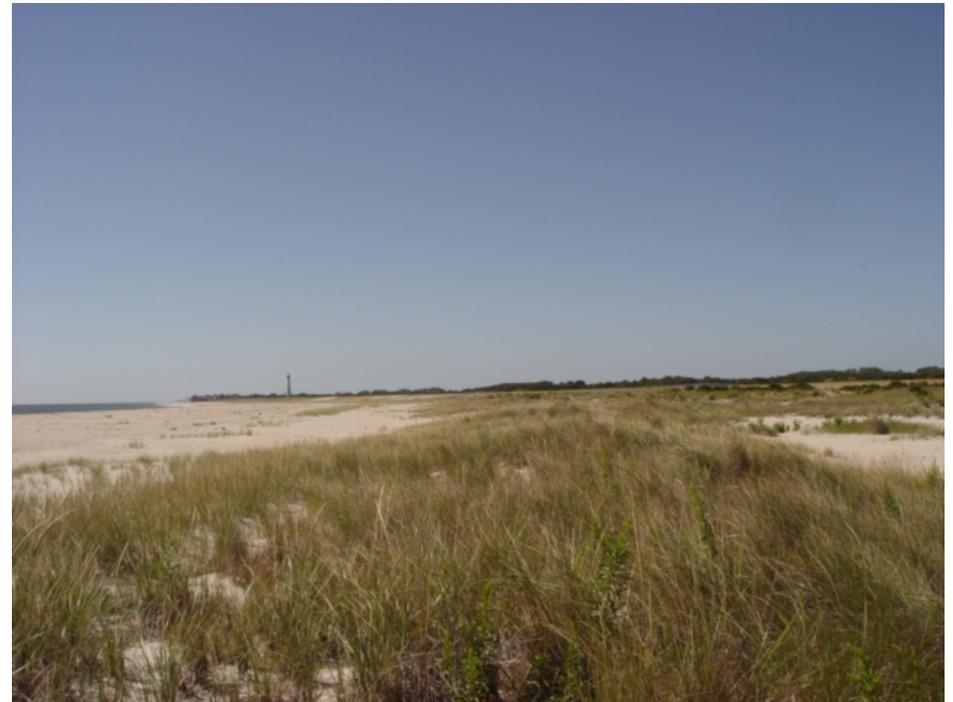
Figure 305. Stepping back into the dunes to the new instrument location, the expanse of the deposit of sand becomes apparent. During this study period an additional 23.59 yds³/ft. of sand were added to the berm, but loss offshore produced a minimal change of only 0.47 yds³/ft. across the entire cross section. However, the shoreline advanced 63 feet further seaward. The original man-made dune line lies to the extreme right along the line of dark green vegetation positioned directly in front of the highest line of dune grass (lighter brown plants).

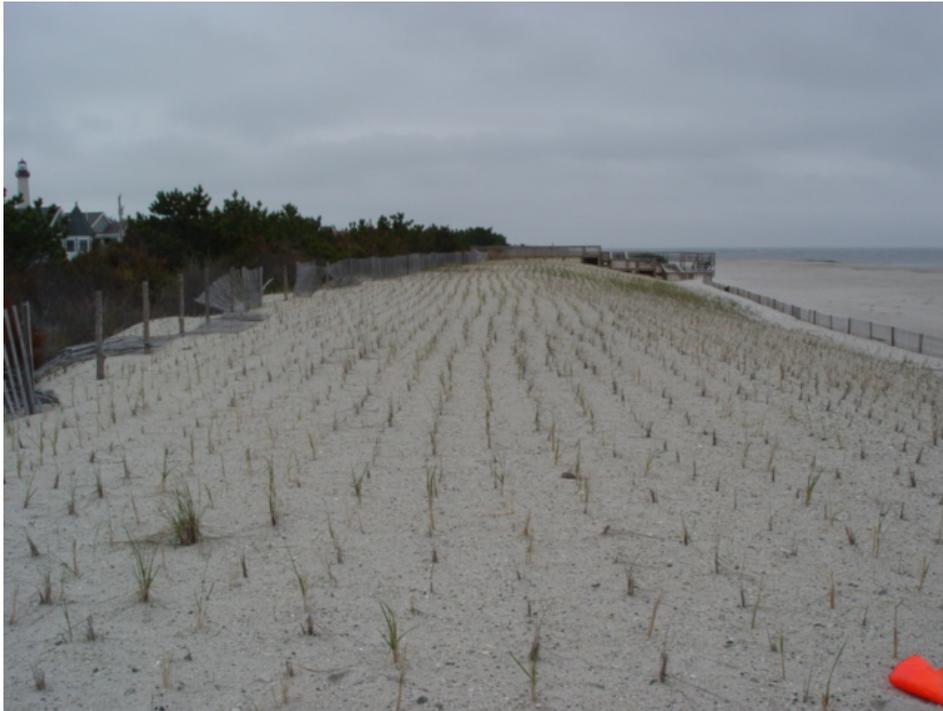
Figure 307. Restoration efforts took place at this location prior to the survey completed April 24, 2006. The plants had been added to the new front slope to the dunes and sand nearly buried the rock groins on either side of this beach.

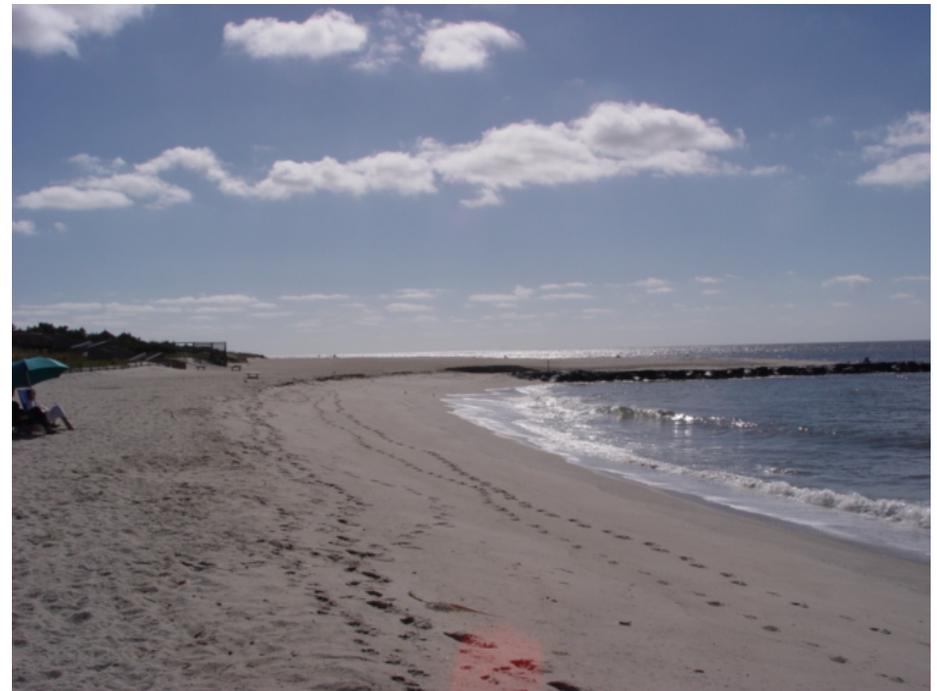
Figure 308. By September 19, 2007 there had been 60 feet of shoreline retreat accompanied by the loss of 37.52 yds³/ft. in sand volume. There were no structures placed offshore as was done in the two groin cells to the west. However, the State and municipality sponsored the placement of rock-filled cages called “gabions” under the new dunes in the beach cells to the east and west. These are designed to provide a measure of resistance to severe storms and preclude dune breaching into the interior development.

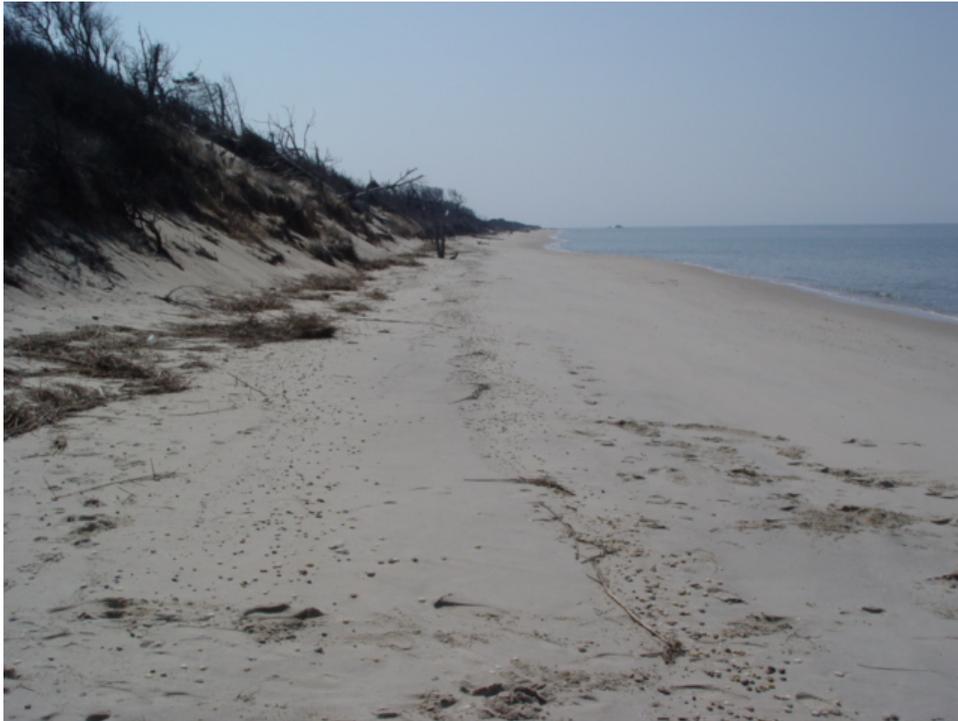
Figure 310. This sequence of profile plots shows a beach retreat between March 29, 2006 (left) and February 28, 2007, followed by a significant advance in the quantity of sand on the beach by December 20, 2007 (below). Shoreline accretion is not common along this undeveloped shoreline, but this series indicates that it does happen.

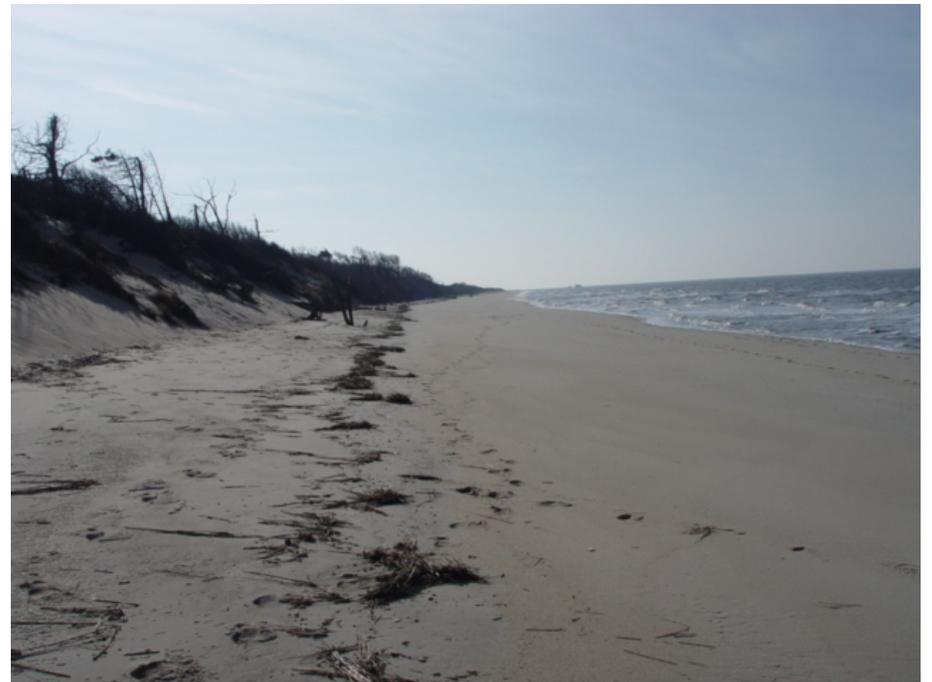
Figure 311. By December 2007 the beach sand volume had increased by 4.03 yds³/ft over the 18 months of study and by 6.26 yds³/ft since February 28, 2007. This produced a 12-foot advance in the shoreline, but a 14-foot advance since February. The two photographs show the increase in sand over the 18-month interval if one looks carefully at the buried stump in the middle distance.

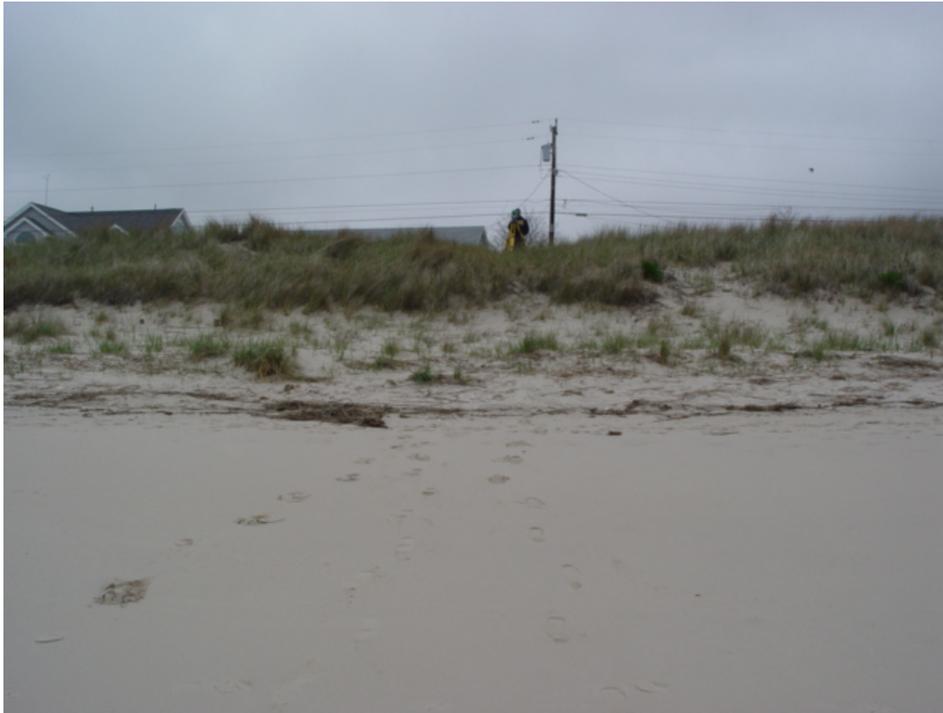
Figure 313. The beachface underwent some winter erosion between November 2006 and May 2007 as waves cut a notch at a high tide elevation (about 4.5 feet). The higher dunes were unaffected, but the beach became considerably steeper. Photograph to the left was taken April 24, 2006.

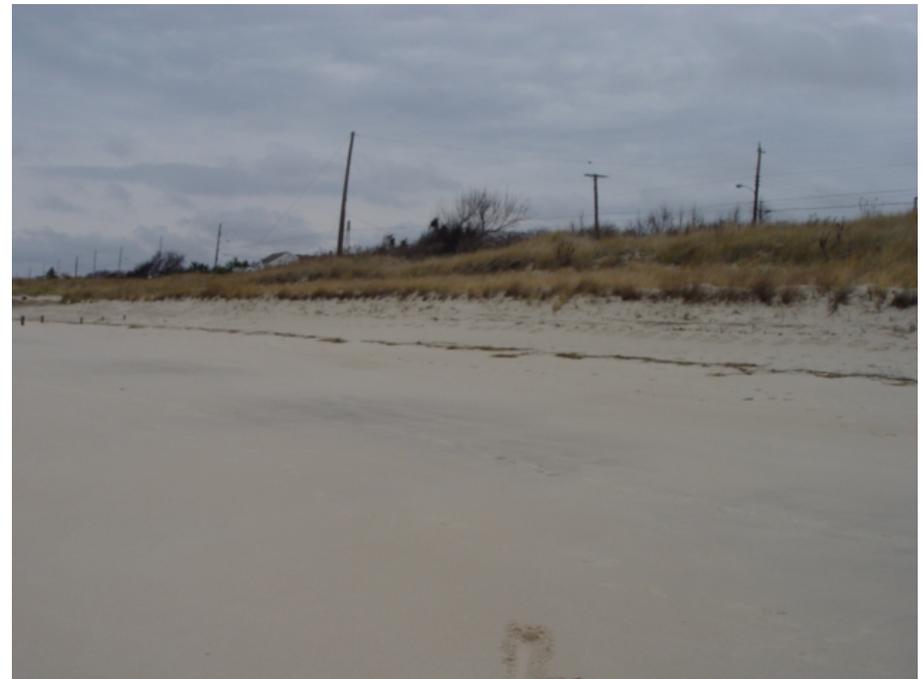
Figure 314. The offshore region remains a broad, flat expanse of sand as a veneer over Delaware Bay lagoon sediments deposited earlier in the development of the western Cape May County shoreline. The majority of the 13.80 yds³/ft. sand loss came from the outermost 200 feet on the intertidal sand flat (0.28 yds³/ft gain out to 572 feet from the reference, then a loss of 14.08 yds³/ft over the final 303 feet of the cross section). The shoreline retreated 5 feet. The photograph to the right was taken December 21, 2007.

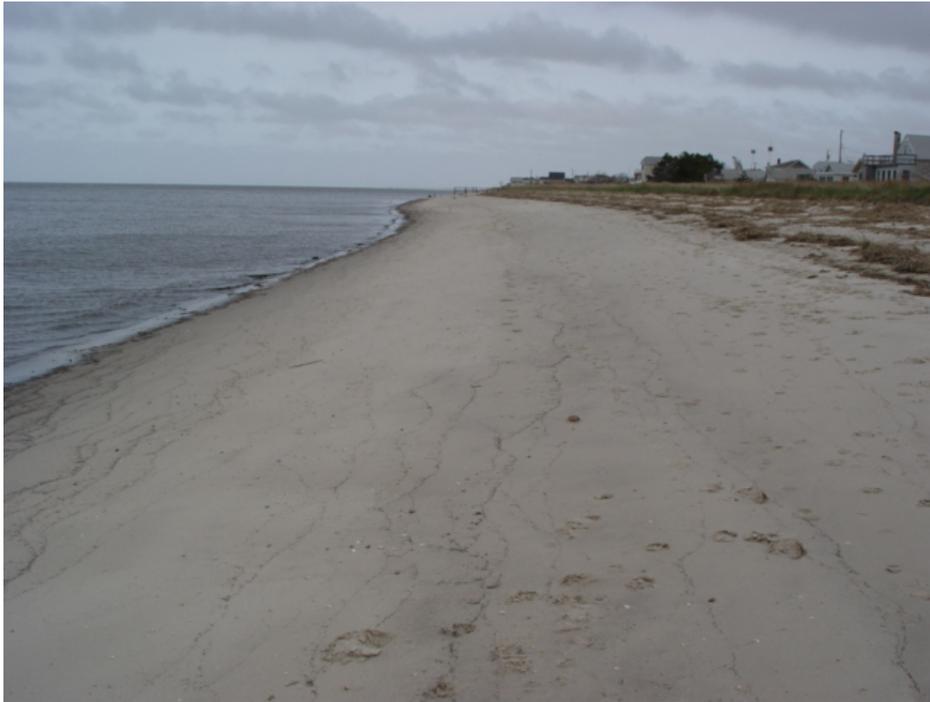
Figure 316. By contrast with Whittier Avenue, the profile site in Villas showed the smallest of impacts of the winter storms cutting notches in the beach slope. The profiles form a tight group with minor shifts offshore at one bar and tiny changes in the beach itself. The photograph to the left was taken April 21, 2006.

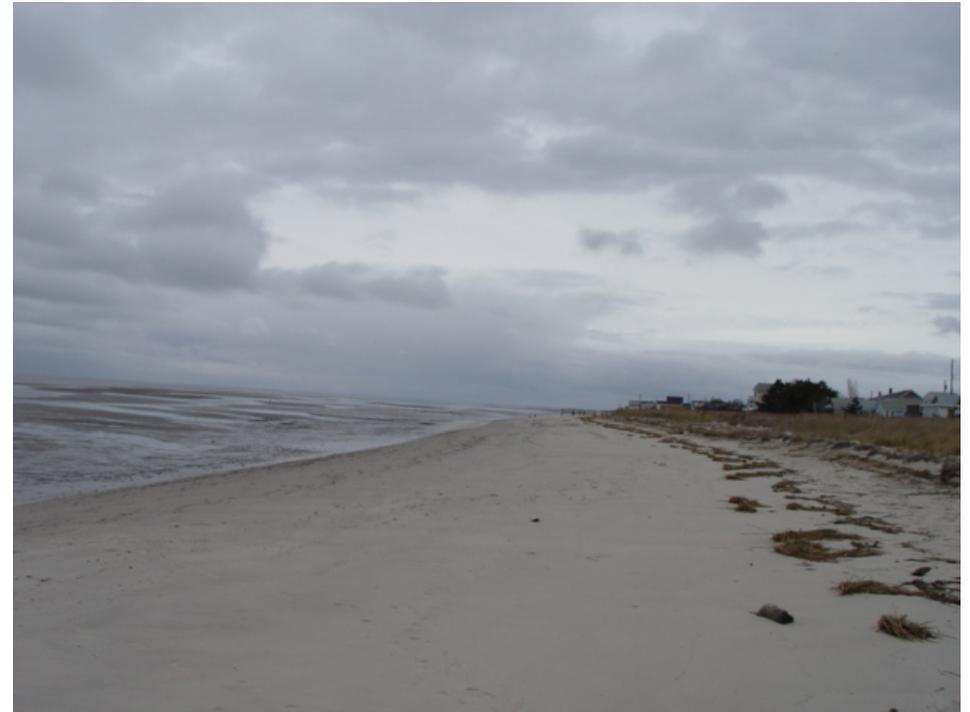
Figure 317. This view taken December 21, 2007, shows accumulated grasses at the wrack line and a small scarp at the toe of live grass plants. Offshore the waves are breaking across the wide tidal terrace typical along the western Cape May County shoreline. The sand volume change was a gain of 3.20 yds³/ft, with a shoreline advance of 13 feet.

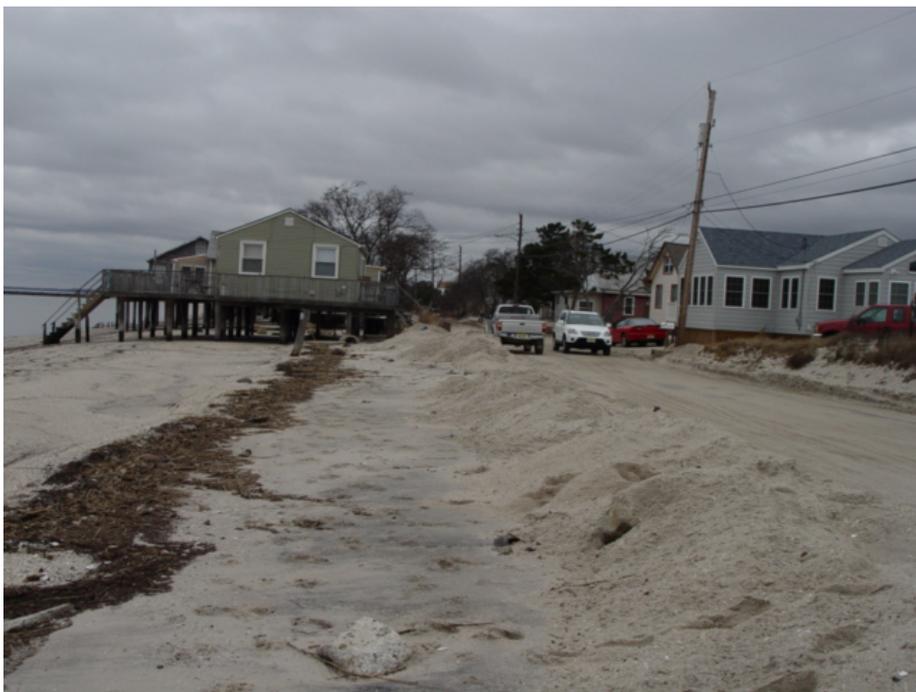
Figure 319. Reeds Beach, NJ is located at the northern limit of sand distribution along the western shoreline of Cape May County. The meager natural supply arriving is not sufficient to offset the losses suffered from landward transport onto the marshes or losses offshore on the terrace. This site has been recessional for decades and shows the wrack line completely landward of the home shown on the beach. Recent overwash shows as sand on the road with a ridge pushed back along the bayside of the roadway.

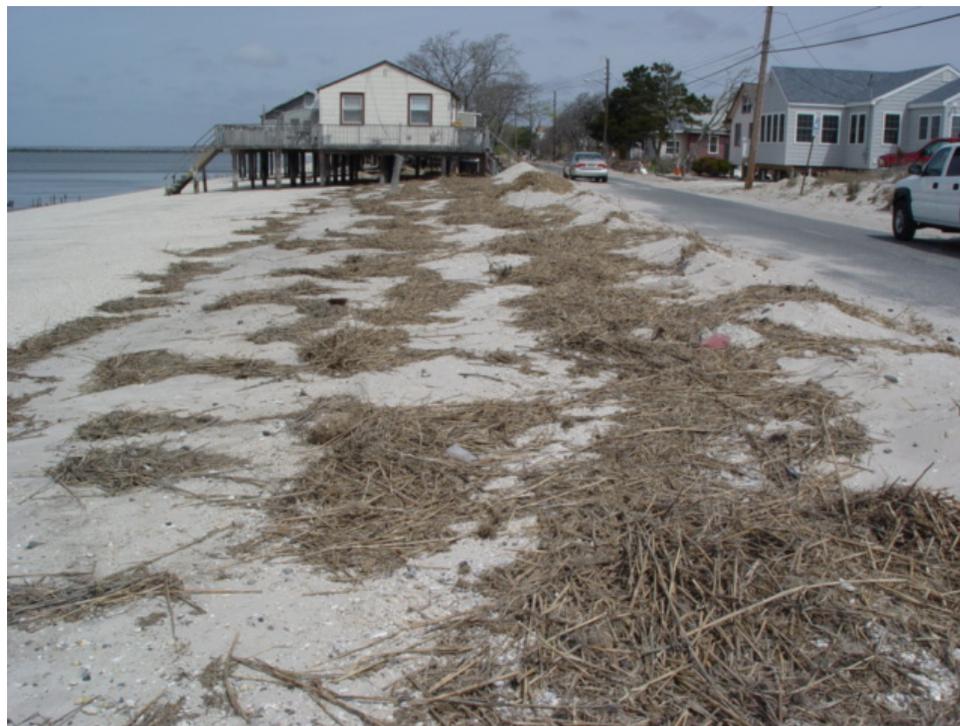
Figure 320. This view taken December 21, 2007, shows accumulated grasses at the wrack line still positioned landward of the home, but with modest overwash for the moment at this site. Multiple attempts have been made to fund beach restoration along this reach and as this report was written a navigation improvement at Bidwell Creek was starting construction with the dredge material applied to this beach. West winds across Delaware Bay are the major threat to these properties. The worst event in modern memory was Hurricane Gloria in 1985 that came from the southwest across the bay into NJ and did tremendous damage to the NJ bayside communities. The beach change was a meager $0.27 \text{ yds}^3/\text{ft}$. in sand volume and a 0.36-foot shoreline advance over 18 months time.

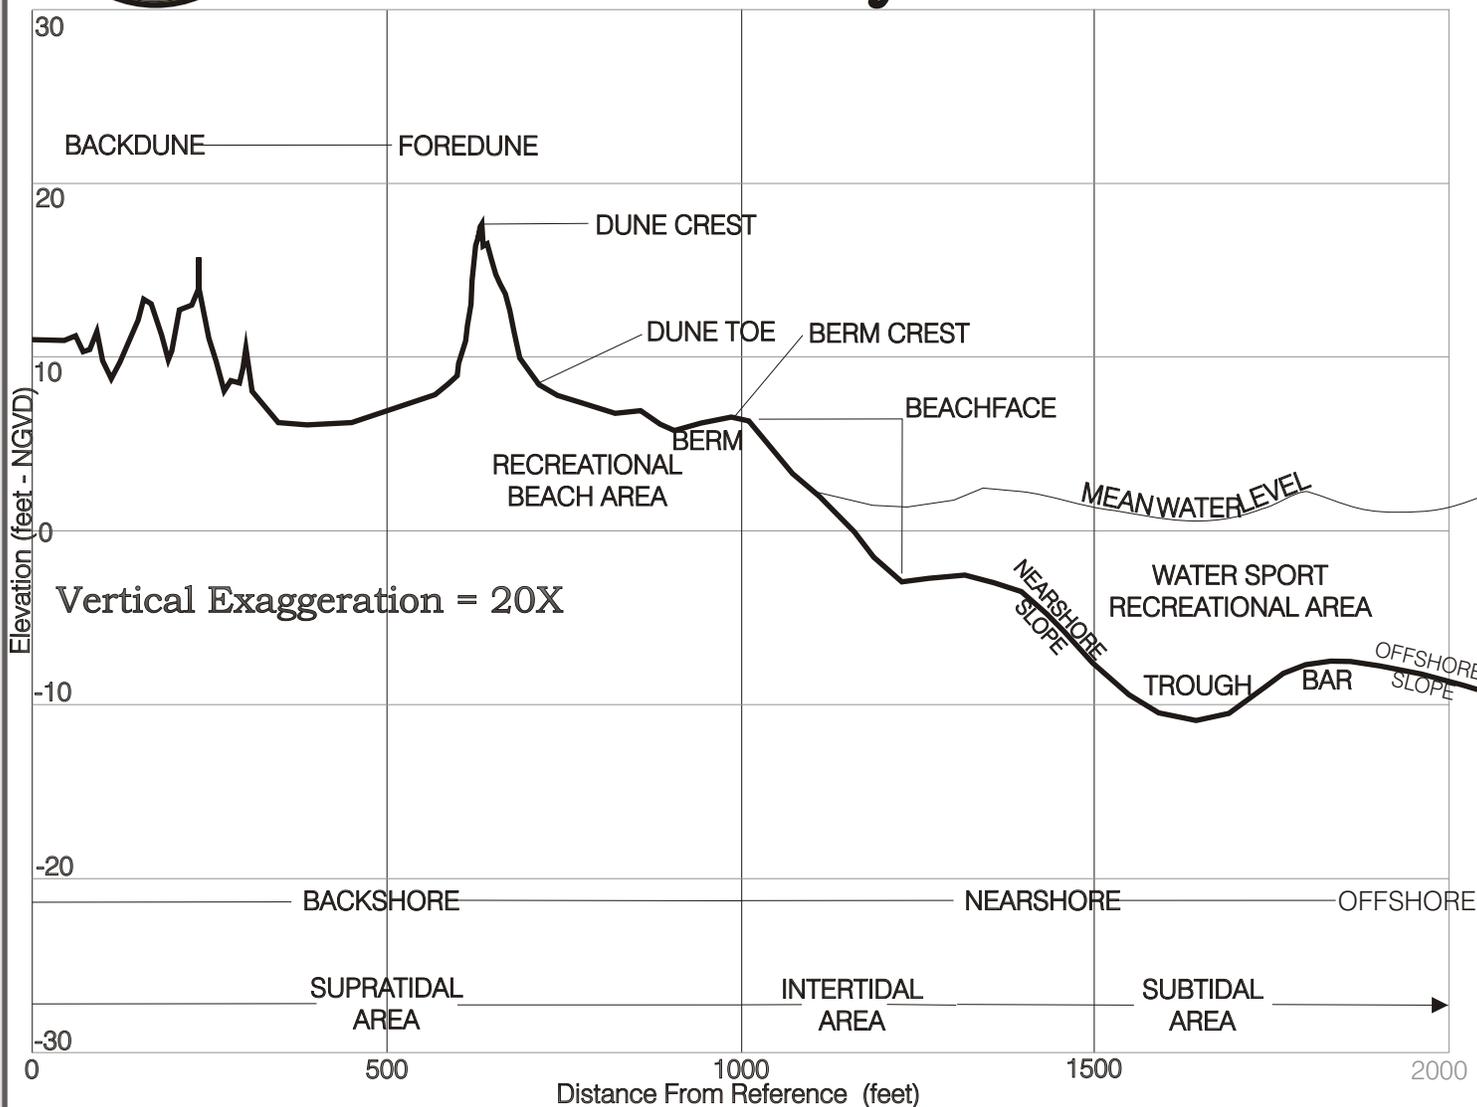
Typical Beach Profiles in New Jersey

Above is a typical beach profile with major features and zones labeled. No beach will show every aspect of this diagram at all times, but it illustrates all important features that appear on the New Jersey shoreline..
