New Jersey Beach Profile Network

Cape May County

Great Egg Harbor Inlet
to Stow Creek

NJBPN Profile #'s
225 - 100

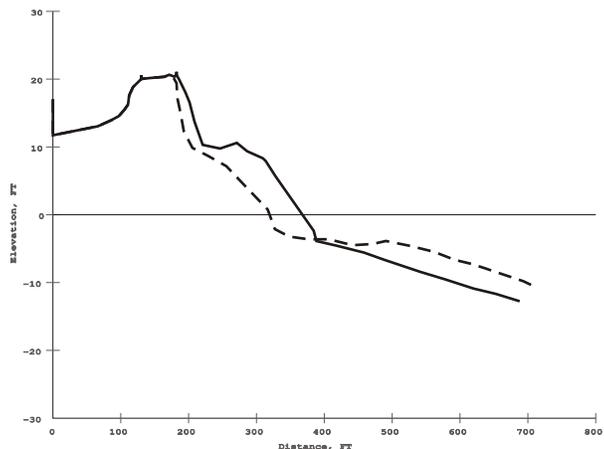
The pair of profiles to the left show some of the typical seasonal beach profile changes. The dashed line profile is the result of a winter season, where ocean conditions moved material offshore. The solid line profile is the result of a summer season, where ocean conditions moved sand onshore. The summer profile has a well developed berm and wider beach and dune, while the winter profile has this beach material present in the offshore region of the profile.

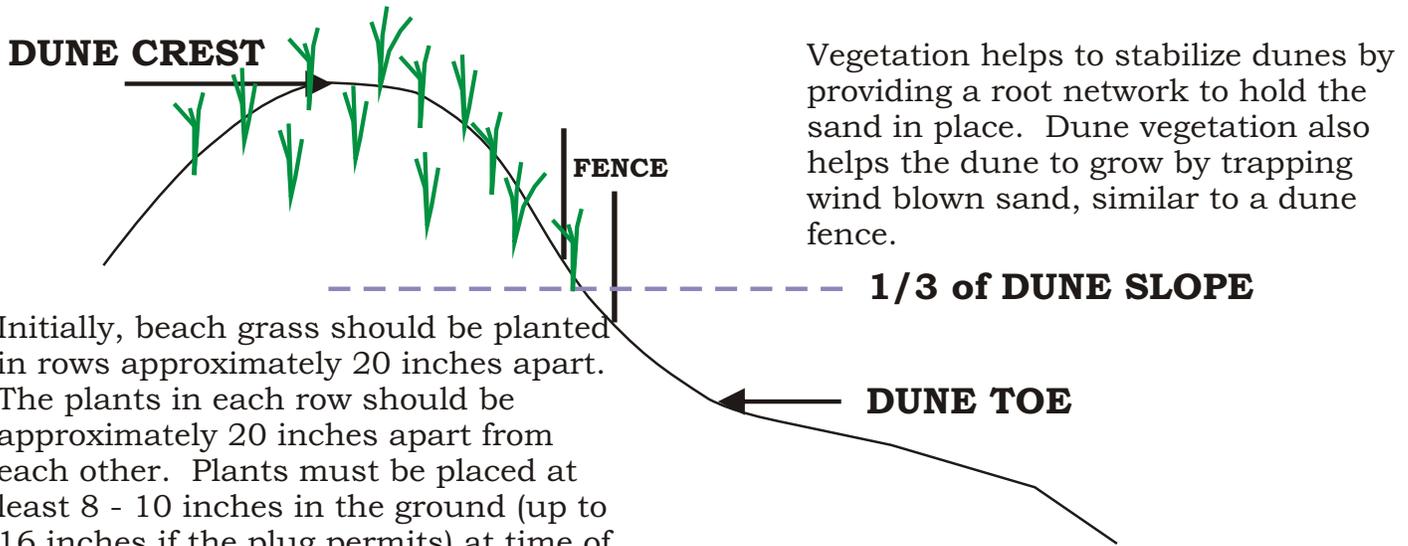
Initially, beach grass should be planted in rows approximately 20 inches apart. The plants in each row should be approximately 20 inches apart from each other. Plants must be placed at least 8 - 10 inches in the ground (up to 16 inches if the plug permits) at time of planting. Shallow planting is the #1 cause of failed beach grass. *Amophila breviligulata* is recommended as the main plant (80%-90%) and *Panicum amarum* as the companion species (10%-20%). Planting multiple species creates a stand that is more resistant to disease and environmental factors.
