New Jersey Beach Profile Network

Cape May County

Great Egg Harbor Inlet
to Stow Creek

Cape May County Storm Damage Report:

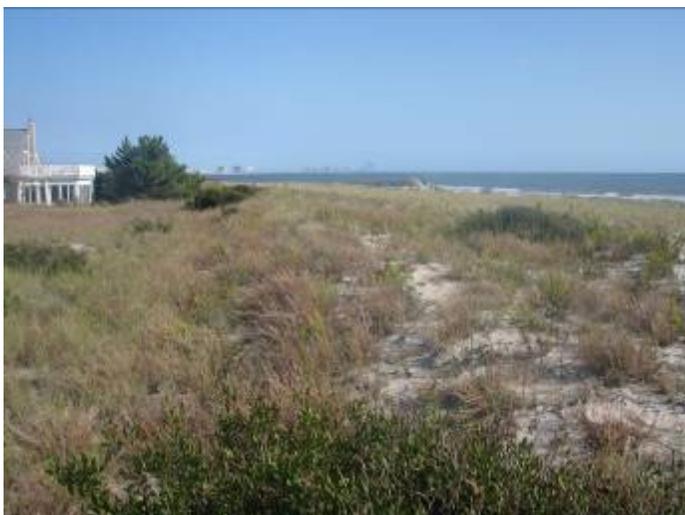
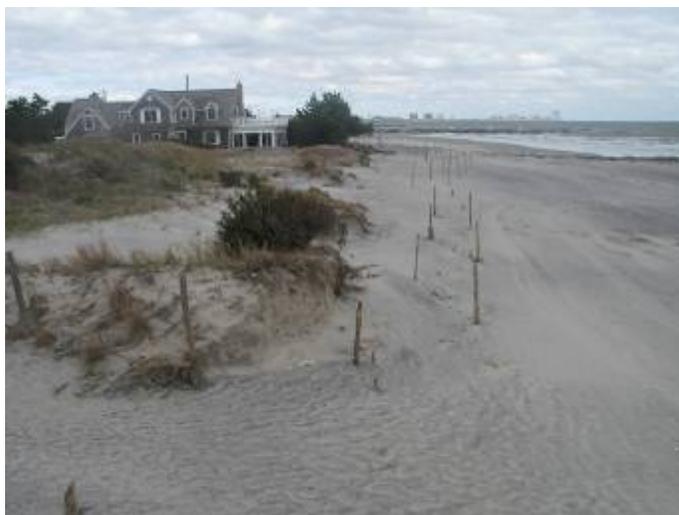
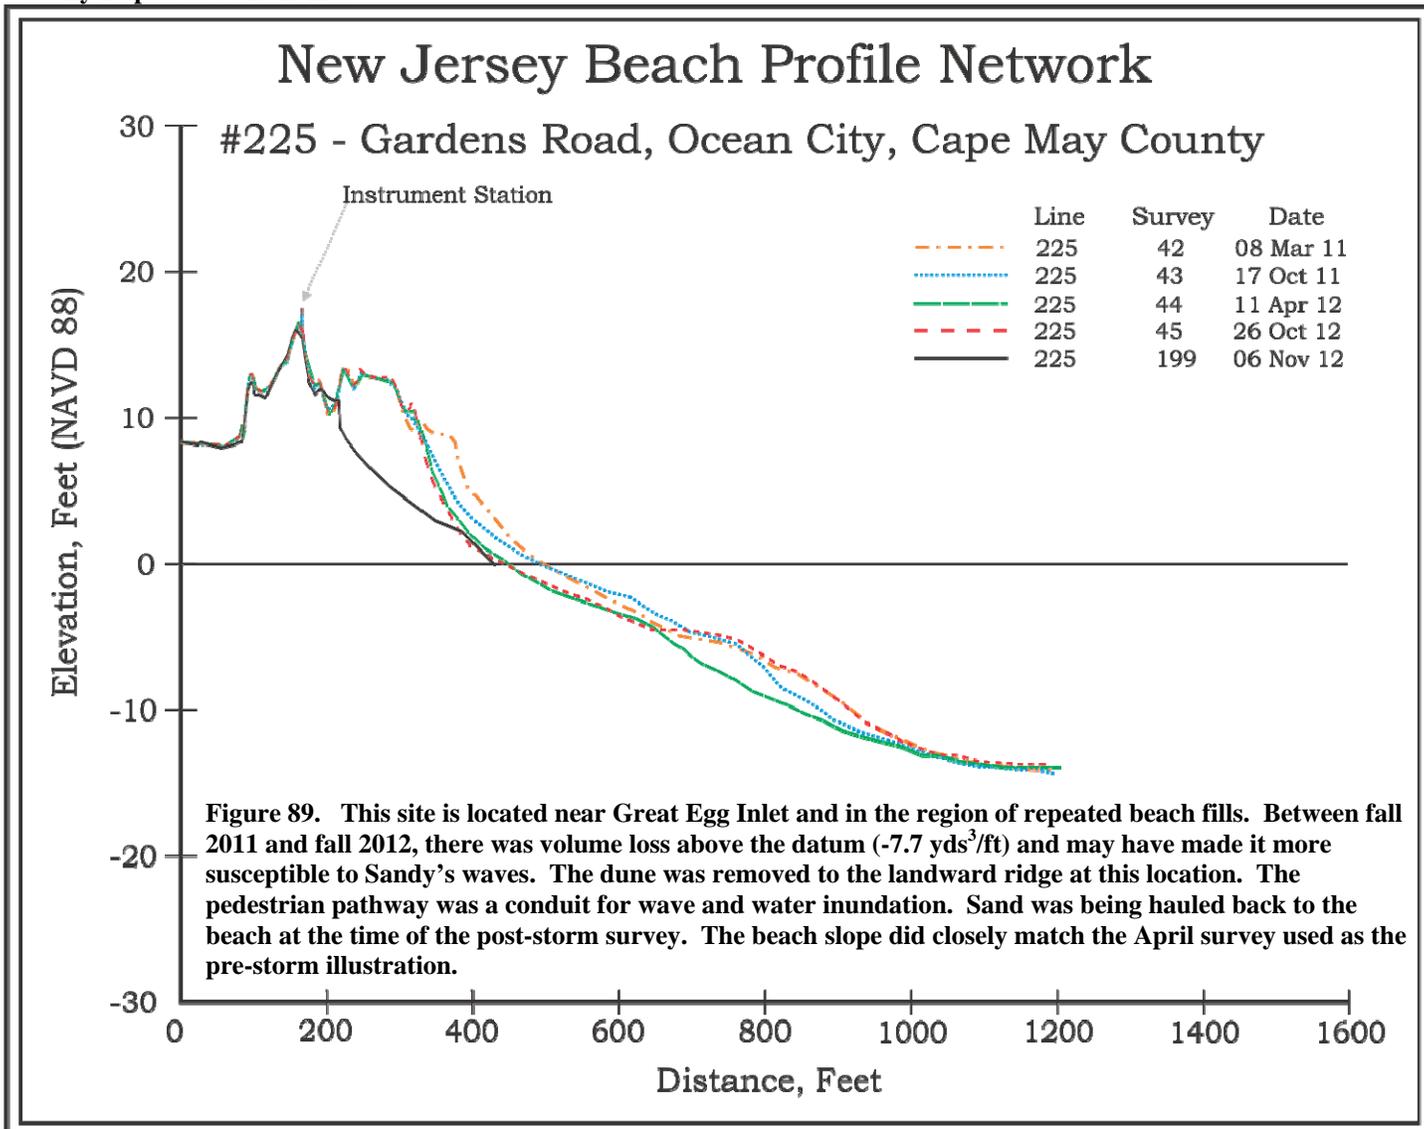
Gardens Road, Ocean City, Cape May County, Site #225;

Between October 26 and November 6, 2012 Hurricane Sandy removed 125 feet of dune vegetation at elevation 12.0 NAVD 88 or higher. The beach was not wide and occupied just 50 feet between the seaward dune toe and the zero elevation position. The home in both pictures was impacted with water inside due to wave surges, but could be repaired. The large pine trees actually helped save the home.

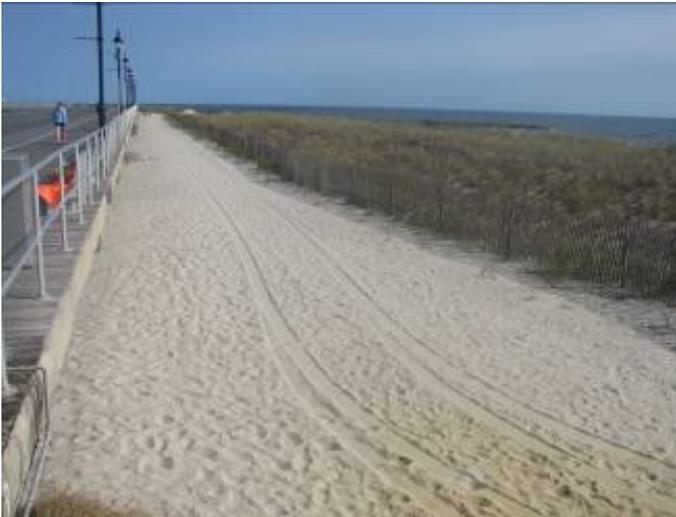
6th Street, Ocean City, Cape May County, Site #125;

The left photograph was taken October 26, 2012 just prior to the storm. The dune was intact, but the beach was extremely narrow so the initial storm action was able to attack the dune. The right photograph was taken November 6, 2012 from the back shot position standing on the street end paving that had been excavated of sand, looking seaward to the boardwalk about 120 feet distant. The sand had been deposited to the top of the timber by the storm surge. The wedge of sand was swept landward of the boardwalk and had spilled into the end of 6th Street.

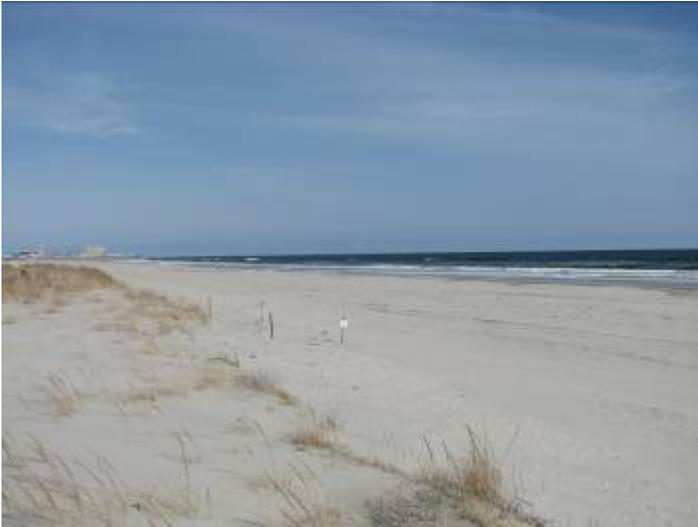
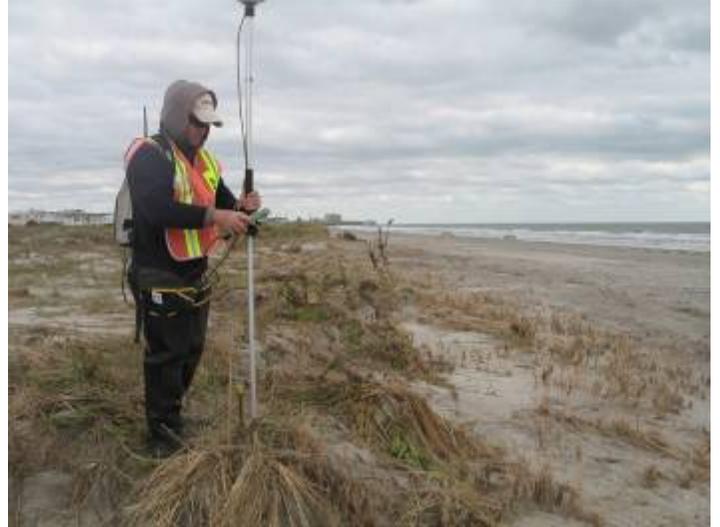
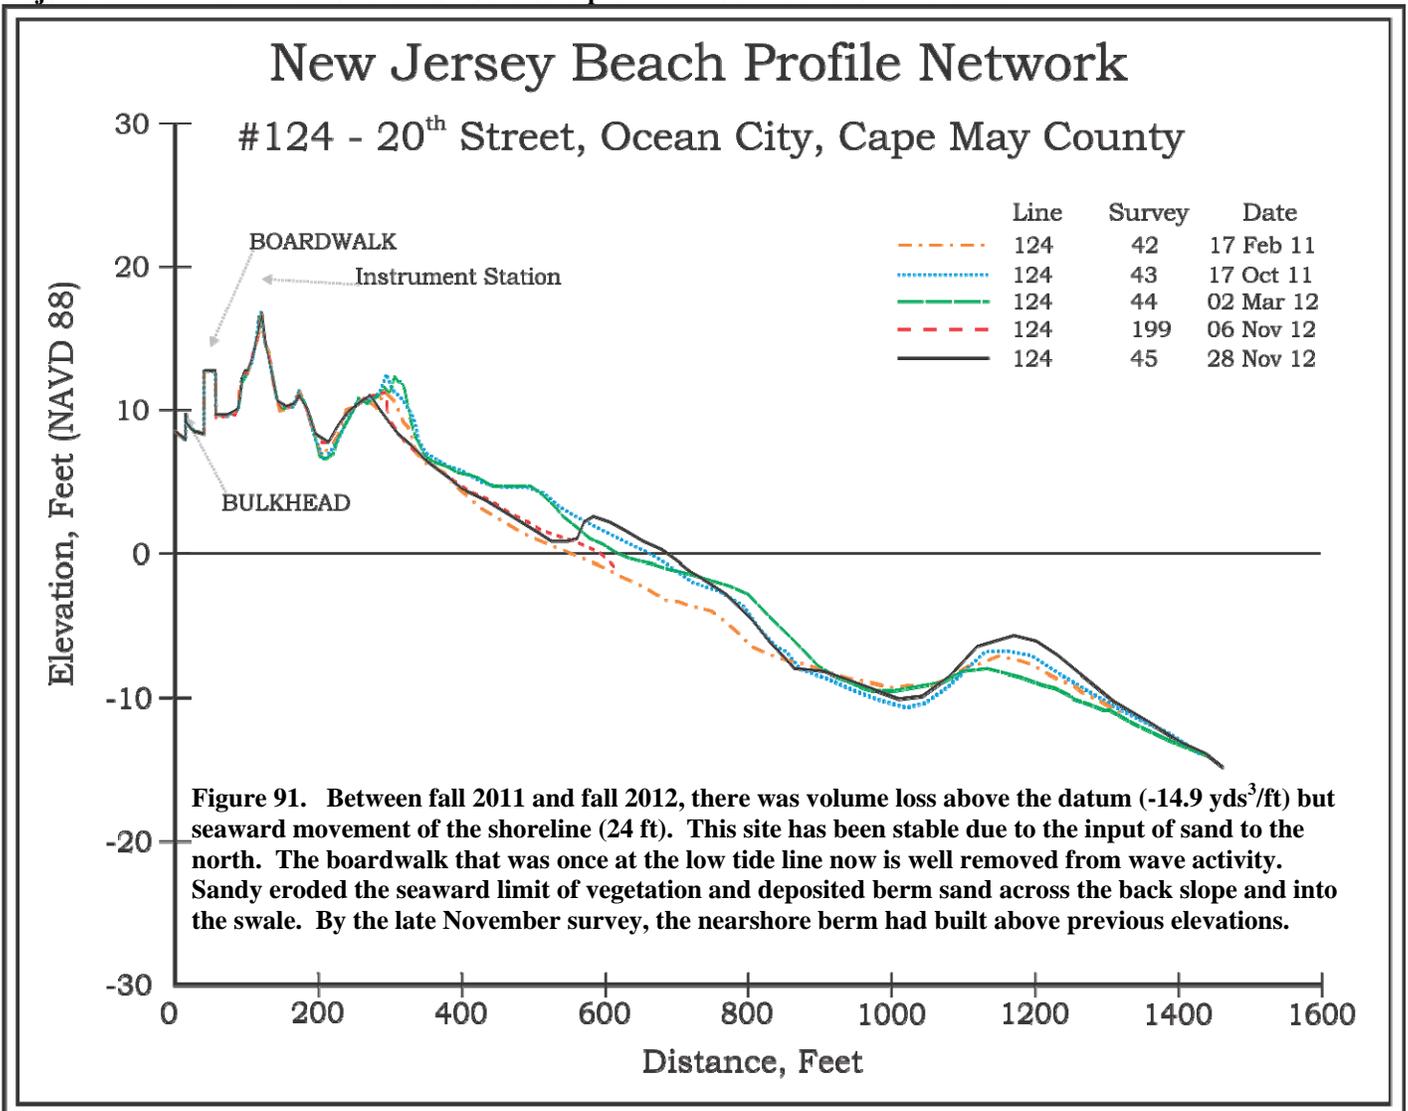
20th Street, Ocean City, Cape May County, Site #124;

The 20th Street site is at the maximum retention of beach restoration sand anywhere along the oceanfront. This site has seen the shoreline move seaward by 600 feet since the 1980's with 460 feet of dunes. The photograph on the left was taken March 2, 2012 showing the beach and gentle gradient into the seaward-most dune ridge. Following Sandy on November 6, 2012 (right photo) the zone of about 150 feet in width had been inundated by the storm surge with sand pushed landward into the first major swale. The berm was lowered as would be expected without much shoreline retreat.

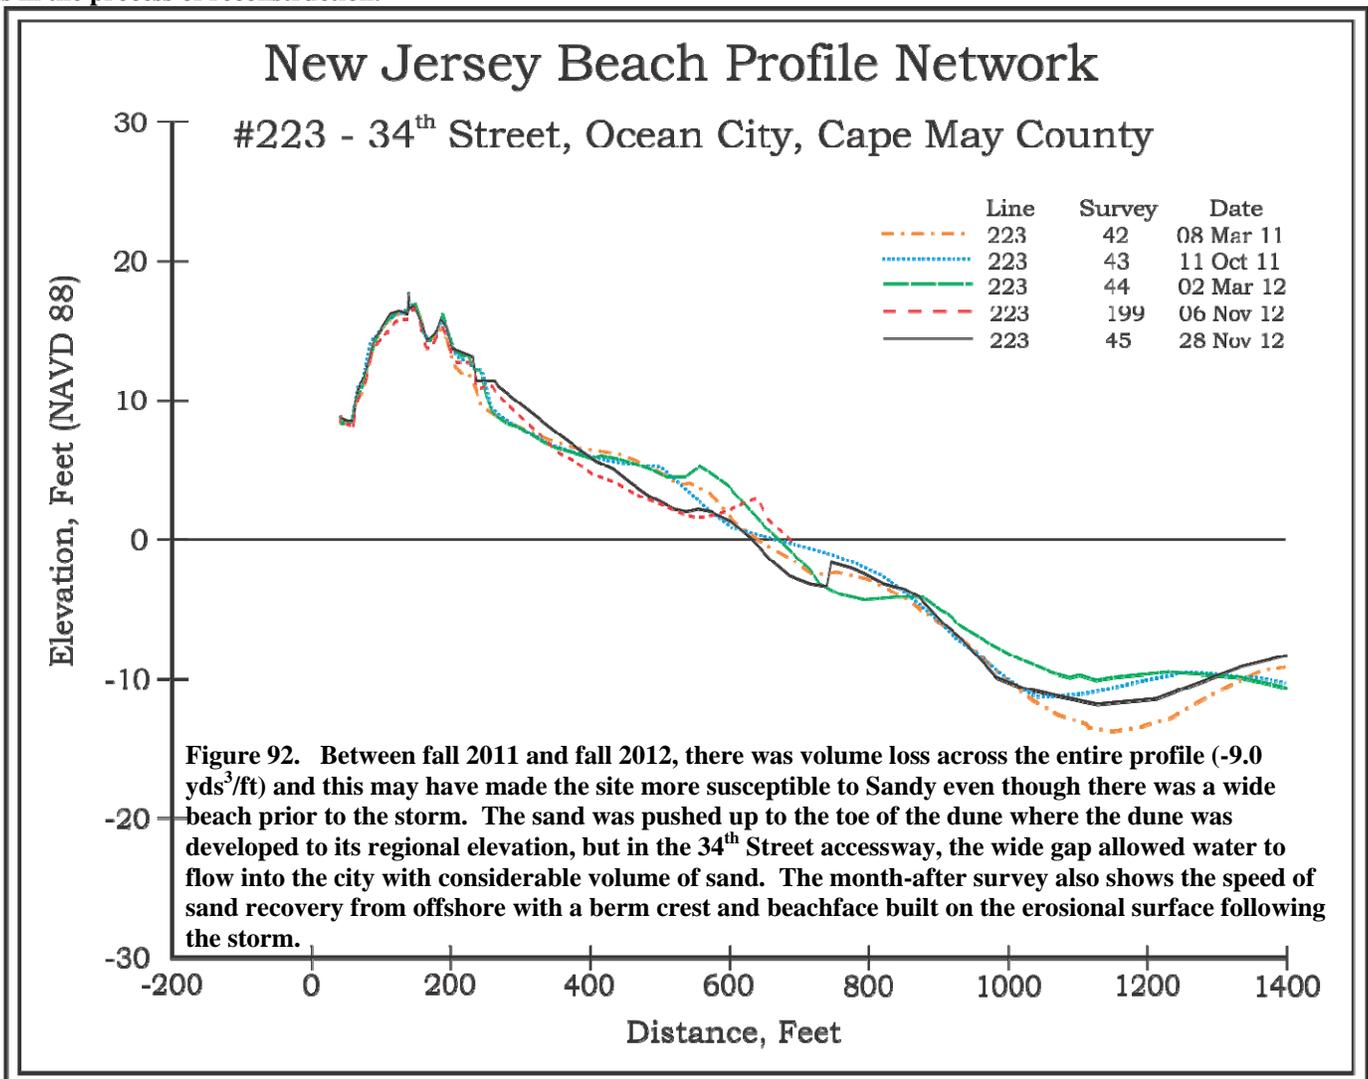
34th Street, Ocean City, Cape May County, Site #223;

The 34th Street site has always possessed a low threshold dune that really is little more than a mound with a wide access path for both vehicles and pedestrians. The March 2, 2012 view (left) shows the relatively wide dunes north of the site, but the storm barreled through the pathway into 34th Street. The piles of sand on the right picture were transported back to the beach as of November 28th. The beach berm was cut back, but since this site was surveyed a month following the storm a new berm was in the process of reconstruction.

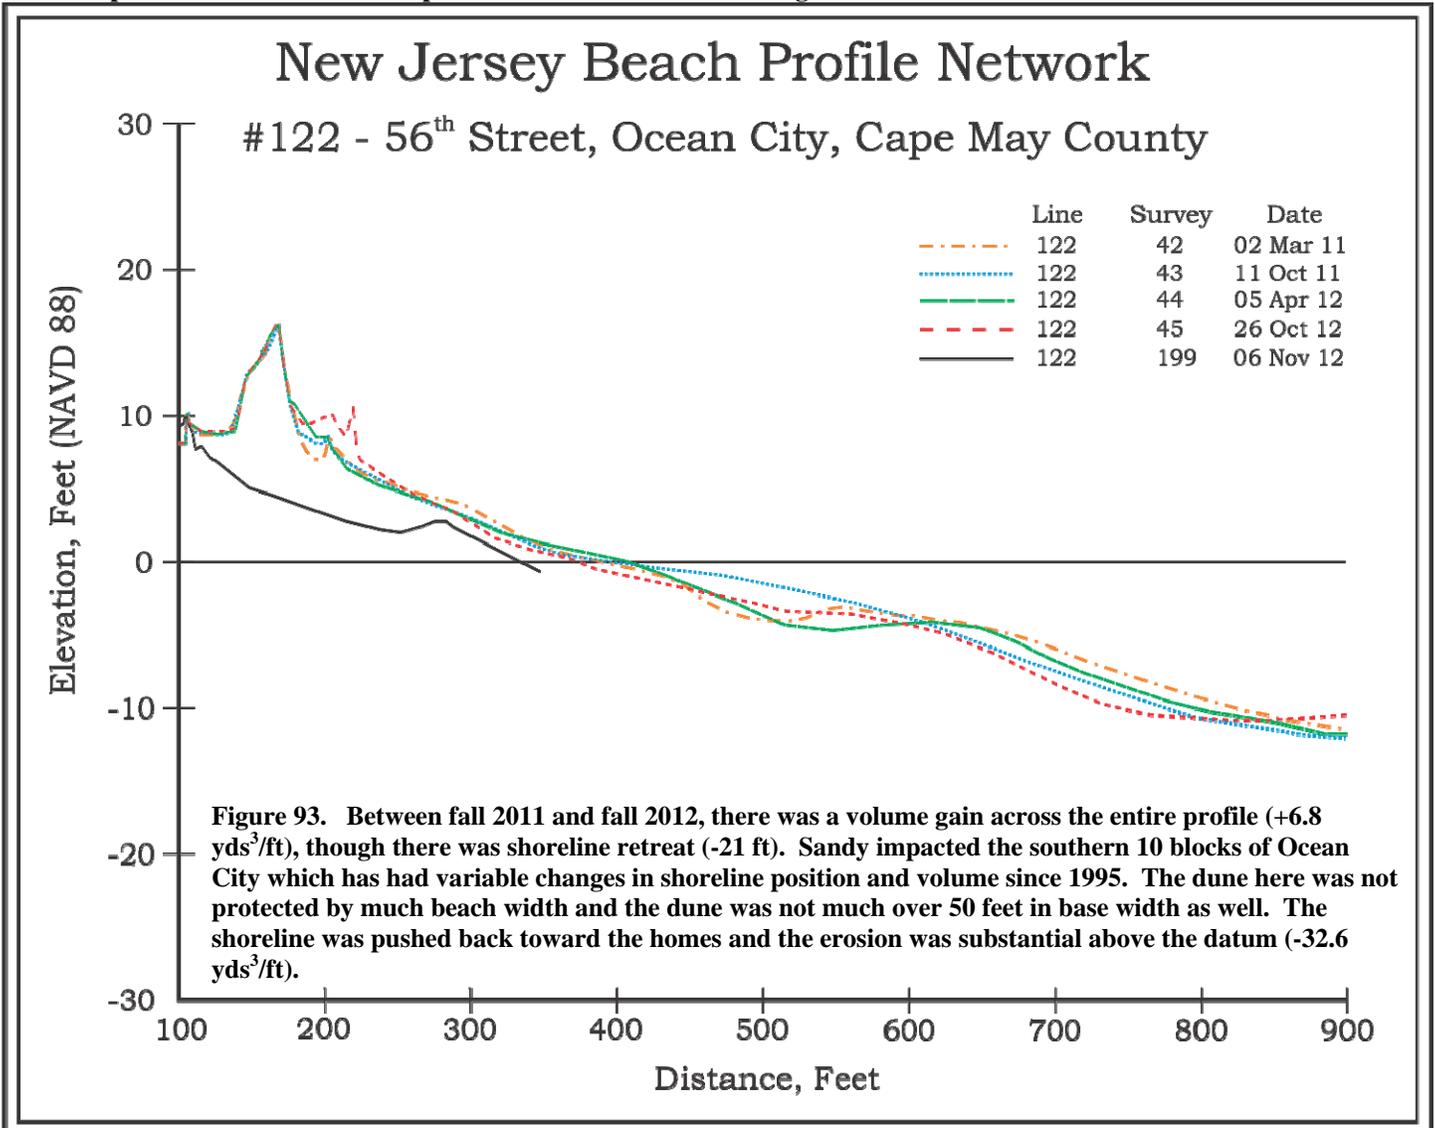
56th Street, Ocean City, Cape May County, Site #122;

The left photograph was taken October 26, as Sandy was approaching NJ. Machines were deployed pushing up a ridge of sand seaward of the existing dunes at this site. Sandy overwhelmed the shore protection, jumped the old bulkhead and washed well inland producing damage and flooding. The right picture was taken November 6th and shows recent bulldozing efforts to provide a small measure of protection for homes with nothing between them and the sea.

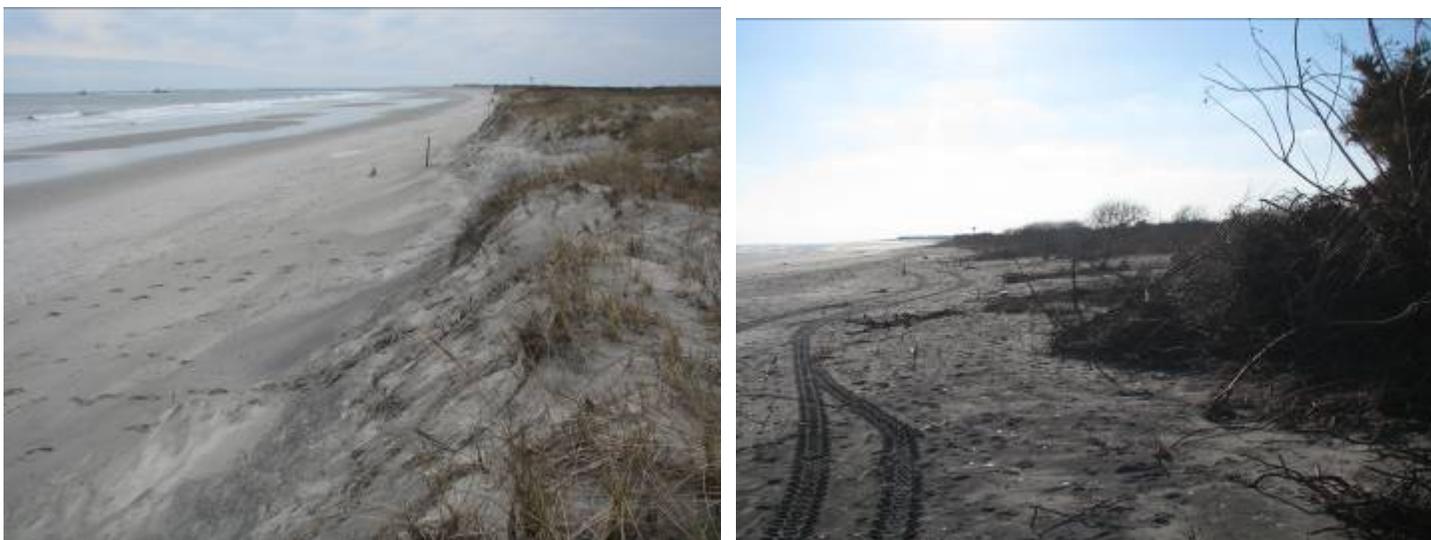
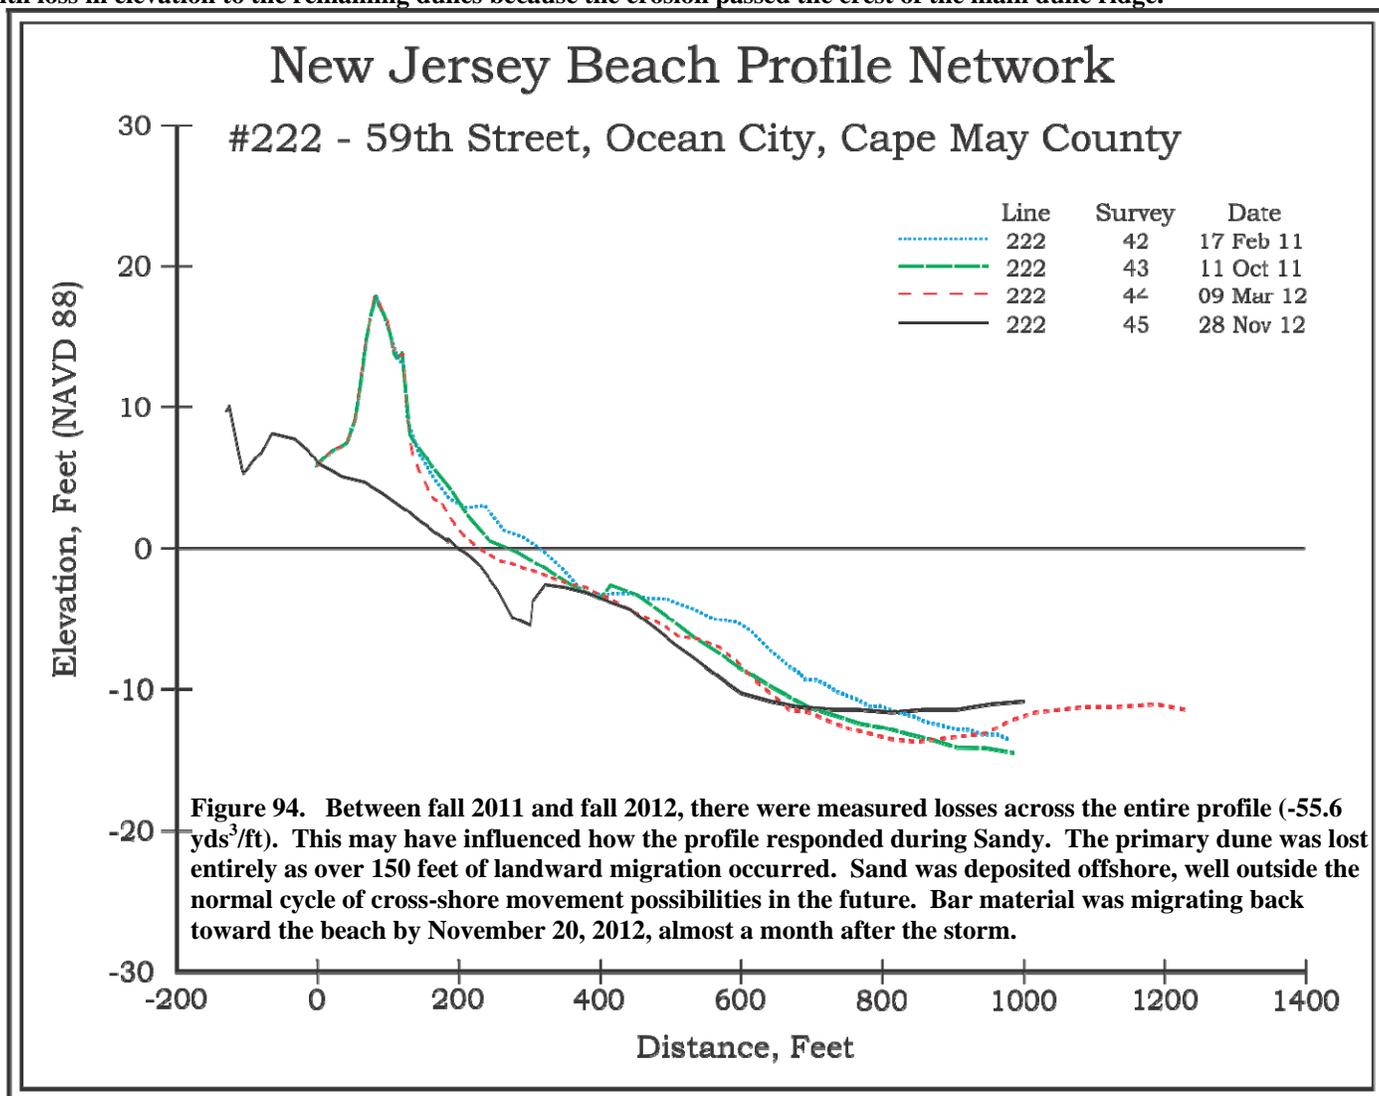
59th Street, Ocean City, Cape May County, Site #222;

The left picture, taken March 9, 2012, shows an erosional scarp in the spring of 2012. This condition did not change during the summer and the waves during Sandy carved deeply into the remaining dunes. The erosion reflected up the beach into the southernmost development in Ocean City as well. The right picture was taken November 28, 2012 and shows large scale overwash and inundation of the lower sections of the dune system. The scarp was pushed landward a minimum of 155 feet with loss in elevation to the remaining dunes because the erosion passed the crest of the main dune ridge.

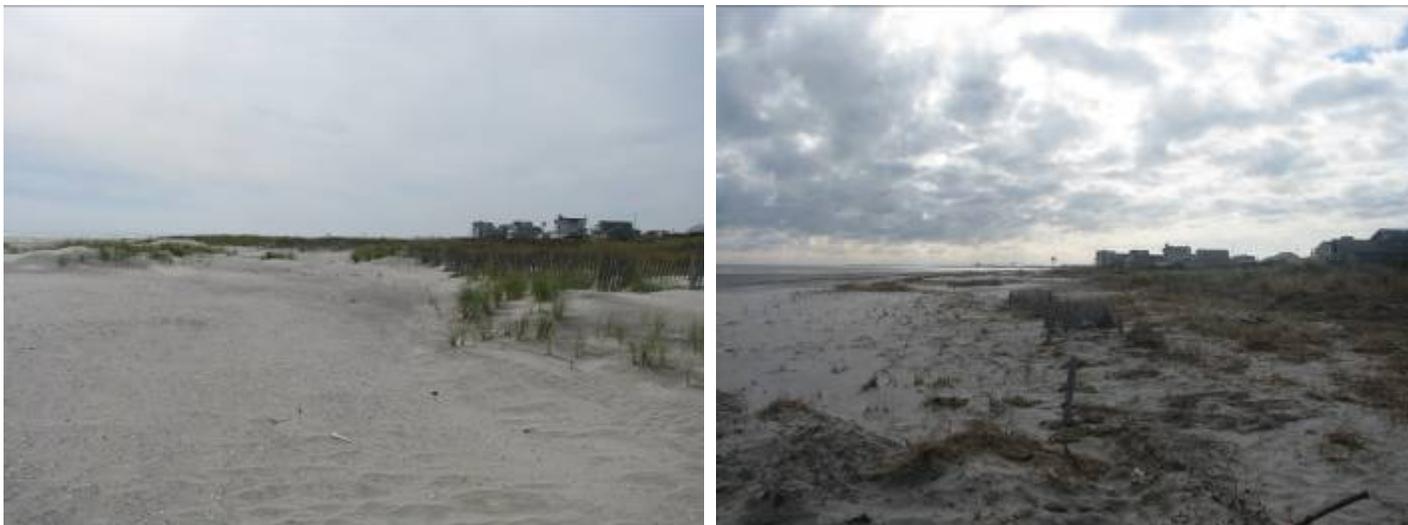
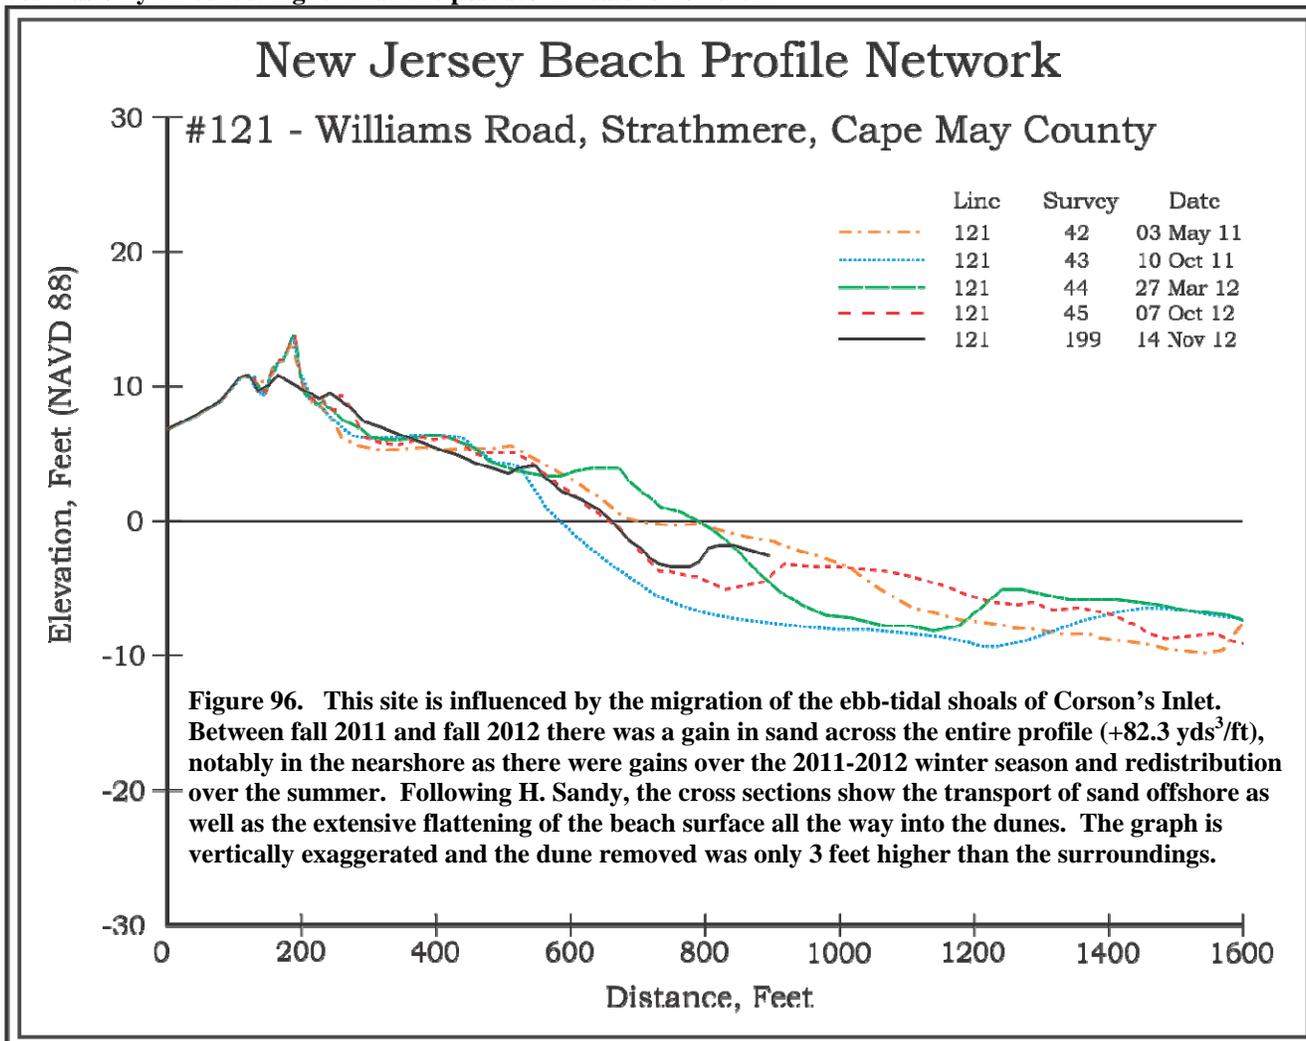
Williams Road, Strathmere, Cape May County, Site #121;

The left picture was taken October 17, 2012 looking across the wide dune zone area seaward of the primary feature. On November 5, 2012 the same view following Sandy shows that the area was flooded by waves that knocked down the highest primary dune, but did not flood the immediate landward area. The beach was flattened by the storm surge. The dune removed was only three feet higher than the post-storm feature however.

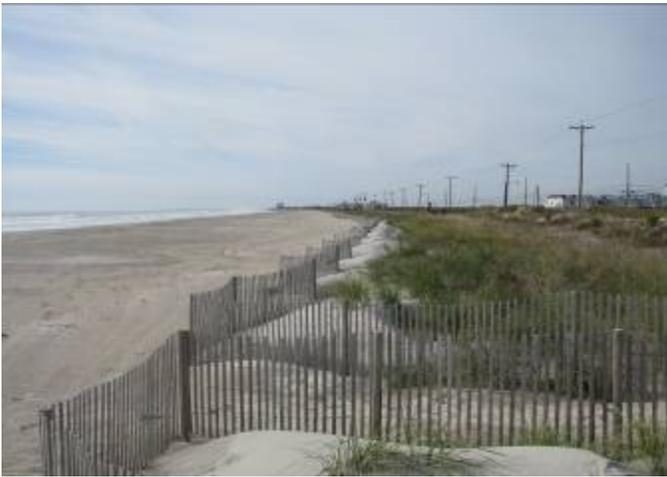
1st Street, Sea Isle City, Cape May County, Site #120;

This location is on the boundary between Sea Isle City and Strathmere along the main (and only) road parallel to the ocean. The sand transported into the dune by October 17, 2012 was washed across by Sandy as seen on the left picture on November 14, 2012. Some minor breaching occurred along Commonwealth Avenue, but the dune remained relatively intact.

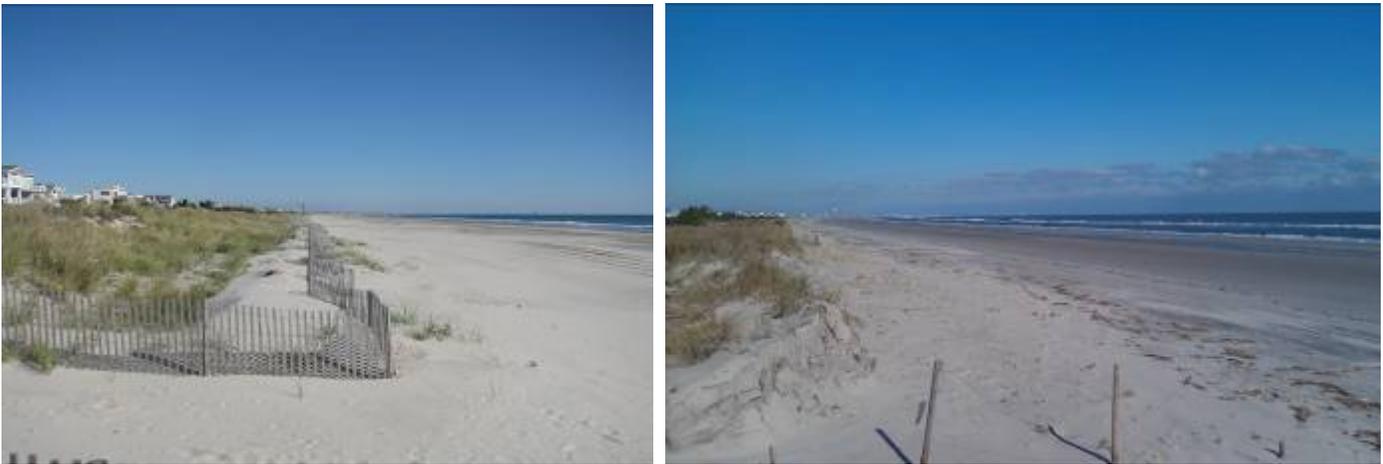
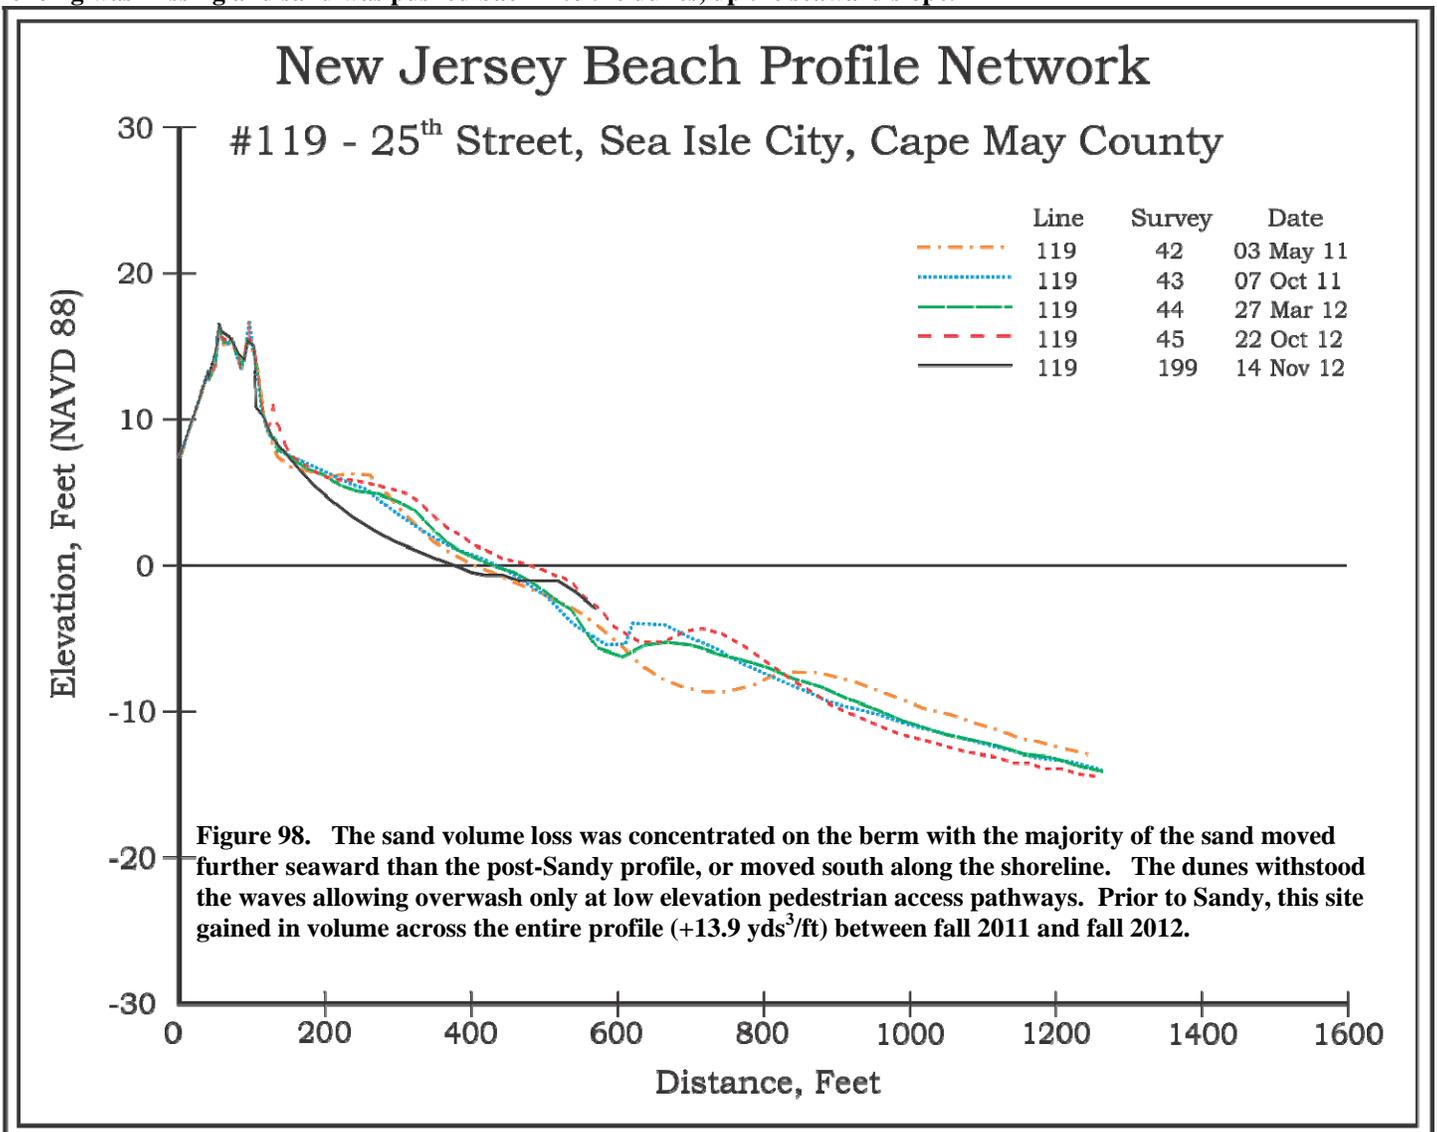
25th Street, Sea Isle City, Cape May County, Site #119;

On October 22, 2012, the beach was relatively wide and dry with a decent new deposit of sand along the recent fencing installed at the seaward toe of the dune system. After Sandy on November 14, 2012 the beach was lower in elevation, all the fencing was missing and sand was pushed back into the dunes, up the seaward slope.

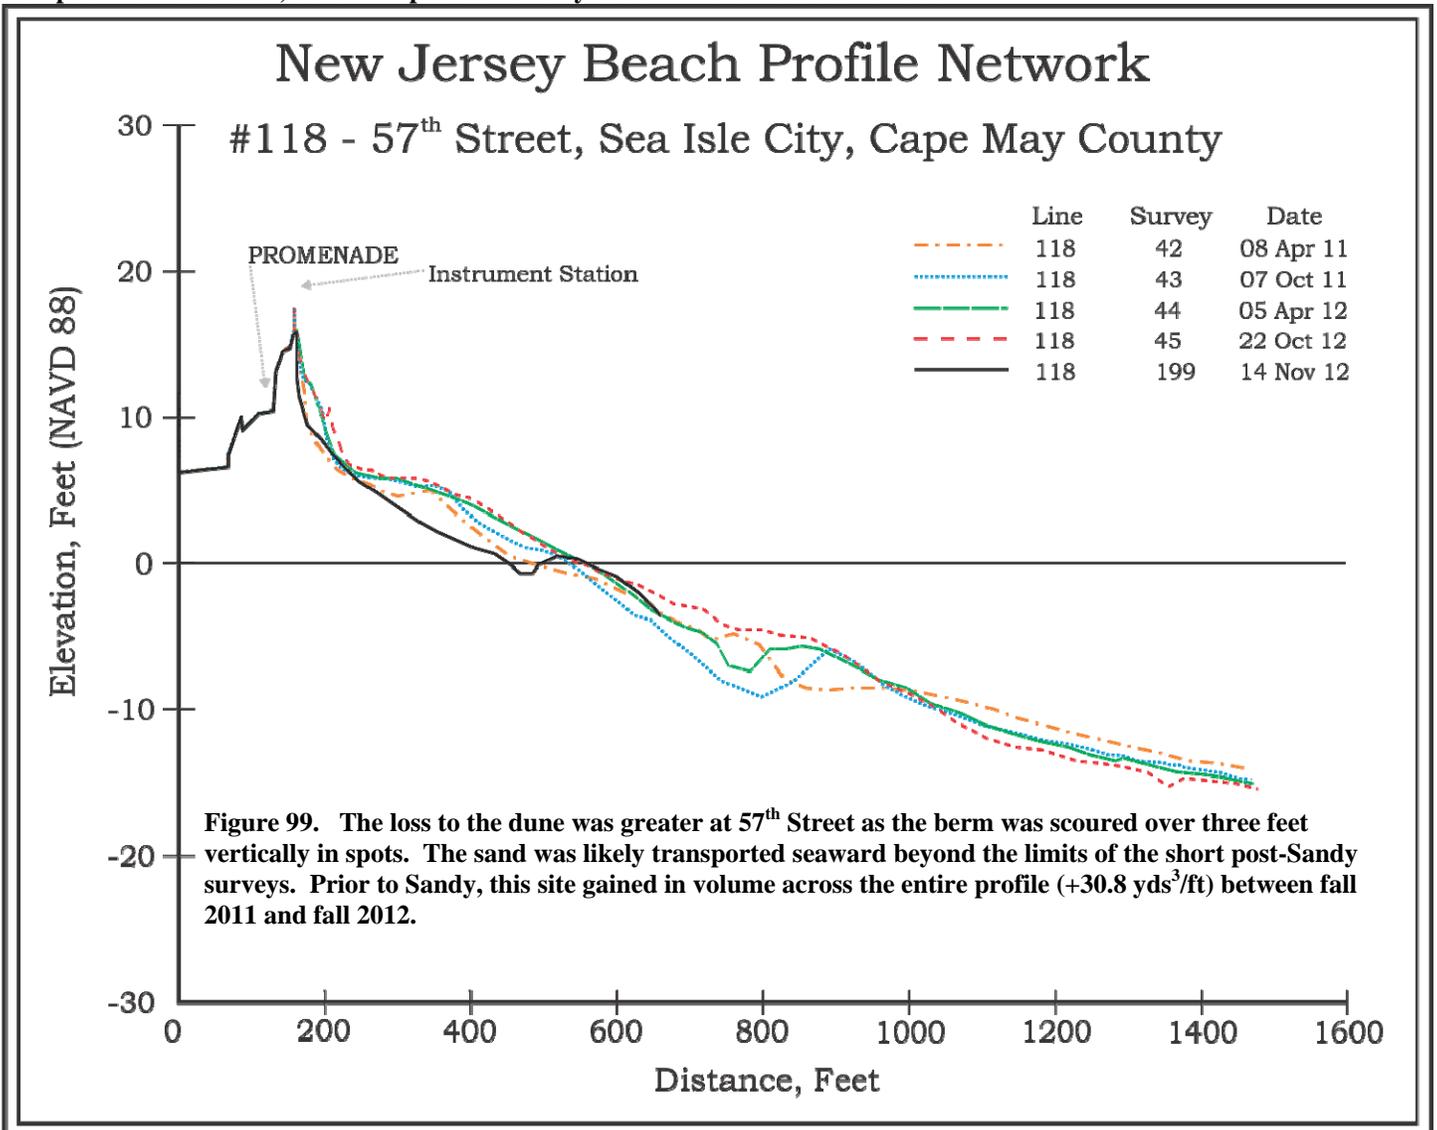
57th Street, Sea Isle City, Cape May County, Site #118;

The left picture was taken October 22, 2012 and shows the dune system landward of a wide, dry beach. Following Sandy on November 14, 2012, the beach was much lower in elevation and the dune was carved away nearly to the crest. The scarp had slumped two weeks later, but the impact can clearly be seen in the cross section below.

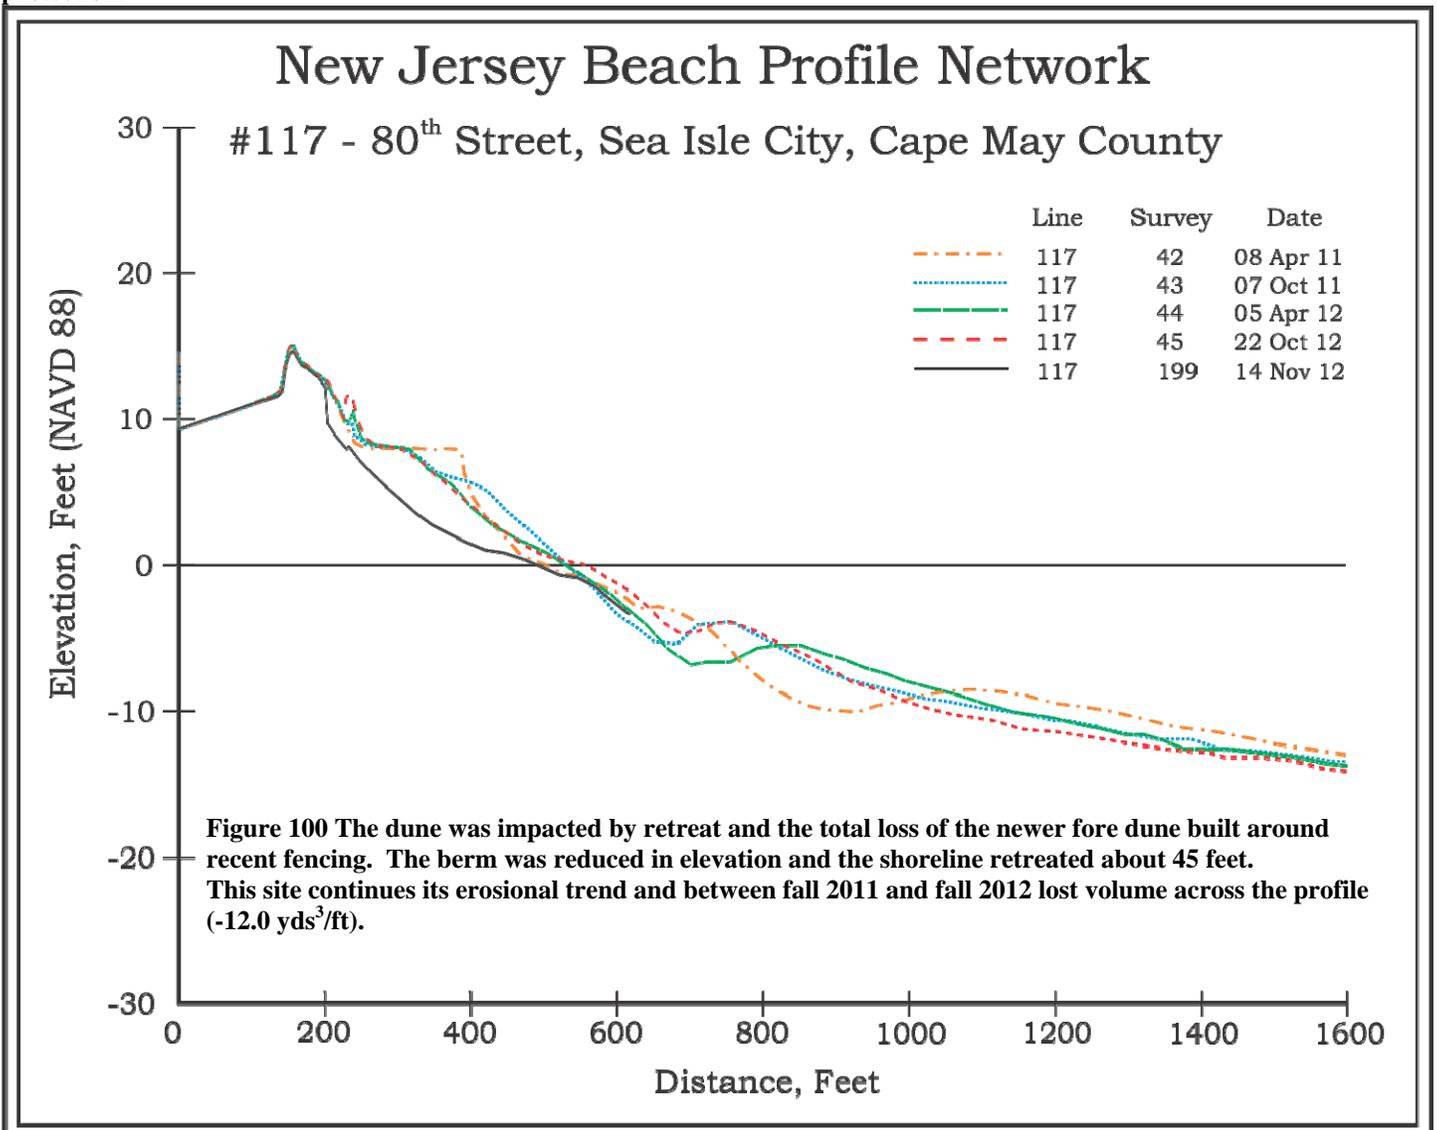
80th Street, Sea Isle City, Cape May County, Site #117;

On October 22, 2012 the beach possessed a recently deposited foredune developed at fencing installed in the past year. The beach was wider and higher than the scene following the storm. On the right, the post-Sandy clean-up was responsible for the deposition of sand, washed inland, having been hauled back to the beach to form a linear ridge to help with future storm protection.

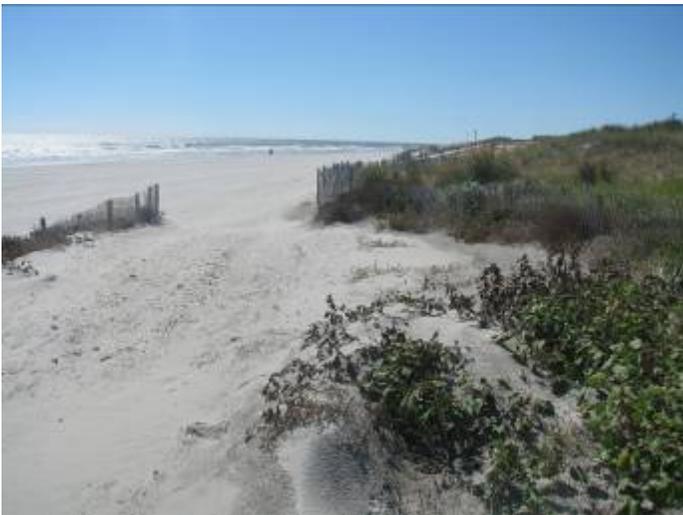
9th Street, Avalon, Cape May County, Site #216;

The September 25th photograph shows the wide berm and seasonal plant growth at the 9th Street site. Following Sandy the fence was taken out as was the wide berm with erosion cutting into the seaward dune toe slope. The litter deposited on the dune slope shows the elevation to which the waves ran up the dunes (14.0 feet NAVD88 in Avalon).

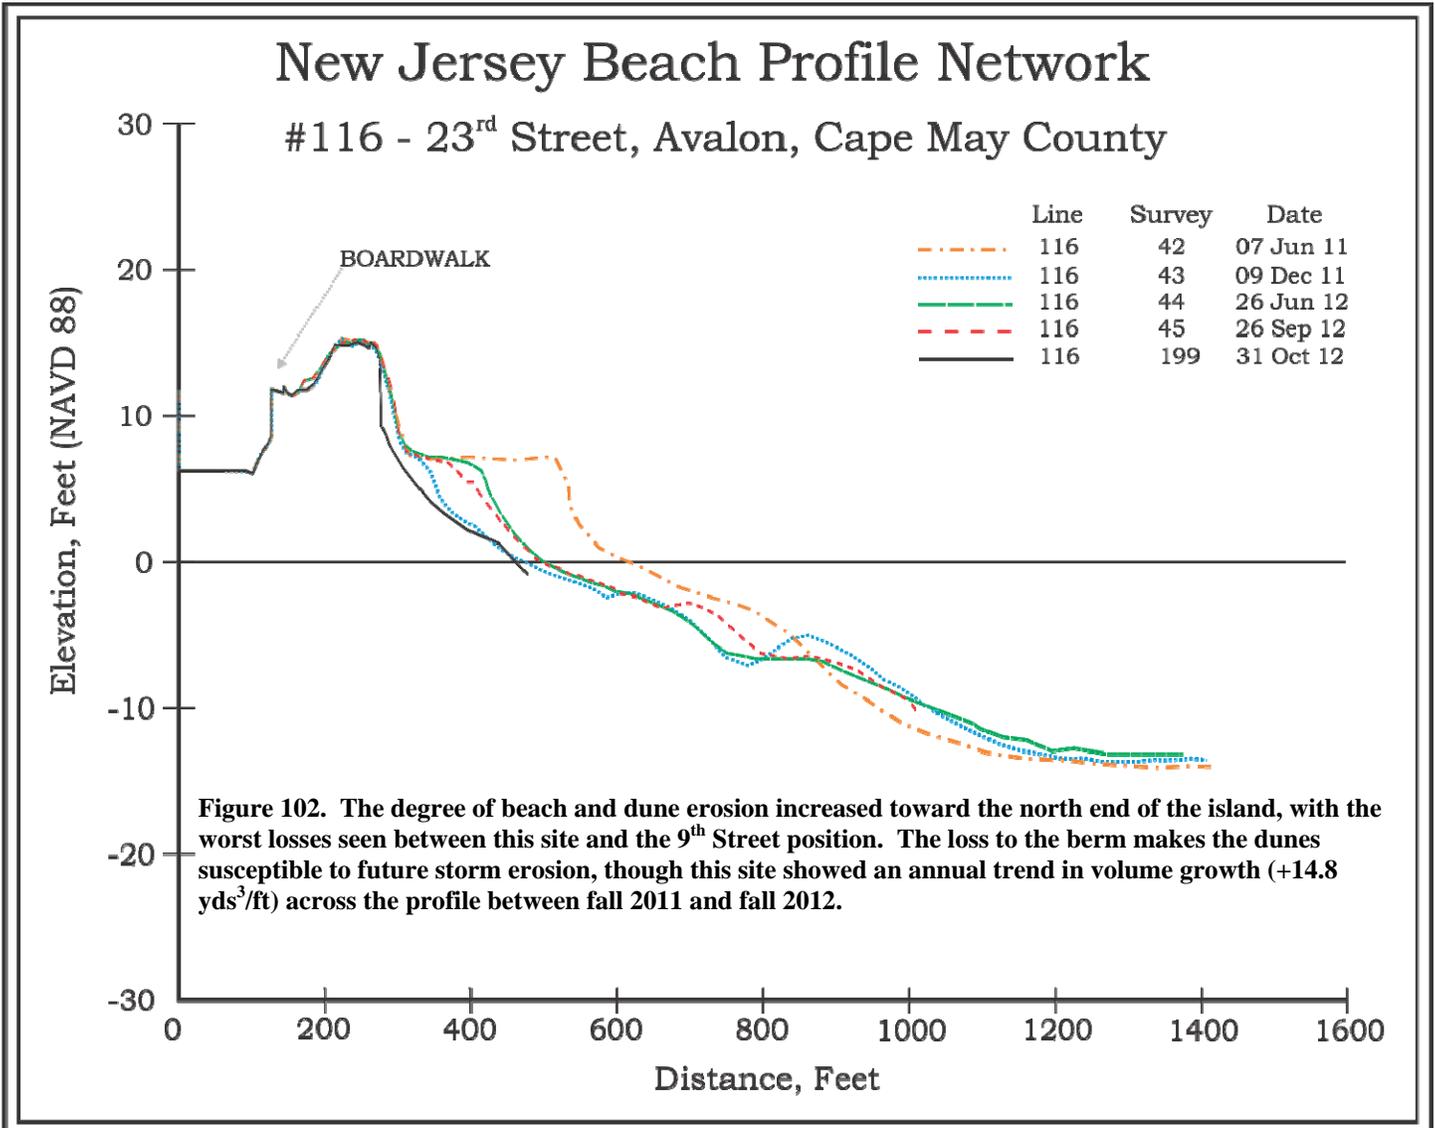
23rd Street, Avalon, Cape May County, Site #116;

The left picture was taken September 25, 2012 and shows the beach late in the summer with a generous post-sand fill berm present and a healthy season's growth in new dune plants. By October 31st, the beach was much lower in elevation as sand was carried offshore and the dune's seaward slope was cut and sand washed into the grasses. The entrance pathway was truncated at most Avalon street-end entrances.
