New Jersey Beach Profile Network

Cape May County

Great Egg Harbor Inlet
to Stow Creek

Cape May County Storm Damage Report:

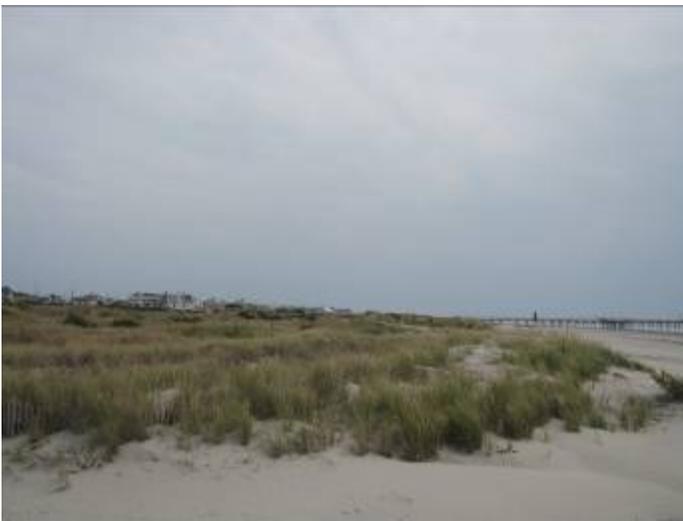
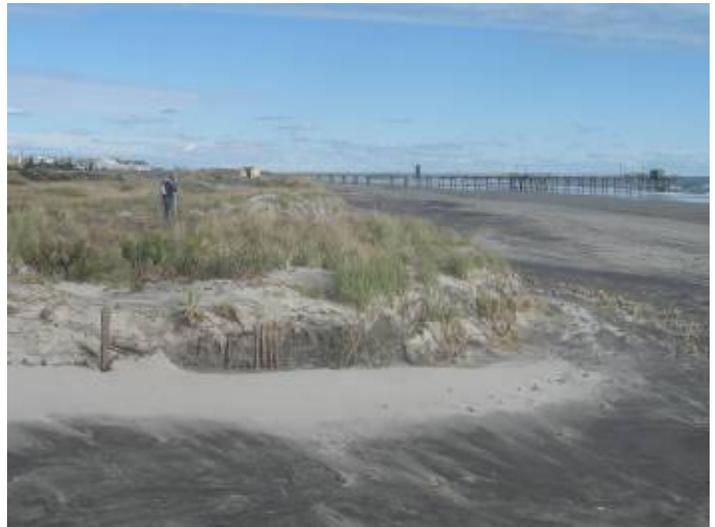
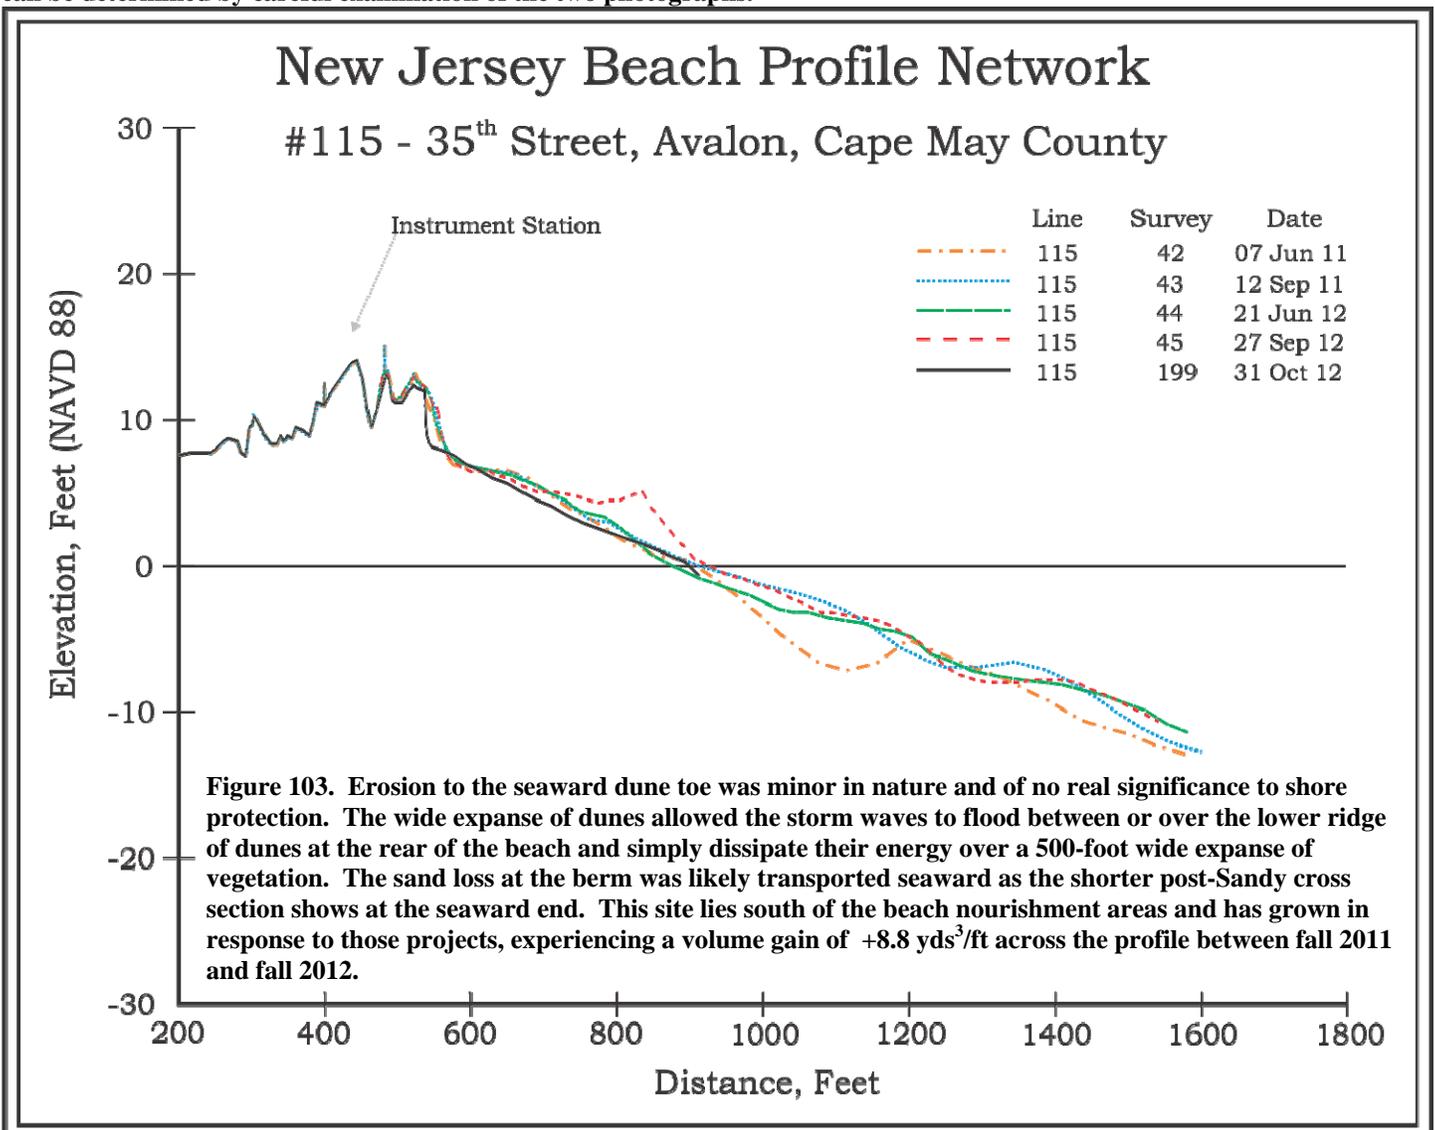
35th Street, Avalon, Cape May County, Site #115;

Between September 27th and October 31st, the beach at 35th Street suffered foredune flooding and minor erosion of the seaward toe. Sand was stripped from the berm and washed into the lower elevation dune field. The loss to individual plants can be determined by careful examination of the two photographs.

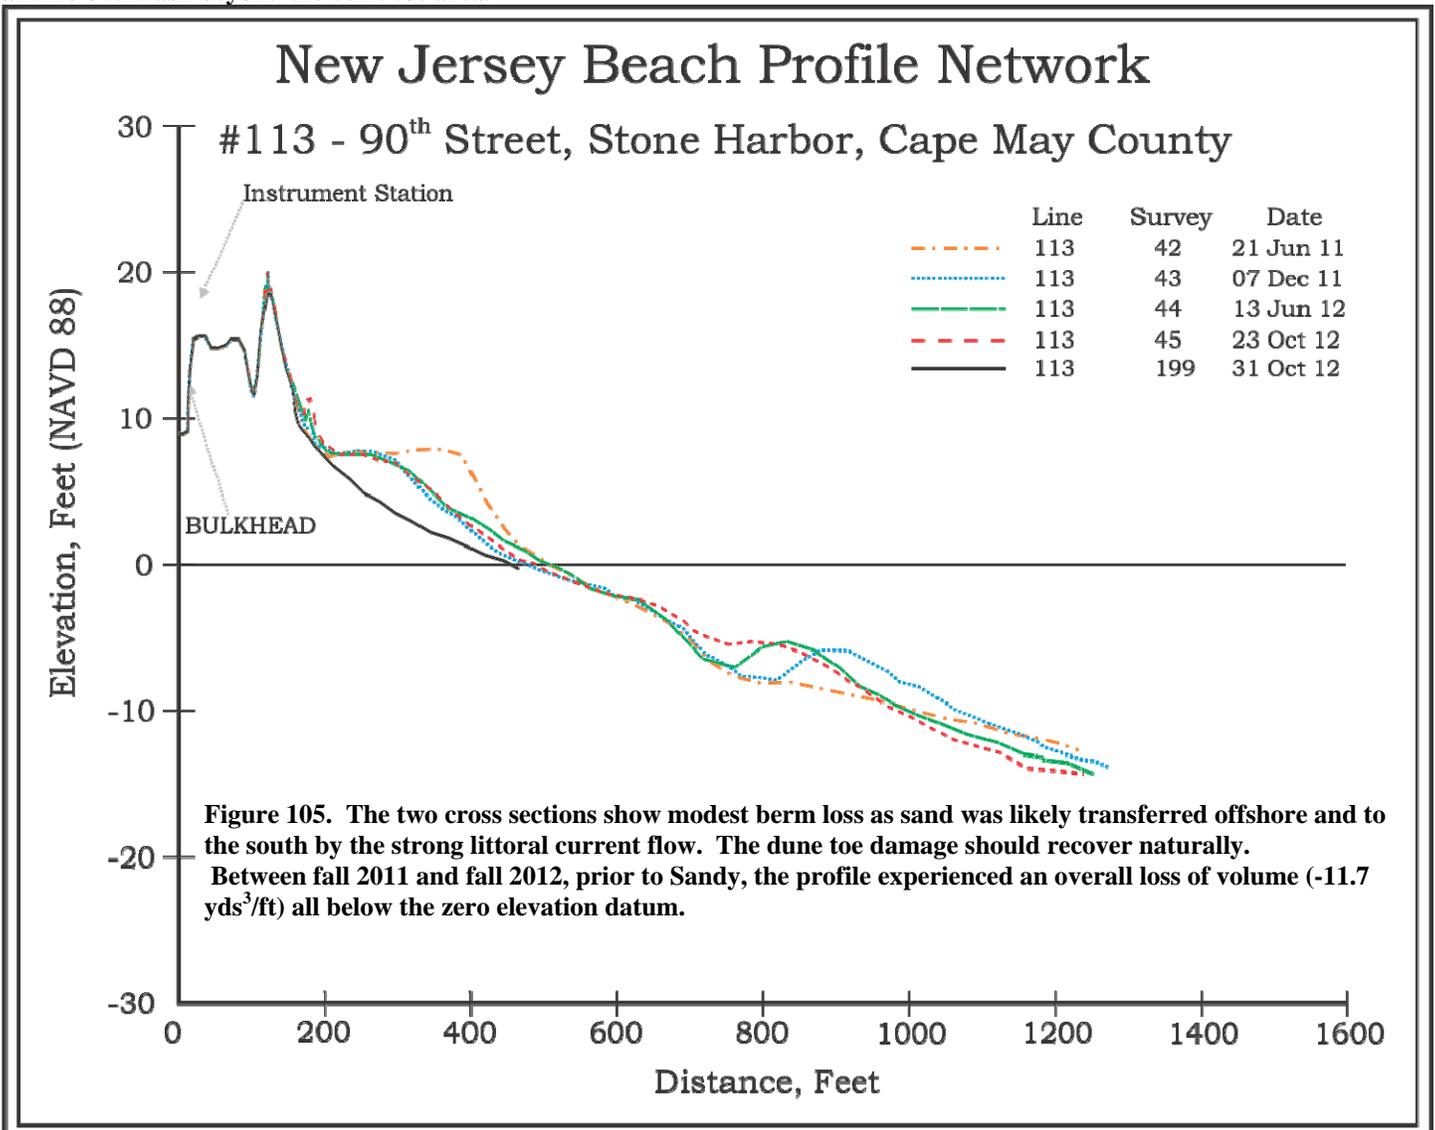
90th Street, Stone Harbor, Cape May County, Site #113;

The left photograph was taken October 24, 2012 just prior to Sandy. The right picture was taken October 31, 2012 and shows the effects of lowering the berm elevation and some minor dune toe erosion. This site did not suffer significant erosion damage and no overwash beyond the dune toe area.

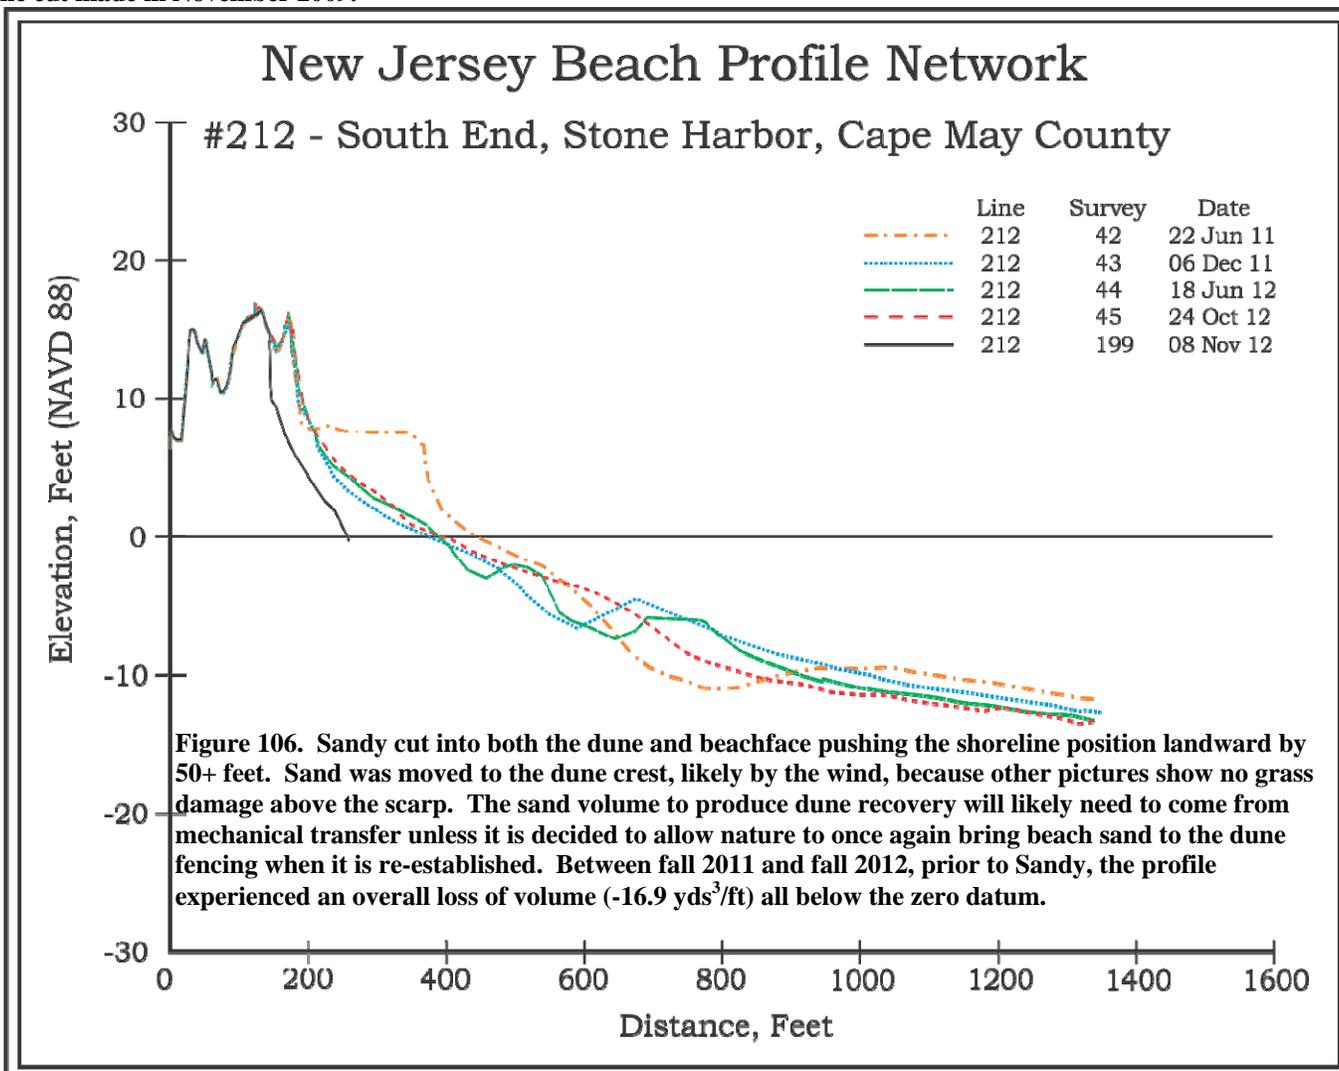
121st Street, Stone Harbor, Cape May County, Site #212;

The southern cross section in Stone Harbor was re-established just north of the terminal rock groin along the Borough oceanfront following the loss of South Point in 1990. The left picture shows the conditions in June 2012 where sand had deposited seaward of an older scarp cut into the dunes, building out to the sand fencing. Sandy eliminated all the newly-deposited material moving the beach landward uniformly by 50 feet. The catamaran pilings show a closer proximity to the surf after Sandy than prior to the storm (Nov. 8, 2012). The erosional cut in the dunes returned to approximately the location of the cut made in November 2009.

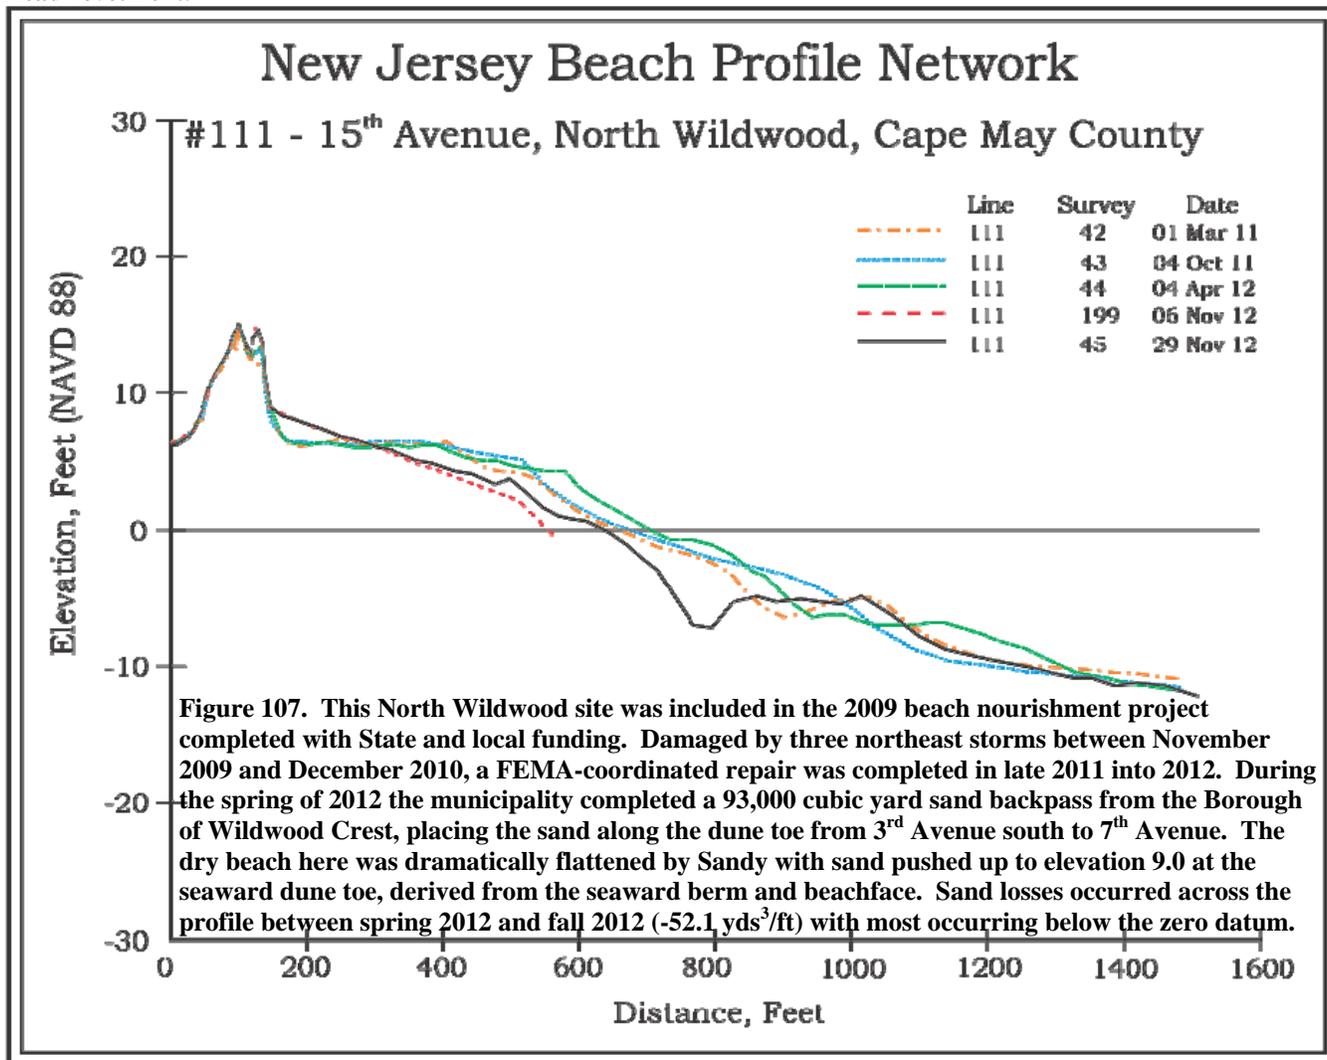
15th Avenue, North Wildwood, Cape May County, Site #111;

The view to the southeast from 15th Avenue dune crossover was taken April 4, 2012. The picture following Sandy was taken on November 29th and is on the right. Summer dune grass growth shows in spite of the storm. The waves did flow across the entire dry beach and ramped up a deposit onto the seaward dune toe. No dune breach occurred near this location. Further south at the piers, the dune was erased because it was built to pass seaward of the pier ends and was far more exposed to wave action. Erosion at the very northeast corner of the City also removed the dune south to 4th Avenue and over-topped the bulkhead revetment.

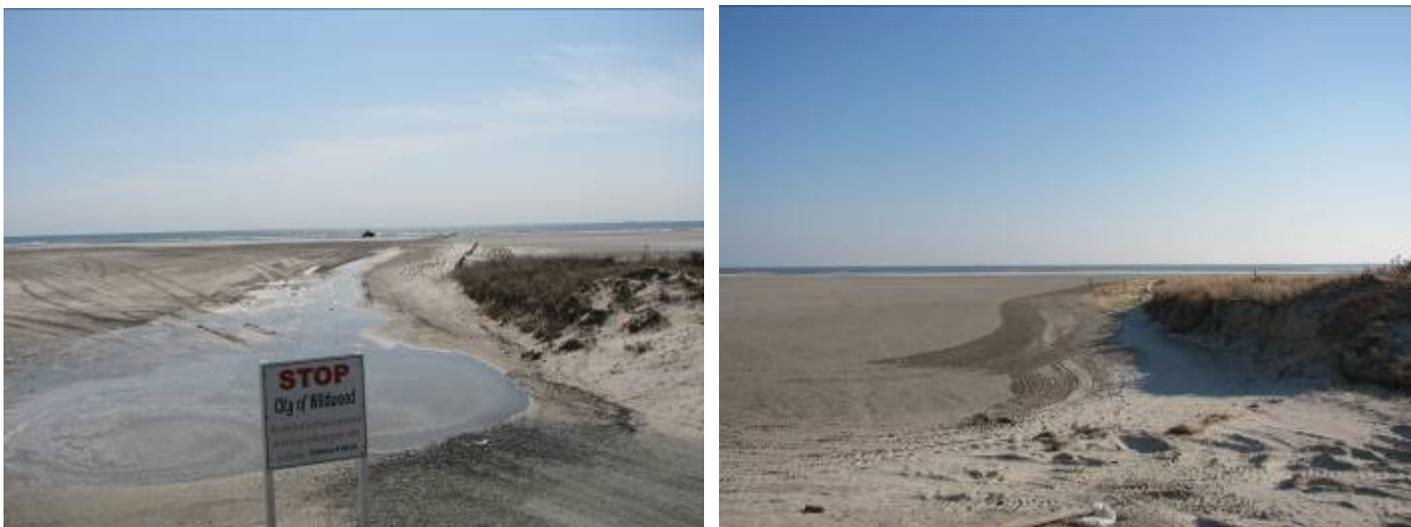
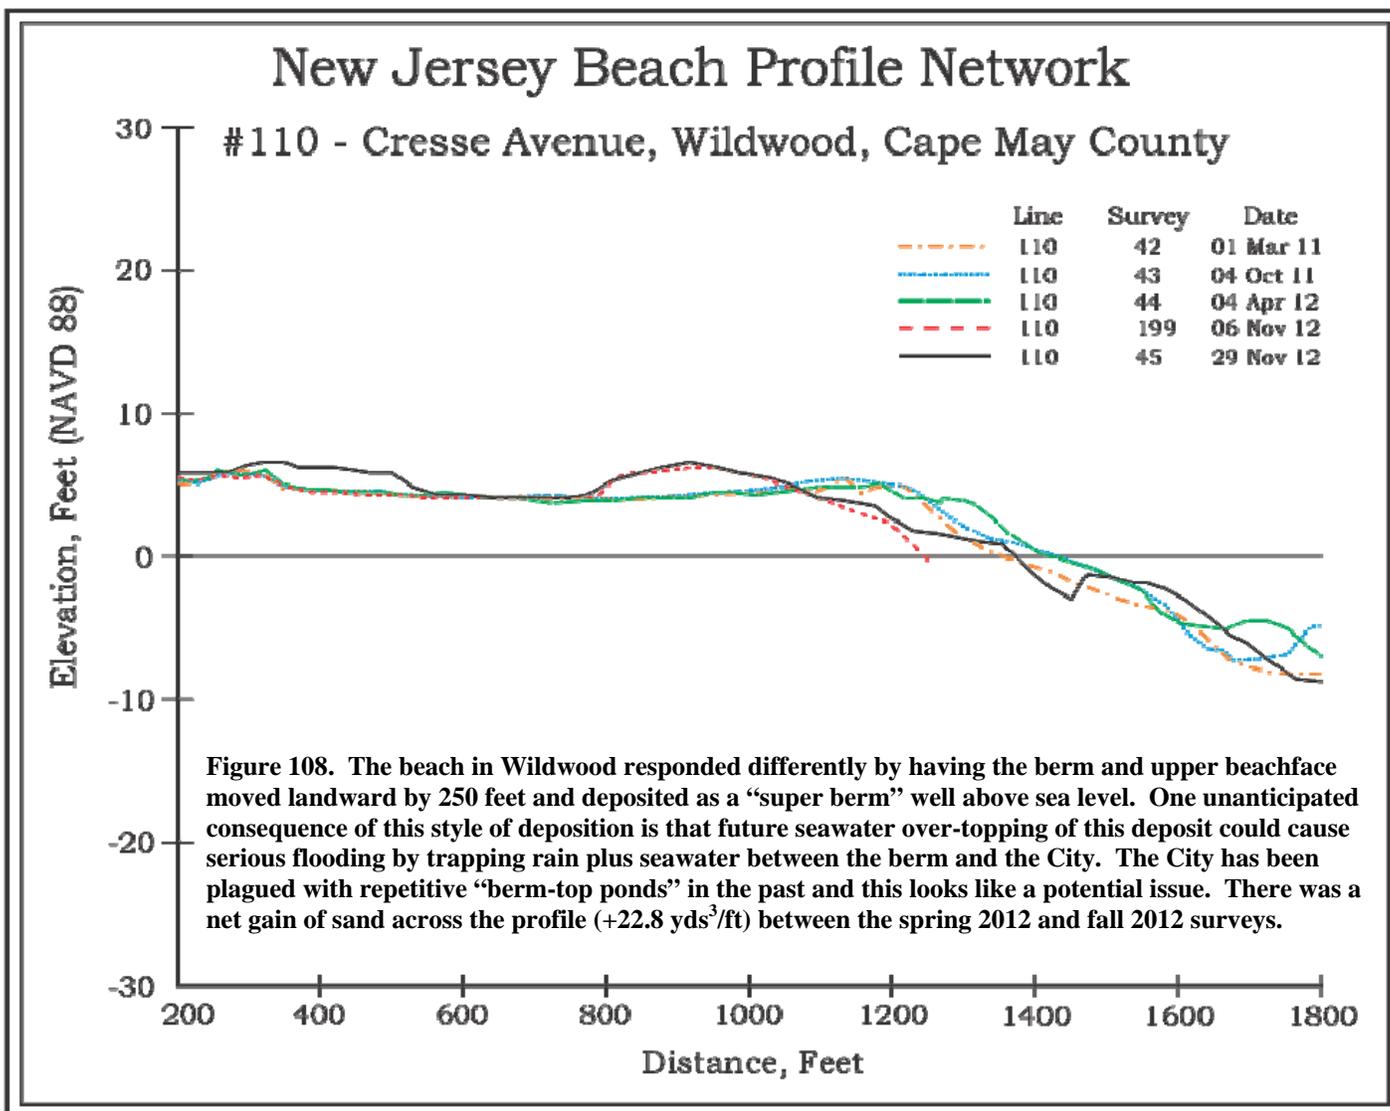
Cresse Avenue, Wildwood, Cape May County, Site #110;

On April 4, 2012 the view across the beach in Wildwood was taken from the tiny dune in front of the boardwalk. The November 29th view on the right was taken from the same location, but minus the sign. The beach gained sand at the berm 600 feet seaward of the boardwalk. The sand deposit probably was derived from the erosion of the spring survey's berm.

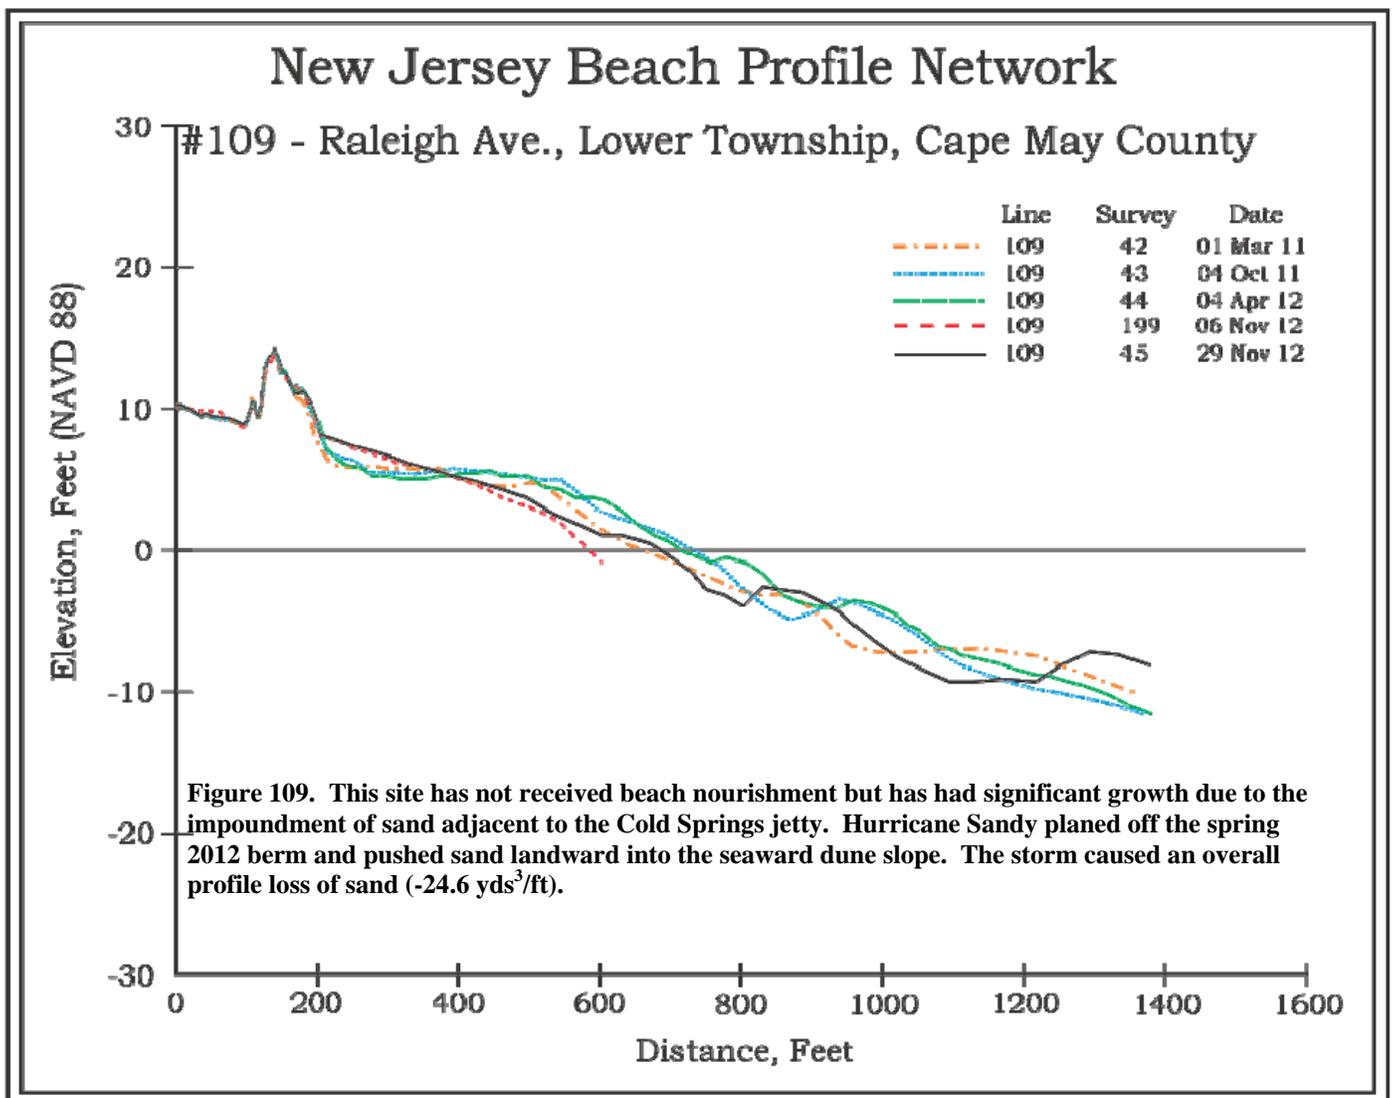
Raleigh Avenue, Lower Township, Cape May County, Site #109;

The early spring photograph of the beach taken April 4, 2012 is shown on the left. The right-hand view was taken November 29th a month after the storm. Here sand was forced landward to the toe of the dunes where a deposit filled in a slightly lower part of the beach than the berm. The sand on the berm was likely the source of the deposit since the storm surge flooded the entire dry beach.

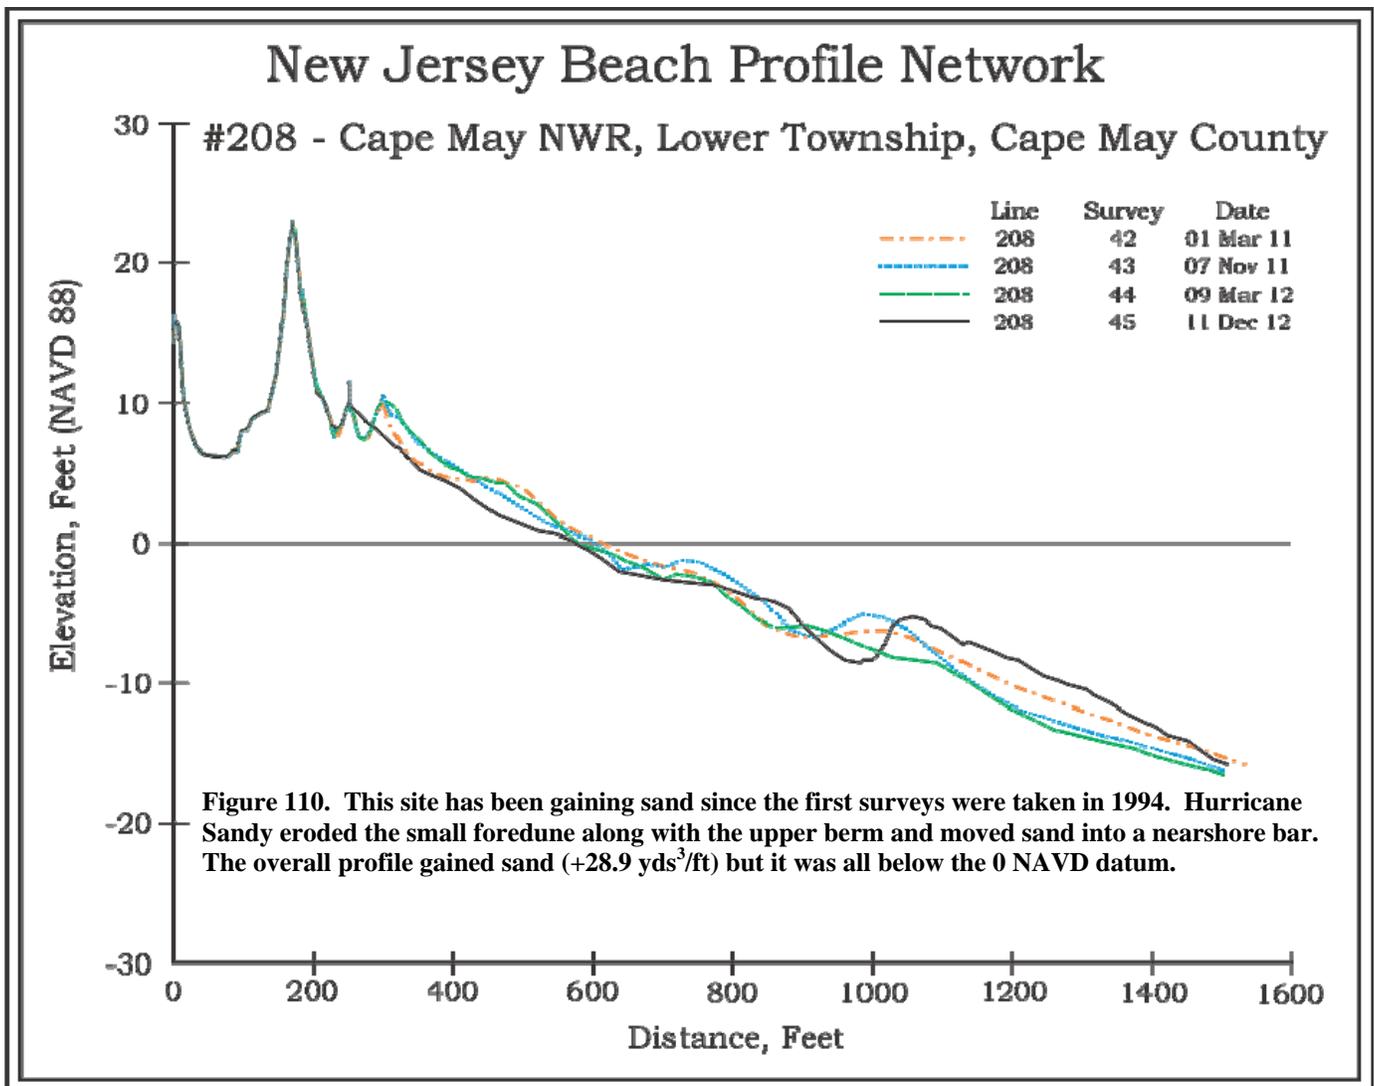
US Coast Guard Base, Lower Township, Cape May County, Site #208;

The left picture was taken March 9, 2012 looking toward the sea. The natural areas were surveyed last and done with normal procedures, so the length of the surveys are equal and extend well off shore. The outfall line shows in both photographs (December 11th for the right side) and shows that little change in beach elevation occurred. The berm was eroded somewhat and transported toward the dunes. Water reached into the new foredune area directly landward of the vehicle and washed up into the second ridgeline. The new, white sand in the center of the right photo is not present on the left side.

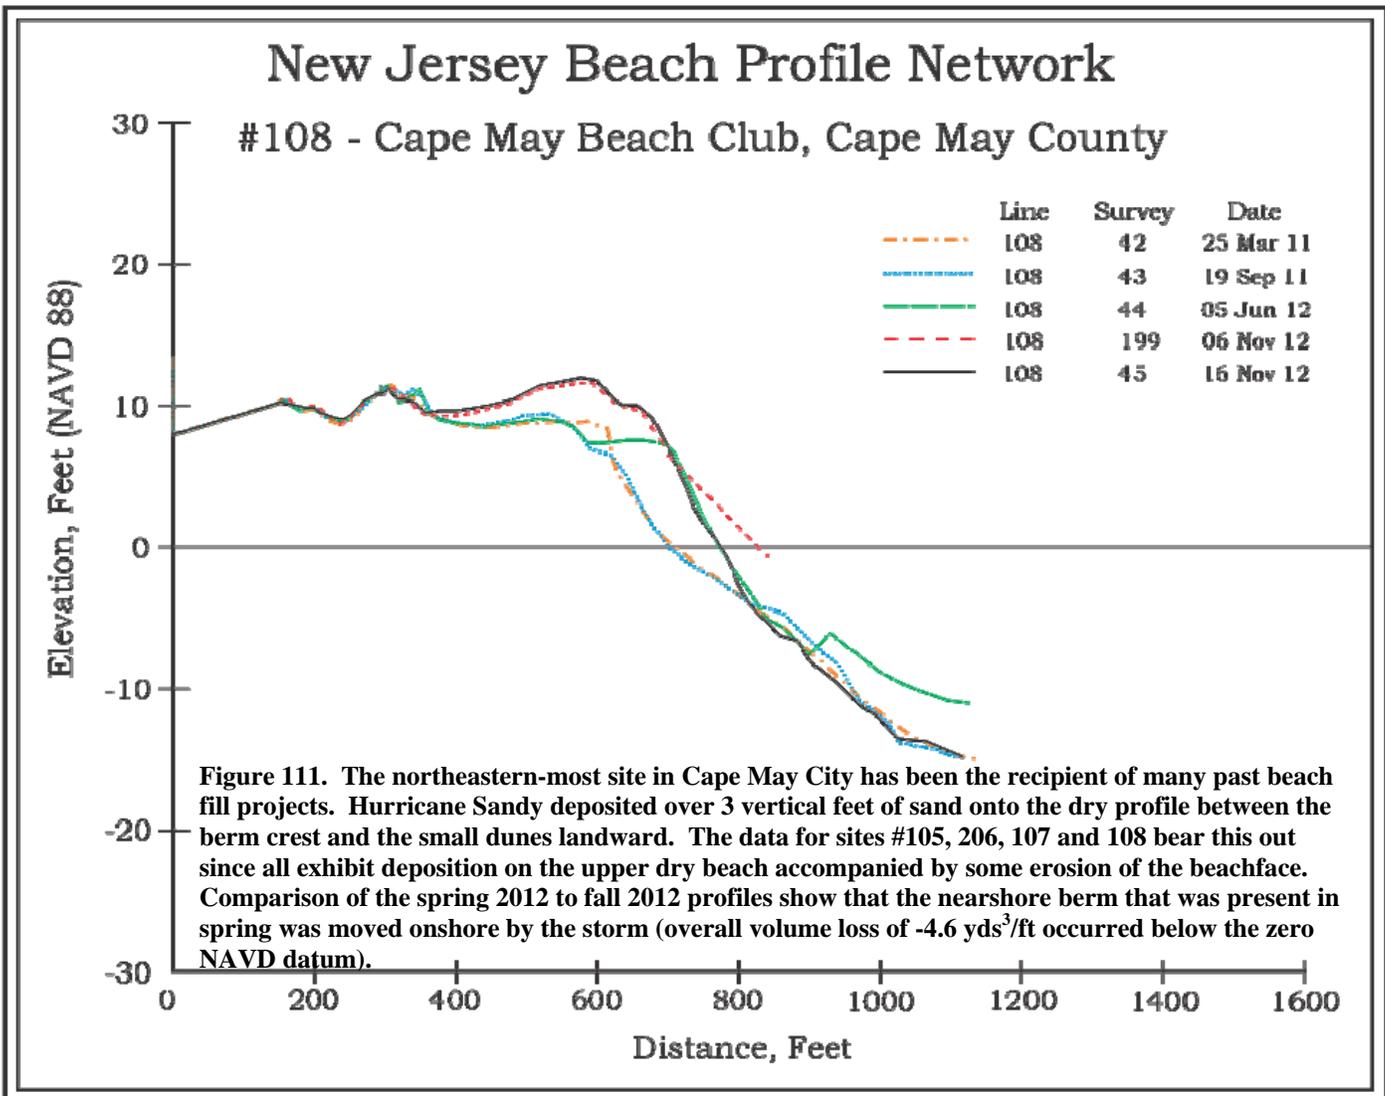
Cape May Beach Club, Cape May City, Cape May County, Site #108;

On June 5, 2012, the beach was wide with the removable boardwalk ready for the summer. The post-storm picture on the right was taken November 9th at approximately the same spot looking southeast to the ocean. Assuming that the photographers are all about the same height and were standing when they took the shots, the berm elevation covers far more of the view of the ocean in November than it did in June. The cross section below shows why.

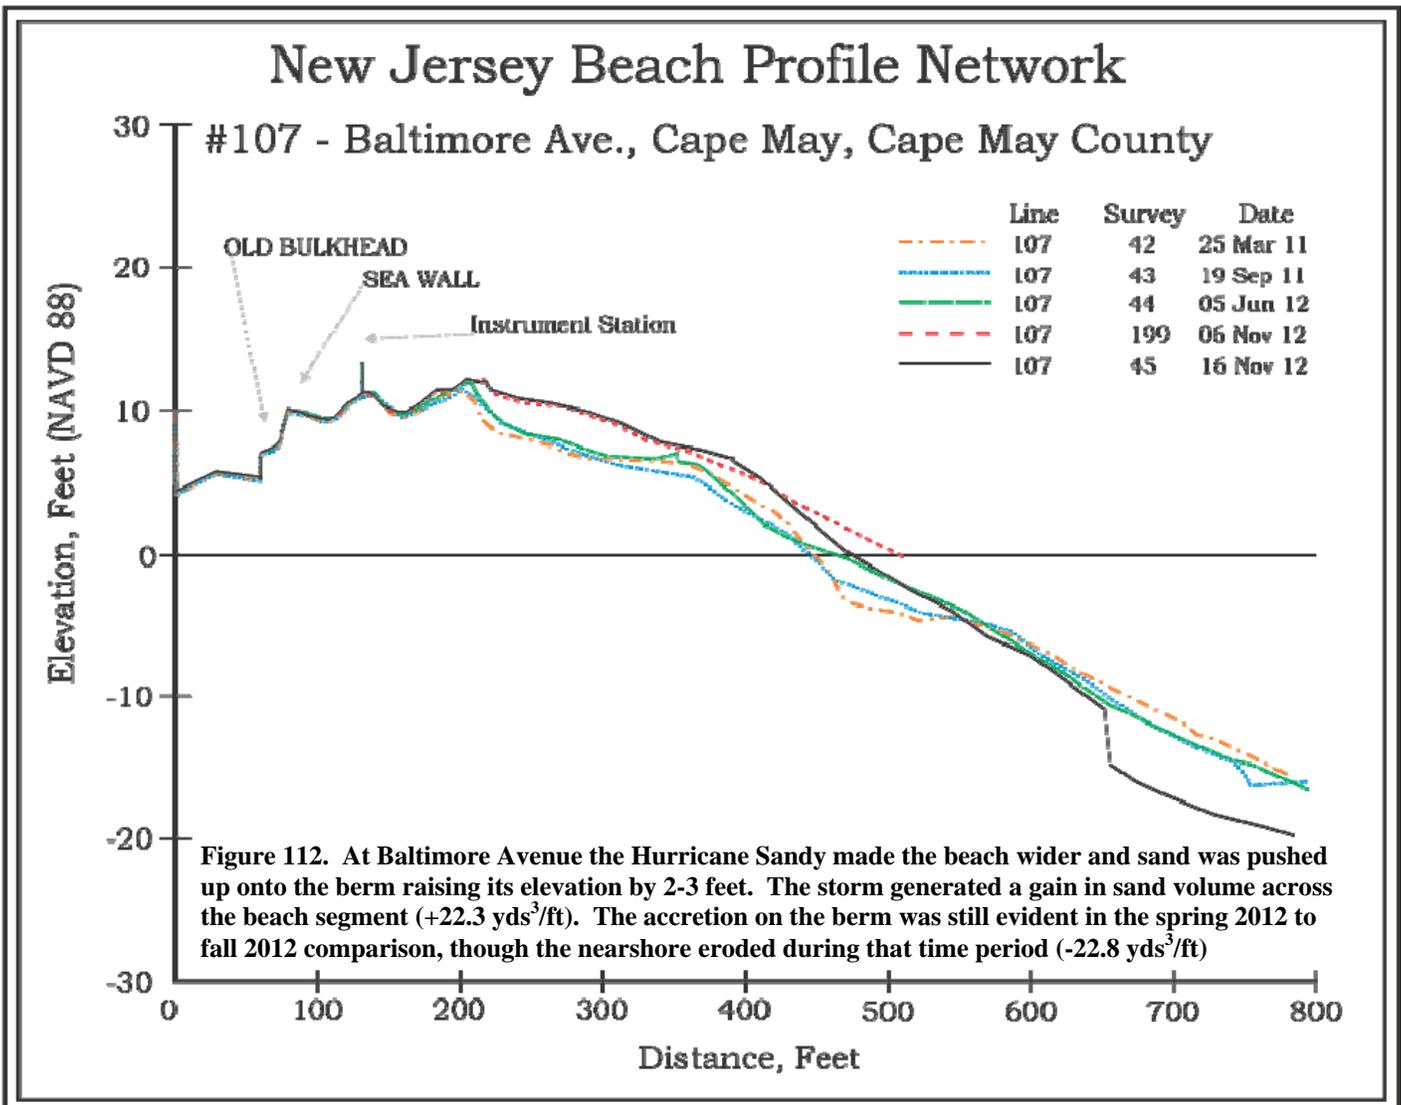
Baltimore Avenue, Cape May City, Cape May County, Site #107;

The left picture was taken in June 5, 2012 showing the beach toward the northeast. The post-storm shot on the right was taken November 9th. The sand can be seen deposited around the fencing leaving only two rows of wire above the sand while in June there were 5 rows of wire showing. Here the beach was also widened toward the zero elevation position.

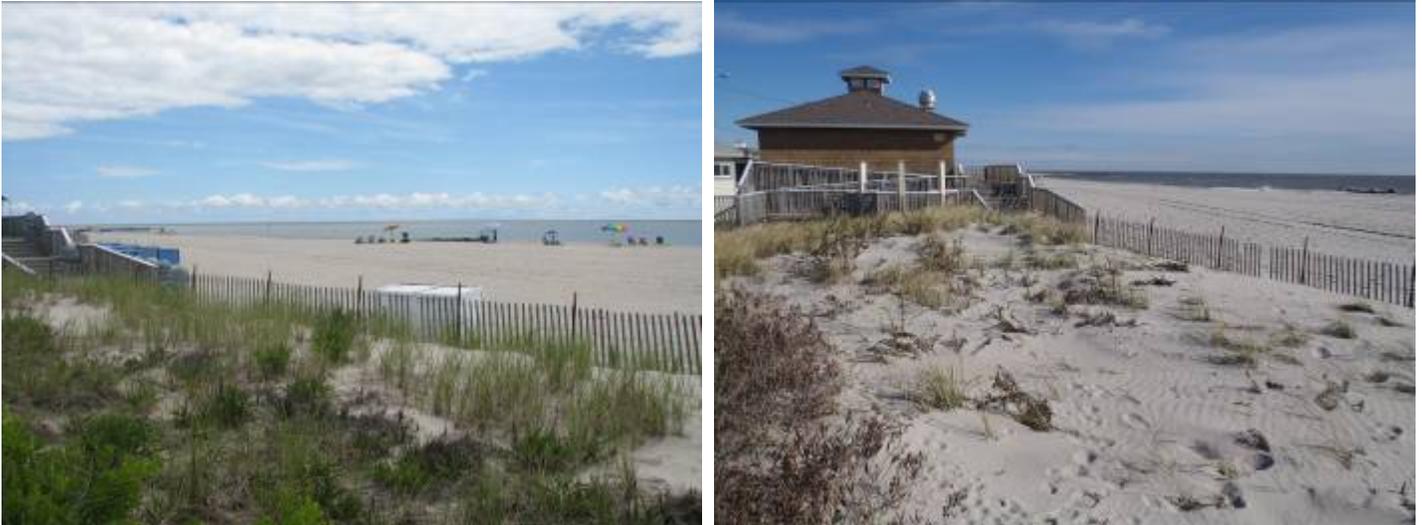
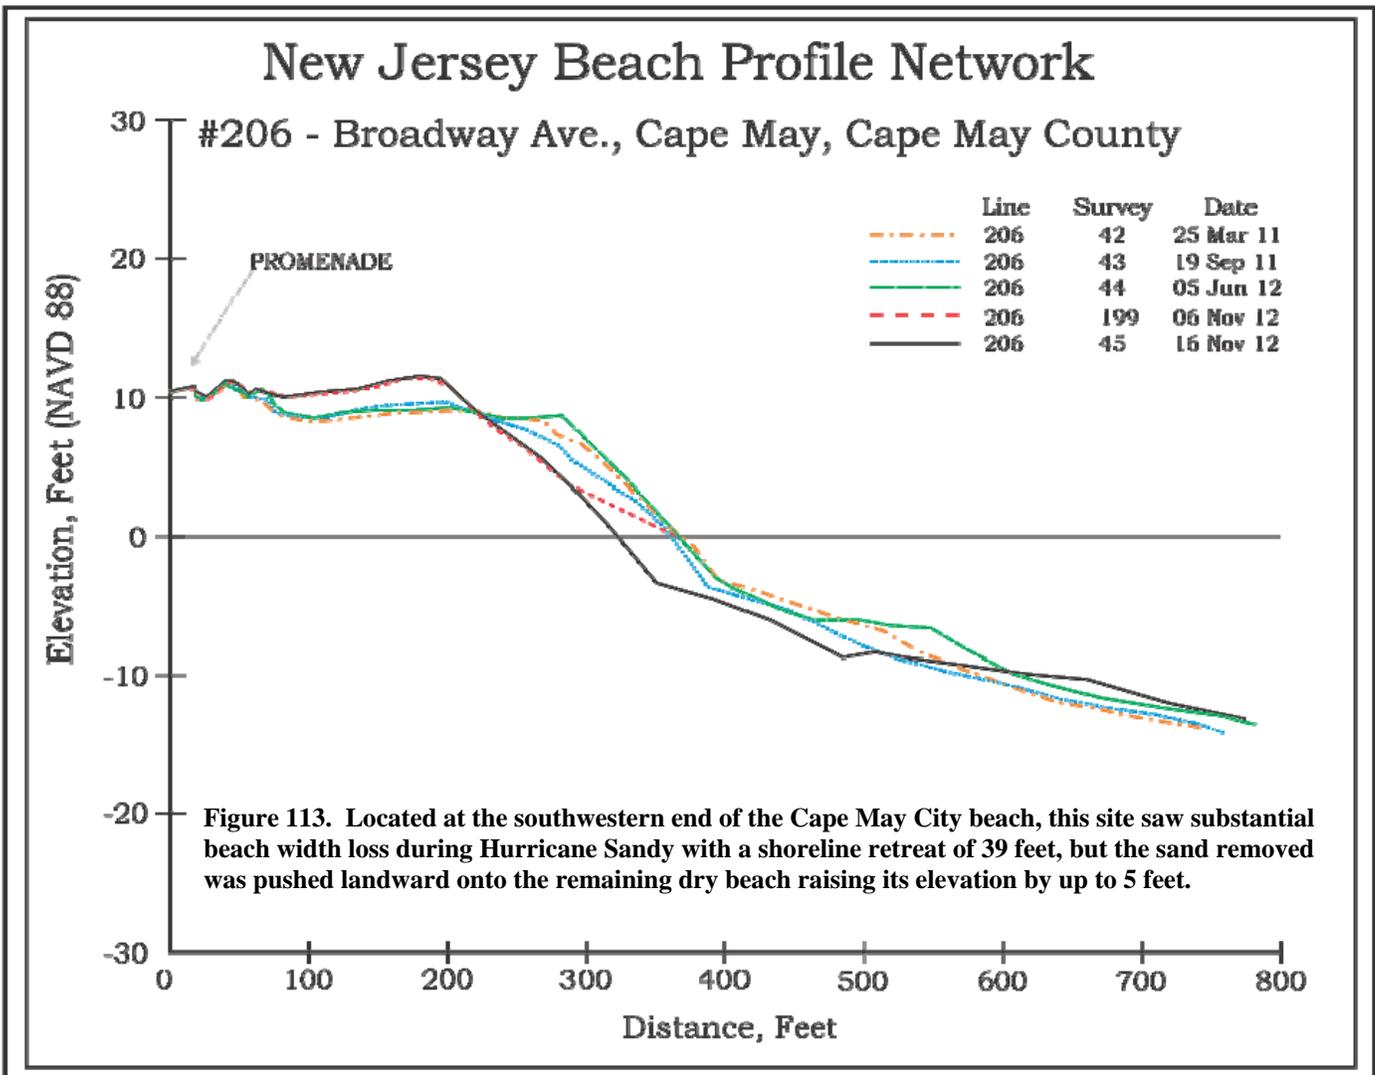
Broadway Avenue, Cape May City, Cape May County, Site #206;

The June 5, 2012 picture shows the popular bathing beach at the beginning of the last summer season. The right side shows the post-storm view on November 9th. The elevation increase shown below can be seen in the smaller slice of ocean in the right-hand view as compared to the left side. The seaward stair railings in both pictures have the same relative relationship to the horizon indicating that the view from the camera is almost the same elevation in both pictures.

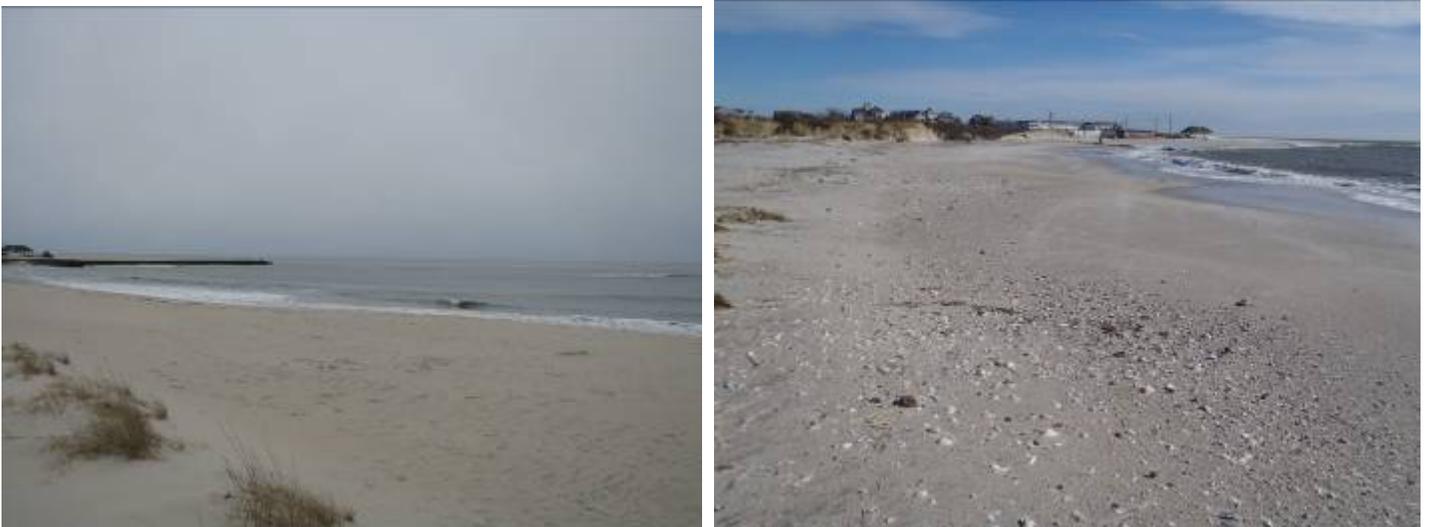
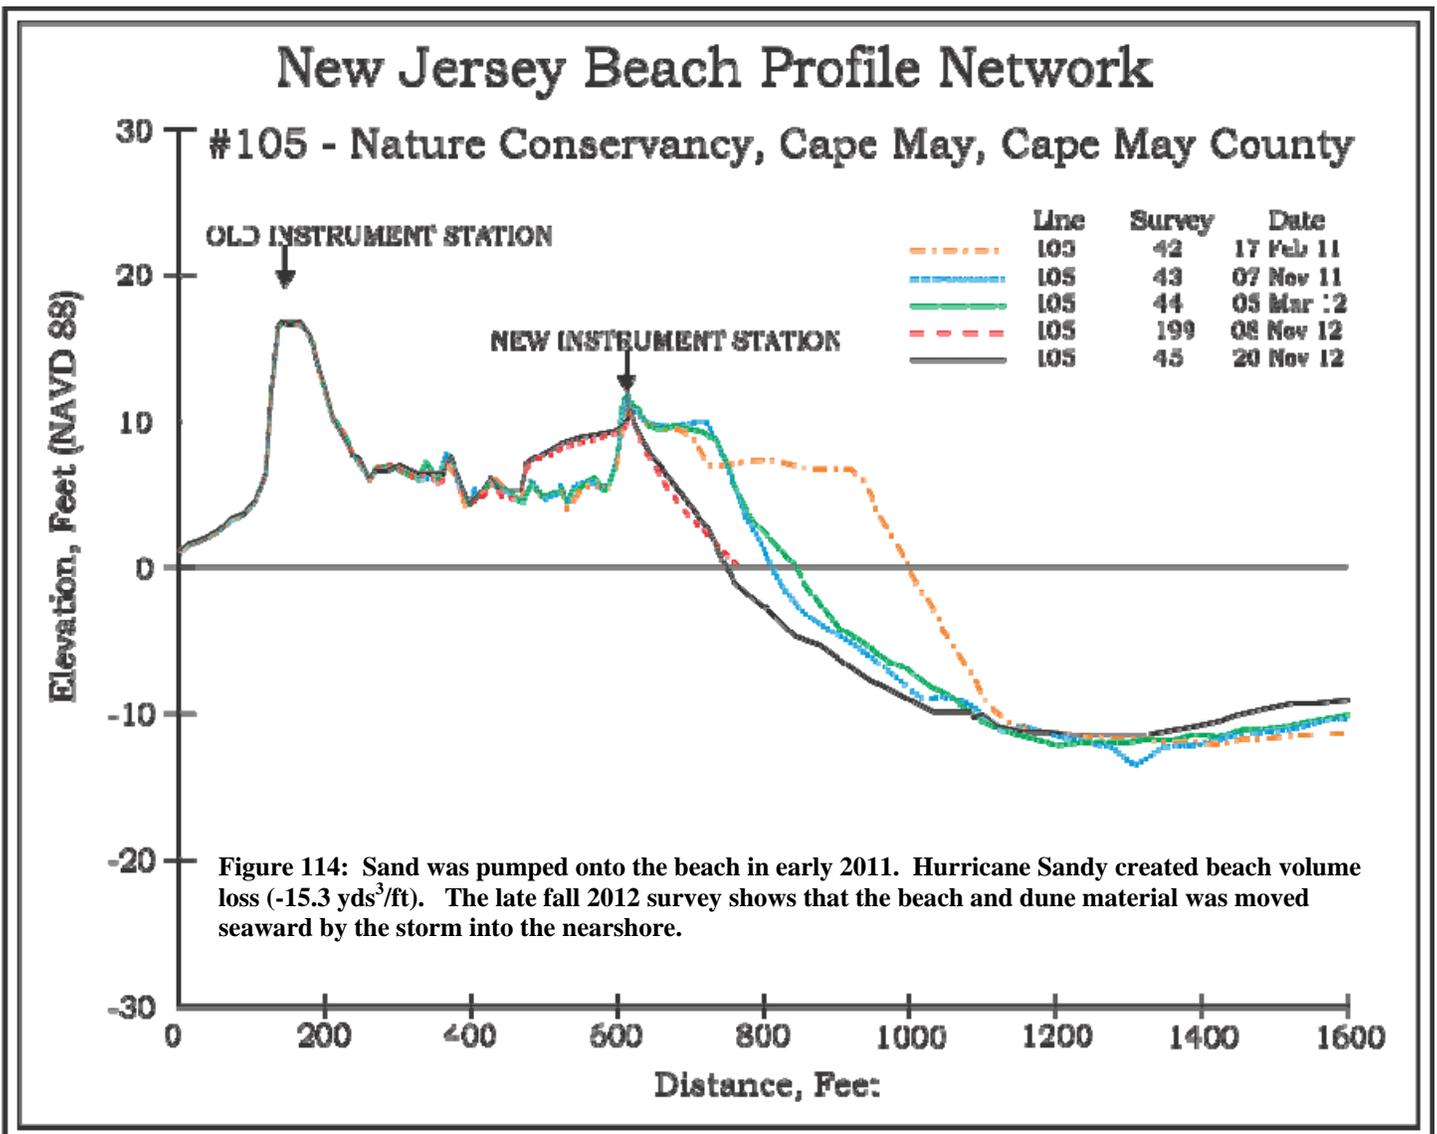
Nature Conservancy, Cape May County, Site #105;

The left picture was taken March 5, 2012 looking toward the terminal groin in Cape May City. The left shot was done November 9th showing the dune erosion and overwash into the newer dune development that has occurred over the past 22 years since the initial beach restoration took place in Cape May City in 1990.

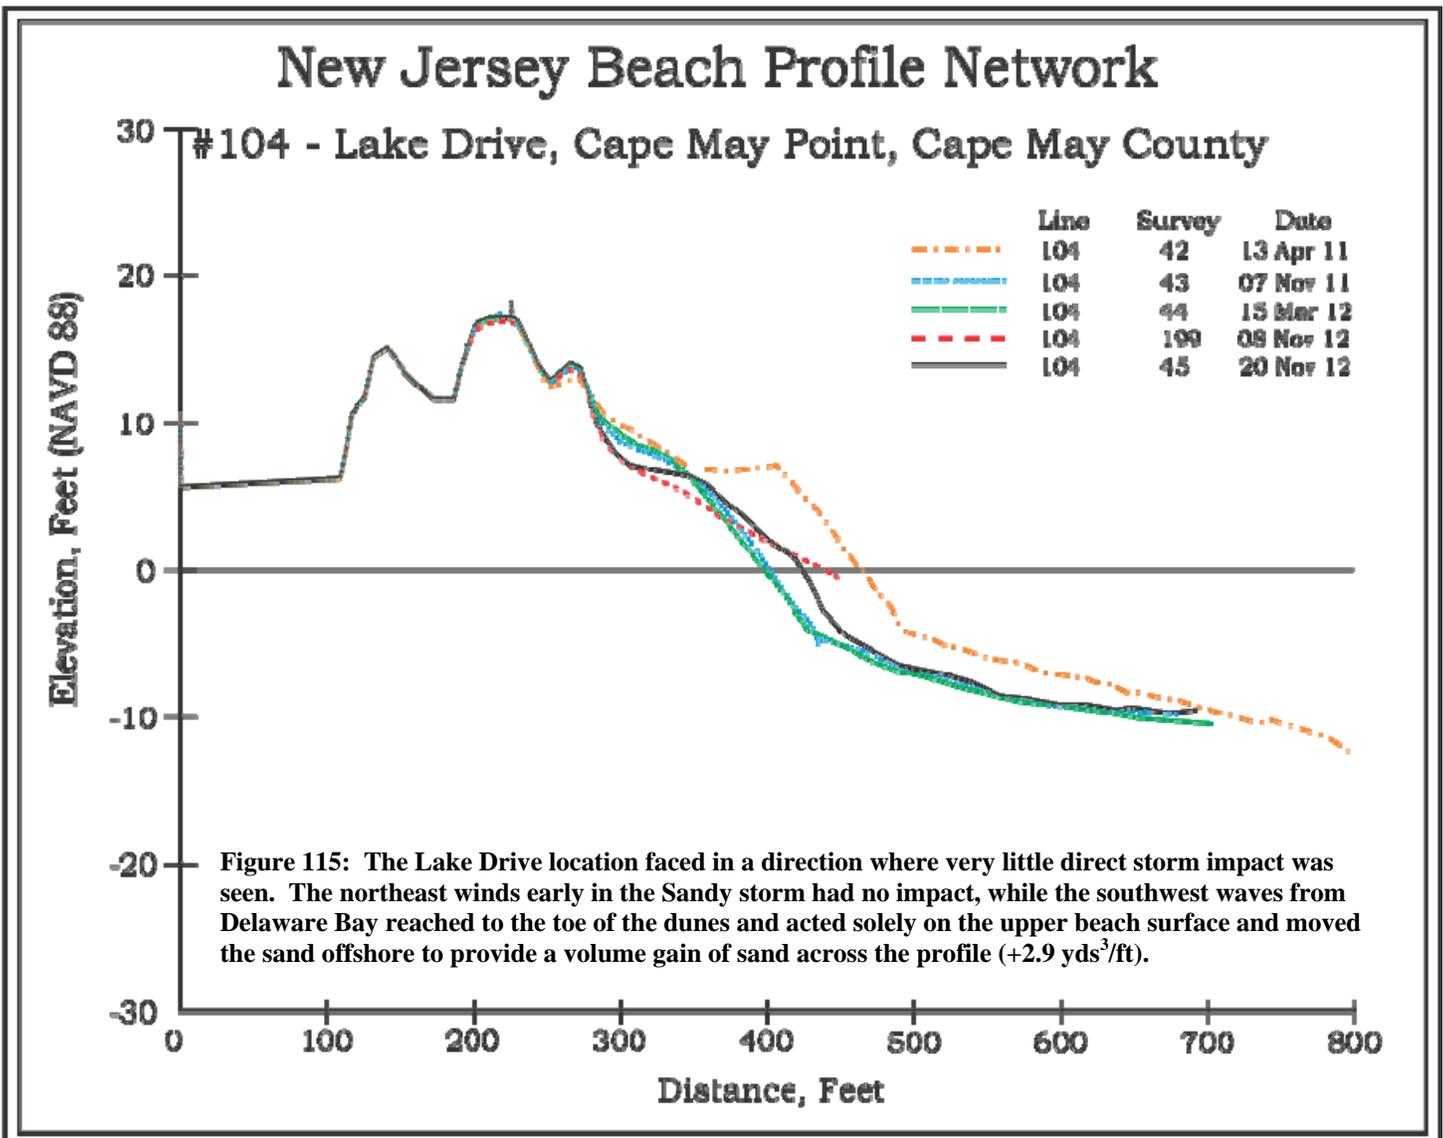
Lake Drive Cape May Point, Cape May County, Site #104;

The left picture was taken March 15, 2012 while the post-storm photograph was taken November 20th looking across the dunes to the bay. The beach was reduced in width somewhat, but no erosion occurred in the dunes. This location was essentially untouched by the storm.
