New Jersey Beach Profile Network

Cape May County

Great Egg Harbor Inlet
to Stow Creek

Cape May County Storm Damage Report:

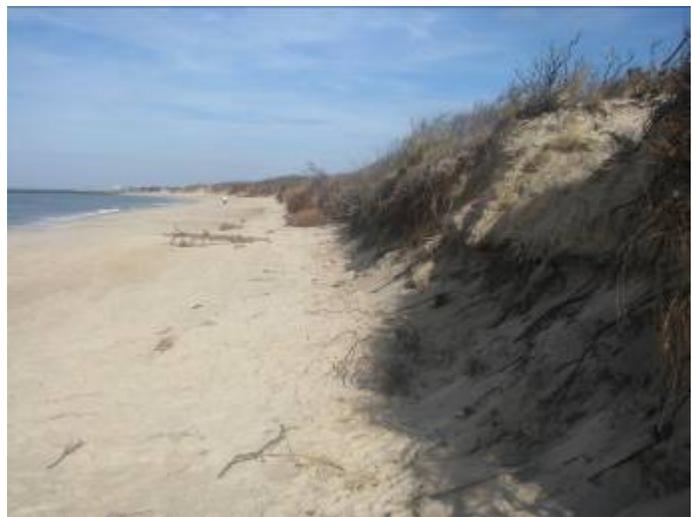
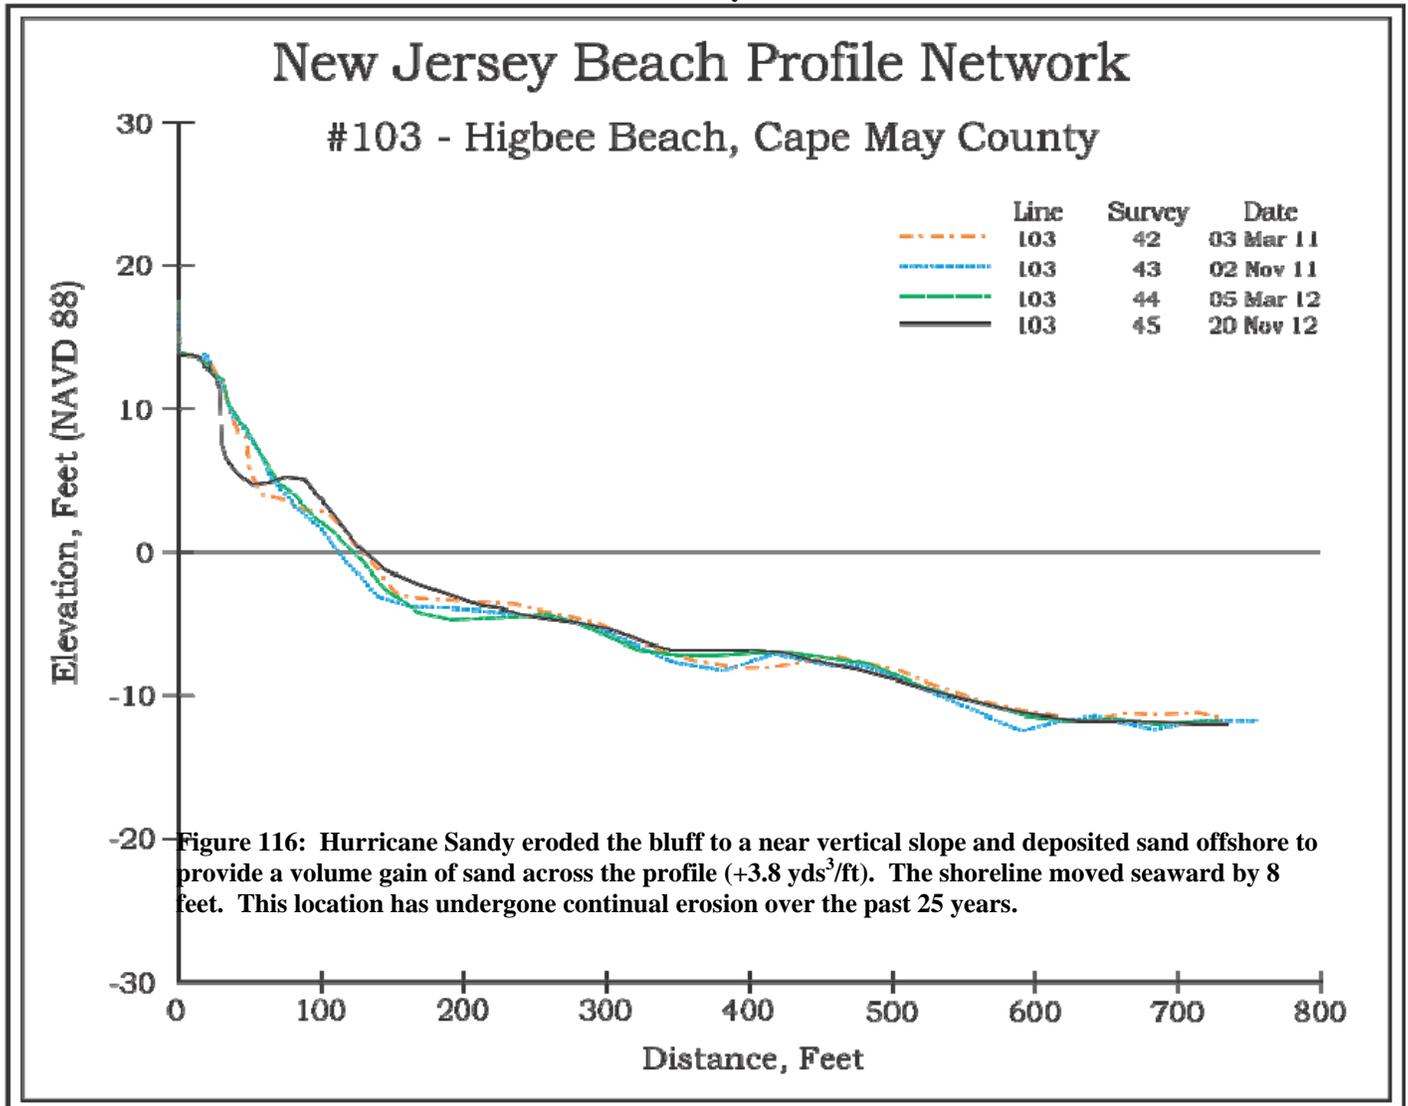
Higbee Beach State Park, Cape May County, Site #103;

The left picture was taken March 5, 2012 while the post-storm picture on the right was taken November 20, 2012. The shoreline at the State Park, south of the Cape May Canal suffered bluff erosion into the mantle of wind-deposited sand that mantles the scarp. The incipient grasses were stripped away between the high tide line and the base of the bluff during Sandy. The beach was lower but wider with some sand moved into the bay.

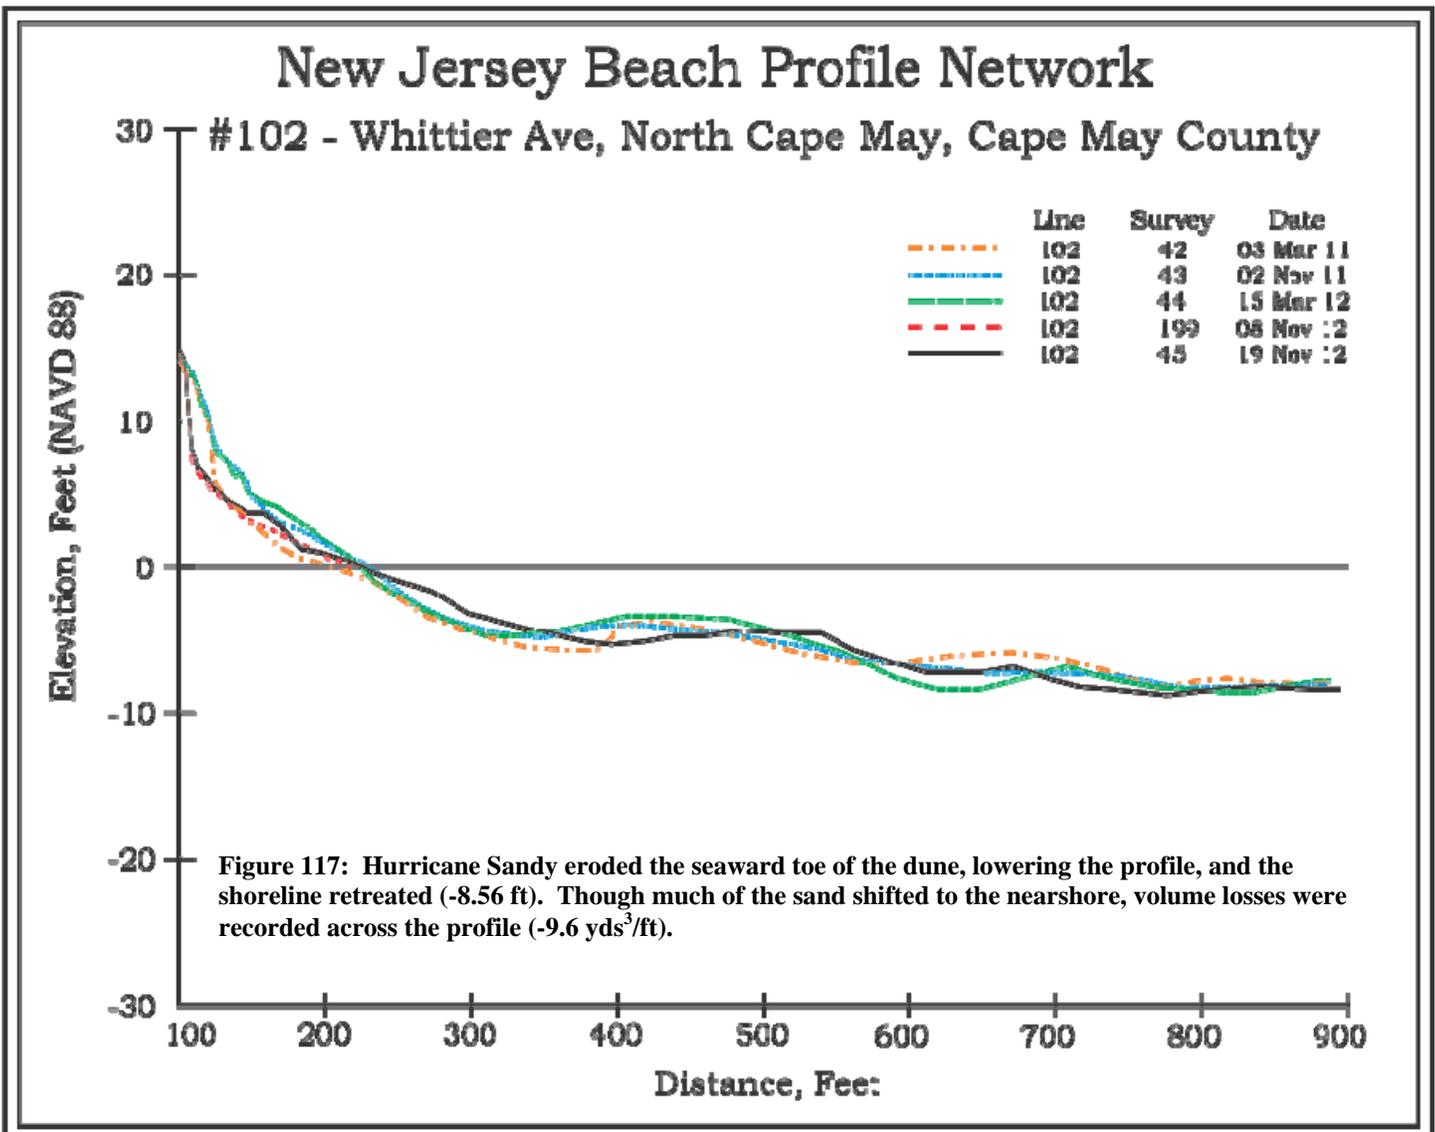
Whittier Avenue, North Cape May, Cape May County, Site #102;

At Whittier Avenue the drainage line shows the extent of beach erosion between March 15, 2012 and after Sandy on November 9th. Sand was moved offshore onto the terrace, but the dune withstood the majority of the Delaware Bay wave assault on this shoreline.

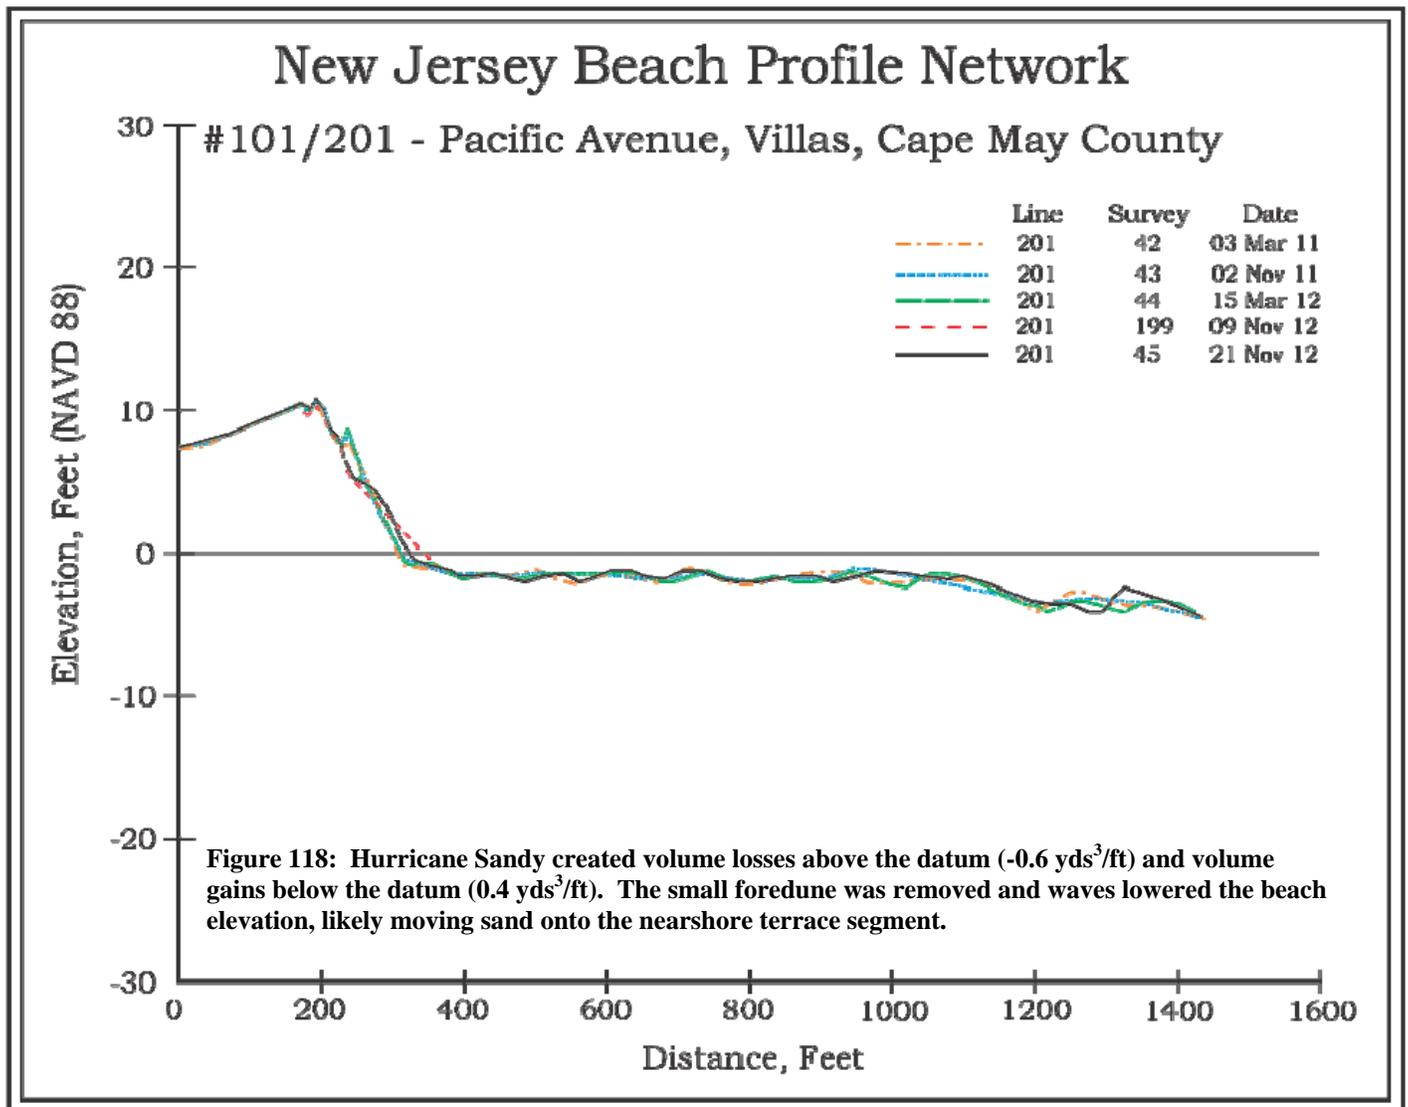
Pacific Avenue, Villas, Cape May County, Site #201;

The left view was taken March 7, 2012 looking south along the beachfront. By November 9th the storm impact was found to have eroded the beach into the toe of the dune reducing the beach elevation and creating a minor scarp. The height of the uplands bluff prevented local wave or tidal flooding.

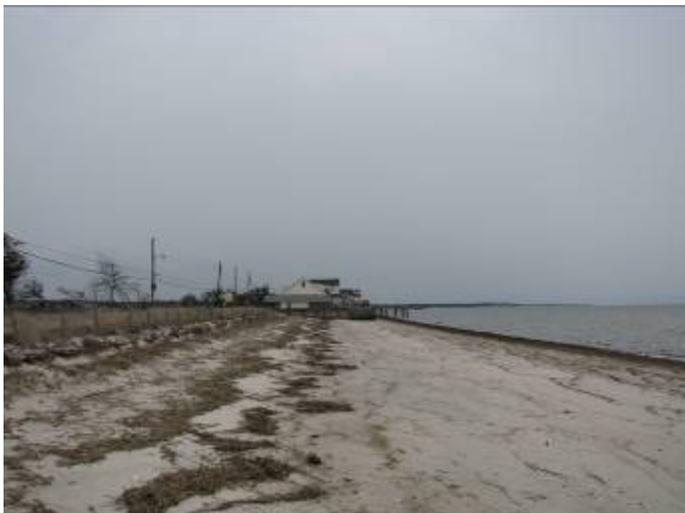
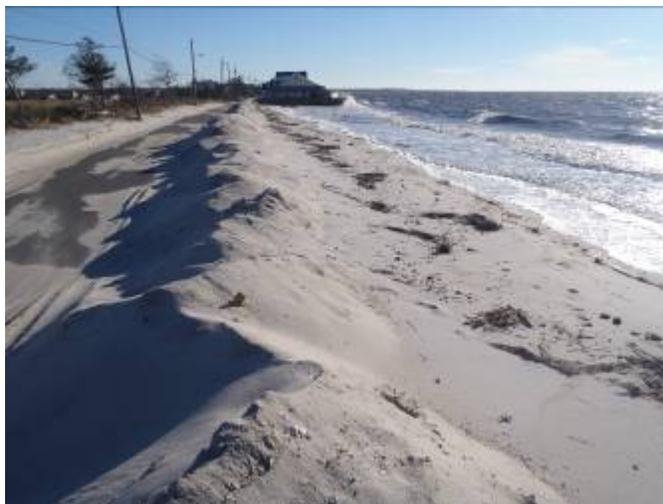
Reeds Beach, Cape May County, Site #100;

The left photograph was taken March 5, 2012 looking south. The dune was vegetated and the beach was higher in elevation compared to the post-Sandy picture on the right taken November 8, 2012. The sand in the center of the right photo has been transferred from the roadway back to the beach as a series of piles.

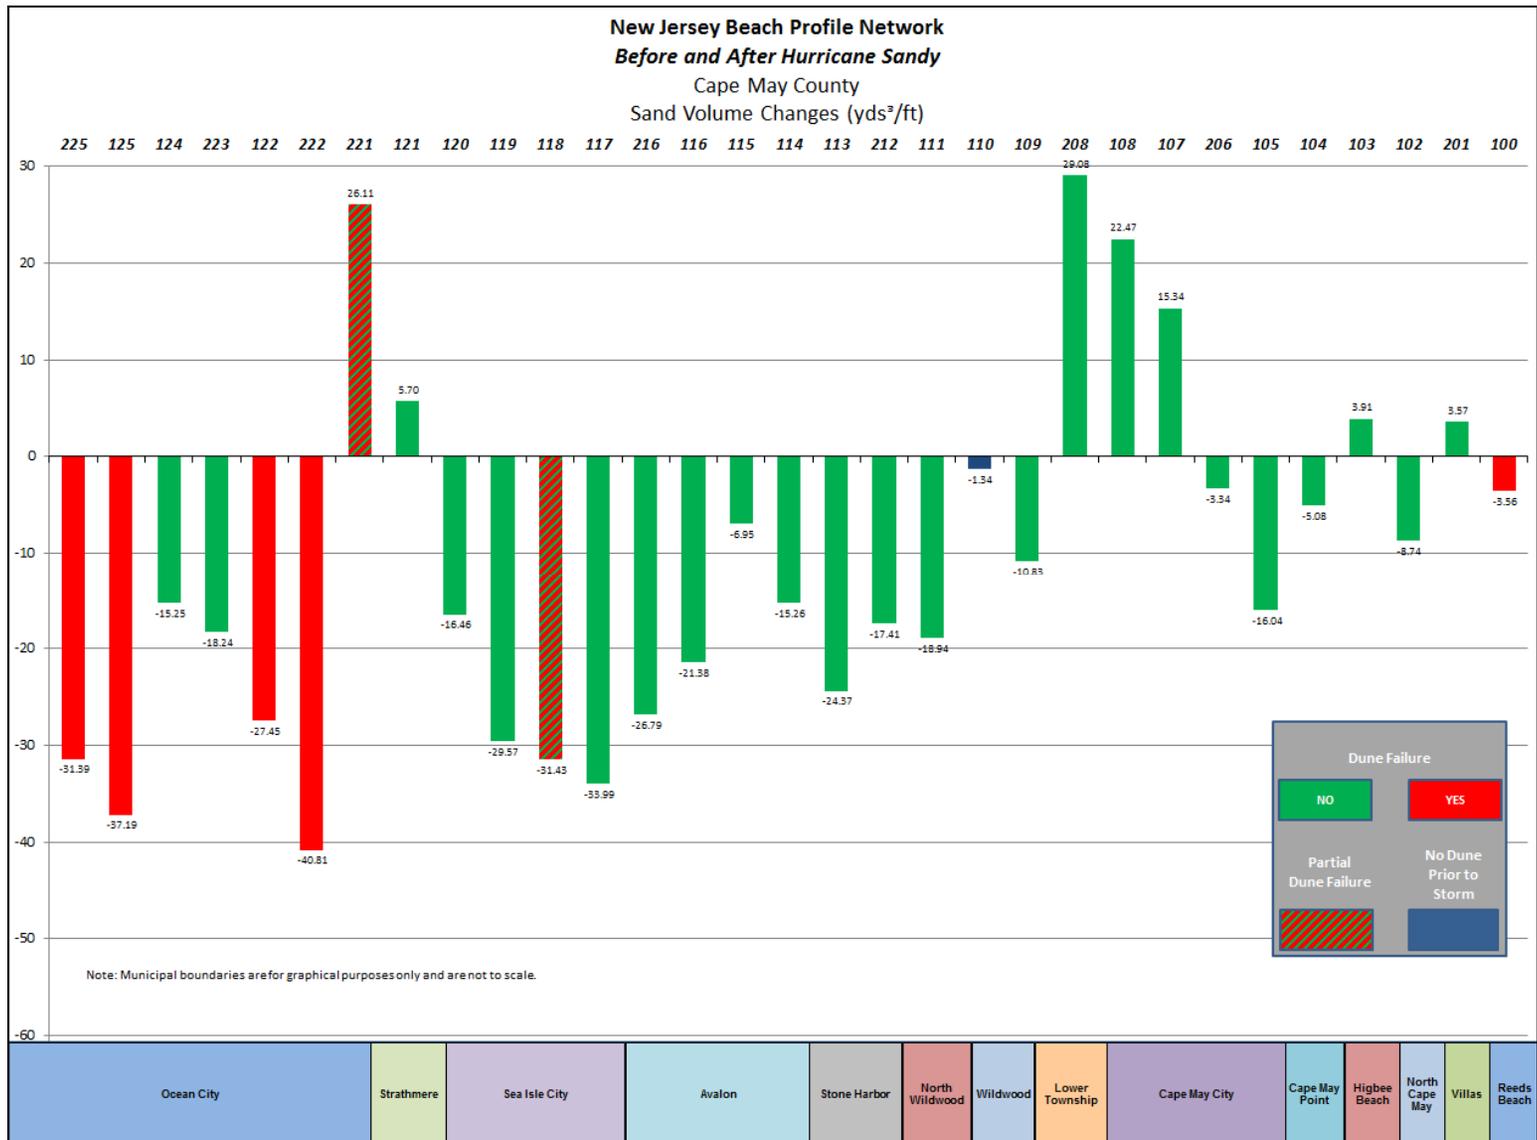
Figure 120. This graphic shows the sand volume loss figures for each of the communities within the developed sections of the Cape May County shoreline. Federal shore protection projects have occurred along this portion of the New Jersey shoreline in Ocean City, Strathmere, Sea Isle City, Avalon, Stone Harbor, North Wildwood, Cape May City, Cape May Point, and Reeds Beach. The engineered beach and dune systems have been maintained by the USACE recently and kept the storm generated waves from breaching the dunes. All sites experienced berm erosion and dune losses except for site 221 Corson’s Inlet State Park, which is undeveloped, site 121 in Strathmere, which recently completed a beach nourishment project, sites 208 Cape May National Wildlife Refuge, sites 108 and 107 in Cape May City, where the orientation of the storm and location of landfall actually created long period swell waves that built up the beach. There were also moderate gains at site 103 in Higbee Beach State Park and site 201 in the Villas, which is located in the Delaware Bay. True dune failures occurred in Ocean City, where the greatest sand volume losses also occurred and overwash of waves transported sand landward of the beach.

The table below shows the sand volume change between either the earlier fall survey at each site or the spring 2012 survey (natural sites) and the post-Hurricane Sandy survey.
