New Jersey Beach Profile Network

Monmouth County

Raritan Bay and Sandy Hook
to Manasquan Inlet

**NJBPN Profile #'s
187 - 256**

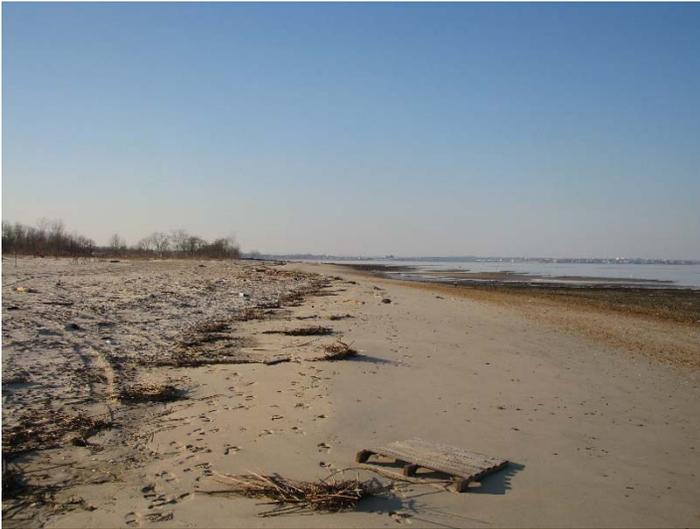
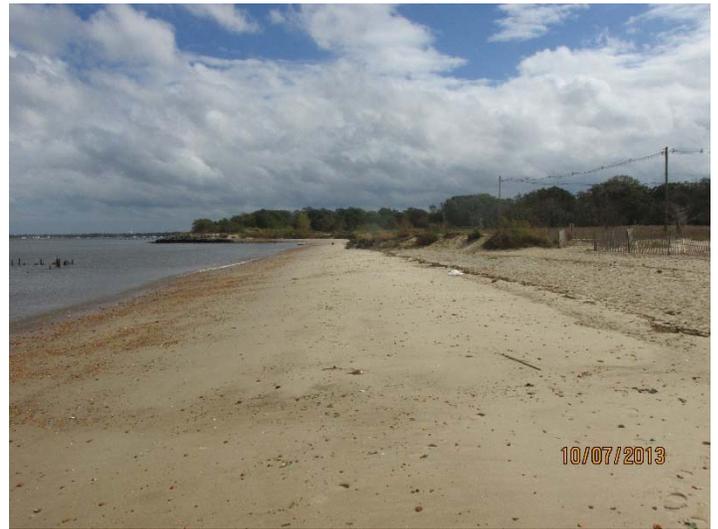
This is the westernmost NJBPN site located on Raritan Bay. The photograph on the left shows the shoreline on December 13, 2012. The photo on the right, at low tide shows the new dune fence with a modest dune (taken on October 7, 2013).

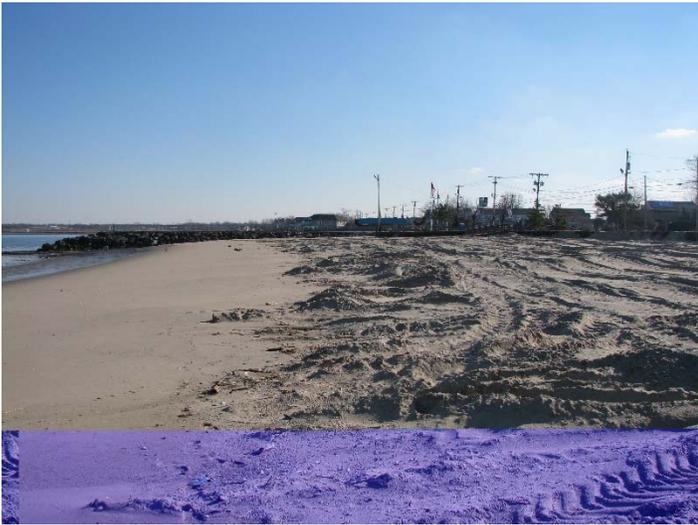
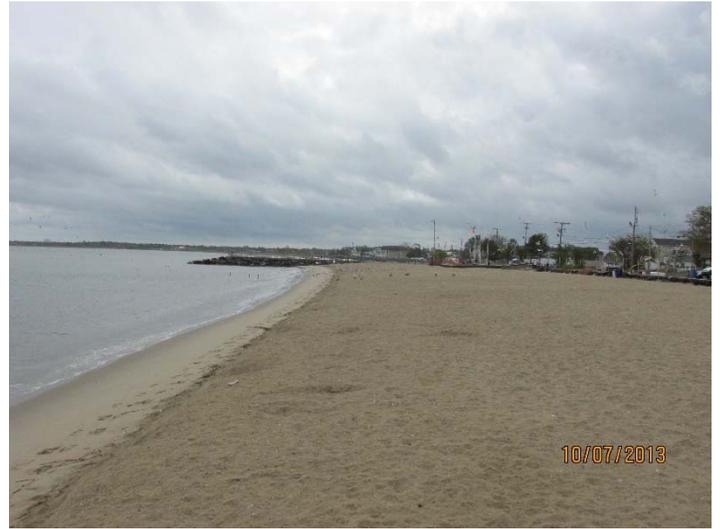
This site is located at the public bathing beach and was established in 2009. The photograph on the left shows the shoreline on November 13, 2012. The photo on the right shows the beach following addition of 14,000 cu. yds. of trucked in sand as a result of the municipality’s efforts in replacing lost sand following Sandy (taken on October 7, 2013).

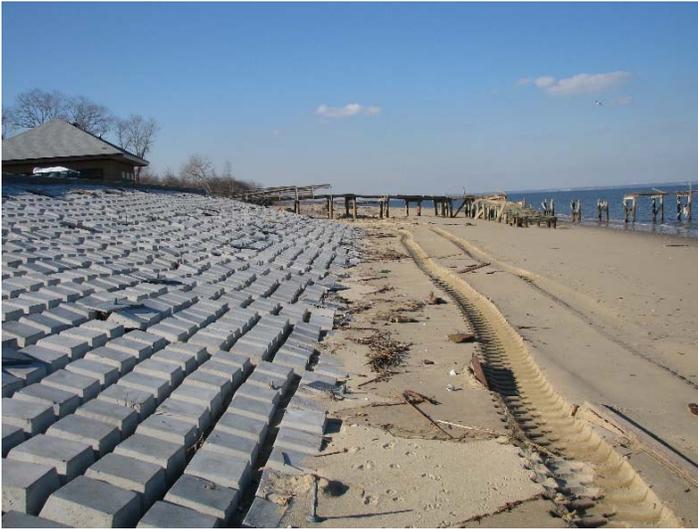
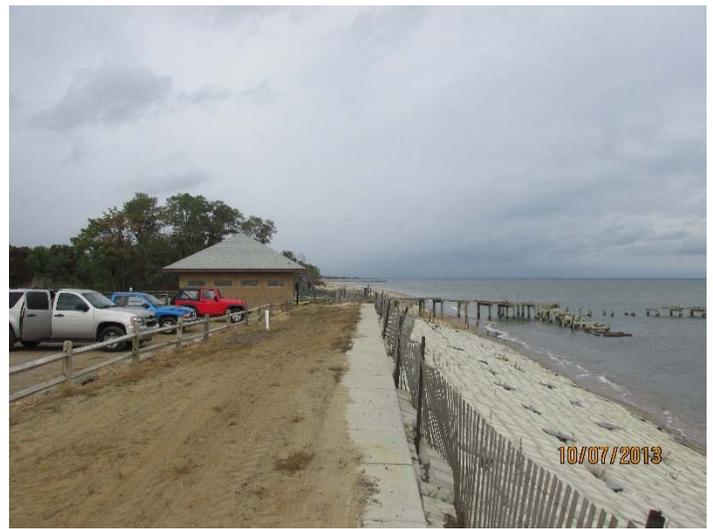
This site was enhanced by adding slope protection to the eroding uplands bluff prior to Sandy. The photograph on the left shows the shoreline on December 13, 2012. The right picture was taken October 7, 2013 at a higher level of the tide.

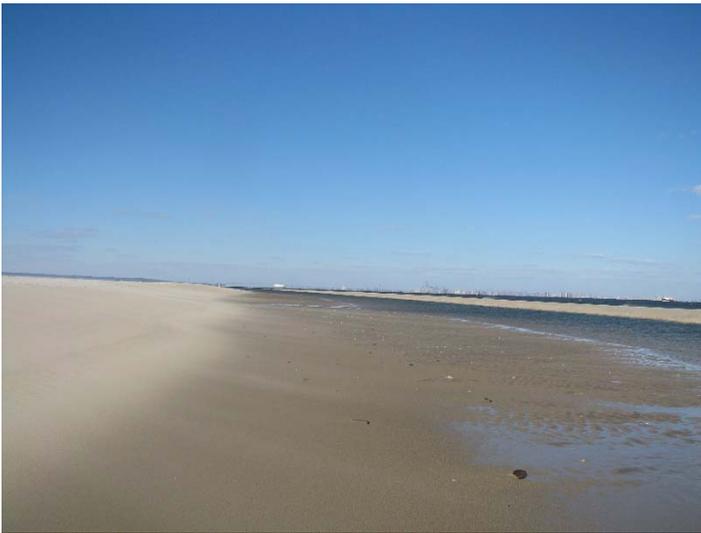
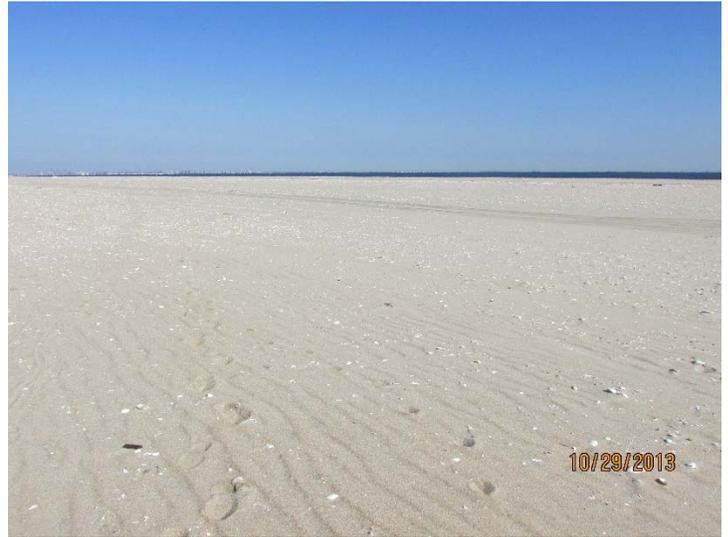
This is the northernmost ocean NJBPN survey site that has shown advances in the berm position since 1999. The photograph on the left shows a sand ridge in the process of attaching to the beach following Sandy (Jan. 22, 2013). By October 29, 2013 the sand was effectively added to the shoreline widening the beach another 100 feet.

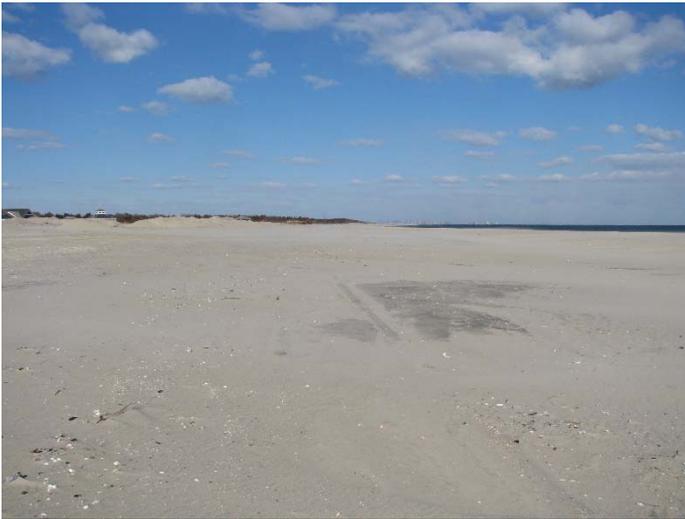
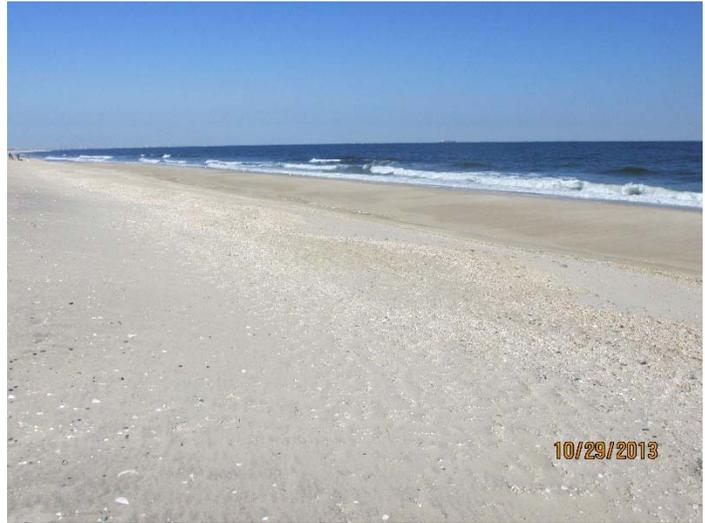
Hurricane Sandy’s damage was significant because it broke through the dunes, but the beach remained (Jan. 22, 2013). By October 29, 2013 a modest berm had welded back to the shoreline and a new dune had been completed.

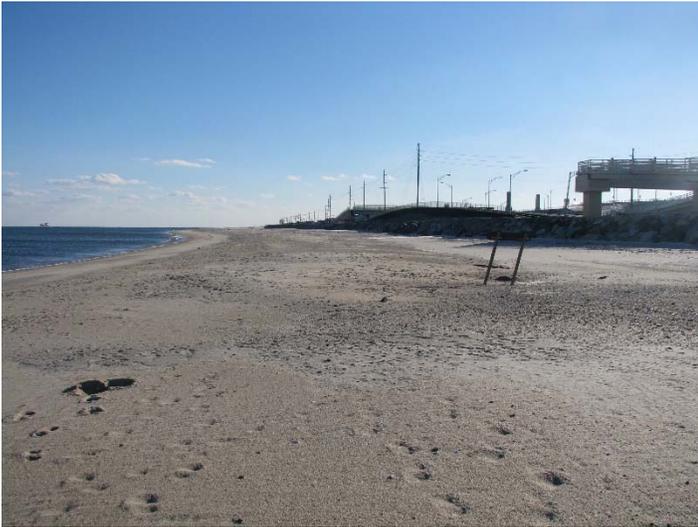
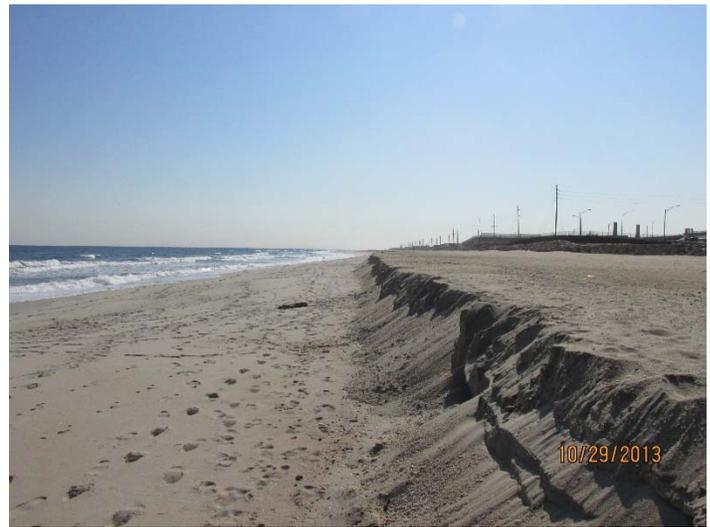
This southern Sandy Hook site is located near the entrance to the park and has gained in volume since the 1995 start of the federal shore protection project. The left view was taken following Sandy on Jan 22, 2013. By October 29, 2013 the ACOE had returned and placed sand to design template cross section. Erosion of the berm is evident following a minor NE storm.

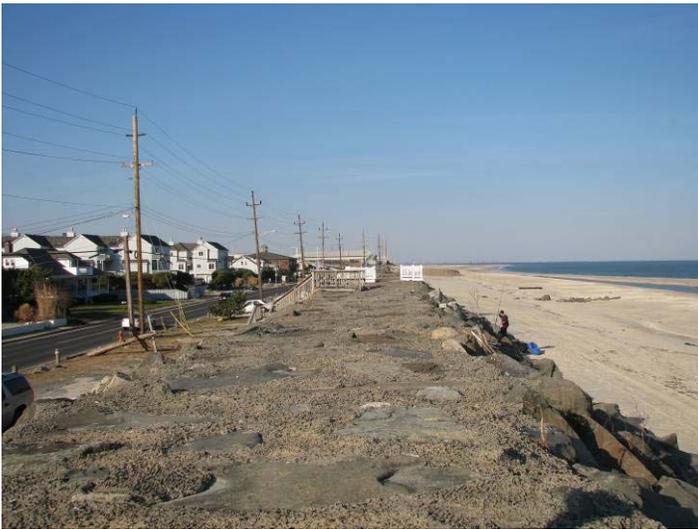
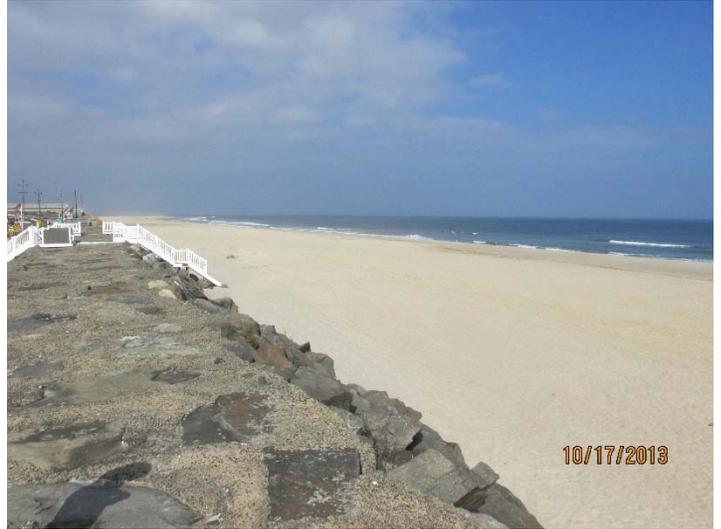
This site was near the northern limit of the initial Federal shore protection project and shows the narrower beach following Sandy on Nov. 26, 2012. The right side shows the results of the placement of 40.12 yds³/ft. of new sand on the beach by Oct 17, 2013.

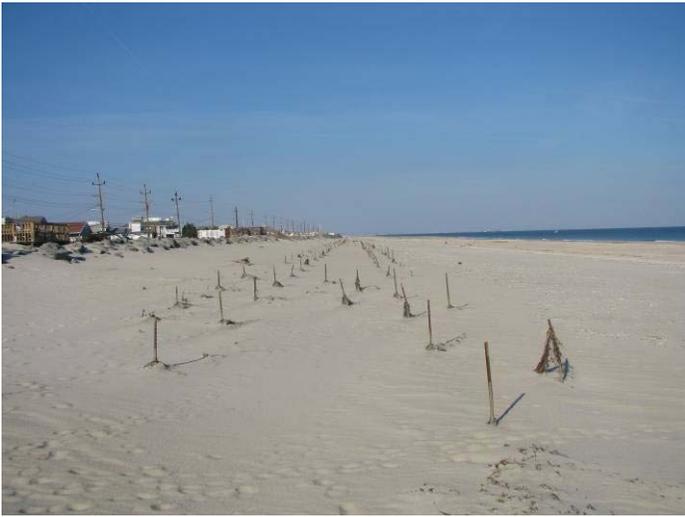
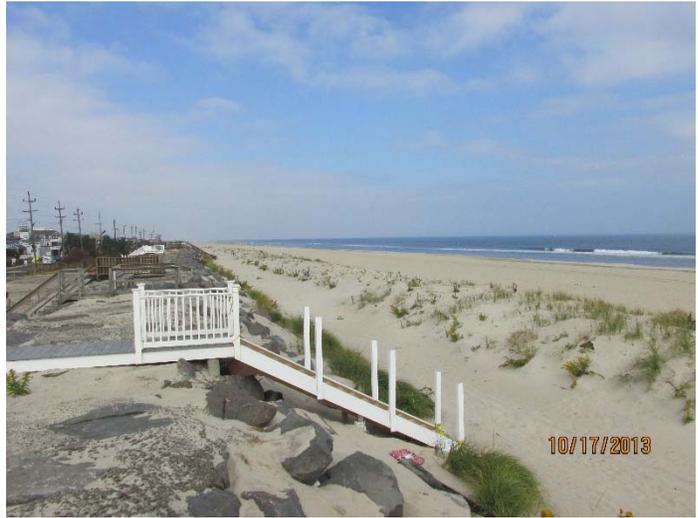
The left view shows the remnants of the “dunes” with sand ramped up to the seawall taken November 26, 2012. The ACOE pumped sand back to the original design cross section and the sand the storm pushed up the seaward face of the seawall was extracted and formed into the dune seen on the right view October 17, 2013.

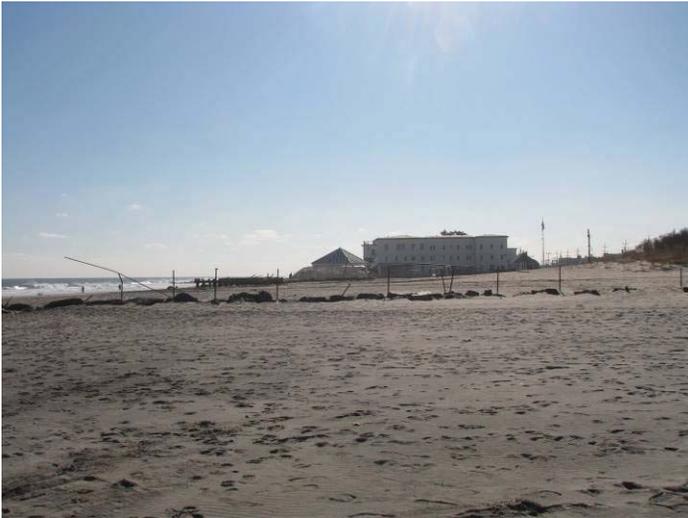
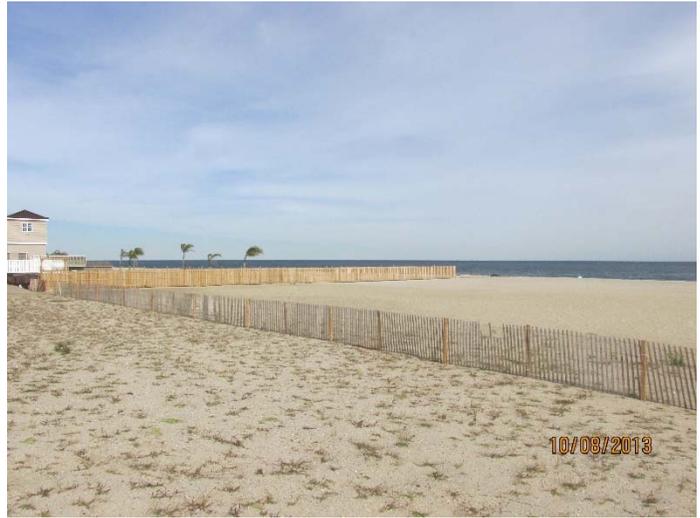
Low, wide dunes established naturally following the initial Federal beach nourishment project did not stop the Sandy storm waves (left view November 26, 2012. By October 8, 2013 the ACOE had restored the beach width and a dune was added from sand extracted from inland and the material ramped up to the rock seawall.

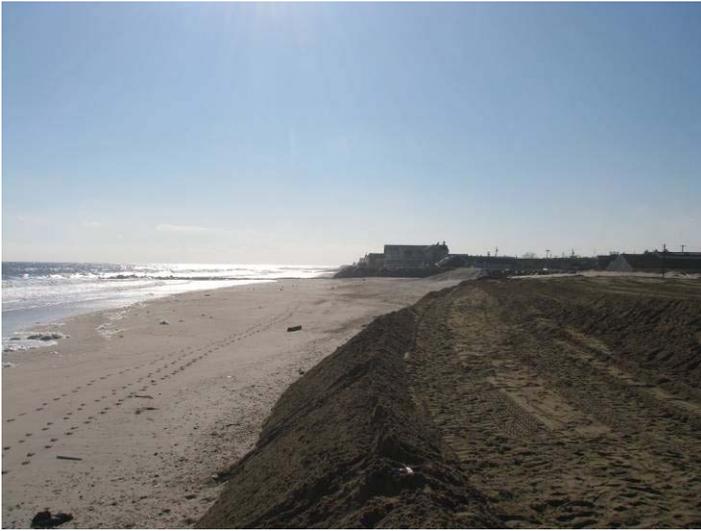
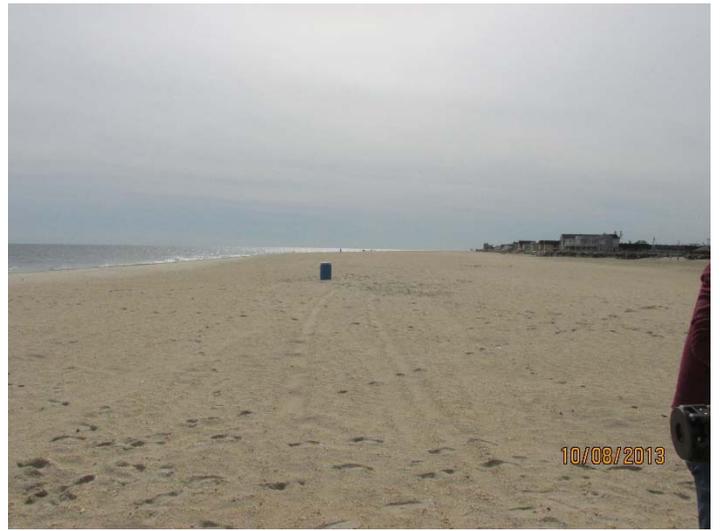
This site was the most heavily damaged along the northern Monmouth County shoreline from Hurricane Sandy, with the left view showing sand pushed back to the beach from inland deposits in November 26, 2012. By October 8, 2013 the ACOE had deposited 110.88 yds³/ft. to restore the design cross section. The change in proximity of the buildings to the water is evident.

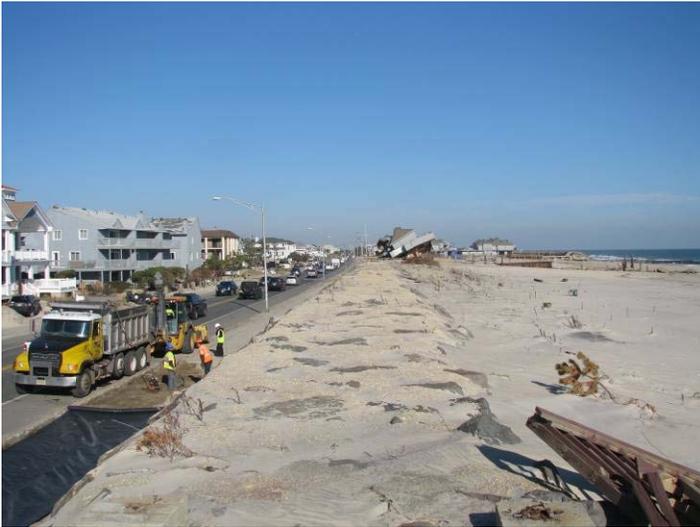
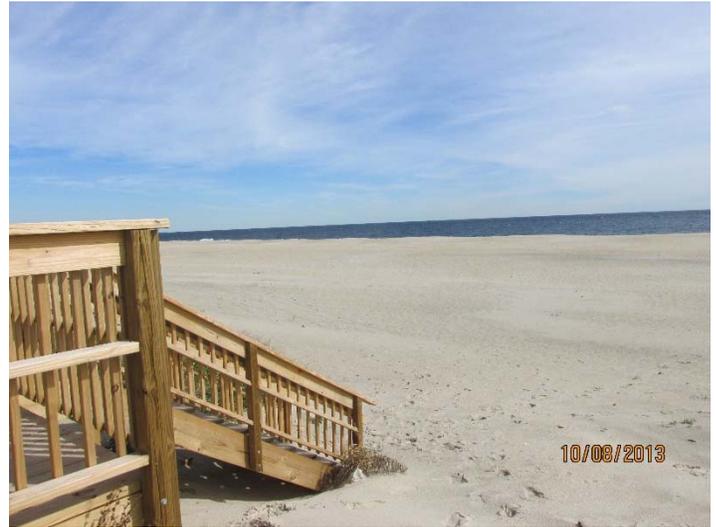
This site received sand from the initial Federal beach nourishment project. The left photograph (Nov. 21, 2012) shows where Sandy’s waves pushed sand into a gentle ramp up the seaward rock slope and allowed the wave bores to pour over the wall into Ocean Avenue and associated properties. The restoration by the ACOE had just been completed in the right photo taken October 8, 2013 with the addition of 101.64 yds³/ft. to the profile’s cross section.

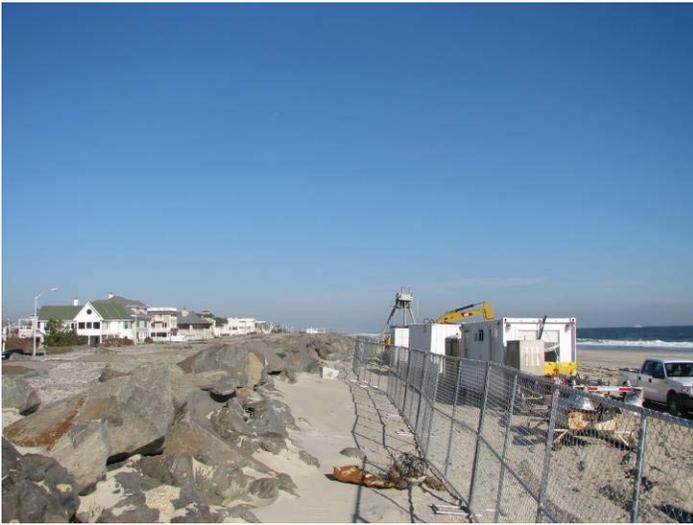
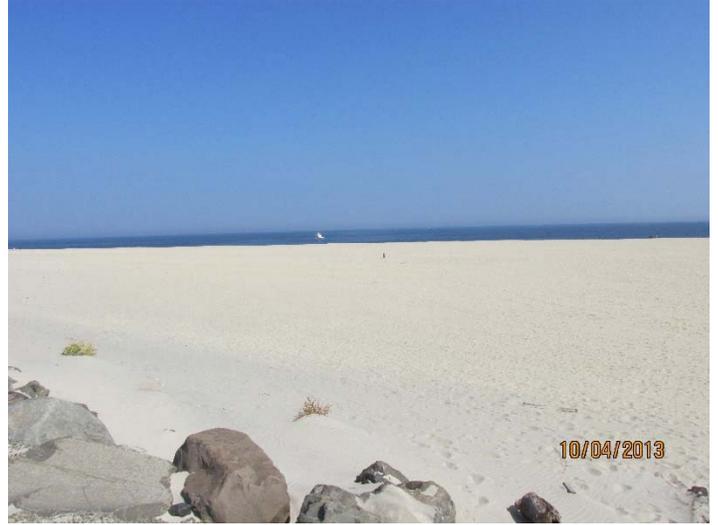
This site has the worst erosion history of any site in Monmouth County. Chronic volume losses have been recorded over the years because the rock groin just south of the site blocks sand transport from the south. Most of the sand placed by Jan. 2012 was moved to the nearshore or over the seawall during Sandy. The left photograph (Nov 21, 2012) shows the renourishment activities following the storm and the Oct. 4, 2013 shows the completed work (182.99 yds³/ft. added to the beach).

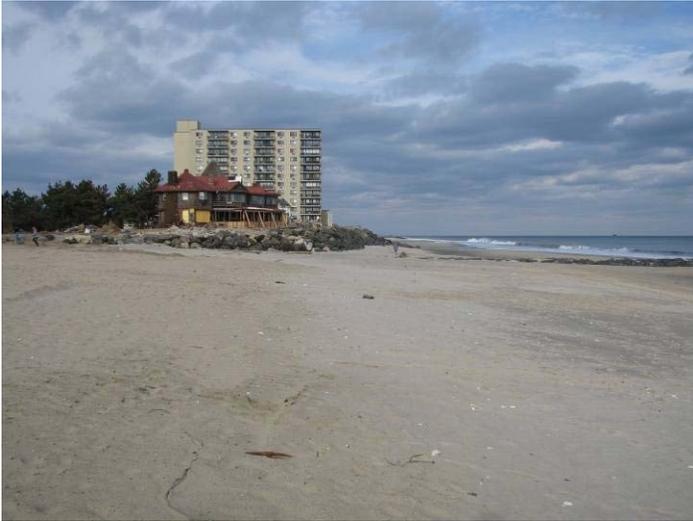
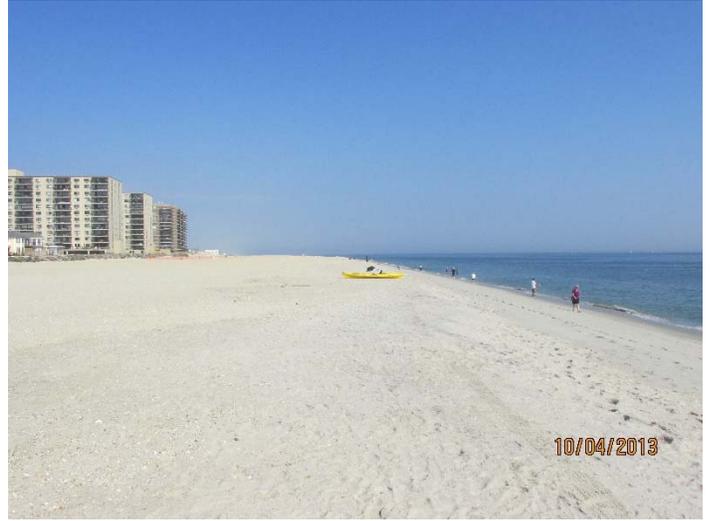
This profile received the initial Federal beach nourishment project and the winter 2011 to 2012 renourishment (left photo taken Nov. 25, 2012 after Sandy). Hurricane Sandy removed significant amounts of sand from the berm, destroyed a moderate-sized dune and badly damaged the beach club buildings. The right photo taken October 4, 2013 shows the results of the ACOE work to restore the project to design specifications (140.98 yds³/ft. of added sand).

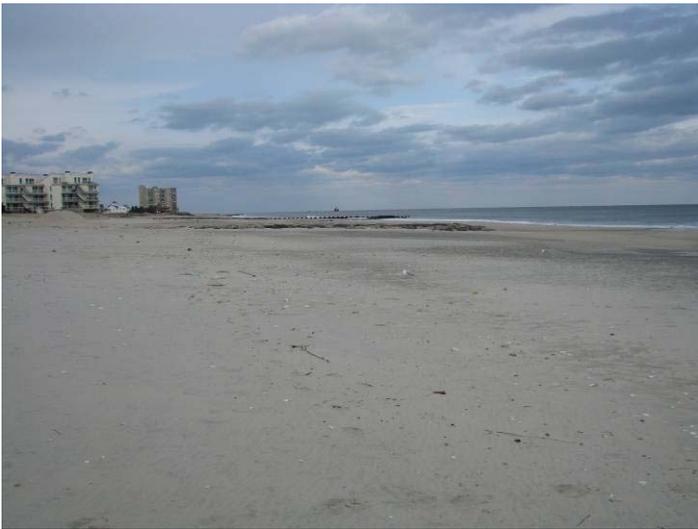
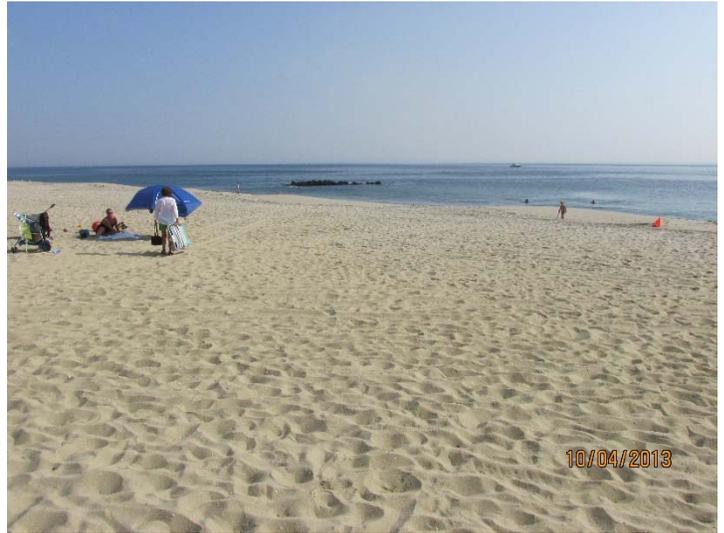
Sand was placed during the initial Federal beach nourishment project. This site was the southernmost one NOT surveyed prior to Sandy. After Sandy, the berm was reduced in elevation and pushed landward (left photo taken November 25, 2012). The right photo was taken October 4, 2013 following the recovery of 22.93 yds³/ft. on the beach naturally, prior to the arrival of the ACOE to complete the northern segment of their project.

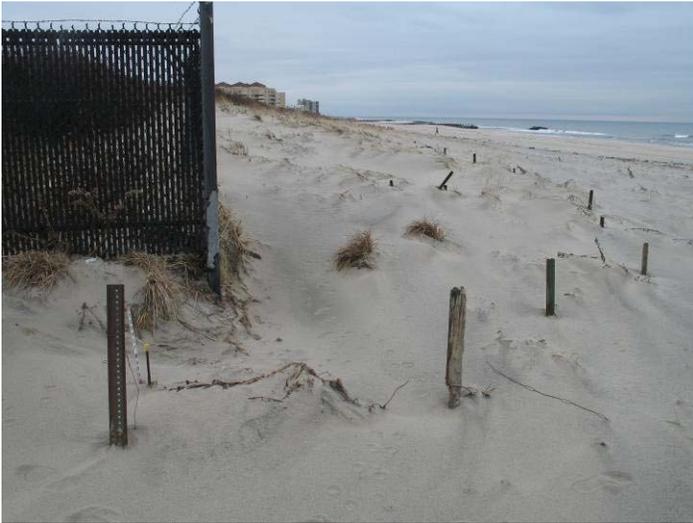
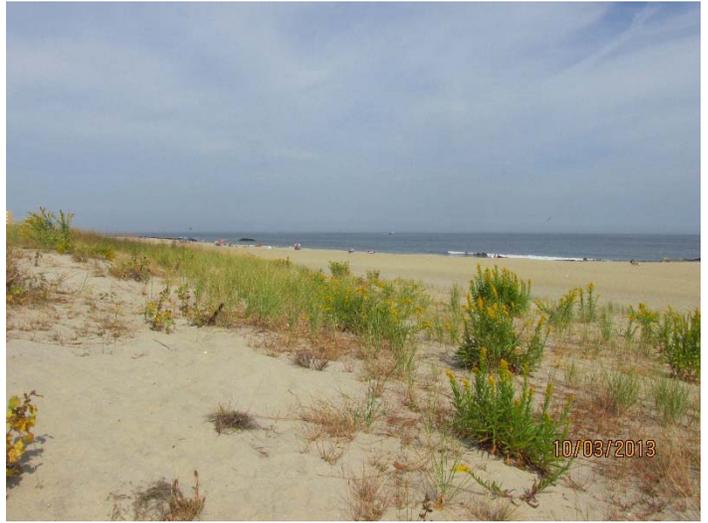
This site is a popular recreational park with a partial ridge of 25-foot elevation dunes and an expansive berm that has undergone variable volume changes through the years (left photo taken Nov. 13, 2012). During Hurricane Sandy, the grade-level public access points created channeled flow from the storm waves and washed sand landward into the parking lots. Natural recovery added 20.68 yds³/ft. to the beach prior to the ACOE work (right photo taken October 3, 2013).

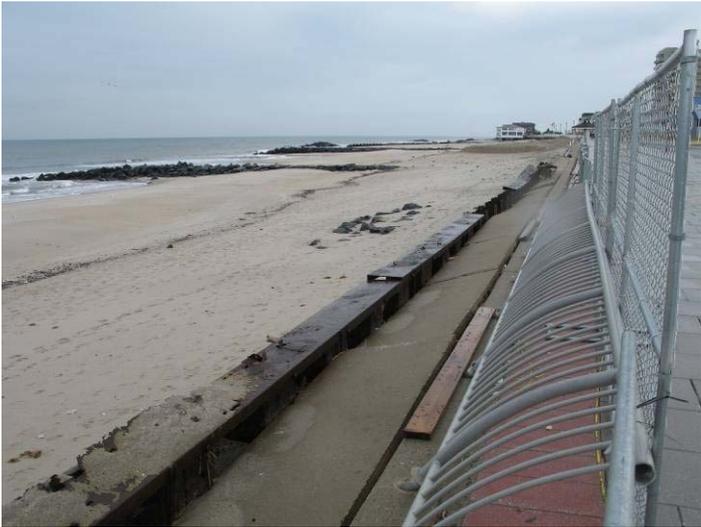
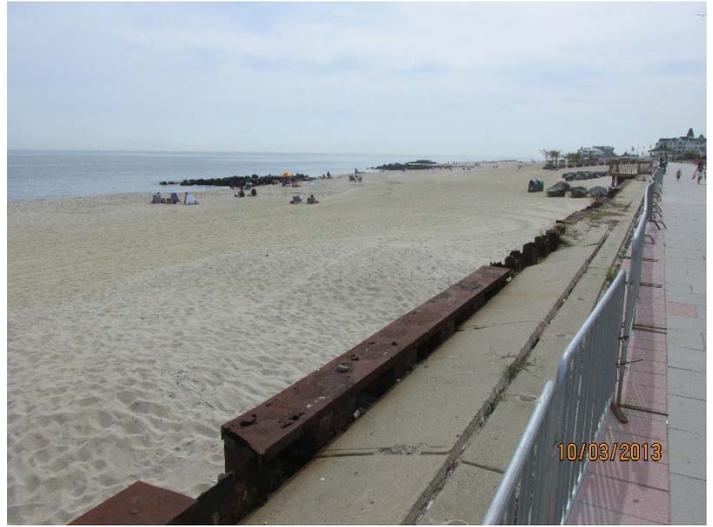
This site was part of the Federal shore protection project and renourishment activities (left photo taken November 13, 2012). H. Sandy relocated the berm sand over the vertical steel wall, but the vast majority of sand was deposited offshore. The railing on the left photograph was bent landward by wave action 17 feet above the zero datum elevation. Natural recovery from the offshore deposits added 22.72 yds³/ft. to the beach prior to 2014 ACOE restoration activities.

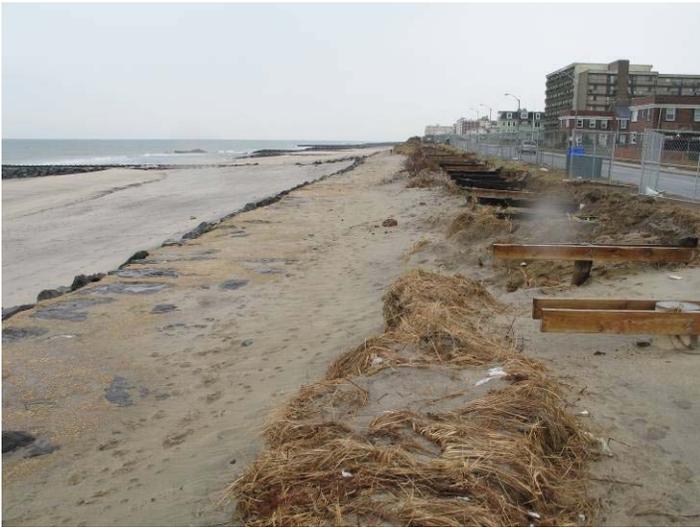
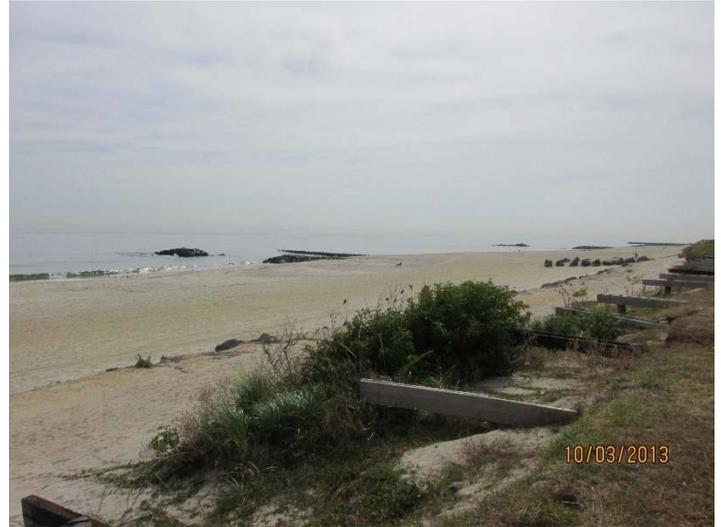
This site participated in the Federal beach nourishment project and was a direct beneficiary from the 2010 maintenance fill completed to the south (left photo taken November 13, 2012). No attempt has been made to replace the boardwalk since Sandy, but natural recovery from offshore deposits returned 12.49 yds³/ft. to the beach prior to the ACOE completing the project's restoration in 2014.

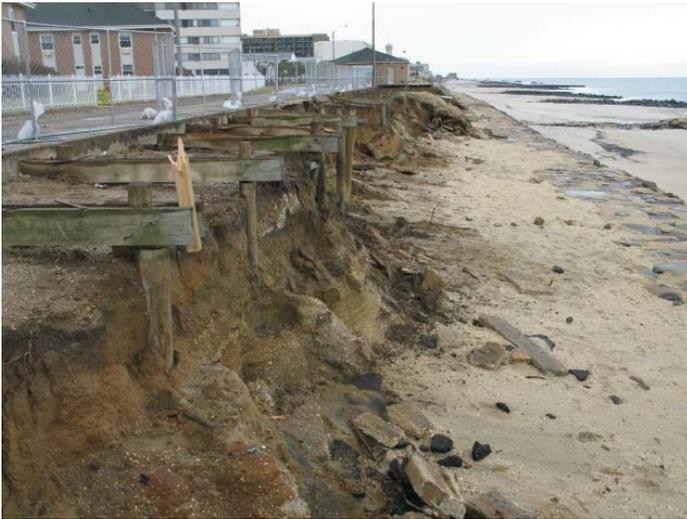
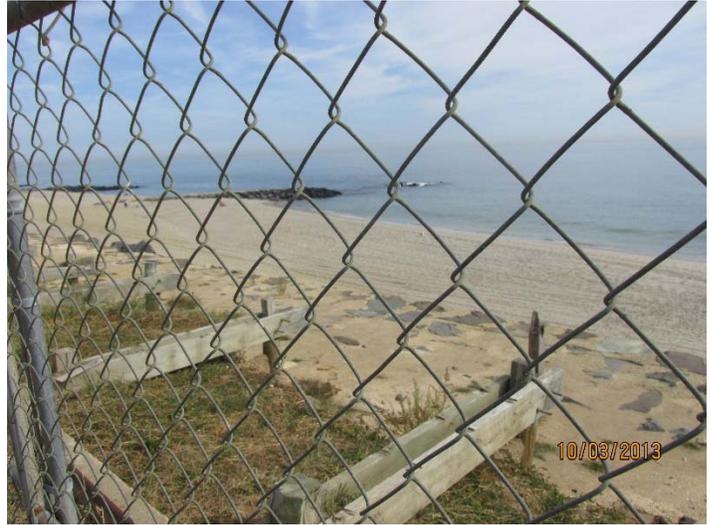
This site is located near the southern limit of the Federal beach nourishment project. Long Branch did not include the construction of a protective dune. It was decided at the time of project planning that the bluff elevation and the presence of the rock revetment was enough protection for landward properties. While the revetment held in place during H. Sandy, the boardwalk built on the upper bluff sediments was destroyed when the bluff retreated to the edge of the old southbound Ocean Ave. roadway (left photo taken November 13, 2012). By October 3, 2013 natural recovery restored 22.96 yds³/ft. to the beach, but no local restoration to the boardwalk had occurred. In 2014 the ACOE announced the project's restoration.

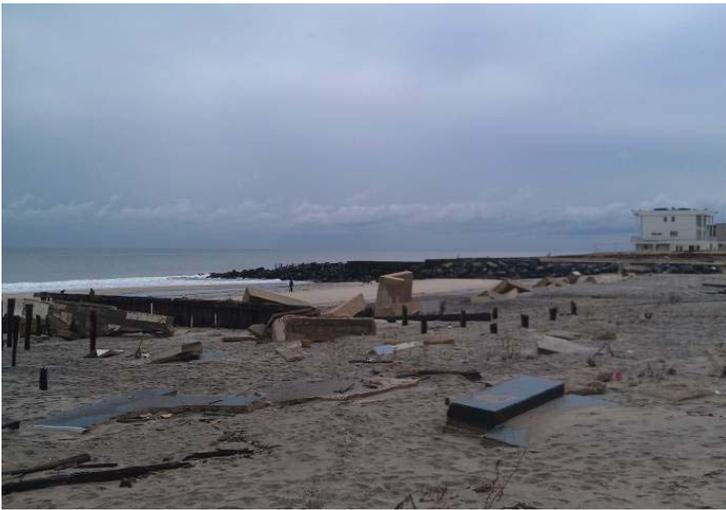
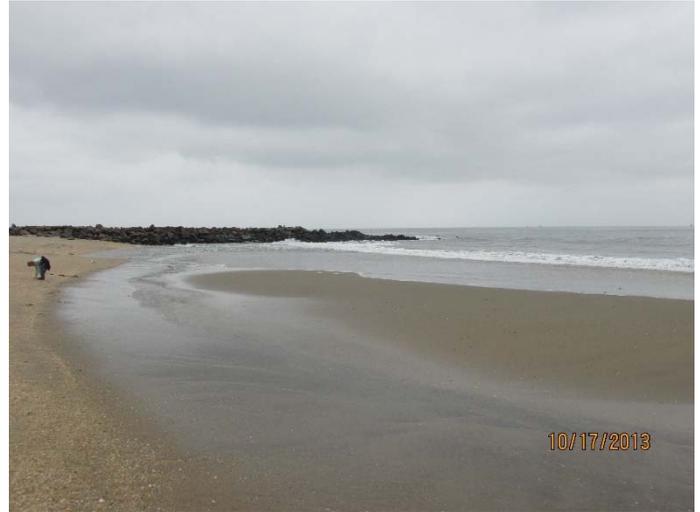
This site, established in 2010, is located on the northeastern edge of Lake Takanassee and within a groin compartment. The left photo (taken November 13, 2012) shows the lowered berm and debris from structures that were destroyed in the storm. On the right (Oct. 17, 2013) the swash zone and beach extends to the north. The ACOE restoration effort will extend to the south into Elberon this coming year.

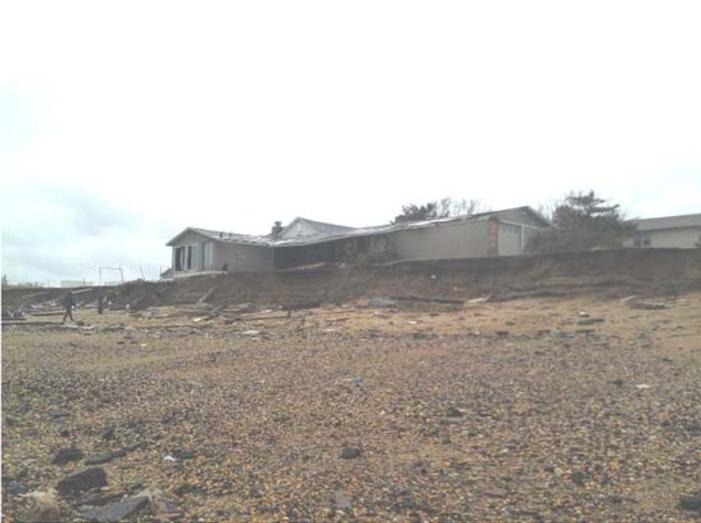
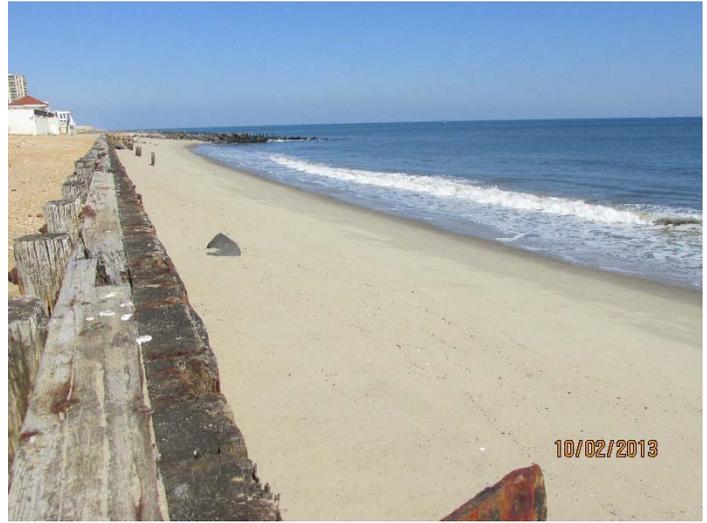
This site is located on the highest point along the bluff shoreline and in the past, has had very little sub-aerial beach as this community was not included in the Federal beach nourishment projects (left photo taken November 13, 2012). Waves apparently broke over the rock revetment, attacked upper un-armored bluff sediments and pushed the edge back 40 feet. The loss of over 12 cubic yards per foot of bluff sediment to the beach zone apparently has resulted in a dry beach by Oct. 2, 2013.

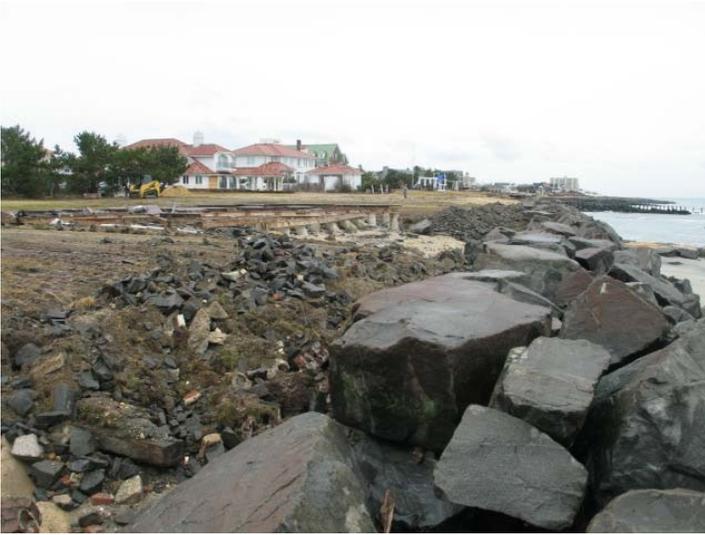
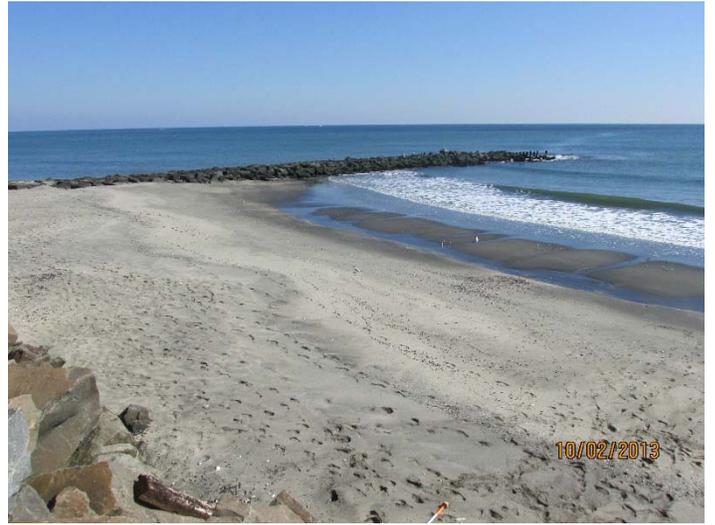
This profile is located between two rock groins that limit sediment movement. This area has never received sand from direct beach nourishment and has never benefited from the addition of sand from the littoral system derived from the Federal beach fills. The photo on the left (taken November 13, 2012) shows the impacts of Sandy where waves crashed over the rocks and dug deeply into the area just landward of the rock revetment. By October 2, 2013 sand moved offshore and eroded from the bluff contributed to an addition of 35.17 yds³/ft. to generate a dry beach at this site for the 2nd time in 28 years.

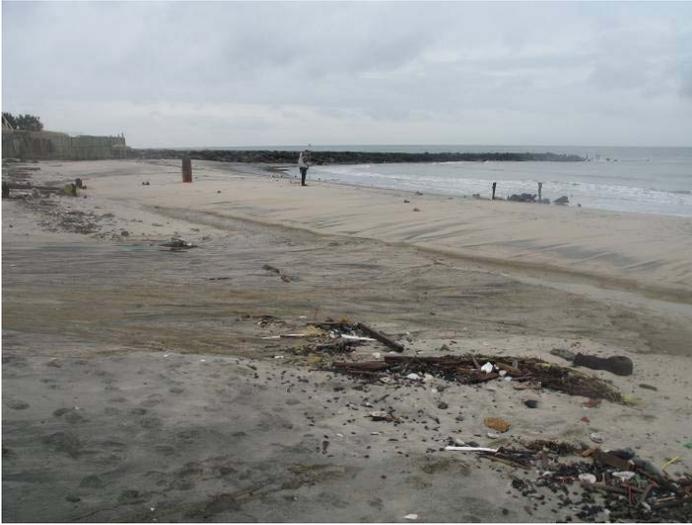
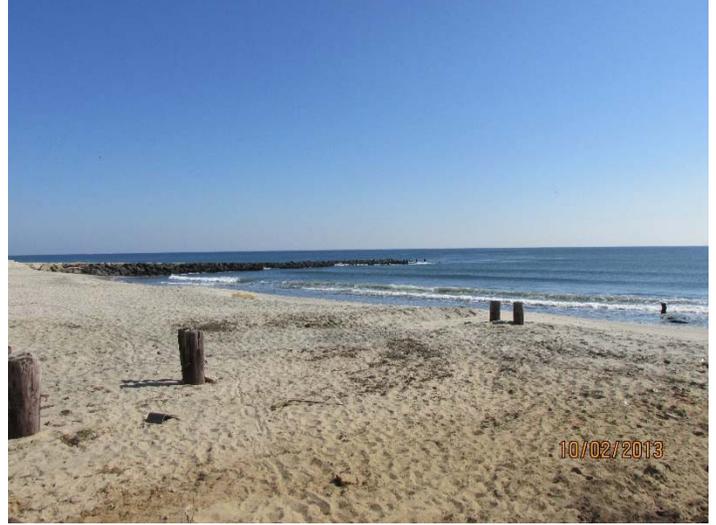
The Darlington site has a small sub-aerial beach contained between two larger groins. The upland bluff was eroded significantly during Sandy and added to the beach sand volume (Nov. 13, 2012). By October 2, 2013 natural recovery added 21.60 yds³/ft. back to the beach with some reconstruction of bluff protection structures.

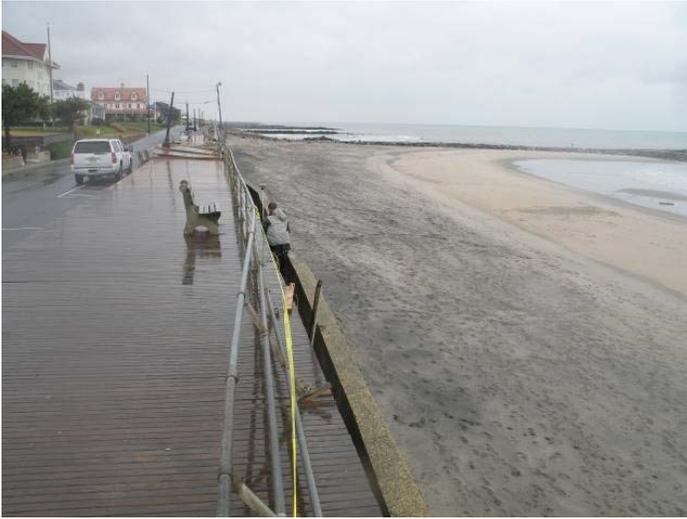
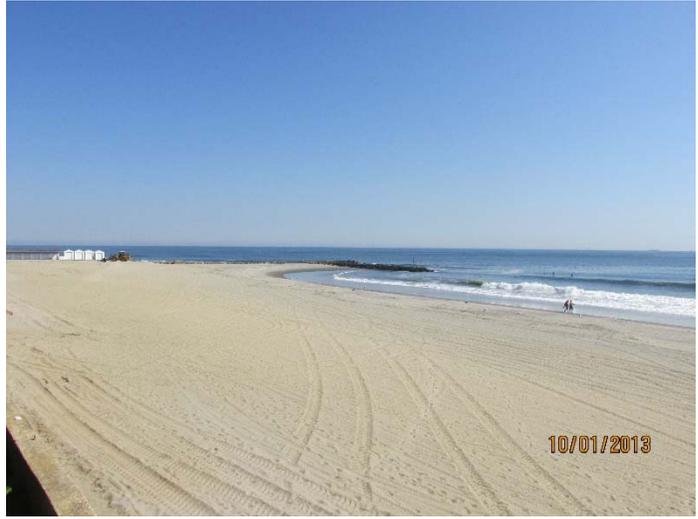
This site in Allenhurst also represents the shoreline conditions for Loch Arbor’s 2-block shoreline. Here an old concrete wall protects the sedimentary bluff. Age and decay has had an effect, but Sandy’s waves clearly broke over the top of the wall with sufficient force to dislodge about 50 feet of the boardwalk (left photograph in front of the white truck, taken November 13, 2012). Substantial sand returned naturally (46.93 yds³/ft.) as offshore deposits migrated landward (Oct. 1, 2013).

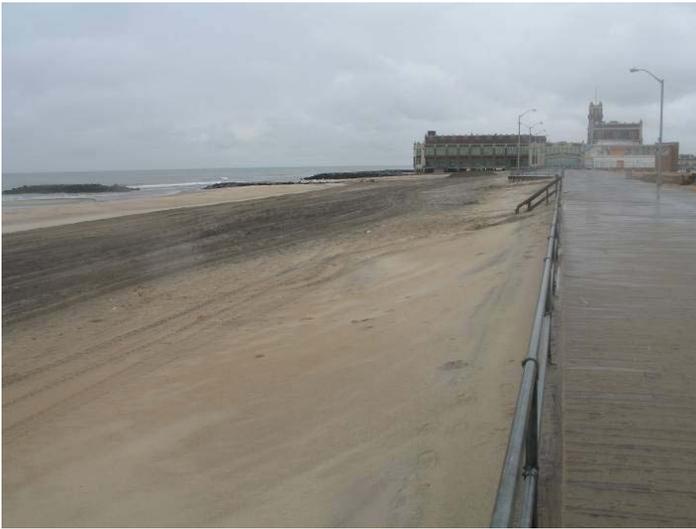
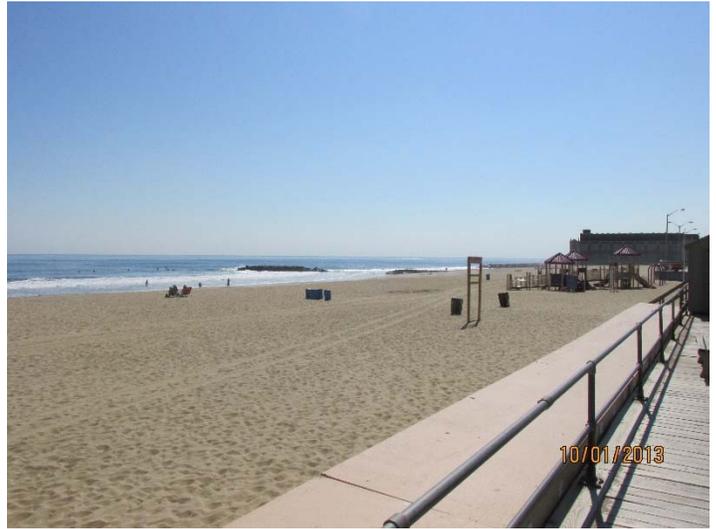
This site is the northernmost site included in the Federal shore protection southern project. The left photo (taken on November 13, 2012) sand stripped from the beach, pushed landward and washed up to the boardwalk as a ramp allowing the waves to pass over the structure inland. Natural recovery permitted 17.79 yds³/ft. in offshore deposition to return to the beach by October 1, 2013.

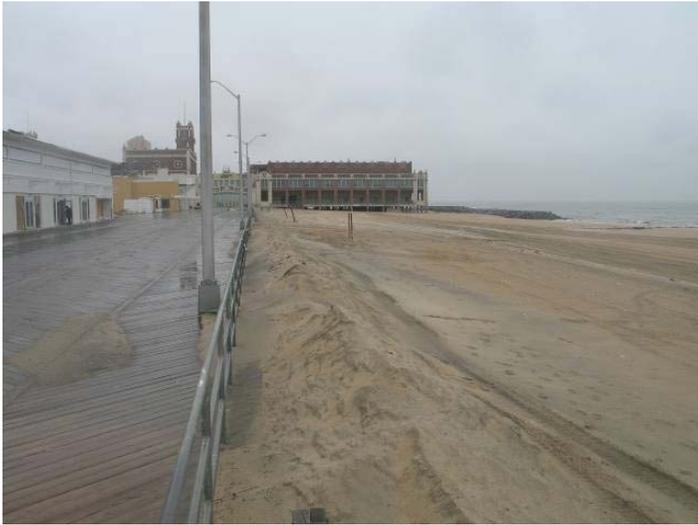
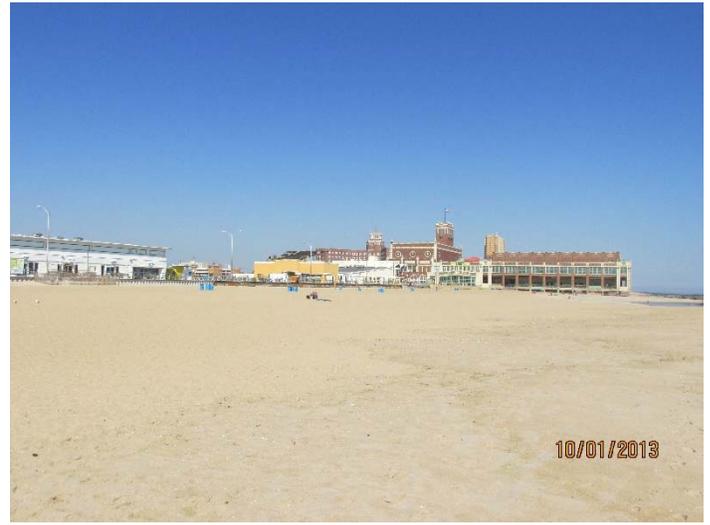
Asbury Park experienced sand stripped from the beach and ramped up to the boardwalk allowing the waves to pass over the structure without destroying it (left photo taken November 13, 2012). By October 1, 2013 natural recovery had restored 26.98 yds³/ft. to the beach prior to the ACOE completing this southern section’s project restoration.

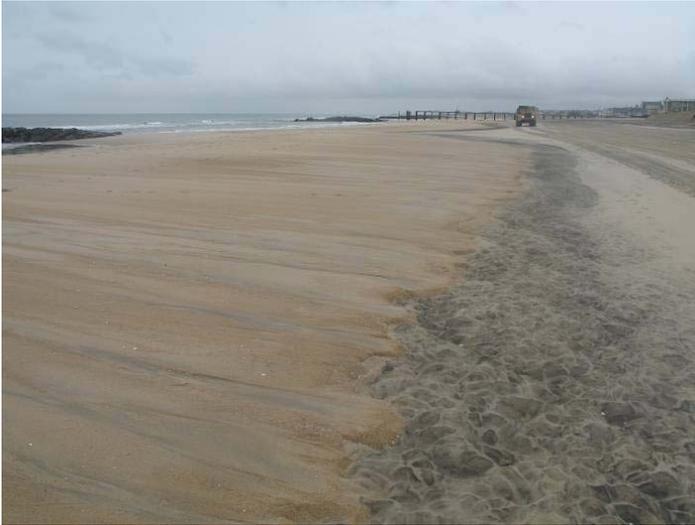
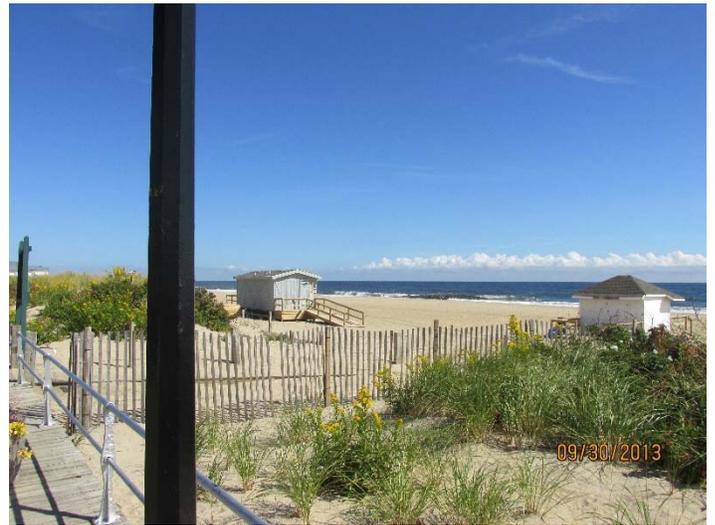
Following Sandy, the dunes along the northern Ocean Grove shoreline survived in partial sections, but were removed south of Main Street. Sand was excavated from Ocean Avenue and carted back to the beach (vehicle in left photo November 13, 2012). By September 29, 2013 the beach had recovered 22.65 yds³/ft. prior to the ACOE commencing restoration work.
