New Jersey Beach Profile Network

Monmouth County

Raritan Bay and Sandy Hook
to Manasquan Inlet

**NJBPN Profile #'s
187 - 256**

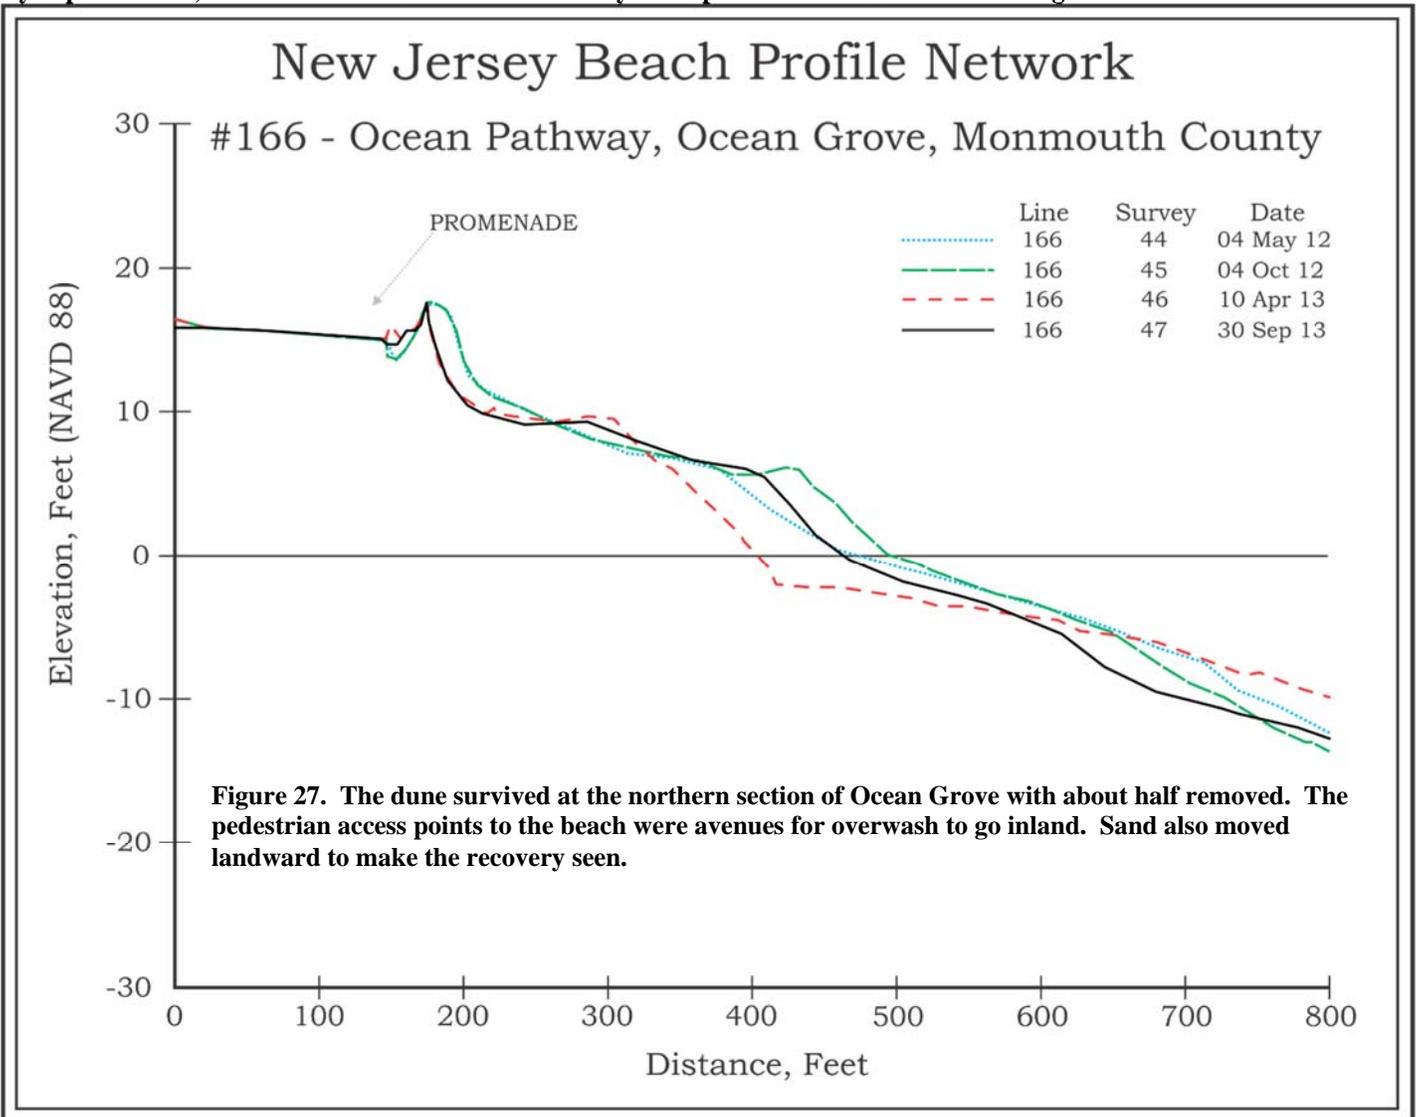
Following Sandy, the dunes along the northern Ocean Grove shoreline survived in partial sections, but were removed south of Main Street. Sand was excavated from Ocean Avenue and carted back to the beach (vehicle in left photo November 13, 2012). By September 29, 2013 the beach had recovered 22.65 yds³/ft. prior to the ACOE commencing restoration work.

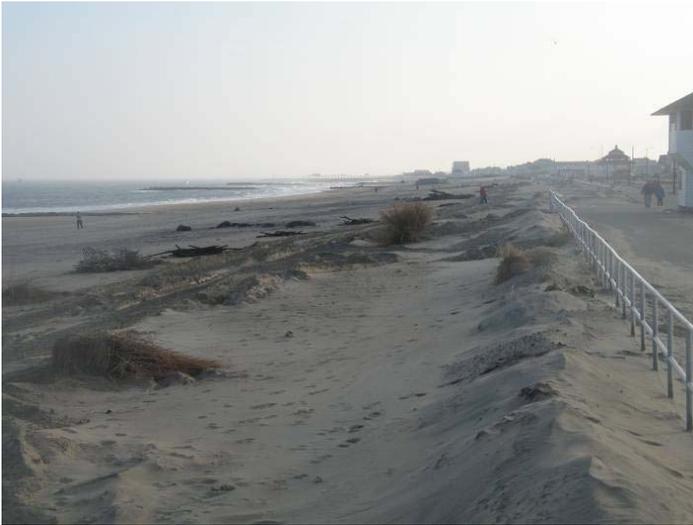
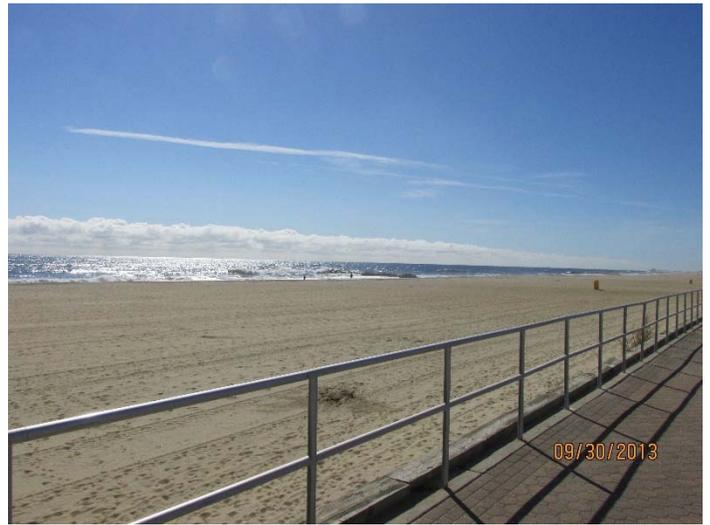
The promenade was impacted, but not destroyed but abundant sand was still present in Ocean Avenue (left photo taken Nov 12, 2012). No dune was restored by September 30, 2013, but 9.77 yds³/ft. in offshore sand deposits had returned to the beach prior to the ACOE work on this shoreline.

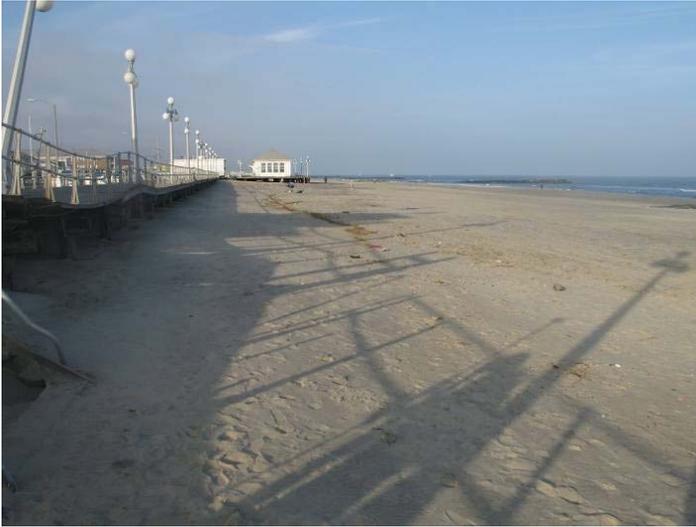
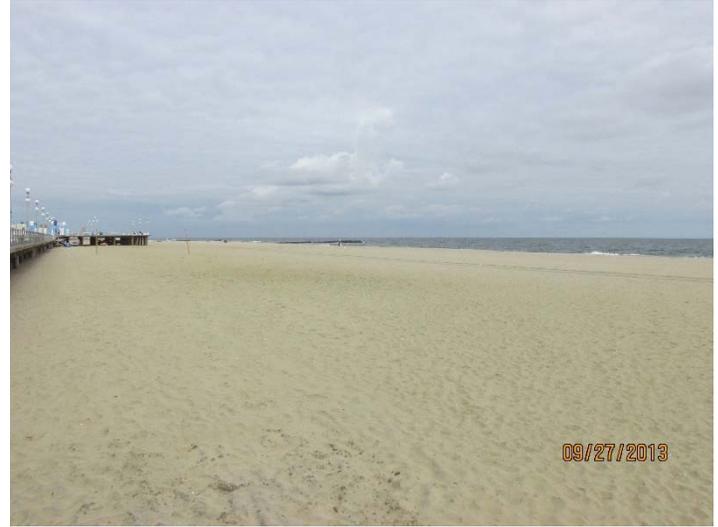
This site is located north of the Shark River inlet and was nourished in the 1999 Federal shore protection project. During Sandy, the beach had been totally submerged and sand was washed inland well beyond Ocean Avenue (left photo taken November 12, 2012). 10.48 yds³/ft. in natural recovery was added to the beach by Sept 27, 2013 prior to the ACOE restoring the beach to their design specifications.

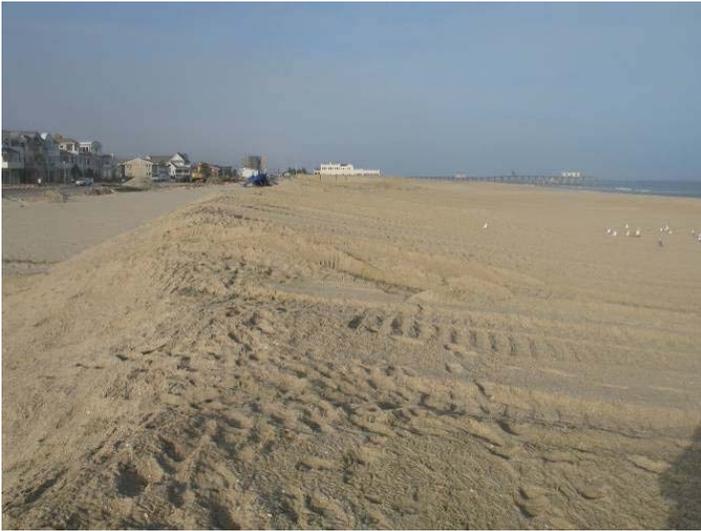
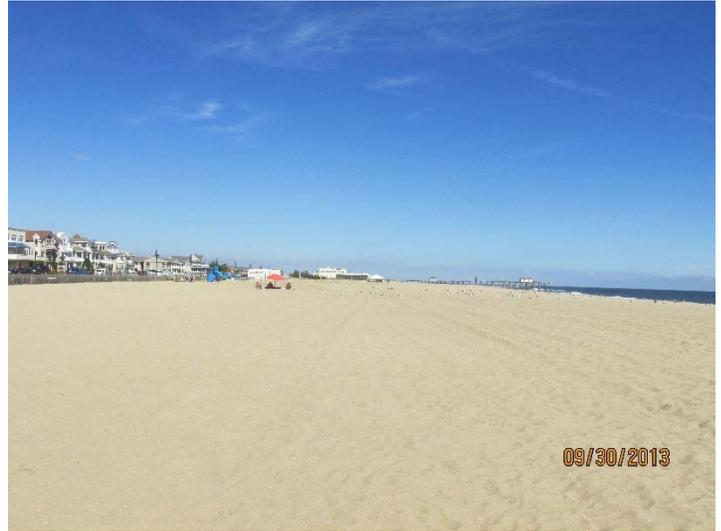
This site did not have a dune prior to Sandy but had a wide, dry beach. During Sandy, the dry beach was submerged by the storm surge. Sand was carried landward onto Ocean Avenue accompanied by extensive flooding (left photo taken November 12, 2012). Natural recovery brought 31.76 yds³/ft. of sand back to the beach leaving little additional sand placement by the ACOE later into 2014.

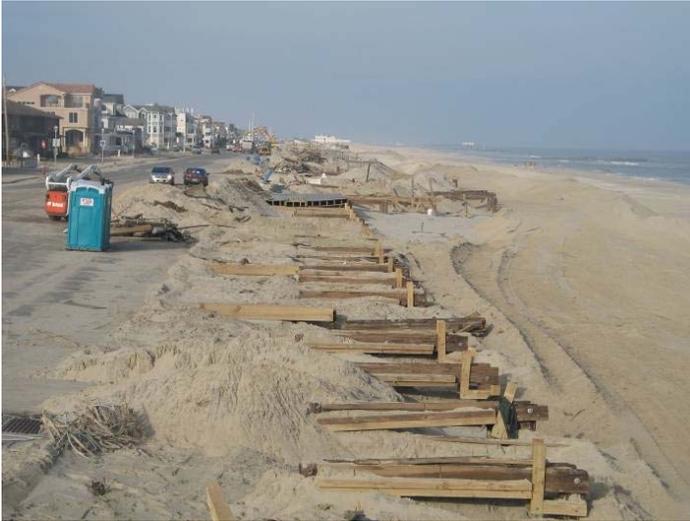
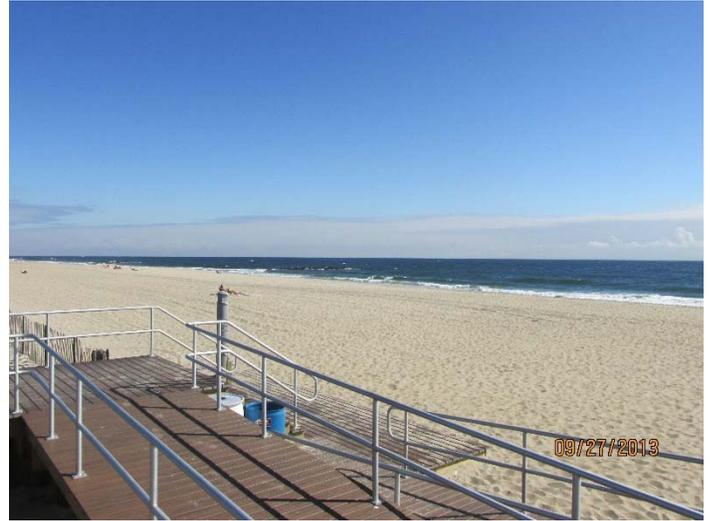
The southern Belmar shoreline was completely overrun by the force of Hurricane Sandy. The Lake Como segment was closed to traffic because multiple pumping pipelines were in place moving lake water back to the sea. Nothing but the supports remained from the boardwalk (left photo, November 12, 2012). 11.23 yds³/ft. recovered on the beach naturally by 9/27/2013.

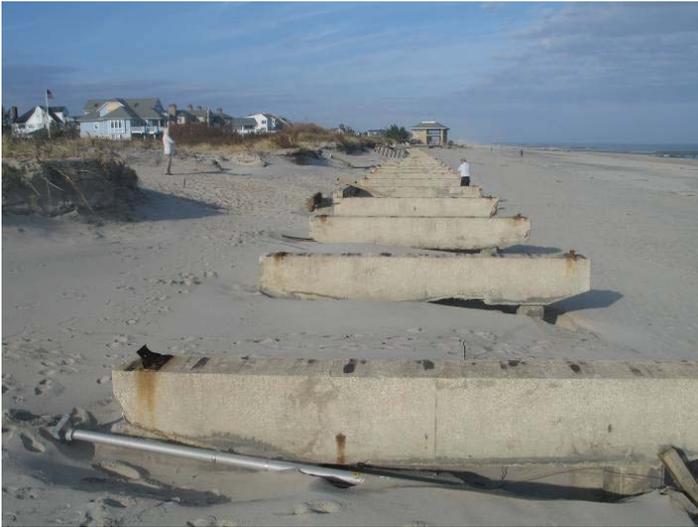
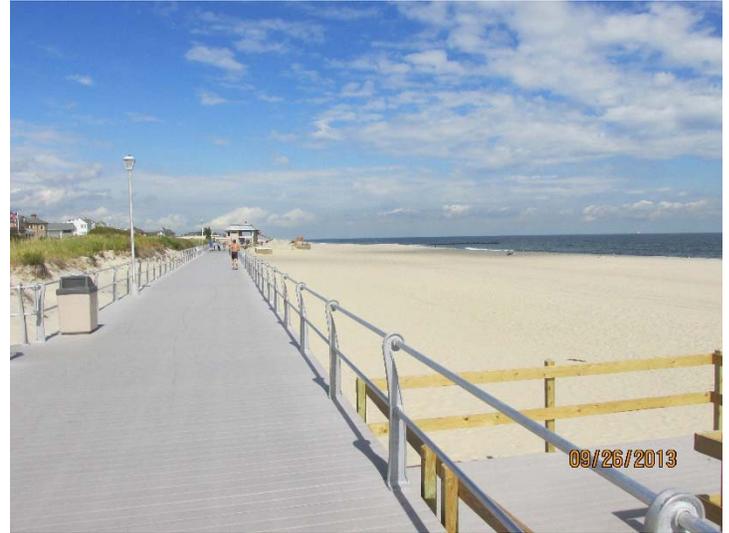
During Sandy, Spring Lake lost the entire boardwalk deck. Extensive damage occurred at the ocean-side bathing buildings with most of the dunes breached and some segments removed entirely (left photo taken November 12, 2012). A massive effort restored the boardwalk by Sept 26, 2013 and 31.40 yds³/ft. in eroded beach/dune sand returned to the beach naturally.

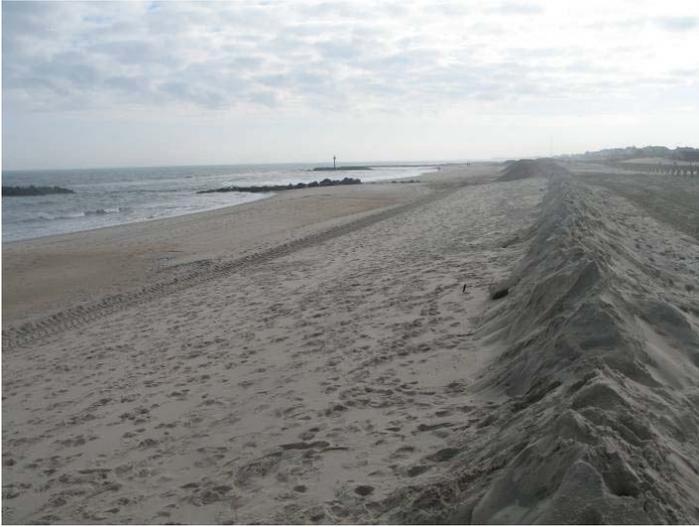
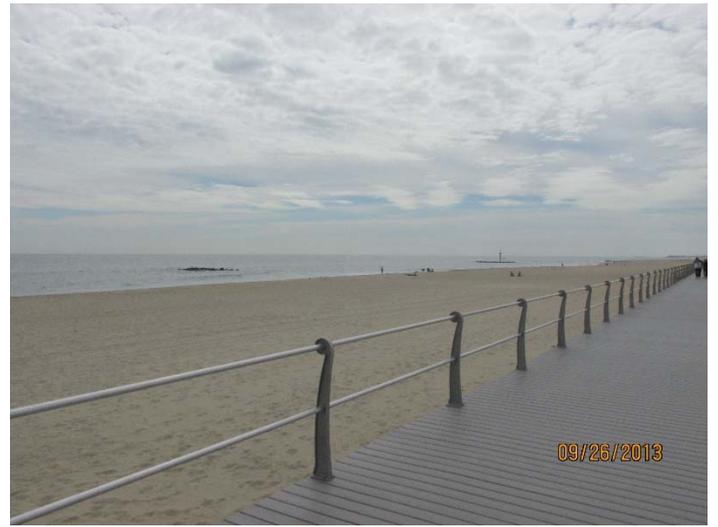
Sandy caused serious dune erosion that allowed waves to move sand into Ocean Avenue and strip the boardwalk deck from the supports. A ridge of sand had been carted back to the beach as the feature showing on the beach on the November 12th survey line (left photo taken November 12, 2012). By the end of September 2013 the boardwalk was replaced with a modest recovery in beach sand from offshore sources. The ACOE completed restoration in 2014.

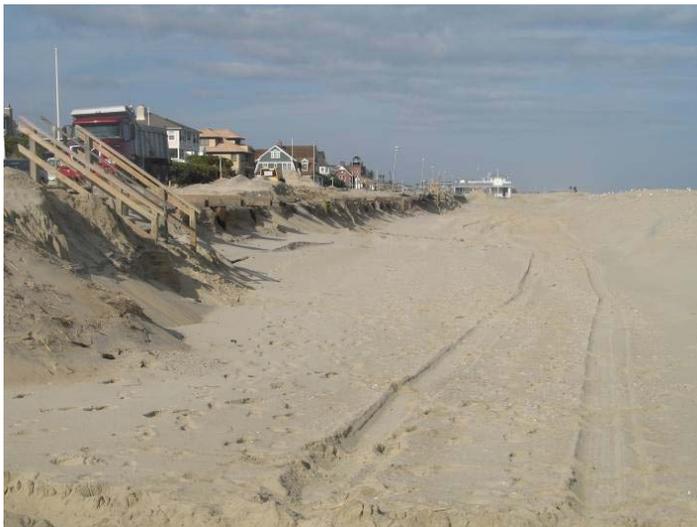
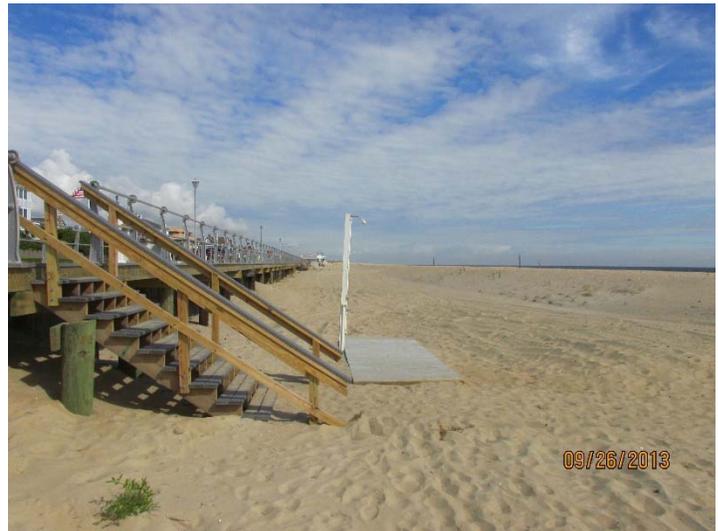
Sandy caused damages along the northern Sea Girt shoreline and impacted the infrastructure more intensely than at locations further south. The boardwalk was damaged and washed over completely. Sand was being carted back the beach as a sizable ridge (left photo taken November 12, 2012). Boardwalk damage restored and 39.16 yds³/ft. in lost sand was returned by Sept 26, 2013 from deposits formed offshore.

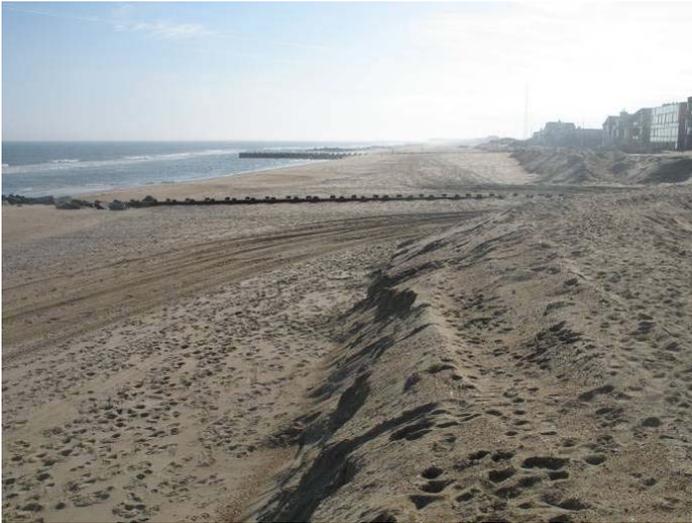
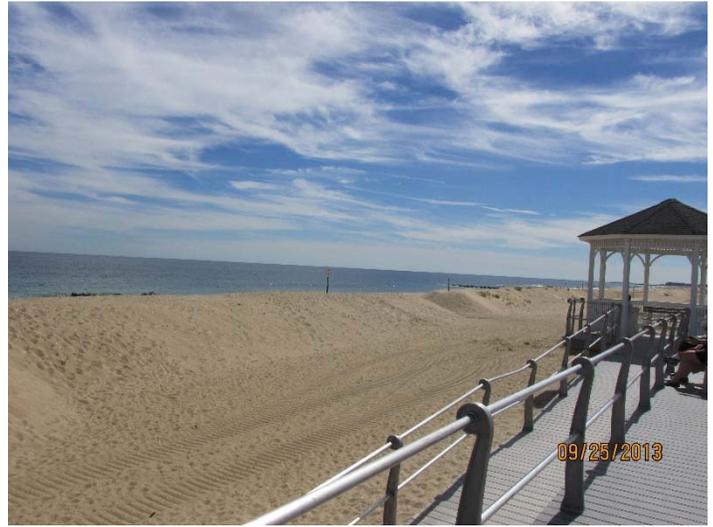
H. Sandy reduced the elevation and width of the berm and the sand from the street end was carted back to the beach (see the ridge shown in the left photo taken November 12, 2012). The ridge of recovered sand remains along this segment of the Borough beach and was augmented by 35.07 yds³/ft. in sand returned to the beach from offshore.

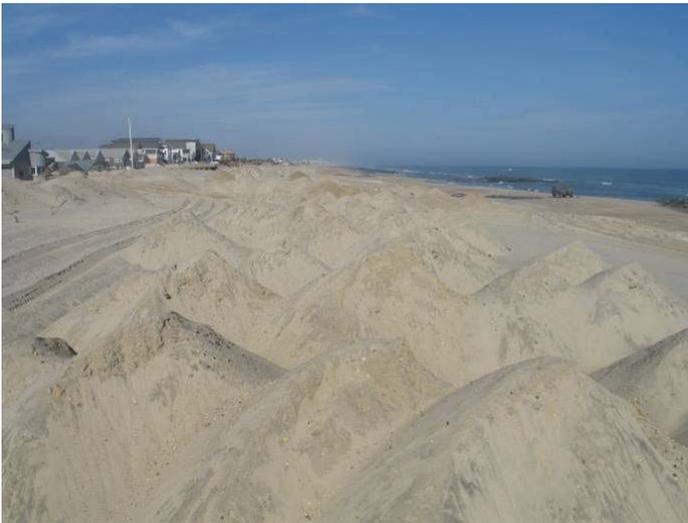
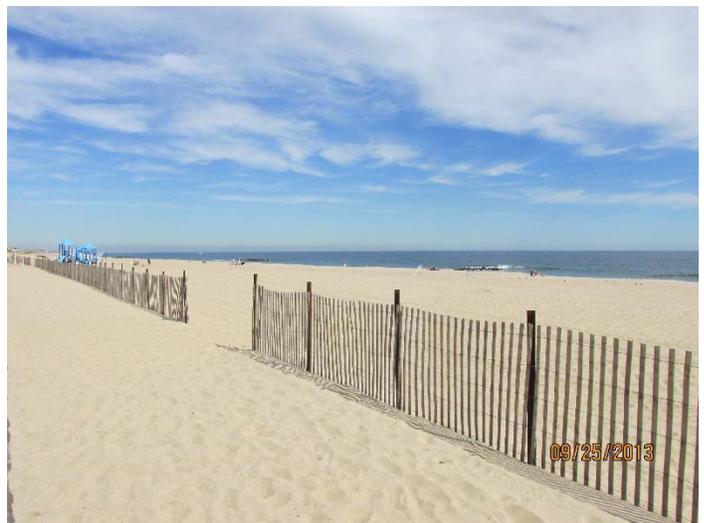
NJBPN 157 – Riddle Way, Manasquan

Both Manasquan sites were heavily damaged with massive waves and flooding that transported sand among the homes and into First Avenue. The promenade survived at Riddle Way, but the dune was removed and washed landward (photo taken November 12, 2012). Material was recovered and spread with little help from offshore migration (1.20 yds³/ft. 9/25/2013).

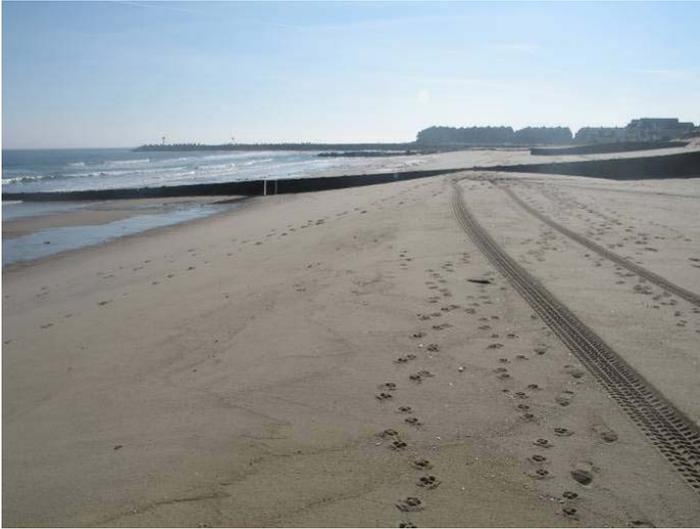
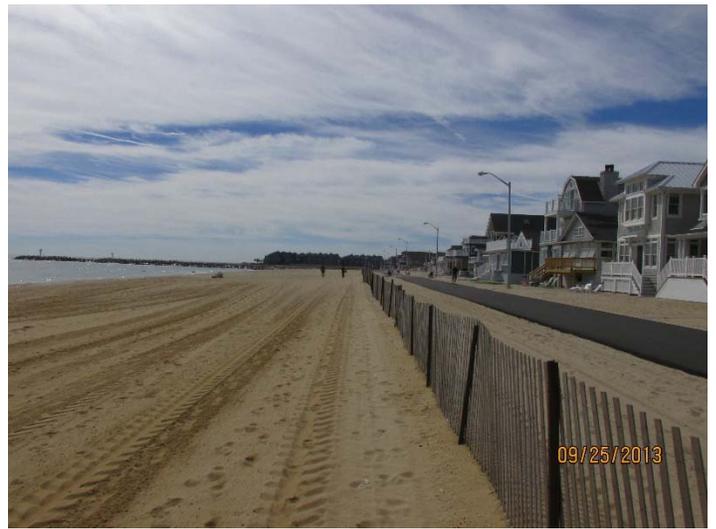
This site is located just north of the Manasquan Inlet. Following Sandy, damages were worse at this location than to the north. The promenade was removed, as were the dunes and all the berm sand had been transported through the homes into First Avenue in the Borough (left photo taken November 12, 2012). By 9/25/2013 the structural damage was restored, no dune replaced the loss and just 12.80 yds³/ft. was recovered naturally by the beach from offshore.
