# STOCKTON UNIVERSITY COASTAL RESEARCH CENTER

## New Jersey Beach Profile Network 2015 Annual Report on Shoreline Changes in New Jersey's Four Coastal Counties Raritan Bay to Delaware Bay Spring of 2014 Through Fall of 2015

# New Jersey Beach Profile Network Monmouth County Site Locations

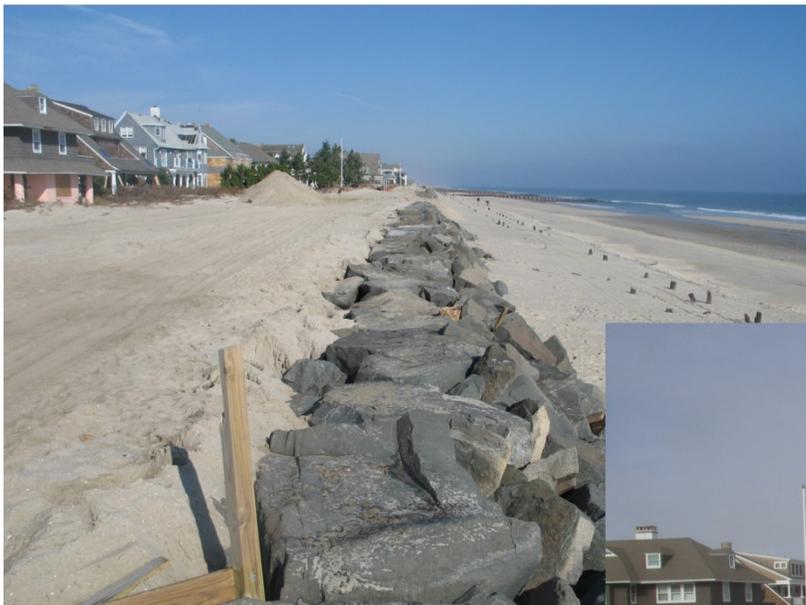
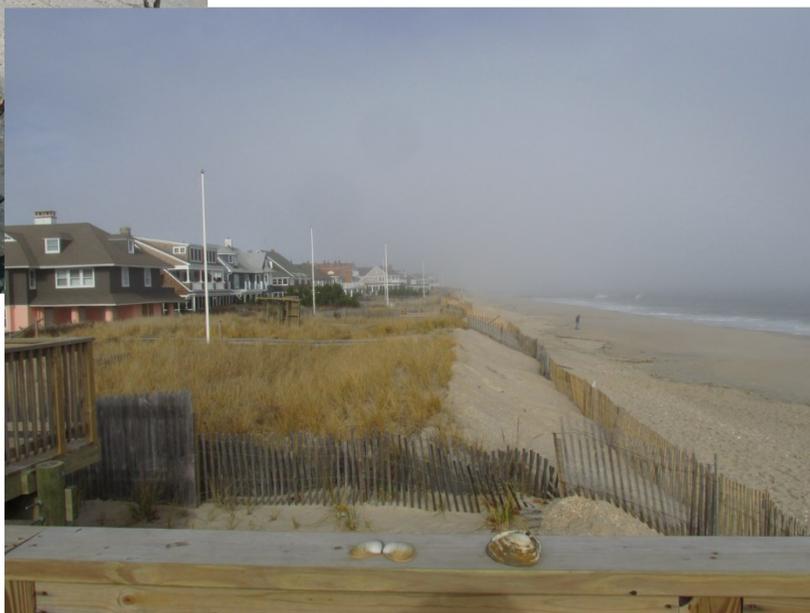
*Johnson Avenue, Bay Head, NJ comparing a view from the Dune Crest north November 12, 2012 with the same view taken December 14, 2015 three years following Hurricane Sandy. The rock revetment reduced, but did not eliminate the damages to properties landward. Sand from overwash was picked up and returned to the beach/dune system.*

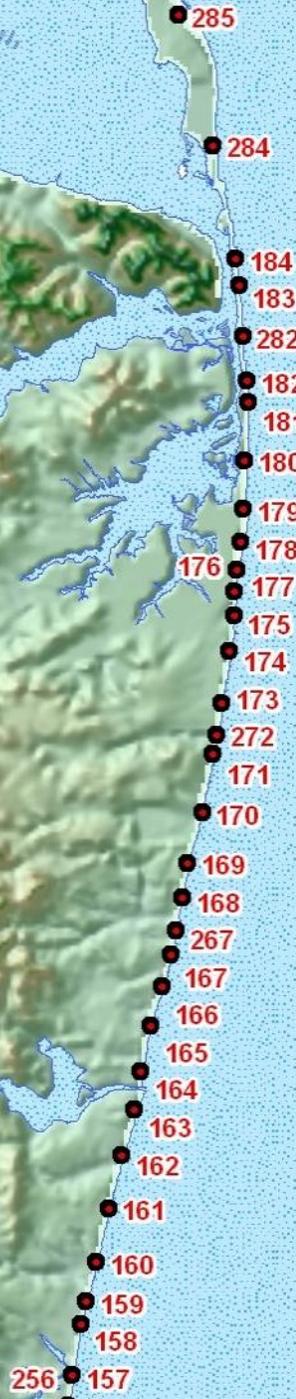
Figure 1. Survey site locations in Monmouth County.

The NJBPN shoreline monitoring sites in Monmouth County extend from three sites along the eastern beaches of the Raritan Bay, to the oceanfront shoreline of Sandy Hook, then south to Manasquan Inlet. Profile sites are located in: Cliffwood Beach in Aberdeen Township, the Borough of Union Beach, Port Monmouth in Middletown Township, Gateway National Seashore, the Borough of Sea Bright, the Borough of Monmouth Beach, the City of Long Branch, the Borough of Deal, the Borough of Allenhurst, the City of Asbury Park, Ocean Grove in Neptune Township, the Borough of Bradley Beach, the Borough of Avon-by-the-Sea, the Borough of Belmar, the Borough of Spring Lake, the Borough of Sea Girt, and the Borough of Manasquan. Monmouth County has the greatest number of beach profile sites due to the complexity of its shoreline. A combination of man-made structures, the natural variety of beach widths and distinct erosional and/or accretional areas made careful site selection a necessity. Several sites have been moved slightly as new development on the profile line created problems. The Union Beach site was moved from the original site because the shoreline was completely armored with rock. The new location is in the middle of a State-owned public beach about a quarter-mile away. Site #172 was reestablished north of Lake Tackanassee in southern Long Branch to track sand movement to the south derived from the ACOE project.

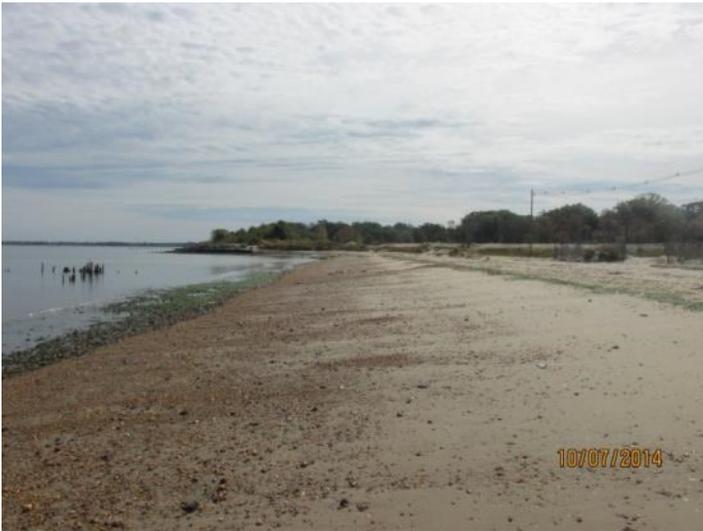
NJBPN 187 – Beach Park, Cliffwood Beach

This is the westernmost NJBPN site located on Raritan Bay. The photograph on the left shows the shoreline on October 7, 2014. The photo on the right shows the beach, the transition to the bay floor and a modest dune taken on November 13, 2015.

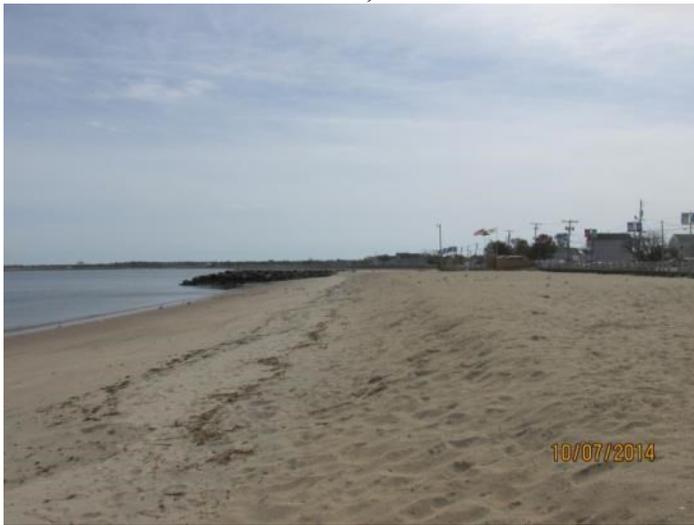
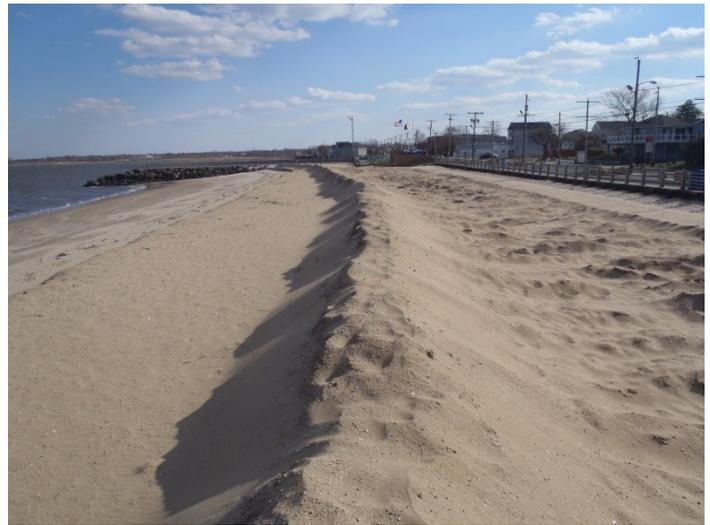
**NJBPN 286 – Beach Street, Union Beach**

This site was moved to the public bathing beach in 2009. The photograph on the left shows the shoreline on October 7, 2014 following the addition of 14,000 cu. yds. of added sand. The photo on the right shows the adjustment in beach width over a year following the municipality's efforts in replacing lost sand by adding a ridge late in 2015 (taken on November 13, 2015).

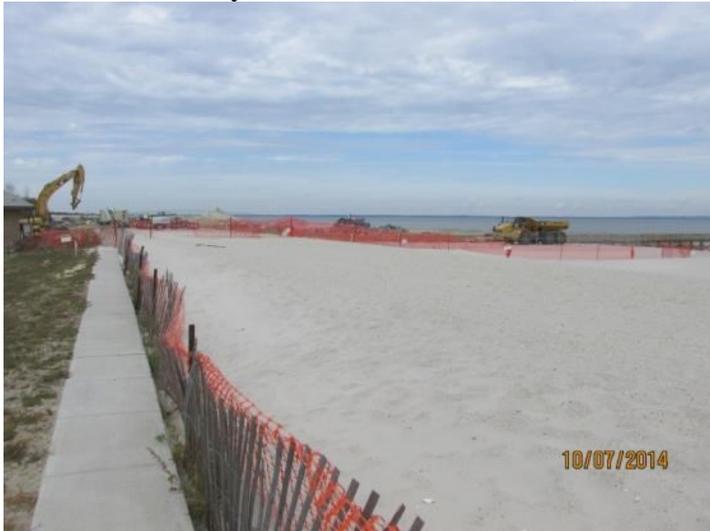
This site was enhanced by adding slope protection to the eroding uplands bluff prior to Sandy. The photograph on the left shows the shoreline on October 7, 2014 following the ACOE project’s completion. The right picture was taken November 13, 2015 where scarping has cut into the “as-built” profile and sand was pushed up to provide storm protection.

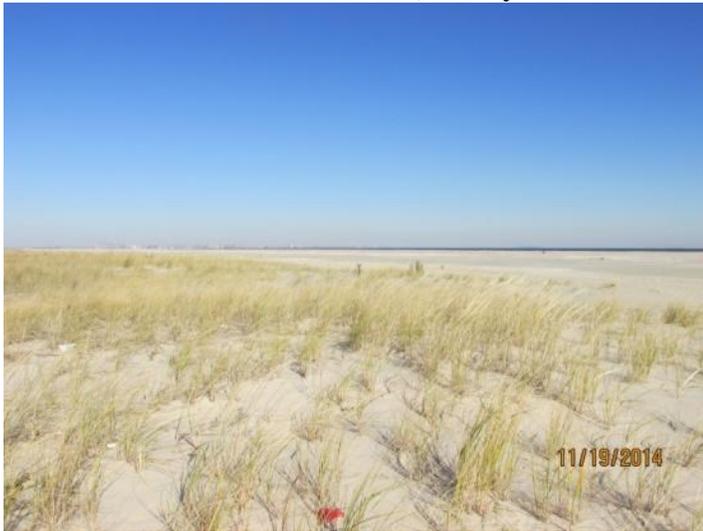
This is the northernmost ocean NJBPN site that has shown advances in the berm position since 1999. The photograph on the left shows the Nov. 19, 2014 beach looking north; on the right is the same view from the toe of the dune Dec. 7, 2015. A single picture cannot grasp the enormity of this section of beach over 1,500 feet in width from the edge of the dune grass.

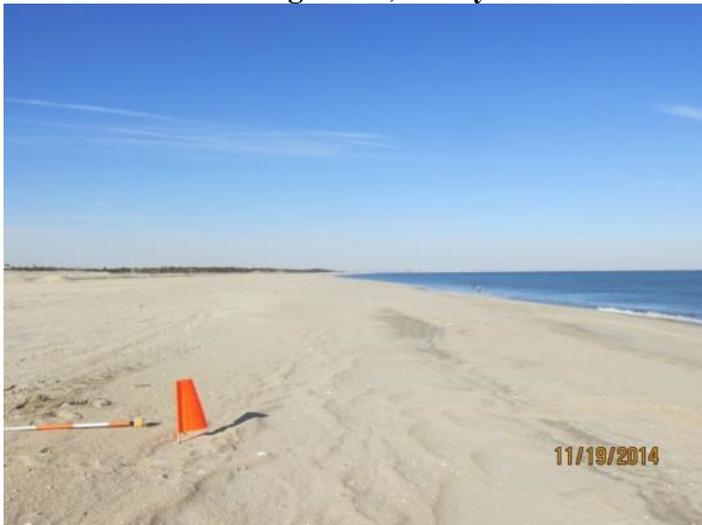
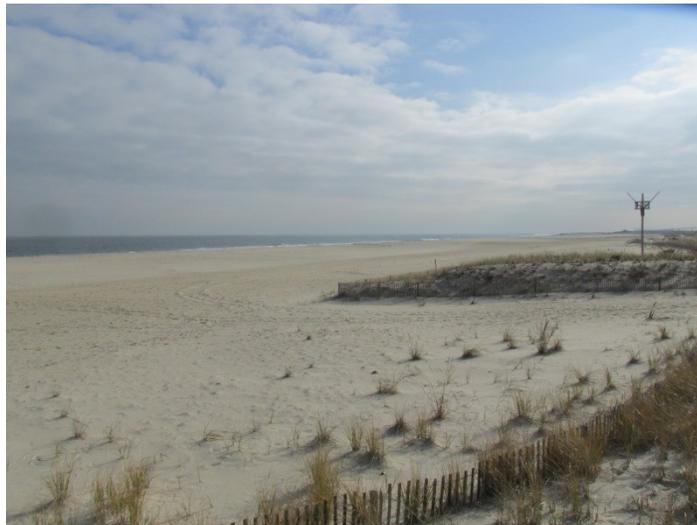
On the left is a beach picture from November 19, 2014 looking north along the shoreline. A different perspective on December 12, 2015 shows the width of the beach from the dune toe looking south from the instrument station.

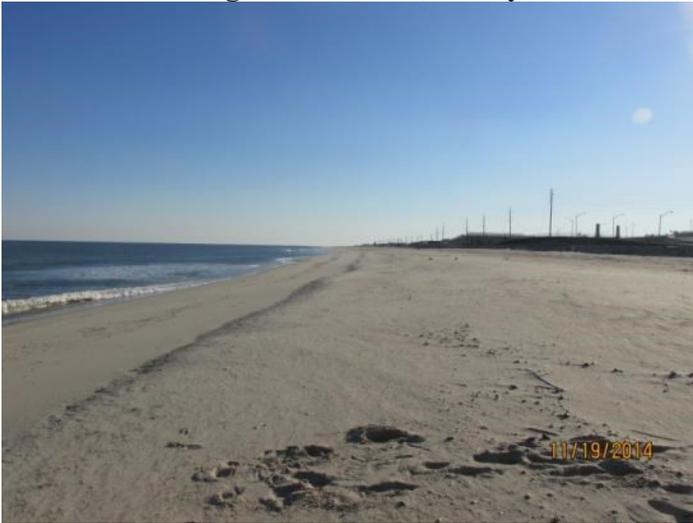
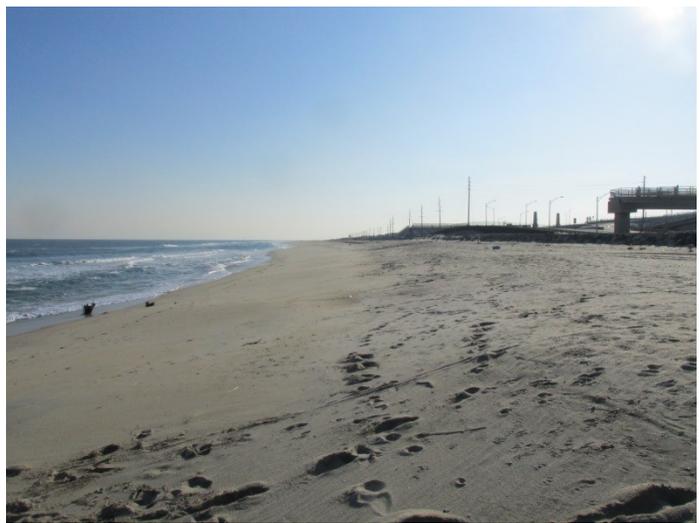
This southern Sandy Hook site is located near the entrance to the park and has gained in volume since the 1995 start of the federal shore protection project. The left view was taken November 19, 2014 after the USACE had returned and placed sand to design template cross section. By December 8, 2015 (following an October event), significant erosion had taken place on the beachface and nearshore regions.

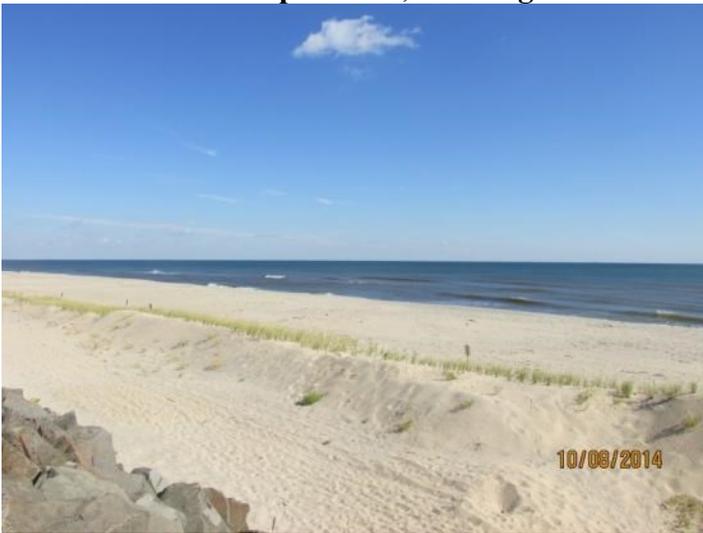
This site is near the northern limit of the initial Federal shore protection. The left side shows the results a year after the placement of 40.12 yds<sup>3</sup>/ft. of new sand and a new dune on the beach by Oct. 8, 2014, while the right side (Sept. 16, 2015) shows how well the dune grass developed and added material to the dune.

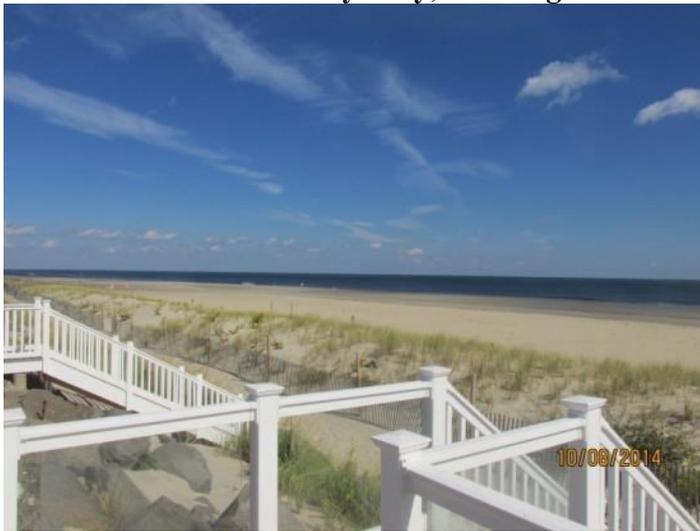
The left view shows the federal restoration project design cross section and the dune that was sand the storm pushed up the seaward face of the seawall was extracted and formed into the dune seen on the left view October 8, 2014. This dune has become well vegetated over the past year (September 16, 2015).

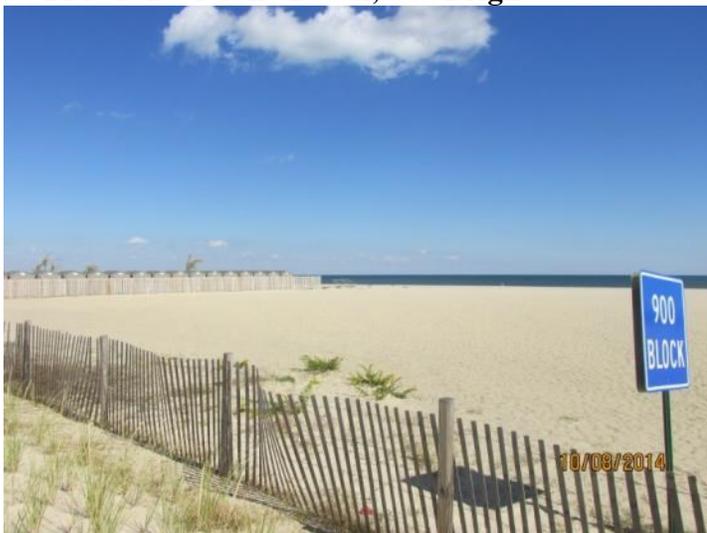
By October 8, 2014 the USACE had restored the beach width and a dune was added from sand extracted from inland and the material ramped up to the rock seawall. The dune developed and by Sept. 16, 2015 was well vegetated with a wide, dry sand beach seaward shown by the view to the north including the fencing that defines the property line.

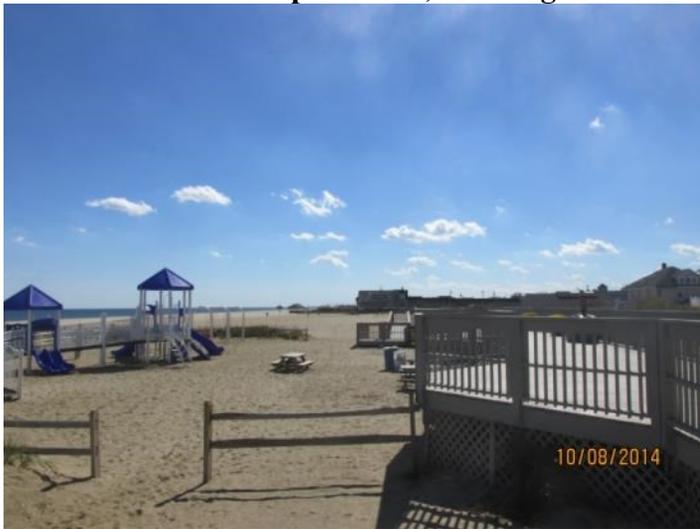
# NJBPN 181 – Municipal Beach, Sea Bright

By October 8, 2014 the ACOE had restored the design cross section. The view one year later (Dec. 2, 2015) shows the wide dry beach seaward of the new dunes and the deck and access ramp to the beach.

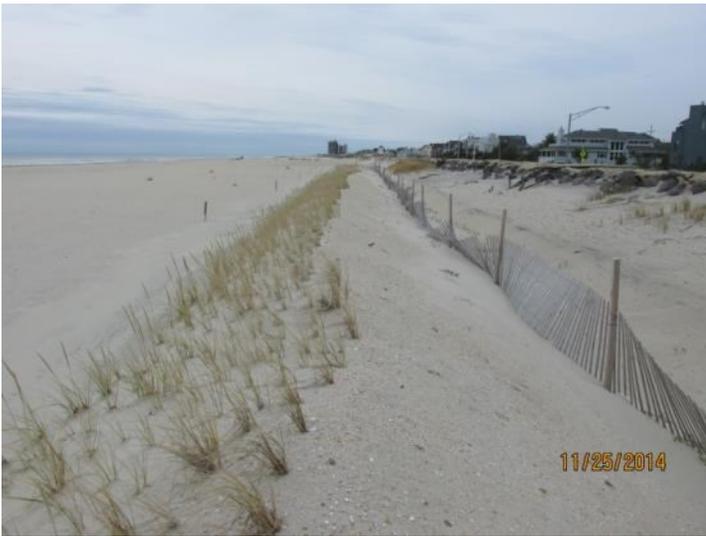
**NJBPN 180 – Sunset Court, Sea Bright**

The restoration by the USACE had been completed in the left photo taken November 25, 2014 for a year, with the addition of 101.64 yds<sup>3</sup>/ft. to the profile's cross section. A small dune was added by the summer of 2014 as sand was redistributed somewhat at the water's edge and enhanced by December 24, 2015 with wind transported sand.

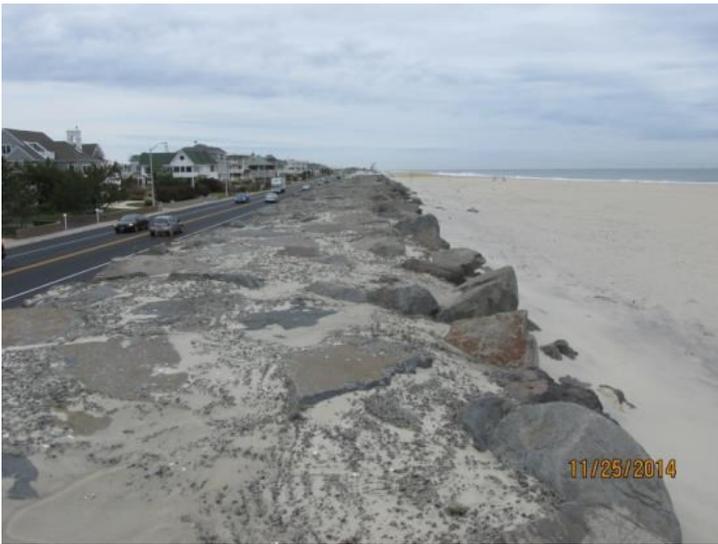
NJBPN 179 – Cottage Road, Monmouth Beach

This site has the worst erosion history of any site in Monmouth County. The left photograph Nov. 25, 2014 shows the completed work by the USACE after one year following a 180-foot berm crest retreat. On the right the existing beach has narrowed further with a single straight line of snow fencing in place to start a dune on site as of Dec. 24, 2015.

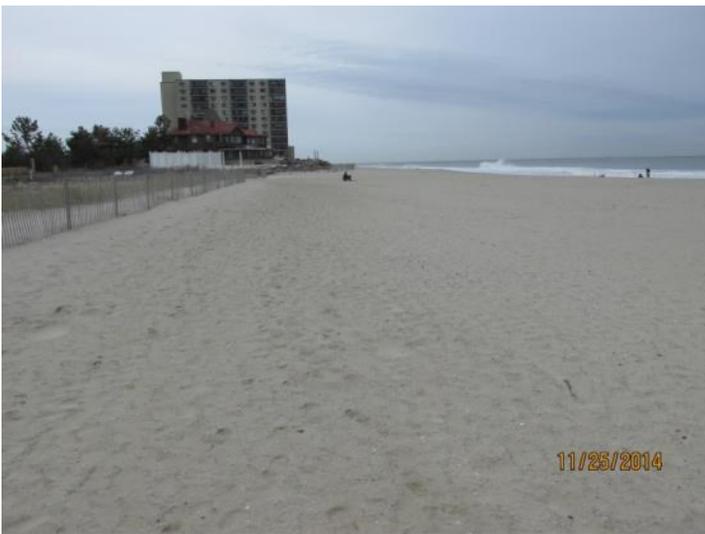
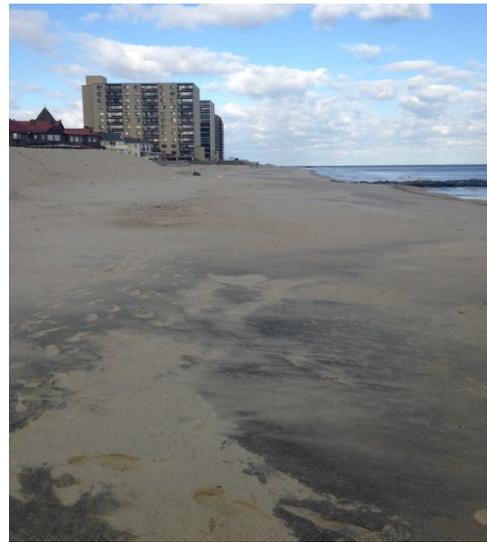
NJBPN 178 – Monmouth Beach Club, Monmouth Beach

The left photo taken November 25, 2014 shows the results of the USACE work to restore the project to design specifications a year following completion. To the right the beach has narrowed exposing the groin by December 3, 2015.

The Valentine Street site is located on the premises of the venerable Monmouth Beach Club with the survey starting point in the landward segment of the timber deck overlooking the seawall. Destroyed by the storm, this site has been rebuilt and the sand replaced to the initial federal project specifications. The dimensions of sand placement between March and October of 2013 is an impressive 181.20 yds<sup>3</sup>/ft. with a 231-foot shoreline

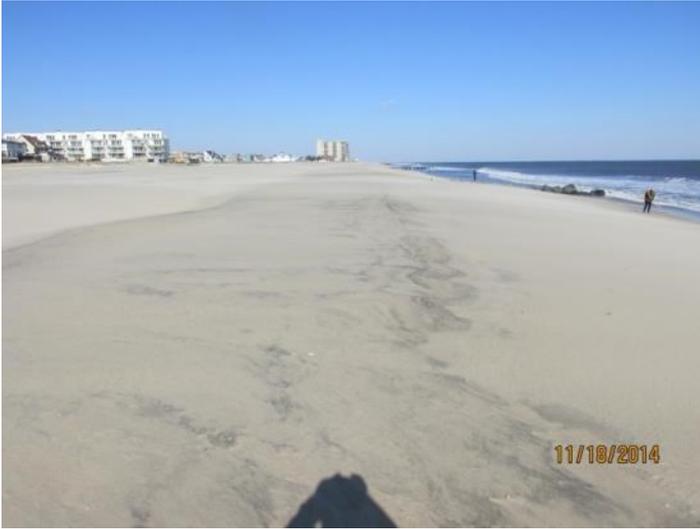
The left photo was taken November 18, 2014 following the addition of 123.04 yds<sup>3</sup>/ft. on the beach after the arrival of the USACE to complete the northern segment of their project. By December 3, 2015 the beach was similar but a little narrower.

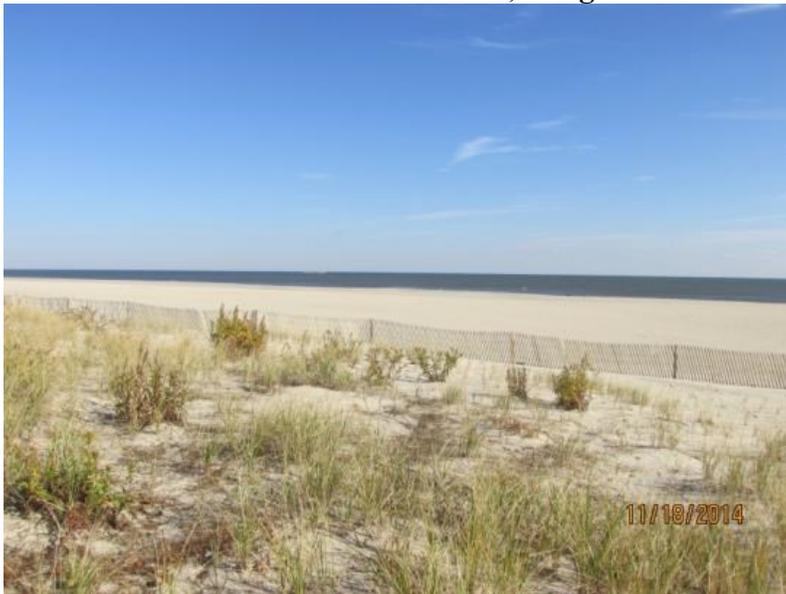
NJBPN 176 – Seven President’s Park, Long Branch

This site is a popular recreational park with a partial ridge of 25-foot elevation dunes. By survey #48, the sand volume increased by 115.73 yds<sup>3</sup>/ft. as a result of ACOE work (November 18, 2014 left photo). The right-hand view shows some shoreline retreat as the rock jetty to the north is re-exposed at low tide (Dec 3, 2015).

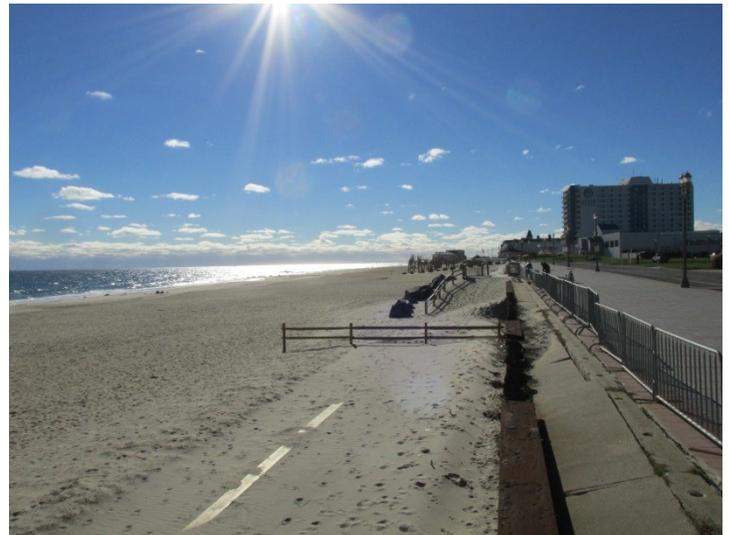
NJBPN 175 – Broadway Avenue, Long Branch

The left photograph taken November 18, 2014 shows the beach six months following the ACOE project completion at this location. By December 15, 2015 the beach is a little narrower, but still wider relative to the rock groins originally exposed following Sandy.

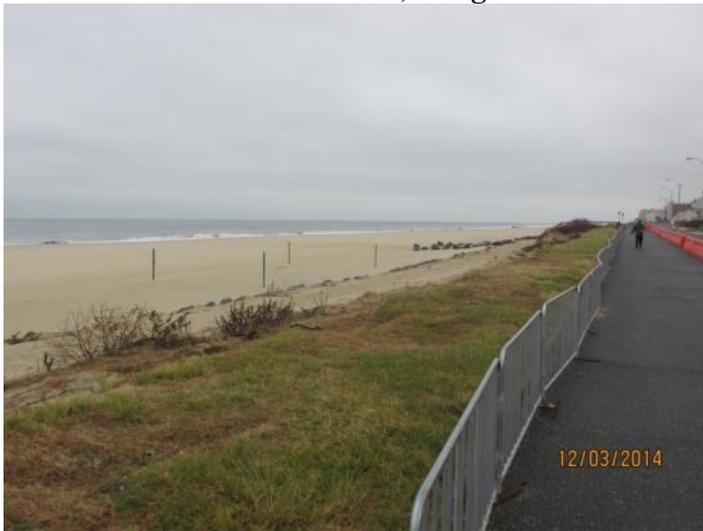
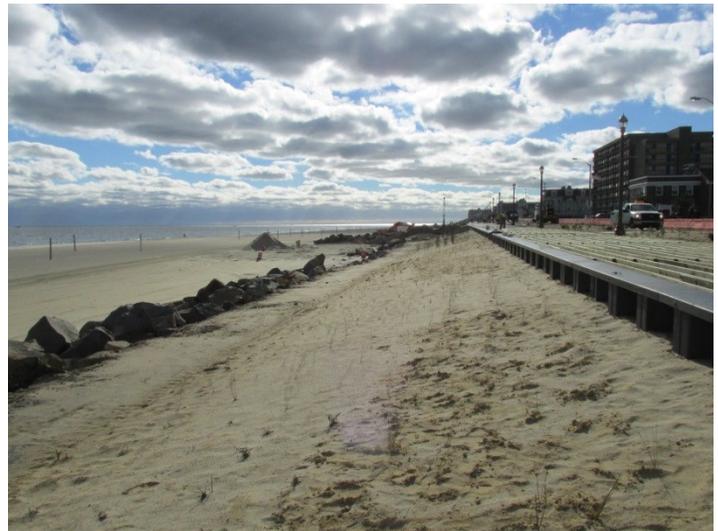
NJBPN 174 – Morris Avenue, Long Branch

It appears as if the City has moved the pedestrian walking zone onto half the remaining southbound roadway that once existed here as a dual road as Ocean Avenue plus the boardwalk in 1960. The ACOE activity is very evident in the left picture taken December 3, 2014 (complete as of survey #48). By December 16, 2015 a new roadside bulkhead was installed and a graded slope to the rock revetment completed the storm damage repairs. The beach remains in good condition.

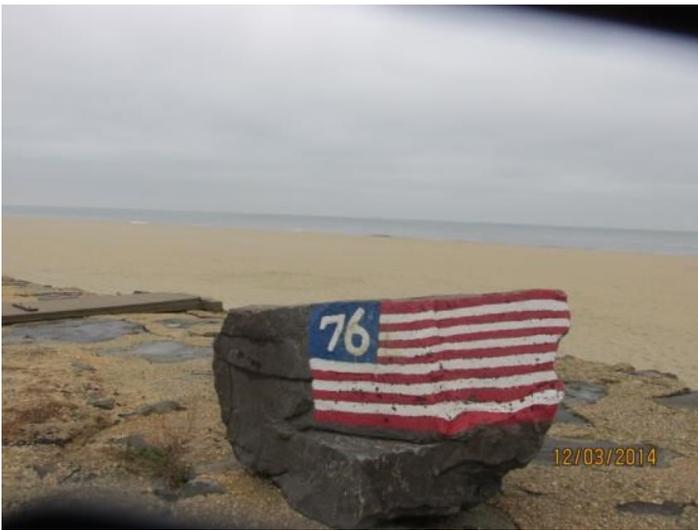
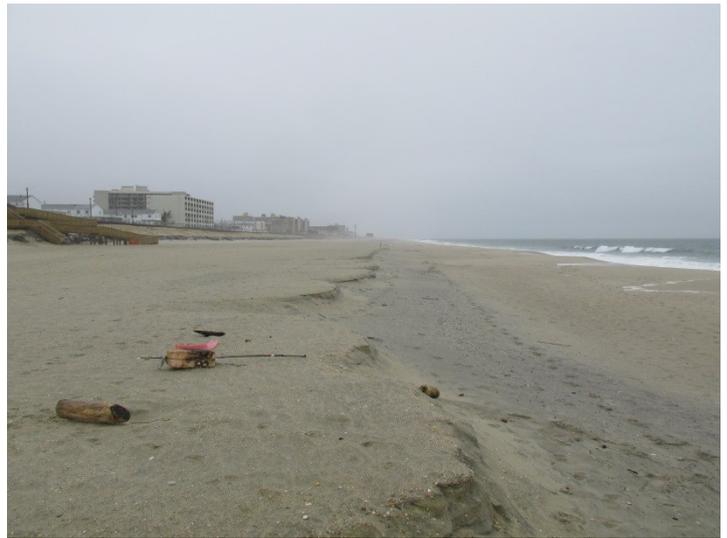
This site is located near the southern limit of the Federal beach nourishment project. The fencing keeping people out has been removed with the walkway moved onto the southbound road once part of Ocean Avenue. The December 3, 2014 view shows artwork on one revetment rock re-deposited on the seawall, looking over the new federal beach. The December 16, 2015 view on the right illustrates berm erosion followed by bar welding onto the beach generating a new berm position.

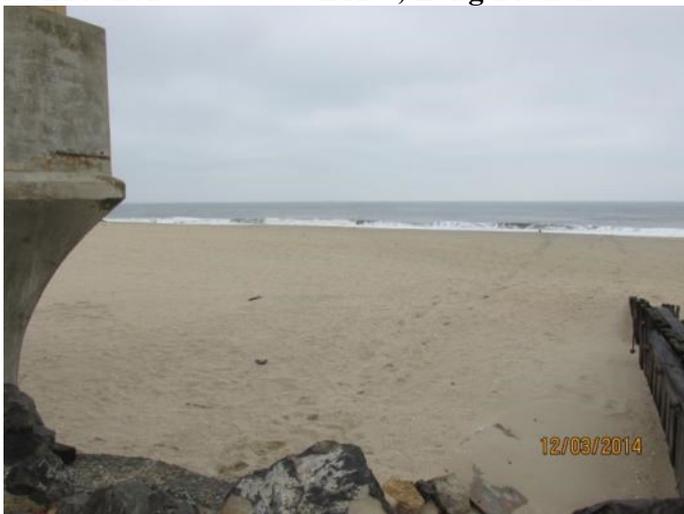
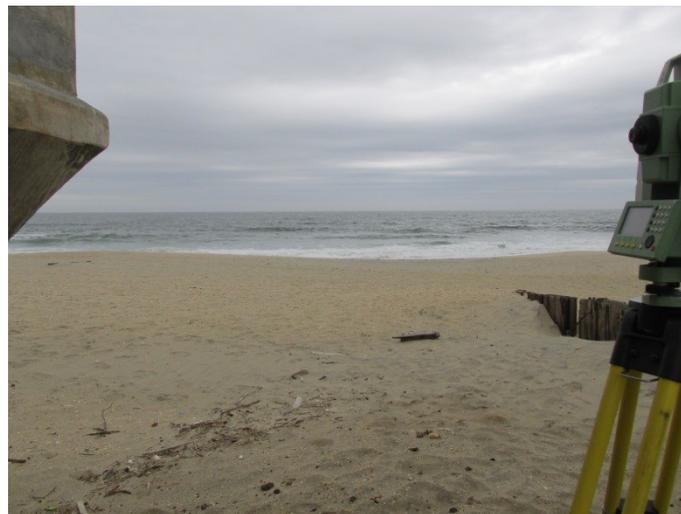
This site, established in 2010, is located on the northeastern edge of Lake Takanassee and within a groin compartment. On the left (Dec. 3, 2014) the swash zone and beach extends to the north. The USACE restoration effort extended to the south into Elberon during 2014. The right view (December 17, 2015) shows a narrower beach with construction work underway to re-engineer the discharge from Lake Takanassee that had re-opened to the sea during Sandy.

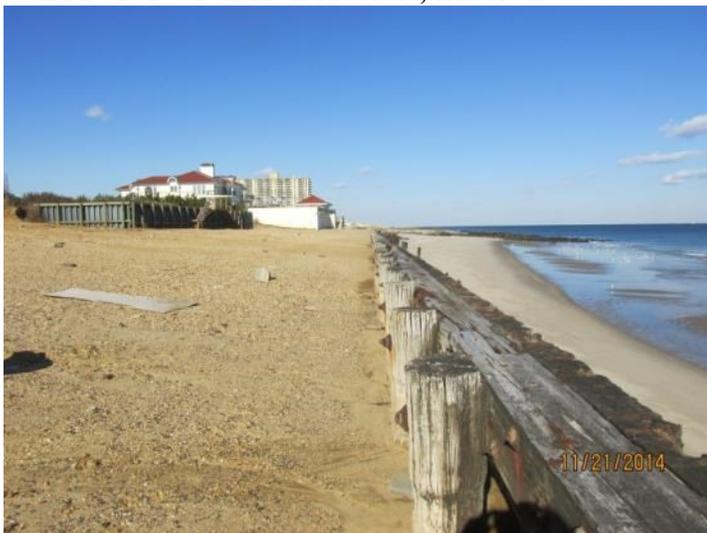
This site is located on the highest point along the bluff shoreline and erosion of the bluff generated the first dry beach ever seen after Sandy that remained by November 14, 2014. By December 16, 2015 this beach was wider as the sand extracted from the sedimentary bluff returned to the shoreline. The USACE project has yet to reach this location.

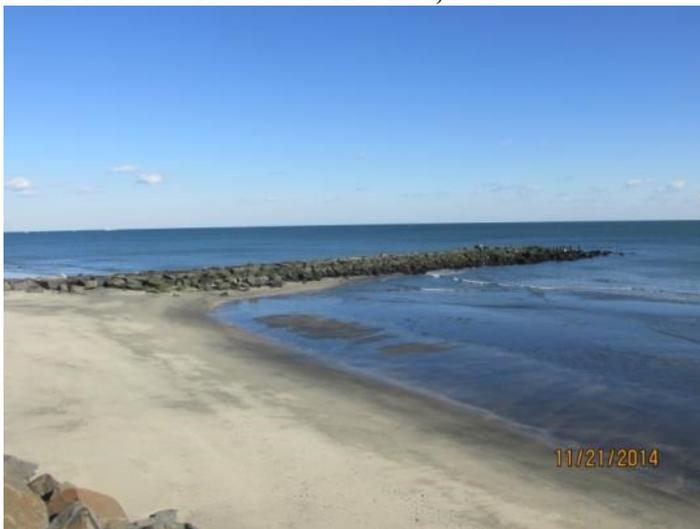
This profile is located between two rock groins that limit sediment movement. This area has never received sand from direct beach nourishment. The photo on the left (taken November 21, 2014) shows the deposit of sand derived from the storm erosion of the bluff. By December 4, 2014 sand moved offshore and adjusted lower at the rocks.

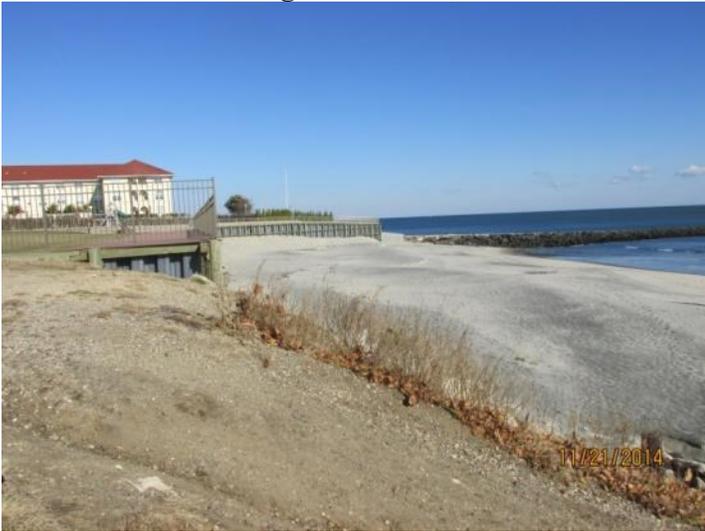
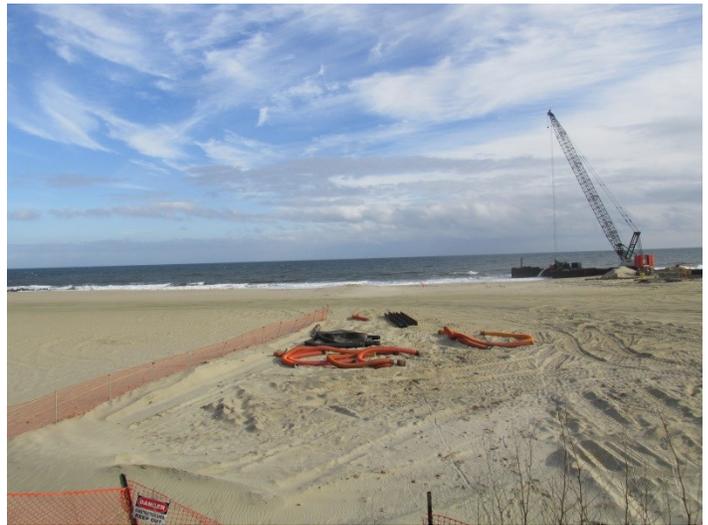
The Darlington site has a small sub-aerial beach contained between two larger groins. The upland bluff was eroded significantly during Sandy and added to the beach sand. By November 14, 2014 (left) natural recovery added 26.32 yds<sup>3</sup>/ft. back to the beach with some reconstruction of bluff protection structures. A year later (Nov. 30, 2015) the USACE project was underway adding dramatically to the beach with additional groin work in progress as well.

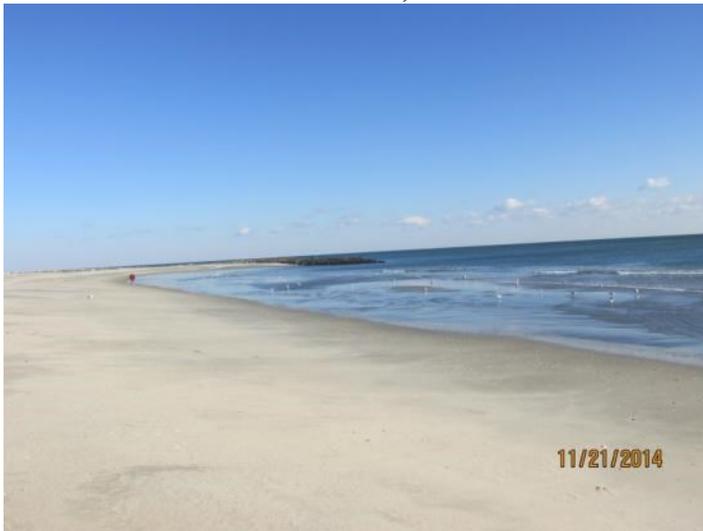
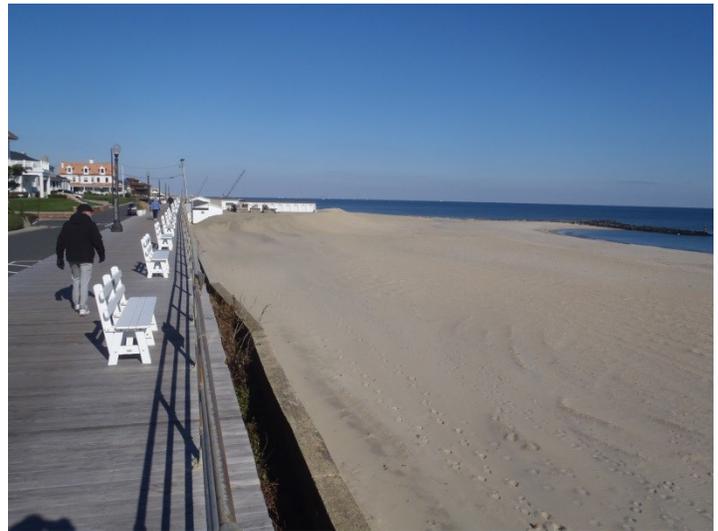
This site in Allenhurst also represents the shoreline conditions for Loch Arbor’s 2-block shoreline. Here an old concrete wall protects the sedimentary bluff. The left photograph shows conditions as of November 21, 2014 prior to the federal project starting. By November 30, 2015 a wide beach was present protected by a massive groin complex at the Deal border.

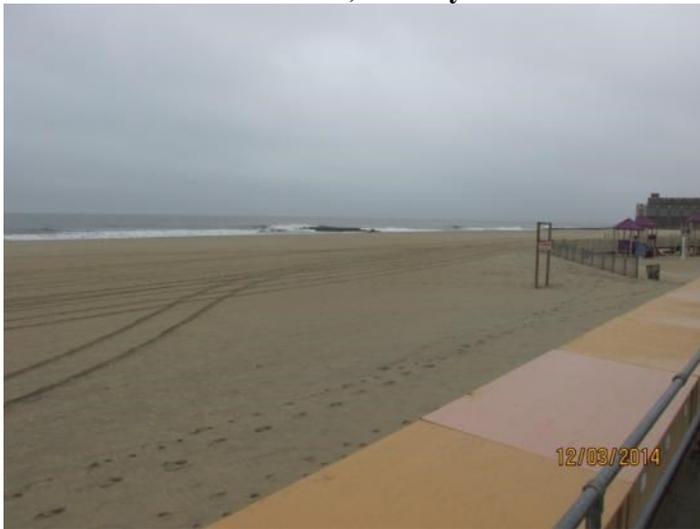
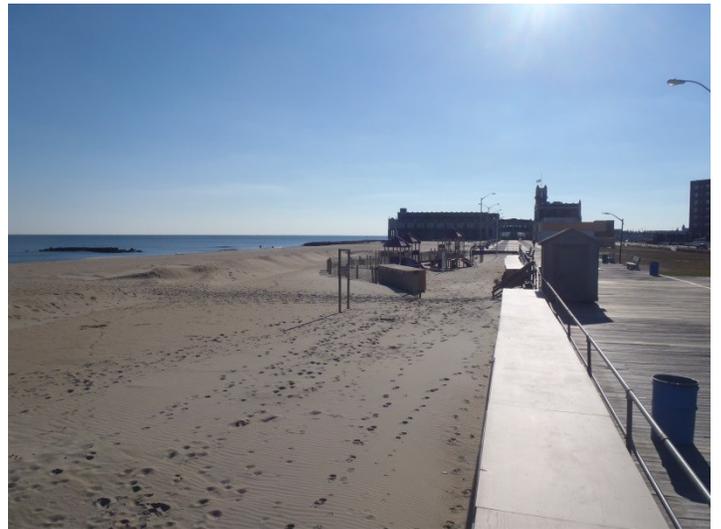
This site is the northernmost site included in the Federal shore protection’s southern project segment. The left photo (taken on December 3, 2014) shows that the federal project added 92.68 yds<sup>3</sup>/ft. and produced a 100-foot shoreline advance. By November 30, 2015, conditions remained similar, but with a pushed-up ridge of sand in the mid-beach area.

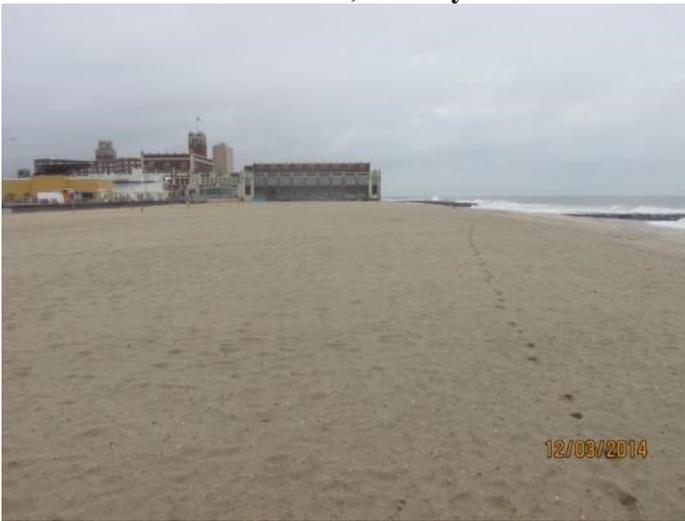
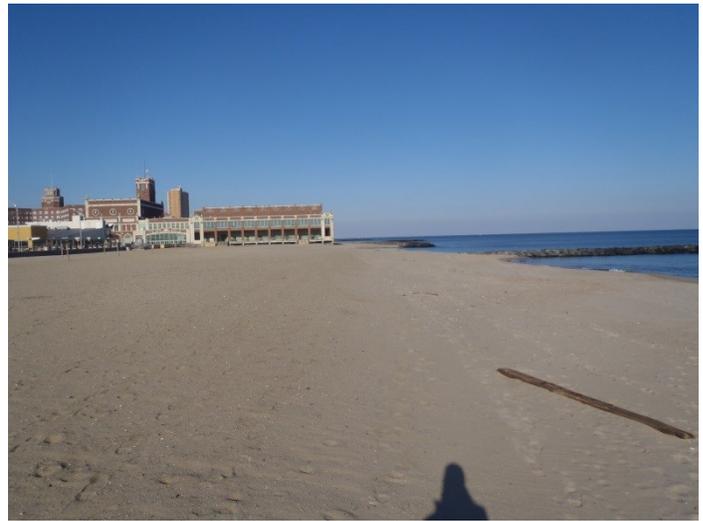
The USACE work added the berm as more sand accumulated offshore as of survey #48. The December 3, 2014 view on the left shows the restored beach. By December 4, 2015 some shoreline retreat had occurred, but the project remains in good shape.

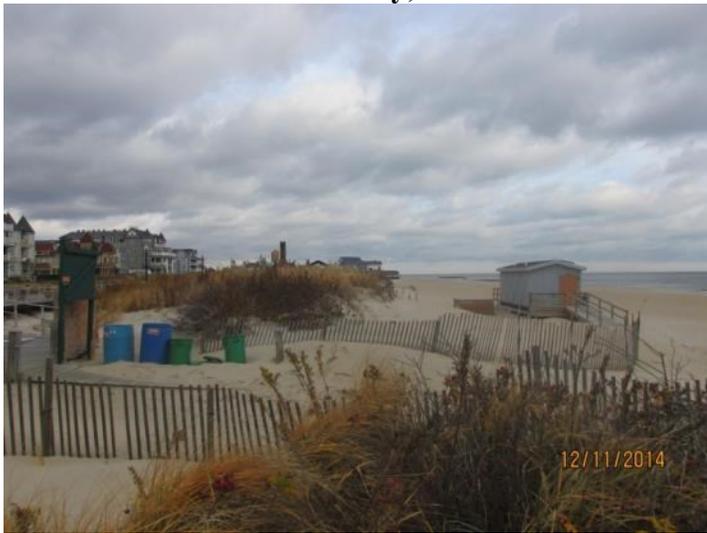
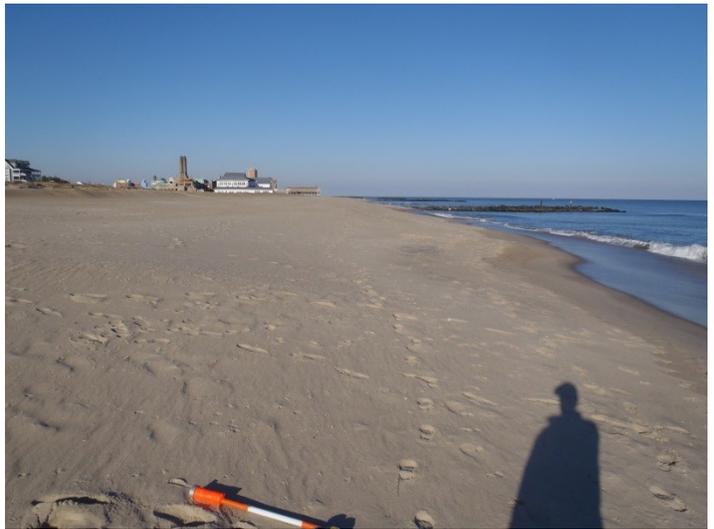
The sand volume added during 2014 amounted to 35.79 yds<sup>3</sup>/ft. with a 12-foot shoreline advance (12/11/2014). By December 4, 2015 the beach remained in good shape with minor shoreline retreat.

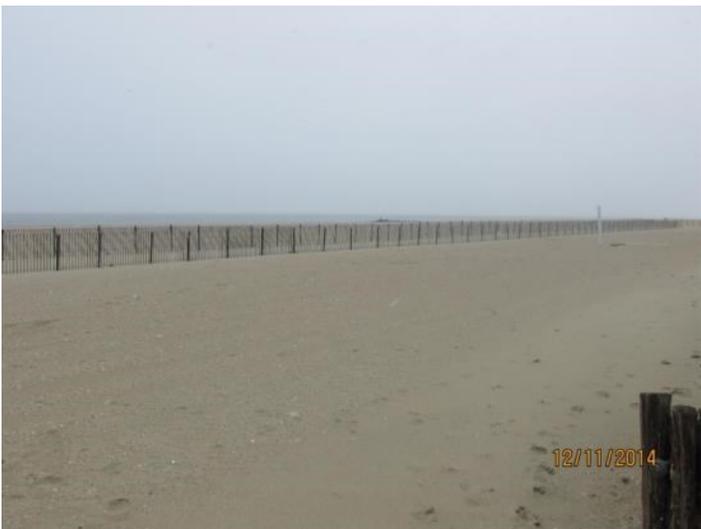
The beach and fencing was restored as of December 11, 2014 adding elevation to the beach if not much width. By December 3, 2015 a small dune zone had been established and the beach retained most of the applied material.

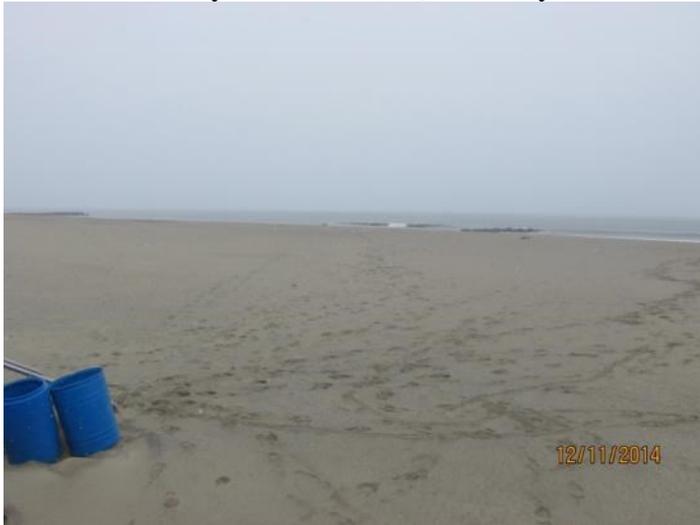
This site is located north of the Shark River inlet. By the spring of 2014 the site had received Sandy-recovery sand with a higher berm and wider beach (survey #48). The December 11, 2014 left view shows that beach extending to the groins. By December 4, 2015, the groin appears to be offshore beyond the wave breaker zone (extreme right edge of the right photo).

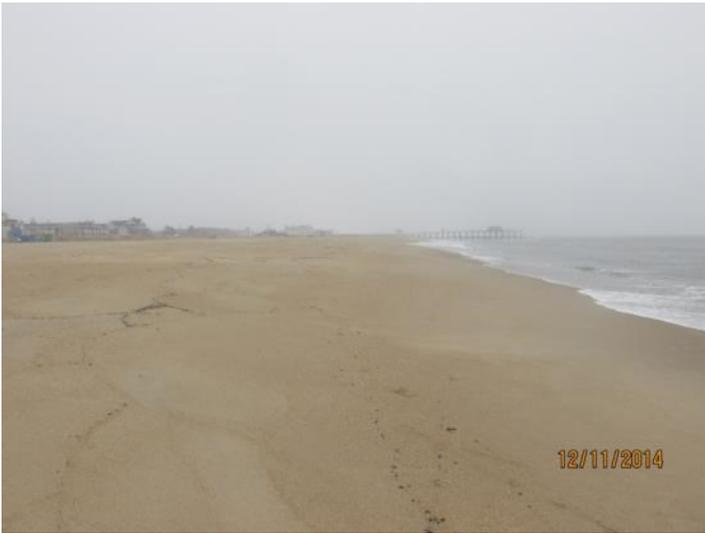
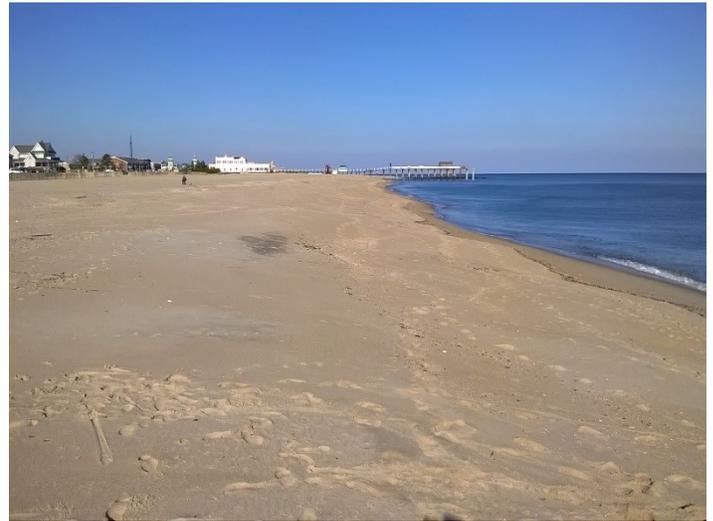
This site did not have a dune prior to Sandy but had a wide, dry beach. Natural recovery brought sand back to the site allowing the USACE to accept this width as sufficient to their design. The December 4, 2015 (right) shows a steeper beach reaching essentially the same position on the left (Dec. 11, 2014).

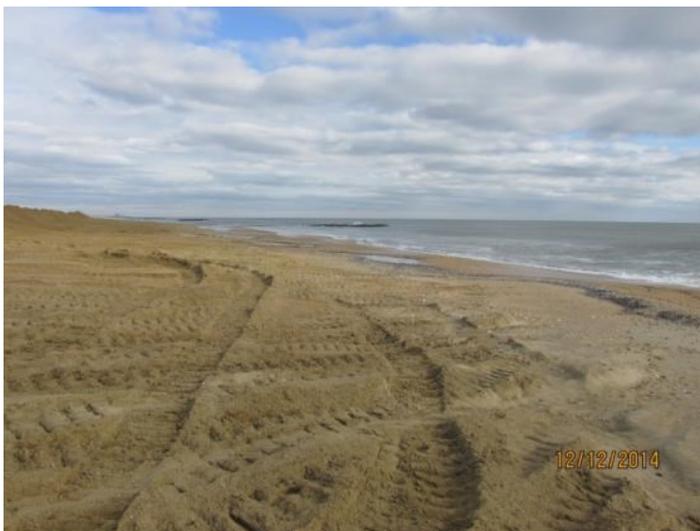
USACE work was in progress on December 12, 2014 to widen the beach and add sand. By December 4, 2015 the beach had a sand ridge pushed up to act as a winter “dune”. Its performance during the late January 2016 northeast storm was marginal.

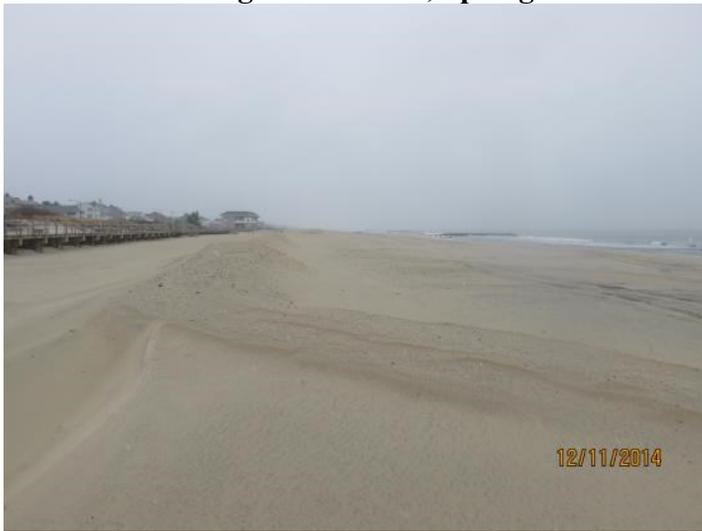
NJBPN 161 – Brighton Avenue, Spring Lake

By December 11, 2014 (left) the USACE had added 40.47 yds<sup>3</sup>/ft. in new sand advancing the shoreline by 13 feet. The right view on November 29, 2015 shows the wide beach with an active surf zone breaking on an offshore bar.

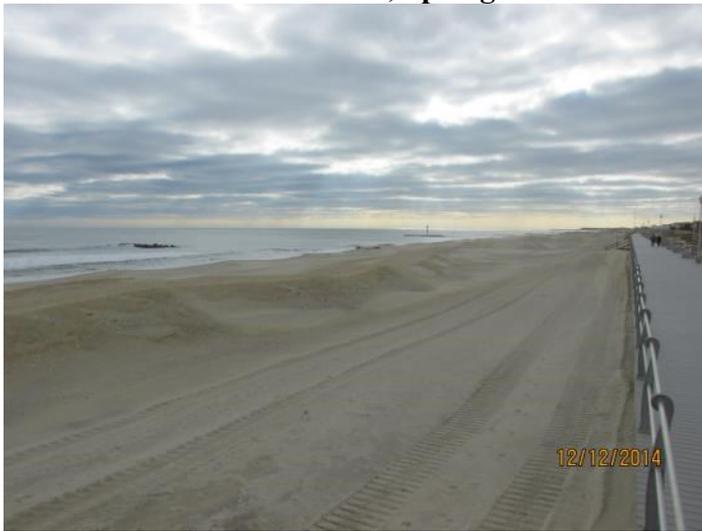
NJBPN 160 – Salem Avenue, Spring Lake

The USACE completed restoration in 2014 adding 32.29 yds<sup>3</sup>/ft. The view on December 11, 2015 shows a similar beach width with the winter storm “dune” in place seaward of the boardwalk. The vegetated dune still exists landward of the boardwalk.

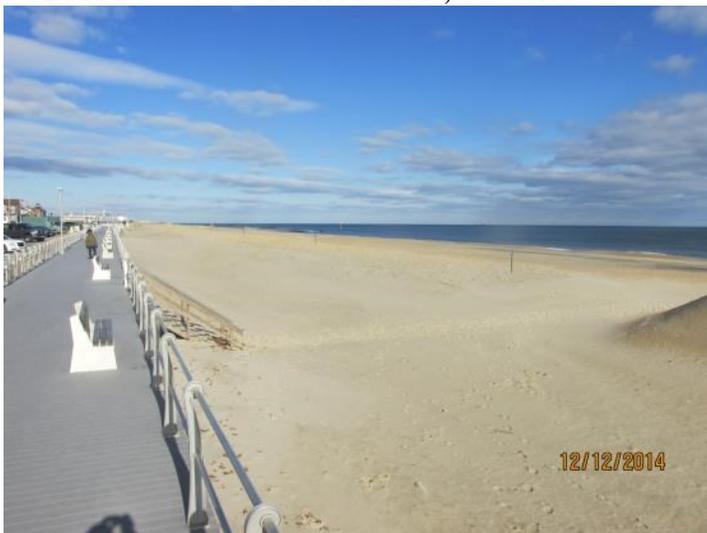
Modest additions were made by the USACE during 2014 (23.81 yds<sup>3</sup>/ft.) and the beach was wider (on left 12/12/2014). By December 11, 2015 the small dune seaward of the boardwalk has grass and gains some sand.
