# STOCKTON UNIVERSITY COASTAL RESEARCH CENTER

## New Jersey Beach Profile Network 2015 Annual Report on Shoreline Changes in New Jersey's Four Coastal Counties Raritan Bay to Delaware Bay Spring of 2014 Through Fall of 2015

# New Jersey Beach Profile Network Monmouth County Site Locations

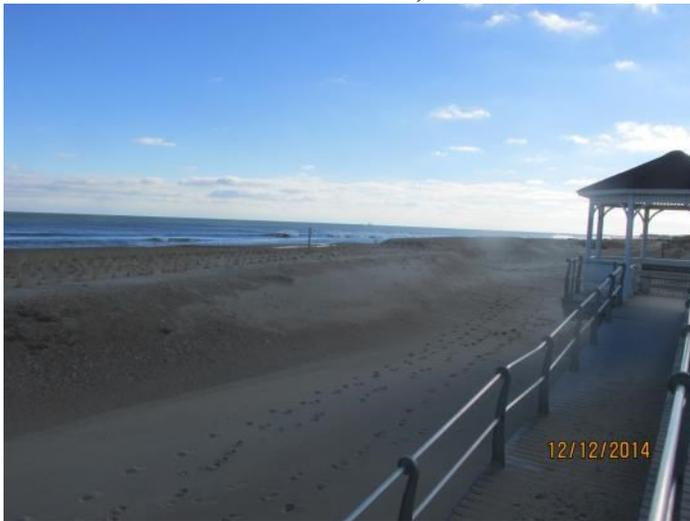
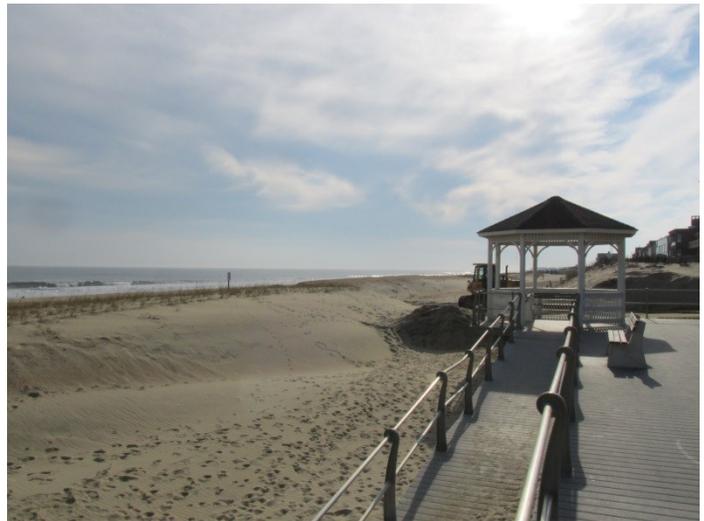
NJBPN 158 – Trenton Avenue, Sea Girt

Sand was added by the USACE in early 2014 and the recovered sand was molded into a dune ridge at the toe of the primary dune (left view 12/12/2014). The same view on December 11, 2015 shows wind deposits landward of the dune ridge, some grass growth and a similar width to the beach.

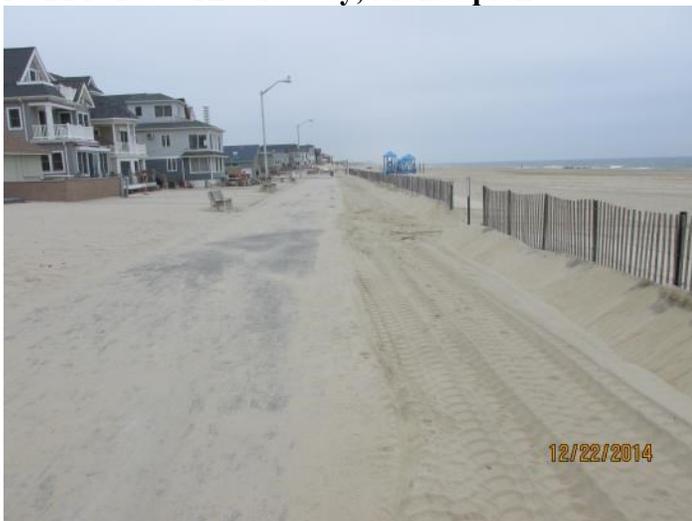
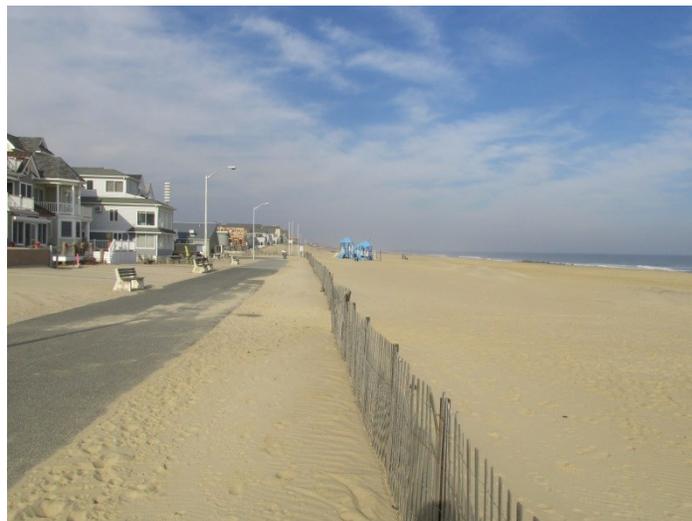
NJBPN 157 – Riddle Way, Manasquan

By May 2014 the USACE had added sand to the beach, but with the shoreline-parallel sand fencing located at the promenade, there has been little dune development since Sandy (left view 12/22/2014). A year later (Dec. 11, 2015) the same width appears to be present on the beach and the sand fence has accumulated a little sand. No real dune exists yet though.

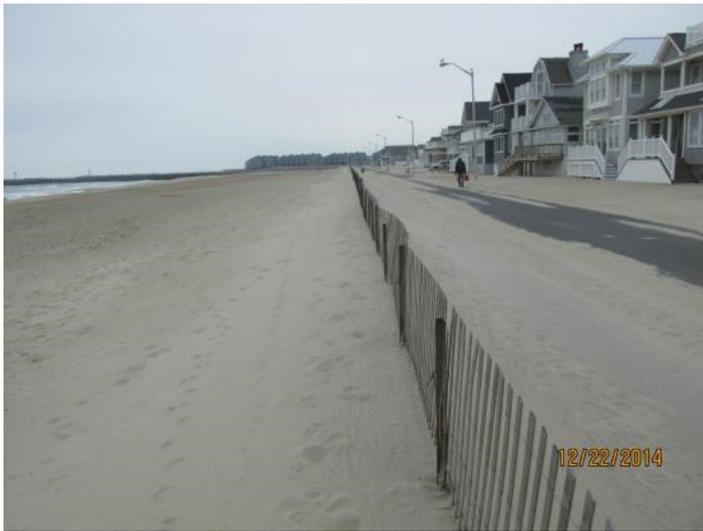
NJBPN 256 – Pompano Avenue, Manasquan

By May of 2014 the beach had 82.26 yds<sup>3</sup>/ft. in new sand added by the USACE resulting in a 113-foot shoreline advance. The Dec. 22, 2014 view on the left shows a single fence and no dune, while the Dec. 11, 2015 view on the right shows that the municipality had pushed up a sand ridge as a winter “dune”. This precludes any sand building around the fence line.

At the Pompano Avenue site (#256) the dune was removed as well as the entire promenade with most of the sand transported inland. A huge bar appeared offshore (59.36 yds<sup>3</sup>/ft. deposited). Since April 2013 only 12.80 yds<sup>3</sup>/ft. has returned to the beach, but 32.27 yds<sup>3</sup>/ft. of that deposit has moved elsewhere either landward or toward the Manasquan Inlet. The Army Corps placed 82.26 yds<sup>3</sup>/ft. at this site generating a 113-foot shoreline advance, but there is no significant dune present along the rebuilt promenade. Between spring 2014 and fall 2015 the site gained 14.03 yds<sup>3</sup>/ft. with a 37-foot shoreline retreat. Many of the Monmouth County towns have taken to pushing ridges of sand up as winter approaches generating a "dune ridge" of beach sand about mid-way across the berm width as added storm protection. This ridge appears on the December 2015 profile surveys below in numerous cases.
