THE RICHARD STOCKTON COLLEGE OF NEW JERSEY

**Beach-Dune Performance Assessment of
New Jersey Beach Profile Network (NJBPN) Sites at
Northern Ocean County, New Jersey
After Hurricane Sandy Related to FEMA Disaster DR-NJ 4086**

November 28, 2012

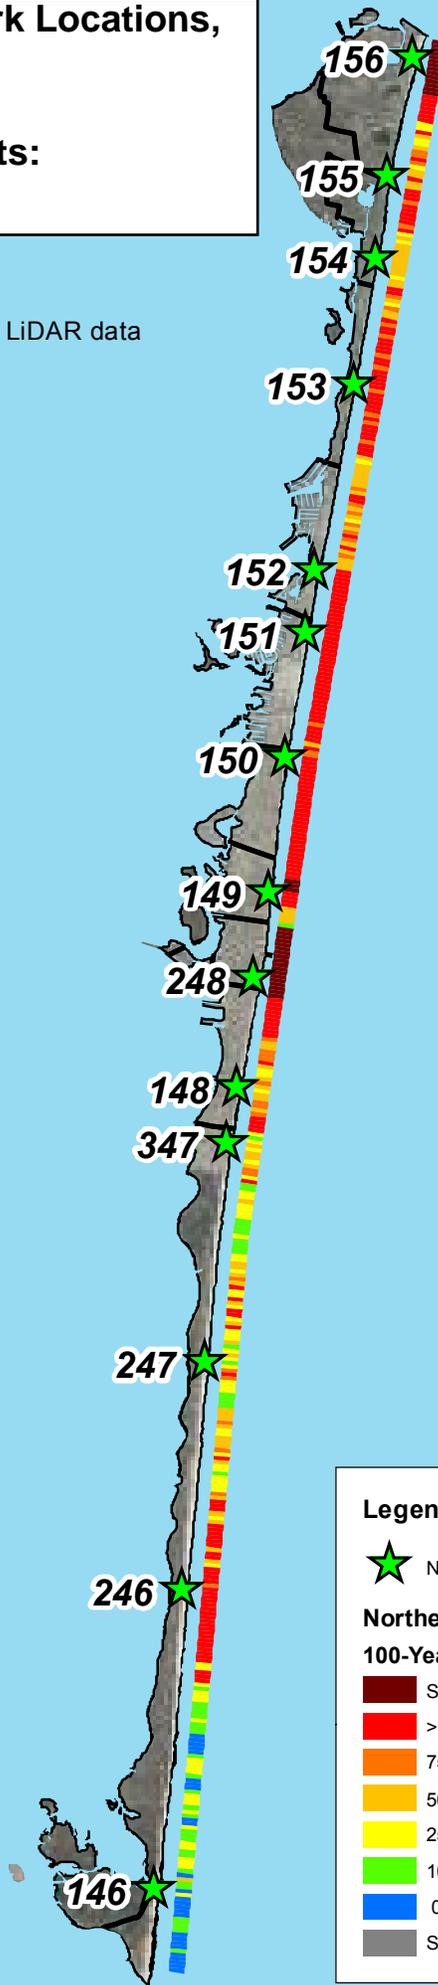
**New Jersey Beach Profile Network Locations,
Northern Ocean County
&
Beach-Dune Susceptibility Results:
100-year Storm**

Note: Assessment results are based on year-2000 LiDAR data

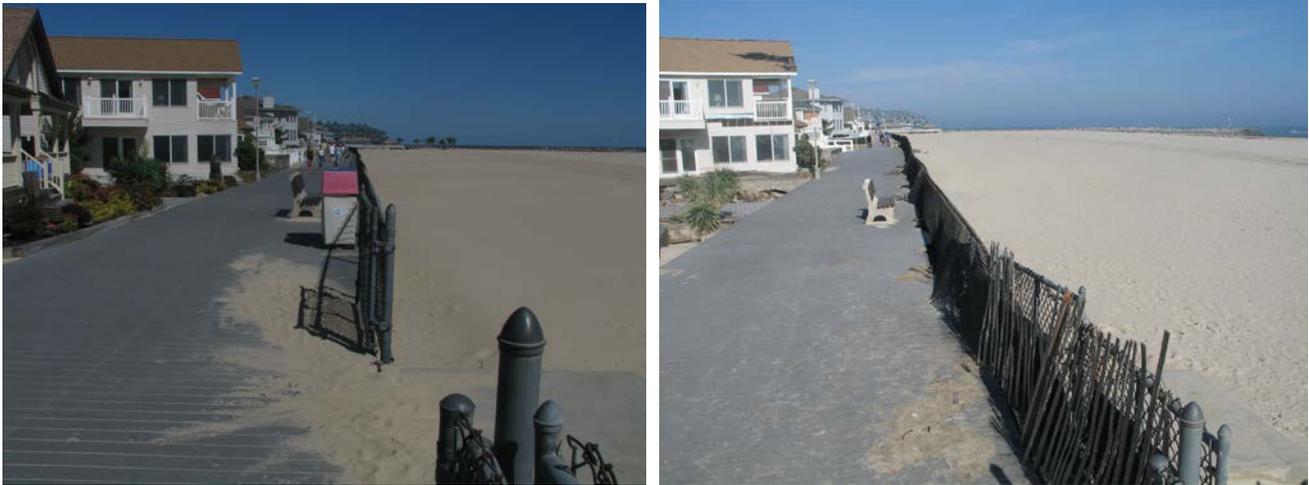
NJBPN 156 – Water Street, Point Pleasant

The photographs above were taken on September 21, 2012 (left) and November 12, 2012 (right).

The two cross sections in Point Pleasant Beach demonstrated that with no dune system or a smaller, poorly vegetated dune system, there would be little resistance from the tidal surge and the associated waves to cross inland from the ocean. The entire beach and dune system along this segment of northern Ocean County experienced wide-scale overwash and breaching of dunes. The northern profile located at Water Street had no dune in front of the boardwalk, which was damaged and a large amount of sand from the beach was carried inland from wave action. Damage would have been more severe had there not been a 600-foot wide berm in front of the boardwalk. The southern profile at Maryland Avenue was significantly eroded (dune breach) with sand losses totaling 45.7 yds³/ft. along the profile due to the storm. By the time of the post-storm survey, the municipality had begun relocating sand from the berm to the former dune location.

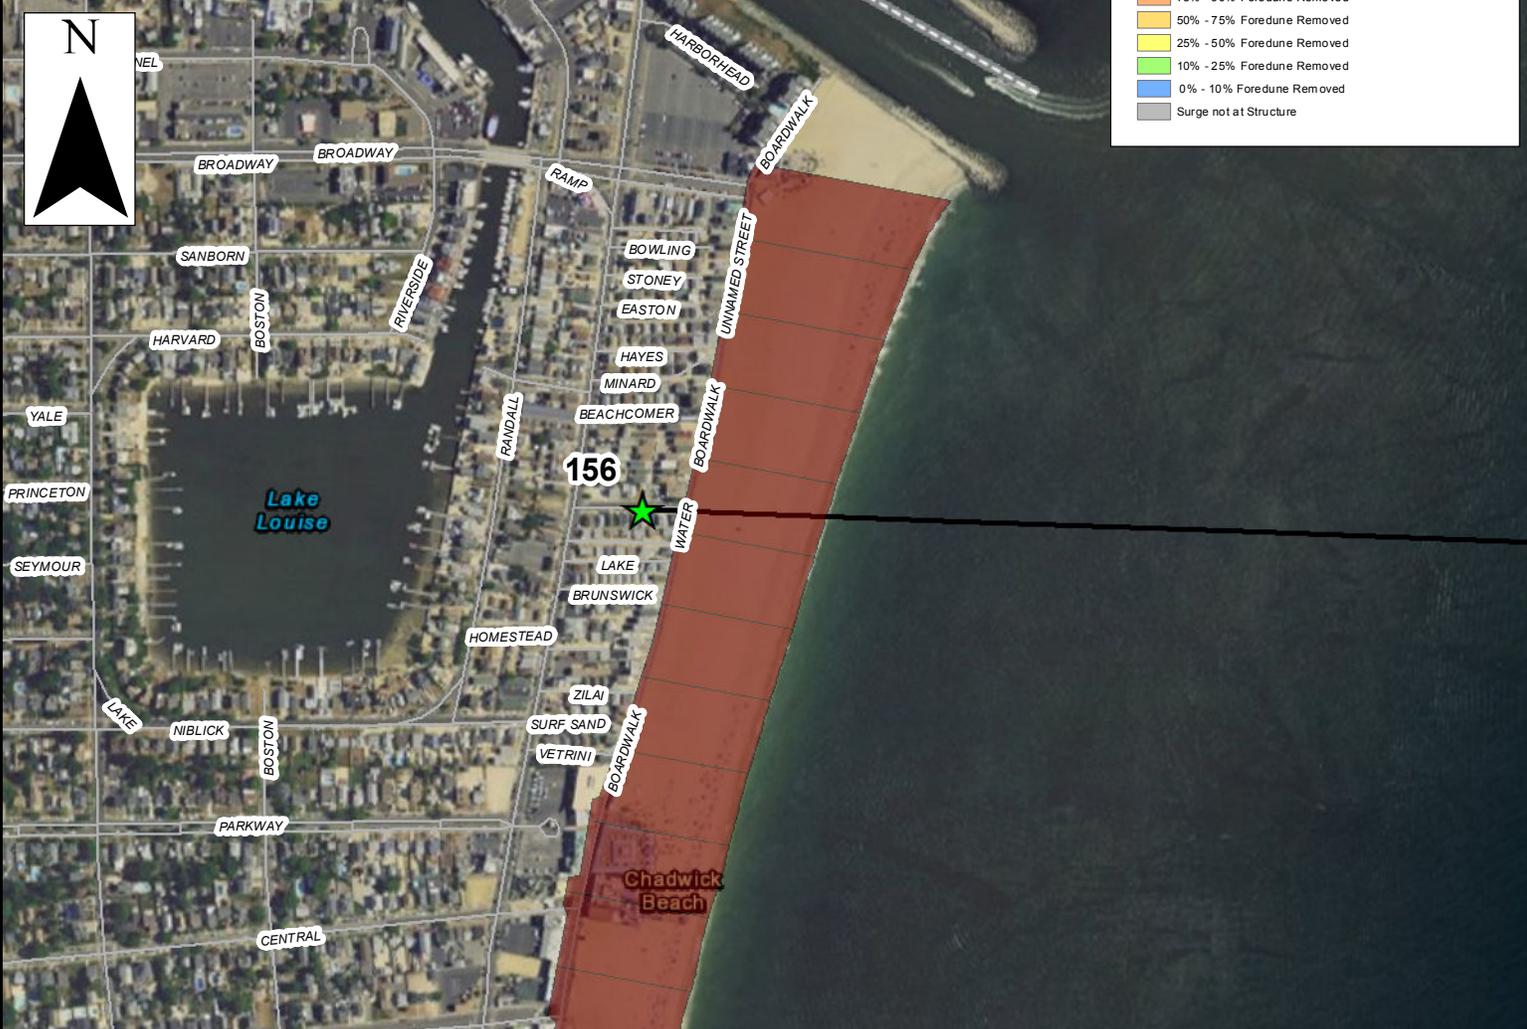
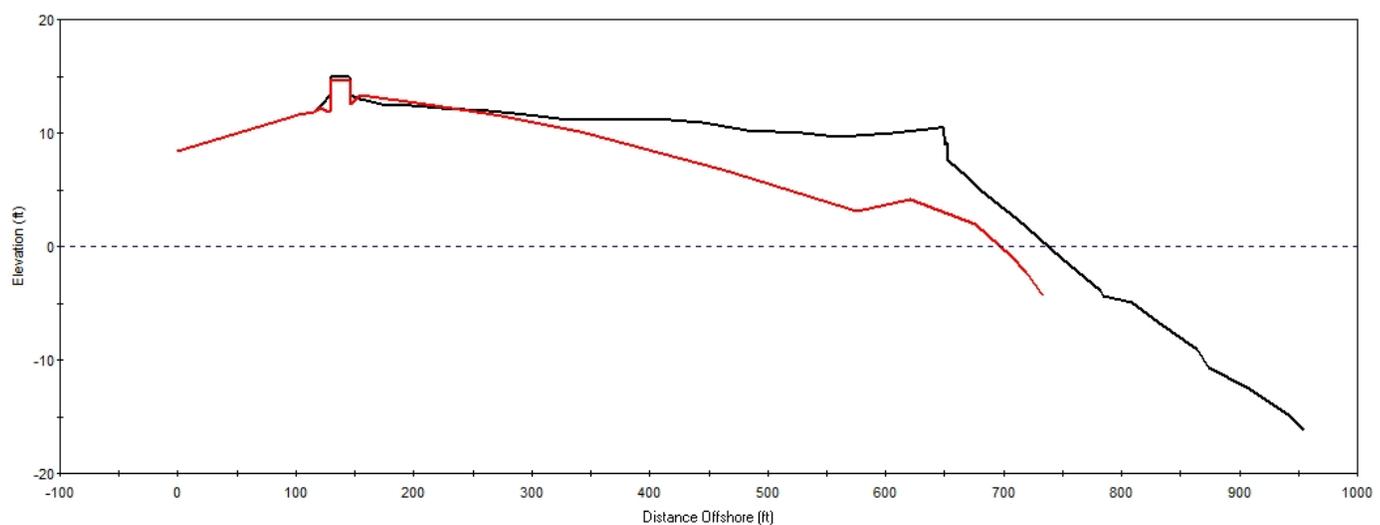
NJBPN Site 156 Water Street, Point Pleasant Beach Before & After Hurricane Sandy

Figure 2. The following figure shows the predicted impacts from a 100-year storm surge at Point Pleasant Beach. The predicted susceptibility was based upon the lack of an established dune system. Also shown is the comparison plot between the pre- and post-storm surveys. The plot depicts the changes caused by the storm and the losses of the berm where $62.7 \text{ yds}^3/\text{ft.}$ of sand were removed during the storm. The sand losses were extensive as predicted in the susceptibility study. This urban beach did not have a dune system but was spared from more severe damages by the over 600-foot protective berm.

Pre vs. Post Sandy
Site 156
Water St., Point Pleasant

Volume Change = -62.677 cu. yd/ft

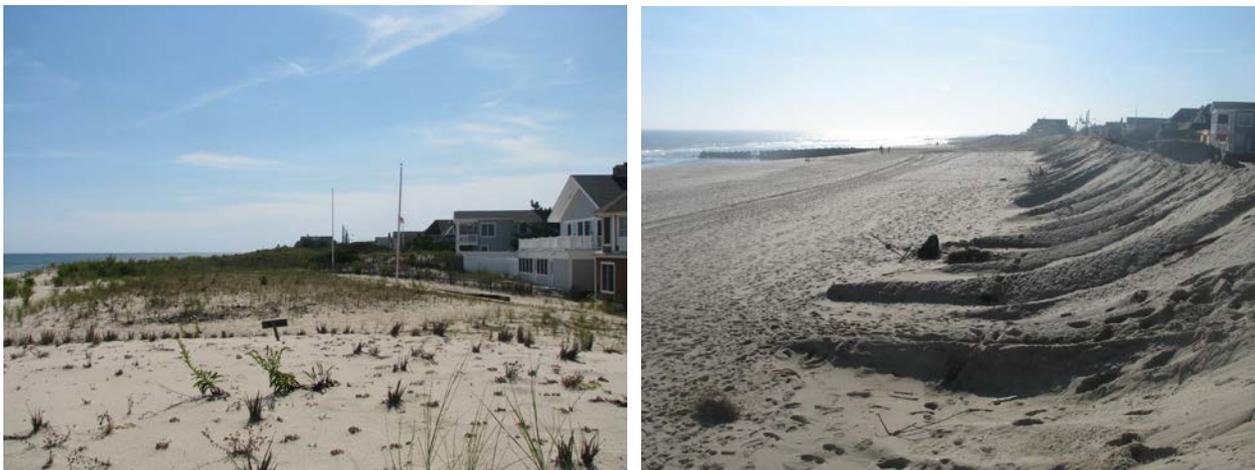
NJBPN 155 – Maryland Avenue, Point Pleasant

The photographs above were taken on September 17, 2012 (left) and November 12, 2012 (right).

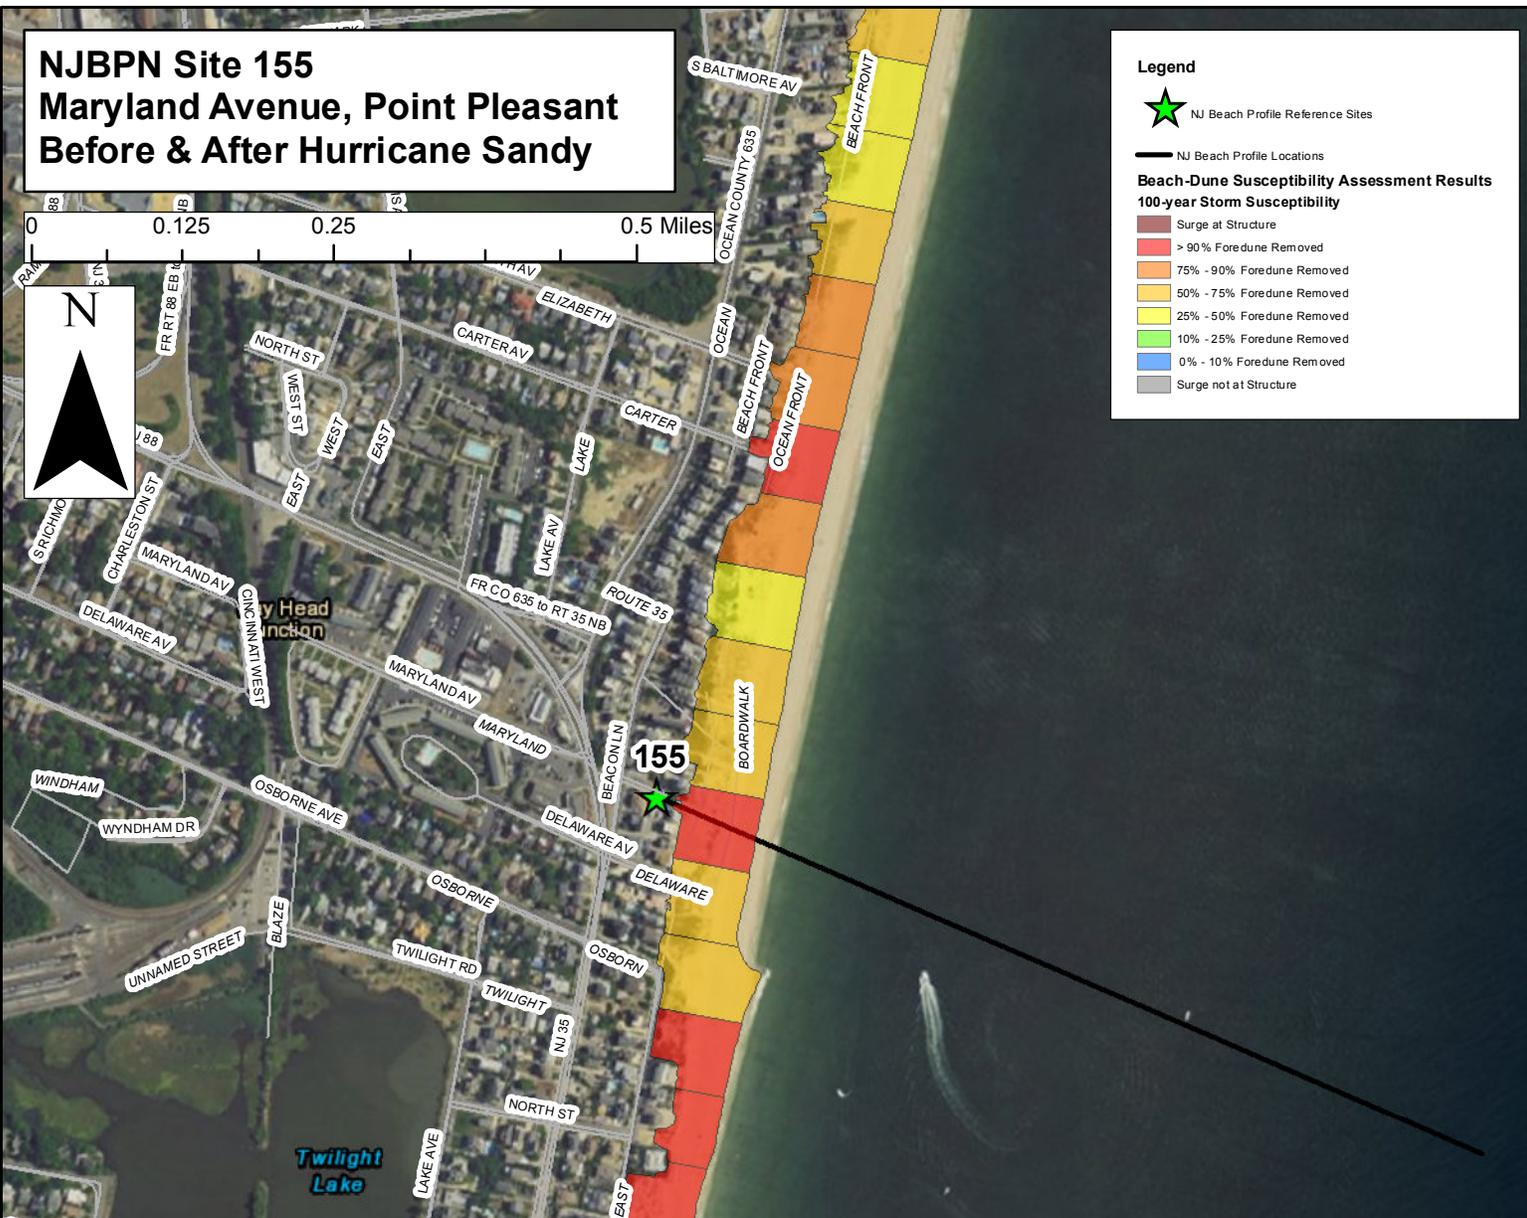
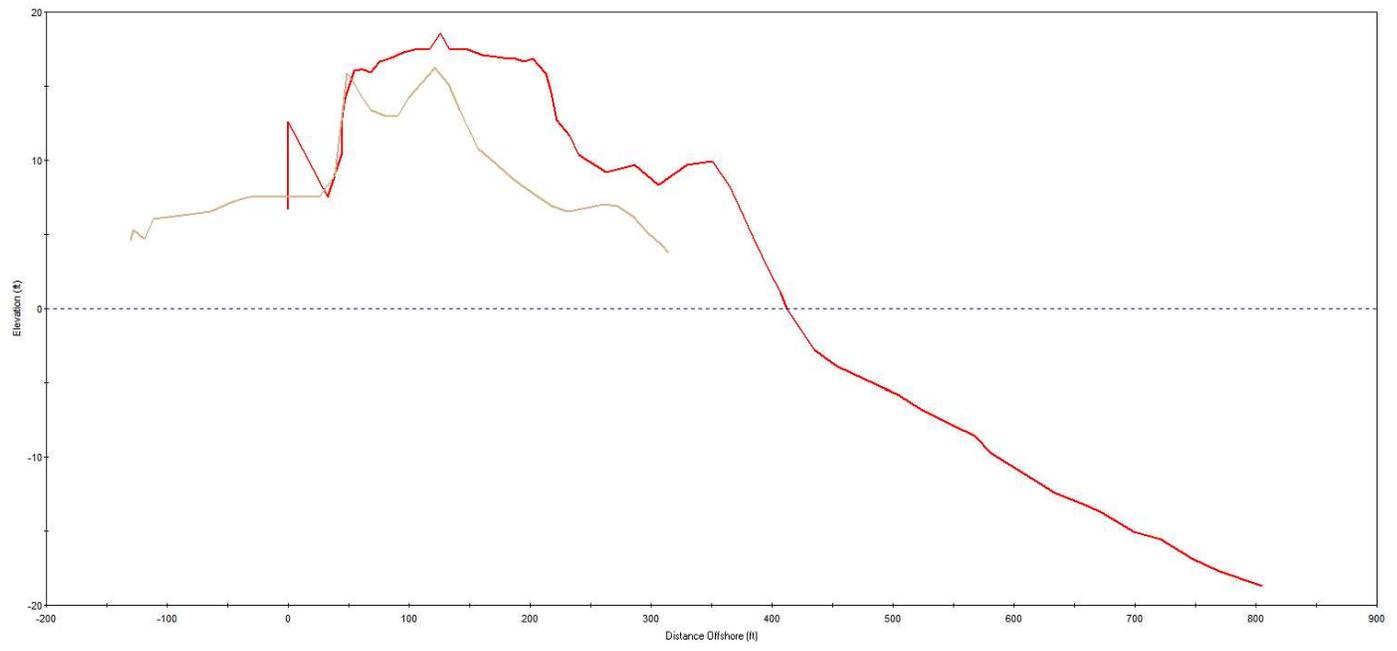
NJBPN Site 155 Maryland Avenue, Point Pleasant Before & After Hurricane Sandy

Figure 3. The following figure shows the predicted impacts from a 100-year storm surge at the second location in Point Pleasant Beach. The predicted susceptibility shows possible impacts created by the shore-perpendicular accessway as those areas tend to be lower in elevation. Also shown is the comparison plot between the pre- and post-storm surveys. The plot depicts the changes caused by the storm and the losses of the berm and poorly vegetated dune system where 45.7 yds³/ft. of sand were removed during the storm. By the time of the post-storm survey, the municipality had begun relocating sand from the berm to the former dune location.

Pre vs. Post Sandy
Site 155
Maryland Avenue, Point Pleasant

Volume Change = -45.752 cu. yd/ft

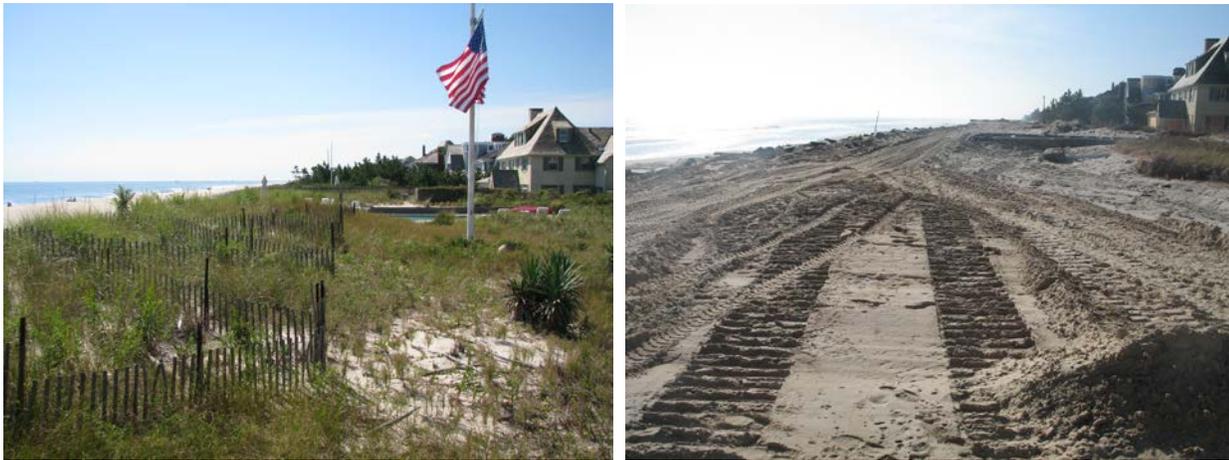
NJBPN 154 – Johnson Avenue, Bay Head

The photographs above were taken on September 17, 2012 (left) and November 12, 2012 (right).

The entire beach and dune system along this segment of northern Ocean County experienced wide-scale overwash and breaching of dunes. Approximately 5,500 feet of this 9,500-foot municipal shoreline had a rock revetment constructed following the storm 50 years ago that did comparable damage to the State's shoreline. Since 1992 the rocks have been buried as the core of a continuous dune line fronting the development. The 1992 northeast storm over-topped the wall of rocks and put sand into the street ends without significant property damage. Restored shortly afterward, no storm since until Sandy approached stripping the sand from the rocks. Hurricane Sandy treated the rock revetment as if it were a speed bump. Sand and water poured down each street end to the tidewater several blocks inland. The beachfront homes were still standing, but had suffered substantial structural damage in many cases ranging up to the deposition of 2+ feet of sand on the building's lot without damage to the building. Sand was being excavated from the streets two blocks inland. Where there was no rock revetment, there was greater structural damage to homes and their surroundings. Accelerated erosion surrounded the larger groins present in the northern part of Bay Head due to wave energy reflecting off the northern side of the structure and adding to the incident wave coming onto the beach directly. Small segments of dune remained either between the revetment and the homes or where no revetment was built. Dense vegetation or a significantly wider cross section at a high elevation seemed to make the difference.

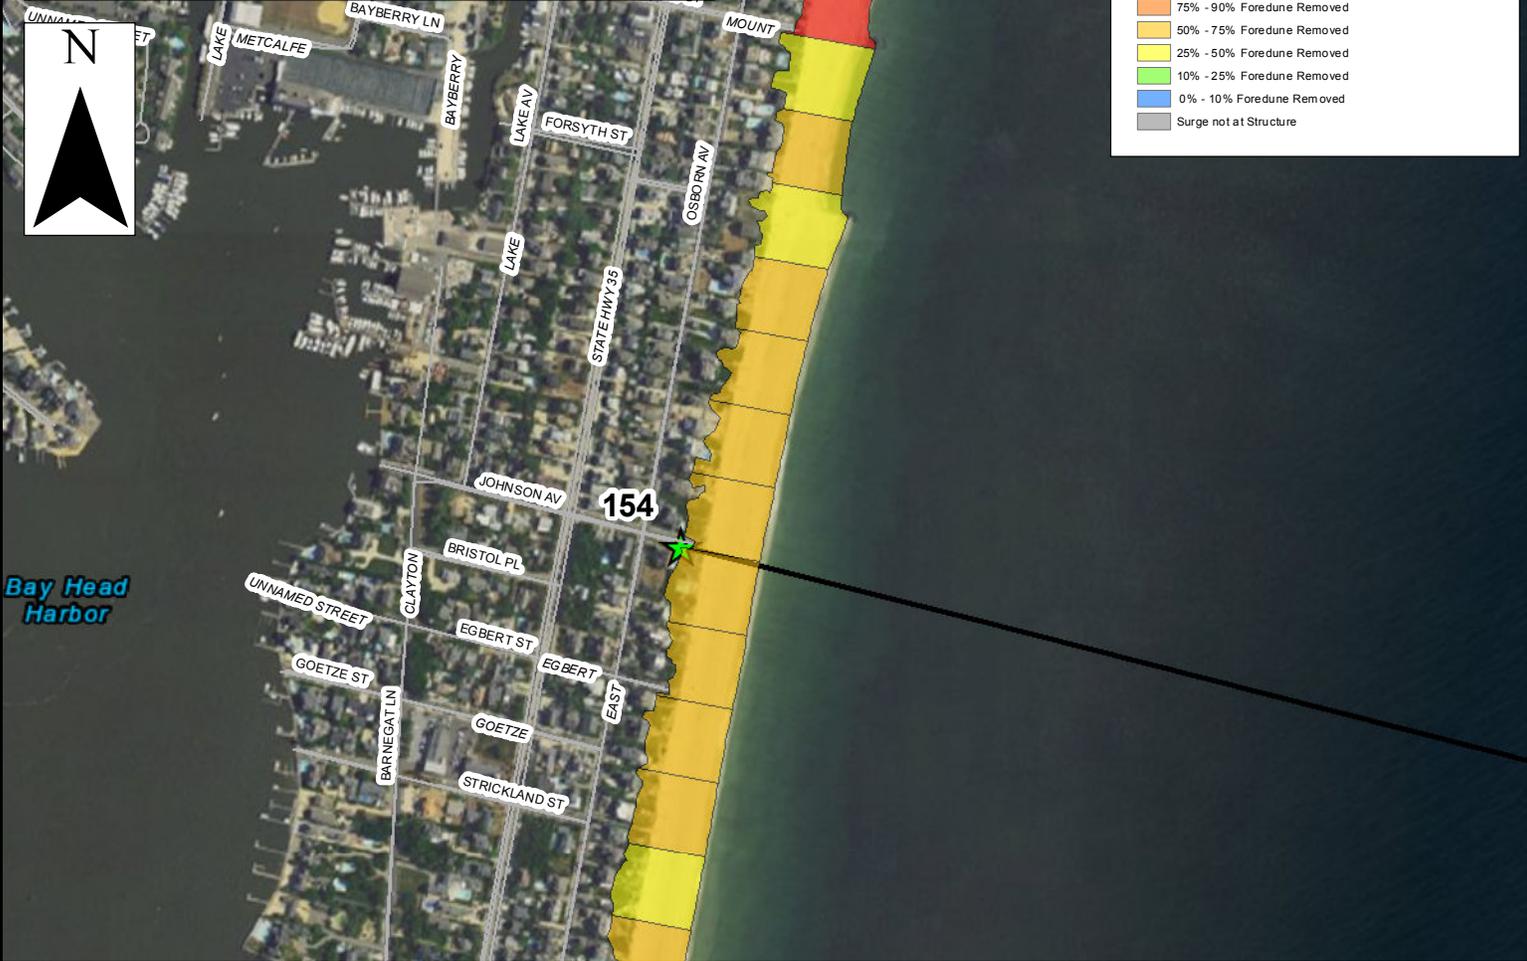
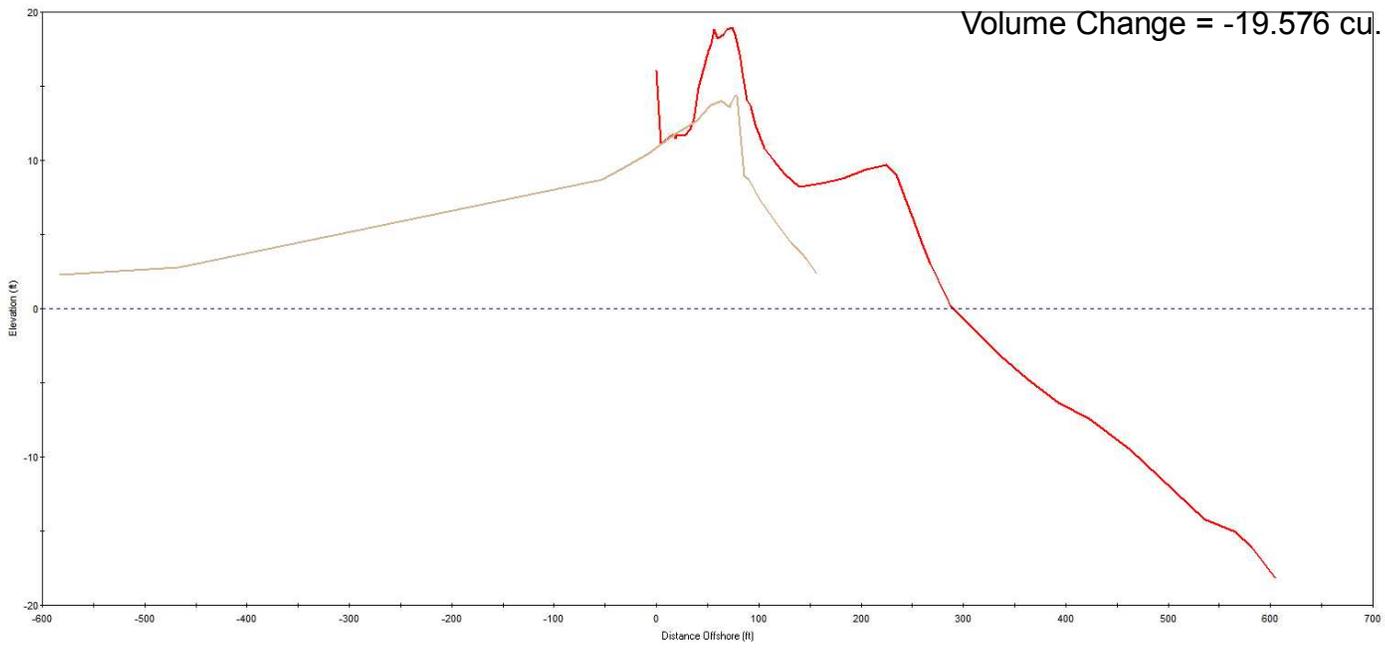
NJBPN Site 154 Johnson Street, Bay Head Before & After Hurricane Sandy

Figure 4. The following figure shows the predicted impacts from a 100-year storm surge at Bay Head located at the northern section of the barrier spit complex. Susceptibility to a 100-year storm event was based upon the low dune elevation and limited size of the berm. Also shown is the comparison plot between the pre- and post-storm surveys. The plot depicts the changes caused by the storm and the losses of the berm and moderate dune where 19.6 yds³/ft. of sand were removed during the storm. The dune seaward of the homes was obliterated during the storm and exposed a base rubble-mound revetment layer. The beach was lowered, and sand was overwashed between the oceanfront homes and carried landward to the backbarrier.

Pre vs. Post Sandy
Site 154
Johnson Street, Bay Head

Volume Change = -19.576 cu. yd/ft

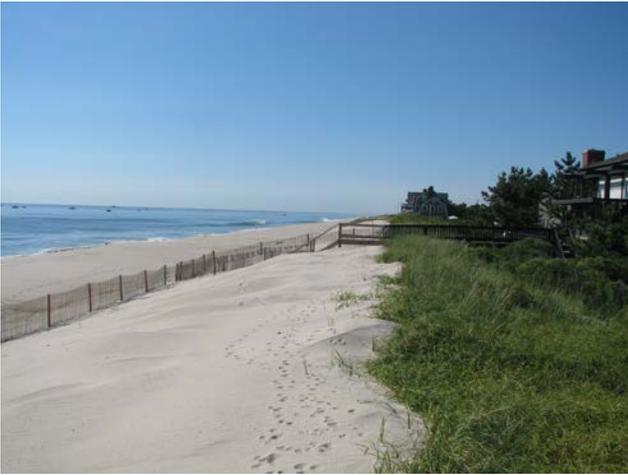
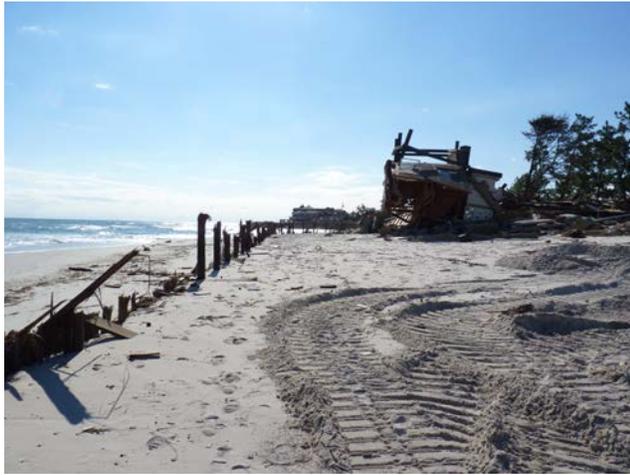
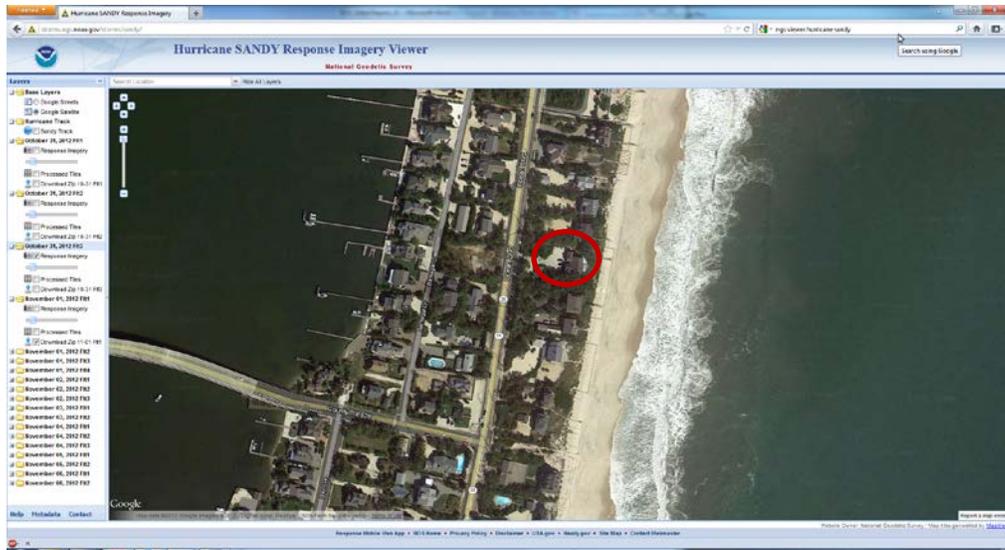
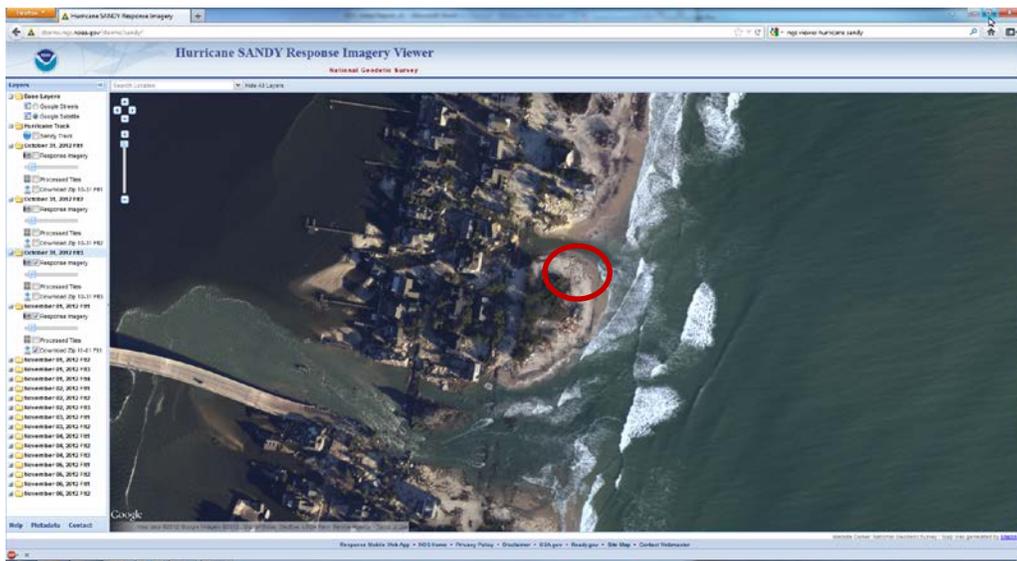
The photographs above were taken on September 17, 2012 (left) and November 5, 2012 (right). This profile location is within 300 feet from the temporary channel that opened during Sandy. The home at 1117 Ocean Avenue was completely removed from its location. See comparison screen captures below and the home circled in red.

The Borough of Mantoloking extends for over two miles further south and has no regional shore protection hard structures on the beach. Individual owners have constructed private rock or timber structures across the front of private homes over time. The dunes have been maintained meticulously over the past decade in an effort to maximize the municipal shore protection they afford. The crest elevation exceeded 14 feet with some as high as 25 feet. The major problem was that insufficient sand was on the coastline to provide both a major dune system and a wide beach to force waves to break early and not on the dune slope. By late September a municipally-sponsored dune evaluation revealed that this year the Borough's situation was about as good as it was possible to make it without a major beach nourishment project. The highest, widest dunes served to protect homes on the southern segment of the Borough from damage, but a declining width of the dune base combined with lower average elevations allowed massive failure along the remainder of the municipality. The mid-section was the most heavily impacted with three channels cut across the entire peninsula into Barnegat Bay. The worst was seen at Herbert Street where a new bridge connects with mainland Ocean County. Here a tidally flowing inlet was generated that allowed in the storm surge flood and permitted several days of tidal flow erasing at least 12 properties. A second, small cut occurred at 1117 Ocean Avenue and a third occurred at Lyman Street all mostly due to narrow, lower elevation dunes with no significant beach width to absorb some of the wave attack.

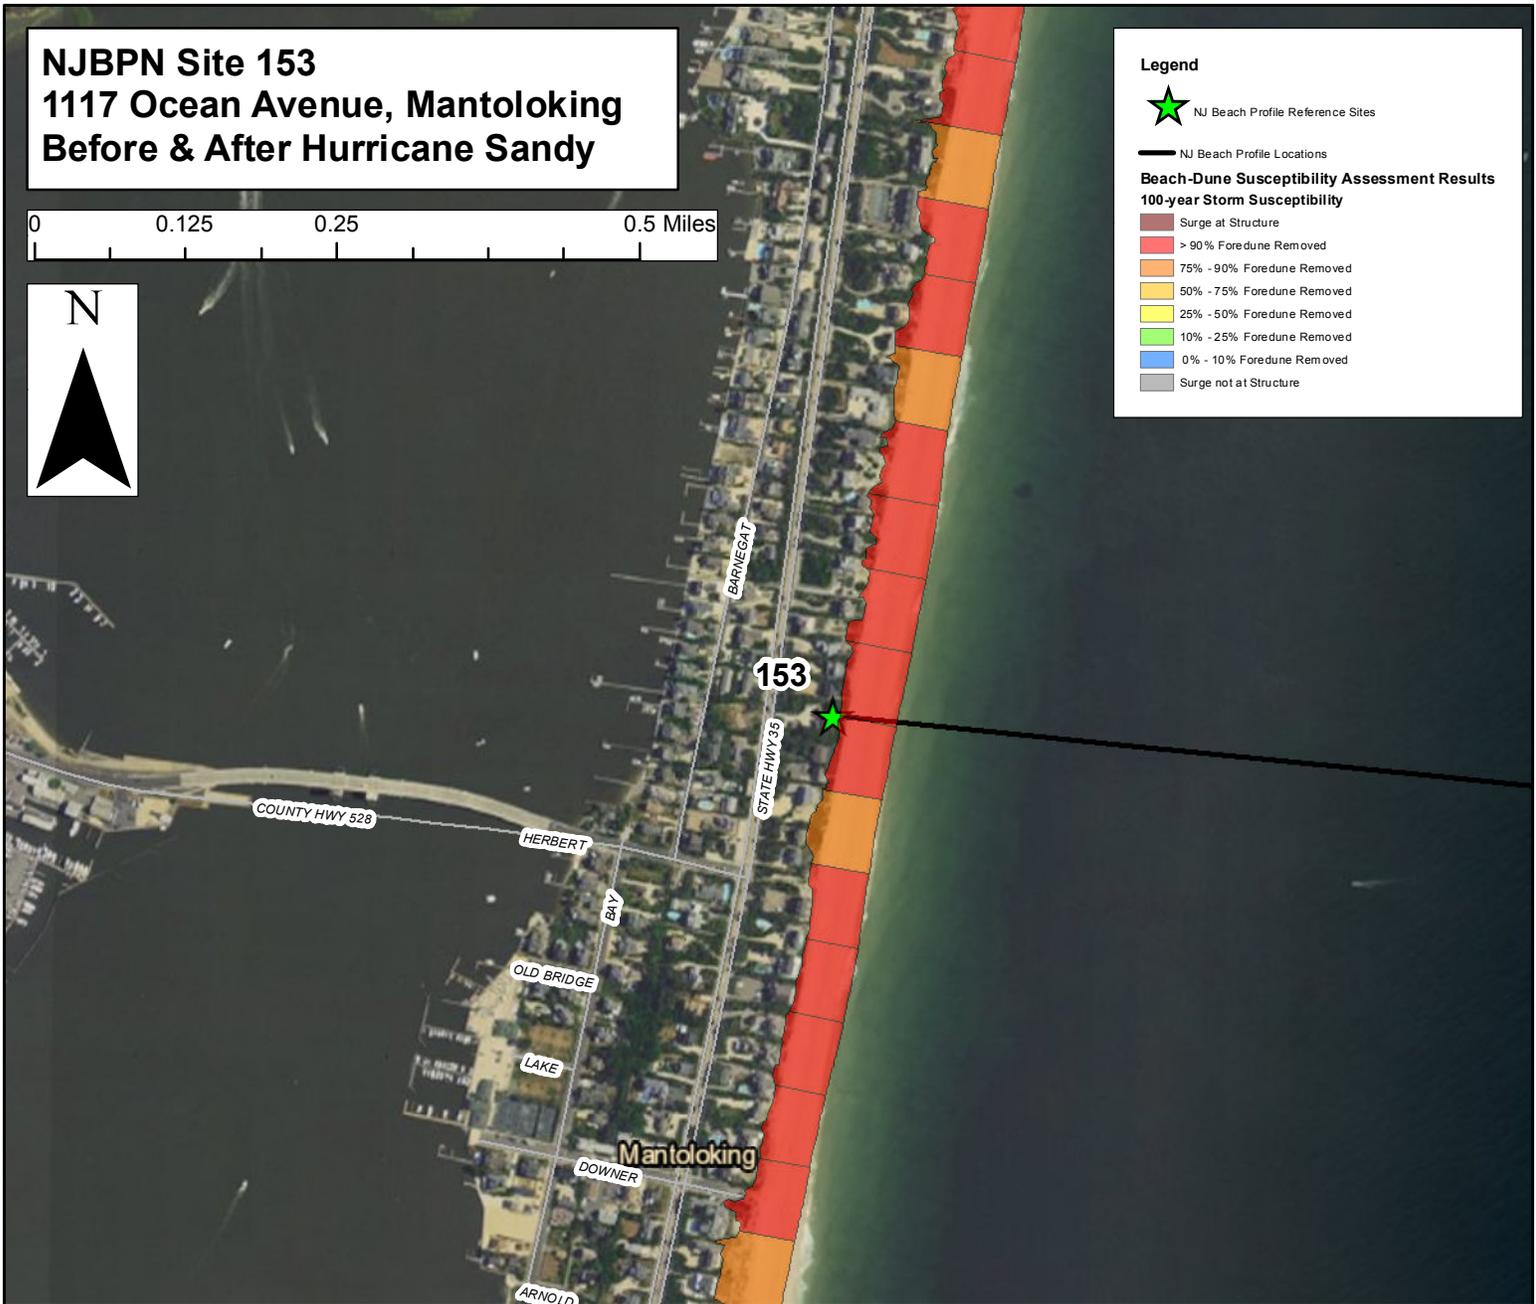
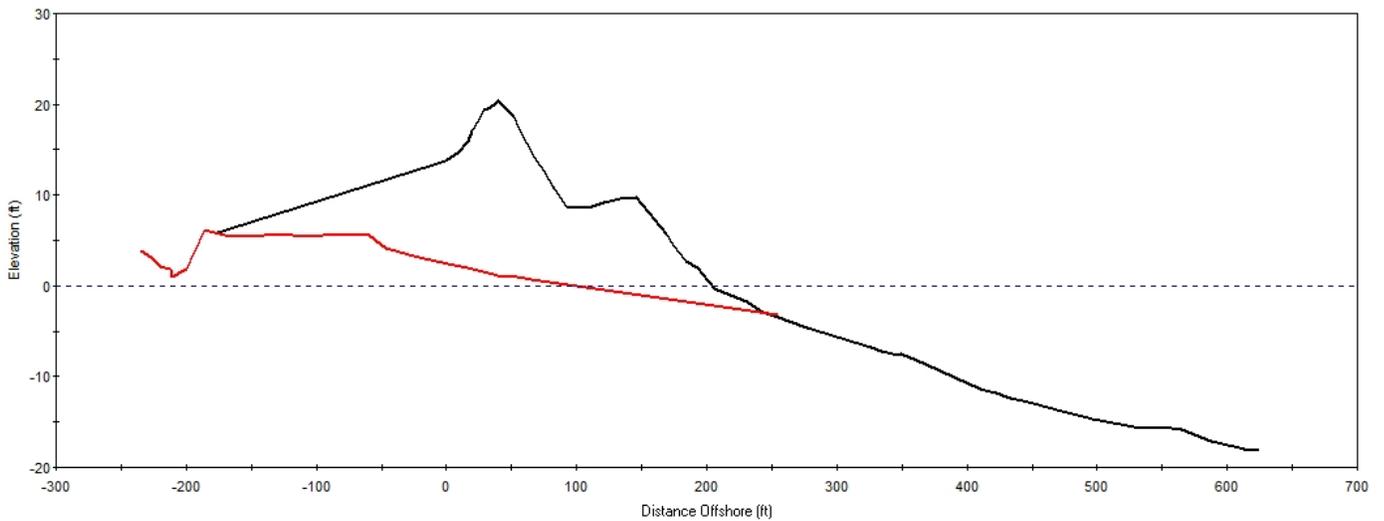
NJBPN Site 153
1117 Ocean Avenue, Mantoloking
Before & After Hurricane Sandy

Figure 5. The following figure shows the predicted impacts from a 100-year storm surge at Mantoloking. The predicted susceptibility was based upon the relatively short beach and moderate dune system. Also shown is the

comparison plot between the pre- and post-storm surveys. As predicted, there was significant damage to the beaches and dunes. The plot depicts the changes caused by the storm and the losses of the berm where 109.6 yds³/ft. of sand were removed during the storm. This site suffered the greatest sand losses of all of the profiles in Northern Ocean County. The loss here is far greater due to the presence of the storm-generated inlet and deep scours into the area landward of the dunes. The sand loss volume includes the dune, the land between Route 35 and the current shoreline, but based on a uniform slope from Route 35 to the original back-shot position at the landward limit of the dune. This site was an incipient inlet breach north of the main cut at Herbert Street. (See comparison aerial photos shown above.) The shoreline wrapped landward toward the beach opening. While the closure of the flow was accomplished by November 5th, the original shoreline had retreated 150 feet. Here the dune width was far too narrow in spite of a 20-foot maximum elevation. Hurricane Irene took almost half the dune volume in August 2011.

Pre vs. Post Sandy:
Mant 3
1117 Ocean Ave.

Volume Change = -109.595 cu. yd/ft

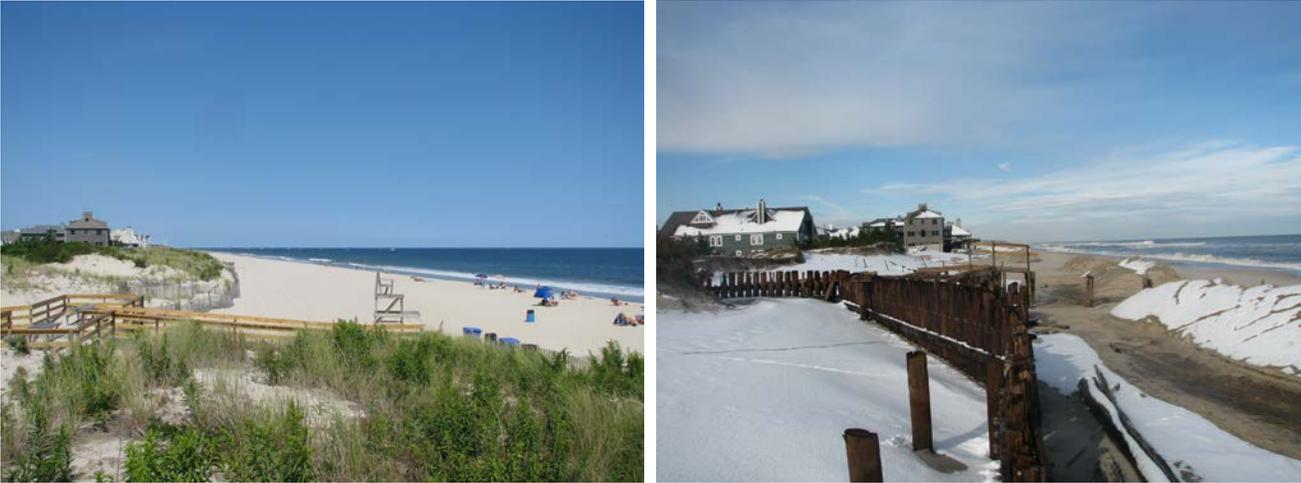
The photographs above were taken on September 14, 2012 (left) and November 8, 2012 (right).

The wider, higher dunes existing just north of the municipal boundary in Mantoloking continued south into Brick Township. Here there was little municipal oversight of dune maintenance so elevations, low spots and placement of access stairways to the beach were at the option of individual owners. At the municipal beach #3, the dune failed to the south on the property and waves directly impacted a multi-family building that was built very close to the beach. Overwash was evident, especially to the south toward Normandy Beach.

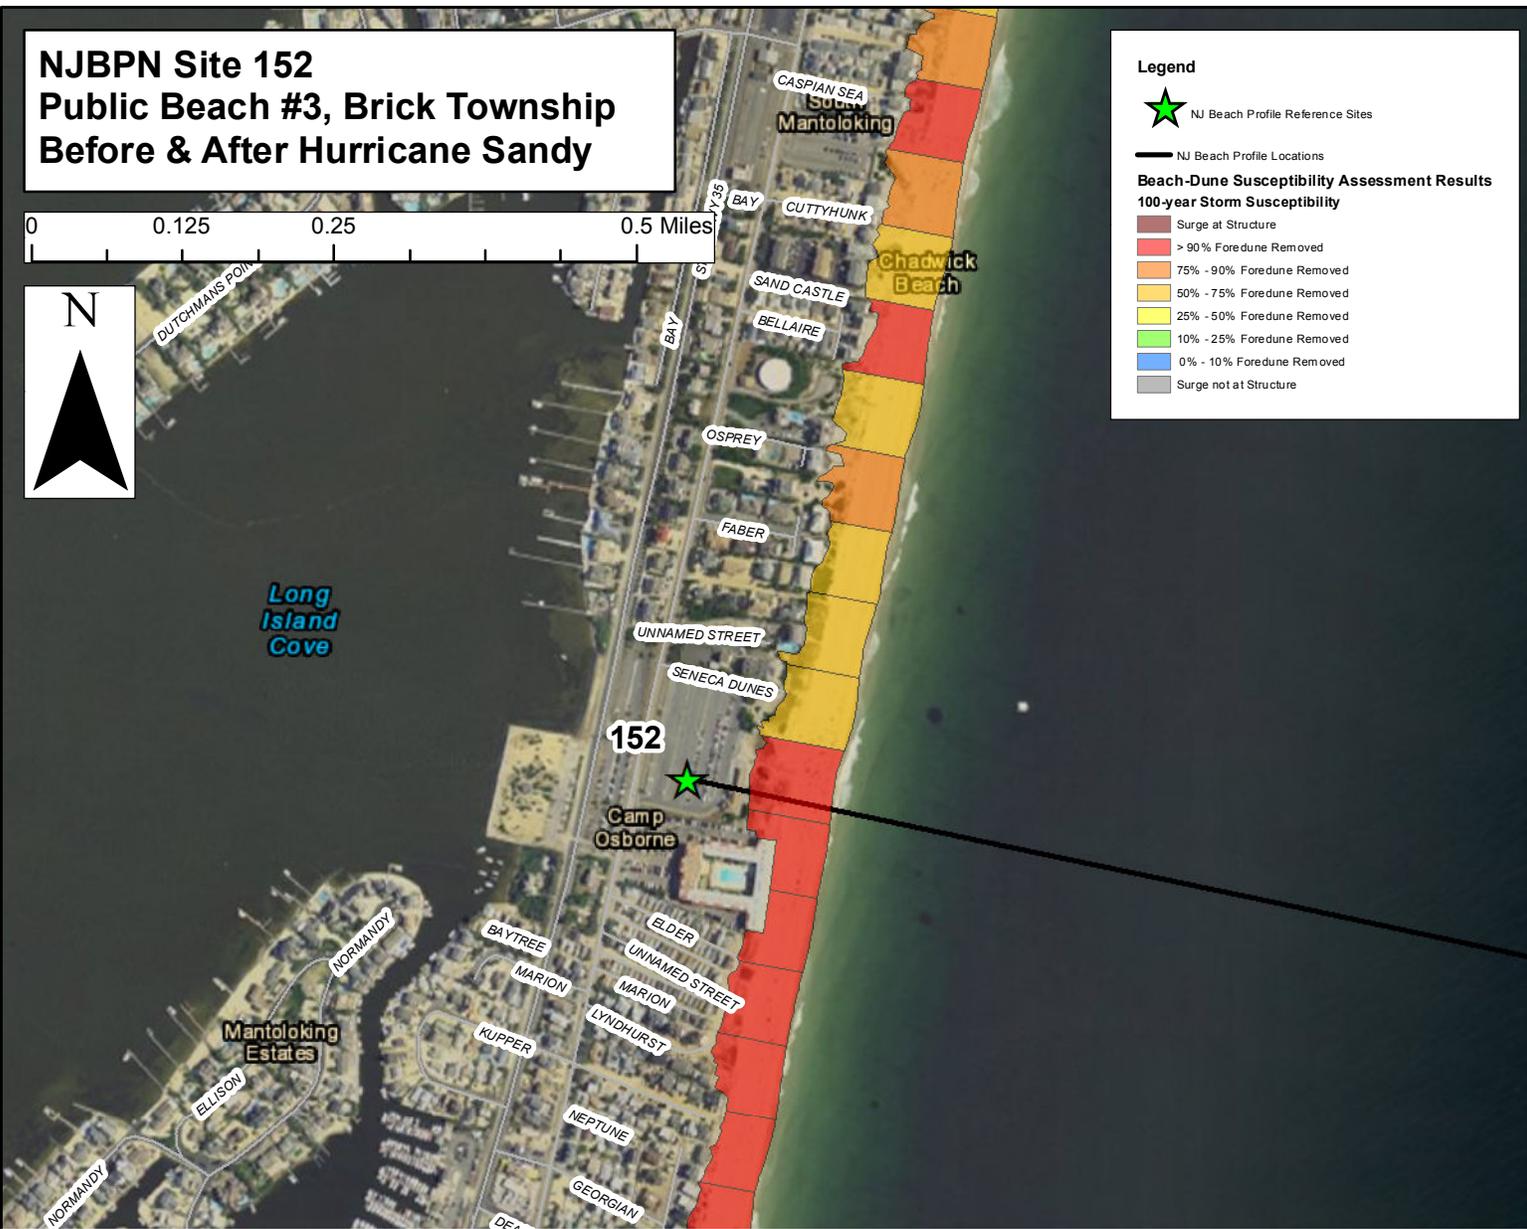
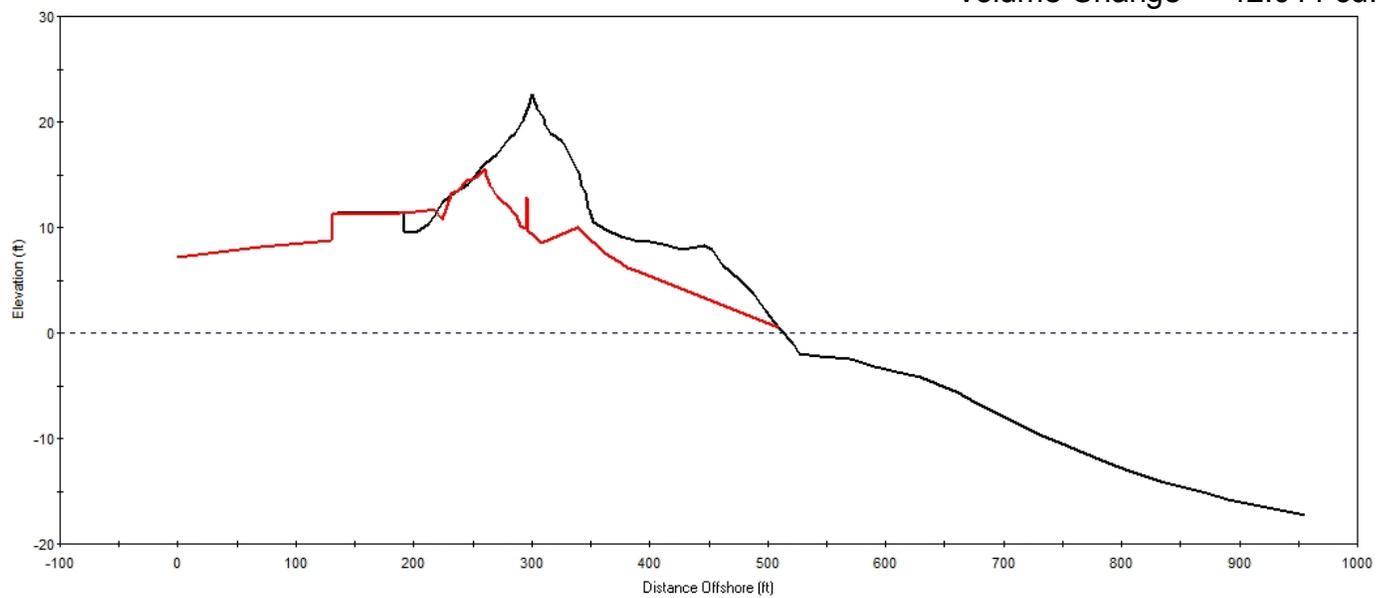
**NJBPN Site 152
Public Beach #3, Brick Township
Before & After Hurricane Sandy**

Figure 6. The following figure shows the predicted impacts from a 100-year storm surge at the Public Beach in Brick Township. The predicted susceptibility was based upon the moderate berm width. Also shown is the comparison plot between the pre- and post-storm surveys. The plot depicts the changes caused by the storm and the losses of the berm and moderate dune where 42.0 yds³/ft. of sand were removed during the storm. Prior to Sandy, the bulkhead was buried at least 10 feet below the dunes. Sand was transported landward in overwash deposits and several landward homes were damaged.

**Pre vs. Post Sandy
Site 152
Public Beach #3, Brick Township**

Volume Change = -42.014 cu. yd/ft

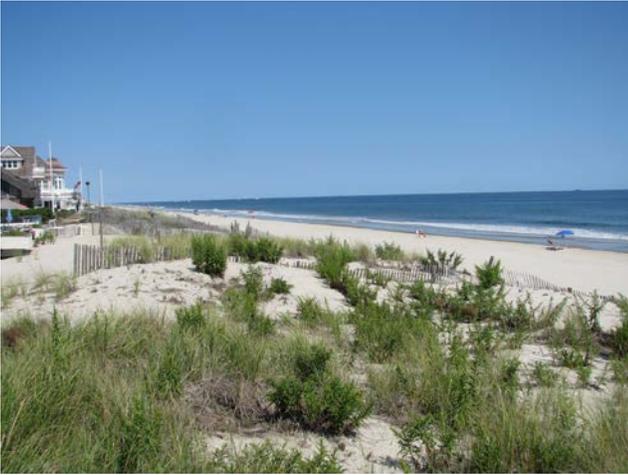
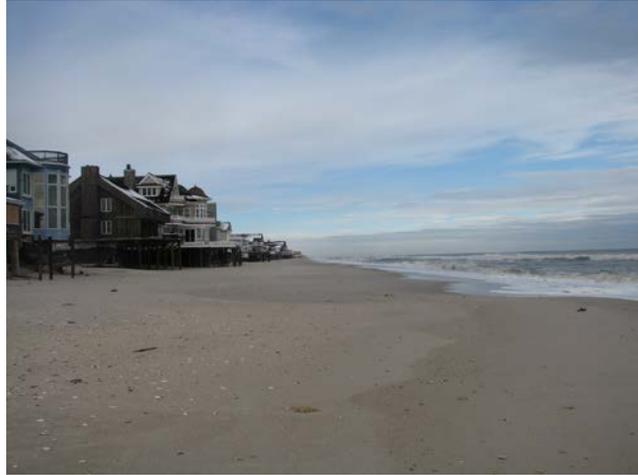
The photographs above were taken on September 14, 2012 (left) and November 8, 2012 (right).

The northern Township shoreline fared better than did the Ortley Beach section to the south, but significant overwash occurred in this section and many oceanfront and landward homes were damaged. This was due to beach-dune widths and elevations not adequate to withstand the tidal surge and wave action produced by Hurricane Sandy. Site #151 had losses of the dune and berm where 46.1 yds³/ft. of sand were removed during the storm.
