THE RICHARD STOCKTON COLLEGE OF NEW JERSEY

**Beach-Dune Performance Assessment of
New Jersey Beach Profile Network (NJBPN) Sites at
Northern Ocean County, New Jersey
After Hurricane Sandy Related to FEMA Disaster DR-NJ 4086**

November 28, 2012

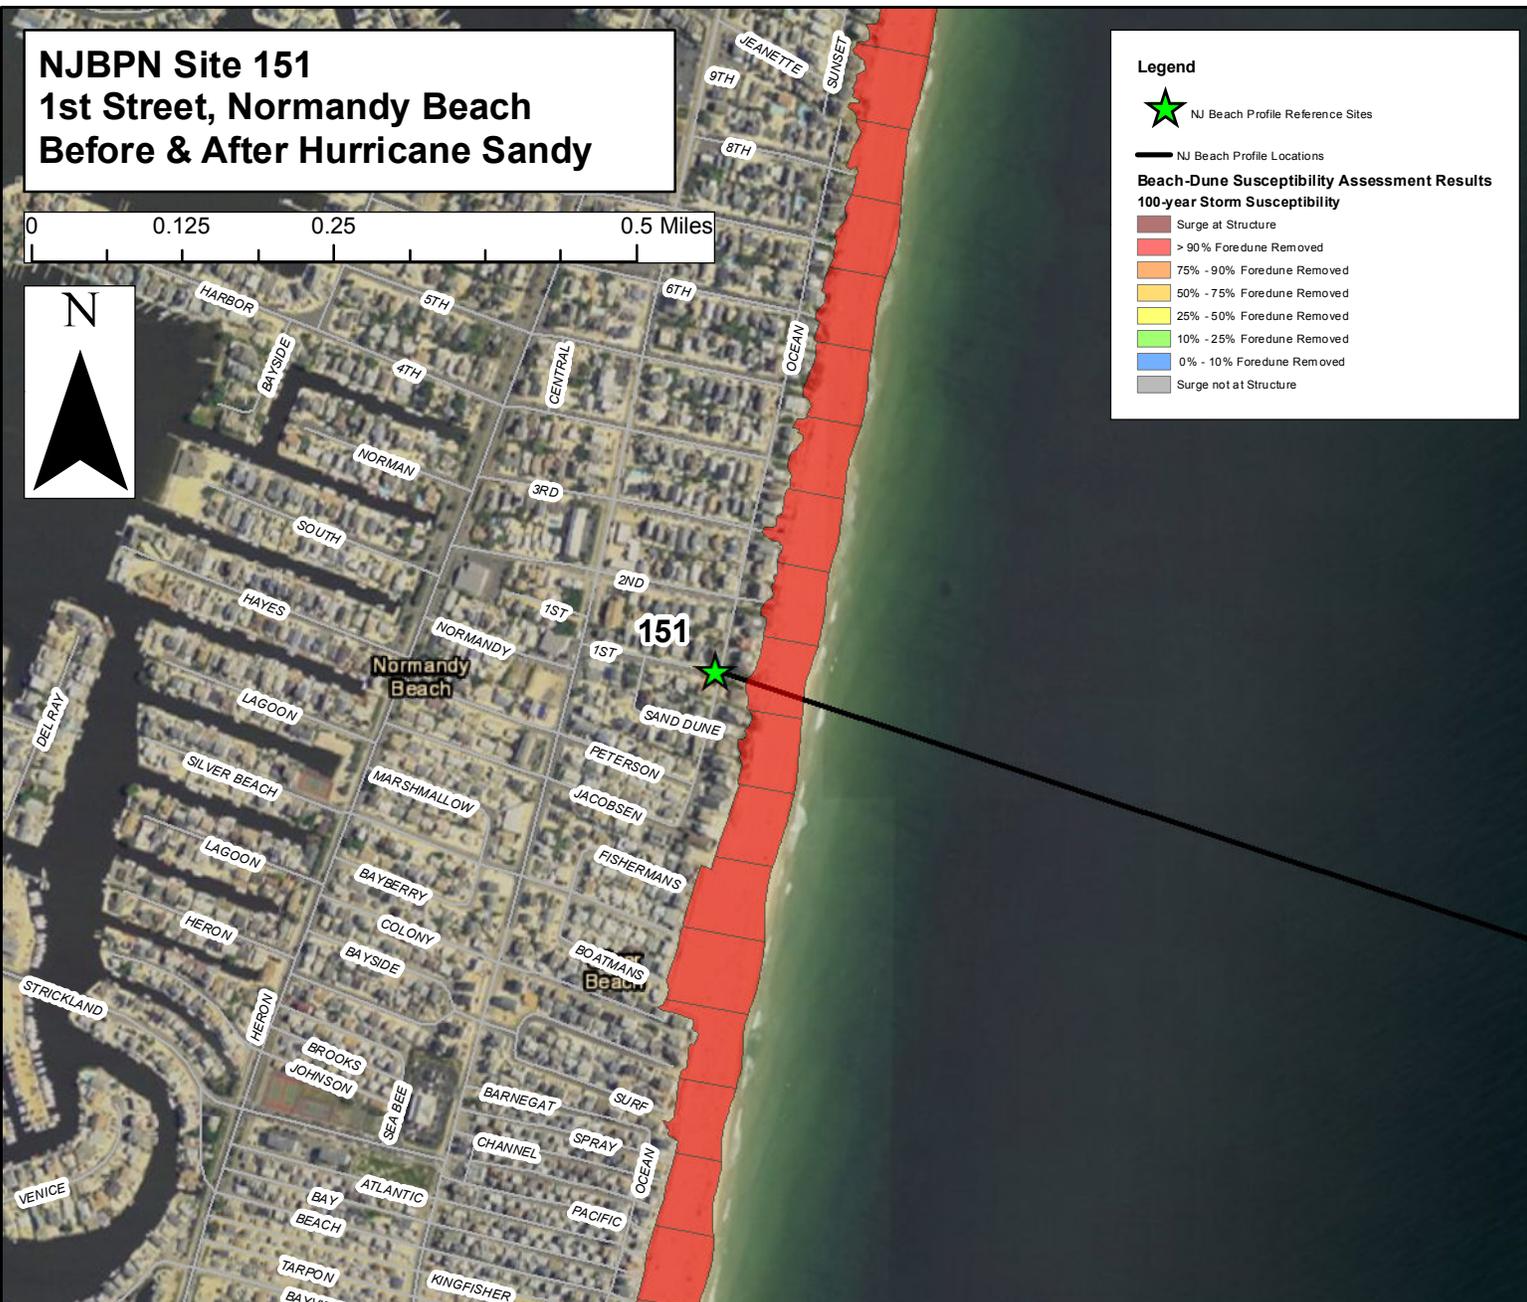
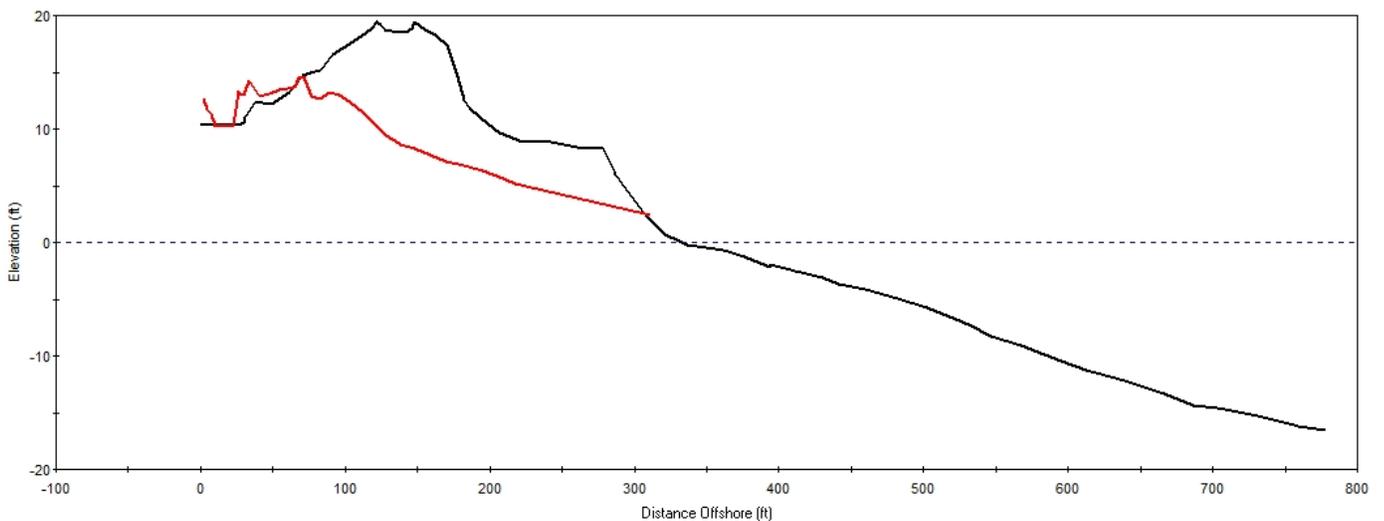
NJBPN Site 151 1st Street, Normandy Beach Before & After Hurricane Sandy

Figure 7. The following figure shows the predicted impacts from a 100-year storm surge at Normandy Beach. The predicted susceptibility was based upon the lack of an established dune system and minimal berm. Also shown is the comparison plot between the pre- and post-storm surveys. The plot depicts the changes caused by the storm and the losses of the berm where $46.1 \text{ yds}^3/\text{ft.}$ of sand were removed during the storm. Significant overwash occurred at this site and many oceanfront and landward homes were damaged.

Pre vs. Post Sandy
Site 151
1st Ave., Normandy Beach

Volume Change = -46.139 cu. yd/ft

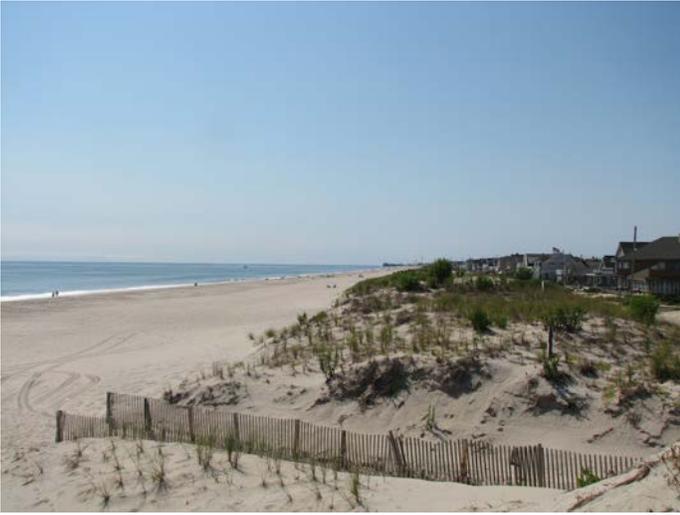
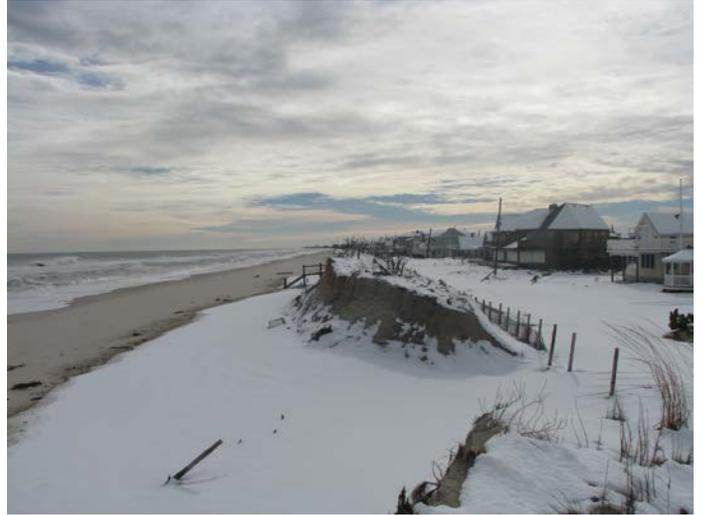
The photographs above were taken on September 14, 2012 (left) and November 8, 2012 (right).

Lavallette had no dunes and suffered damage from Hurricane Gloria in 1985. The municipality developed a dune system between the paved promenade and the beach, but areas where beach accessways were carved through the dune system created low areas allowing the intense waves riding on the evening storm surge to easily erode those areas and create a number of serious breaches. While some remnants of dunes remained following the storm in the northern portion of the municipality (proximal to site #150), beach-dune widths and elevations in areas to the south were not adequate, and wide-scale overwash and breaching occurred. This caused catastrophic damage to infrastructure and property. Following Hurricane Sandy, Site #150 had sand volume loss of 51.7 yds³/ft.

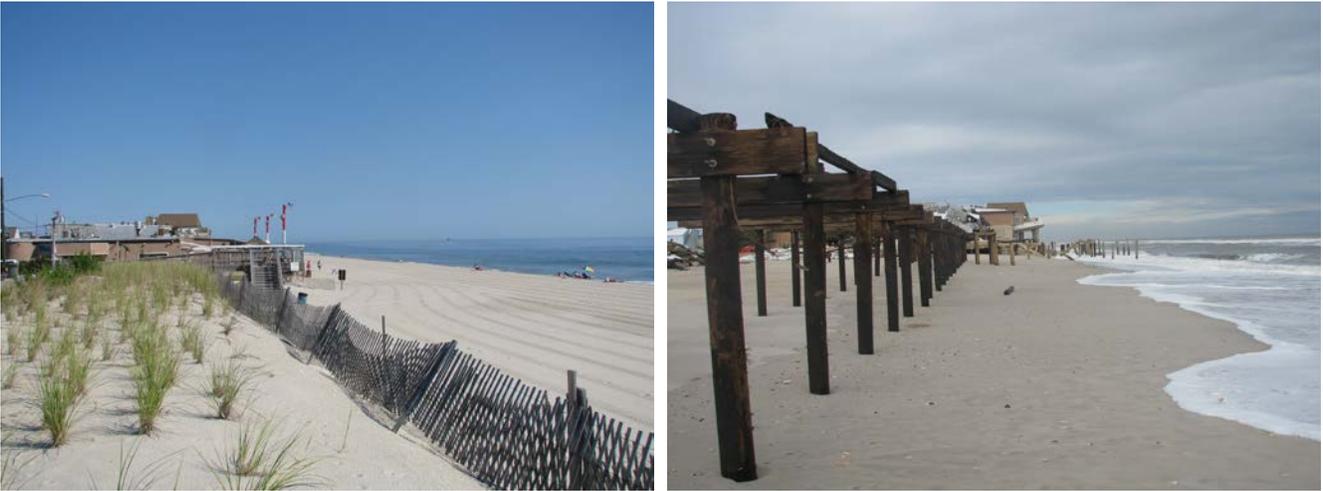
The photographs above were taken on September 14, 2012 (left) and November 8, 2012 (right).

Ortley Beach had a 25-year history of shoreline retreat and sand volume loss as determined by the Coastal Center's 8th Avenue survey site. Ocean Avenue, the boardwalk and many homes were completely destroyed in this segment. Site #149 located at 8th Avenue showed a sand volume loss of 68.7 yds³/ft. with over 10 feet of dune removed and pushed landward in overwash deposits. Everything was stripped away leaving a flat, featureless beach sloping into the sea. This was the site of the worst and most wide spread structural damage in Northern Ocean County.

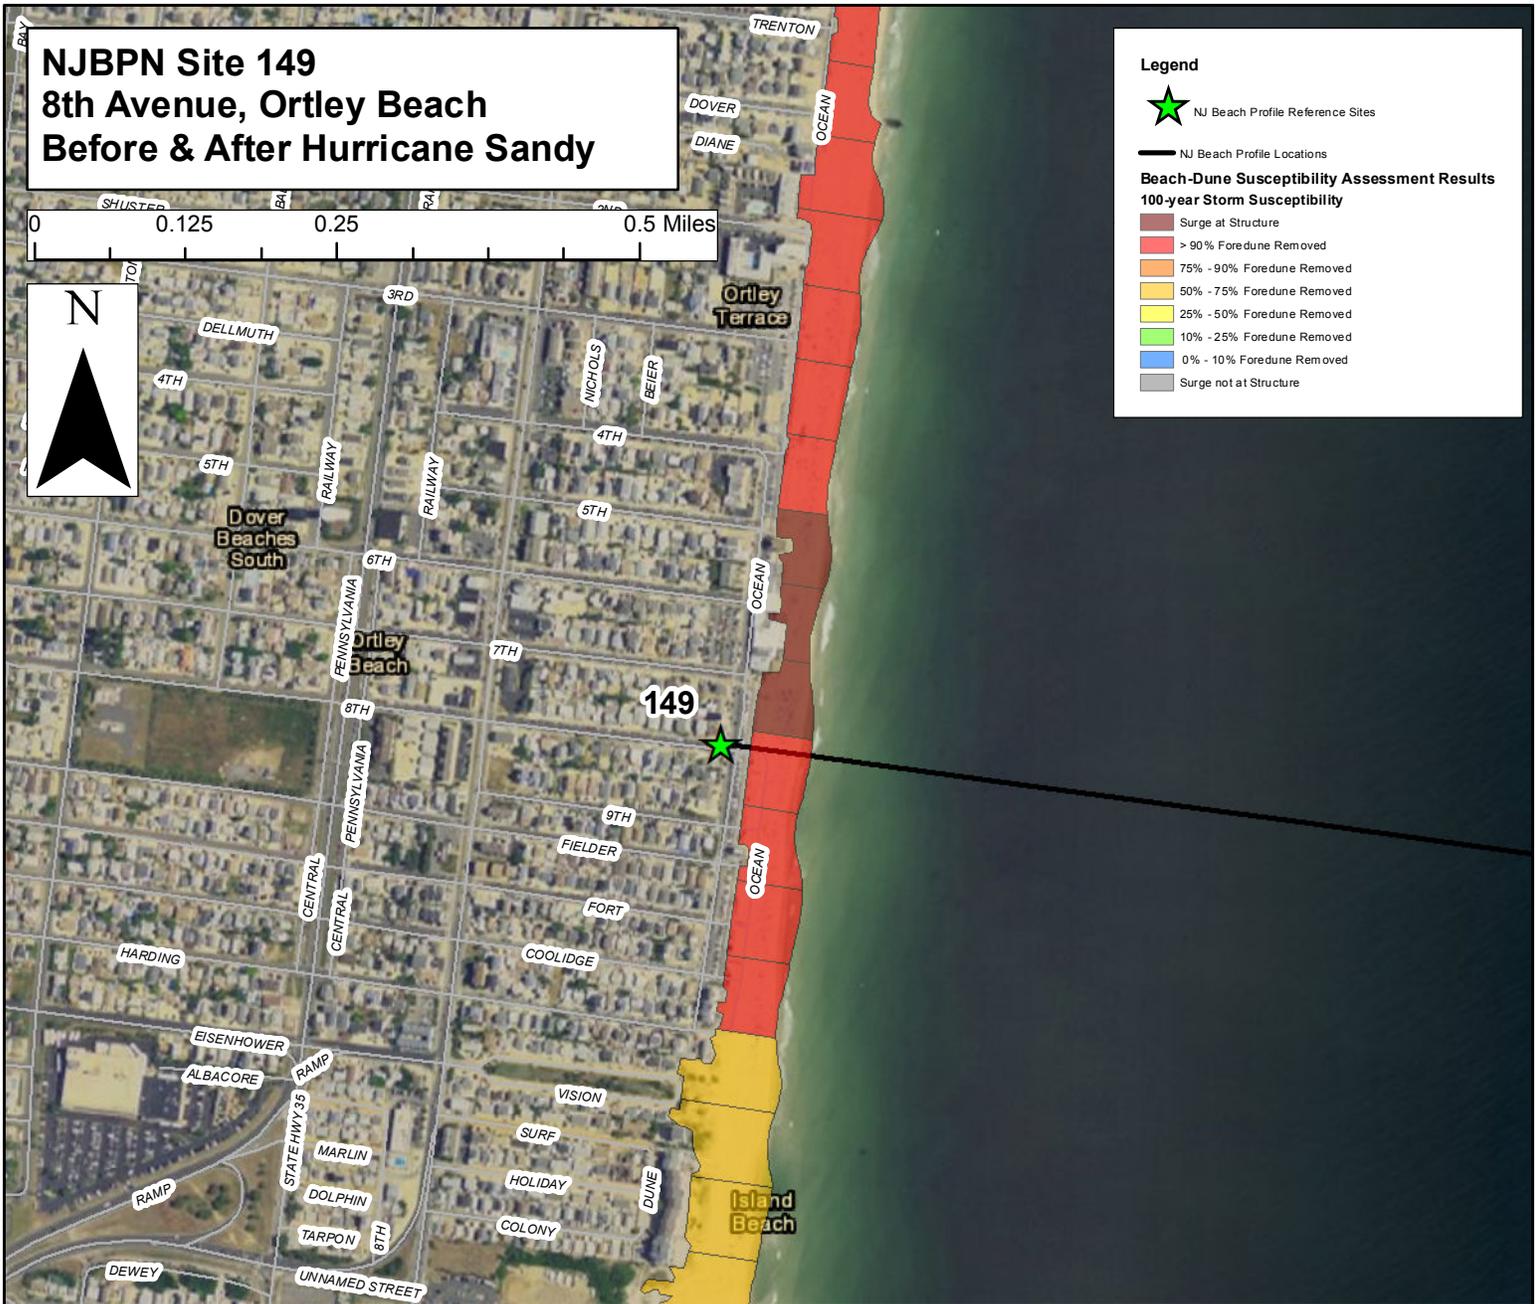
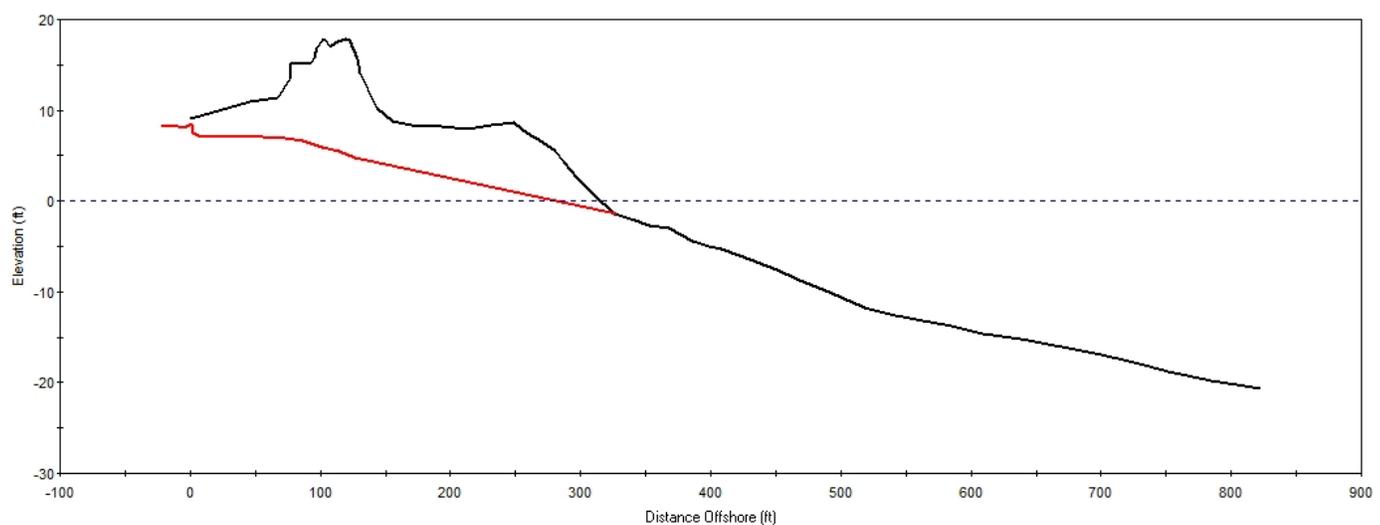
NJBPN Site 149 8th Avenue, Ortle Beach Before & After Hurricane Sandy

Figure 9. The following figure shows the predicted impacts from a 100-year storm surge at Ortley Beach. The predicted susceptibility was based upon the lack of an established dune system and minimal berm width. Also shown is the comparison plot between the pre- and post-storm surveys. The plot depicts the changes caused by the storm and the losses of the berm and dune where $68.7 \text{ yds}^3/\text{ft.}$ of sand were removed during the storm. Over 10 feet of dune was removed and pushed landward in overwash deposits. Ocean Avenue was completely destroyed as well as several homes. The photo on the right shows a classic planed beach caused by the large waves. Follow-up surveys will determine whether some of the sand moved seaward into nearshore bars.

Pre vs. Post Sandy
Site 149
8th Ave., Ortle Beach

Volume Change = -68.744 cu. yd/ft

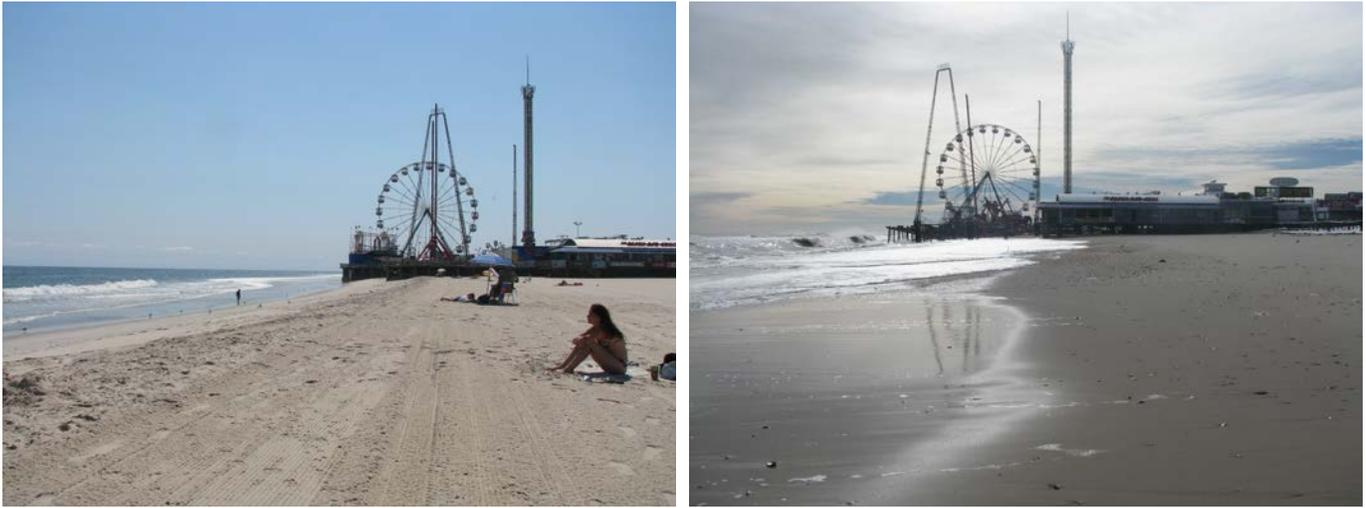
The photographs above were taken on September 13, 2012 (left) and November 8, 2012 (right).

This segment of the shoreline experienced catastrophic damage to infrastructure and property as a result of having no dune system and an approximate berm width of 250-feet. The boardwalk and piers sustained heavy damage and in some places were completely destroyed. The cross-section located at Franklin Avenue (site #248) showed a sand volume loss of 39.3 yds³/ft to the beach in front of the boardwalk.

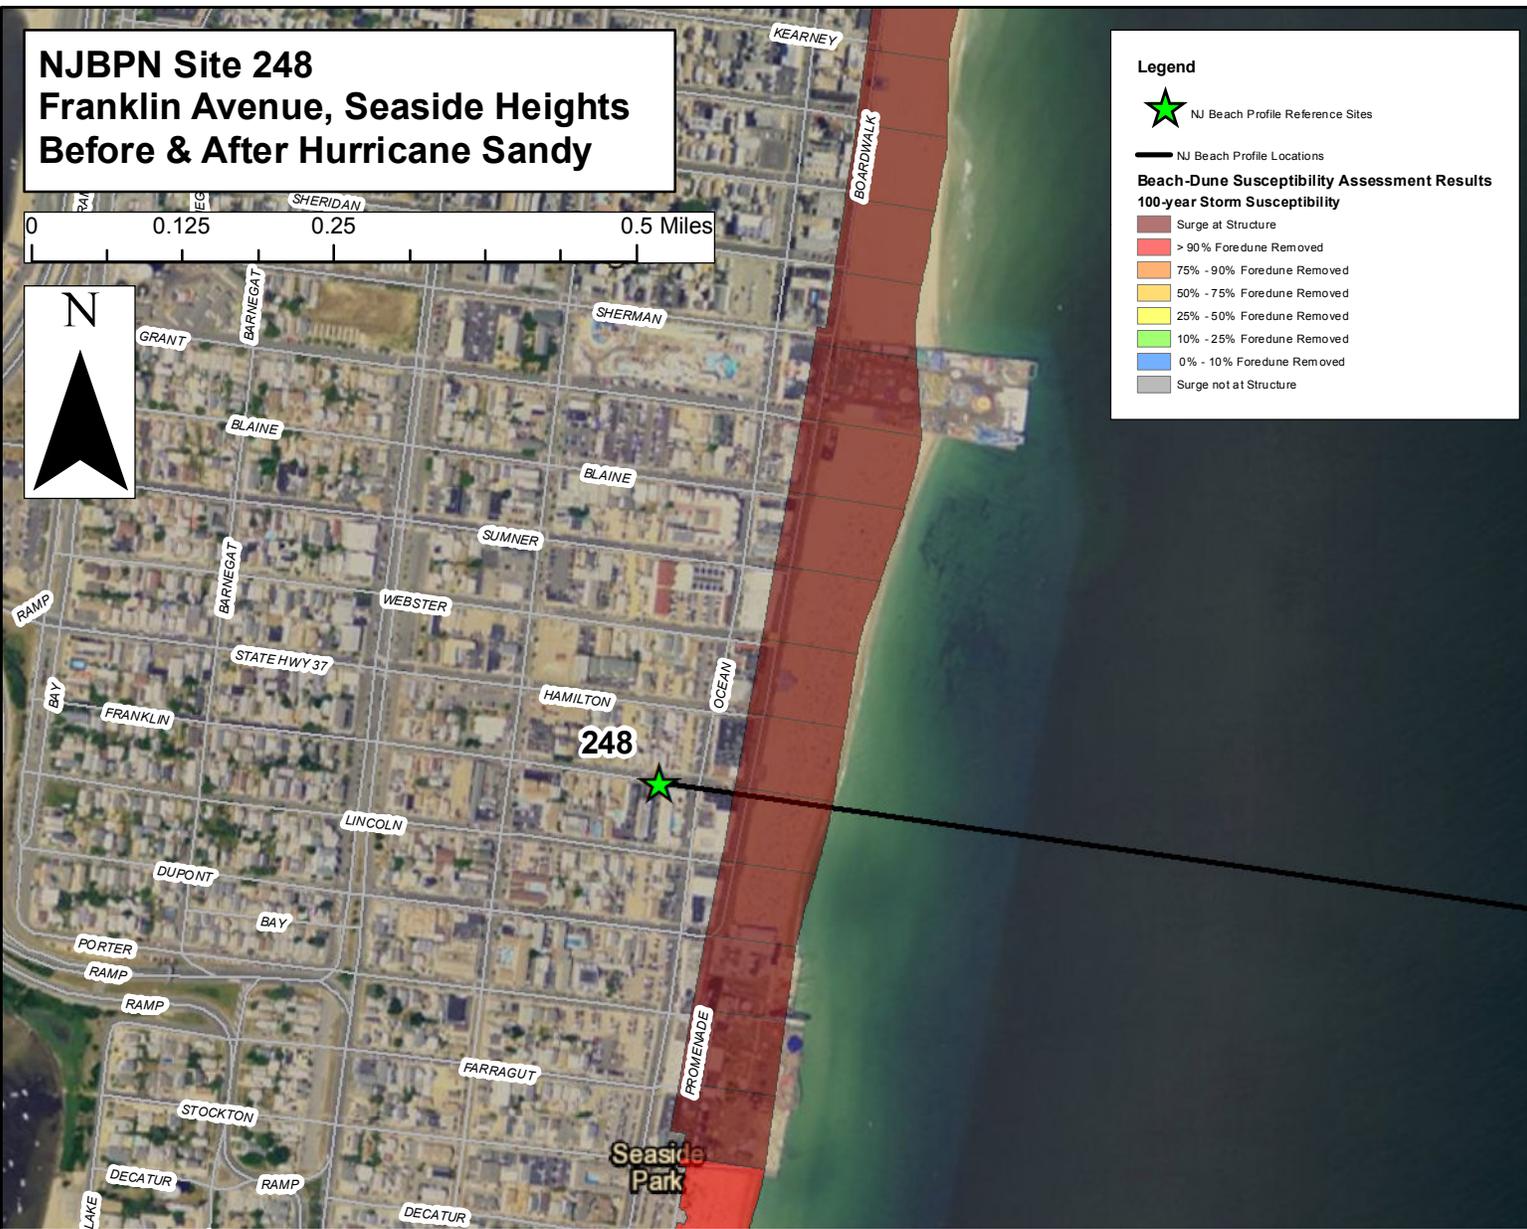
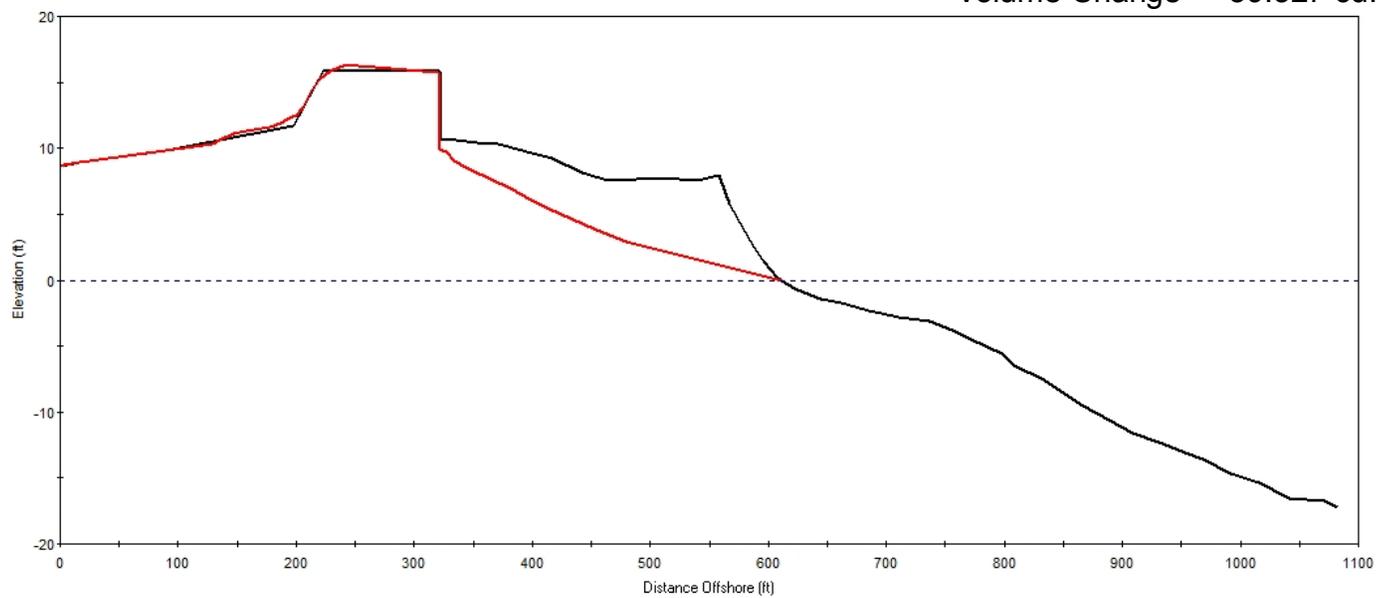
NJBPN Site 248 Franklin Avenue, Seaside Heights Before & After Hurricane Sandy

Figure 10. The following figure shows the predicted impacts from a 100-year storm surge at Seaside Heights. The predicted susceptibility was based upon the lack of an established dune system and minimal berm width. Also shown is the comparison plot between the pre- and post-storm surveys. The plot depicts the changes caused by the storm and the losses of the berm where $39.3 \text{ yds}^3/\text{ft.}$ of sand were removed during the storm. This urban beach did not have a dune system and the photo on the right shows the obvious damages to the pier and amusements. As predicted in the susceptibility study, storm surge damaged the boardwalk and structures landward of it.

Pre vs. Post Sandy
Site 248
Franklin Ave., Seaside Heights

Volume Change = -39.327 cu. yd/ft

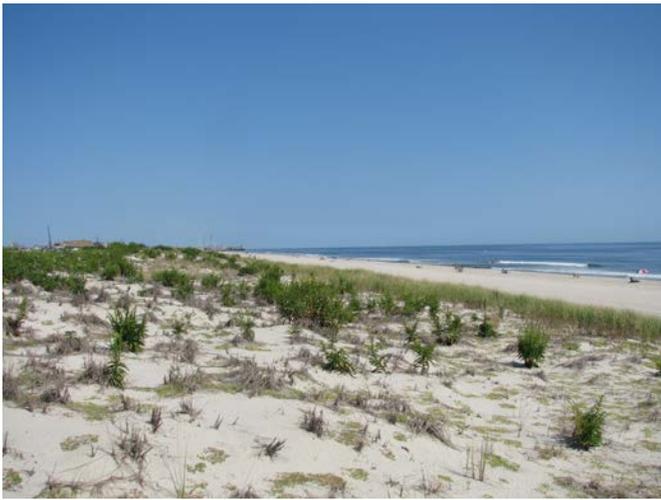
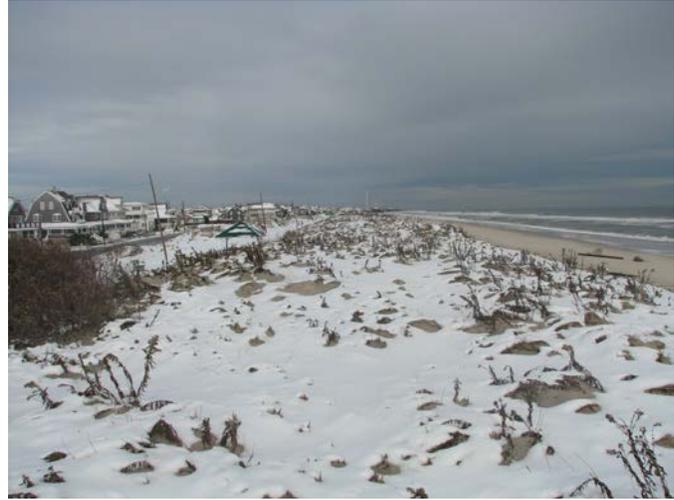
The photographs above were taken on September 13, 2012 (left) and November 8, 2012 (right).

The pre- and post-storm analysis for site #148 at 4th Avenue showed that a portion of the foredune was removed during the storm; however, the remainder of the dune provided protection to the landward structures. No overwash occurred at the profile location. The dune's approximate 25-foot elevation (NAVD88) and 150-foot width (at the base) combined with a 150-foot wide beach provided adequate protection from tidal surge and wave action. As has been noted in other areas along the northern Ocean County barrier-spit, areas where beach accessways were carved through the dune system created low areas that were more easily eroded, resulting in wave overwash and sand being transported landward of the beach-dune system into the streets and private properties. While homes

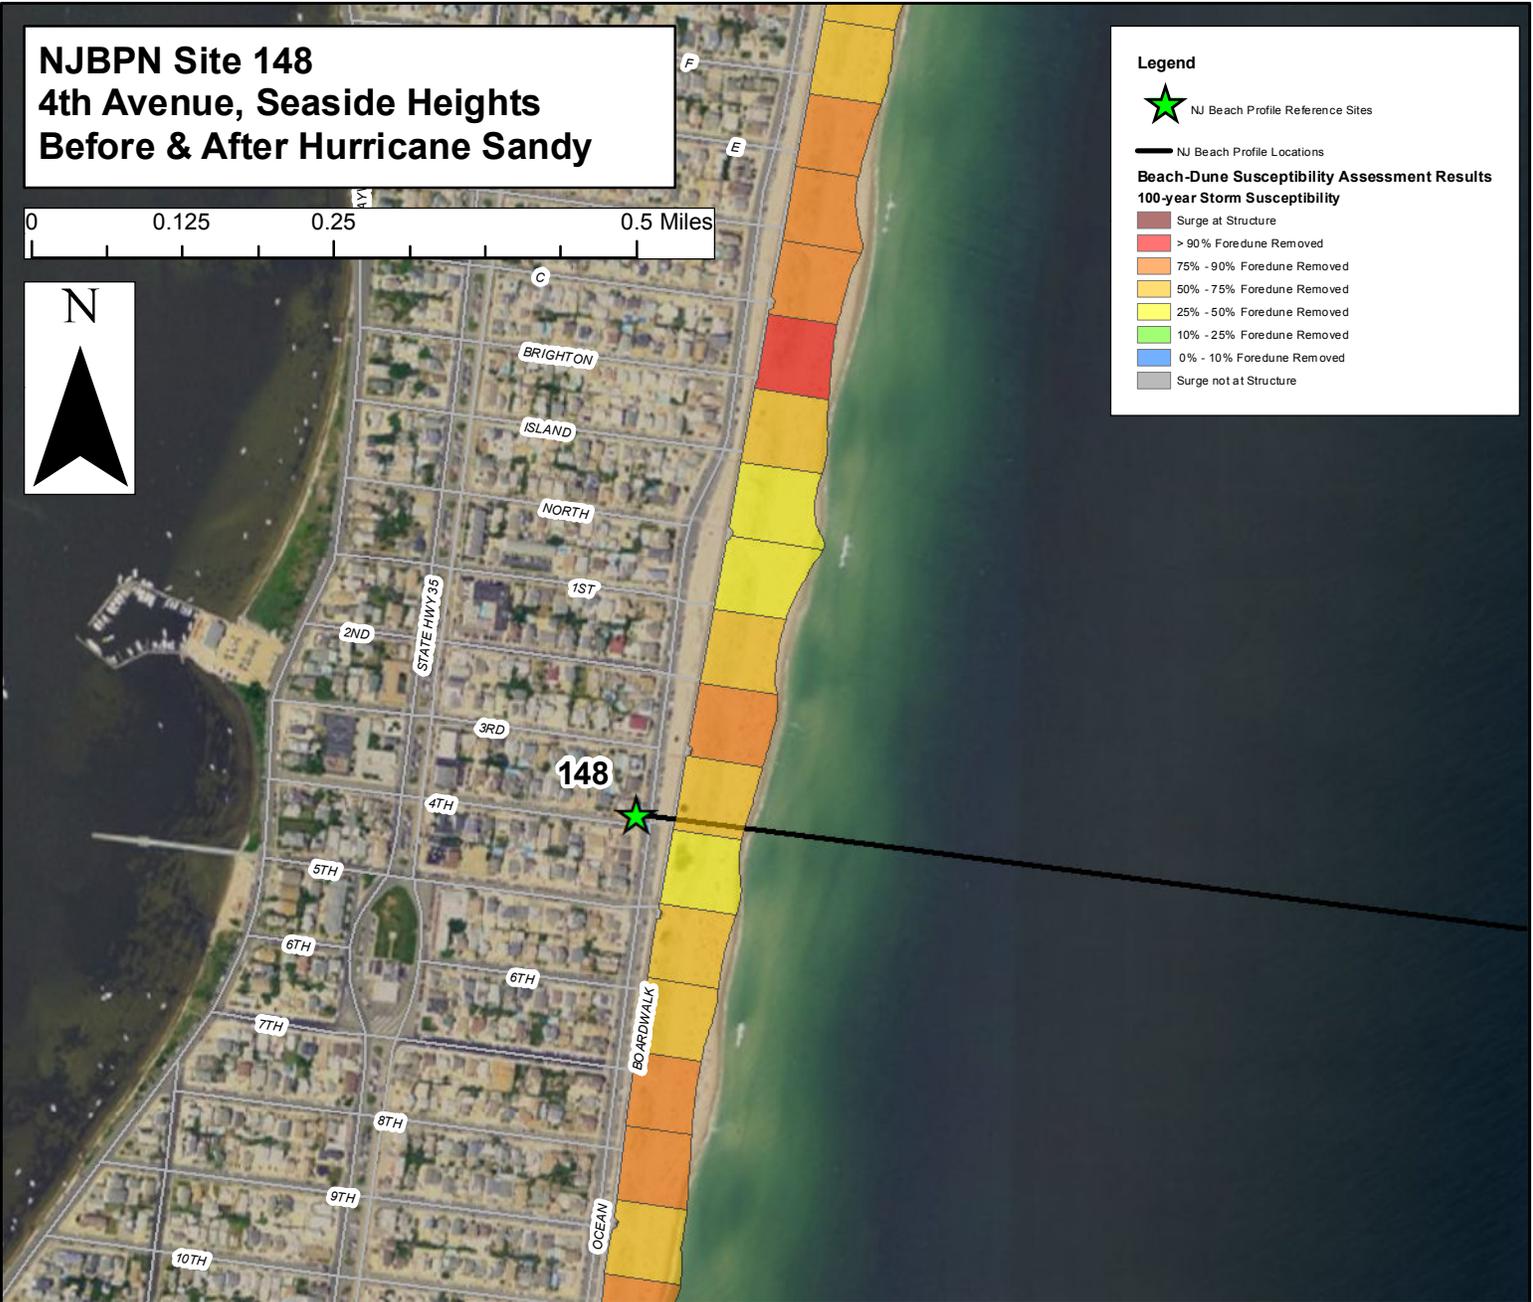
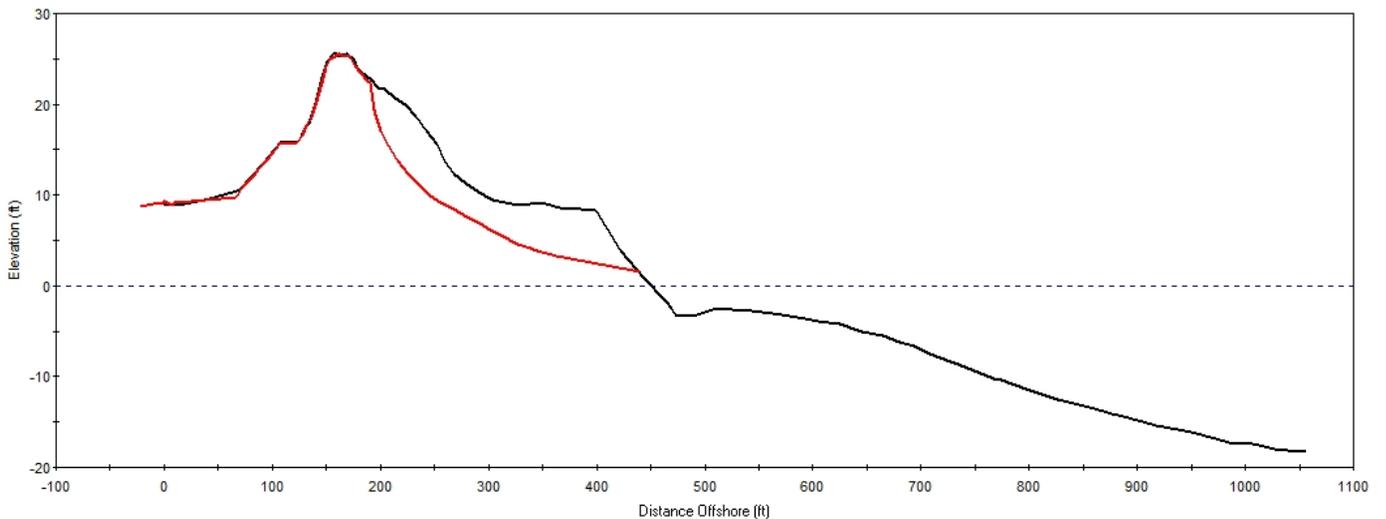
NJBPN Site 148 4th Avenue, Seaside Heights Before & After Hurricane Sandy

Figure 11. The following figure shows the predicted impacts from a 100-year storm surge at Seaside Park. The predicted susceptibility was based upon the established dune system. Also shown is the comparison plot between the pre- and post-storm surveys. The plot depicts the changes caused by the storm and the losses of the berm and dune where $43.7 \text{ yds}^3/\text{ft.}$ of sand were removed during the storm. As predicted in the susceptibility study, a portion of the foredune was removed during the storm; however, the remainder of the dune provided protection to the landward structures. No overwash occurred at this location.

Pre vs. Post Sandy
Site 148
4th Ave., Seaside Park

Volume Change = -43.722 cu. yd/ft

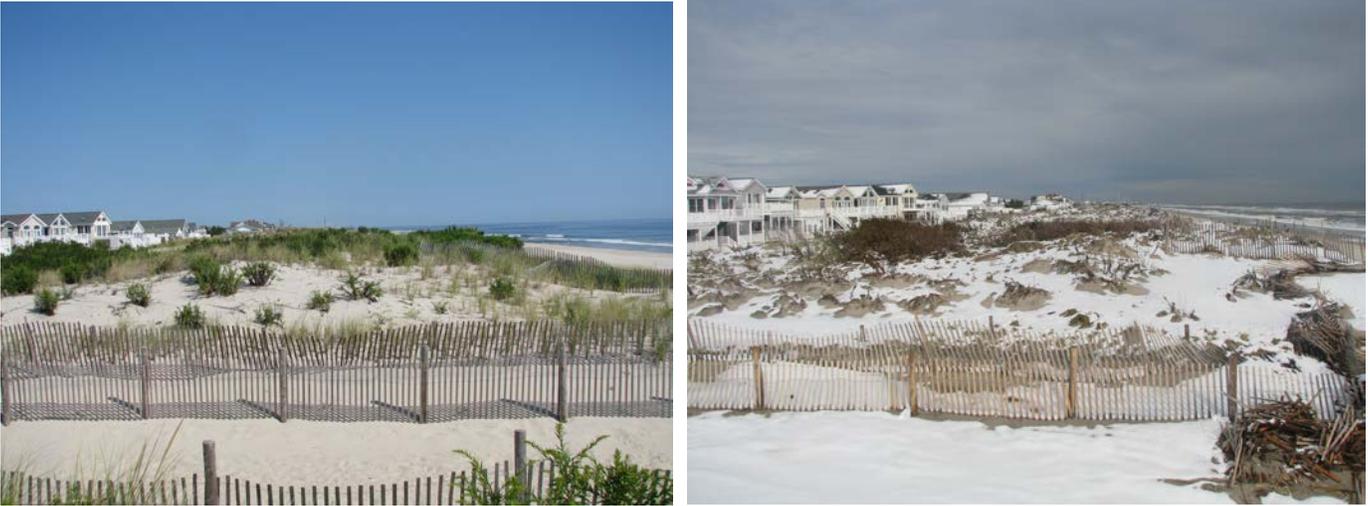
The photographs above were taken on September 13, 2012 (left) and November 8, 2012 (right).

Site 347 in Midway Beach showed significant sand losses to the beach and dune but a portion of the dune remained to protect the landward homes and infrastructure. While overwash covered some of the streets and properties with sand, much of the overwash was limited areas proximal to the street ends. There areas are where beach accessways were carved through the dune system, creating low areas that were more easily eroded, resulting in wave overwash. While homes sustained flood damage in this segment, loss of infrastructure and homes was minimized due to the larger beach-dune system.

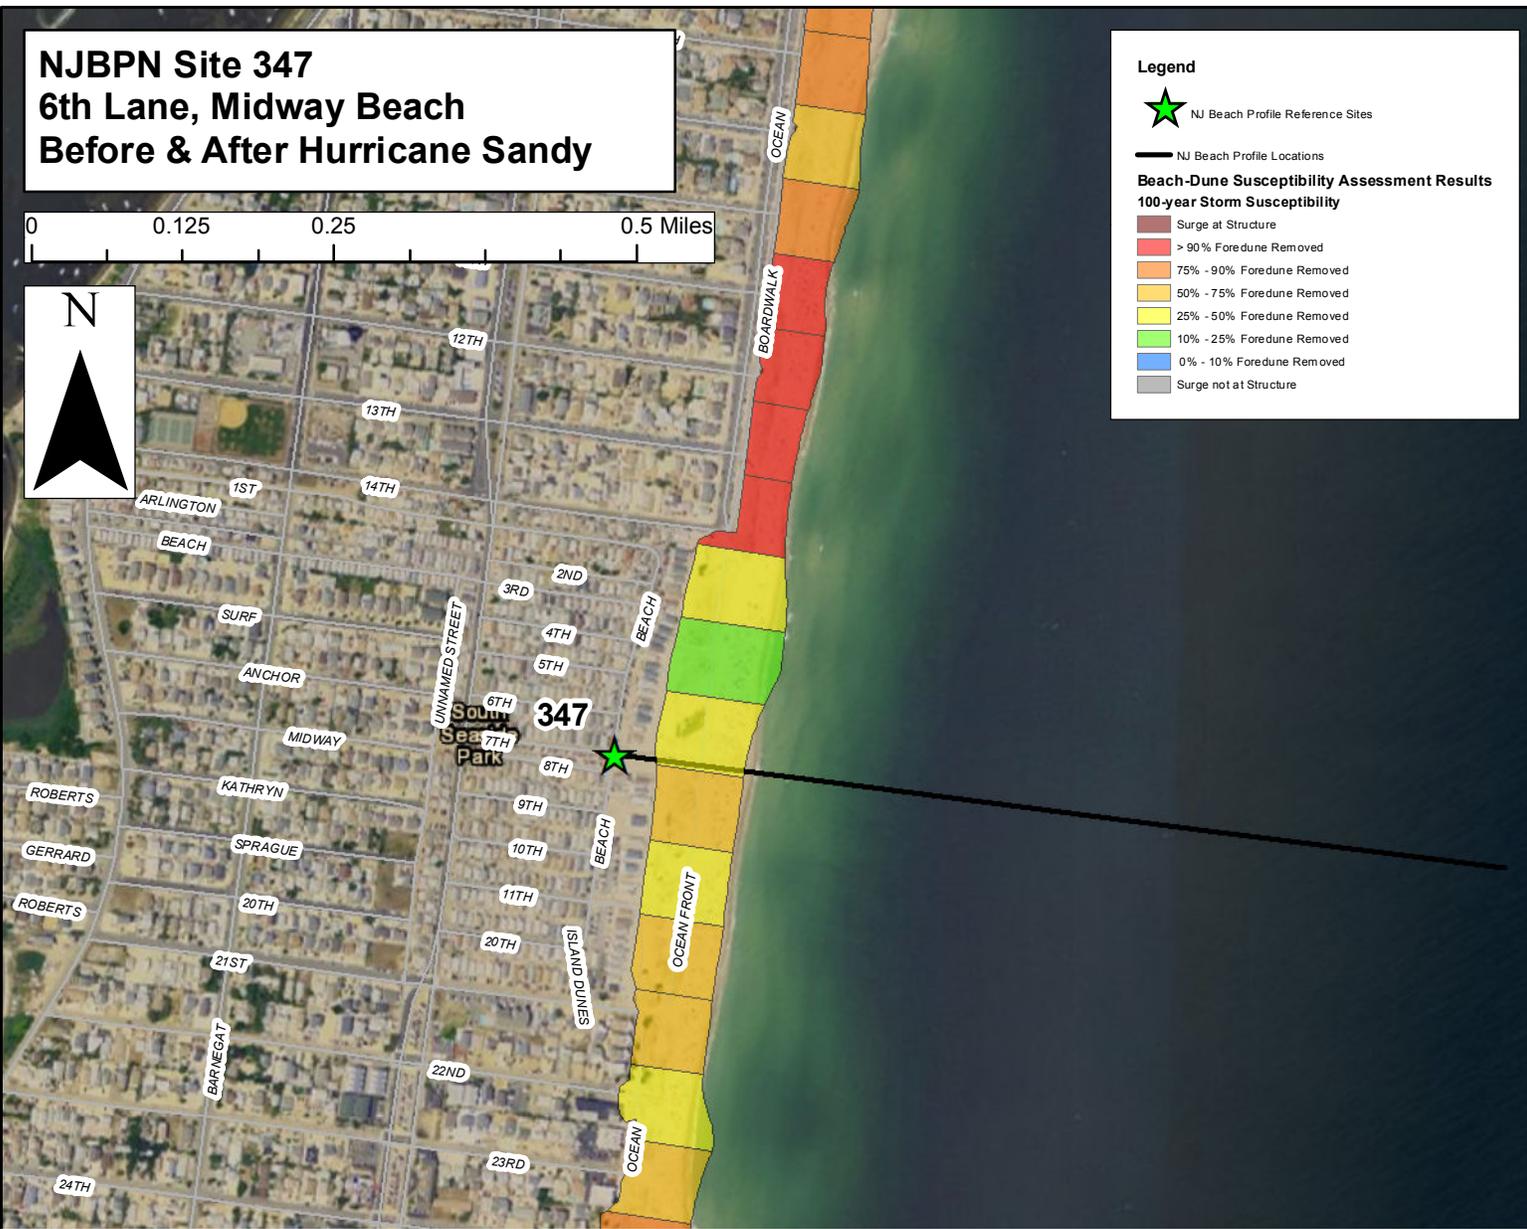
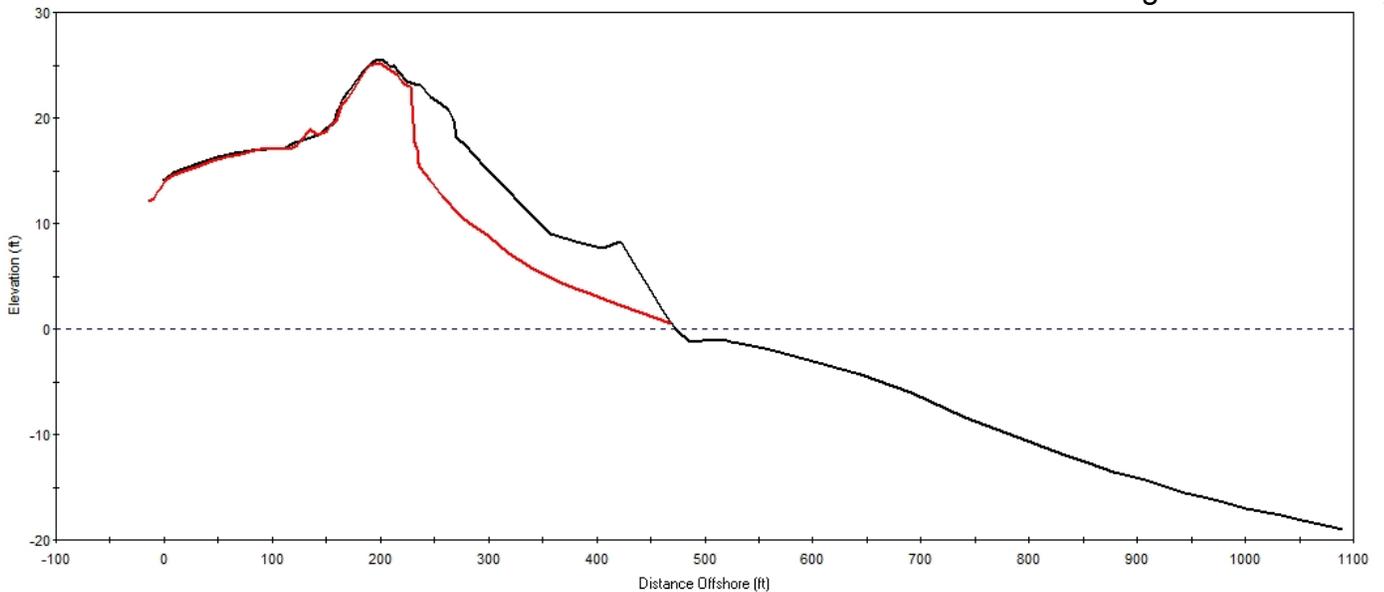
NJBPN Site 347
6th Lane, Midway Beach
Before & After Hurricane Sandy

Figure 12. The following figure shows the predicted impacts from a 100-year storm surge at Midway Beach. Of all the northern Ocean County NJBPN developed shoreline sites, this one was predicted to have the least amount of foredune removal. Also shown is the comparison plot between the pre- and post-storm surveys. The plot depicts the changes caused by the storm and the losses of the berm and dune where 48.7 yds³/ft. of sand were removed during the storm. Though there were measured losses of the berm and dune, a portion of the dune remained to protect the landward homes and infrastructure.

Pre vs. Post Sandy
Site 347
6th Ln., Midway Beach

Volume Change = -48.673 cu. yd/ft

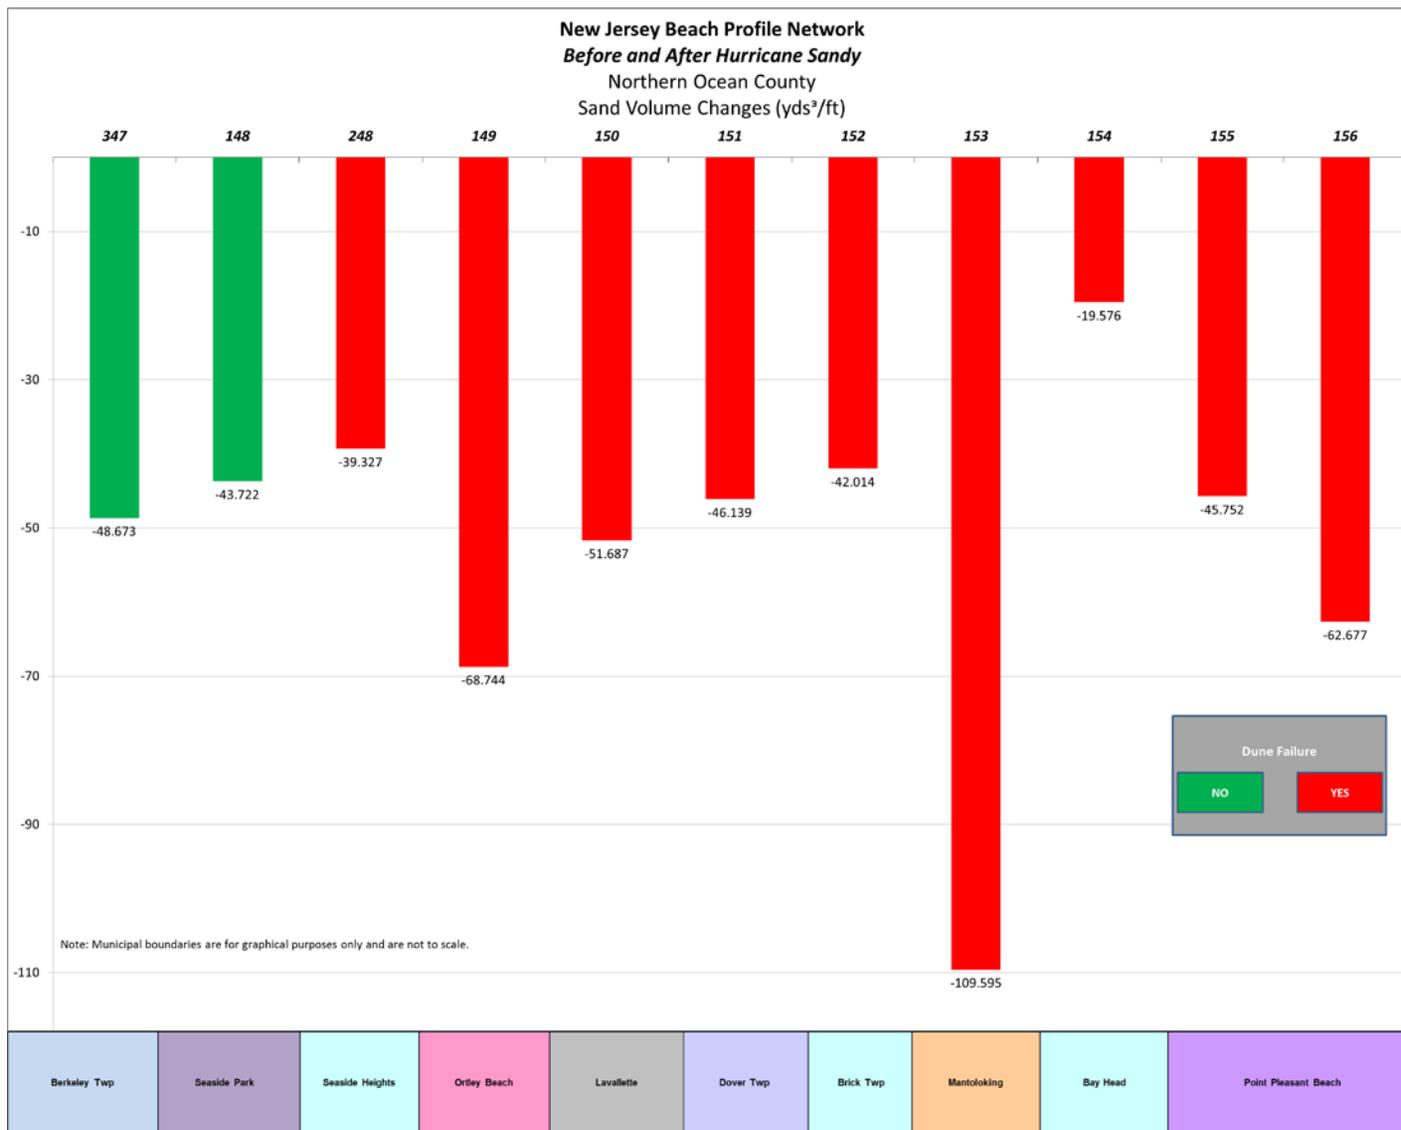
Figure 14. This graphic shows the sand volume loss figures for each of the communities within the developed sections of the northern Ocean County Atlantic shoreline. No Federal shore protection projects have occurred along this portion of the New Jersey shoreline. All sites experienced berm erosion and dune losses. Sites 347 and 148 contained a greater dune volume prior to the storm and though dune losses were recorded, there was no dune failure. The losses measured at Site 153 were enhanced due to the presence of a newly-opened inlet (with depths measured at approximately 18 feet). The dune at Site 154 contained a rock/timber core that was included in the pre-storm dune volume calculation.
