## New Jersey Beach Profile Network 2009 Annual Report on Shoreline Changes in New Jersey Coastal Reaches One Through Fifteen Raritan Bay to Delaware Bay

The Richard Stockton Coastal Research Center  
Richard Stockton College of New Jersey  
30 Wilson Avenue, Port Republic, NJ 08241

June 30, 2010

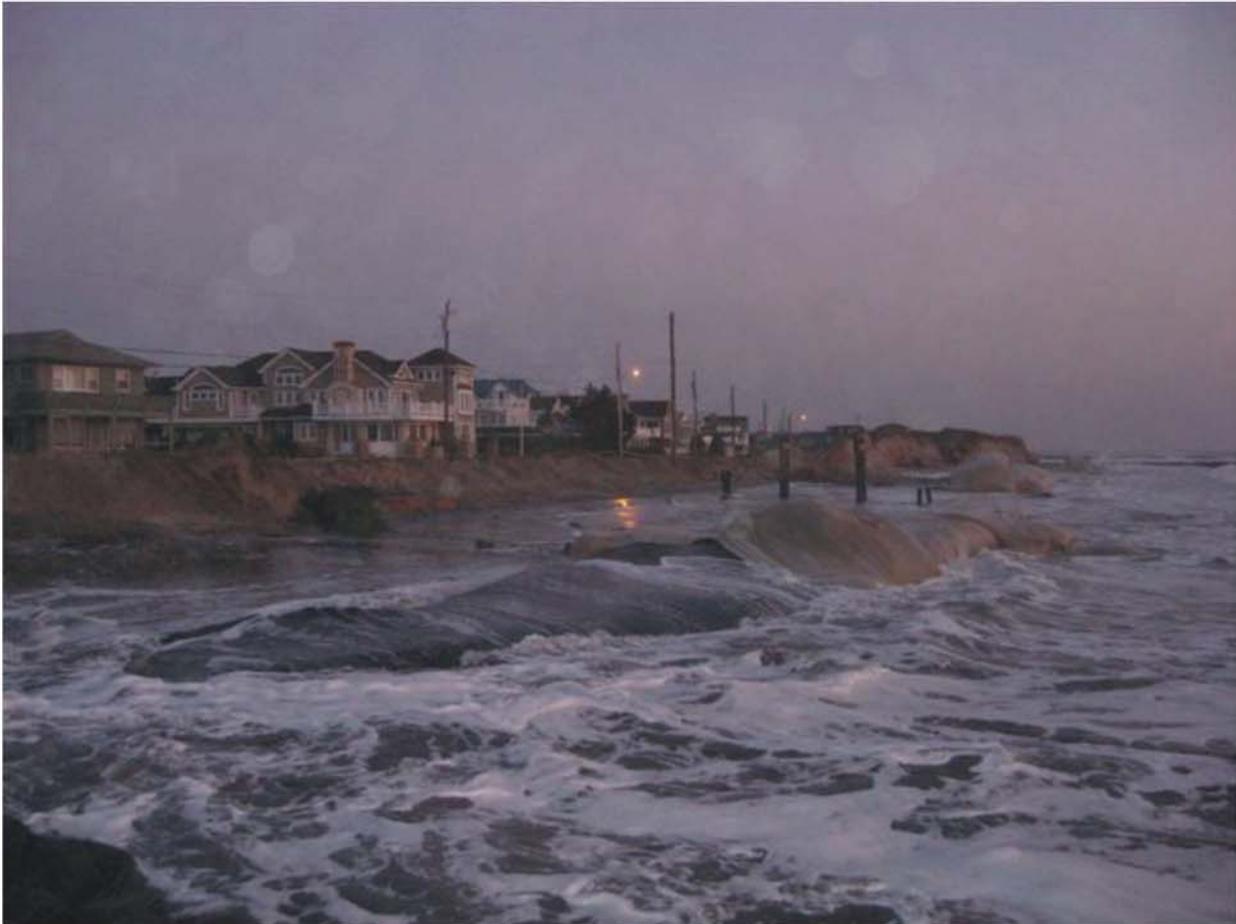
*This photo of northern Ocean City was taken during the November 11-15, 2009 northeaster shows extensive damage to the beach and dunes along East Atlantic Blvd. along the northern Ocean City, Cape May County shoreline.*

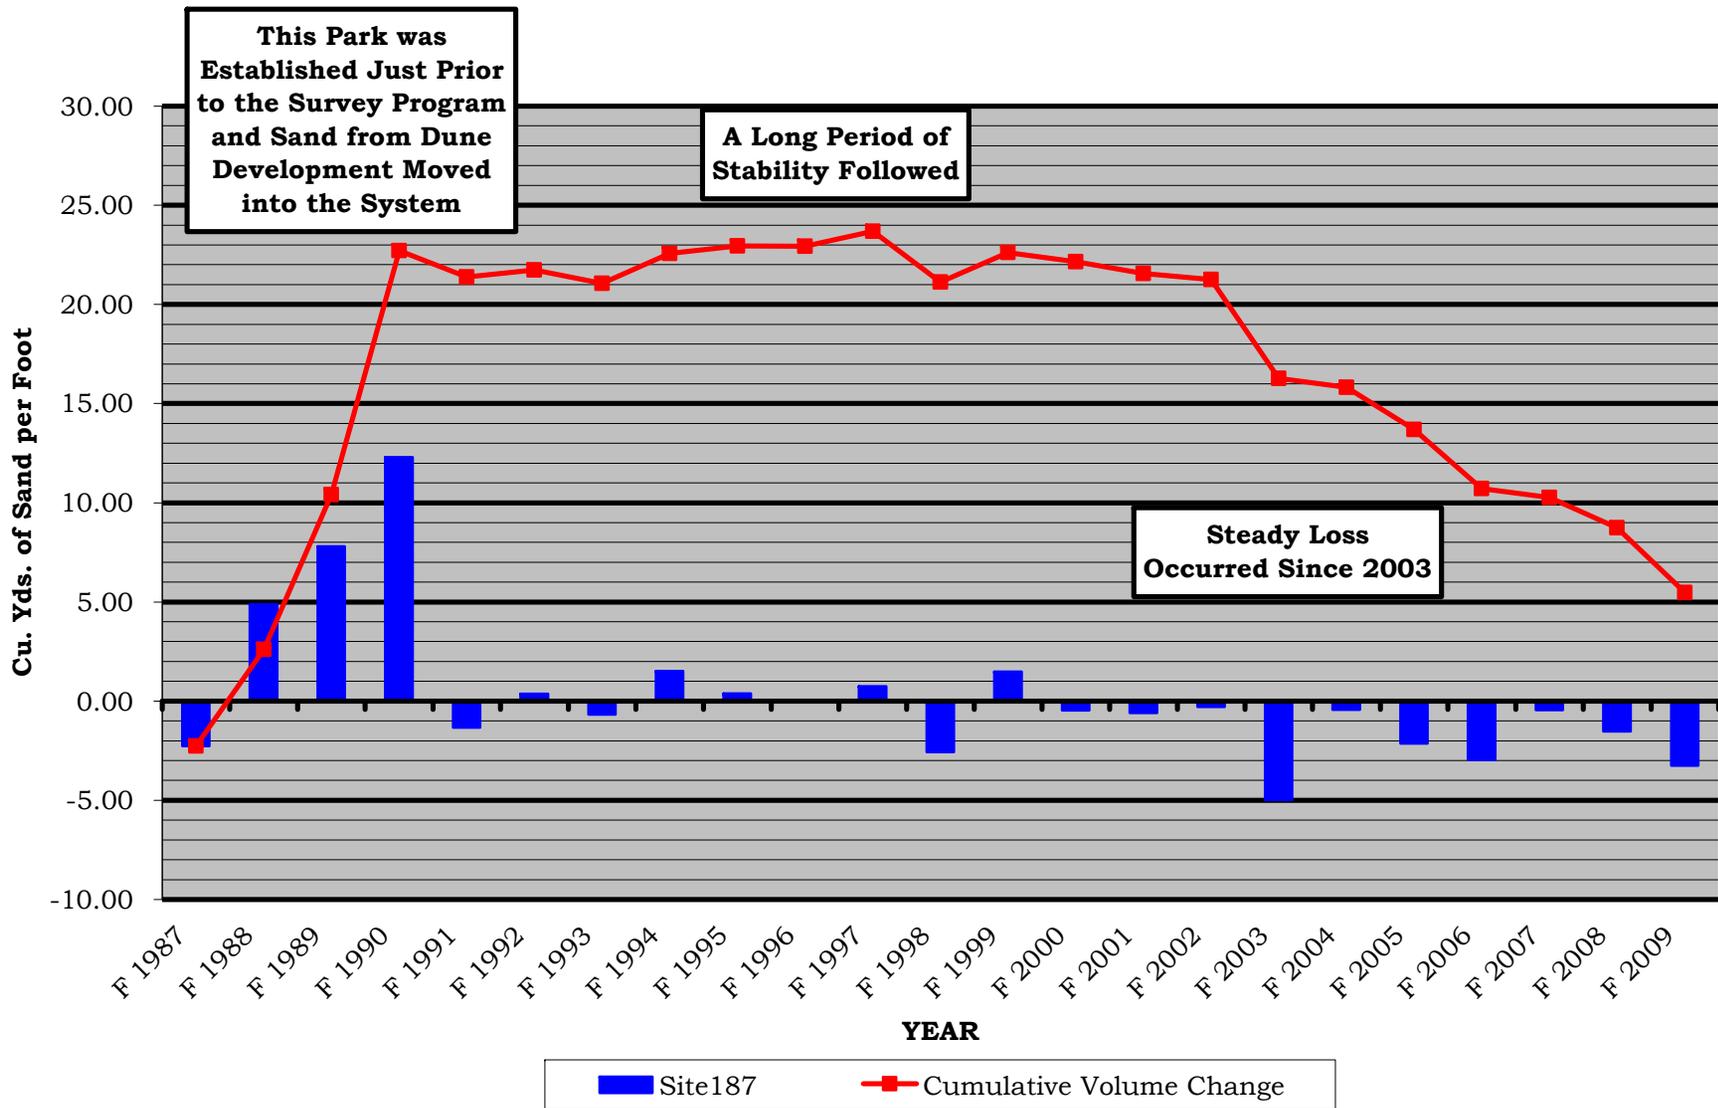
## 23-Year Sand Volume Changes at Site 187, Cliffwood Beach, Aberdeen

**Figure 2.** There are three sites along the eastern Raritan Bay shoreline in Monmouth County where Cliffwood Beach is the westernmost of the three. Located in a park created just before the establishment of the NJBPN program, the sand available in the system added to the beach/dune system during the three years following the initial pair of surveys. During the next 12 years the shoreline was stable in spite of northeast storms and other events. In 2003 a slow sand loss commenced that has reduced the net gain by three-quarters by 2009.

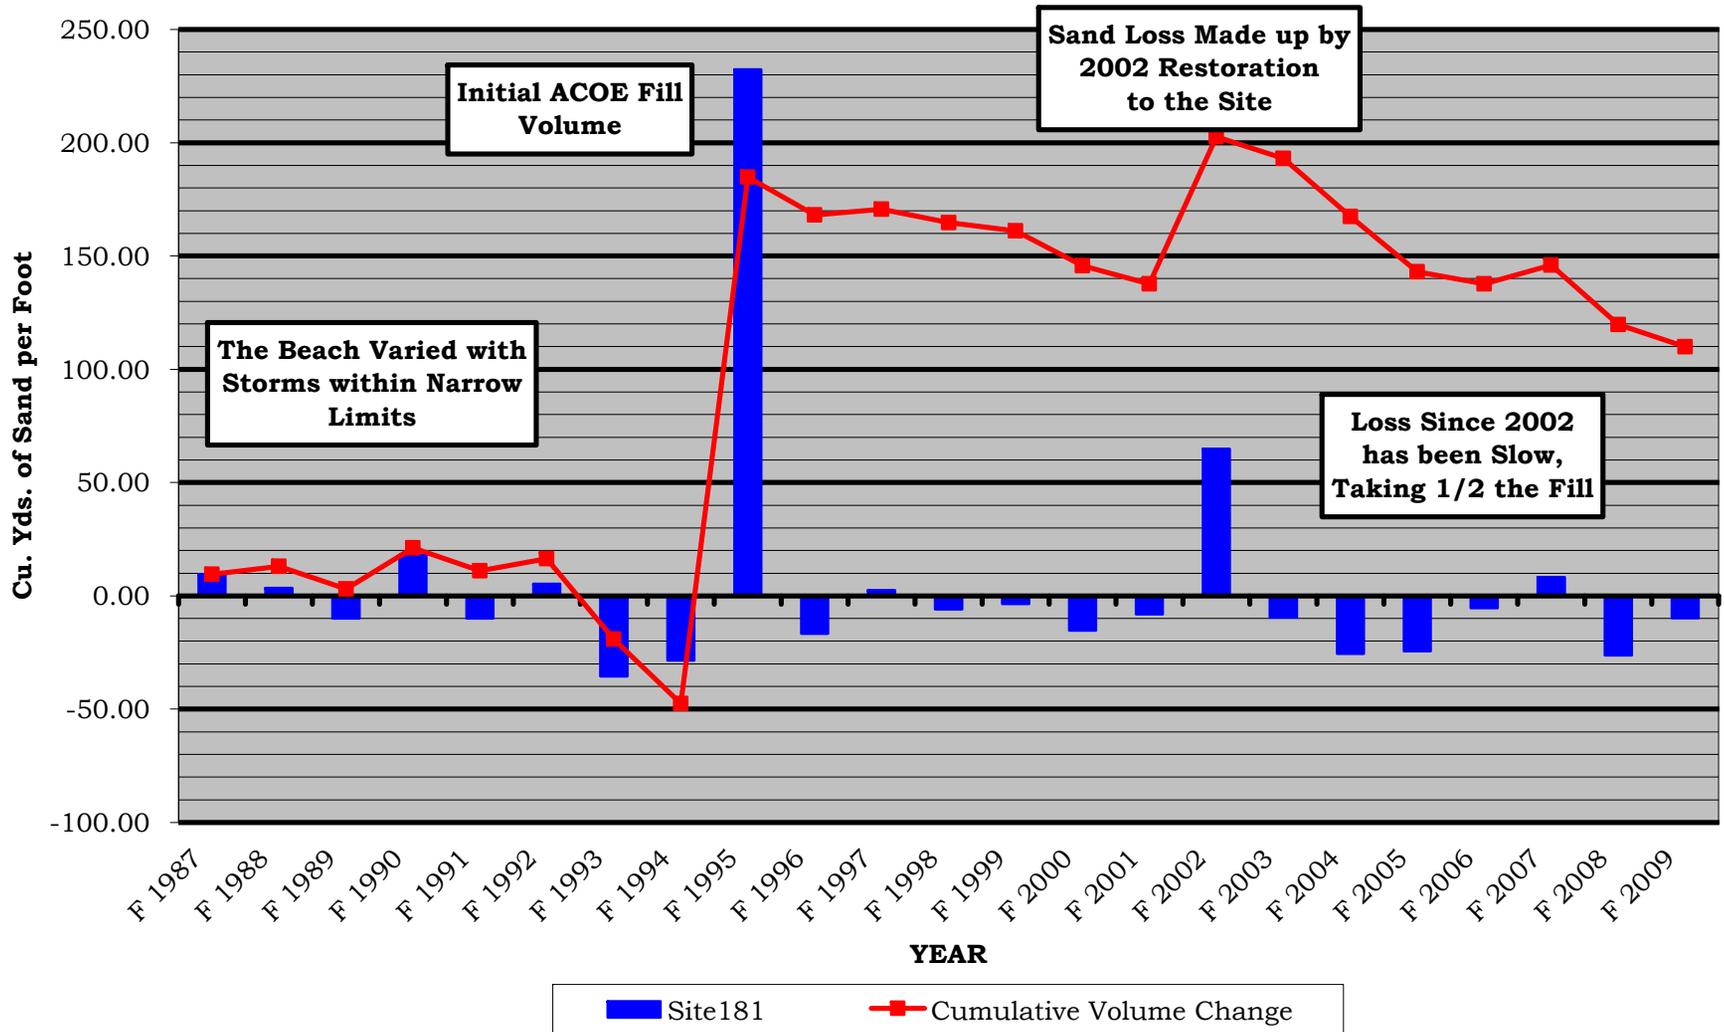
### 23- Year Sand Volume Changes at Site 181, Municipal Lot, Sea Bright

Figure 3. This site was added for 2009 to show the retention rates of the northern Sea Bright beaches for the ACOE project sand deposits. Placed in 1995, the shoreline lost material, but was restored in 2002 to levels exceeding the initial deposit. Six of the past seven years saw loss rates that have nearly reduced the 200 yds<sup>3</sup>/ft. to half that amount. Sand lost from Sea Bright ends up in Sandy Hook adding to the National Seashore beach.

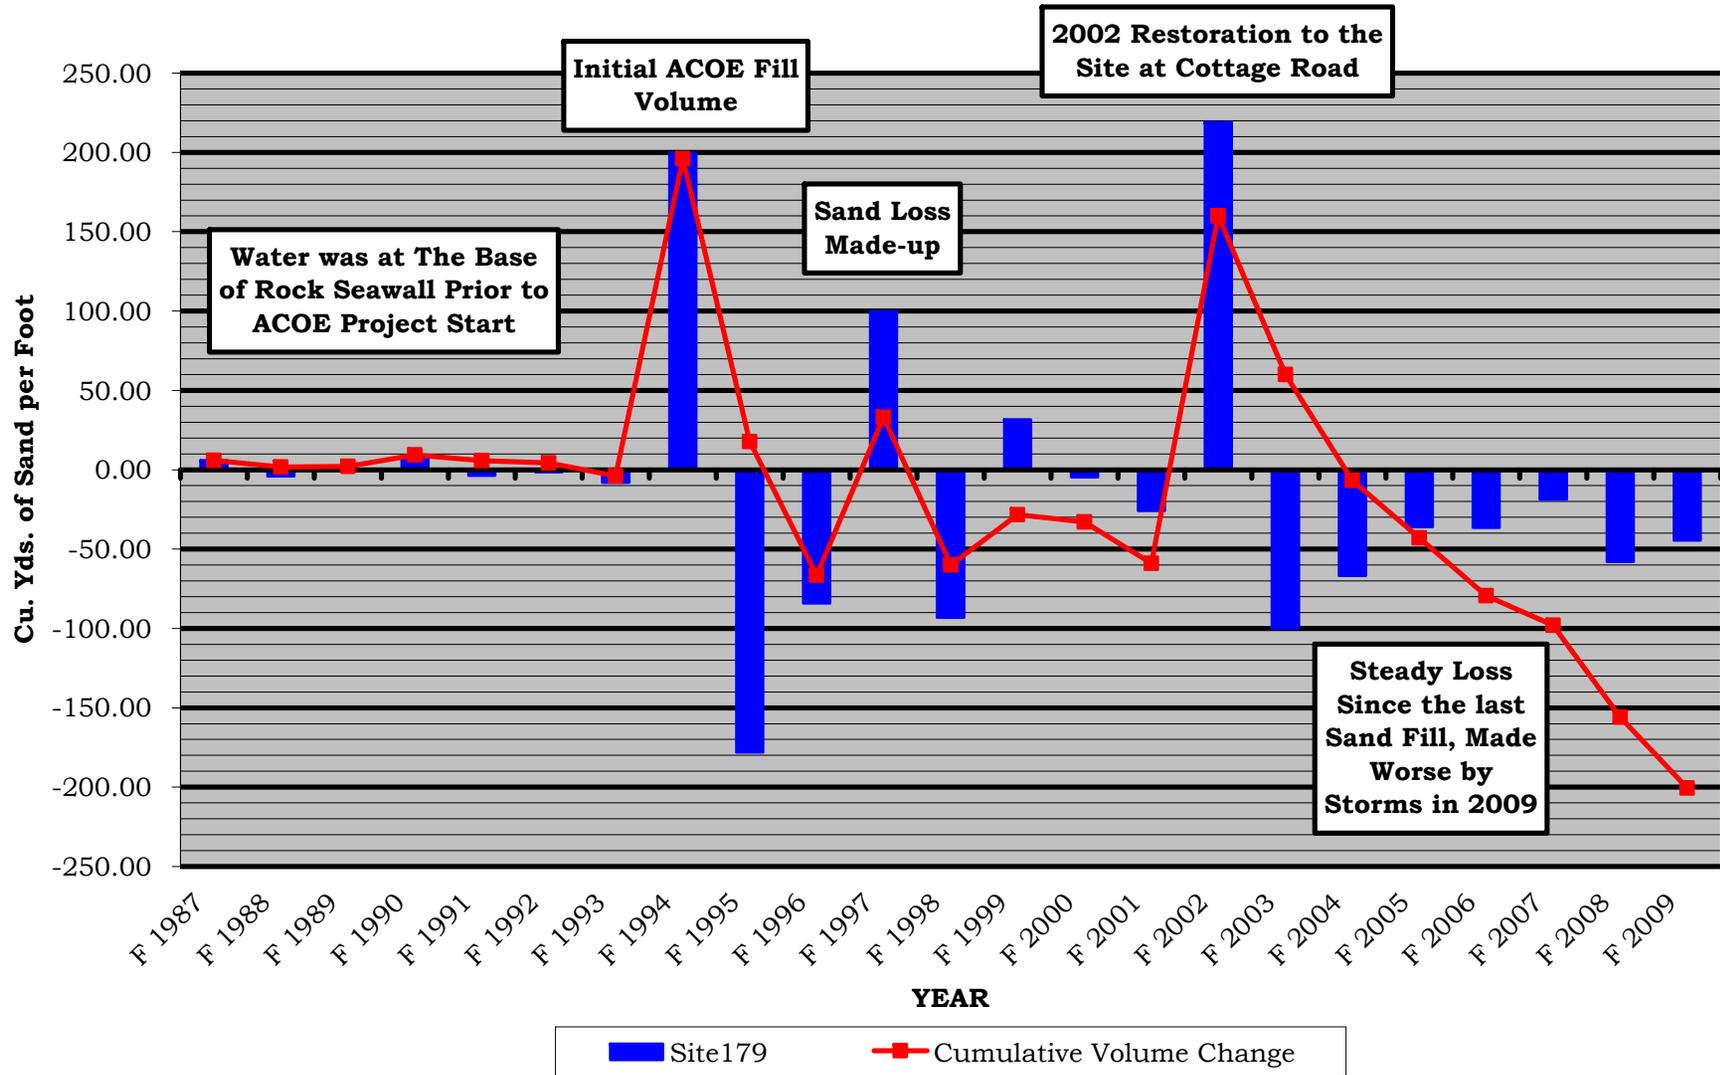
### 23- Year Sand Volume Changes at Site 179, Cottage Road, Monmouth Beach

Figure 4. Site #179 at Cottage Road in Monmouth Beach initially had several feet of water at the seaward base of the seawall rocks prior to the ACOE project starting in 1994. Storm losses were made up in 1997 followed by maintenance work in 2002. Chronic losses have piled up because the groins once the sole protection for the Monmouth Beach Club now prevent sand from reaching this site from the south. Storms continuing through the winter reversed this trend and the beach has recovered significantly as NE storms moved sand south to the groins.

Cottage Road in Monmouth Beach has been an enigma due to persistent, rapid loss of sand deposits. Observations made this year may lead to possible reasons. There is a massive stone groin protecting the Monmouth Beach Club property positioned about 500 feet south of this site. During non-storm periods of time the dominant littoral currents are directed to the north, so the sand moves north away from the groin and site not being replaced by significant material coming north around the groin. By the fall 2009 survey the site was devoid of sand, the dune was gone and the beach was wet at low tide, not far from the conditions existing here prior to the beach fill. Then the northeast storms started and by the winter of 2010 sand had reappeared as a dry beach fronting the rocks of minimal, but significant dimensions compared to the fall 2009 survey situation. The littoral currents were reversed by the storms and were of increased magnitude during the storms. However, the groin served to impound the sand and not let it pass further south so the beach accumulated sand during the period of severe weather.

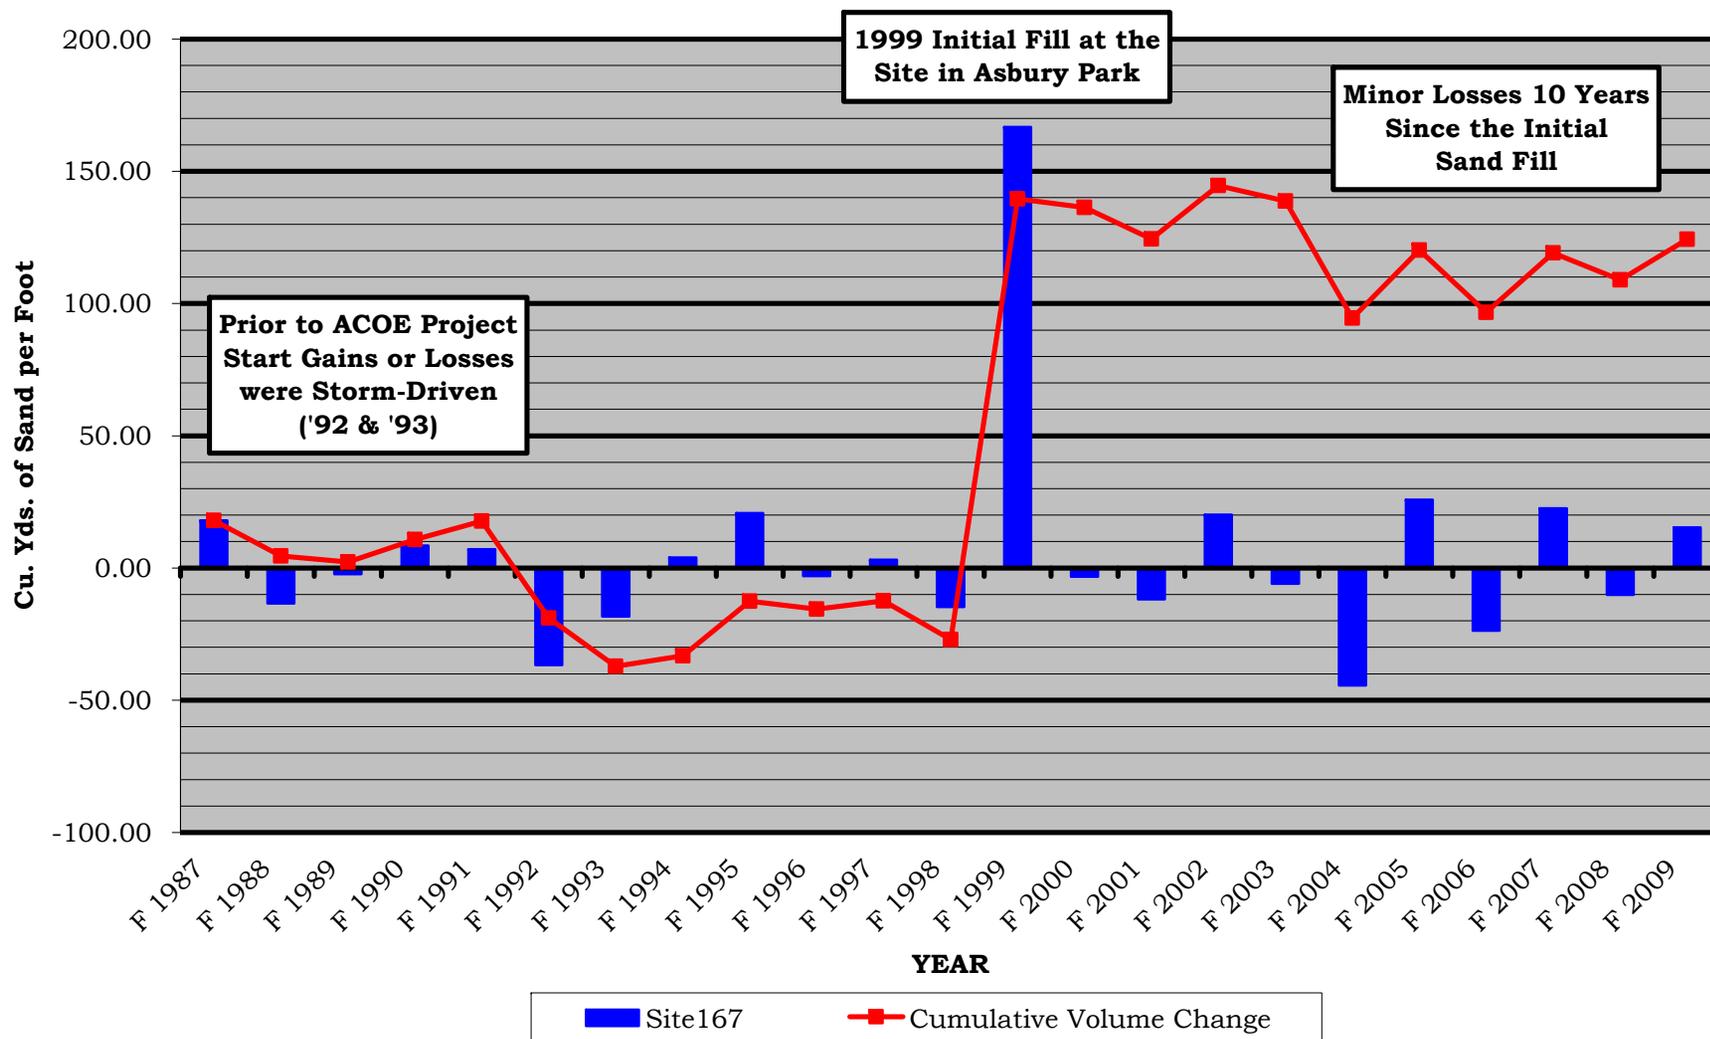
### 23- Year Sand Volume Changes at Site 167, 3rd Avenue, Asbury Park

Figure 5. The Third Avenue location in Asbury Park received the Federal beach nourishment in 1999. No additional work has been required since. Four of the ten years since saw additional natural accretion that helped keep the beach near the ACOE sand placement volume seen in 1999. The fall 2009 survey preceded the majority of the northeast events so loss may be greater in 2010.

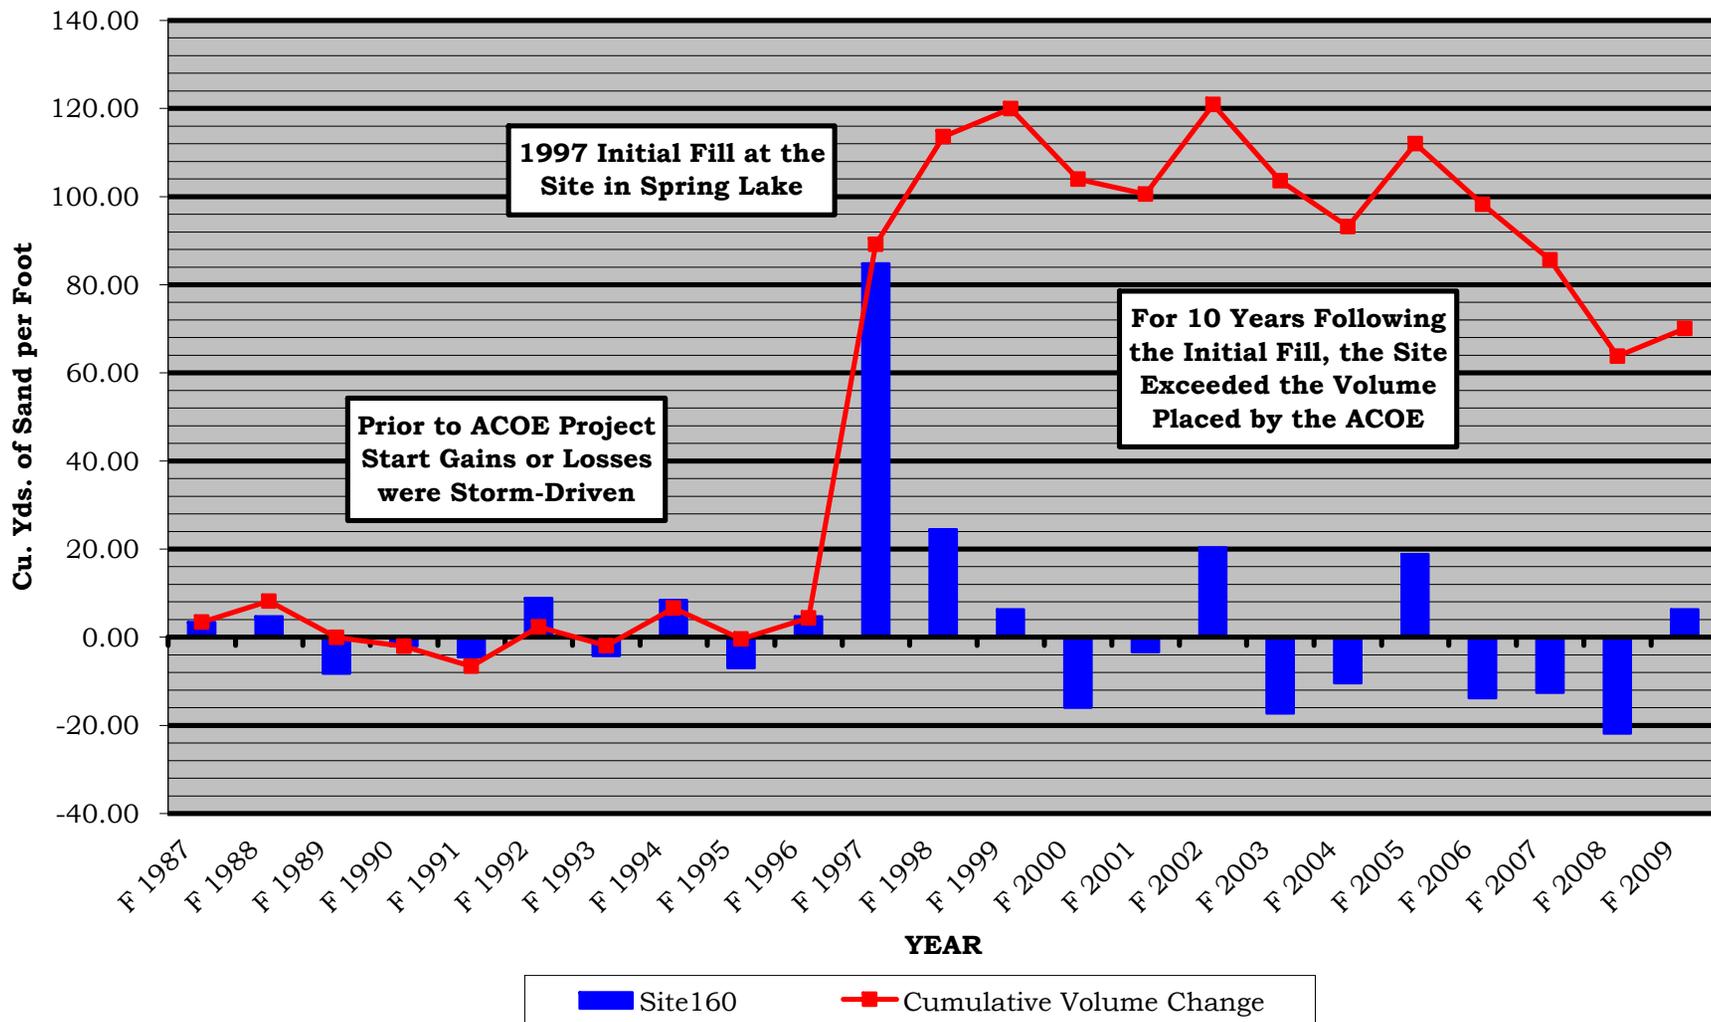
### 23- Year Sand Volume Changes at Site 160, Salem Avenue, Spring Lake

Figure 6. This is the second new site selected to show the relative stability of the southern fill sector in Monmouth County. The fill volume of 85 yds<sup>3</sup>/ft. completed in 1997 was followed by 5 of 12 years with sand added to that placed in 1997. For a decade the site maintained an excess volume of sand over that placed by the ACOE. 2008 took the biggest bite out of the sand supply with a partial recovery in 2009. That survey in 2009 preceded most of the northeast storms.

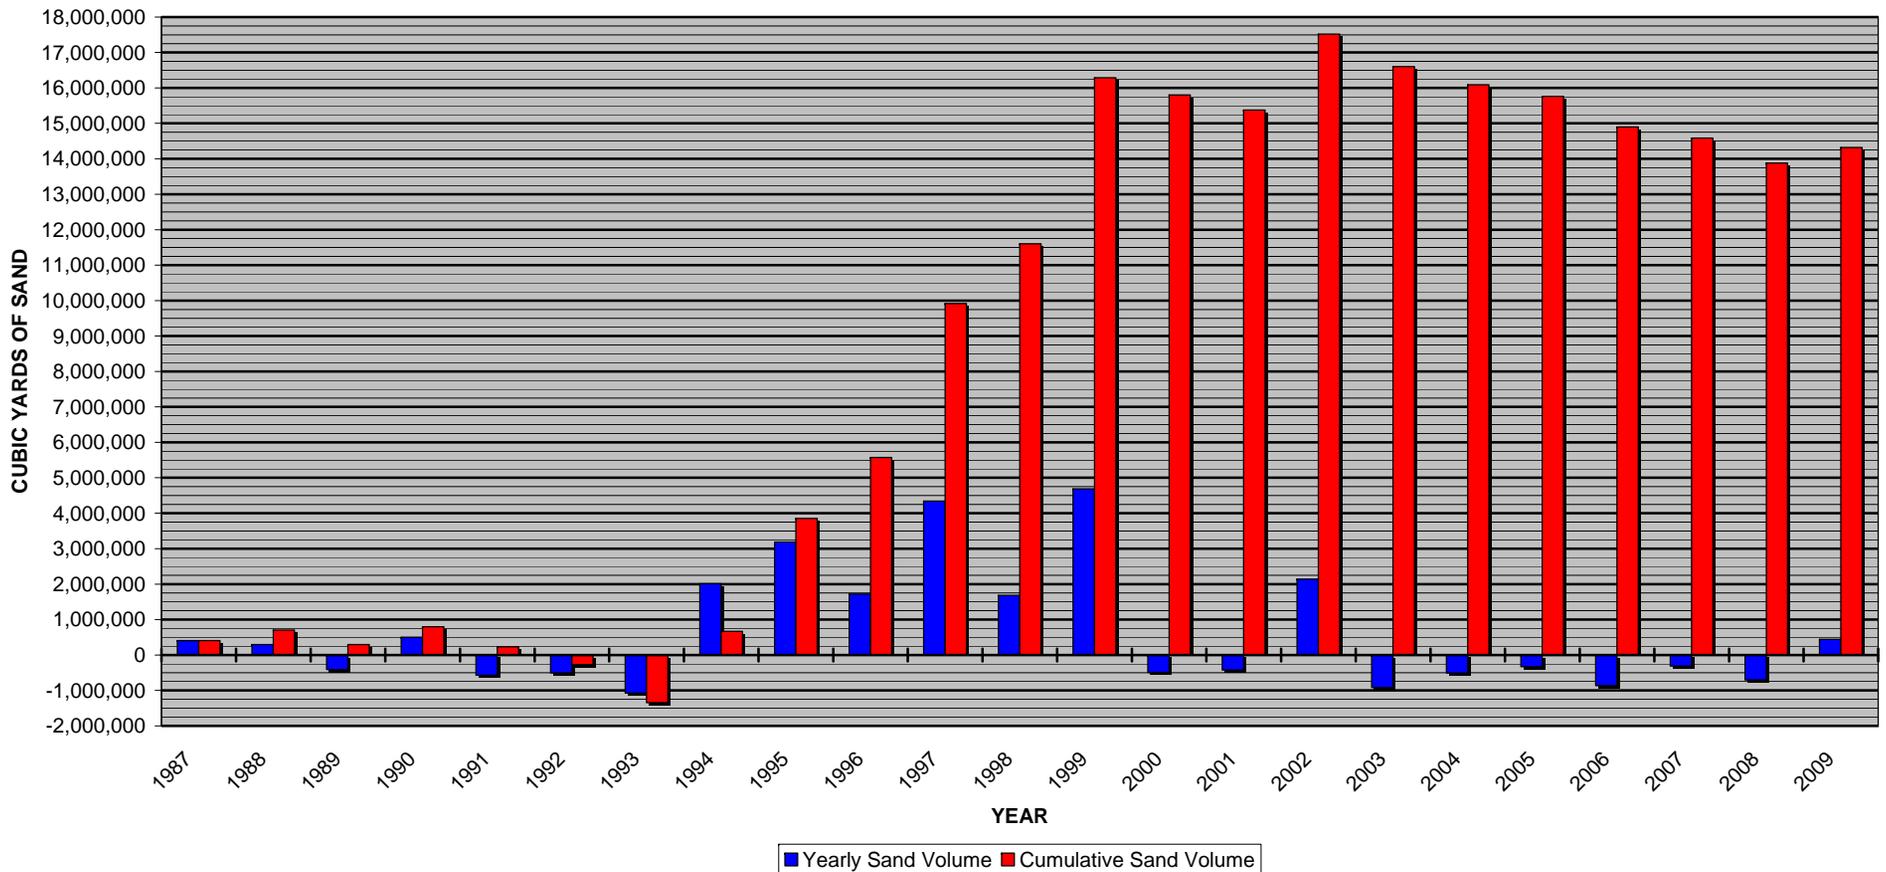
ANNUAL & CUMULATIVE OCEANFRONT SHORELINE SAND VOLUME CHANGES, MONMOUTH COUNTY 1987 to 2009

**Figure 7.** The final bar graph illustrates the trend and each year’s average sand volume change for all 35 of the Monmouth County survey sites. Between 1994 and 1999 the ACOE project was underway along 21 miles of the county shoreline adding 140 yds<sup>3</sup>/ft. in average cumulative sand volume to the county’s beaches. Storm recovery work in 1997 and maintenance work performed in 2002 added sand to portions of the project, but no new sand was placed until 2009’s work in Long Branch. The El Nino year of 2009 and 2010 may show in the spring survey data for 2010, but the surveys in the early fall of 2009 show as an average net accumulation of sand along the project shoreline. This was the only year since 2002 when the Monmouth County average was positive, but the county remains as the graph shows, over 15,000,000 cubic yards of sand ahead of the 1993 situation.

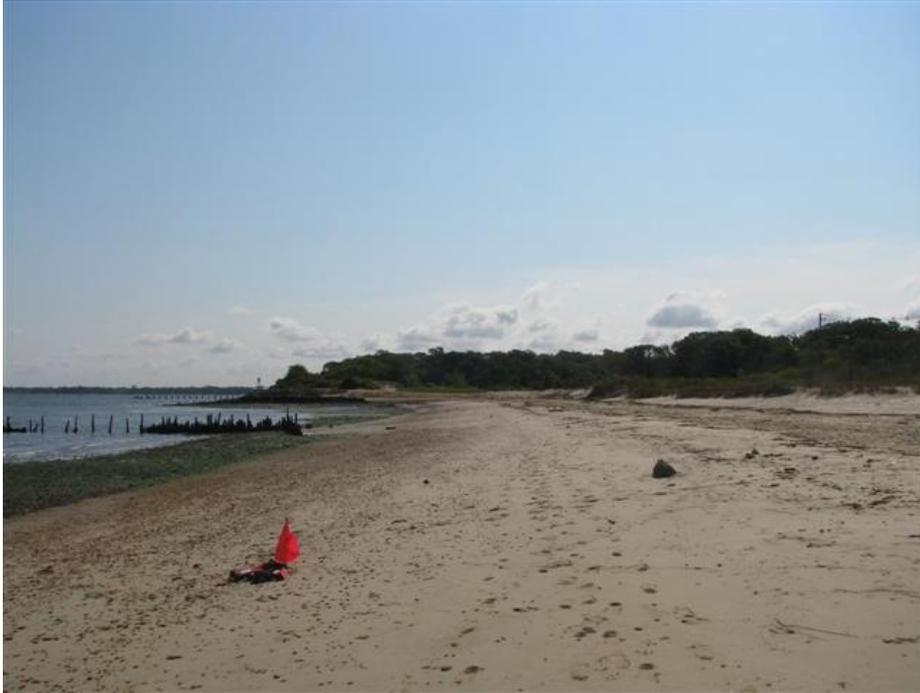
Photo taken September 24th 2008. View to the east.

Shoreline retreat exposed an old timber structure on the beach in 2007 and continued in 2008.

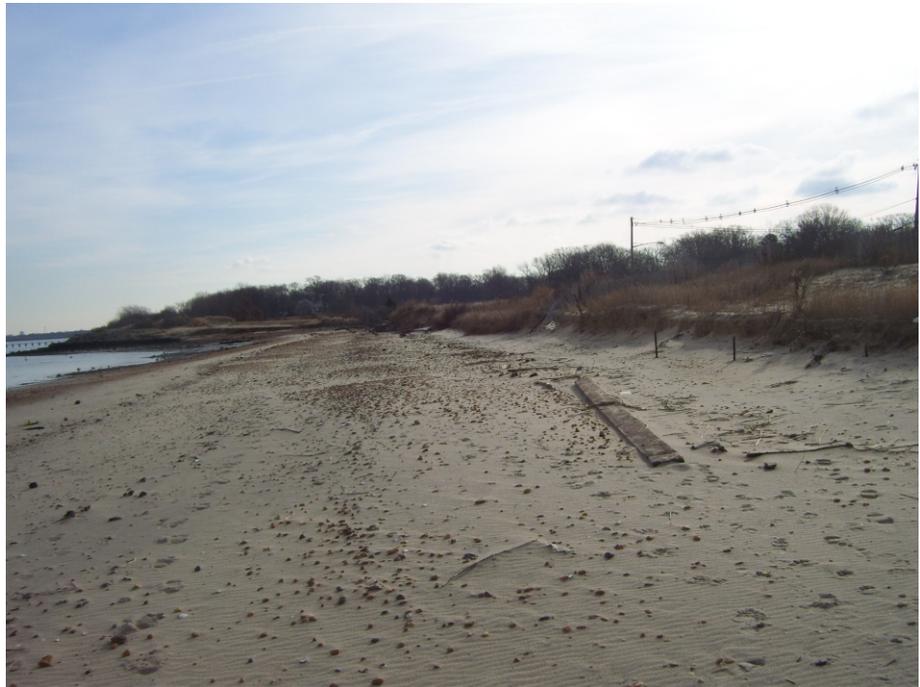
Photo taken December 14, 2009. View to the east.

Comparing the profiles over the 15 month time period, the profile location lost volume (-3.26 cu yd/ft) and the shoreline moved seaward (6.78 ft). Raritan Bay northeast storm waves cut into the dunes and pushed back the beach.

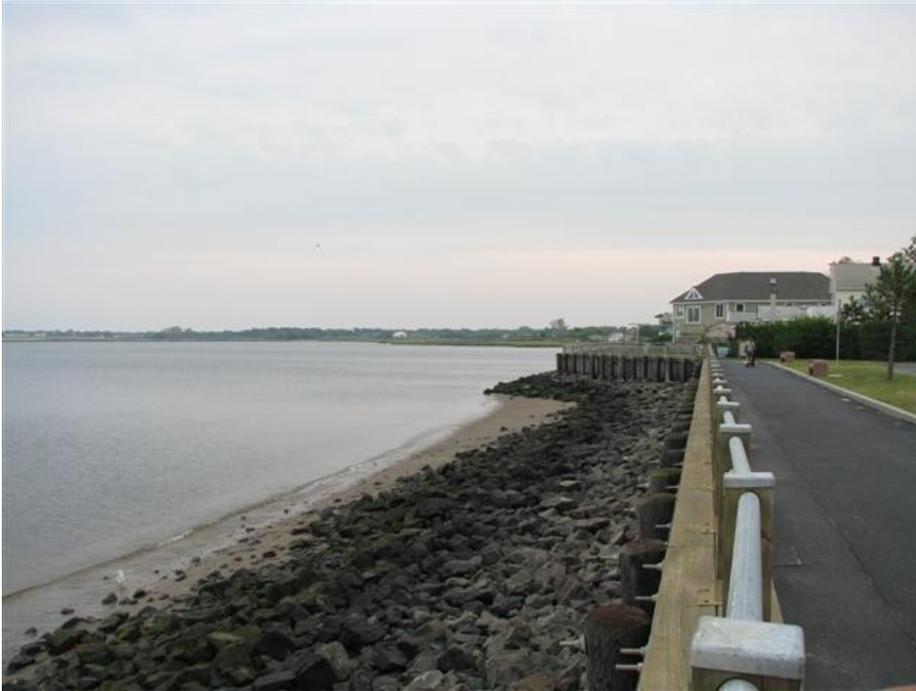
## UNION BEACH - SITE 286 (formerly Site 186)

Photo taken September 9, 2008. View to the east. Photo of Site 186.

This shoreline was upgraded with hard structures about a decade ago. This photograph shows the new bulkhead/railing and pedestrian walkway with an apron of medium stone extending to the low tide line. Since changes rarely occur beyond the low tide line in the 22 years of study, this site has become an exercise in futility to continue surveying. The last comparison was between surveys 36 and 37 (July 15, 2008 and Sept 9, 2008) where the site lost 1.61 cu yd/ft and the shoreline retreated 1.35 feet. After discussions with the NJDEP, the site was moved about a quarter mile to the northwest along the shoreline to a public bathing beach so that more normal shoreline changes could be followed. The new site is near the intersection of Beach and Front Streets in Union Beach.

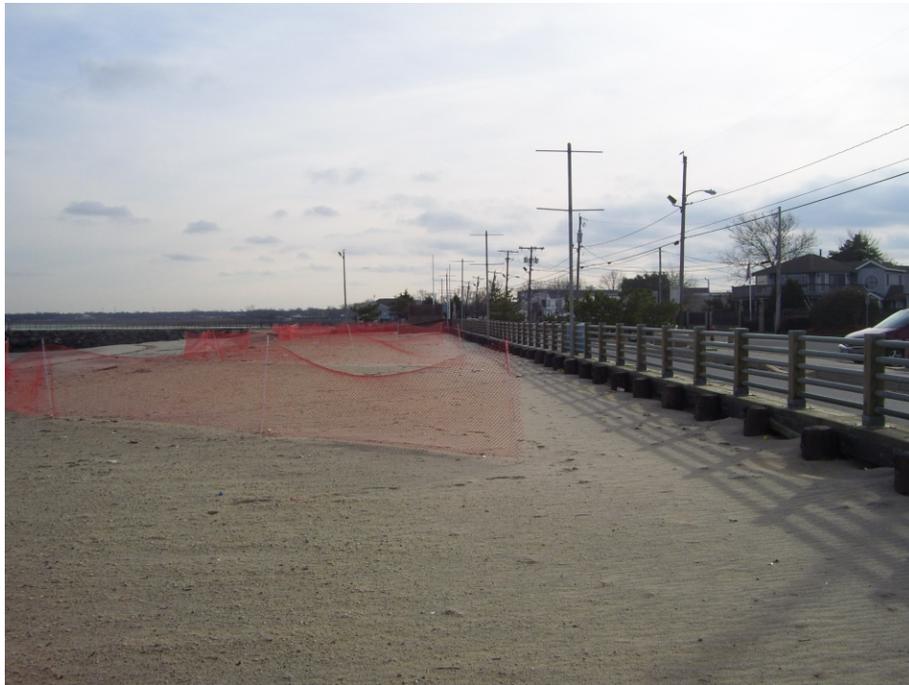
Photo taken December 14, 2009. View to the east. Photo of Site 286.

Comparing the profiles since inception in April 2009, the profile location gained volume (0.69 cu yd/ft) and the shoreline moved seaward (11.94 ft). The orange fencing on the beach appears to be designed to prevent sand from blowing onto the parking/roadway area during the winter.

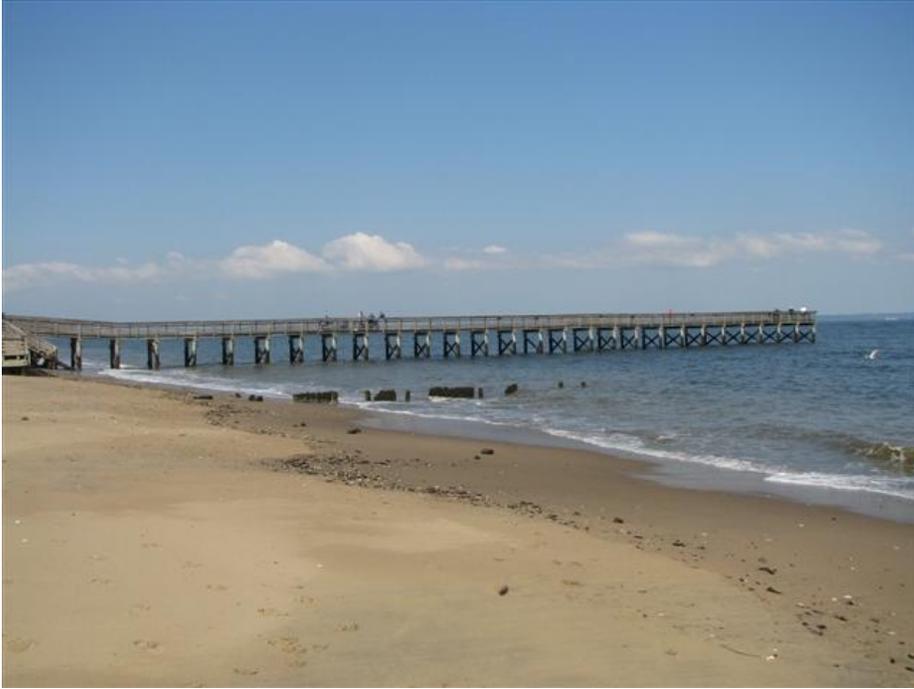
## SPY HOUSE MUSEUM - SITE 185

Photo taken September 24, 2008. View to the west.

Fishing pier and an old structure exposed near the low tide line.

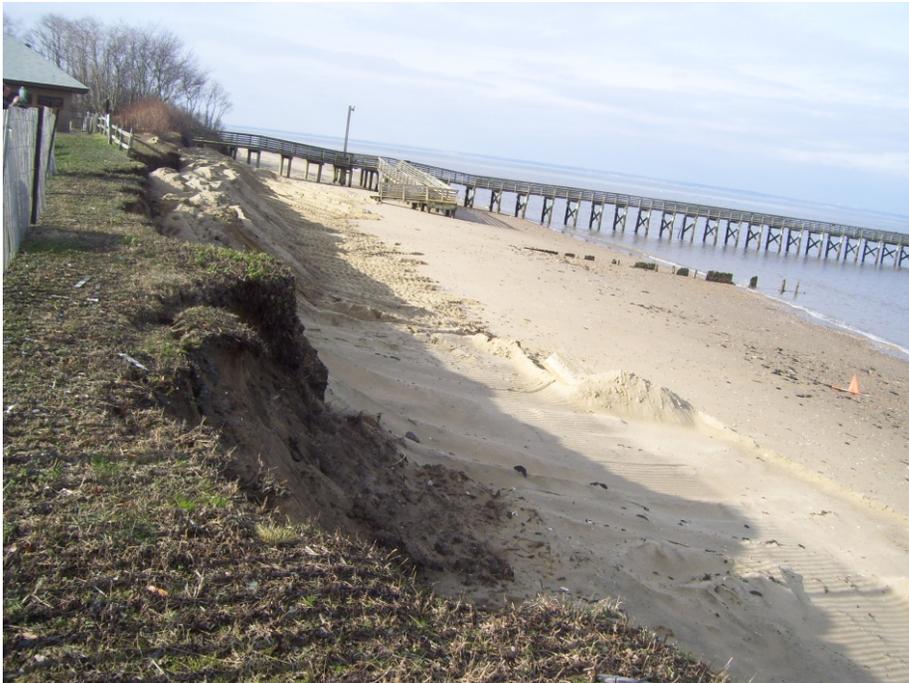
Photo taken December 14, 2009. View to the west.

Comparing the profiles over the 15 month time period, the profile location lost volume (-5.63 cu yd/ft) and the shoreline moved landward (-13.48 ft). Northeast storms cut away at the dune as the beach retreated before the erosion produced by the waves generated on Raritan Bay.

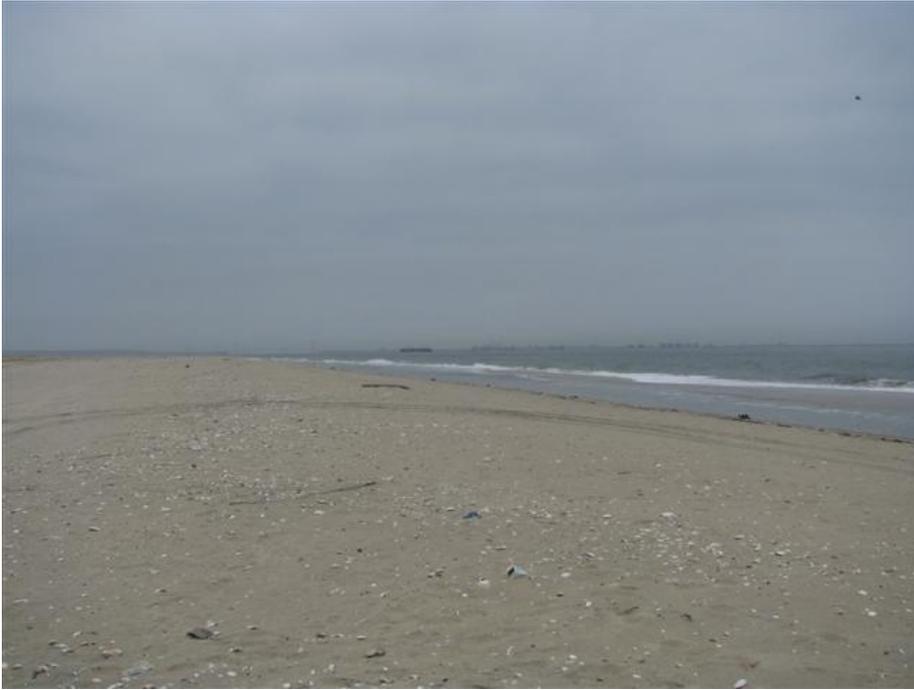
## SANDY HOOK NATIONAL SEASHORE - SITE 285

Photo taken November 3, 2008. View to the north/east.

The beach grows relatively continuously since the Federal project provided abundant material to move north to the end of Sandy Hook.

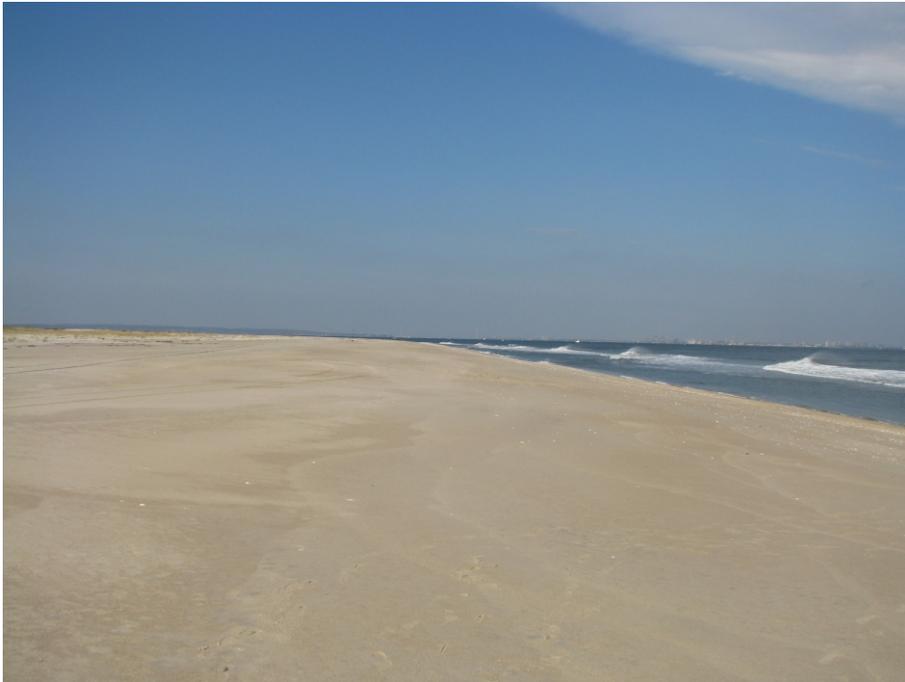
Photo taken November 3, 2009. View to the north/east.

Comparing the profiles over the one year time period, the profile location was relatively stable with a volume change of only (0.32 cu yd/ft) and the shoreline moved seaward (19.71 ft).

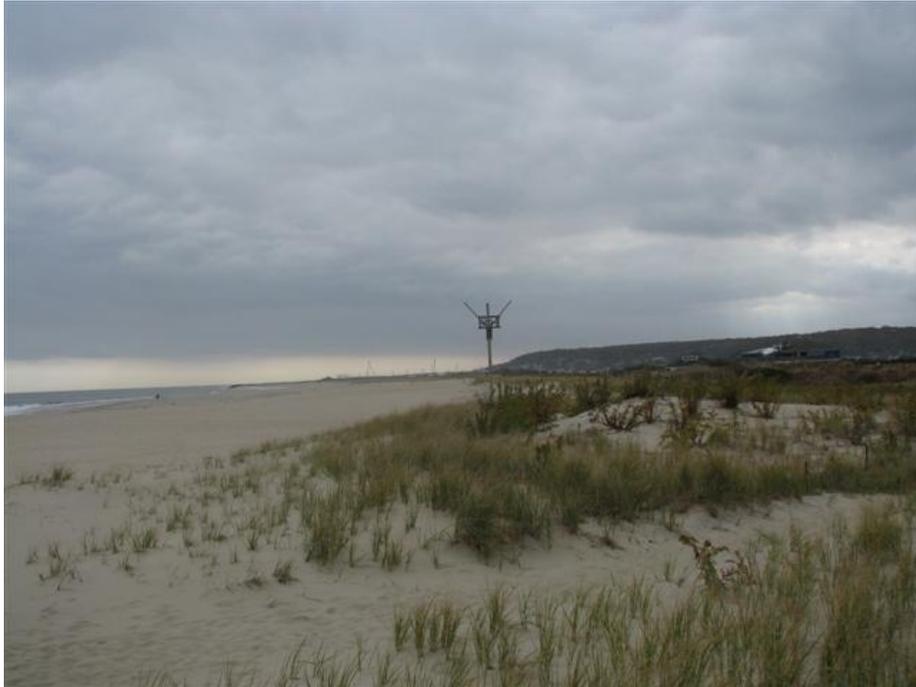
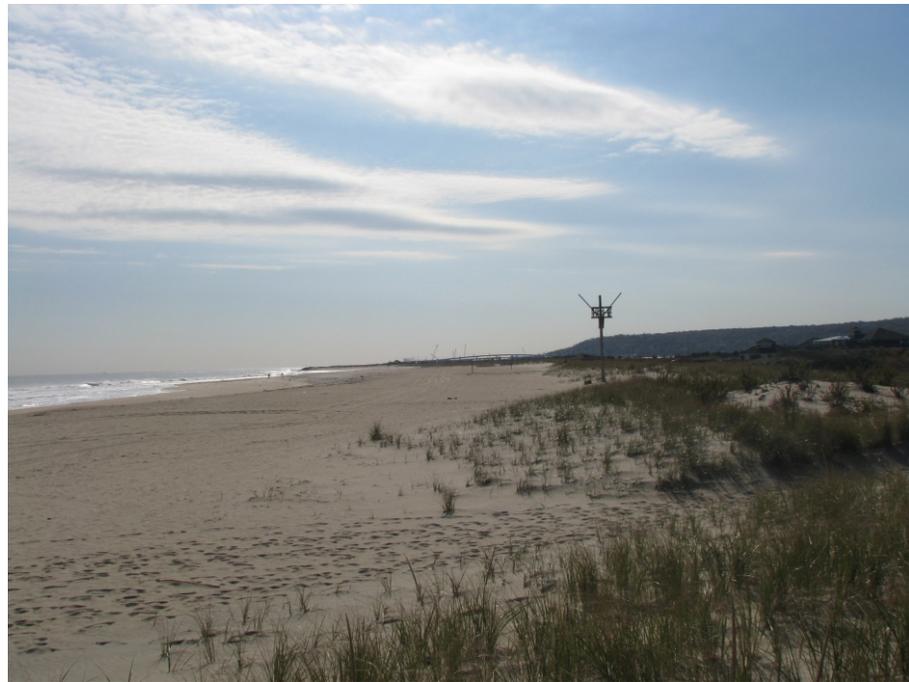
# SANDY HOOK NATIONAL SEASHORE, PARKING LOT E - SITE 284

Photo taken November 3, 2008. View to the south.

Photo taken November 3, 2009. View to the south.

Comparing the profiles over the thirteen month time period, the profile location gained volume (13.42 cu yd/ft) but the shoreline moved landward (-27.56 ft).

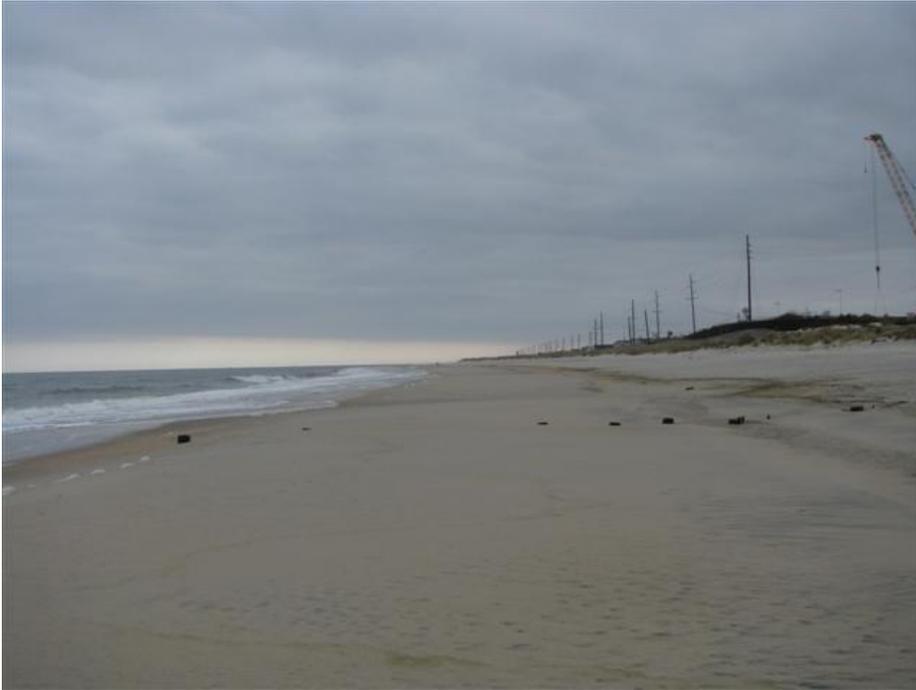
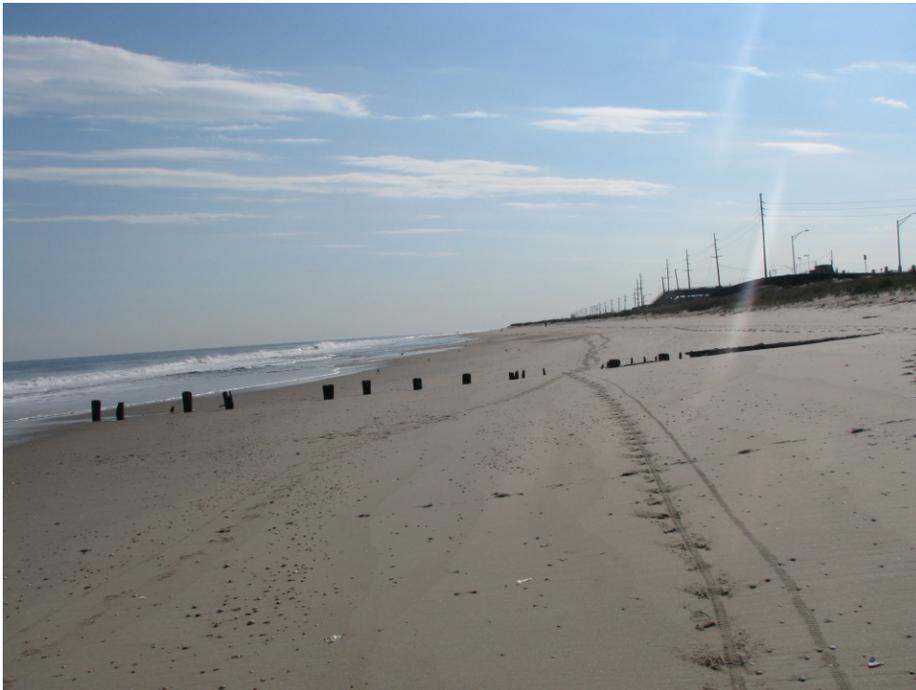
## SANDY HOOK, HIGHLANDS BEACH - SITE 184

Photo taken November 3, 2008. View to the south.

Photo taken November 3, 2009. View to the south.

Comparing the profiles over the thirteen month time period, the profile location gained volume (16.05 cu yd/ft) and the shoreline moved landward (-36.68 ft). This landward movement is demonstrated by examining the number and height of the timber pilings showing in 2009 as compared to 2008.

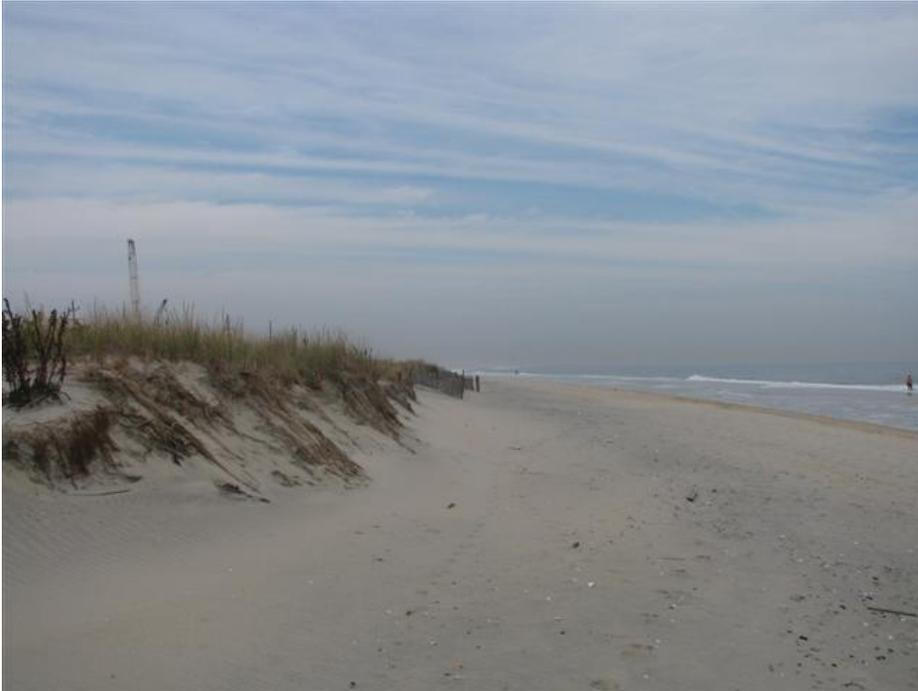
Photo taken November 4, 2008. View to the north.

This site has a natural dune that has been growing since 1998. A single line of fence was all that was established following the Federal project.
