## New Jersey Beach Profile Network 2009 Annual Report on Shoreline Changes in New Jersey Coastal Reaches One Through Fifteen Raritan Bay to Delaware Bay

The Richard Stockton Coastal Research Center  
Richard Stockton College of New Jersey  
30 Wilson Avenue, Port Republic, NJ 08241

June 30, 2010

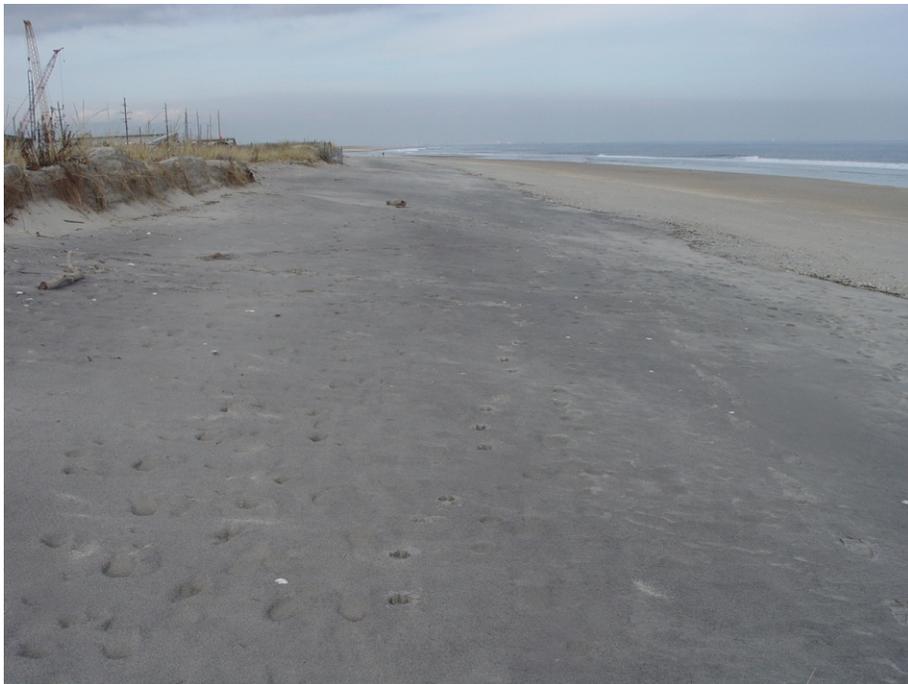
Photo taken December 14, 2009. View to the north.

Comparing the profiles over the thirteen month time period, the profile location lost volume (-20.39 cu yd/ft) and the shoreline moved landward (-83.20 ft). Some loss occurred in the dunes due to the fall 2009 storms.

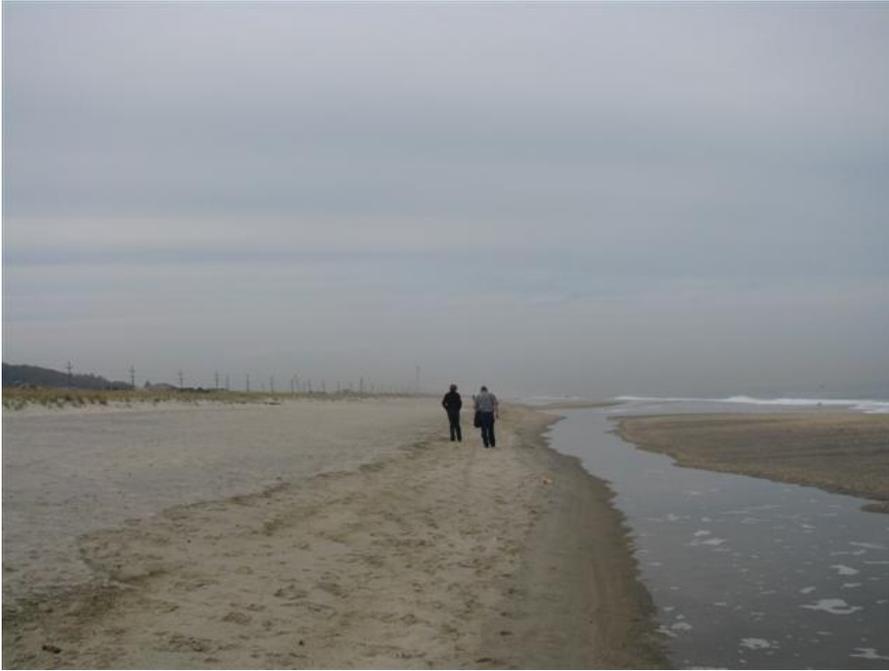
## SHREWSBURY WAY, SEA BRIGHT - SITE 282

Photo taken November 4, 2008.. View to the north. Remember that prior to the 1996 fill at this site, the beach walkers in the picture would have been swimming in 16 to 20 feet of water 350 feet east of the seawall.

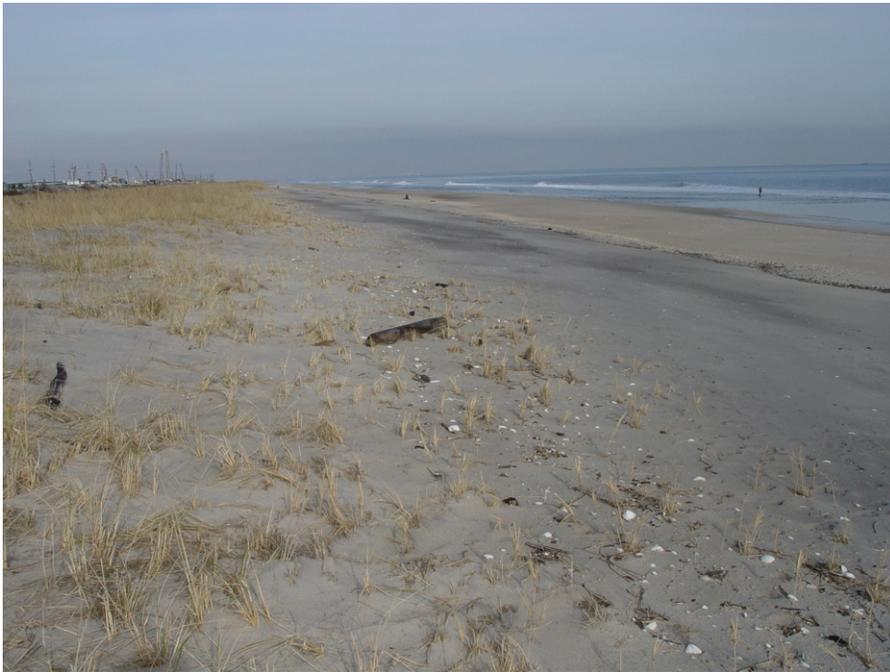
Photo taken December 14, 2009. View to the north.

Comparing the profiles over the thirteen-month time period, the profile location lost volume (-11.71 cu yd/ft) and the shoreline moved landward (-118.74 ft). Note the sizable bar moving onto the beach following partial recovery following the November northeast storm.

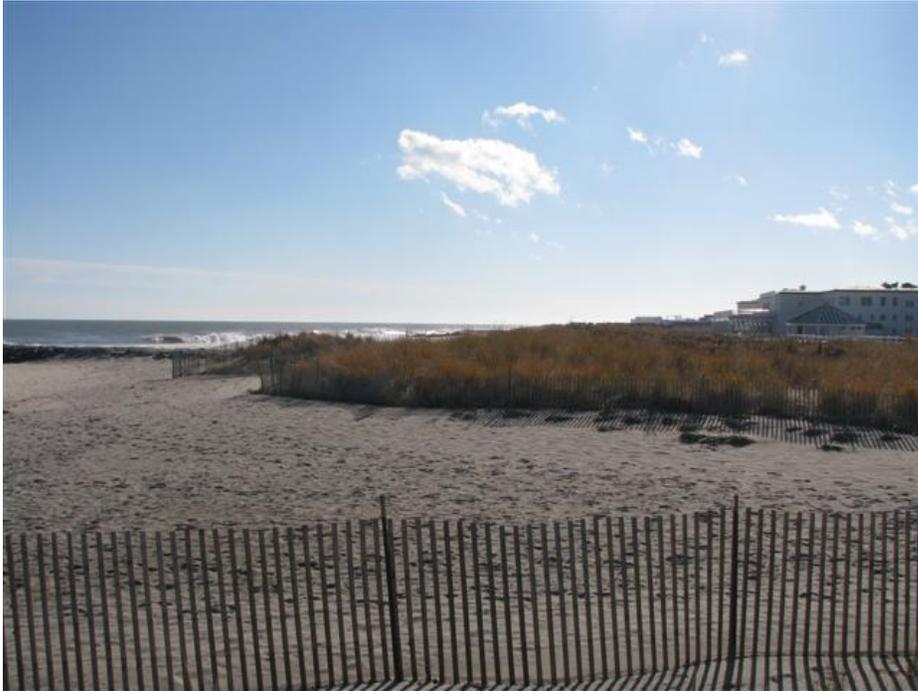
Photo taken December 1, 2008. View to the south. This small segment of public shoreline has maintained its general condition since the fill was completed over a decade ago.

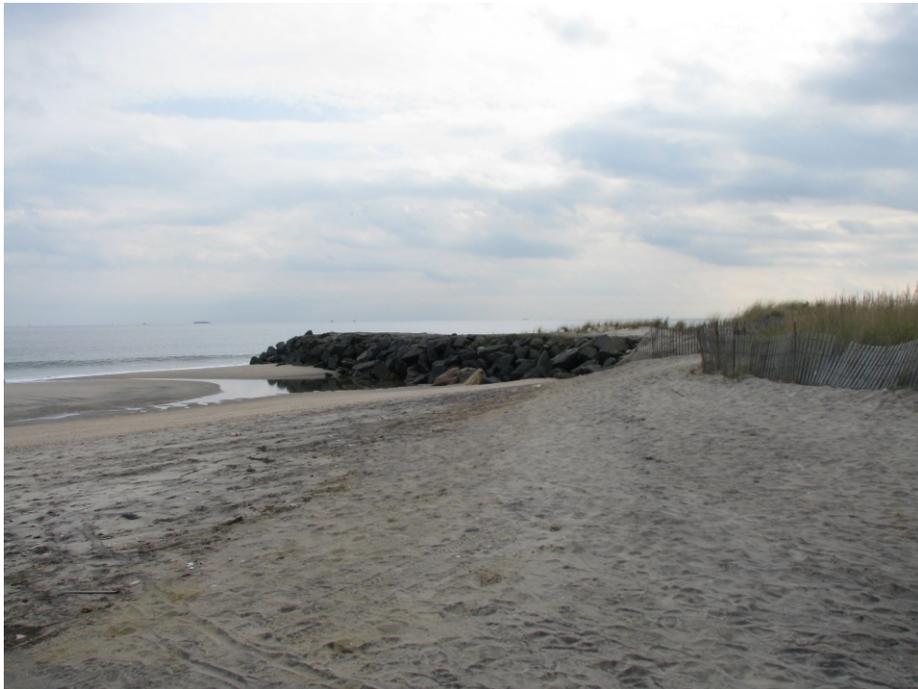
Photo taken November 5, 2009. View to the south.

Comparing the profiles over the eleven month time period, the profile location lost volume (-7.24 cu yd/ft) and the shoreline moved seaward (27.14 ft).

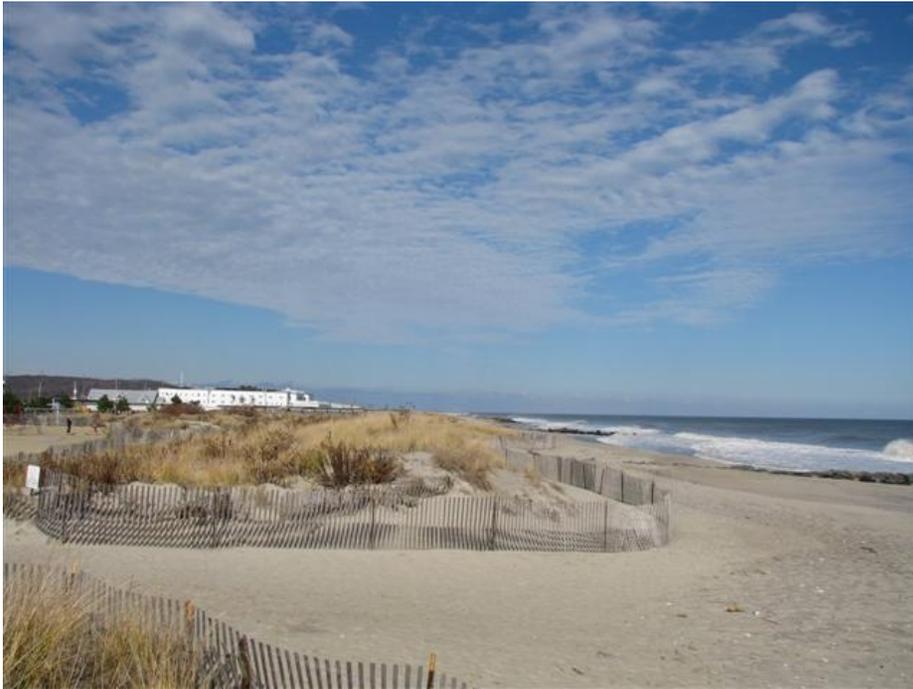
## MUNICIPAL BEACH, SEA BRIGHT - SITE 181

Photo taken December 1, 2008. View to the north. The entrance for bathers cuts through the dune system at this location. The beach has slowly retreated since 1996.

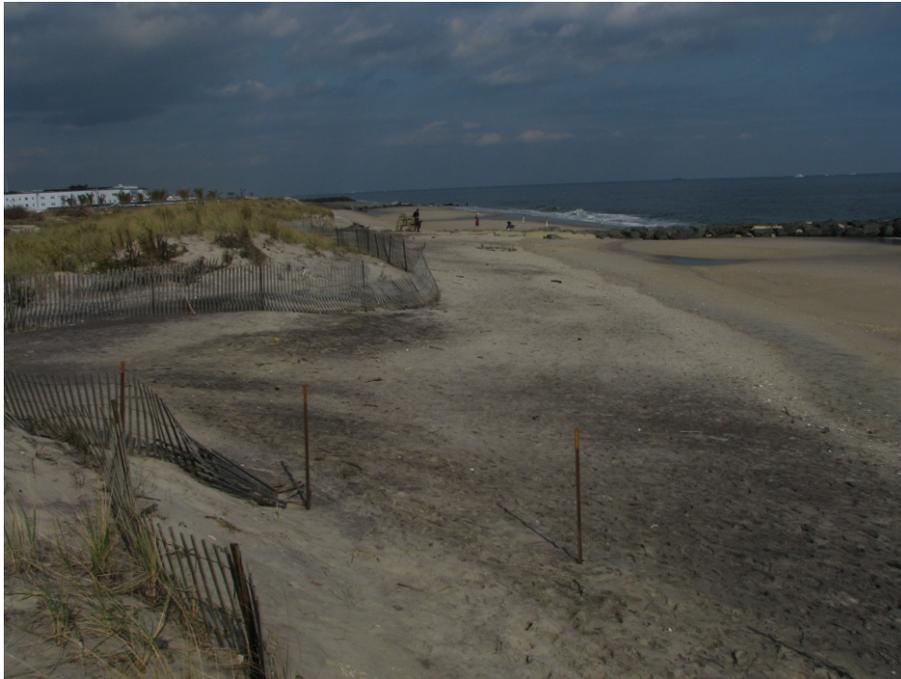
Photo taken November 5, 2009. View to the north.

Comparing the profiles over the one year time period, the profile location lost volume (-9.83 cu yd/ft) and the shoreline moved seaward (6.56 ft).

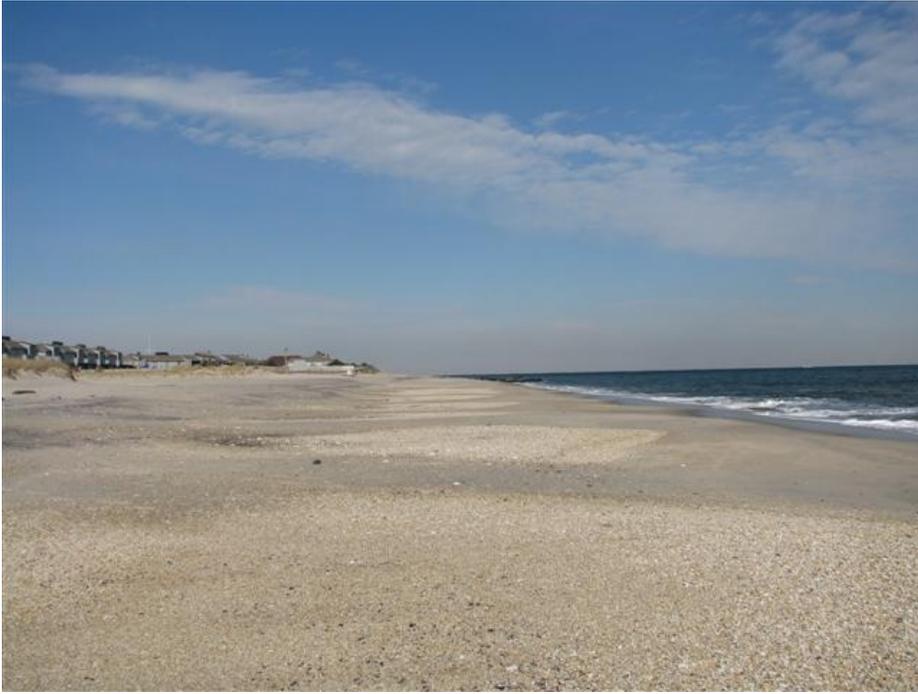
Photo taken November 21, 2008. View to the north. Here, in contrast to Site 179 a short distance away, there is a decent beach and healthy dune system. There is a need for a maintenance fill or modification to the privately-owned structure causing the problem.

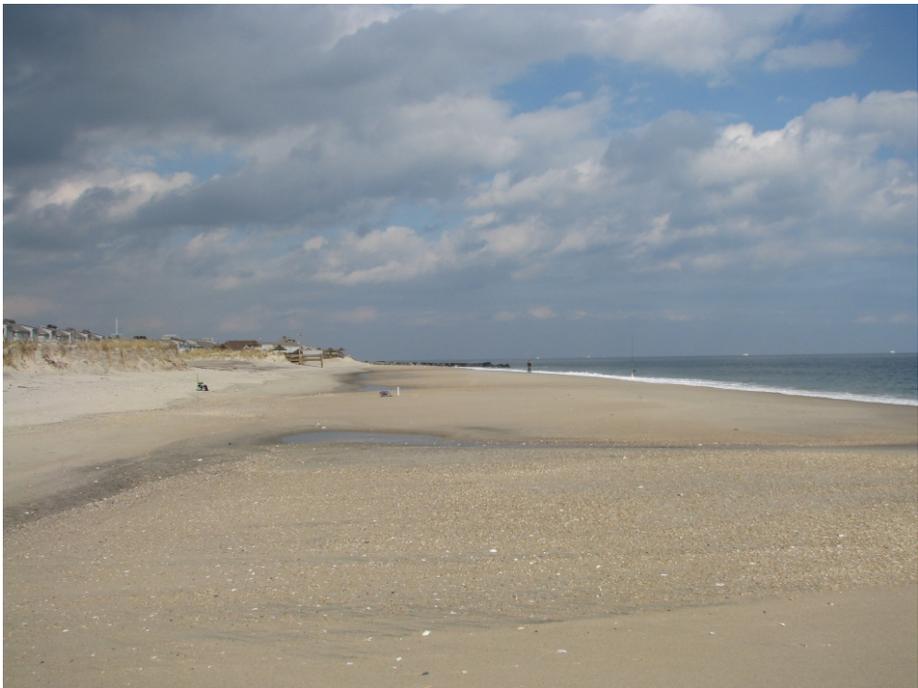
Photo taken November 5, 2009. View to the north.

Comparing the profiles over the one year time period, the profile location gained volume (4.29 cu yd/ft) and the shoreline moved landward (-6.41 ft).

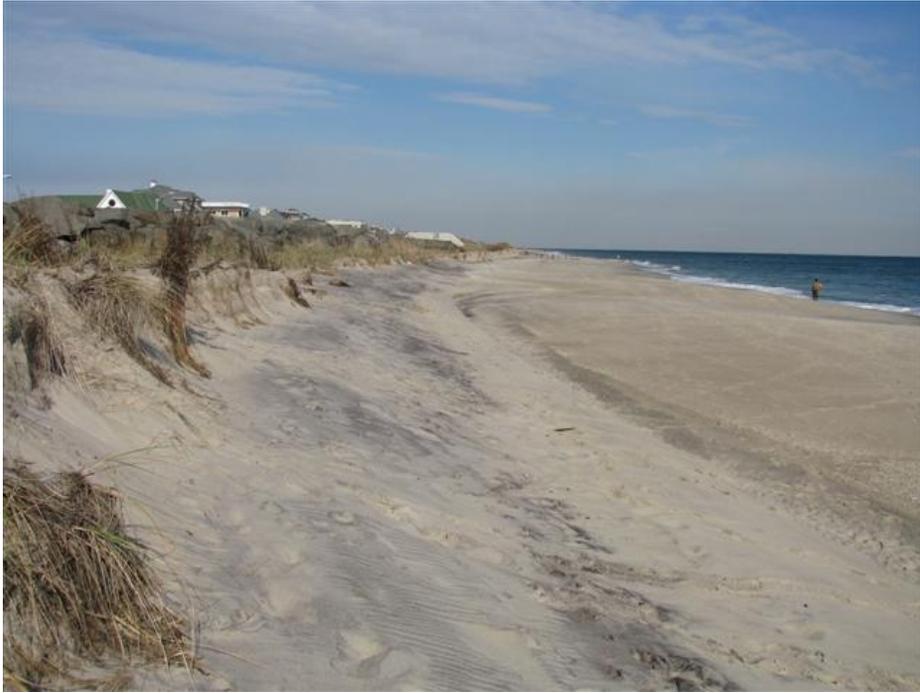
Photo taken November 21, 2008. View to the north.

Cottage Road is the southern source area for sand when littoral currents are moving north toward Sandy Hook. This is because of a massive rock groin built decades ago to protect a private beach club in Monmouth Beach located immediately to the south. The last of the dune plants were left clinging to the rocks in 2008.

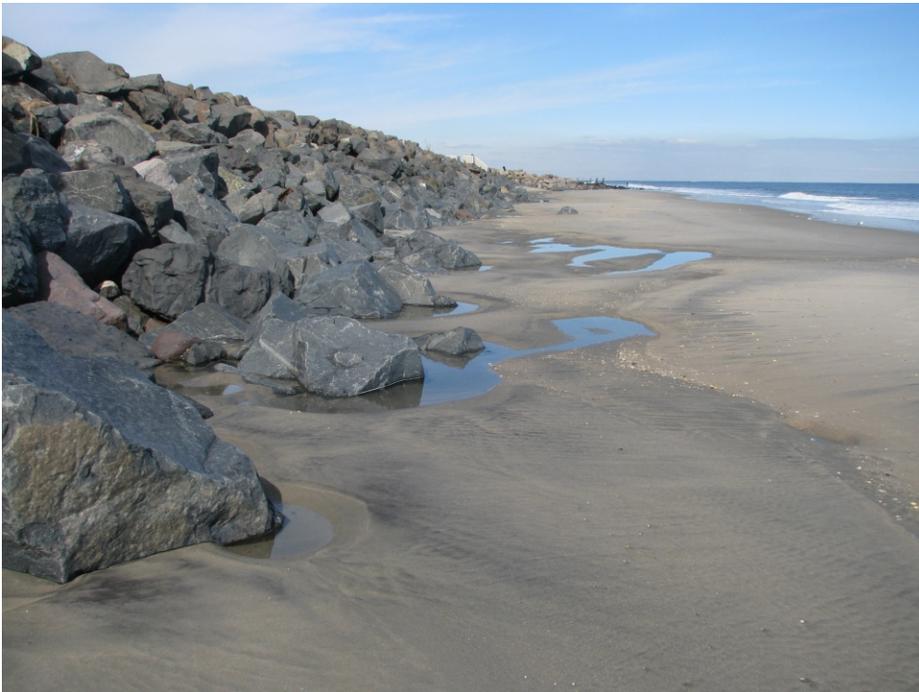
Photo taken November 4, 2009. View to the north.

Comparing the profiles over the one year time period, the profile location lost volume (-44.57 cu yd/ft) and the shoreline moved landward (-67.63 ft). Only a meager quantity of sand remains because the heavy reversal in the direction of longshore transport had yet to occur in sufficient magnitude. The November 2009 northeast storm lasted 5 days and produced abundant sand transport back to this area where the groin trapped it.

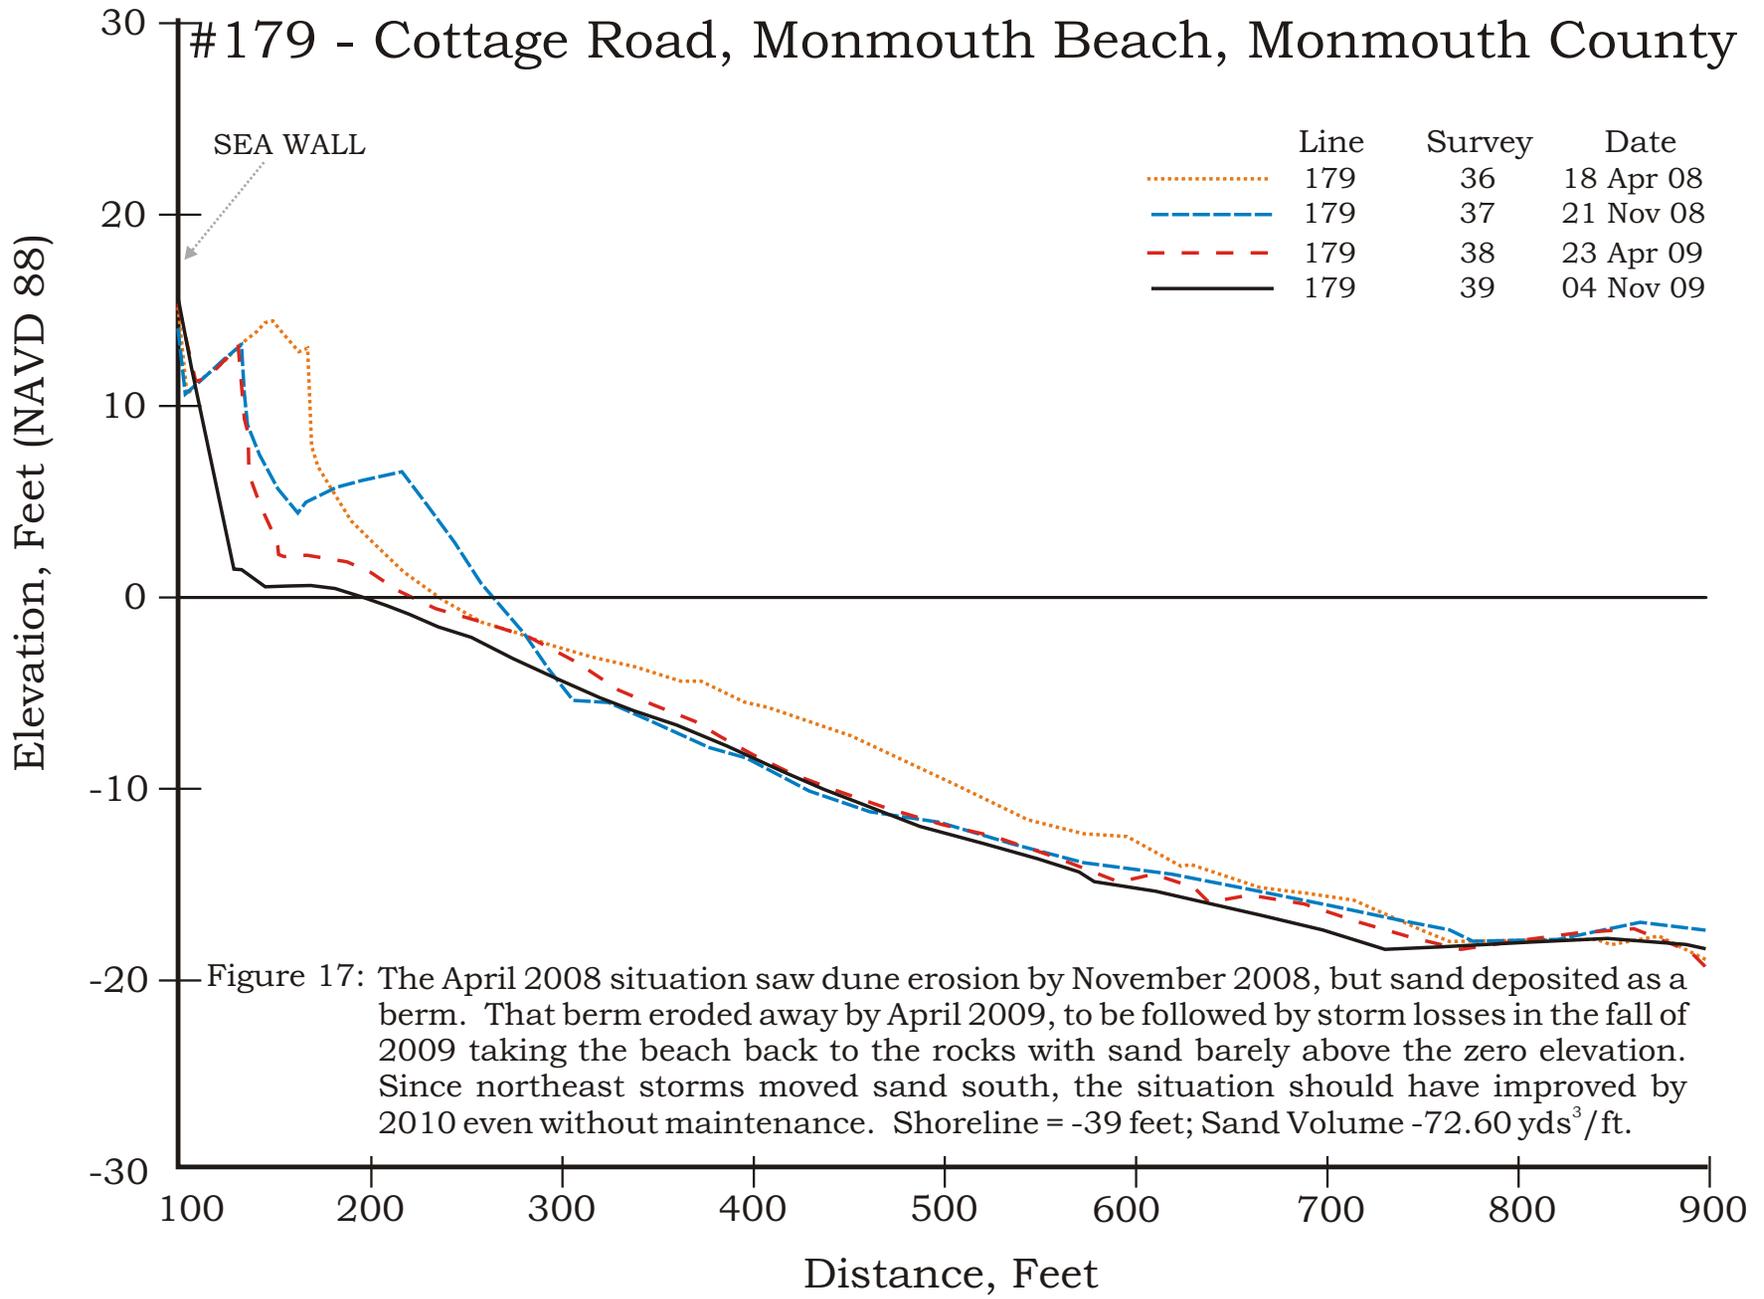
#179 - Cottage Road, Monmouth Beach, Monmouth County

Figure 17: The April 2008 situation saw dune erosion by November 2008, but sand deposited as a berm. That berm eroded away by April 2009, to be followed by storm losses in the fall of 2009 taking the beach back to the rocks with sand barely above the zero elevation. Since northeast storms moved sand south, the situation should have improved by 2010 even without maintenance. Shoreline = -39 feet; Sand Volume -72.60 yds<sup>3</sup>/ft.

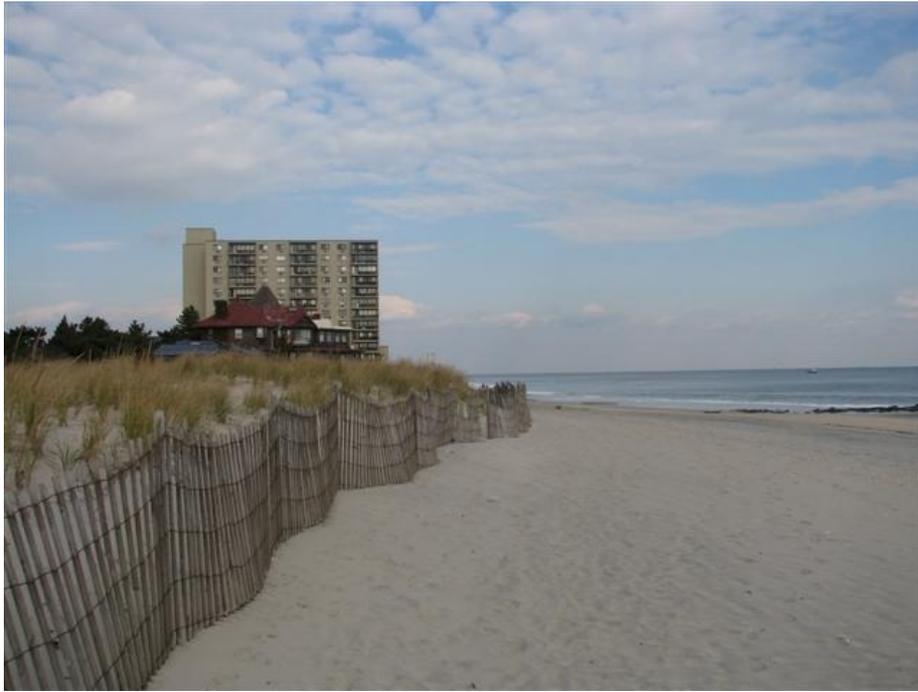
Photo taken November 20, 2008. View to the north.

The Monmouth Beach Club shoreline lies south of the big groin complex just south of Cottage Road. Sand transport around the Monmouth Beach Club area has been continuously difficult since the ACOE project was built.

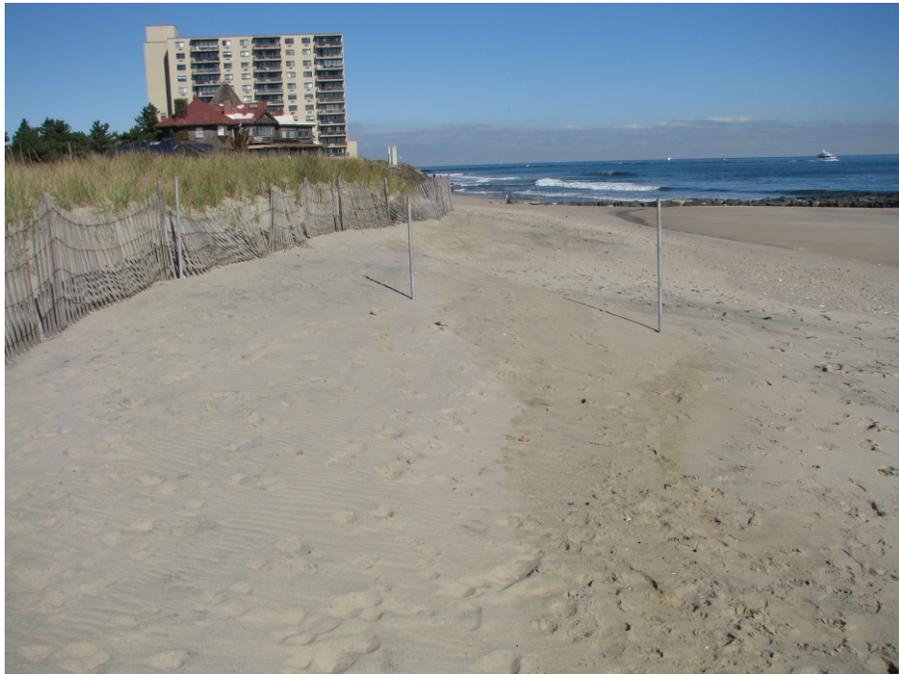
Photo taken November 4, 2009. View to the north.

Comparing the profiles over the one year time period, the profile location lost volume (-30.75 cu yd/ft) and the shoreline moved landward (-38.29 ft).

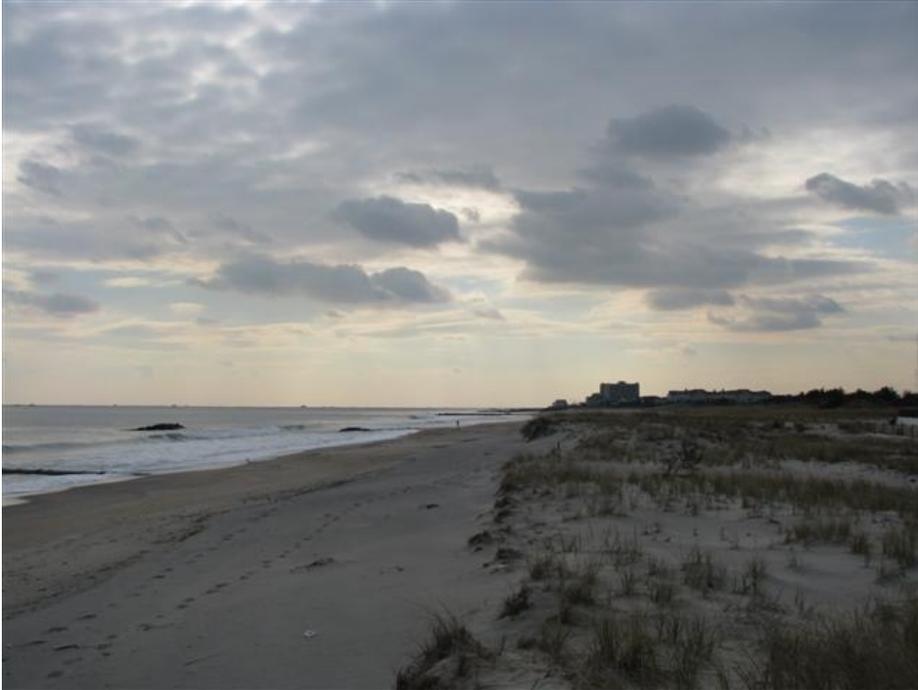
Photo taken November 20, 2008. View to the south.

The site was essentially stable over the 2008-9 study interval.

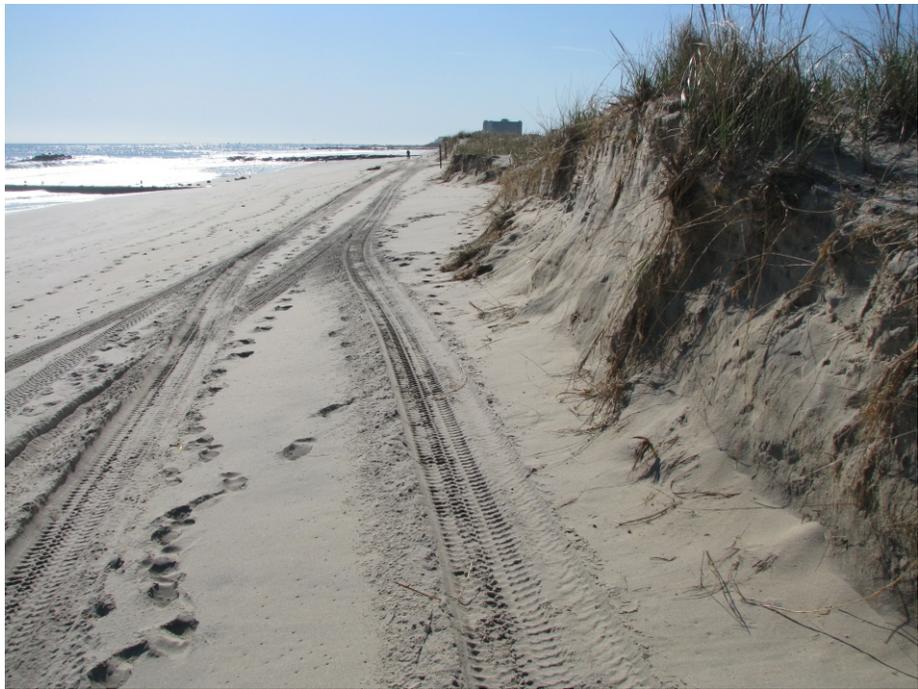
Photo taken November 4, 2009. View to the south.

Comparing the profiles over the eleven month time period, the profile location lost volume (-9.21 cu yd/ft) and the shoreline moved seaward (26.59 ft). Waves had reached the dune toe in mid-October.

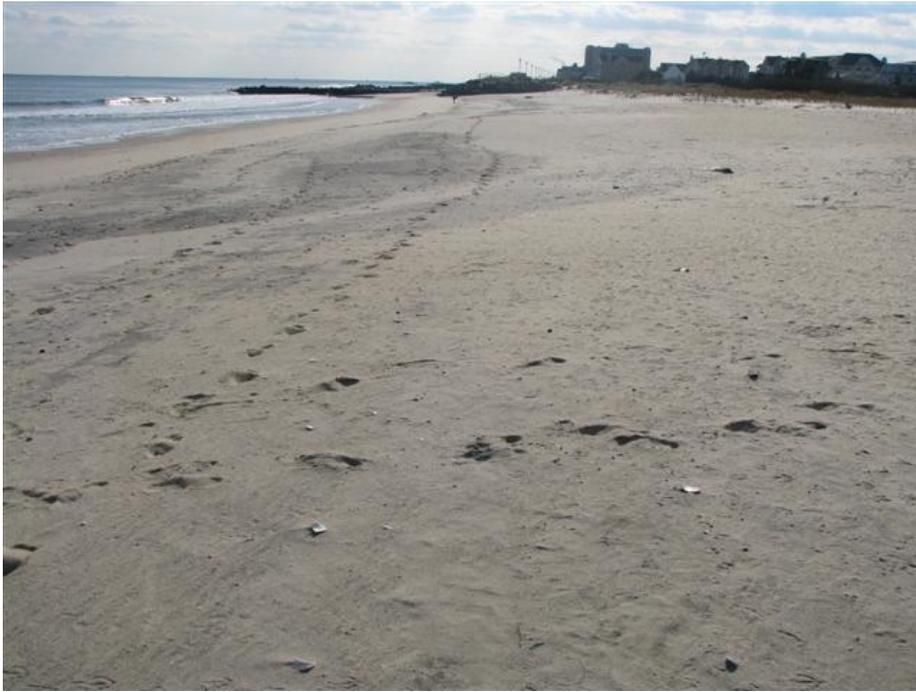
Photo taken November 17, 2008. View to the south.

At the Seven Presidents Park the beach had a broad flat slope to the water from a narrow segment of flat dry beach.

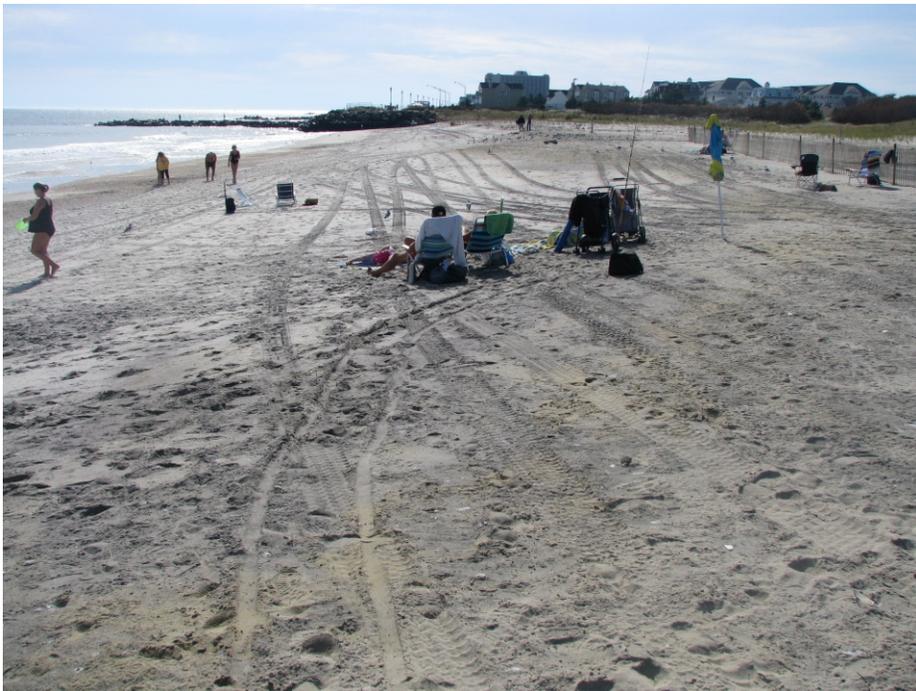
Photo taken October 22, 2009. View to the south.

Comparing the profiles over the eleven month time period, the profile location lost volume (-12.83 cu yd/ft) and the shoreline moved landward (-22.84 ft).

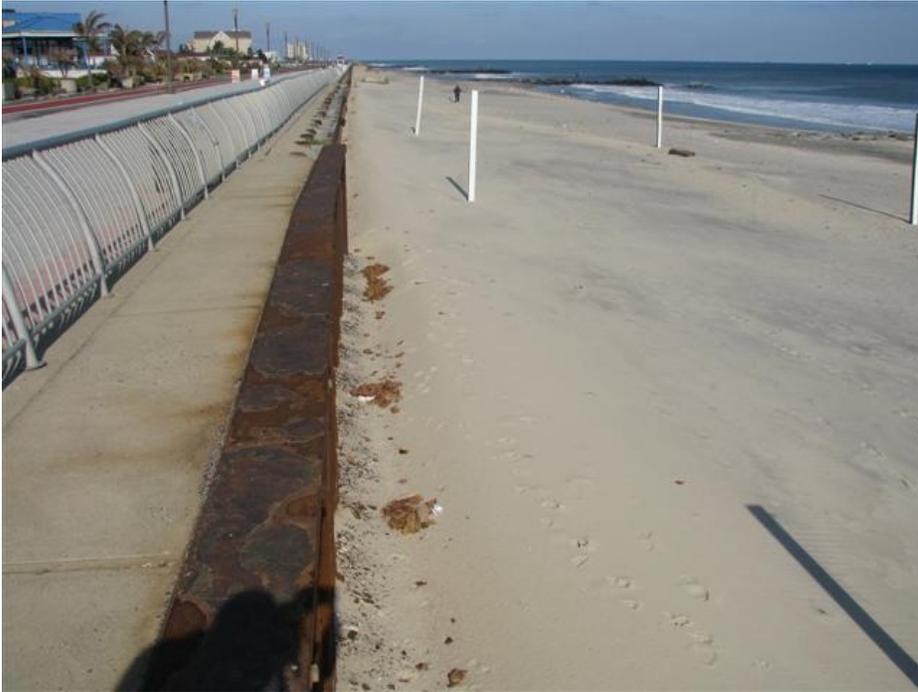
Photo taken November 17, 2008. View to the north.

The old rusted steel showing in both photographs is the top of the 70-year old vertical steel bulkhead used to defend the uplands bluff.

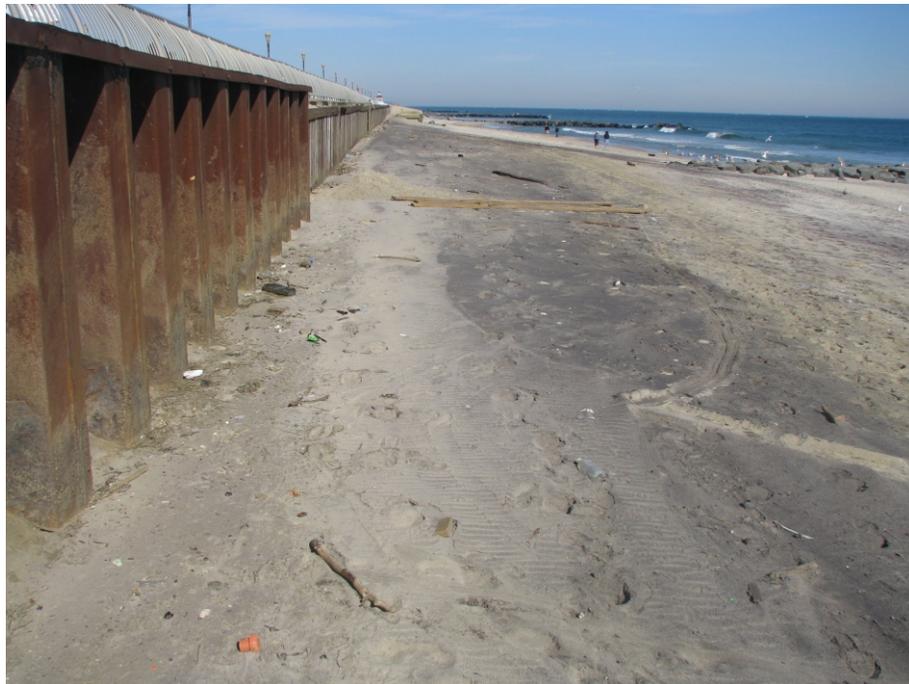
Photo taken October 22, 2009. View to the north

Comparing the profiles over the eleven month time period, the profile location gained volume (7.33 cu yd/ft) and the shoreline moved landward (-48.58 ft). Storm-generated loss is obvious in the 4-foot vertical segment of the steel wall now showing in 2009. This is the first year since the fill in 1996 that you could not just walk off the wall onto the beach.

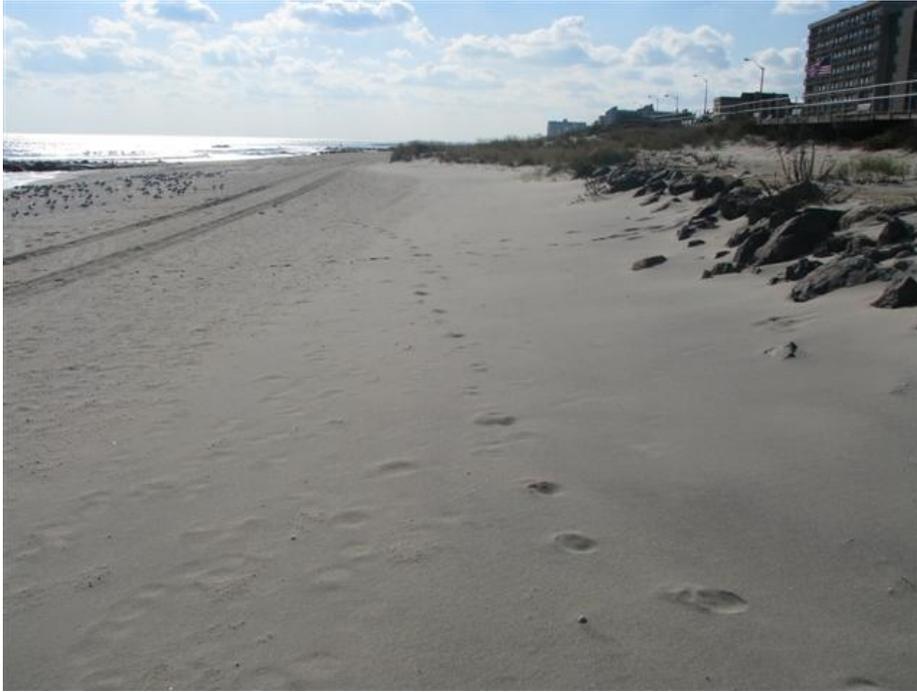
## MORRIS AVENUE, LONG BRANCH - SITE 174

Photo taken November 17, 2008. View to the south.

This central area of the Long Branch municipal beach is defended by both groins and a rock sea wall at the bluff. Some retreat has occurred here since the artificial end of the project is but one additional survey site away to the south. This November 17, 2008 view shows the rocks and stray grass plants that have established up the slope toward the pedestrian walk. This area received sand indirectly in 2009 as the ACOE performed a maintenance on the southern end of the Long Branch beaches.

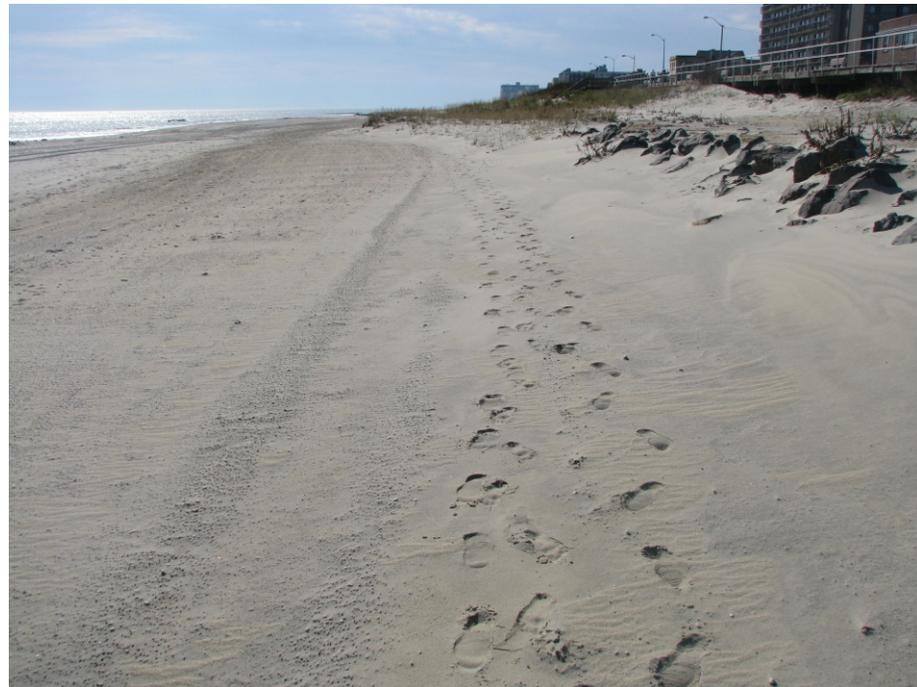
Photo taken October 22, 2009. View to the south.

Comparing the profiles over the eleven month time period, the profile location gained volume (52.98 cu yd/ft) and the shoreline moved seaward (122.89 ft). This was all due to the northerly transport of maintenance fill sand applied to the southern end of the Long Branch segment of the Monmouth County fill in 2009.

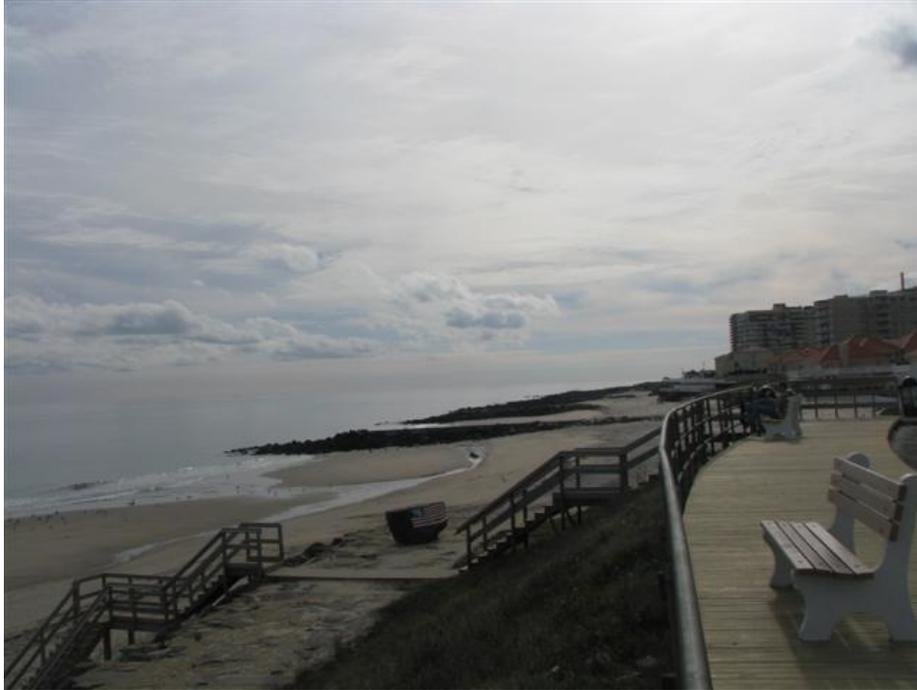
## WEST END AVENUE, LONG BRANCH - SITE 173

Photo taken November 12, 2008. View to the south.

This is the southernmost survey site within the Long Branch to Sandy Hook segment of the Monmouth County beach fill. The deposition stopped just south of here due to real estate issues along privately owned oceanfront tracts in Elberon and Deal into Allenhurst. This view shows the top of the bluff, the rock sea wall and the remaining beach between the groins. The 2009 beach restoration maintenance fill augmented this site substantially by March 2009.

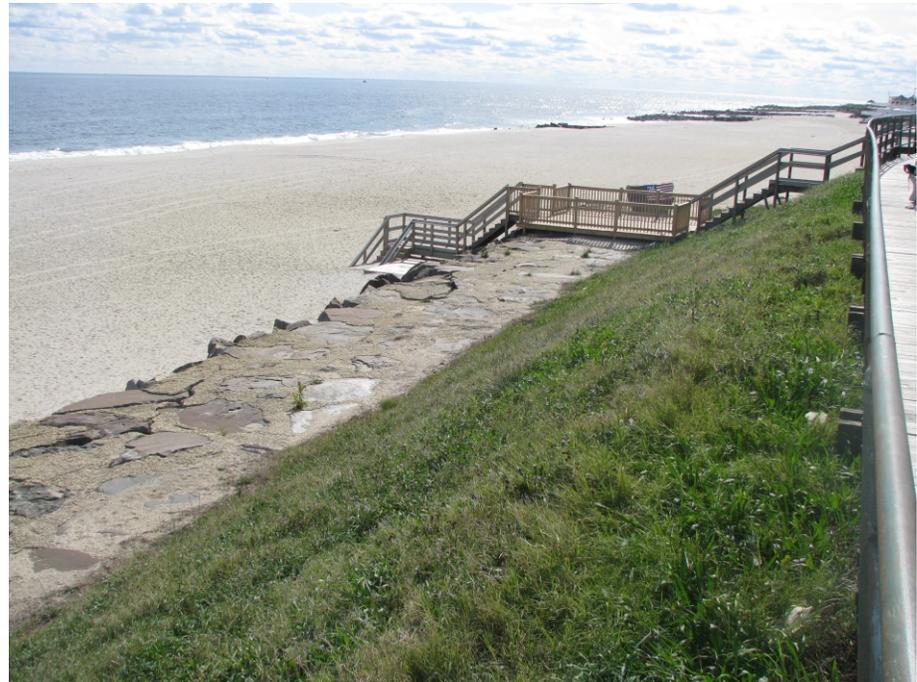
Photo taken October 14, 2009. View to the south.

Comparing the profiles over the eleven month time period, the profile location gained volume (158.86 cu yd/ft) and the shoreline moved seaward (146.14 ft). Some berm retreat has occurred as this maintenance fill adjusted to the shoreline conditions. Northeast storms would have acted to move material south into Elberon.

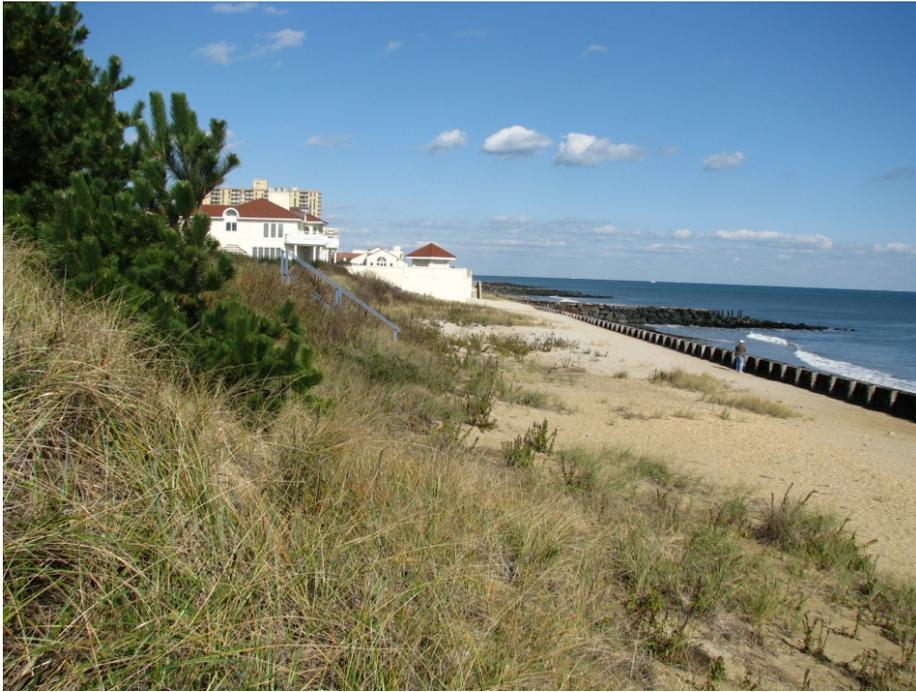
## PULLMAN AVENUE, ELBERON - SITE 171

Photo taken November 10, 2008. View to the north.

Located on the highest elevation (+36 feet) along the Monmouth County bluff, this site lies about a mile south of the southern end of the beach fill in Long Branch. This view shows the entire bluff, the flat terrace between the steel bulkhead and the bluff and a relative distant view of the shoreline.

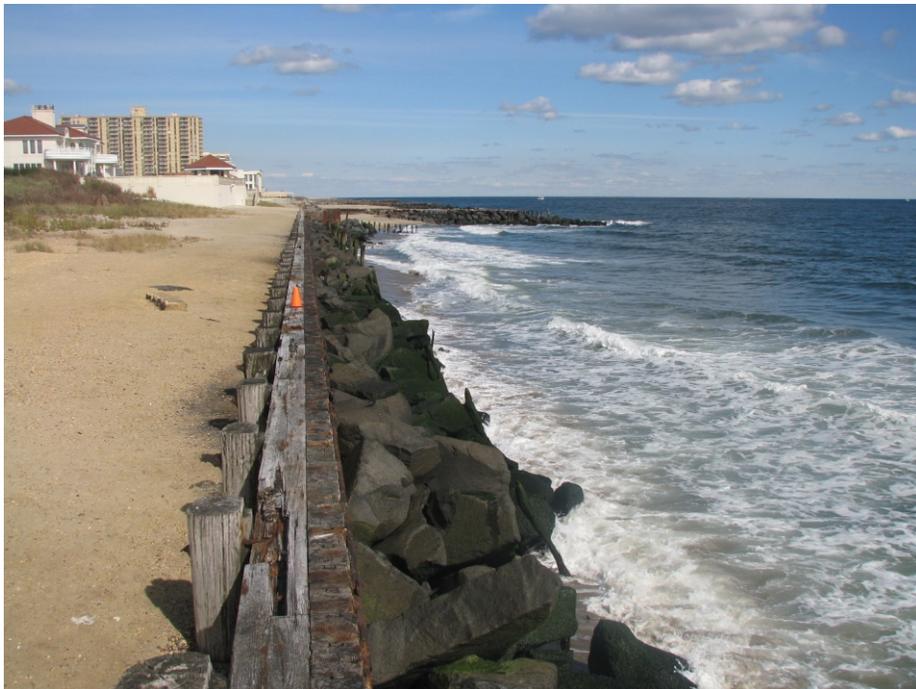
Photo taken October 14, 2009. View to the north at the bulkhead/revetment. There was no dry beach in 2009, in fact none has existed since the May 2008 survey.

Comparing the profiles over the eleven month time period, the profile location lost volume (-8.67 cu yd/ft) and the shoreline moved landward (-0.60 ft).

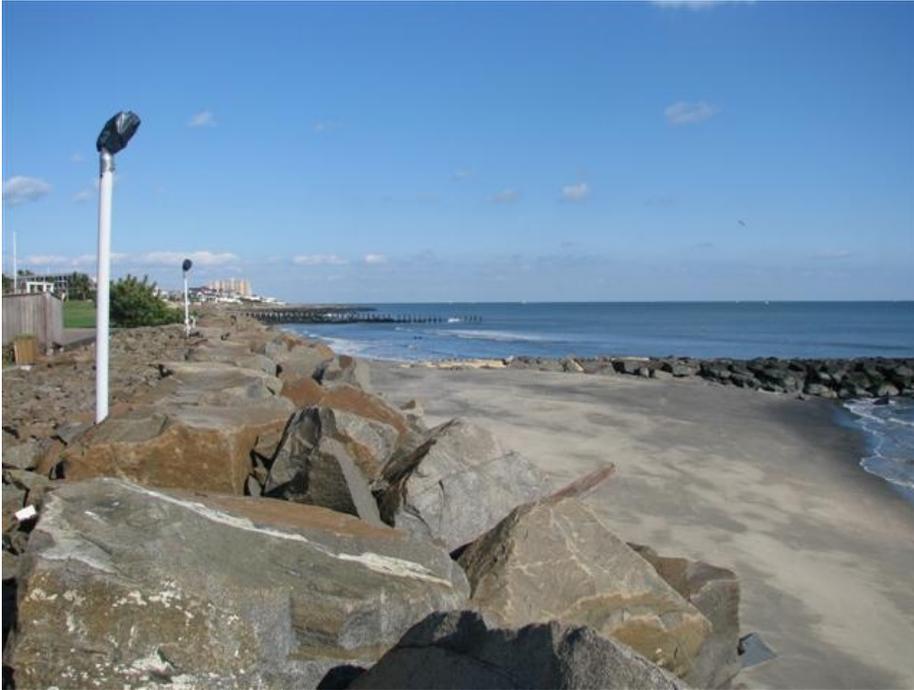
## ROOSEVELT AVENUE, DEAL - SITE 170

Photo taken November 10, 2008. View to the north.

This view to the north along the rock-armored shoreline of Deal shows a small sand pocket trapped against the northern groin in the cell. Sand shifts north to south within the cell, but little new material can move laterally along the shoreline. Groins every 700 to 1,000 feet make that impossible.

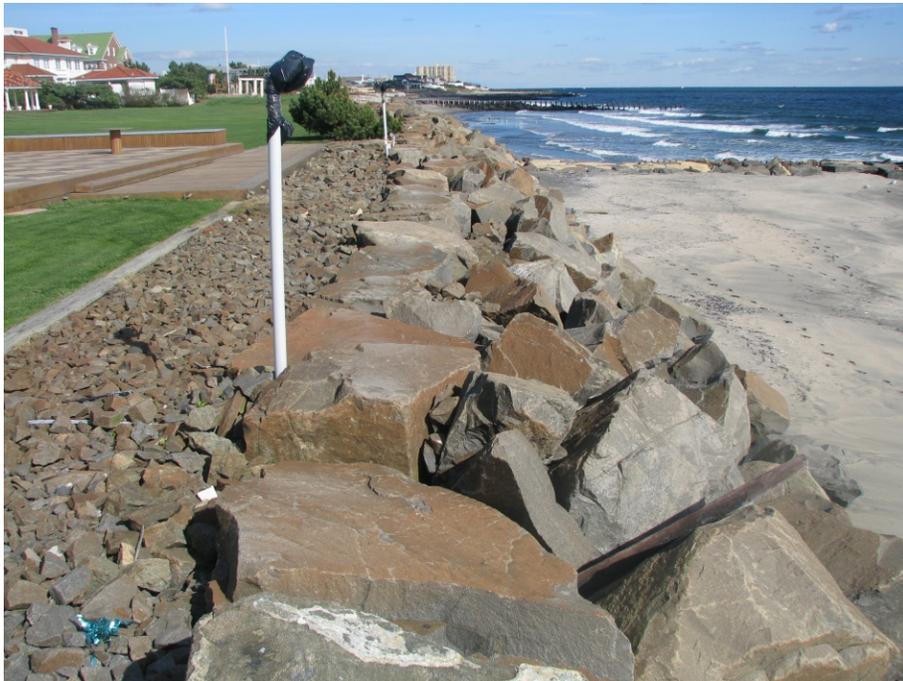
Photo taken October 14, 2009. View to the north.

Comparing the profiles over the eleven month time period, the profile location lost volume (-6.77 cu yd/ft) and the shoreline moved seaward (24.65 ft). The shoreline advanced seaward, but the sand volume declined because the losses offshore exceeded the deposition on the beach.

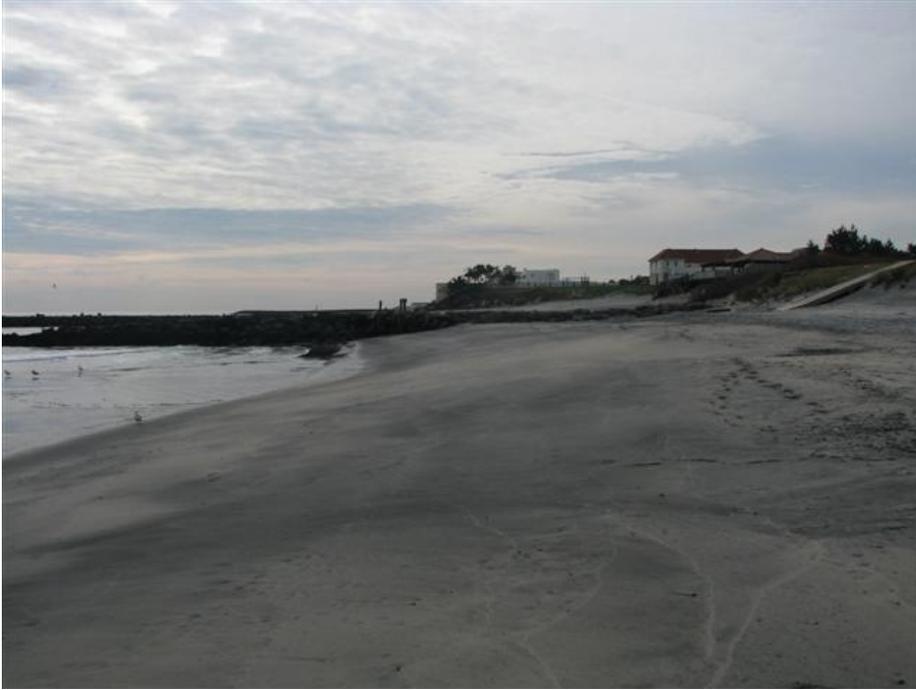
## DARLINGTON AVENUE, DEAL - SITE 169

Photo taken November 12, 2008. View to the south.

Darlington Avenue in Deal has the best preserved bluff shoreline anywhere along the Monmouth County coast. The beach berm protects the toe of the bluff. The sand had ramped up the slope and was vegetated. Recently, owners have placed rock along the toe of the bluff to the south of the line at Darlington Avenue.

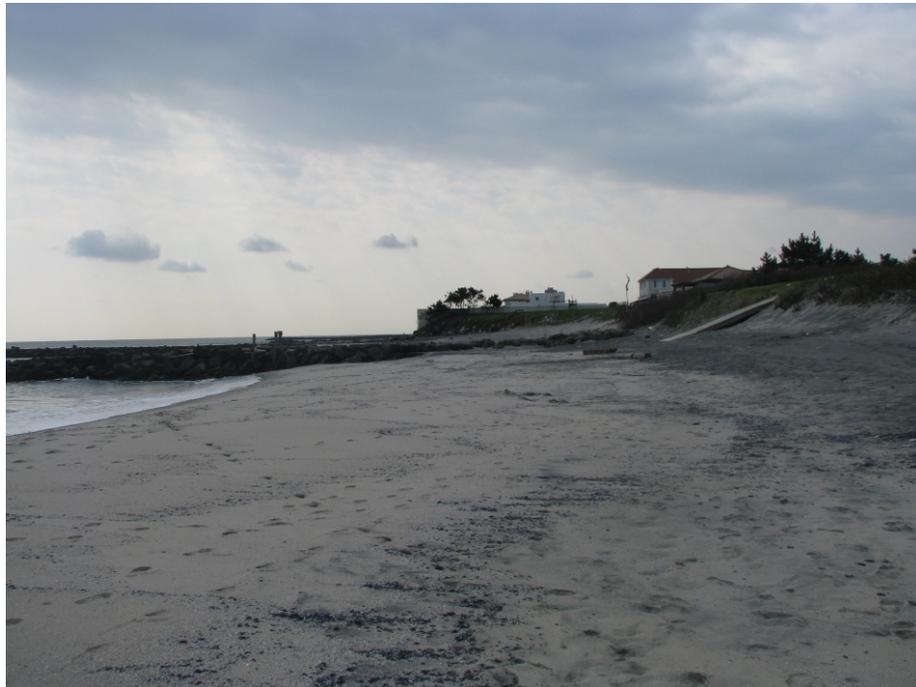
Photo taken October 13, 2009. View to the south.

Comparing the profiles over the one-year time period, the profile location lost volume (-9.68 cu yd/ft) and the shoreline moved seaward (0.26 ft).
