## New Jersey Beach Profile Network 2009 Annual Report on Shoreline Changes in New Jersey Coastal Reaches One Through Fifteen Raritan Bay to Delaware Bay

The Richard Stockton Coastal Research Center  
Richard Stockton College of New Jersey  
30 Wilson Avenue, Port Republic, NJ 08241

June 30, 2010

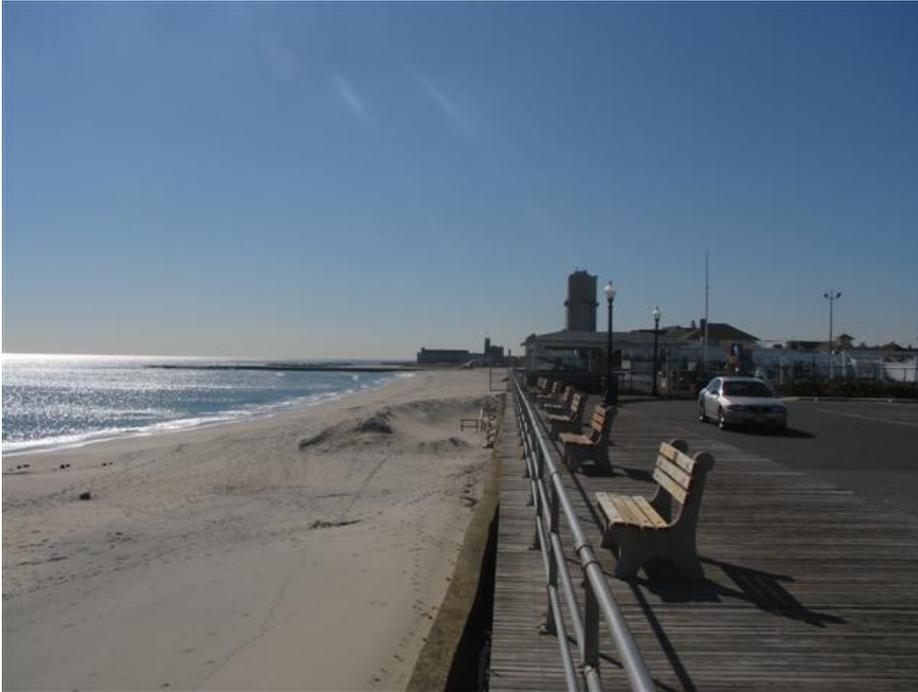
## CORLIES AVENUE, ALLENHURST - SITE 168

Photo taken October 31, 2008. View to the south.

The Allenhurst beach is located in front of an old concrete seawall built to protect the easily eroded bluff years ago. It has survived many storms. The beach was wider than it had been in decades due to sand escape from the groin seen to the south that retains the Asbury Park section of the Federal fill. For some reason neither Loch Arbor (a one-block wide oceanfront community) nor Allenhurst chose to participate in the US Army Corps Monmouth County project. However, the tendency for sand to move north along this part of the NJ coastline has provided a boost to both community beaches.

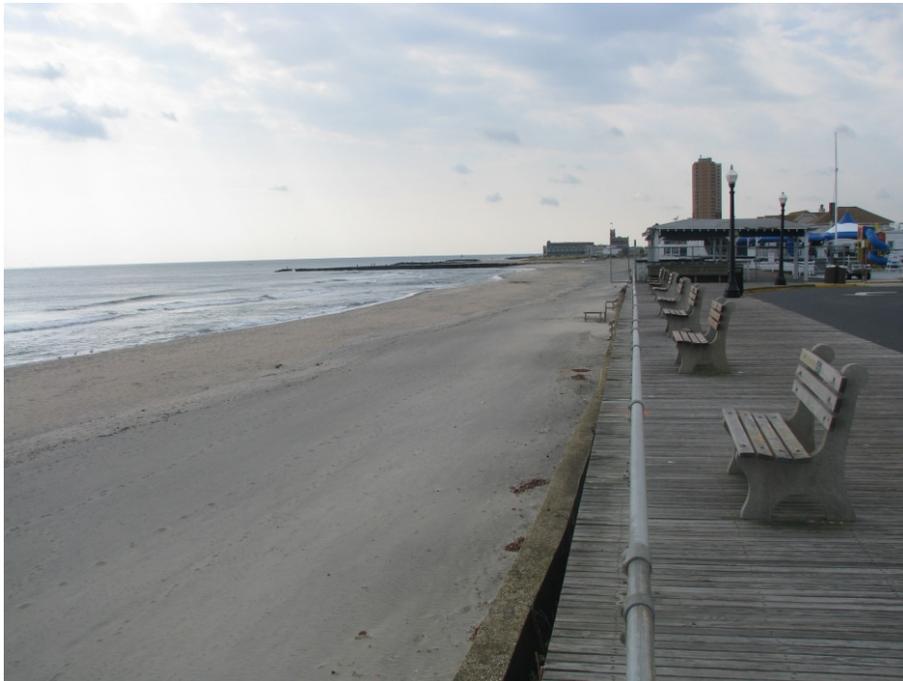
Photo taken October 13, 2009. View to the south.

Comparing the profiles over the one-year time period, the profile location gained volume (14.01 cu yd/ft) and the shoreline moved seaward (34.39 ft).

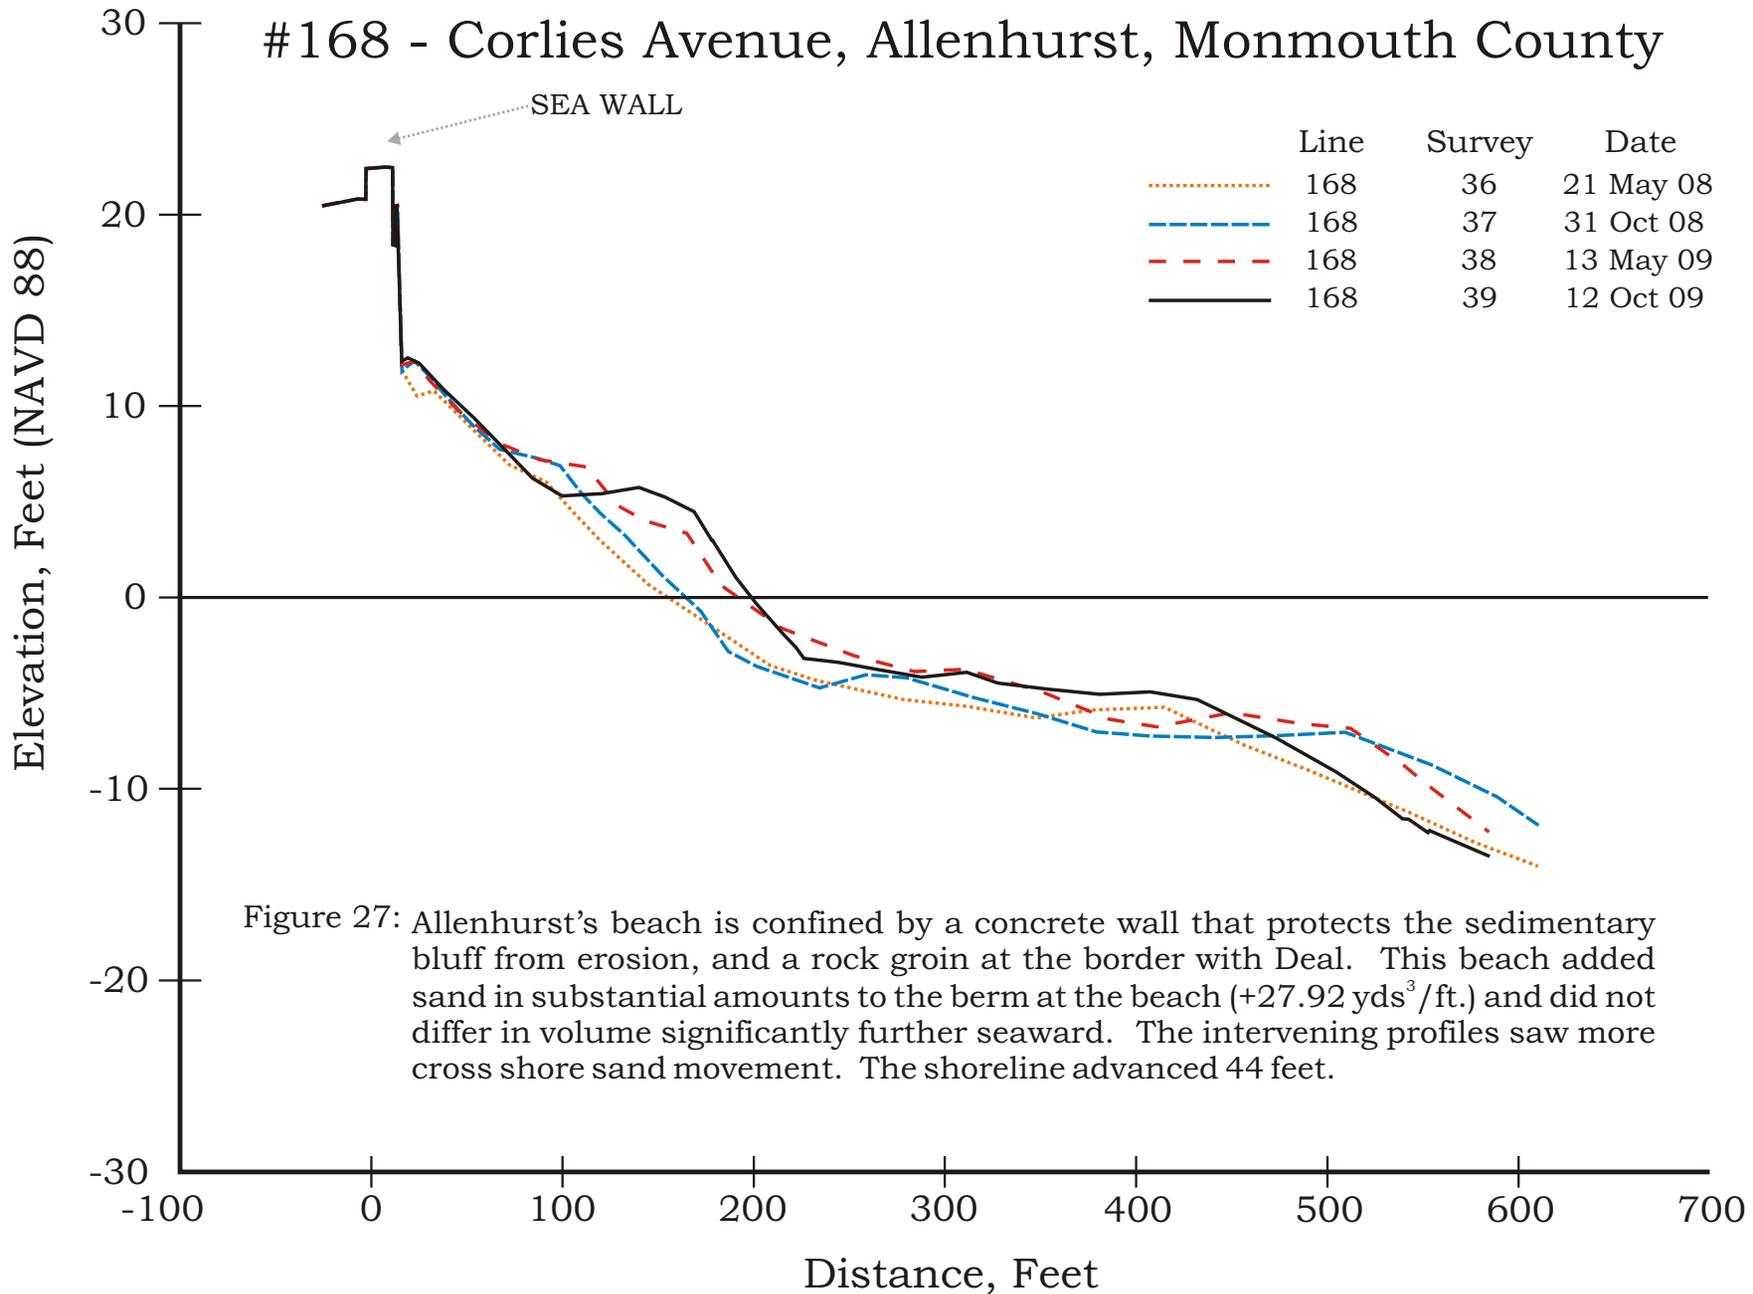
#168 - Corlies Avenue, Allenhurst, Monmouth County

Figure 27: Allenhurst's beach is confined by a concrete wall that protects the sedimentary bluff from erosion, and a rock groin at the border with Deal. This beach added sand in substantial amounts to the berm at the beach (+27.92 yds<sup>3</sup>/ft.) and did not differ in volume significantly further seaward. The intervening profiles saw more cross shore sand movement. The shoreline advanced 44 feet.

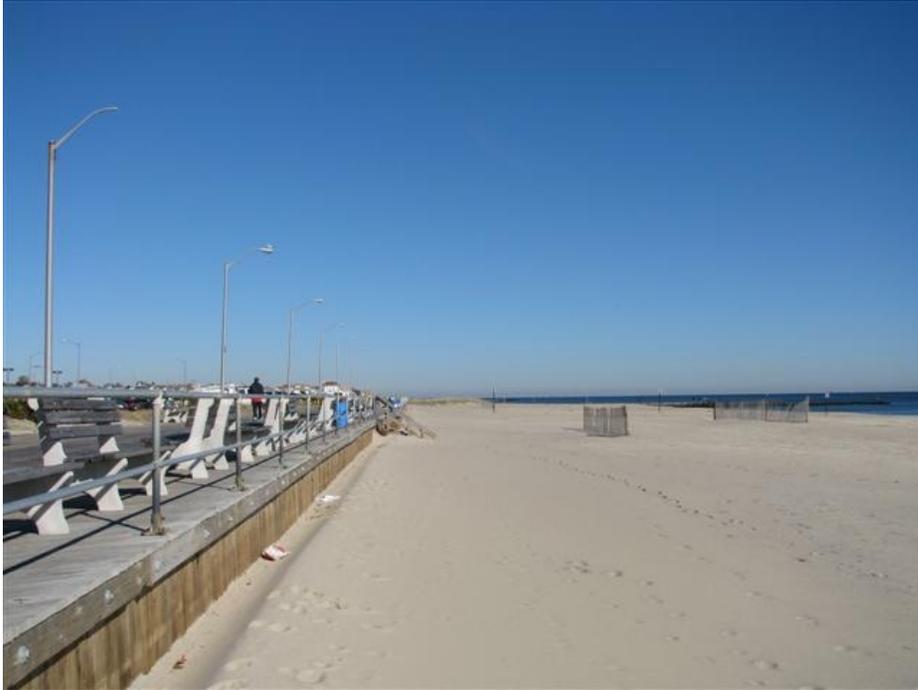
## 7th AVENUE, ASBURY PARK - SITE 267

Photo taken October 31, 2008. View to the north.

Located at the northern end of the south segment of the Monmouth County project, this Asbury Park beach has retained most of the initial deposit of sand. No maintenance has been done since completion in 1999. There is a large terminal groin between Asbury Park and Loch Arbor that some sand has moved around in the last decade, but not enough to be any detriment to the Asbury Park beach.

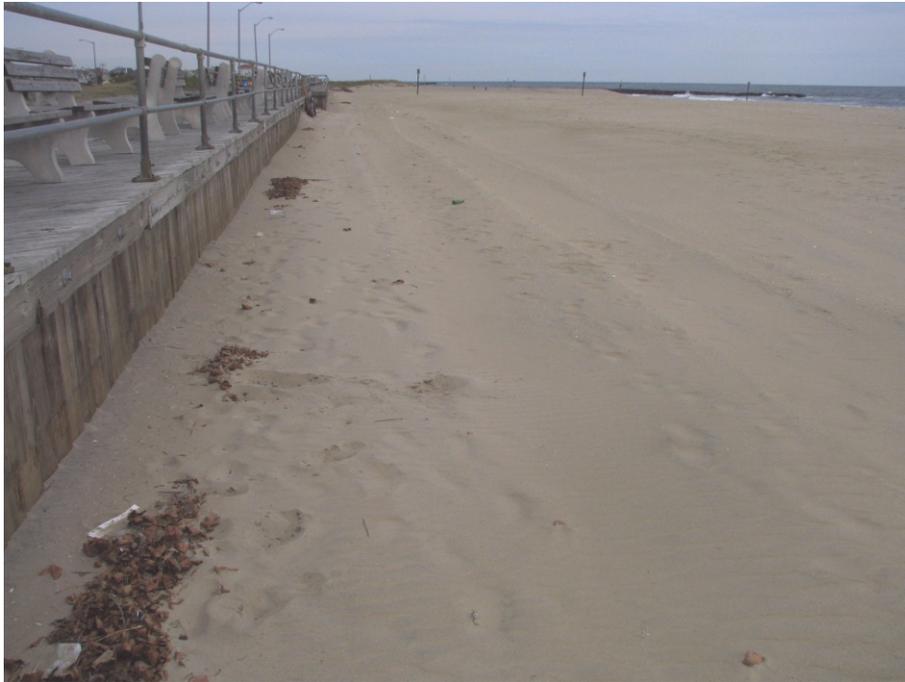
Photo taken October 12, 2009. View to the north.

Comparing the profiles over the one-year time period, the profile location gained volume (11.94 cu yd/ft) and the shoreline moved seaward (18.54 ft).

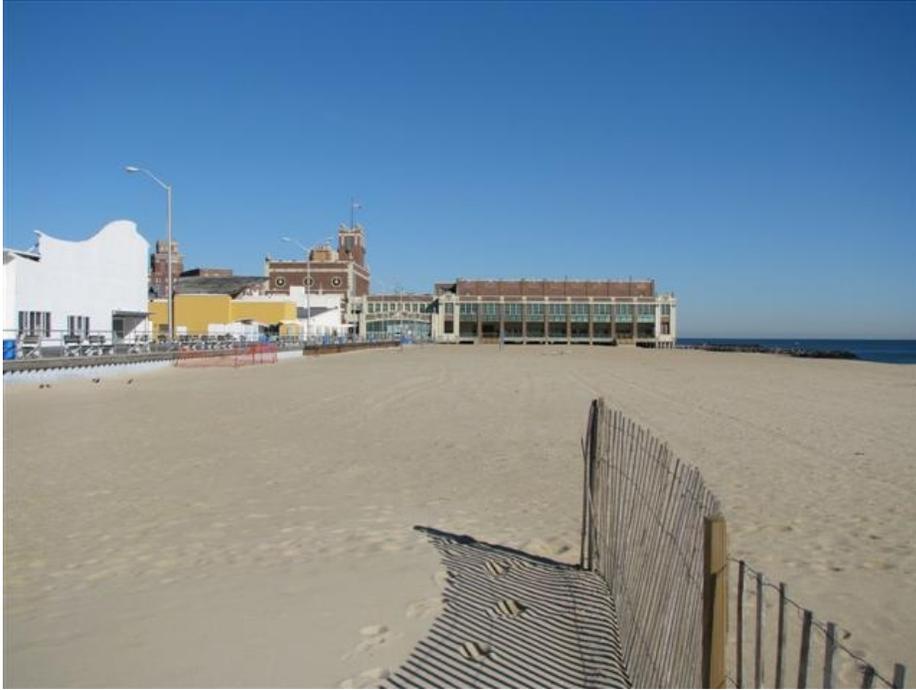
## 3<sup>rd</sup> AVENUE, ASBURY PARK - SITE 167

Photo taken October 31, 2008. View to the north.

The middle of the Asbury Park beach is wide and very flat with no dune. The recreational use precludes a natural dune from forming and no municipal work was done to force a dune to grow near the boardwalk.

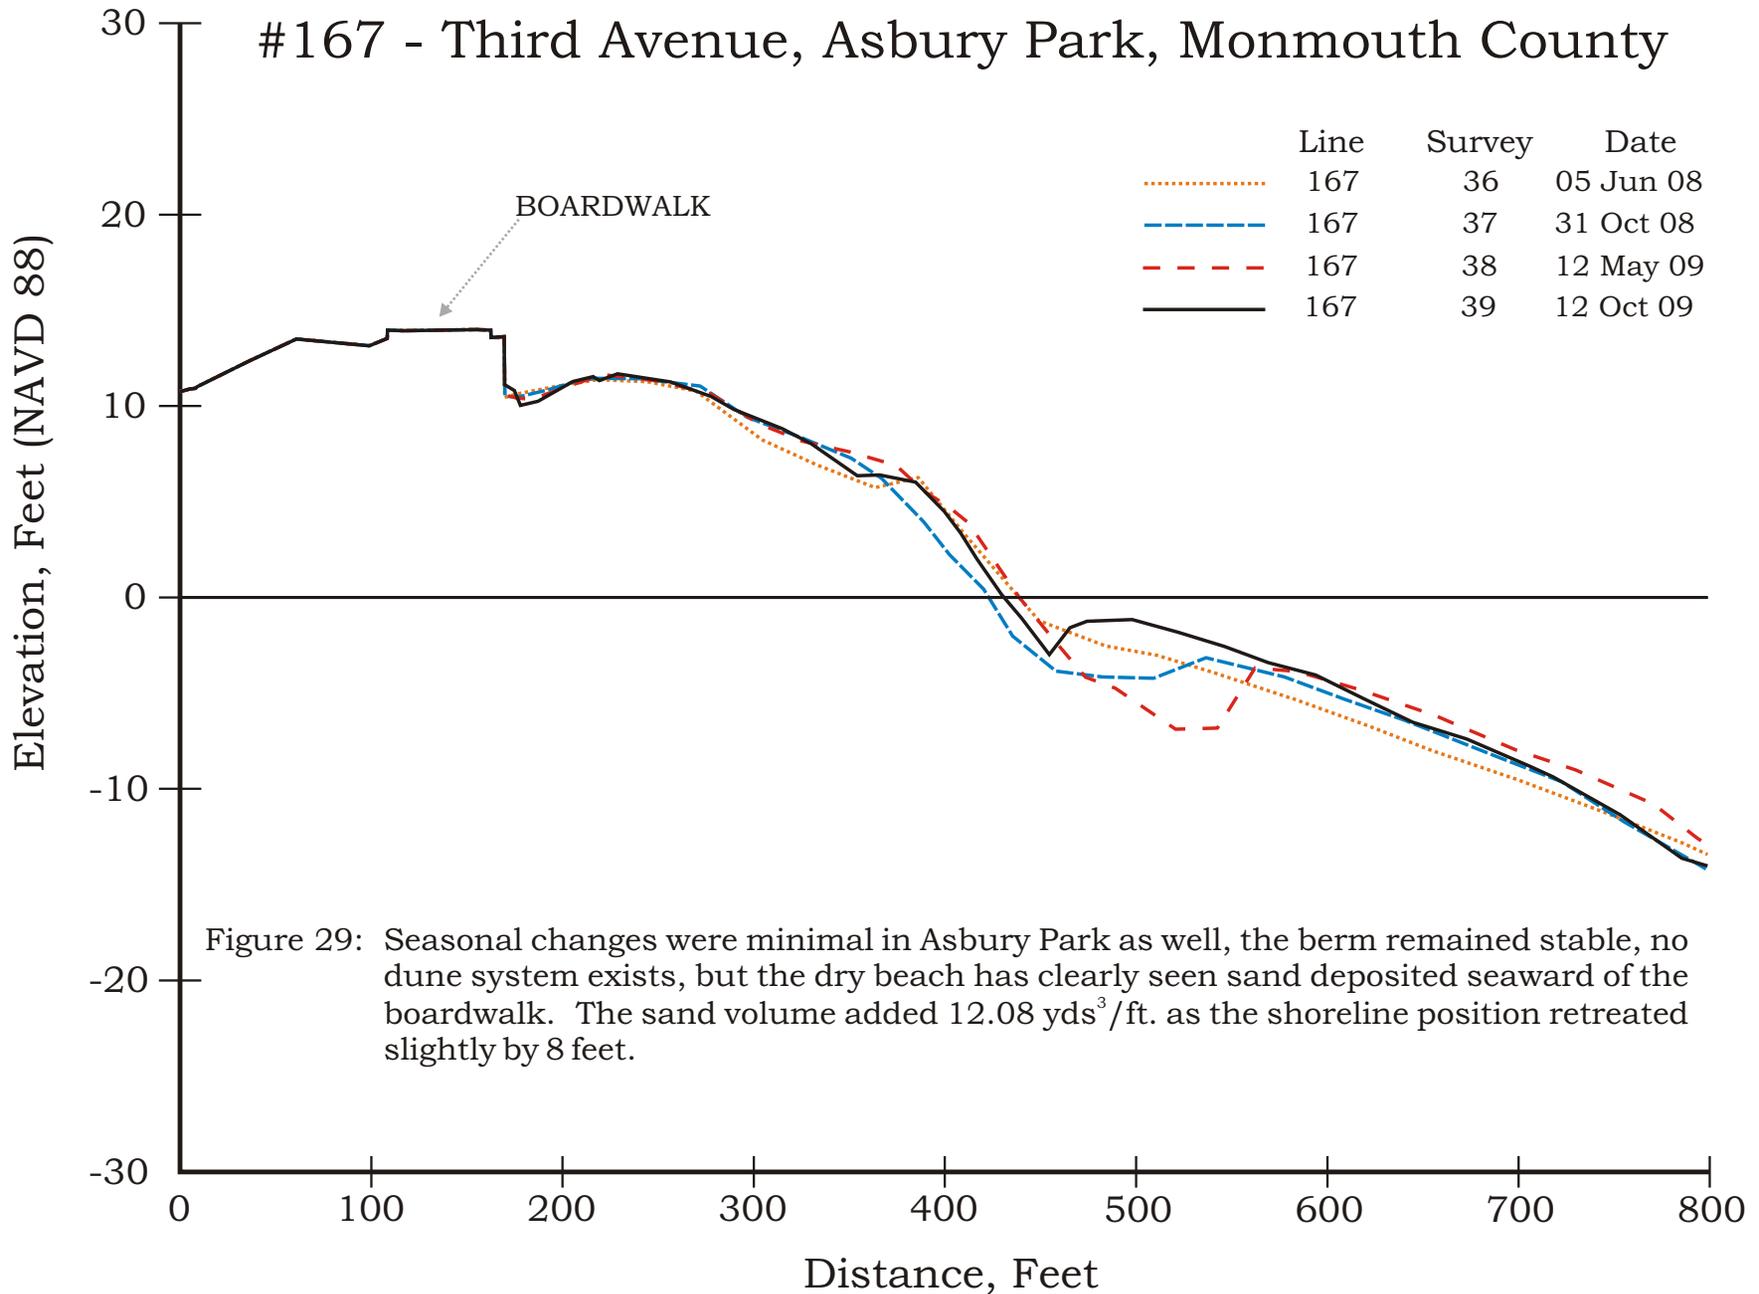
#167 - Third Avenue, Asbury Park, Monmouth County

Figure 29: Seasonal changes were minimal in Asbury Park as well, the berm remained stable, no dune system exists, but the dry beach has clearly seen sand deposited seaward of the boardwalk. The sand volume added 12.08 yds<sup>3</sup>/ft. as the shoreline position retreated slightly by 8 feet.

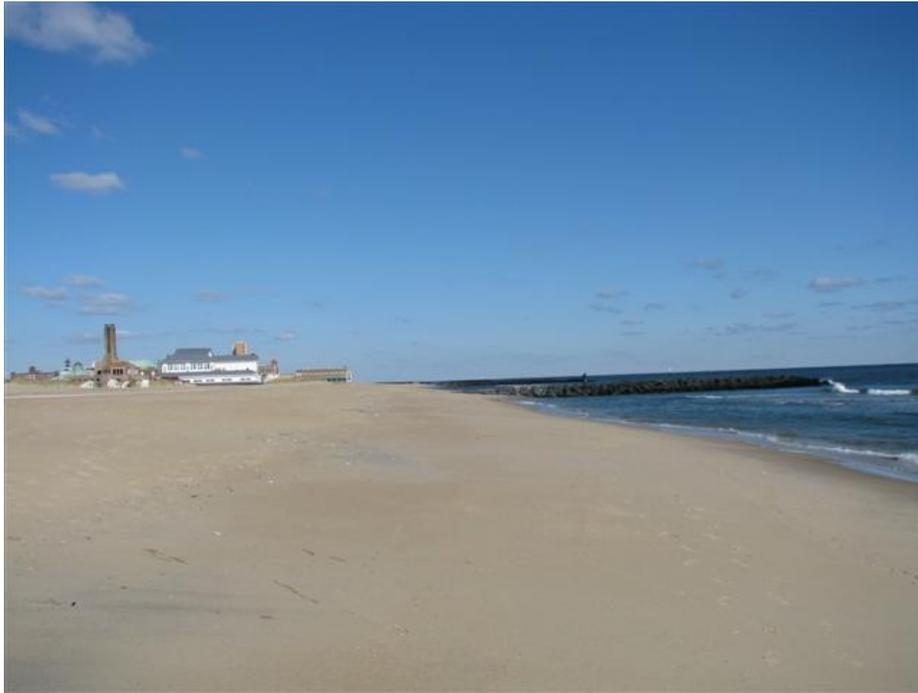
## OCEAN PATHWAY, OCEAN GROVE - SITE 166

Photo taken October 30, 2008. View to the north.

Ocean Grove has an equally wide beach as Asbury Park, but took steps to create a dune between the beach and the boardwalk.

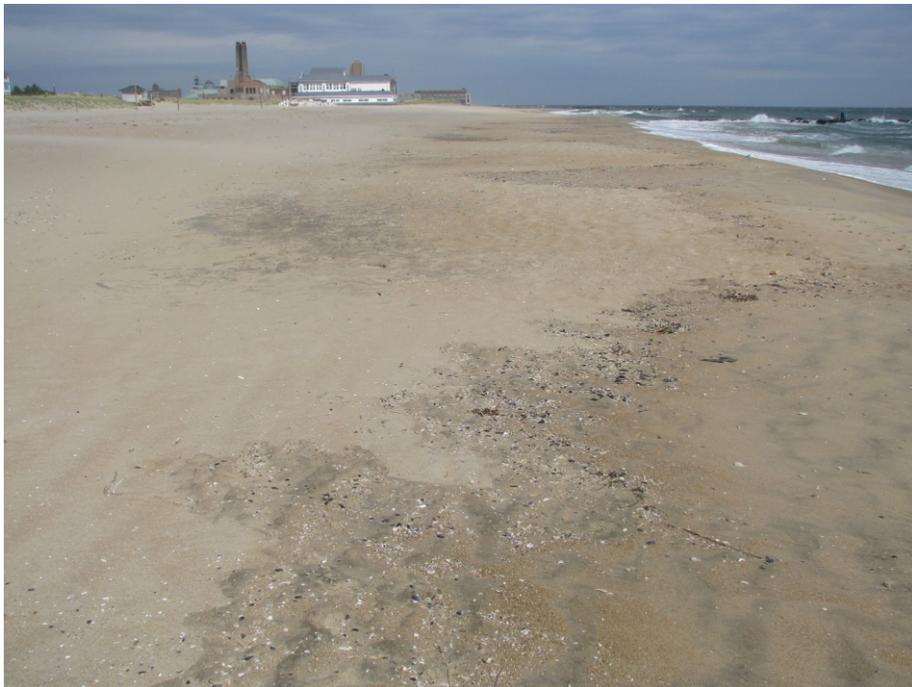
Photo taken October 9, 2009. View to the north.

Comparing the profiles over the one-year time period, the profile location lost volume (-9.16 cu yd/ft) but the shoreline moved seaward (7.54 ft).

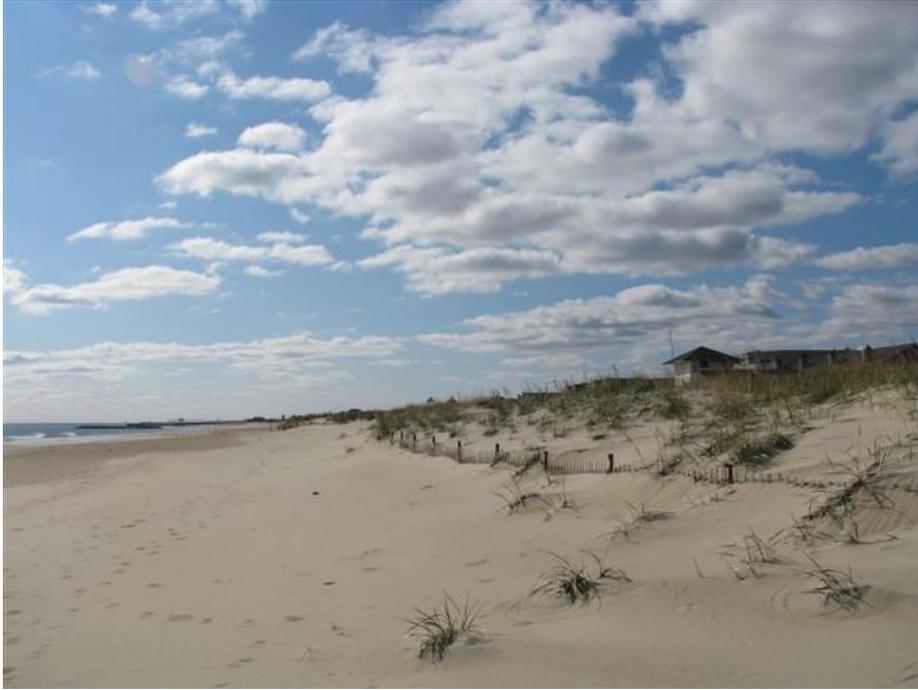
Photo taken October 30, 2008. View to the south.

This location is far different from what it was in 1996 before the beach fill. The first step the community made was to pull the boardwalk back off the beach and replace it with a paver promenade on the top of the bluff between Ocean Avenue and the boardwalk. This provided an additional 40 feet of badly needed beach width. By October 2008, the dune was well developed where the boardwalk once was and the filled beach extended 235 feet further seaward to the berm.

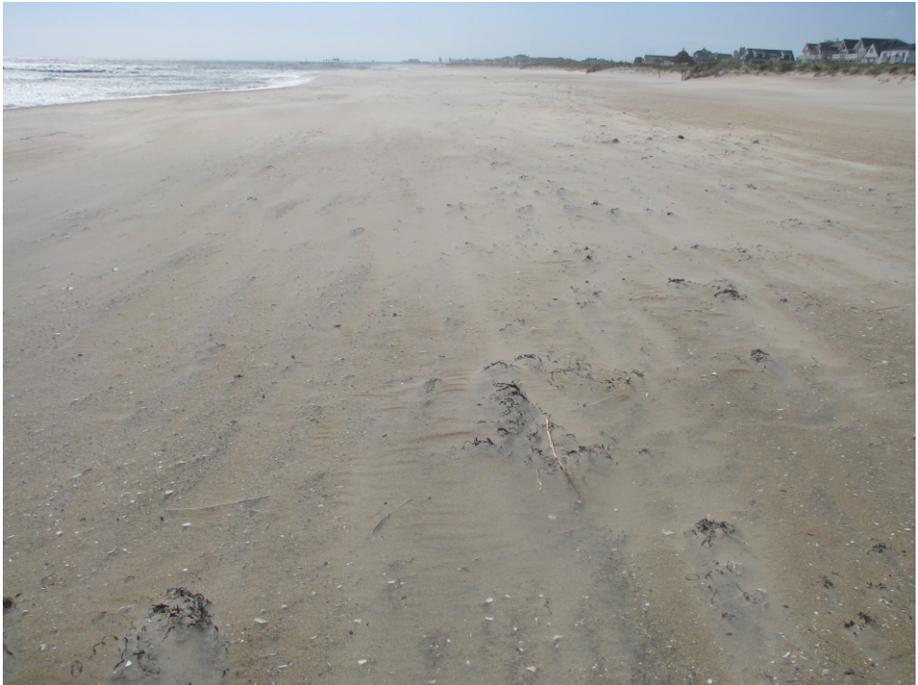
Photo taken October 9, 2009. View to the south.

Comparing the profiles over the one-year time period, the profile location gained volume (7.11 cu yd/ft) and the shoreline moved seaward (13.06 ft). The Federal project has provided this community with a new sense of beach resort pride.

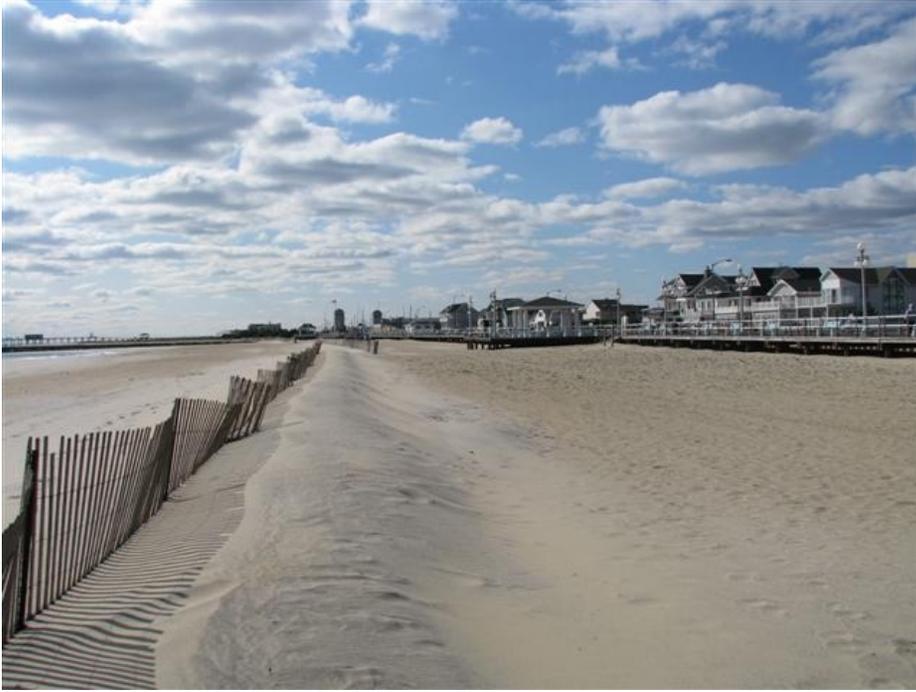
## SYLVANIA AVENUE, AVON BY THE SEA - SITE 164

Photo taken October 30, 2008. View to the south.

This photo shows the beach just north of the Shark River Inlet. This is the most significant barrier to the free movement of sand along this southern Monmouth County fill segment. No dune was built along this community's shoreline so all the fill-widened beach is available for blankets in the summer. The sand fence shown is a winter-only installation designed to avoid developing a permanent dune.

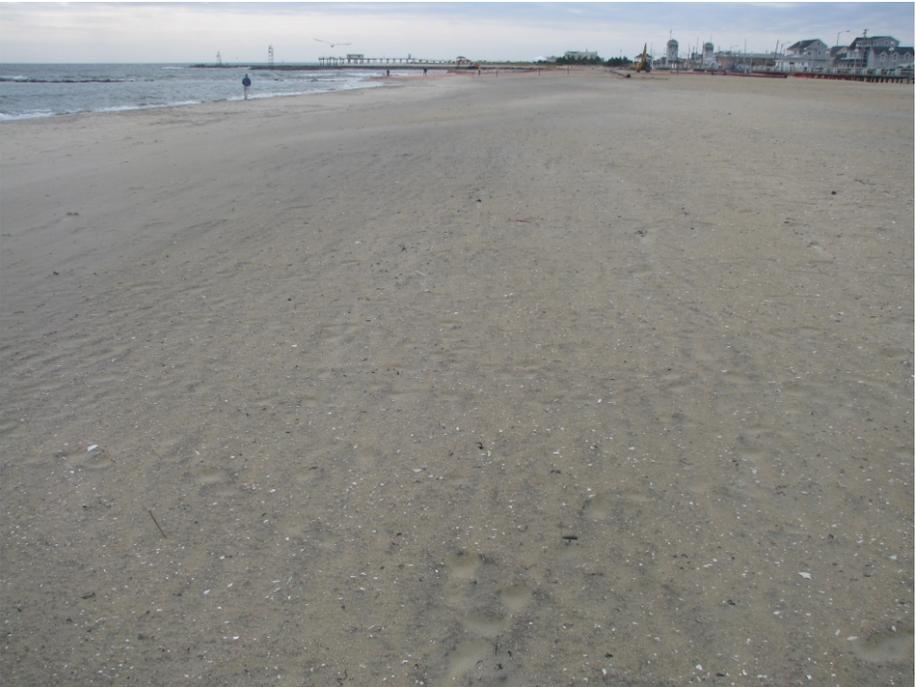
Photo taken October 9, 2009. View to the south.

Comparing the profiles over the one-year time period, the profile location lost volume (-6.1 cu yd/ft) and the shoreline moved landward (-5.49 ft).

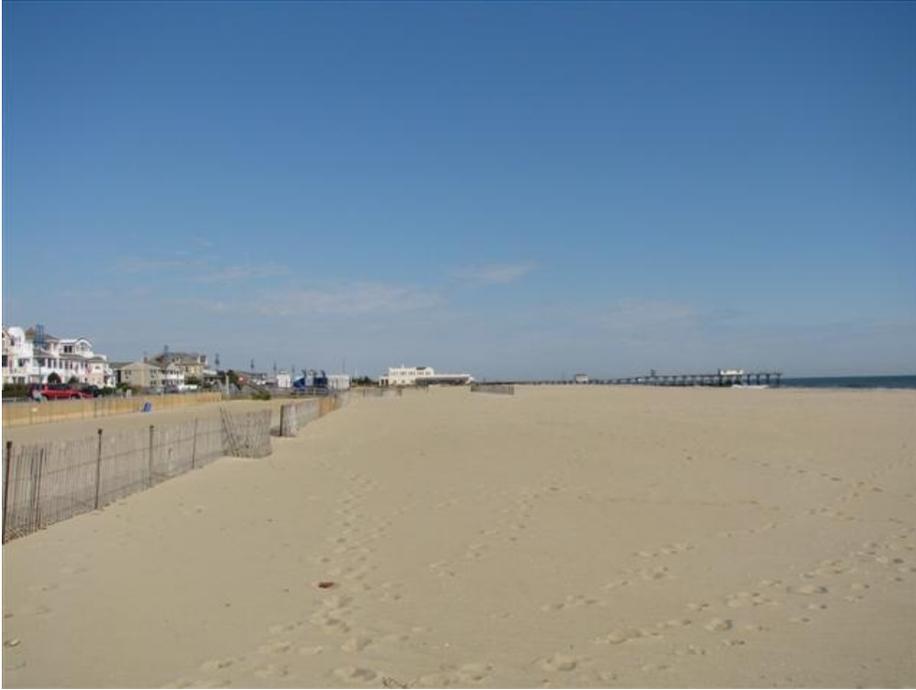
## 5<sup>th</sup> AVENUE, BELMAR - SITE 163

Photo taken October 21, 2008. View to the north.

The northern Belmar beach lies just south of the Shark River Inlet and has historically trapped sand moving north. This photograph illustrates the 350-foot wide, flat beach with a token dune just east of the boardwalk. The fencing is a winter-only installation designed to capture sand on the beach and not on the boardwalk or Ocean Avenue.

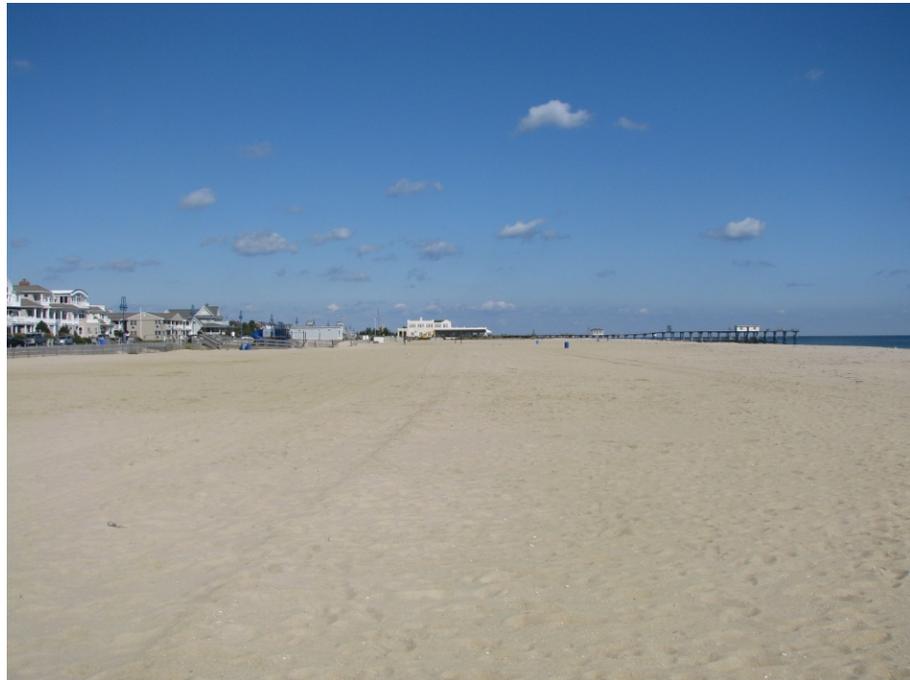
Photo taken October 5, 2009. View to the north.

Comparing the profiles over the one-year time period, the profile location lost volume (-0.75 cu yd/ft) and the shoreline moved landward (-28.86 ft).

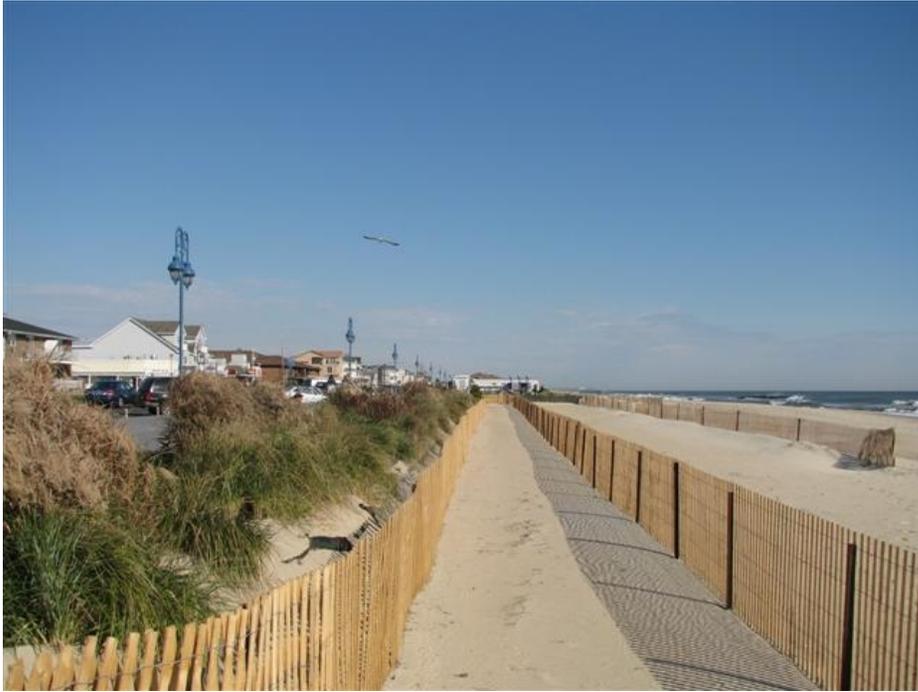
## 18<sup>th</sup> AVENUE, BELMAR - SITE 162

Photo taken October 21, 2008. View to the north.

In southern Belmar the beach is a little narrower, but the “dune” represents a landscaping endeavor. In 2008 the municipality erected three lines of sand fencing in an effort to reduce sand transport onto Ocean Avenue, the boardwalk and the decorative planting that constitutes the City’s dune system.

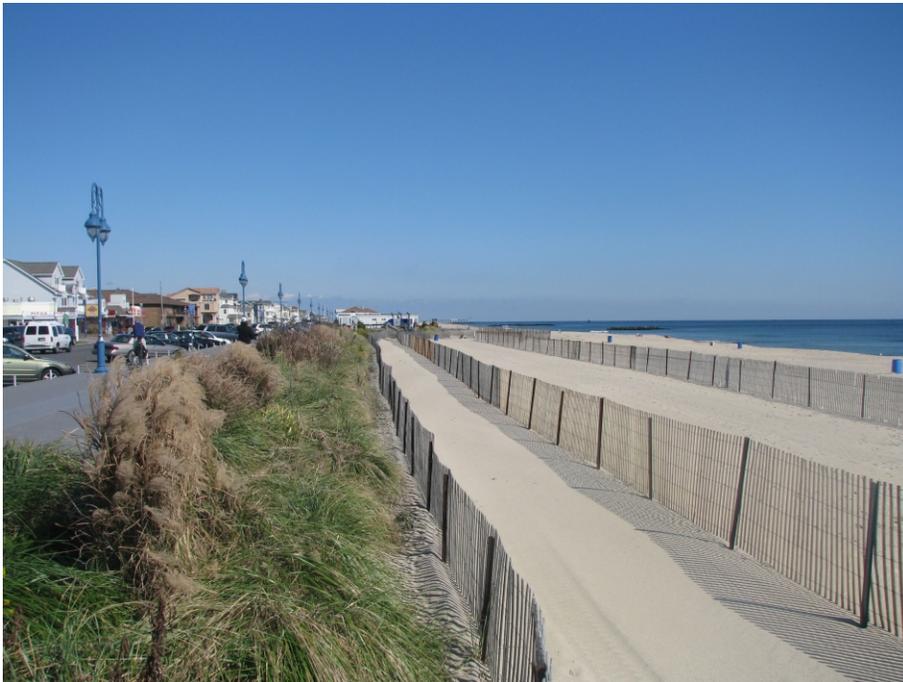
Photo taken October 5, 2009. View to the north.

Comparing the profiles over the one-year time period, the profile location gained volume (1.68 cu yd/ft) but the shoreline moved landward (-14.67 ft). The fencing is back in place for the next winter season.

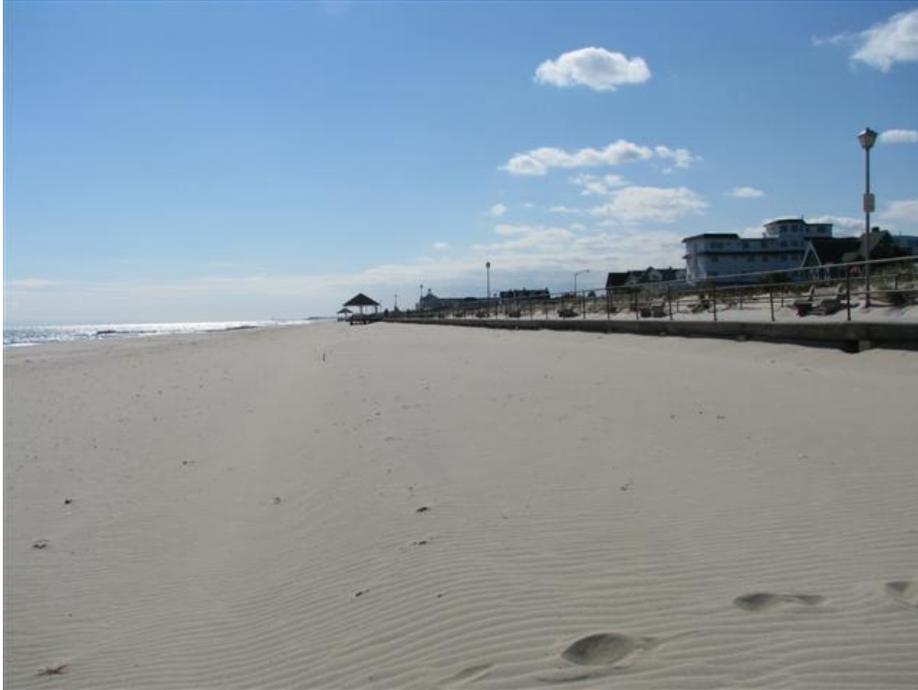
## BRIGHTON AVENUE, SPRING LAKE - SITE 161

Photo taken October 17, 2008. View to the south.

The Spring Lake beach always had a dune located between the boardwalk and Ocean Avenue. This feature has grown larger since the Federal project was completed and a deep trough between the dune and the landward side of the boardwalk filled in with sand.

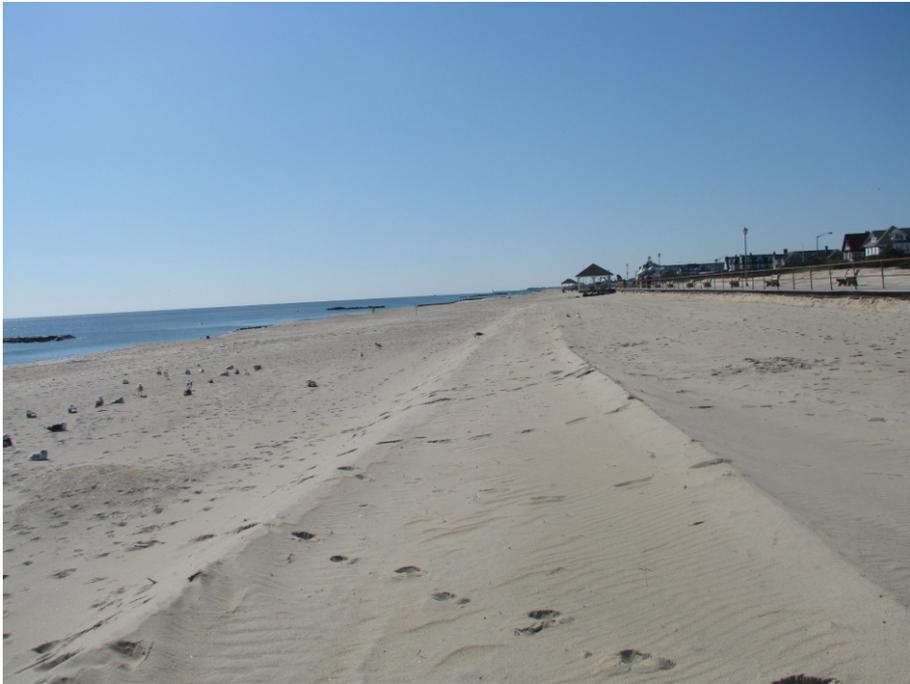
Photo taken October 5, 2009. View to the south.

Comparing the profiles over the one-year time period, the profile location gained volume (4.23 cu yd/ft) and the shoreline moved seaward (7.26 ft).

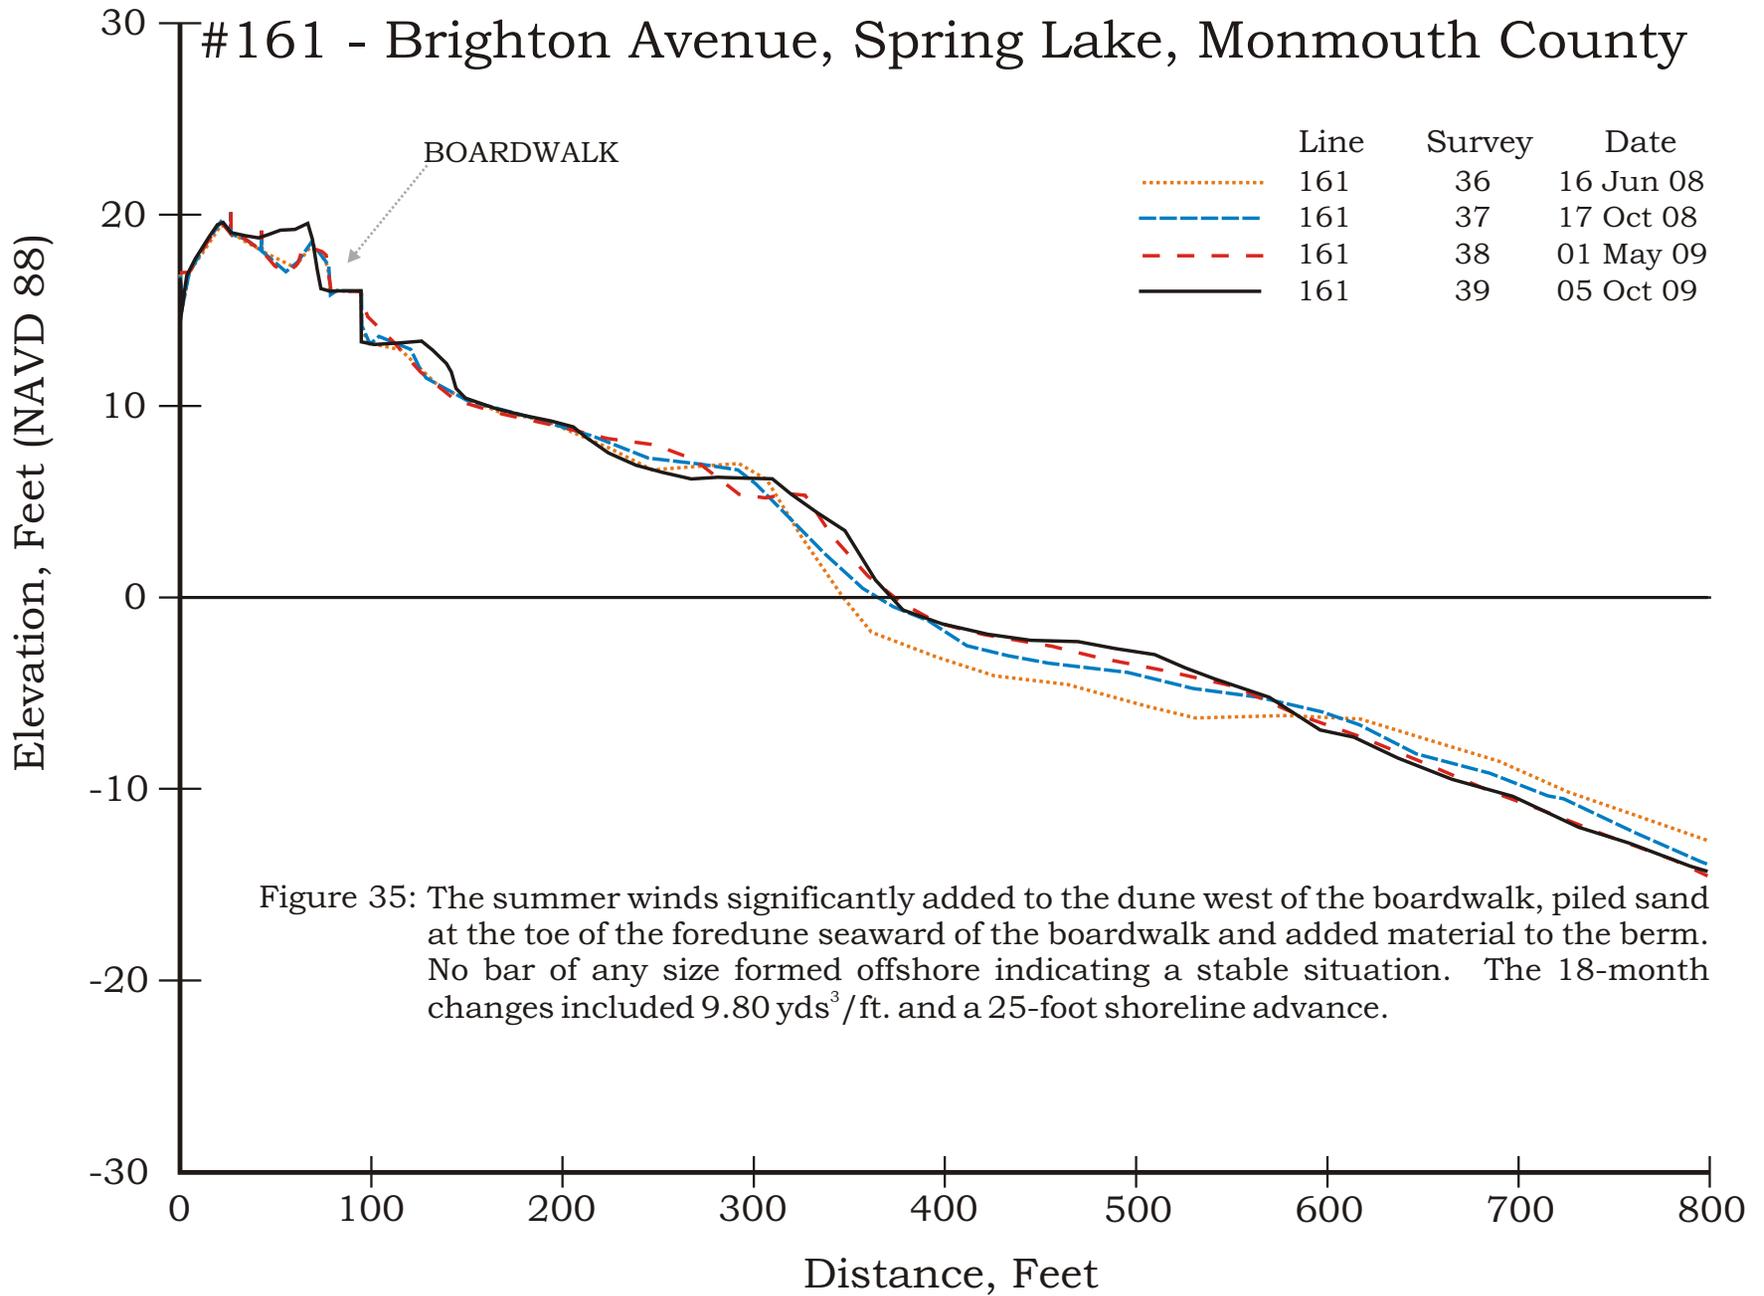
#161 - Brighton Avenue, Spring Lake, Monmouth County

Figure 35: The summer winds significantly added to the dune west of the boardwalk, piled sand at the toe of the foredune seaward of the boardwalk and added material to the berm. No bar of any size formed offshore indicating a stable situation. The 18-month changes included 9.80 yds<sup>3</sup>/ft. and a 25-foot shoreline advance.

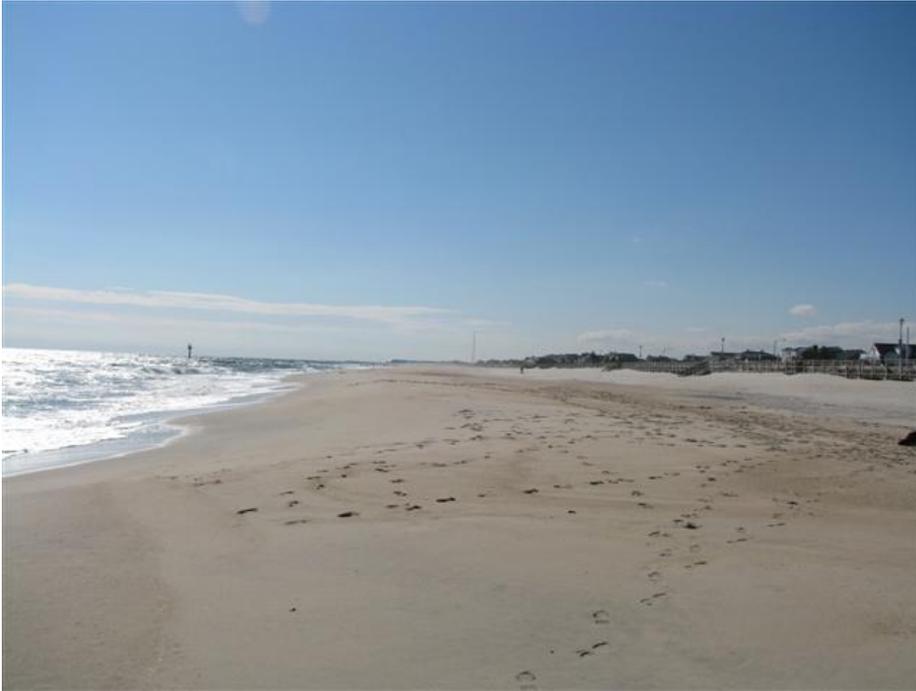
## SALEM AVENUE, SPRING LAKE - SITE 160

Photo taken October 17, 2008. View to the south. The beach restoration project dramatically changed the southern Monmouth County beaches by increasing their width by 200%.

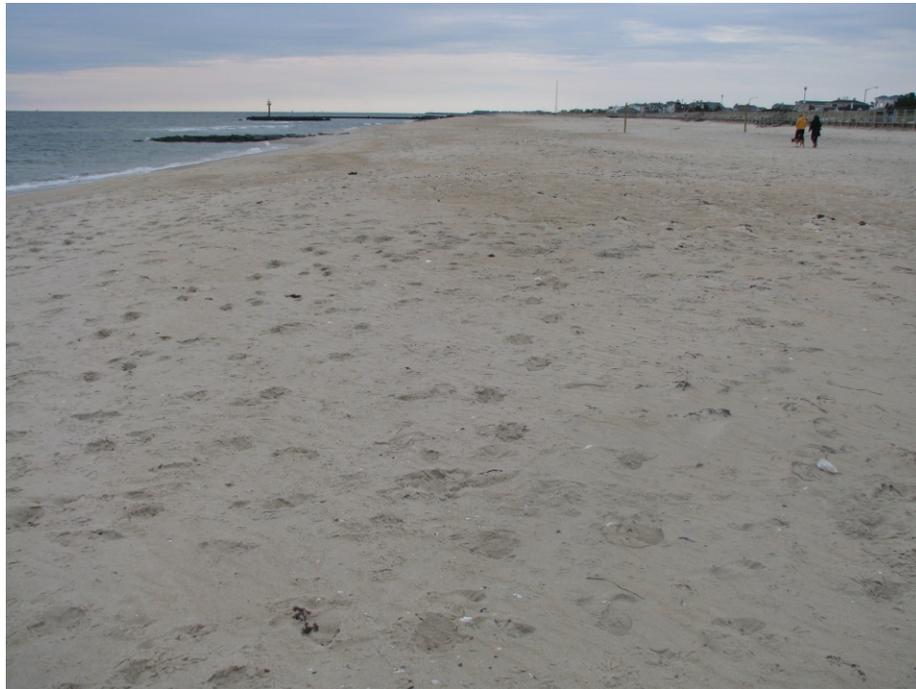
Photo taken October 2, 2009. View to the south.

Comparing the profiles over the one-year time period, the profile location gained volume (6.28 cu yd/ft) and the shoreline moved seaward (10.7 ft).

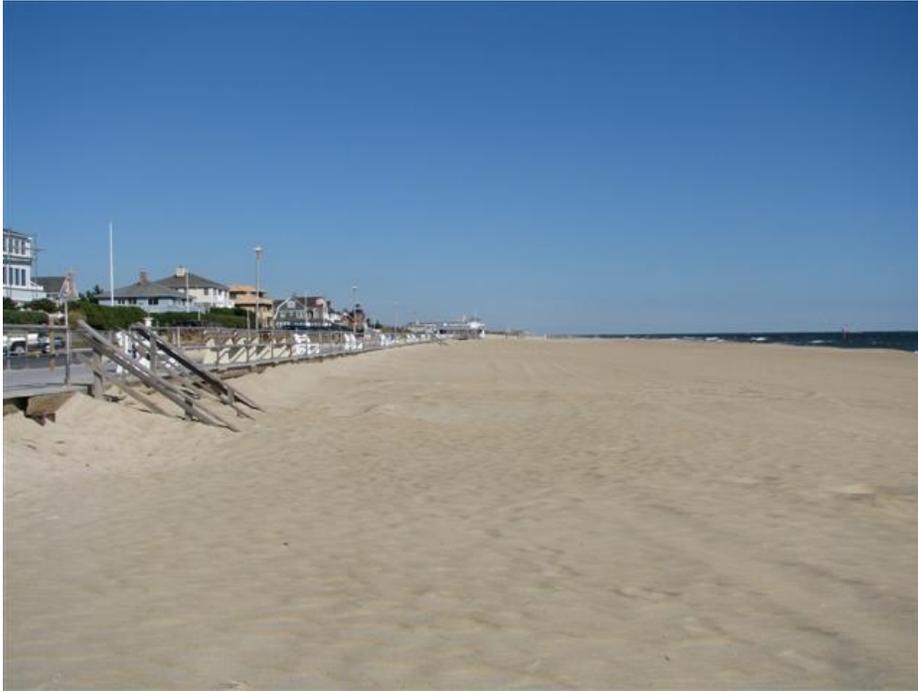
## NEW YORK AVENUE, SEA GIRT - SITE 159

Photo taken October 17, 2008. View to the north.

New York Avenue is located in the public recreational section of the Sea Girt shoreline. This view shows the beach and boardwalk. The dune has yet to be constructed due to conflict over design and issues with the NJDEP. These issues continue to block dune establishment.

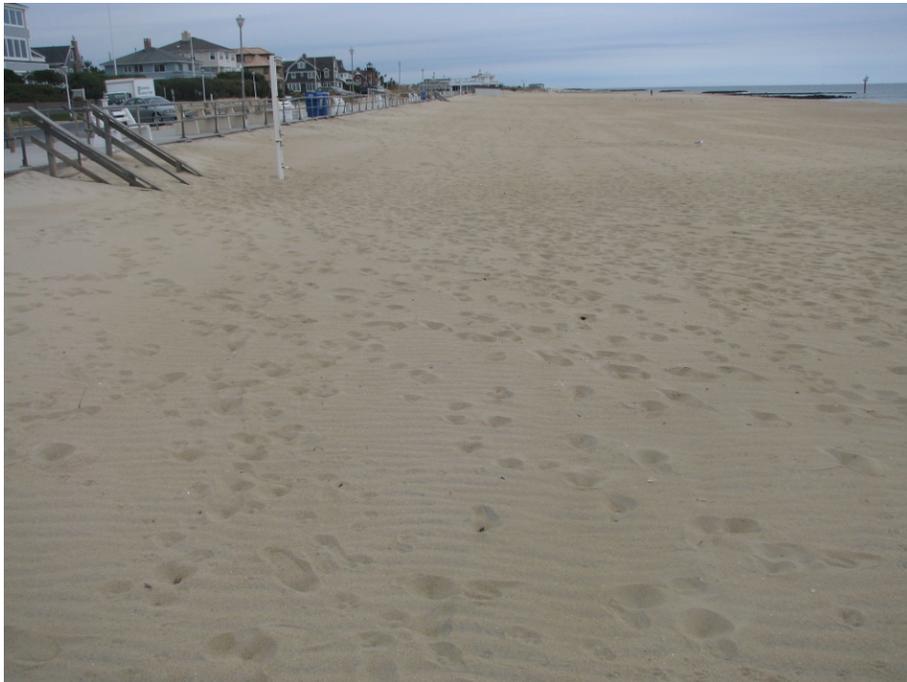
Photo taken October 2, 2009. View to the north.

Comparing the profiles over the one-year time period, the profile location gained volume (13.25 cu yd/ft) but the shoreline moved landward (-3.19 ft).

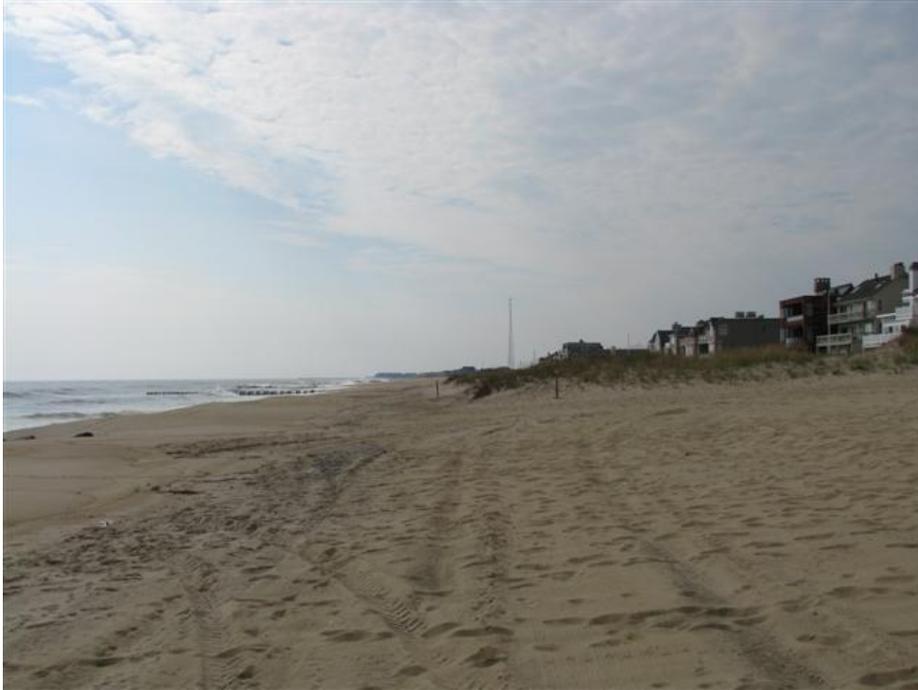
## TRENTON AVENUE, SEA GIRT - SITE 158

Photo taken October 16, 2008. View to the south.

The Trenton Avenue site is near the southern boundary of Sea Girt and the NJ State Police training center between Sea Girt and Manasquan. The beach width is substantial as this view shows. The boardwalk has large dunes between it and the uplands bluff that was last touched by storm erosion during the December 1992 event. Since then the Federal beach restoration project has allowed accretion of dunes and the growth of grass reaching seaward of the elevated boardwalk.
