## New Jersey Beach Profile Network 2009 Annual Report on Shoreline Changes in New Jersey Coastal Reaches One Through Fifteen Raritan Bay to Delaware Bay

The Richard Stockton Coastal Research Center  
Richard Stockton College of New Jersey  
30 Wilson Avenue, Port Republic, NJ 08241

June 30, 2010

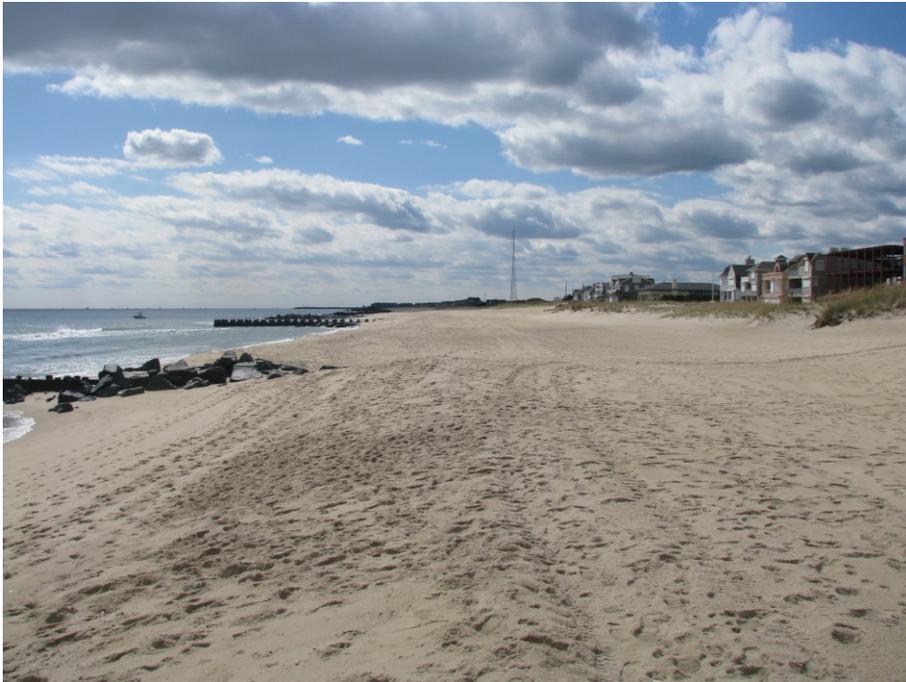
Photo taken October 1, 2009. View to the south.

Comparing the profiles over the one-year time period, the profile location gained volume (17.76 cu yd/ft) but the shoreline moved landward (-5.57 ft). The rock groins are more exposed in 2009 than they were a year earlier.

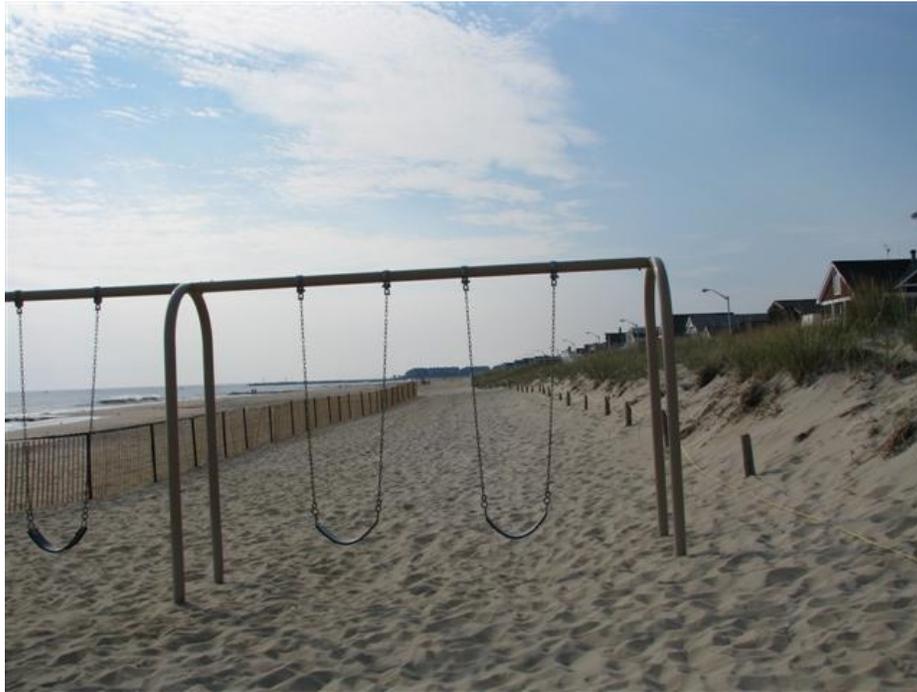
## RIDDLE WAY, MANASQUAN - SITE 157

Photo taken October 26, 2008. View to the south.

Located in the middle of the Manasquan shoreline, Riddle Way has a dune that dates from after the December 1992 storm. The community erected straight line sand fence to capture winter sand transport on the beach rather than in the dunes.

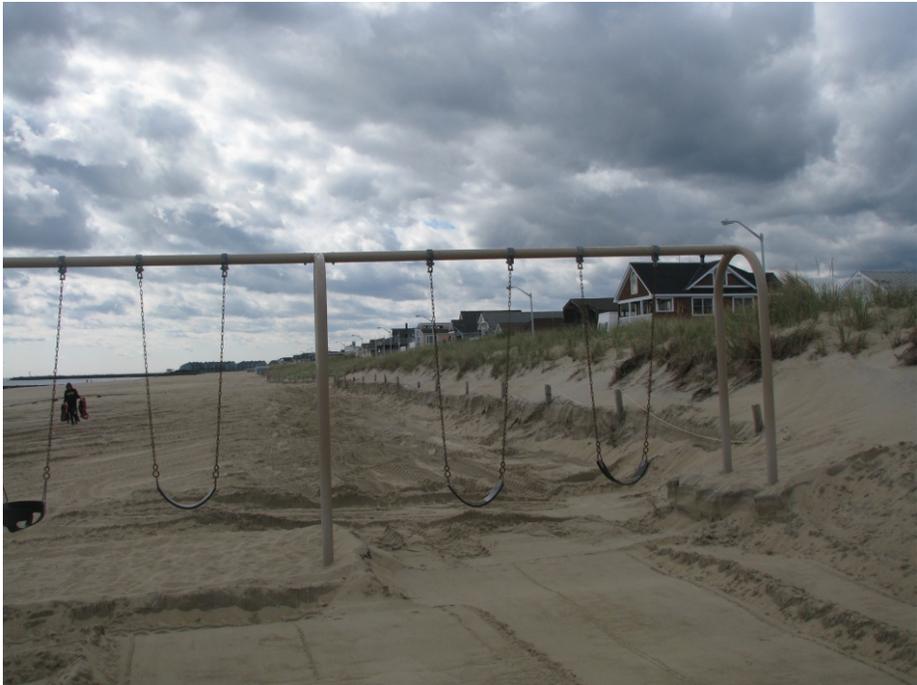
Photo taken October 1, 2009. View to the south.

Comparing the profiles over the one-year time period, the profile location gained volume (10.81 cu yd/ft) and the shoreline moved seaward (3.27 ft).

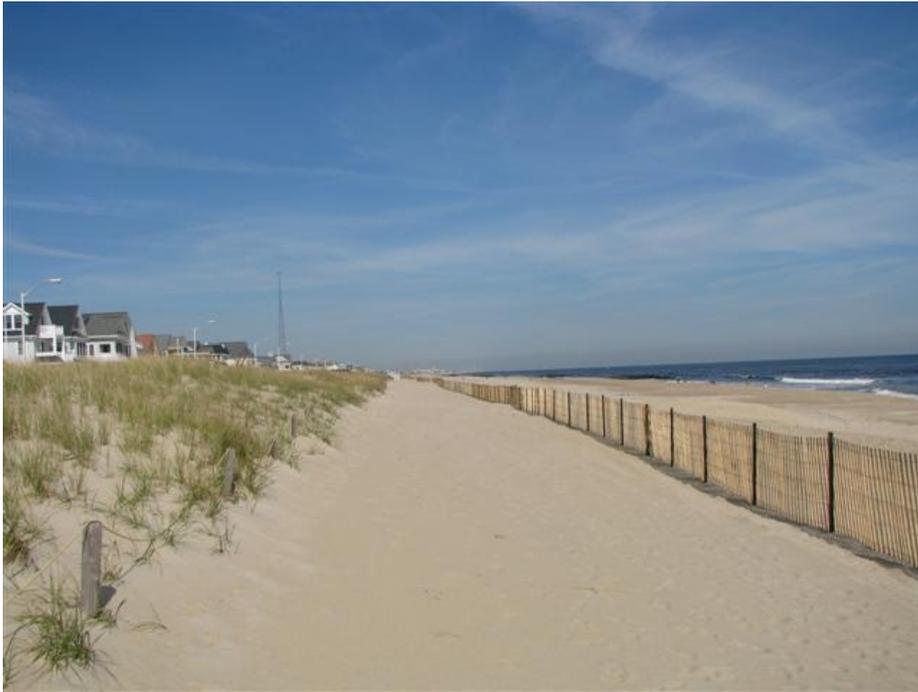
Photo taken October 15, 2008. View to the north.

This site was established following dramatic changes observed after the 1992 northeast storm. Sites near both sides of each inlets were needed to follow the more dynamic changes noted at the 11 NJ inlets. Pompano Avenue is two - three blocks from the north jetty to Manasquan Inlet.

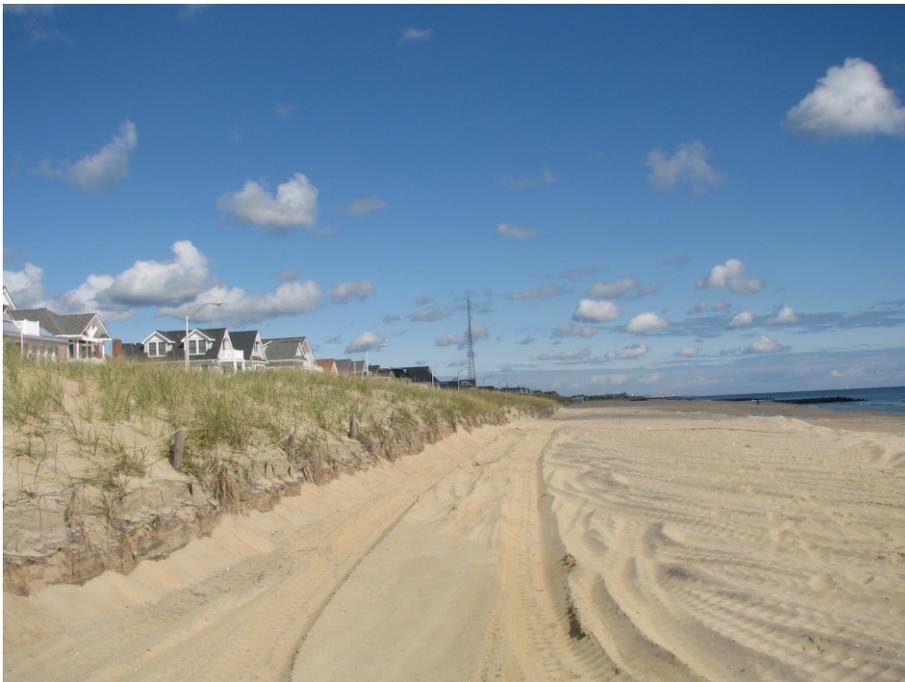
Photo taken October 1, 2009. View to the north.

Comparing the profiles over the one-year time period, the profile location lost volume (-13.74 cu yd/ft) and the shoreline moved landward (-28.33 ft). The new snow fence was designed to trap wind-transported sand before it was added to the dunes particularly raising the crest elevation.
