New Jersey Beach Profile Network 2010 Annual Report on Shoreline Changes in New Jersey Coastal Reaches One Through Fifteen Raritan Bay to Delaware Bay

New Jersey Department of Environmental Protection
Division of Construction and Engineering
1510 Hooper Avenue, Toms River, New Jersey 08753

The Richard Stockton Coastal Research Center
Richard Stockton College of New Jersey
30 Wilson Avenue, Port Republic, NJ 08241

June 30, 2011

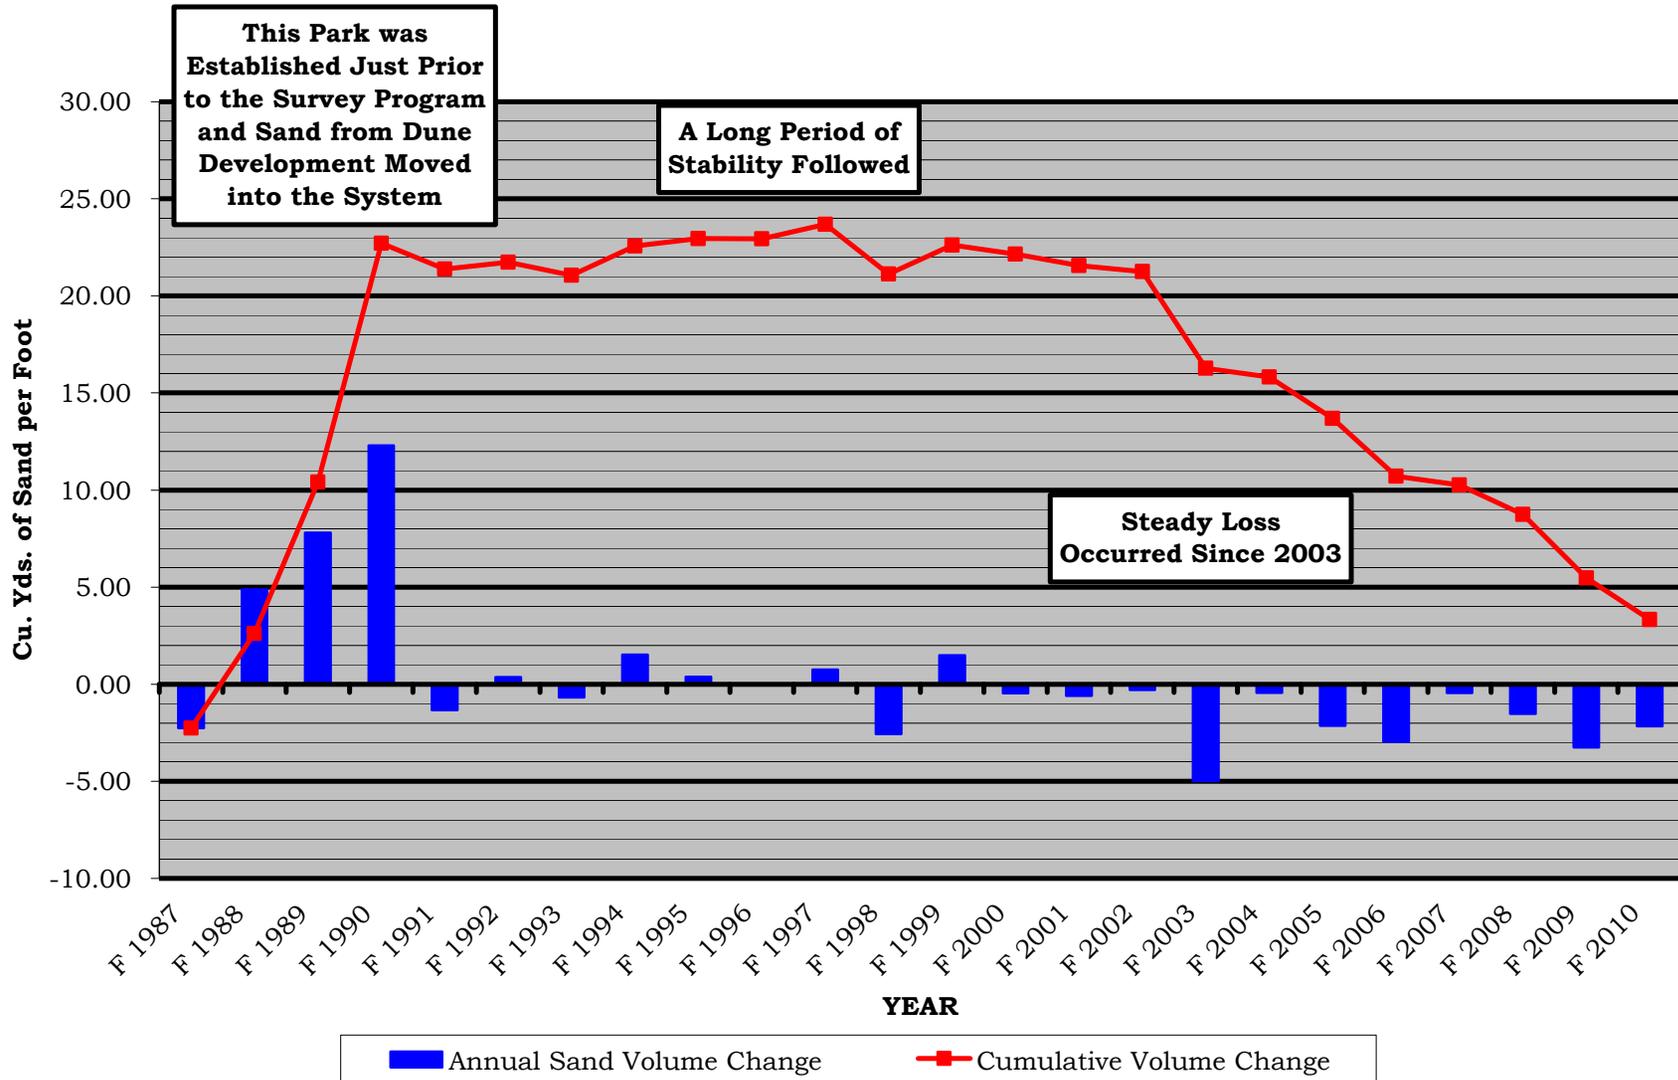
24-Year Sand Volume Changes at Site 187, Cliffwood Beach, Aberdeen

Figure 2. There are three sites along the eastern Raritan Bay shoreline in Monmouth County where Cliffwood Beach is the westernmost of the three. Located in a park created just before the establishment of the NJBPN program, the sand available in the system added to the beach/dune system during the three years following the initial pair of surveys. During the next 12 years the shoreline was stable in spite of northeast storms and other events. In 2003 a slow sand loss commenced that has reduced the sand volume to nearly that present in 1986.

Selected locations were chosen to review trends in shoreline changes. The trend analysis for Site 187 in Aberdeen, one of the three Raritan Bay profile locations, demonstrates the difference in how coastal processes work when fetch is limited. The small size of the waves creates little changes to the offshore bathymetry. Site 181 in Sea Bright shows the changes to the Atlantic shoreline where the Federally-funded beach fill was placed in 1995. All losses were restored in 2002 bringing the net increase in sand volume to just over 200 cy/ft. Since 2002 there have been steady losses of sand (approximately 120 cy/ft) from the placement volume over the past 9 years.

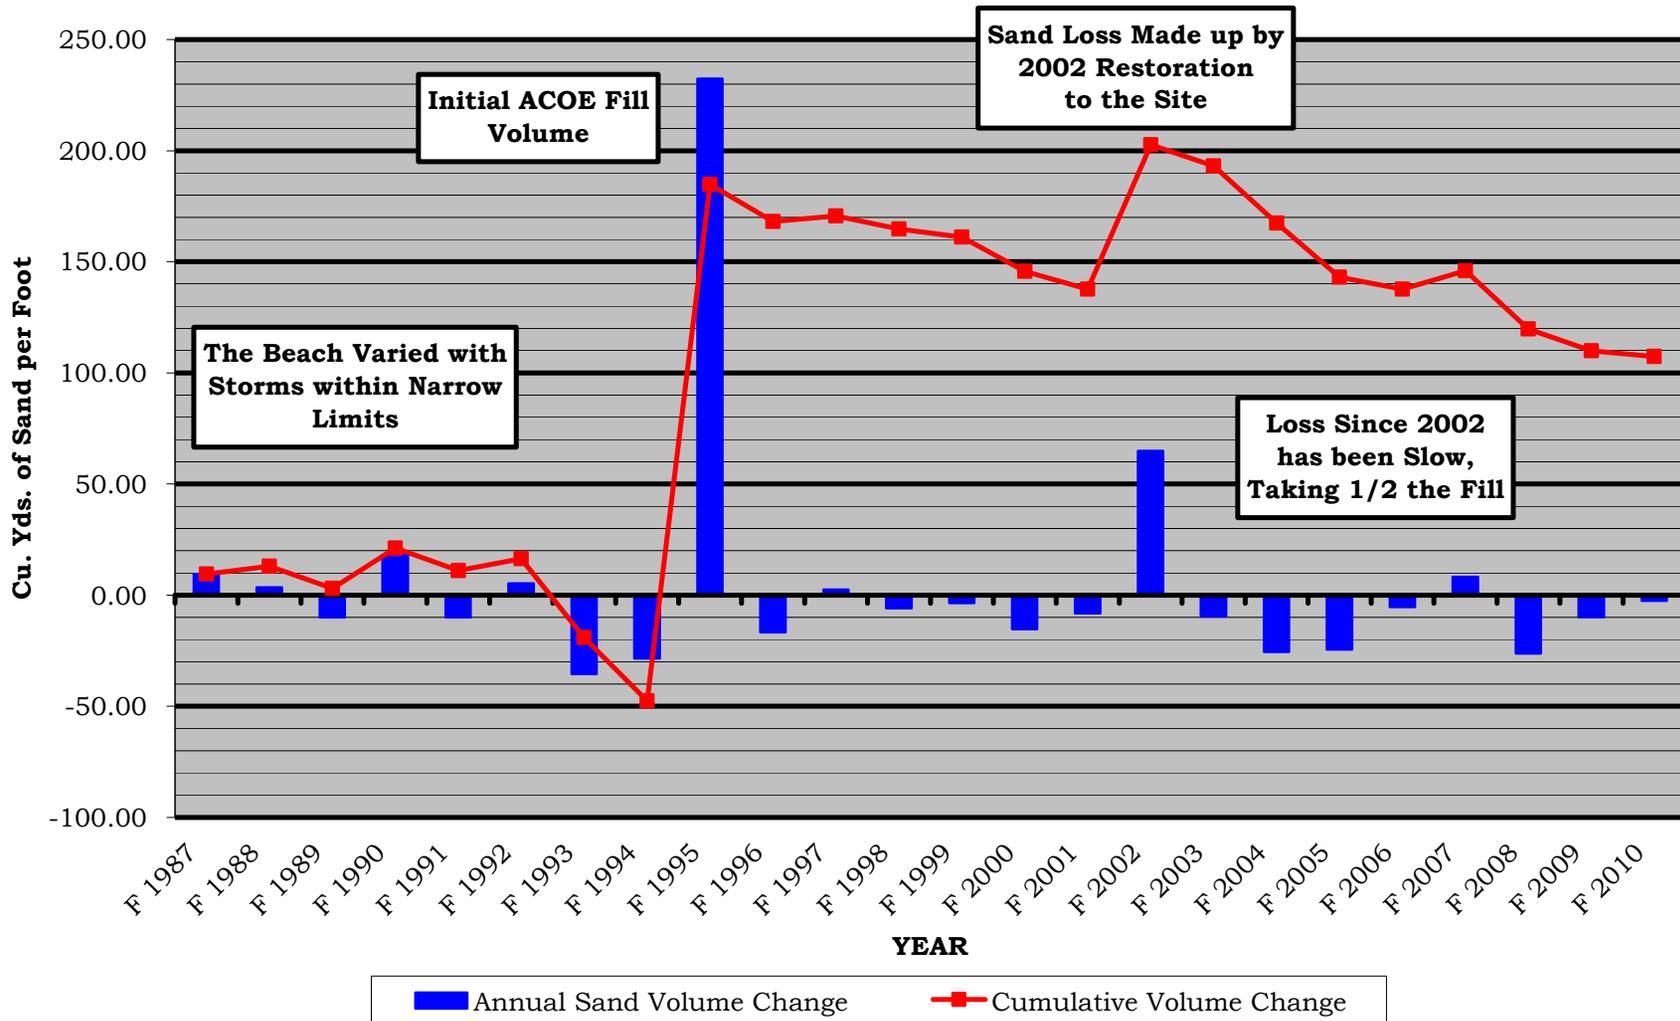
24- Year Sand Volume Changes at Site 181, Municipal Lot, Sea Bright

Figure 3. This site was added in order to show the retention rates of the northern Sea Bright beaches for the ACOE project sand deposits. Placed in 1995, the shoreline lost material, but was restored in 2002 to levels exceeding the initial deposit. Seven of the past eight years saw loss rates that have nearly reduced the 200 yds³/ft. to half that amount. Sand lost from Sea Bright ends up in Sandy Hook adding to the National Seashore beach.

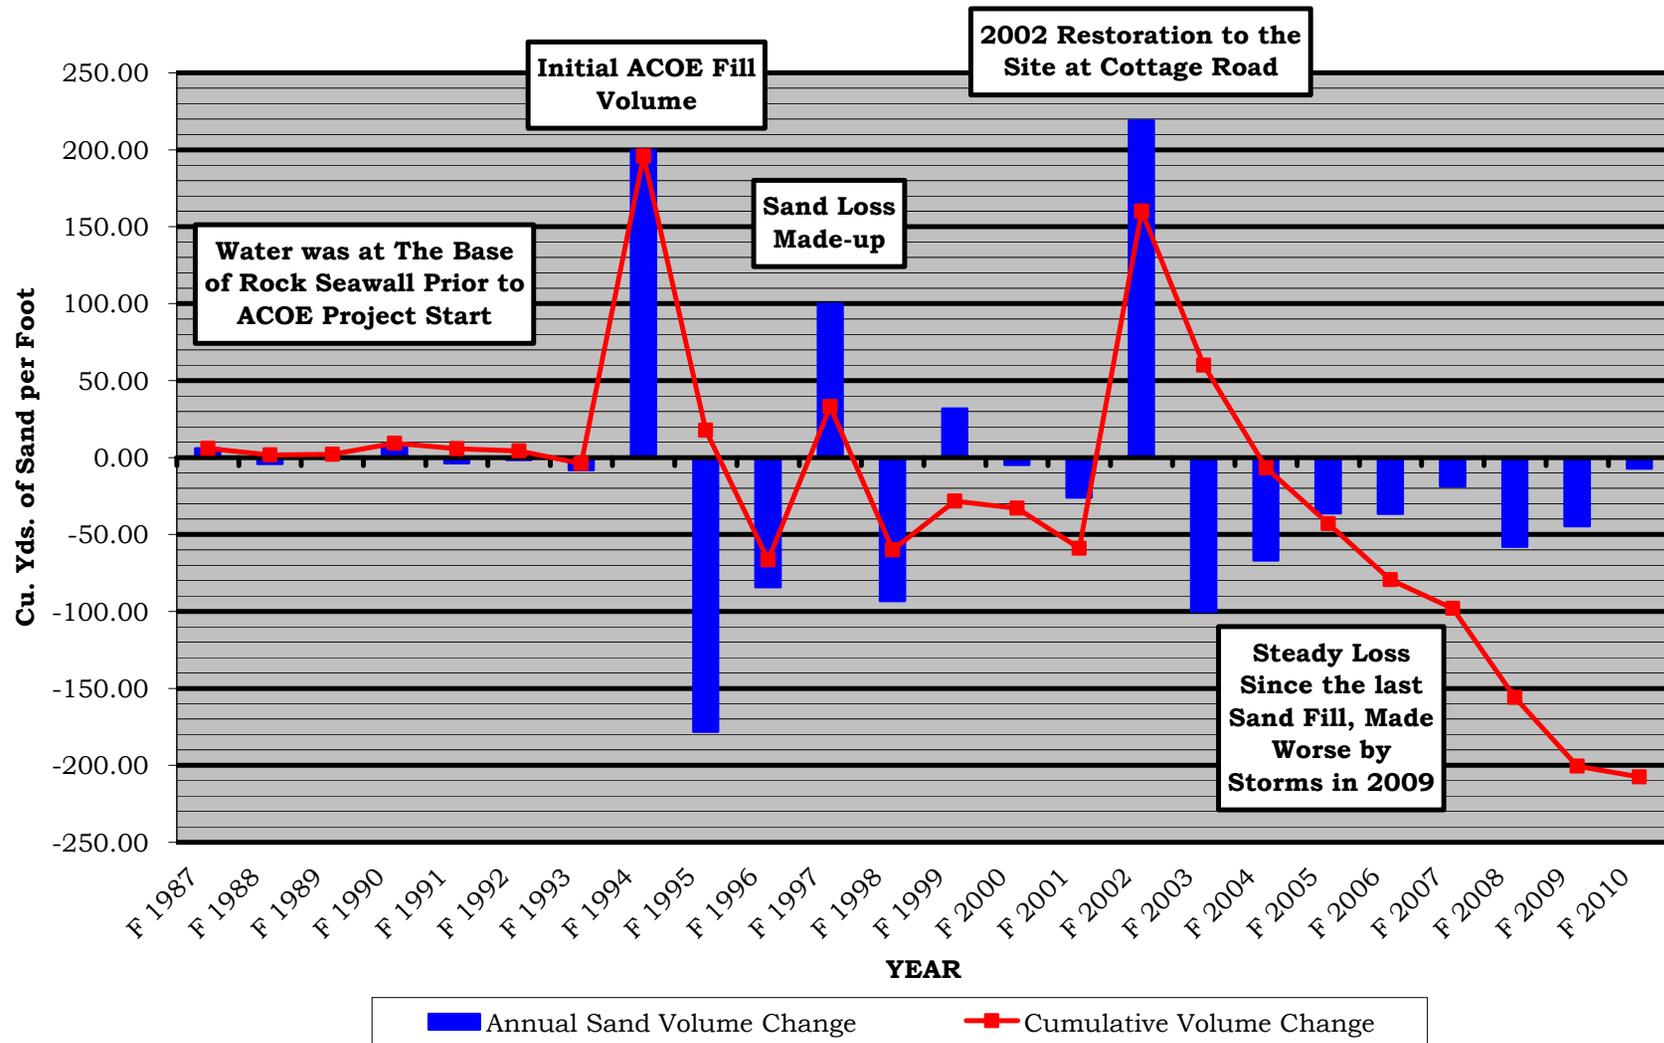
24- Year Sand Volume Changes at Site 179, Cottage Road, Monmouth Beach

Figure 4. Site #179 at Cottage Road in Monmouth Beach initially had several feet of water at the seaward base of the seawall rocks prior to the ACOE project starting in 1994. A high initial loss rate forced The ACOE to make up the deficit in 1997 followed by maintenance work in 2002. Chronic losses continue because the groins once the sole protection for the Monmouth Beach Club now prevent sand from reaching this site from the south. The smaller 2010 loss is due to NE storms moving sand south to the groin, reversing the trend this year.

Site 179, Cottage Road, in Monmouth Beach has been an enigma due to persistent, rapid loss of sand deposits. Observations made the past two years may lead to possible reasons. There is a massive stone groin protecting the Monmouth Beach Club property positioned about 500 feet south of this site. In the absence of northeast storms the dominant littoral currents are directed to the north, so the sand moves north away from the groin and the Cottage Road site and is not being replaced by significant material traveling north around the groin. By the Fall 2009 survey the site was devoid of sand, the dune was gone and the beach was wet at low tide, not far from the conditions existing here prior to the beach fill. Following the 2009-2010 winter storm season sand had reappeared as a dry beach fronting the rocks, a minimal, but significant improvement when

compared to the Fall 2009 survey situation. The littoral currents were reversed by the northeasters and were increased in magnitude during the storms. However, the groin protecting the Beach Club served to impound the sand and did not allow sediment to pass further south and the profile site beach accumulated sand during the period of severe weather. If this is the case, this location will be a perpetual “Hot Spot” for erosion.

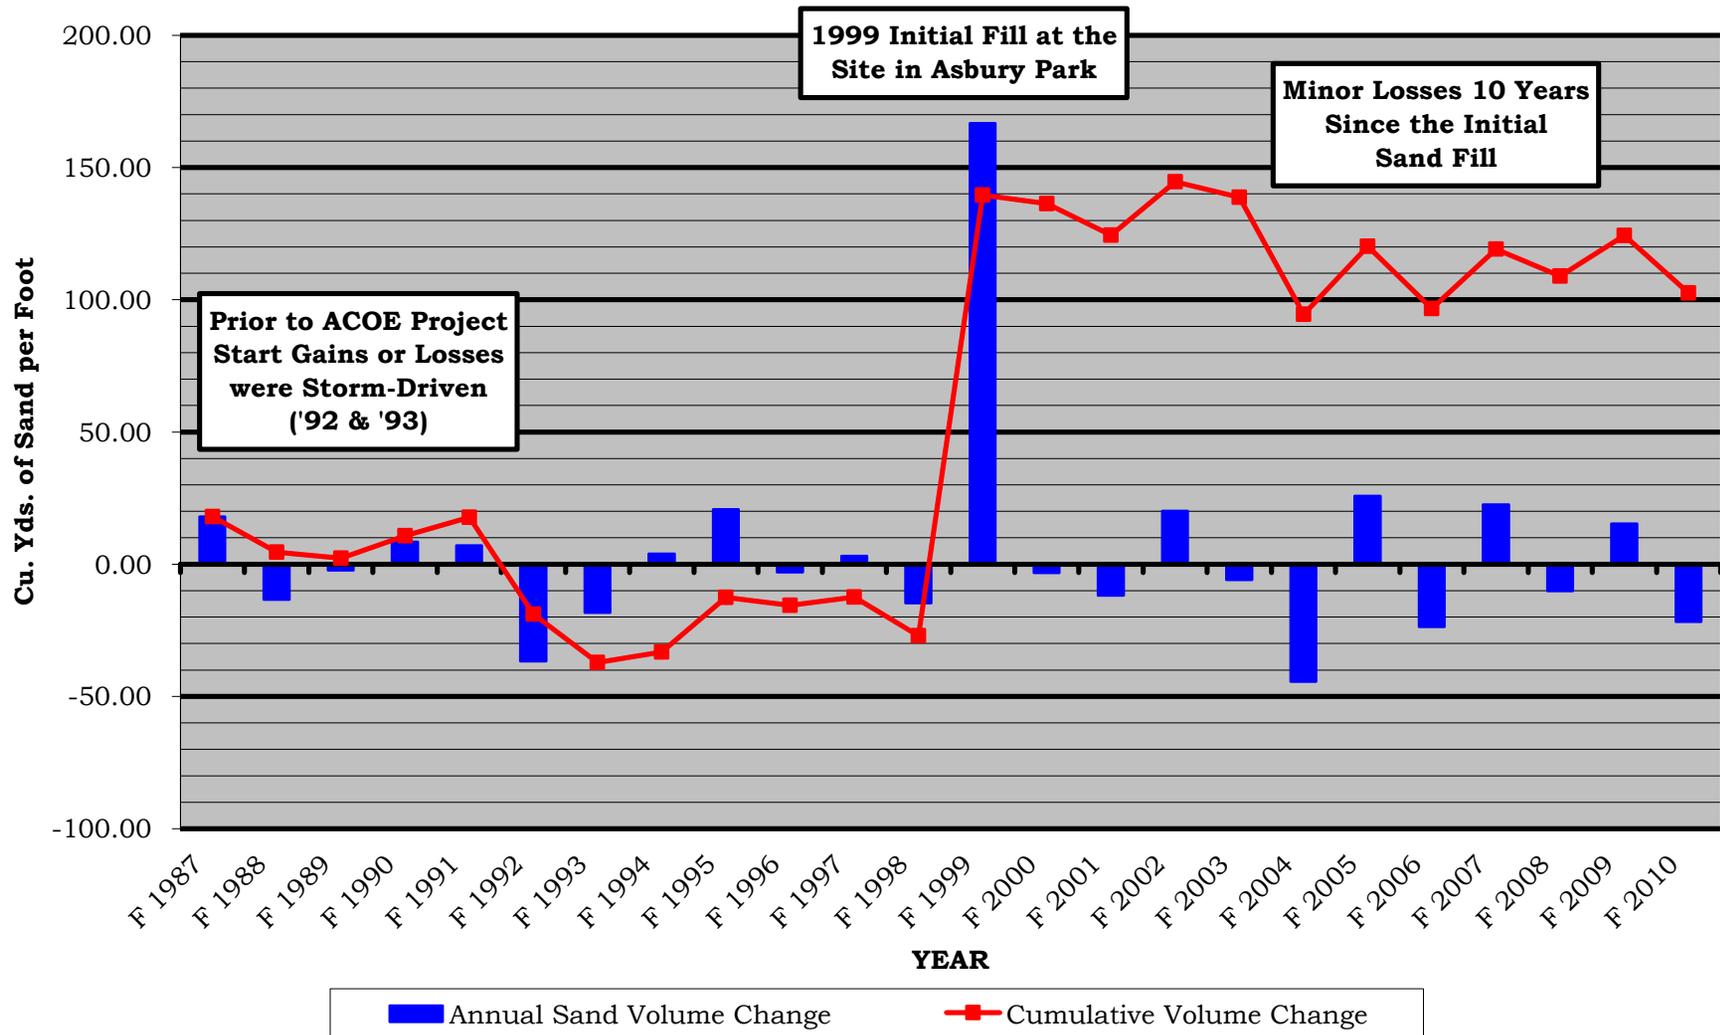
24- Year Sand Volume Changes at Site 167, 3rd Avenue, Asbury Park

Figure 5. The Third Avenue location in Asbury Park received the Federal beach nourishment in 1999. No additional work has been required since. Four of the eleven years since saw additional natural accretion that helped keep the beach near the ACOE sand placement volume seen in 1999. The fall 2009 survey preceded the majority of the northeast events so those losses are reflected in the decline in 2010.

The southern segment of the ACOE project has weathered the 2009-2010 storm events very well. The beach at Site 167 in Asbury Park gained sand volume in 4 of 10 years which allowed the beach to maintain its appearance and storm resistance for a decade without need for maintenance. At Site 160, Salem Avenue in Spring Lake, sand volume increased for over a decade following the initial sand placement. Then, three years of continuous loss dragged the total volume below that placed by the ACOE. However, the site continues to maintain a healthy profile 13 years after the project was completed.

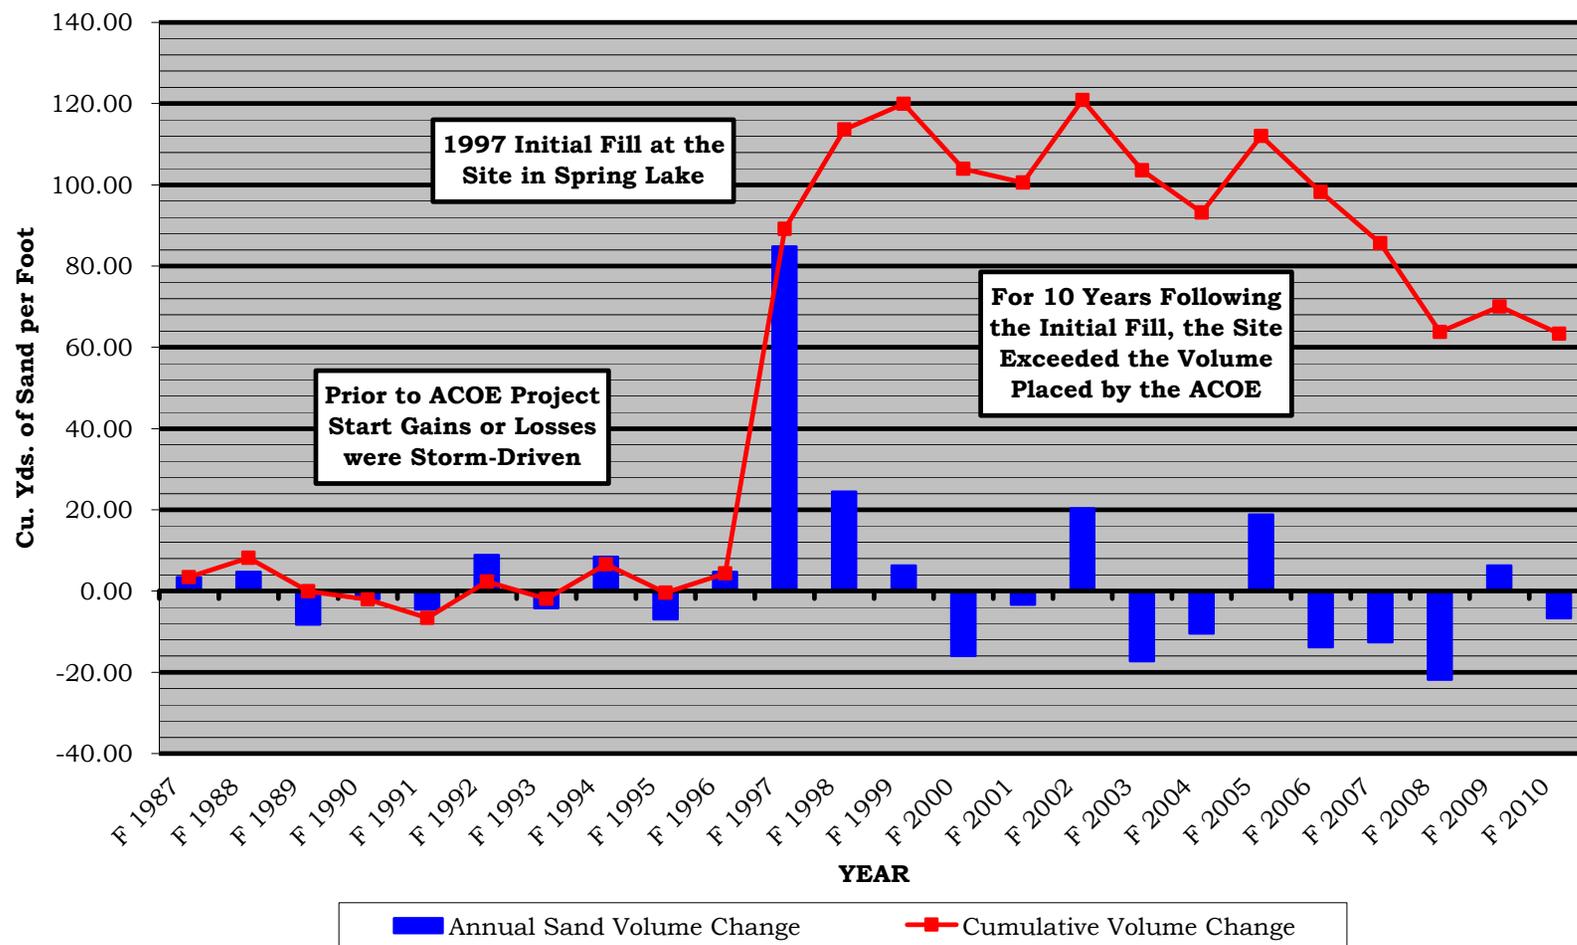
24- Year Sand Volume Changes at Site 160, Salem Avenue, Spring Lake

Figure 6. This is another site selected to show the relative stability of the southern fill sector in Monmouth County. The fill volume of 85 yds³/ft. completed in 1997 was followed by 5 of 13 years with sand added to that placed in 1997. For a decade the site maintained an excess volume of sand over that placed by the ACOE. 2008 took the biggest bite out of the sand supply with a partial recovery in 2009. That survey in 2009 preceded most of the northeast storms which are reflected in the decline shown between the fall of 2009 and 2010.

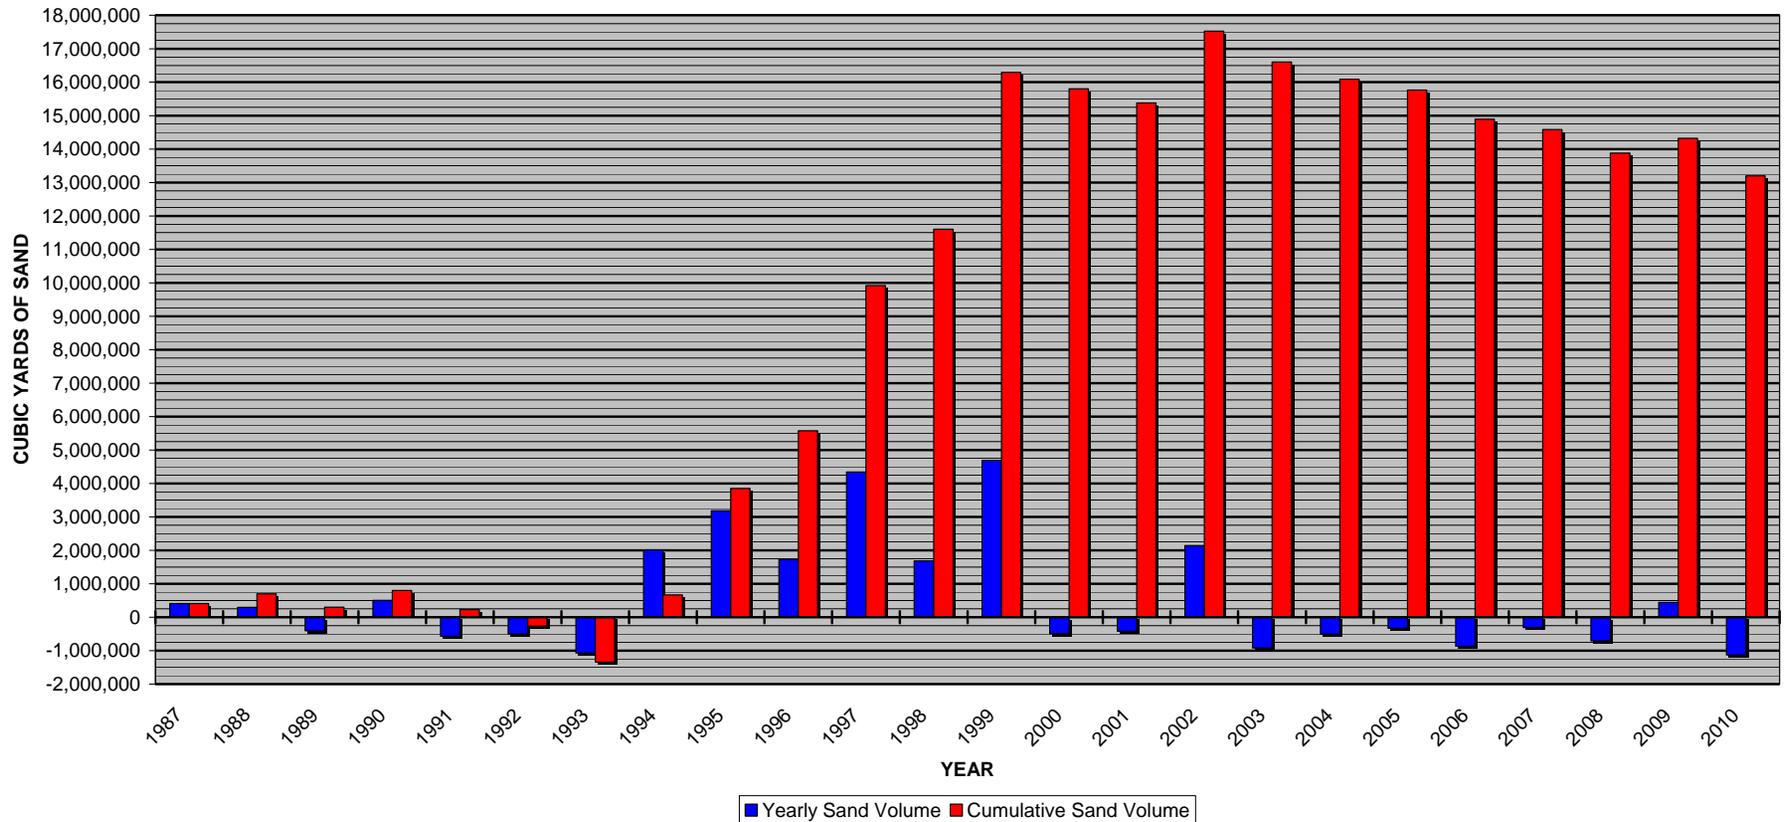
ANNUAL & CUMULATIVE OCEANFRONT SHORELINE SAND VOLUME CHANGES, MONMOUTH COUNTY 1987 to 2010

Figure 7. The final bar graph illustrates the trend and each year’s average sand volume change for all 36 of the Monmouth County survey sites. Between 1994 and 1999 the ACOE project was underway along 21 miles of the county shoreline adding 140 yds³/ft. in average cumulative sand volume to the county’s beaches. Storm recovery work in 1997 and maintenance work performed in 2002 added sand to portions of the project, but no new sand was placed until 2009’s work in Long Branch. The El Nino year of 2009 and 2010 shows up as a substantial loss (-1,127,027 cubic yards) in the 2010 comparison because most of the surveys were complete prior to the November 2009 storm. The county remains as the graph shows, over 13,190,000 cubic yards of sand ahead of the 1993 situation. If the peak value of 17,500,000 cubic yards from 2002 represents 100% of the fill volume, then 75.4% of the sand pumped still resides on Monmouth County beaches 16 years after this project started. This graph is only based on those sites receiving sand and does not count the material that flowed north into Sandy Hook National Seashore. The Gunnison Beach site #285 has gained an average of 19.01 yds³/ft. since 1995 or 304.16 yds³/ft. for each foot of shoreline near that site. The 2.5 mile distance between #285 and #284 where the average gain was 5.18 yds³/ft. would have accumulated 2,554,464 cubic yards of sand over the 16 years since the project was completed. The combination of the Sandy Hook gain with the residual sand accounts for 90% of the ACOE fill volume and only includes half the Sandy Hook shoreline.

This trend is true from Asbury Park south to Manasquan, NJ. Loss from the southern Monmouth County fill section that moved to the north has benefited Loch Arbor and the Borough of Allenhurst as sand slowly moved north around the northern Asbury Park groin into the short shoreline cell containing these two municipalities. An extensive groin complex built at the Allenhurst – Deal boundary prevents sand movement into the Borough of Deal. Likewise, 13 years of observations have shown that little sand has moved south into Elberon or Deal from Long Branch (Pullman Ave., Roosevelt Ave., and Darlington Ave. sites). The groins and shoreline armor stone remain the line of storm defense for this shoreline segment. Had the ACOE project been finished through this area, these groins would have retained much of the sand, but issues similar to that seen in Monmouth Beach (Site 179) could be expected around the largest of the rock groins along this shoreline. Though there was a substantial loss of sediment from the beaches of Monmouth County in the 2009-2010 winter storm season, the county remains over 13 million cy of sand above the amounts in the 1993 beaches (Figure 7).

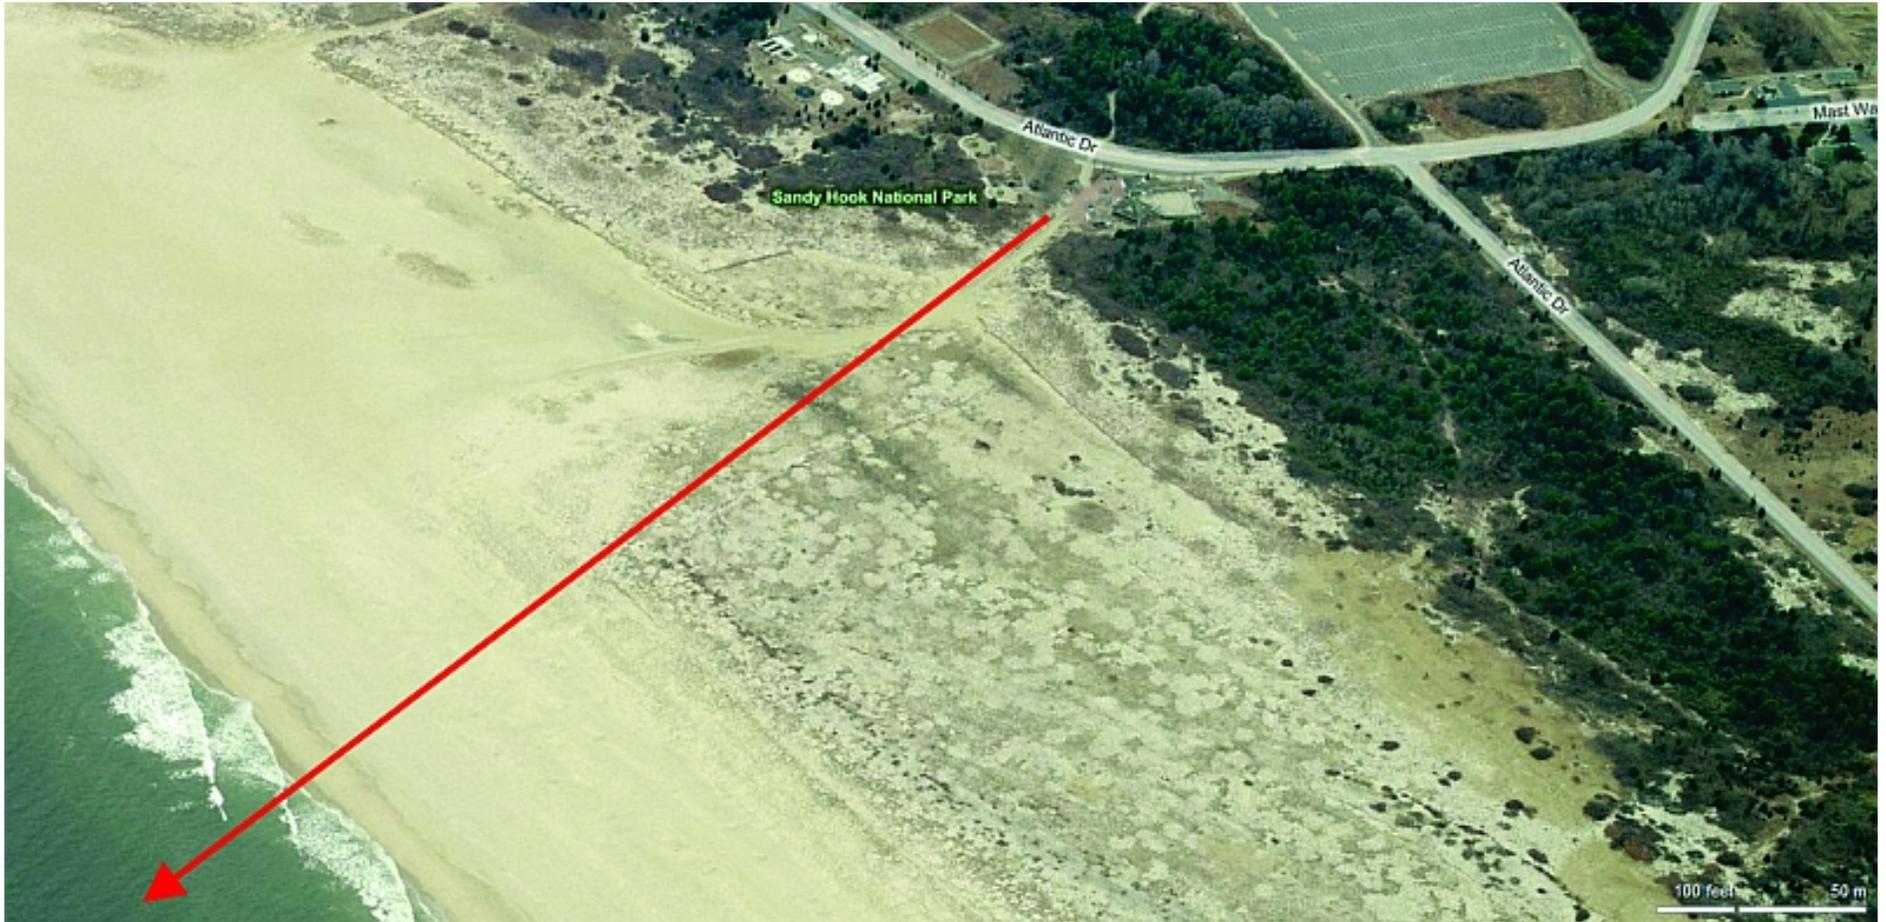
Figure 8. Aerial view of Gunnison Beach in the Sandy Hook National Seashore. This shoreline has been accretional since the NY District Corps of Engineers completed its beach restoration in Monmouth County in 1999. Sand moves north along the Sandy Hook shoreline adding to the northern spit that curves into New York Harbor. The average sand volume increase between the two profile sites in the park (5.18 yds³/ft.) multiplied by the distance in feet between the two sites provides a total accretional volume of sand nearly equal to the loss volume experienced along the 21 miles of nourishment project shoreline (2,554,464 cubic yards). Views such as this are now available from Bingmaps.com if you select the oblique aerial view. The profile location is indicated by the red arrow. The back portion of the beach is an array of incipient dunes and minor dune ridges due to the extensive width of the berm.

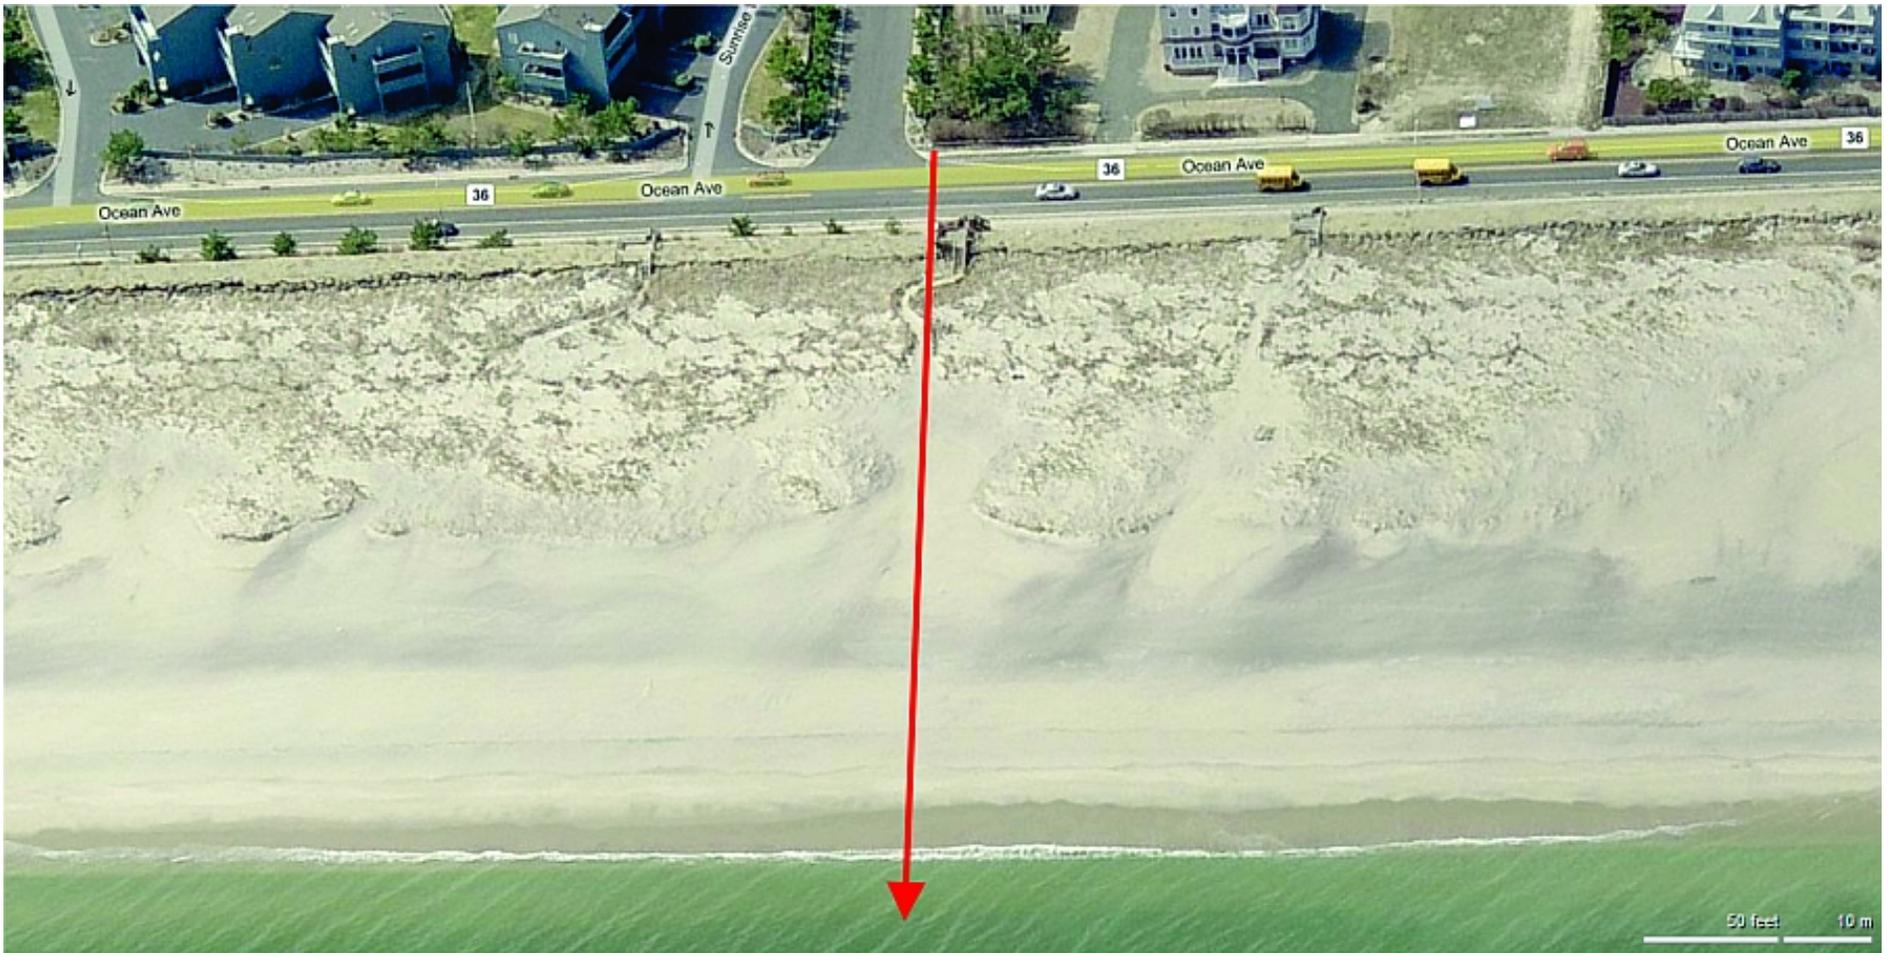
Figure 9. Sunrise Court along NJ Route 36 in Sea Bright, NJ. Prior to the beach restoration, the ocean was at the rock seawall that was defending the highway until 1998. The rocks are still present, but today a substantial beach exists seaward of the wall. The profile line is indicated by the red arrow. No effort was expended in building a dune system, but one developed anyway. The combination of no view from the highway, and a lack of public parking have made this stretch of beach one of the best-kept secrets on the NJ shoreline. During the bathing season the occasional visitor will encounter a few fishermen, several folks walking their dogs, and maybe a serious jogger during any time of day.

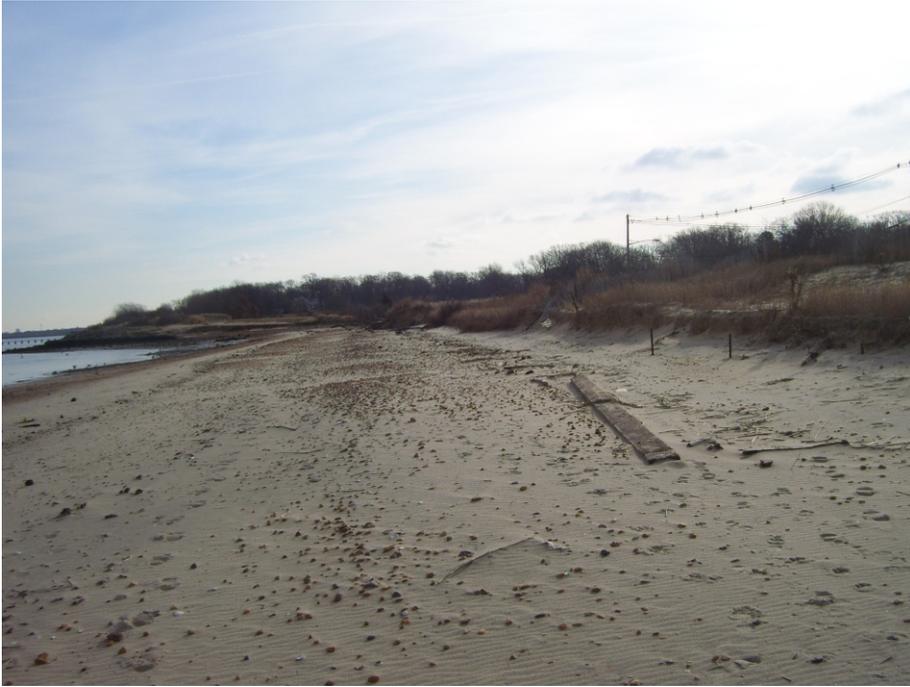
Photo taken December 14, 2009. View to the east.

Shoreline retreat exposed an old timber structure on the beach in 2007 and continued in 2008.

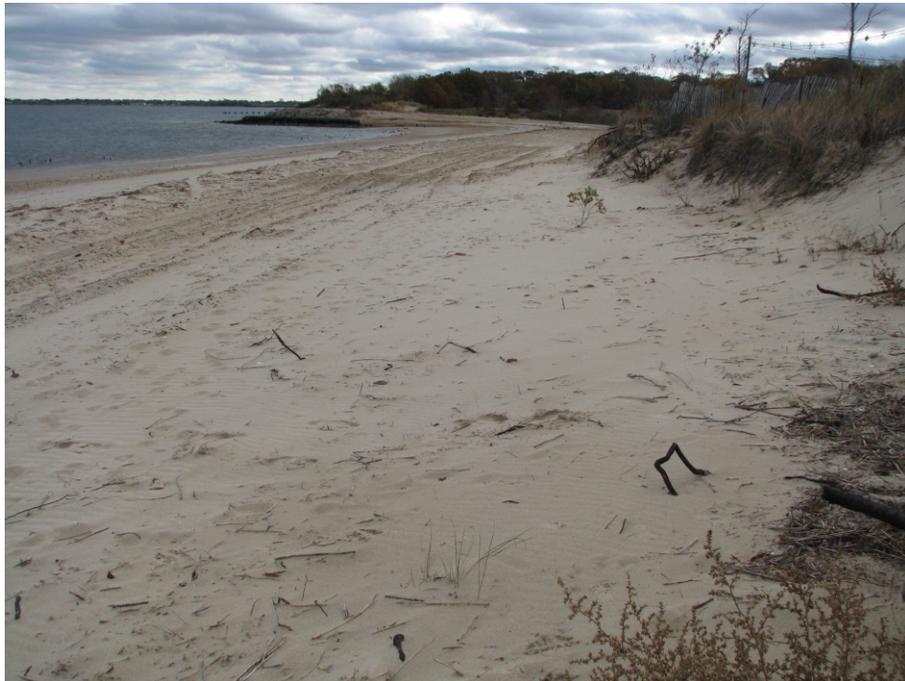
Photo taken November 5, 2010. View to the east.

Comparing the profiles over the year, the profile location lost volume (-2.16 cu yd/ft) and the shoreline moved landward (-14.77 ft). Raritan Bay northeast storm waves cut into the dunes and pushed back the beach.

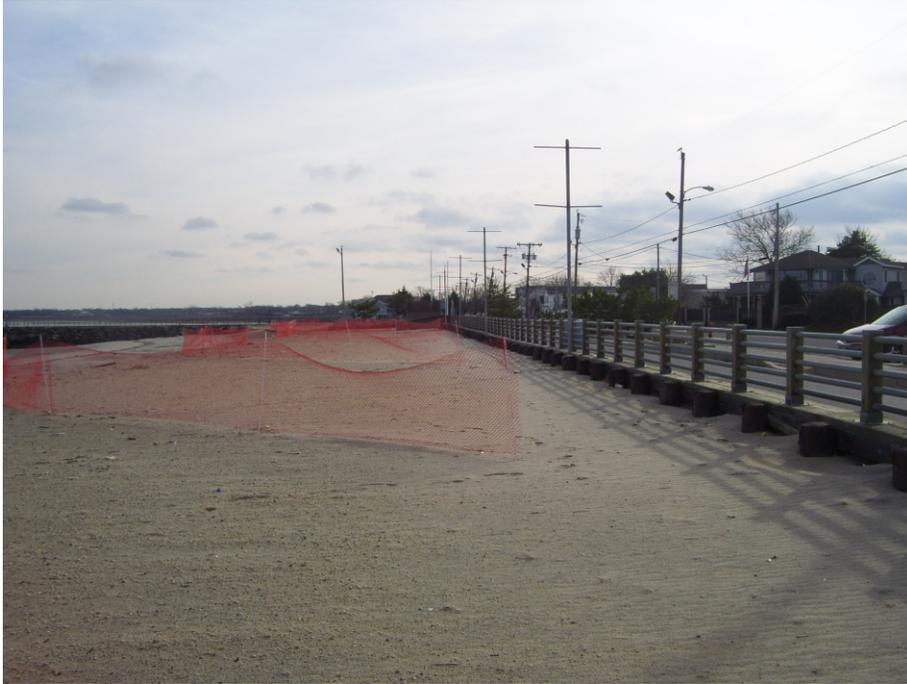
Photo taken December 14, 2009. View to the east.

After discussions with the NJDEP, former site 186 was abandoned and a new one was established about a quarter mile to the northwest along the shoreline to a public bathing beach so that more normal shoreline changes could be followed. This new site was established in 2009 and is near the intersection of Beach and Front Streets in Union Beach. The orange fencing on the beach appears to be designed to prevent sand from blowing onto the parking/roadway area during the winter.

Figure 11: The new site at Union Beach is located northwest along the shoreline at a municipal bathing area far more useful to survey. The smaller fetch across Raritan Bay did impact the elevation of the bathing beach, but the sand was carried offshore. The net change was only $-1.32 \text{ yds}^3/\text{ft}$. with a 12-foot shoreline advance due to a flatter beach slope. The bathing surface lost $4.42 \text{ yds}^3/\text{ft}$.

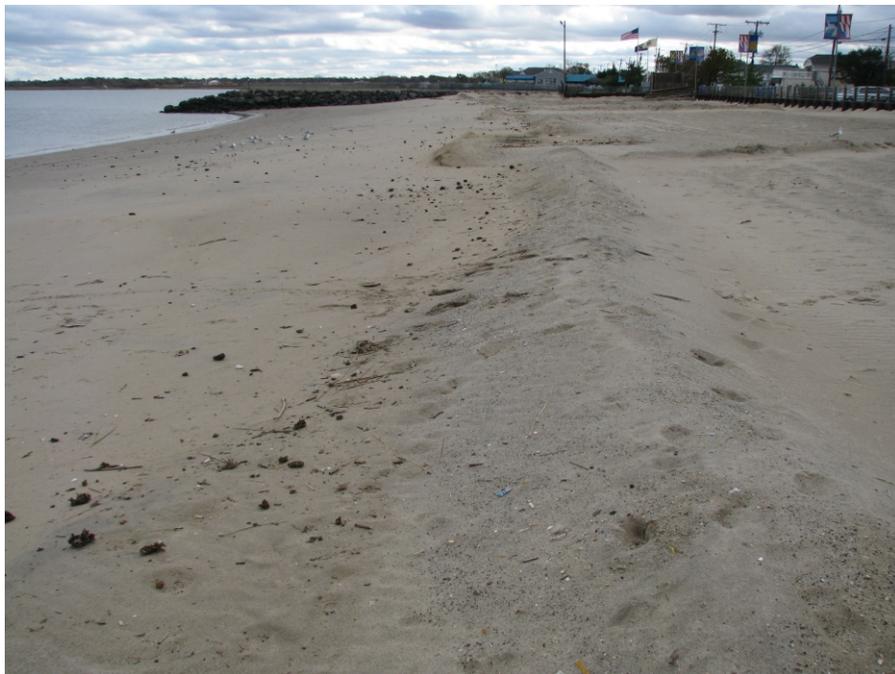
Photo taken November 5, 2010. View to the east.

Comparing the profiles over the year, the profile location lost volume (-2.05 cu yd/ft) and the shoreline moved seaward (0.45 ft).

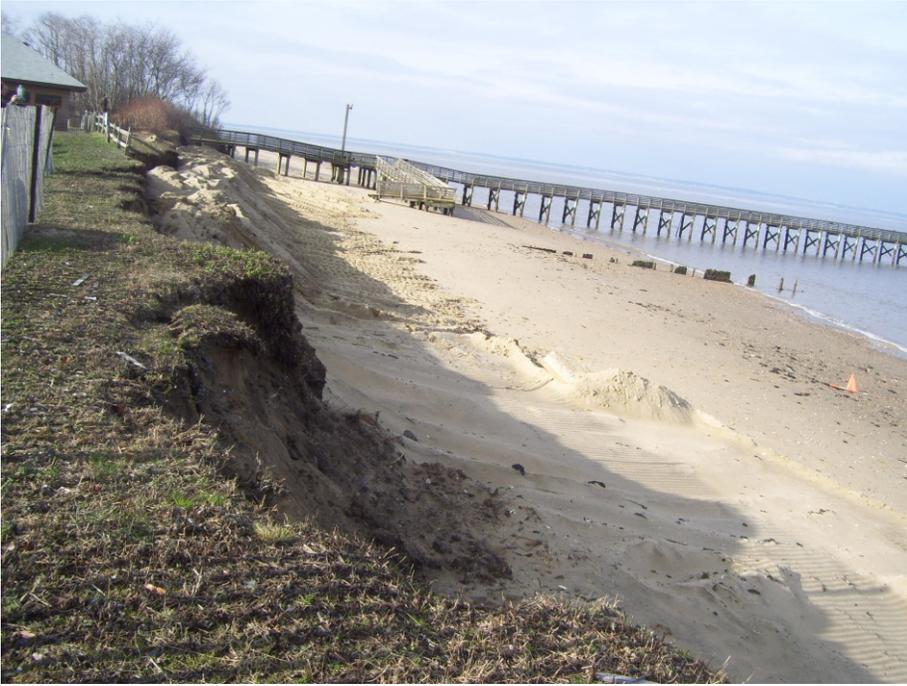
Photo taken December 14, 2009. View to the west.

Northeast storms cut away at the dune as the beach retreated before the erosion produced by the waves generated on Raritan Bay.

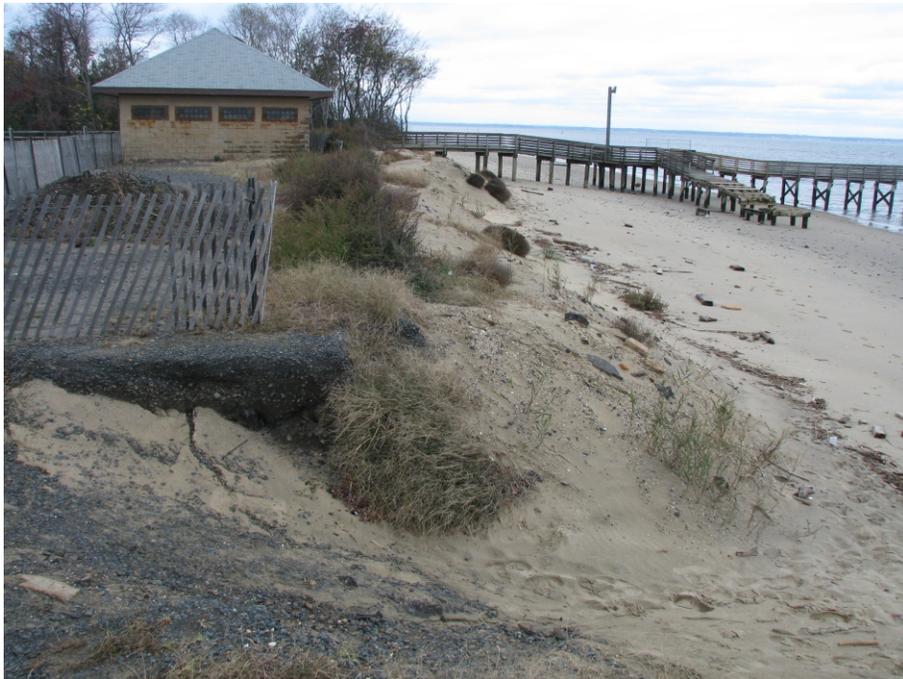
Photo taken November 5, 2010. View to the west.

Comparing the profiles over the year the location lost volume (-2.32 cu yd/ft) and the shoreline moved seaward (6.61 ft).

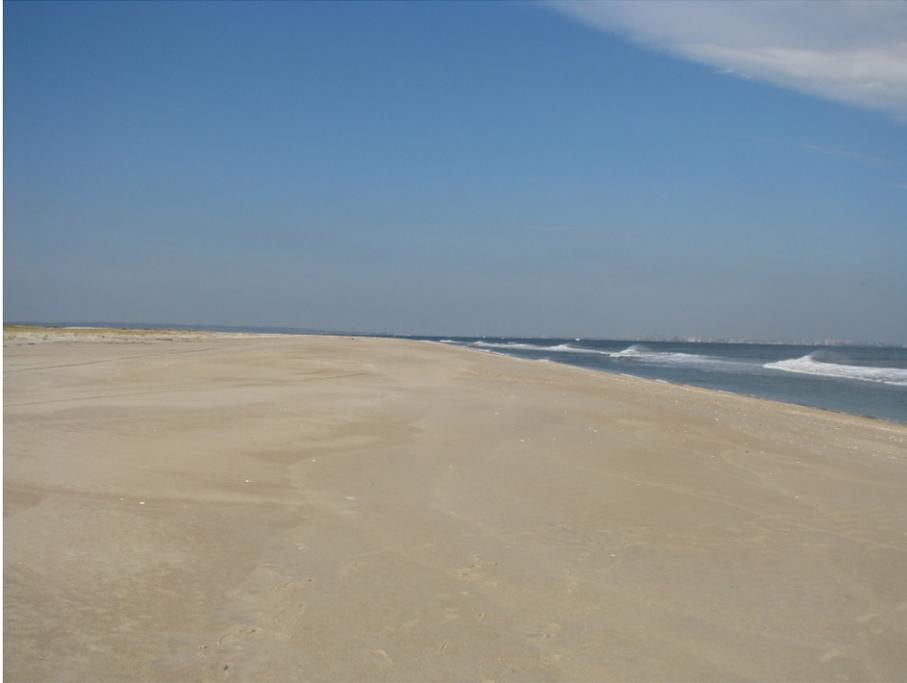
Photo taken November 3, 2009. View to the north/east.

The beach grows relatively continuously since the Federal project provided abundant material to move north to the end of Sandy Hook.

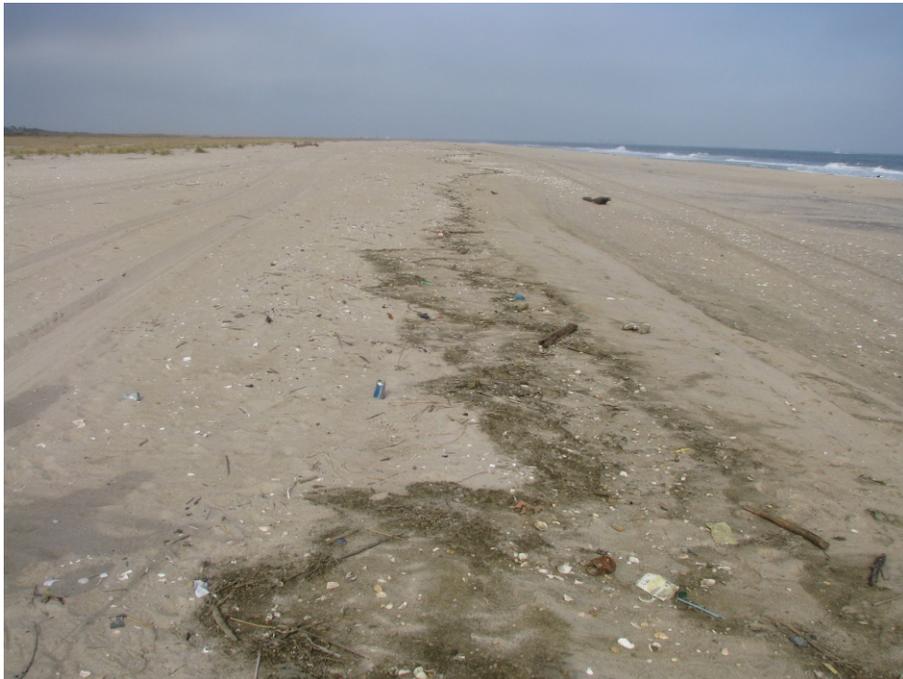
Photo taken November 15, 2010. View to the north/east.

Comparing the profiles over the year, the location gained in volume (32.04 cu yd/ft) and the shoreline moved seaward (24.41 ft).

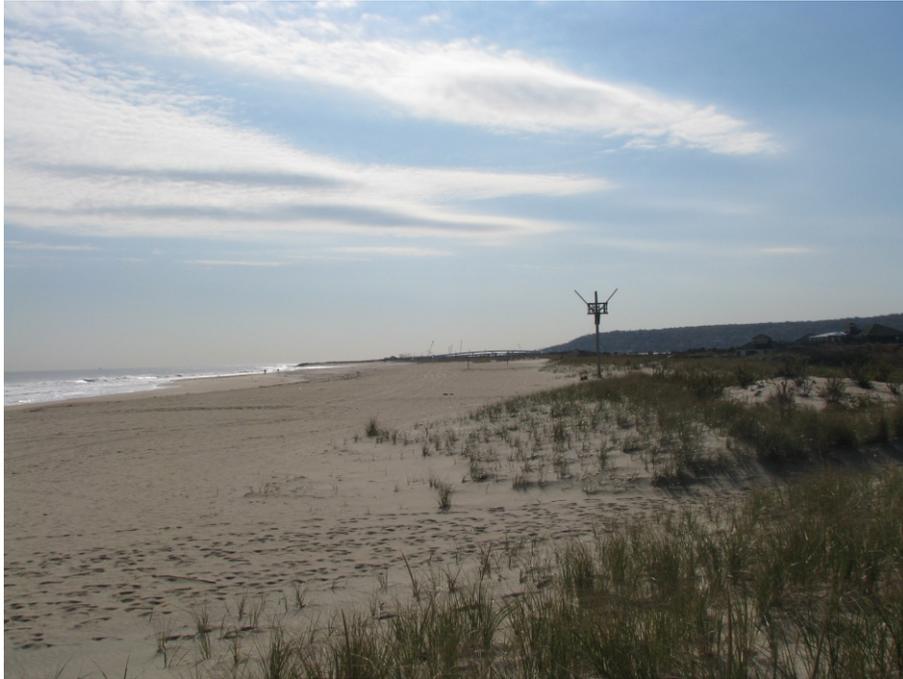
Photo taken November 3, 2009. View to the south.

This site is sheltered from northeast waves by Long Island.
