New Jersey Beach Profile Network 2010 Annual Report on Shoreline Changes in New Jersey Coastal Reaches One Through Fifteen Raritan Bay to Delaware Bay

New Jersey Department of Environmental Protection
Division of Construction and Engineering
1510 Hooper Avenue, Toms River, New Jersey 08753

The Richard Stockton Coastal Research Center
Richard Stockton College of New Jersey
30 Wilson Avenue, Port Republic, NJ 08241

June 30, 2011

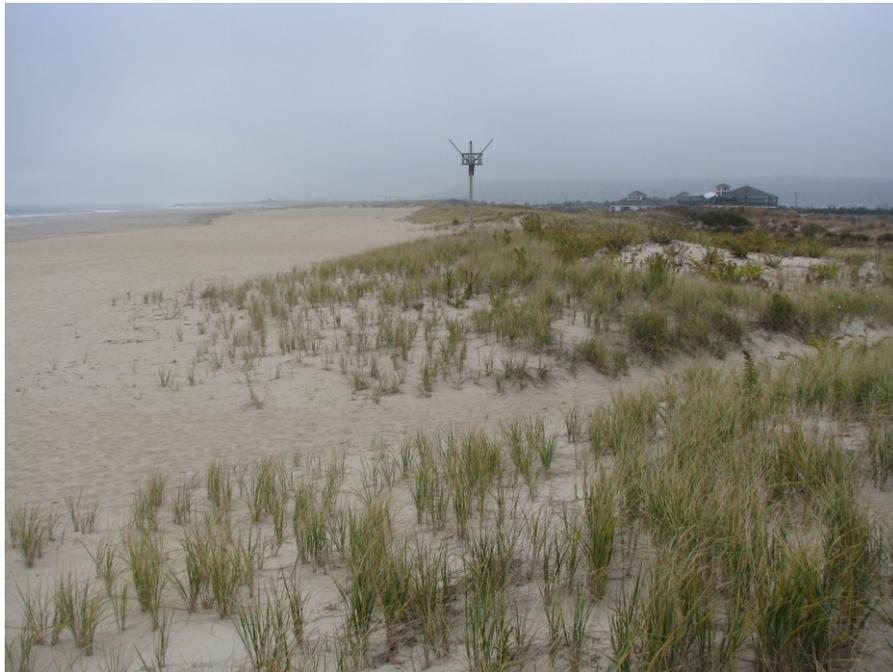
Photo taken . View to the south.

Comparing the profiles over the year, the profile location gained volume (22.52 cu yd/ft) but the shoreline moved seaward (30.56 ft).

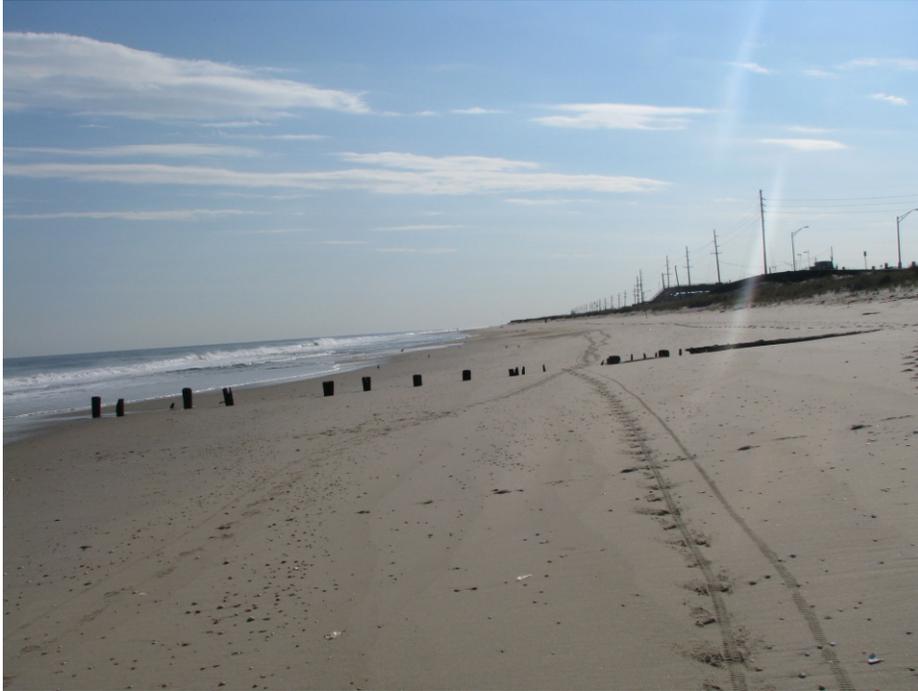
Photo taken November 3, 2009. View to the south.

This site is sheltered from northeast waves by Long Island.

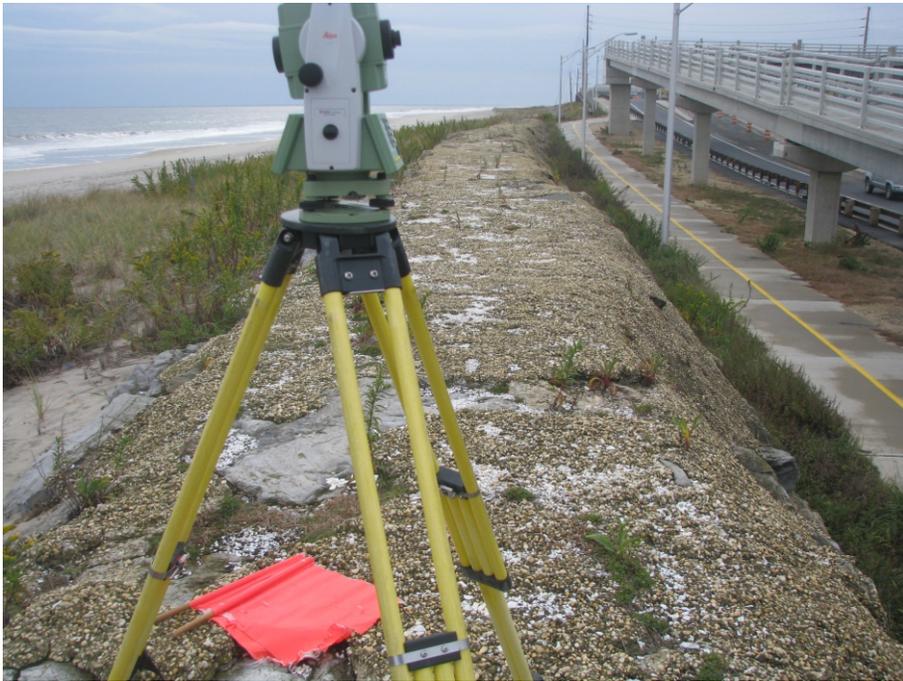
Photo taken November 16, 2010. View to the south.

Comparing the profiles over the year, the profile location gained volume (6.55 cu yd/ft) and the shoreline moved seaward (15.94 ft).

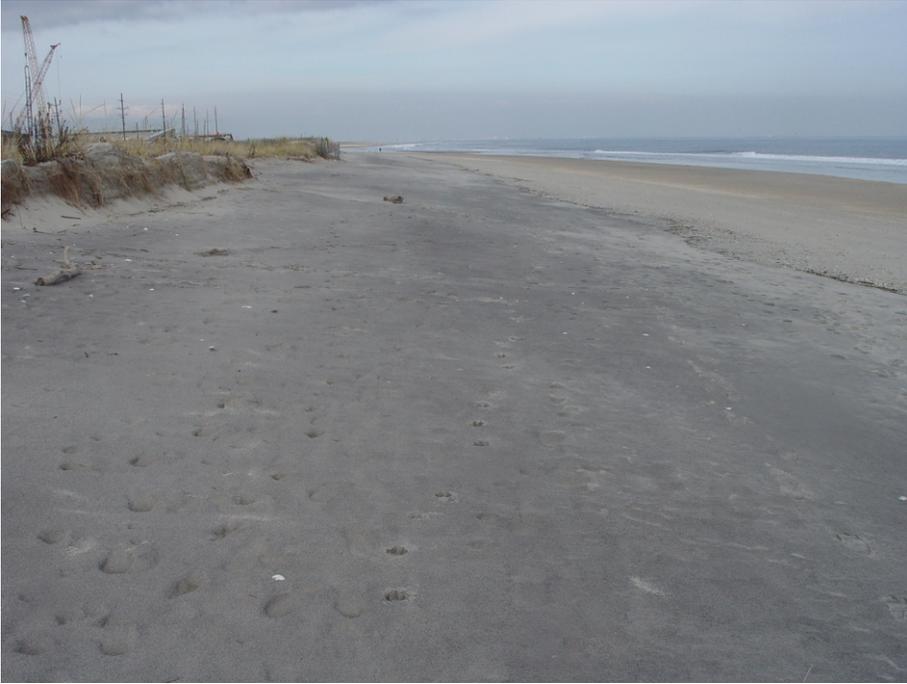
Photo taken December 14, 2009. View to the north.

This site has a natural dune that has been growing since 1998. A single line of fence was all that was established following the Federal project. Some loss occurred in the dunes due to the fall 2009 storms.

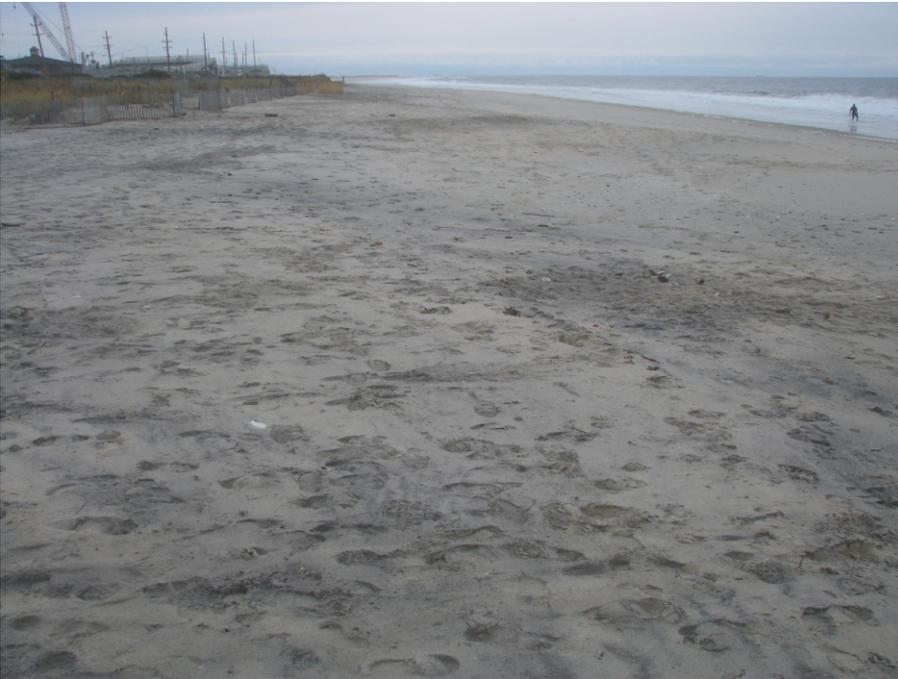
Photo taken November 16, 2010. View to the north.

Comparing the profiles over the year, the profile location gained volume (2.28 cu yd/ft) and the shoreline moved seaward (26.87 ft).

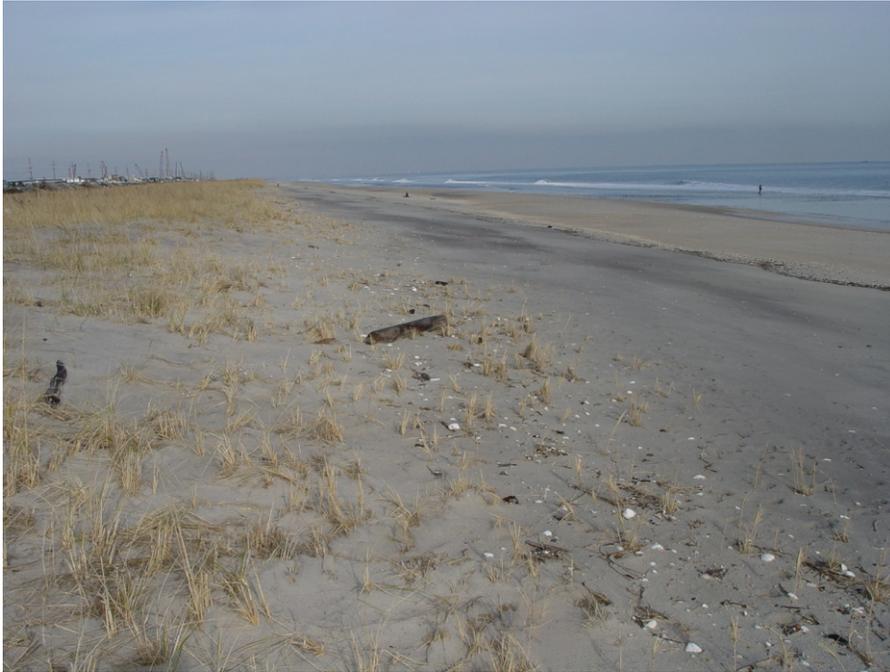
Photo taken December 14, 2009. View to the north.

A sizable bar moved onto the beach in partial recovery following the November 2009 northeast storm.

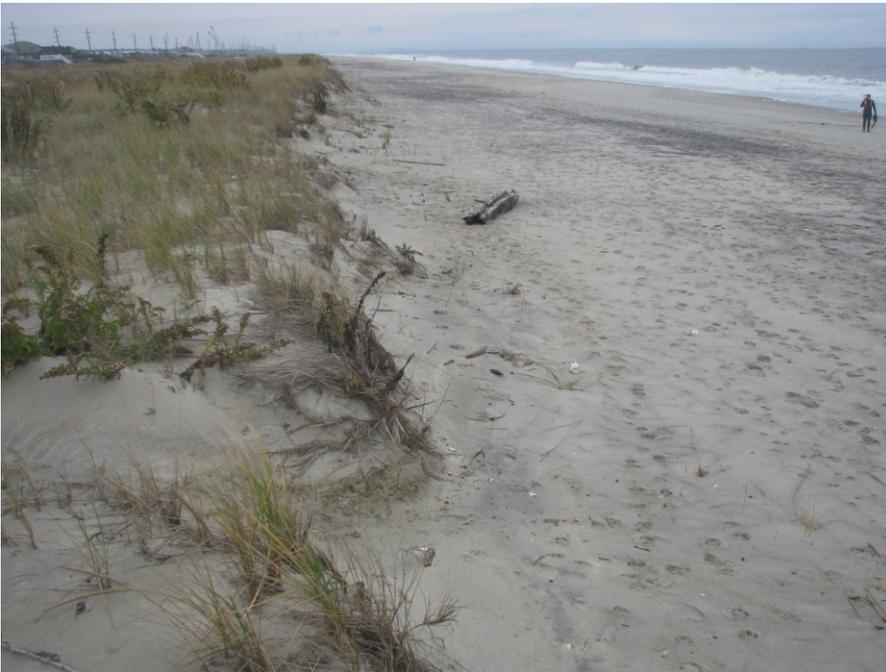
Photo taken November 16, 2010. View to the north.

Comparing the profiles over the year, the profile location lost volume (-19.16 cu yd/ft) and the shoreline moved seaward (44.2 ft). Most of the sand was lost below the 0.0 ft NAVD88 datum.

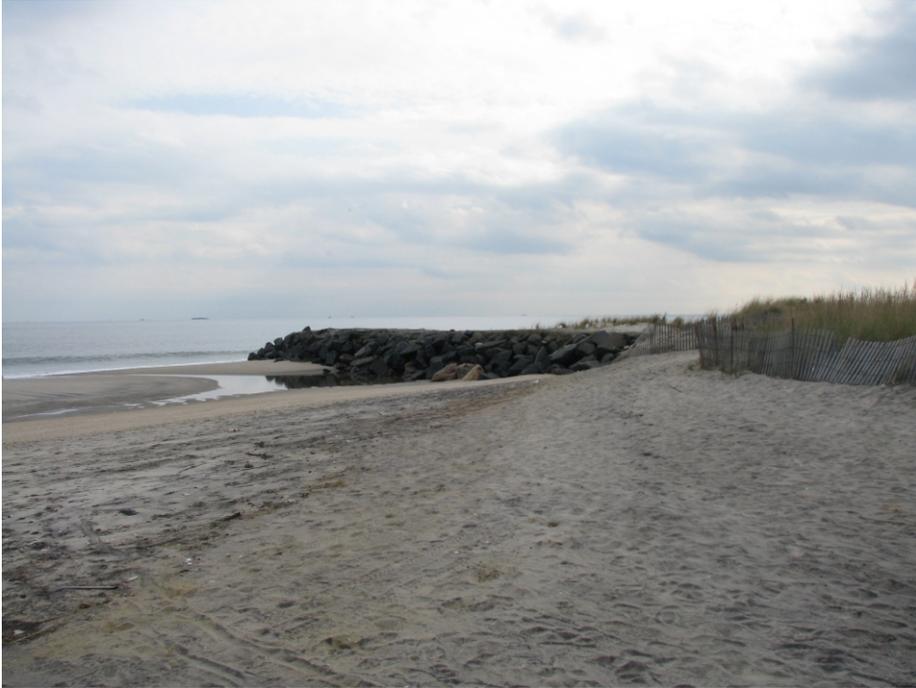
Photo taken November 5, 2009. View to the south.

This small segment of public shoreline has maintained its general condition since the fill was completed over a decade ago.

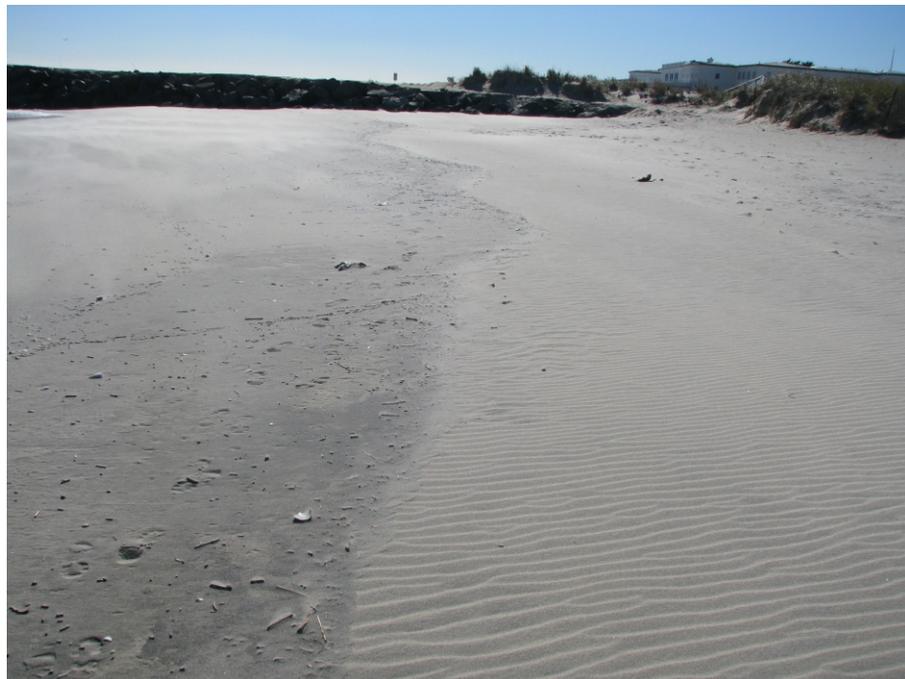
Photo taken November 9, 2010. View to the south.

Comparing the profiles over the year, the profile location lost volume (-41.0 cu yd/ft) and the shoreline moved landward (-68.18 ft).

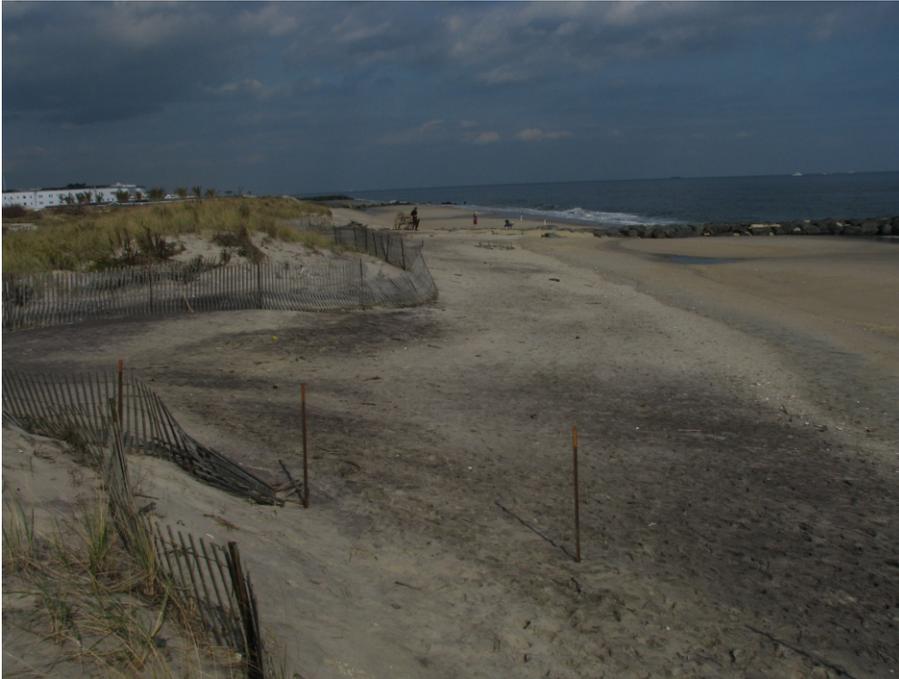
Photo taken November 5, 2009. View to the north.

The entrance for bathers cuts through the dune system at this location. The beach has slowly retreated since 1996.

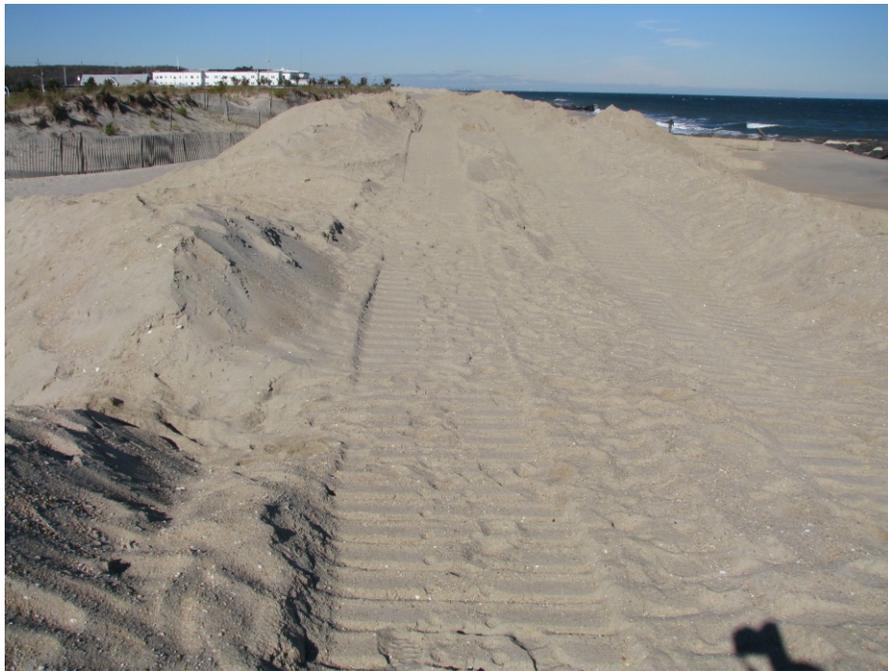
Photo taken November 9, 2010. View to the north.

In 2010, the town pushed sand up from the intertidal area to construct a dune. Comparing the profiles over the year, the profile location lost volume (-2.58 cu yd/ft) and the shoreline moved seaward (3.23 ft). Most of the sand was eroded from the offshore area.

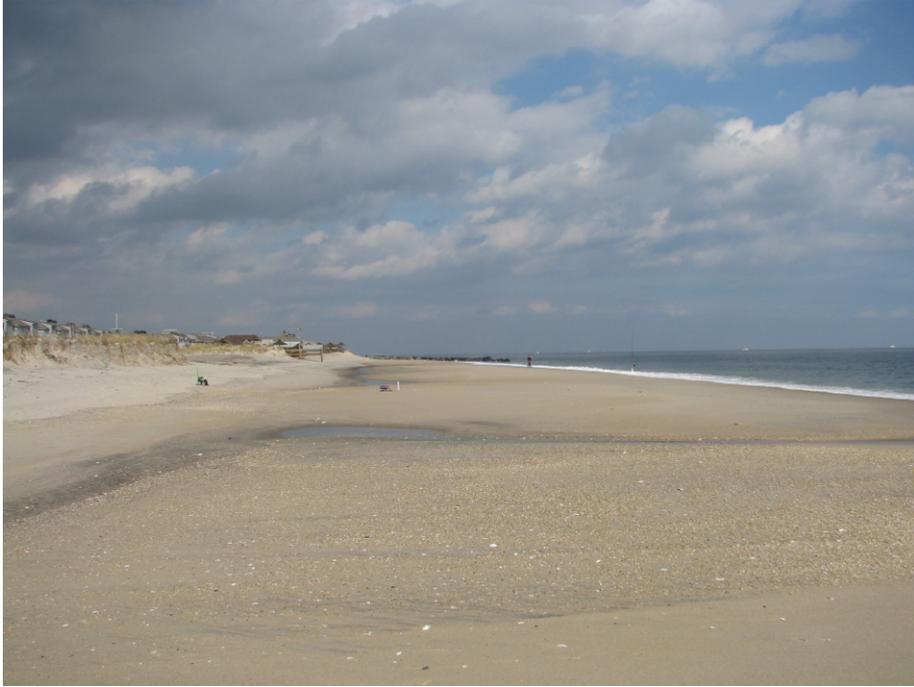
Photo taken November 5, 2009. View to the north.

Here, in contrast to Site 179 a short distance away, there is a decent beach and healthy dune system. There is a need for a maintenance fill or modification to the privately-owned structure causing the problem.

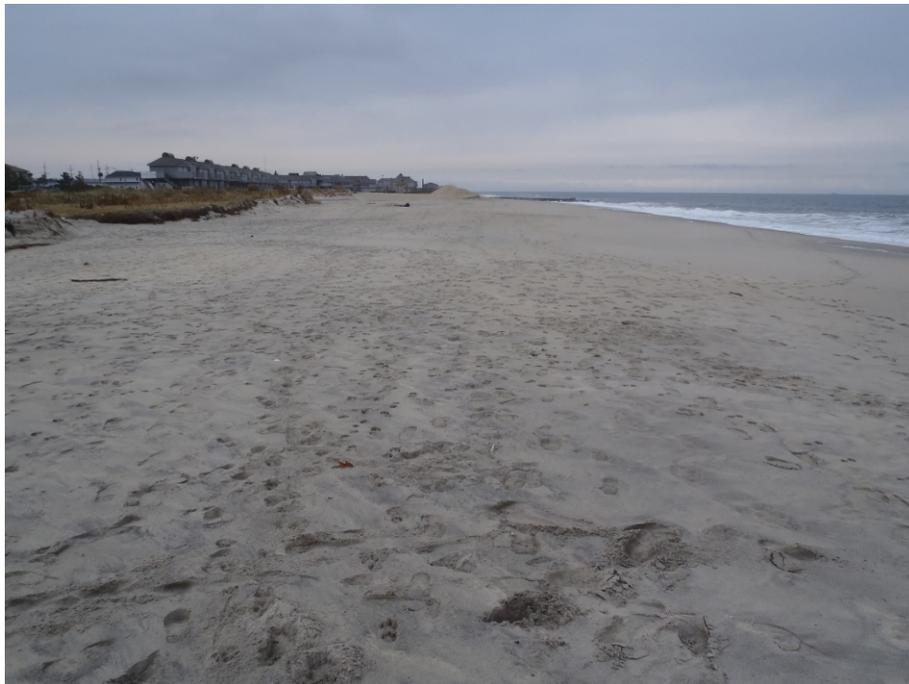
Photo taken November 16, 2010. View to the north.

Comparing the profiles over the year, the profile location lost volume (-18.49 cu yd/ft) and the shoreline moved landward (-14.27 ft).

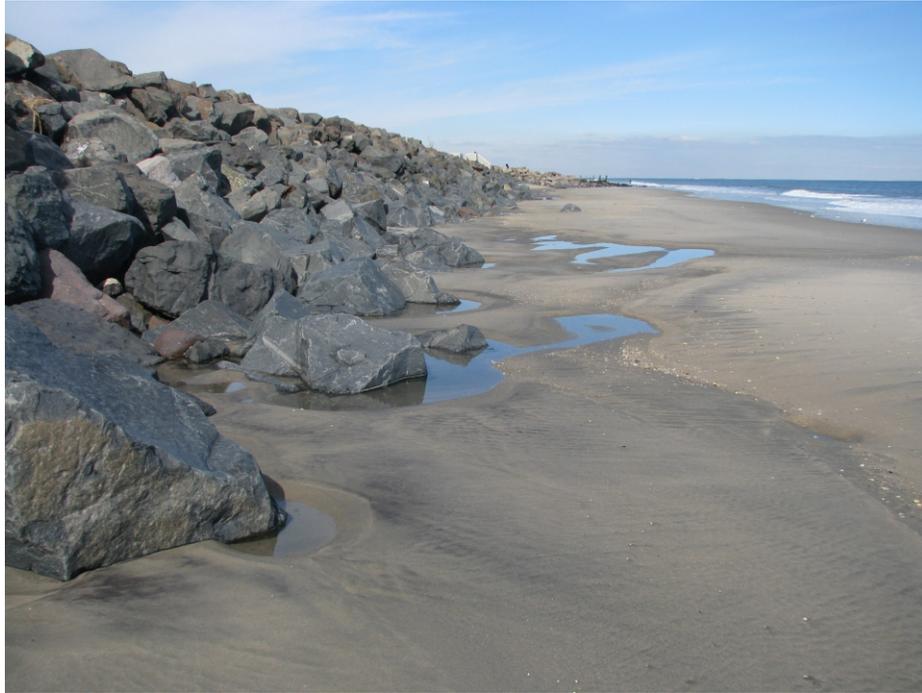
Photo taken November 4, 2009. View to the north.

Cottage Road is the southern source area for sand when littoral currents are moving north toward Sandy Hook. This is because of a massive rock groin built decades ago to protect a private beach club in Monmouth Beach located immediately to the south. Only a meager quantity of sand remains because the heavy reversal in the direction of longshore transport had yet to occur in sufficient magnitude.

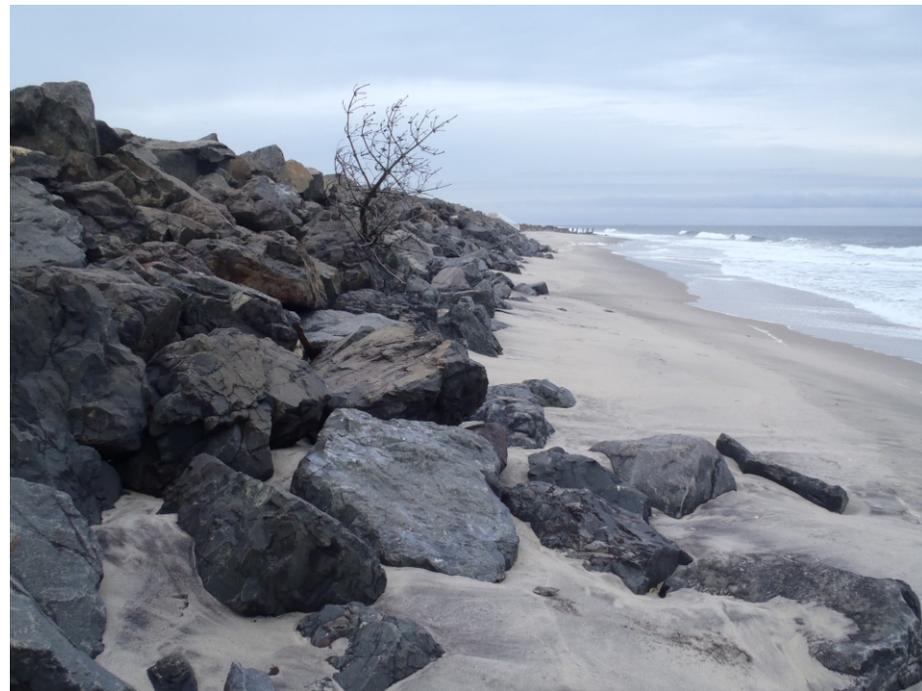
Photo taken November 16, 2010. View to the north.

Comparing the profiles over the year, the profile location lost volume (-7.08 cu yd/ft) and the shoreline moved landward (-19.3 ft).

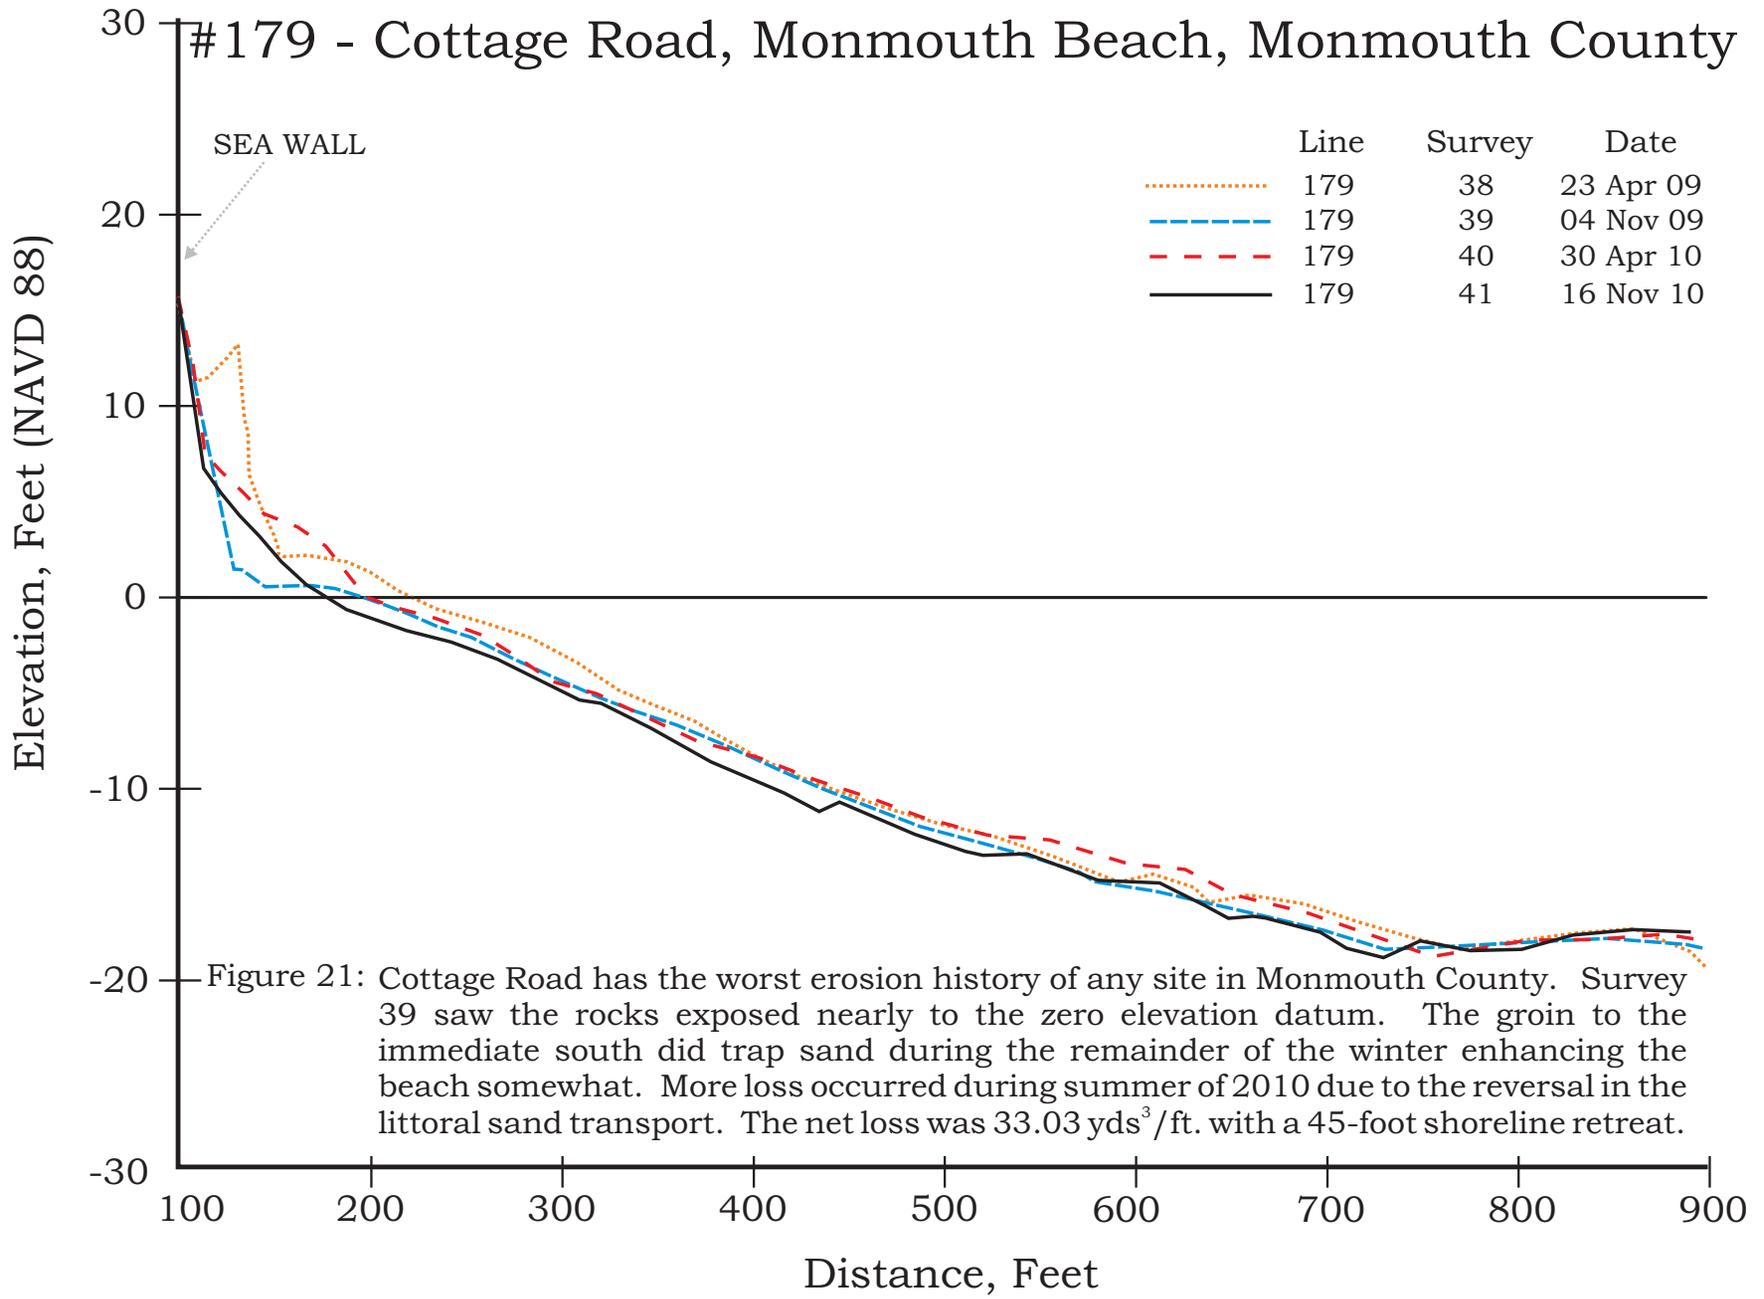
#179 - Cottage Road, Monmouth Beach, Monmouth County

Figure 21: Cottage Road has the worst erosion history of any site in Monmouth County. Survey 39 saw the rocks exposed nearly to the zero elevation datum. The groin to the immediate south did trap sand during the remainder of the winter enhancing the beach somewhat. More loss occurred during summer of 2010 due to the reversal in the littoral sand transport. The net loss was 33.03 yds³/ft. with a 45-foot shoreline retreat.

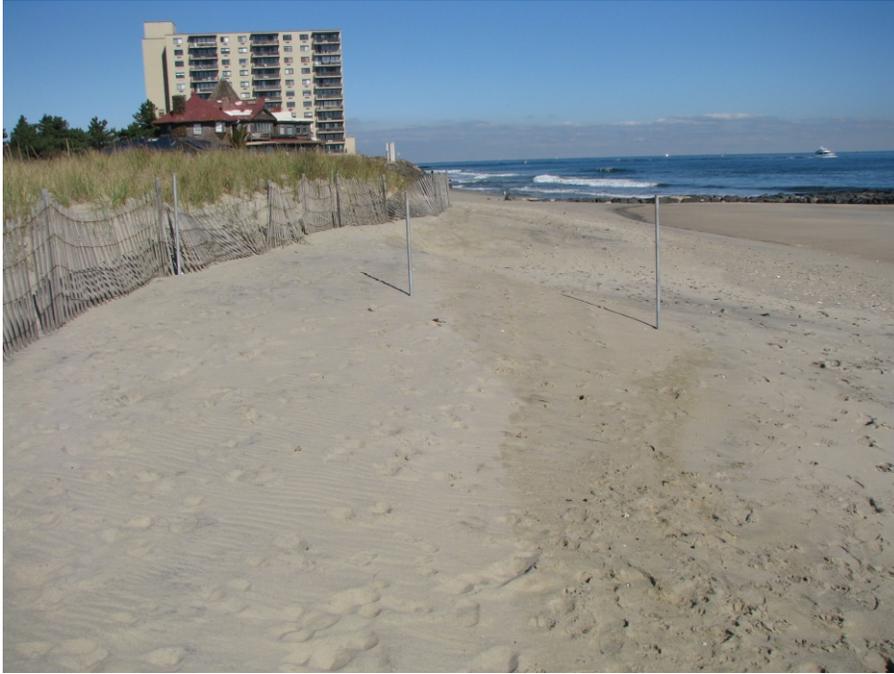
Photo taken November 4, 2009. View to the north.

The Monmouth Beach Club shoreline lies south of the big groin complex just south of Cottage Road. Sand transport around the Monmouth Beach Club area has been continuously difficult since the ACOE project was built.

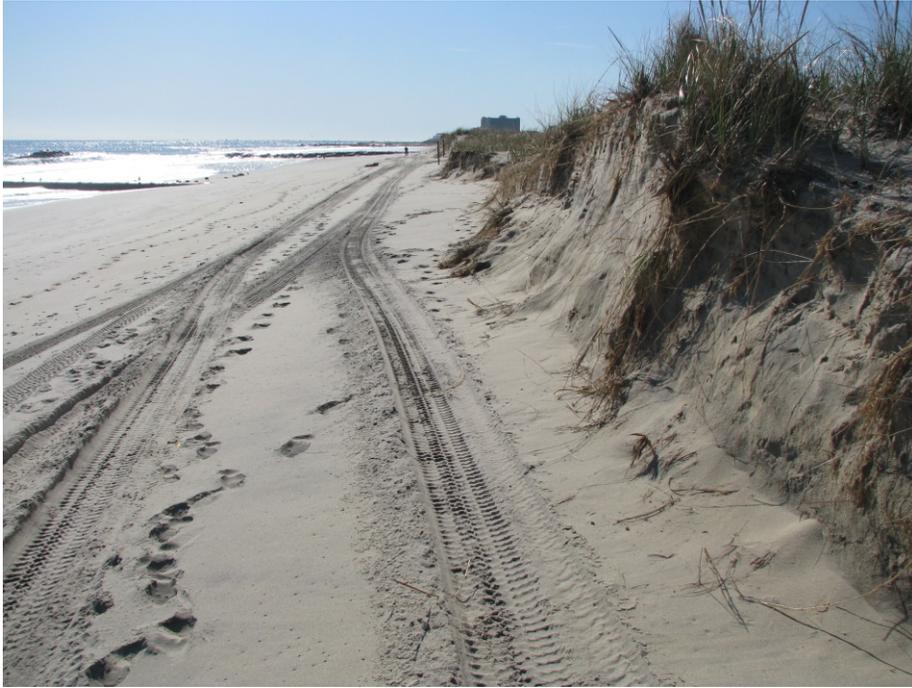
Photo taken November 4, 2009. View to the south.

The photo shows the dunes prior to the 2009 Veteran's Day storm.

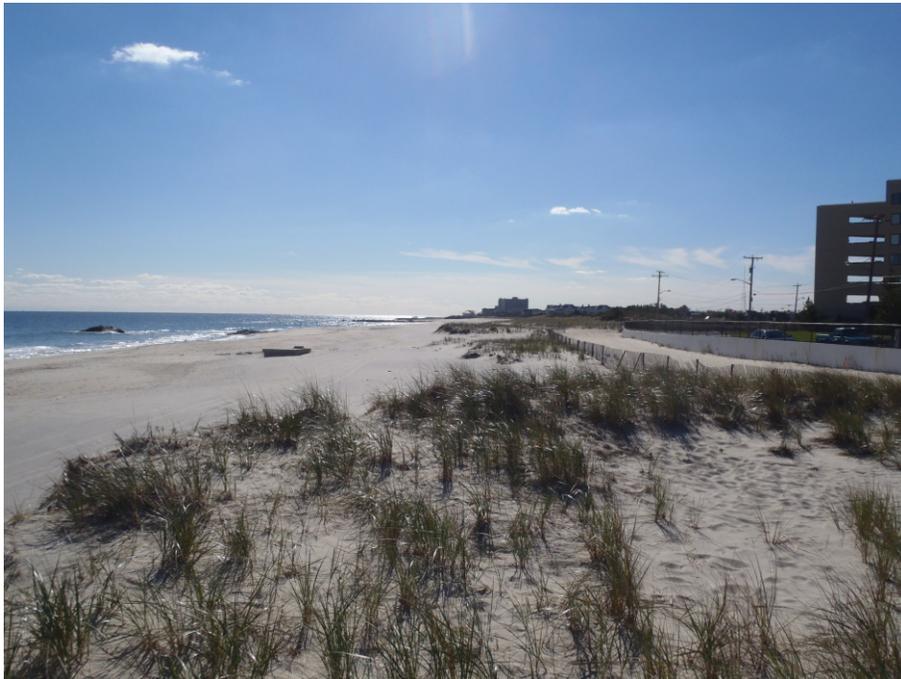
Photo taken November 2, 2010. View to the south.

Comparing the profiles over the year, the profile location lost volume (-18.73 cu yd/ft) and the shoreline moved landward (-66.57 ft).

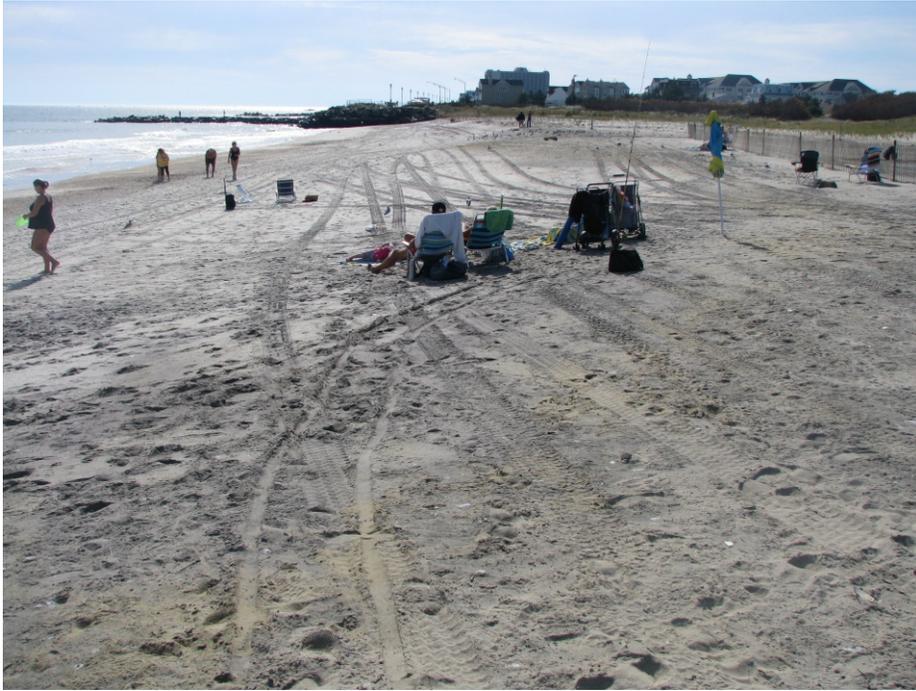
Photo taken October 22, 2009. View to the south.

At the Seven Presidents Park the beach had a broad flat slope to the water from a narrow segment of flat dry beach.

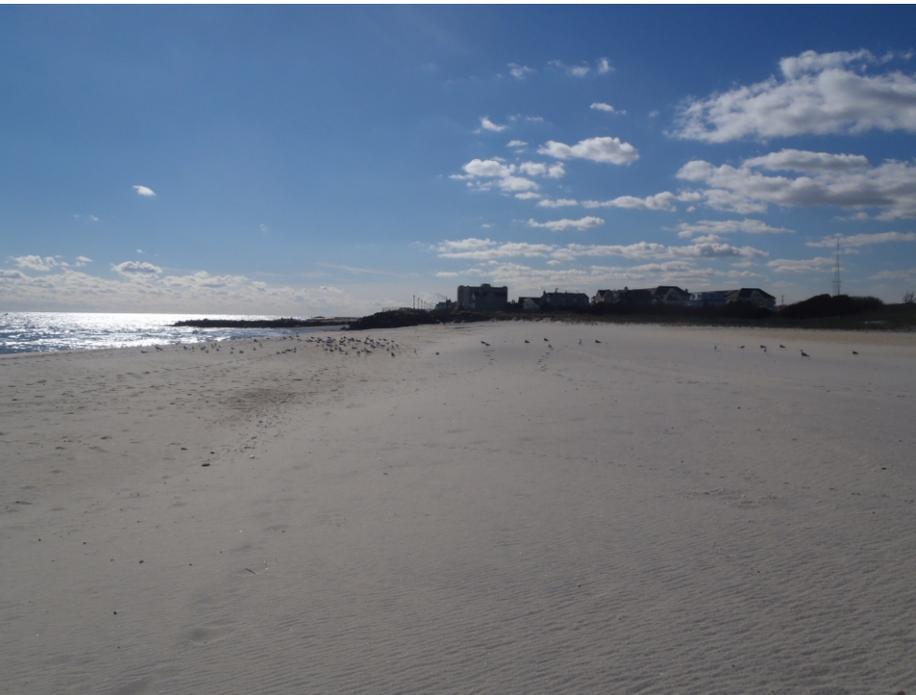
Photo taken November 2, 2010. View to the south.

Comparing the profiles over the year, the profile location lost volume (-1.27 cu yd/ft) and the shoreline moved seaward (44.92 ft). Most of the sand was lost below the 0.0 ft NAVD88 datum.

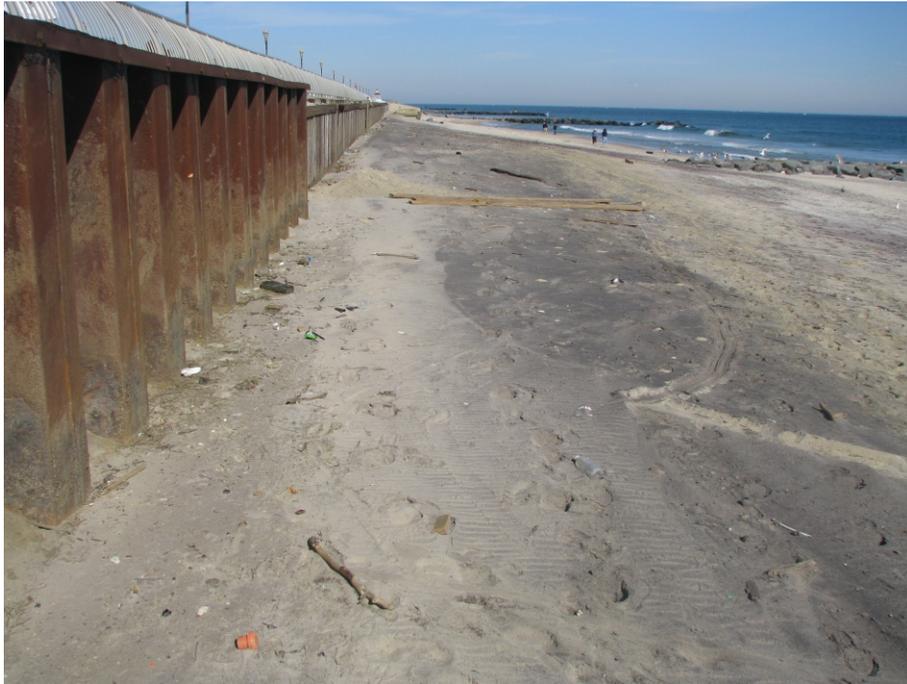
Photo taken October 22, 2009. View to the north.

The old rusted steel showing in both photographs is the top of the 70-year old vertical steel bulkhead used to defend the uplands bluff.

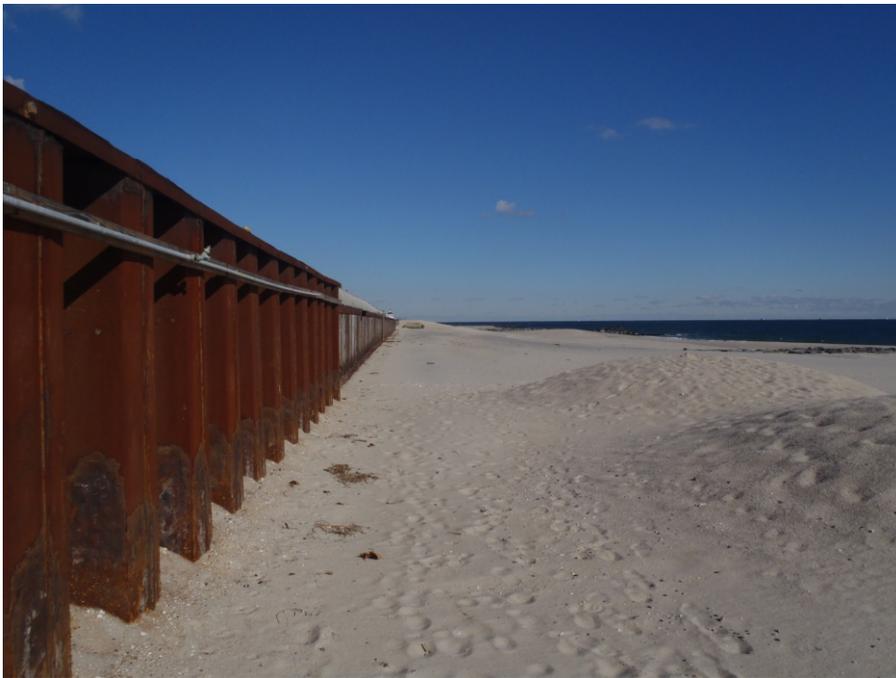
Photo taken November 2, 2010. View to the north

Comparing the profiles over the year, the profile location gained volume (20.62 cu yd/ft) and the shoreline moved seaward (67.5 ft). Most of the gain was above the 0.00 ft NAVD88 datum.

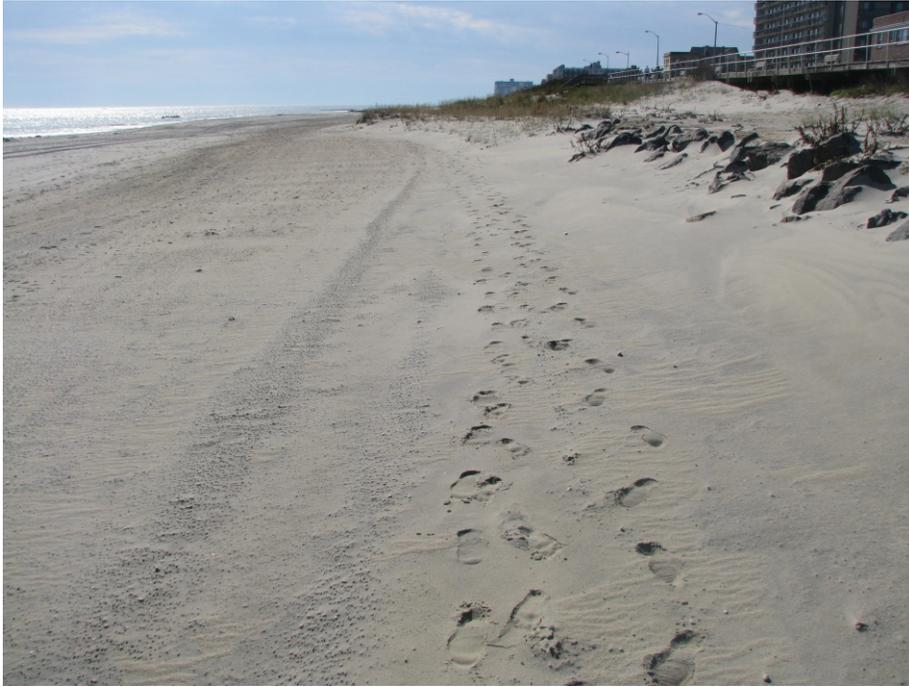
Photo taken October 22, 2009. View to the south.

This central area of the Long Branch municipal beach is defended by both groins and a rock sea wall at the bluff. Sand was placed on the beaches to the south of this site in 2009 by the USACE as maintenance material and this site benefitted from the northward transport of sediment in 2009.

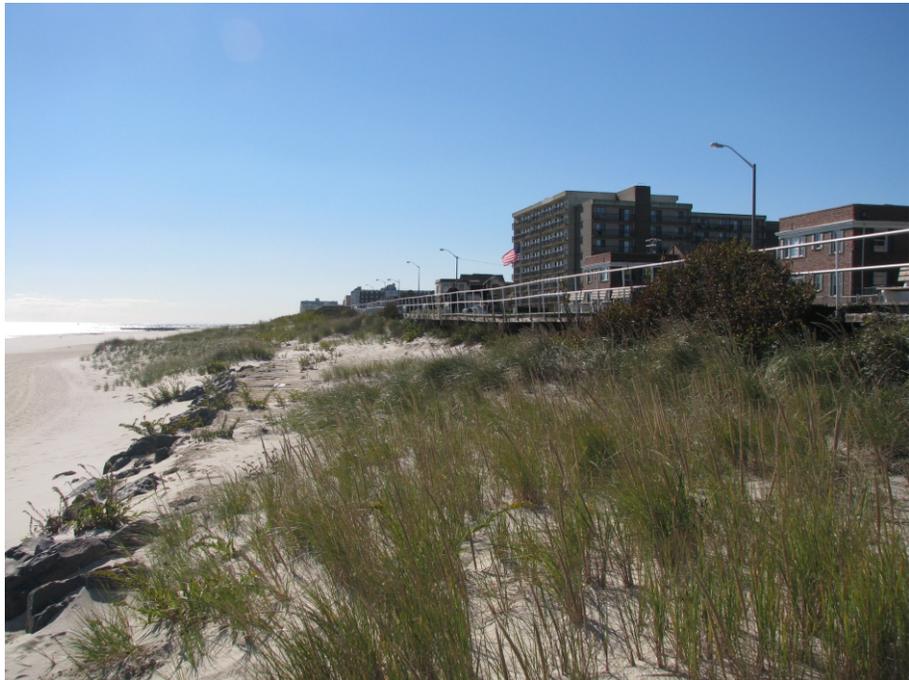
Photo taken November 1, 2010. View to the south.

Comparing the profiles over the year, the profile location lost volume (-15.94 cu yd/ft) and the shoreline moved landward (-25.489 ft). Most of the volume loss occurred below the 0.0 ft NAVD88 datum.

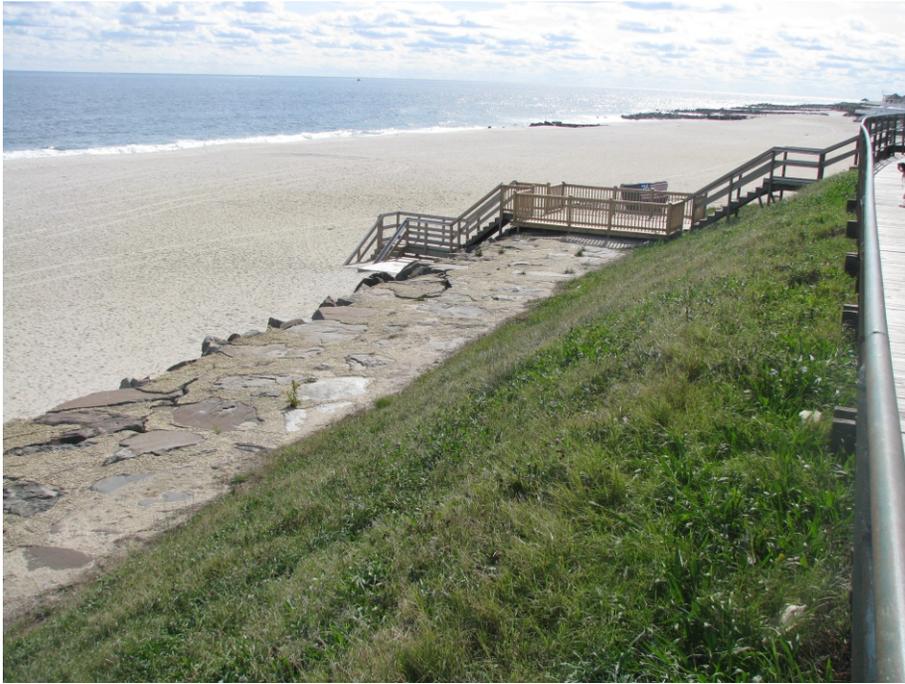
Photo taken October 14, 2009. View to the south.

This is the southernmost survey site within the Long Branch to Sandy Hook segment of the Monmouth County beach fill. The deposition stopped just south of here due to real estate issues along privately owned oceanfront tracts in Elberon and Deal into Allenhurst. This view shows the top of the bluff, the rock sea wall and the remaining beach between the groins. The 2009 beach restoration maintenance fill augmented this site substantially by March 2009.

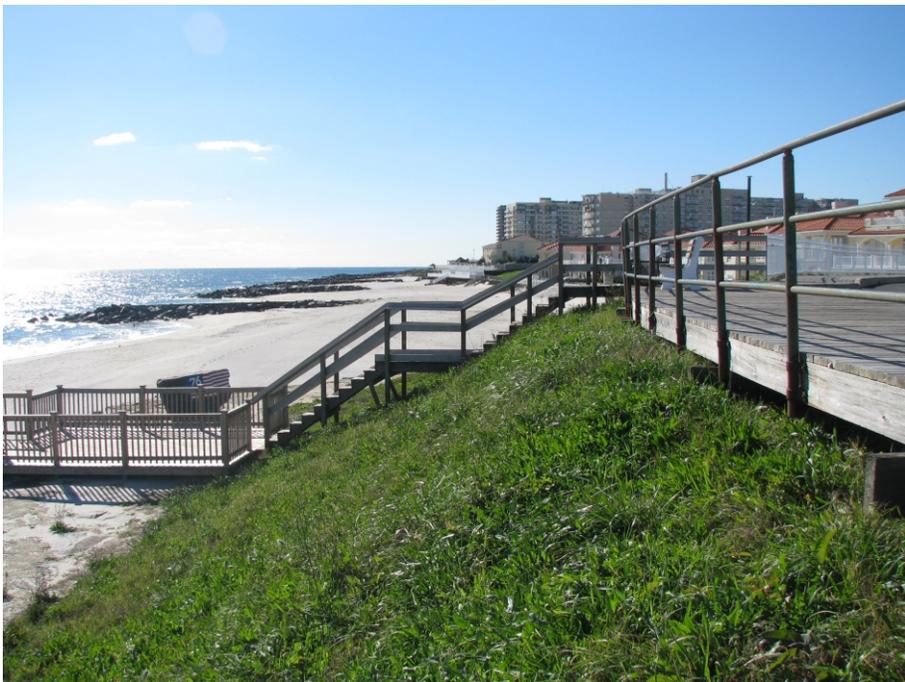
Photo taken November 1, 2010. View to the south.

Comparing the profiles over the year, the profile location lost volume (-85.5 cu yd/ft) and the shoreline moved landward (-107.47 ft). Erosion of the maintenance fill material occurred over the whole profile.

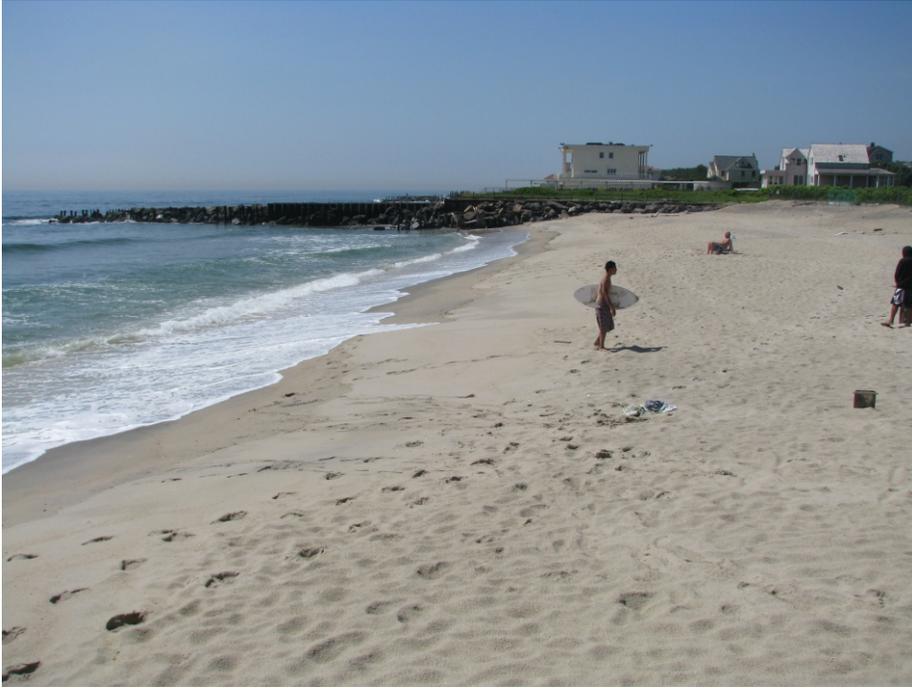
Photo taken June 2, 2010. View to the south.

This new site was established to replace former site 171 that was lost due to development.

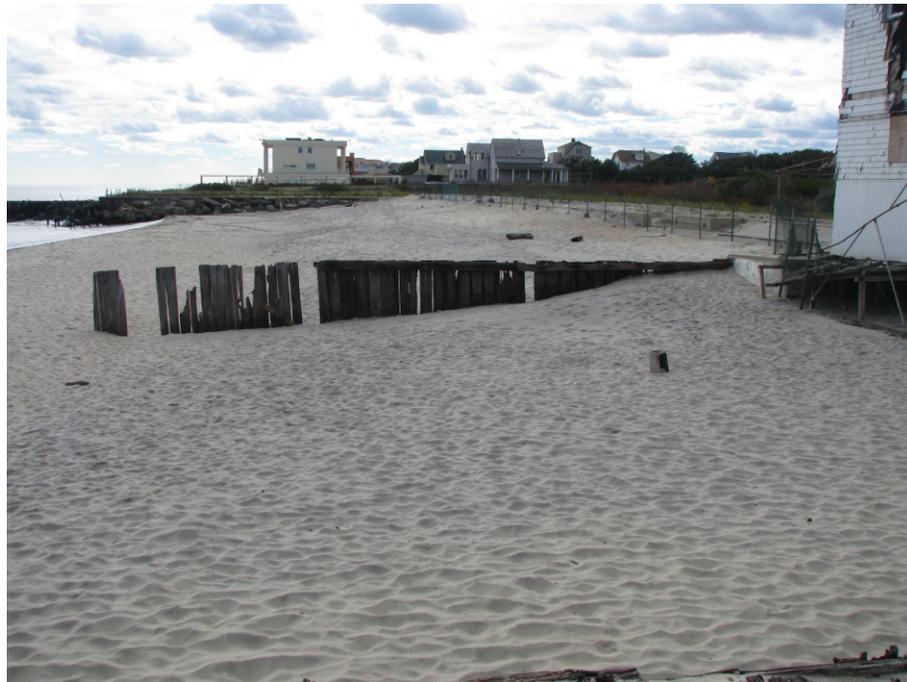
Photo taken October 29, 2010. View to the south.

Comparing the profiles over the summer (four months), the profile location gained volume (14.83 cu yd/ft)

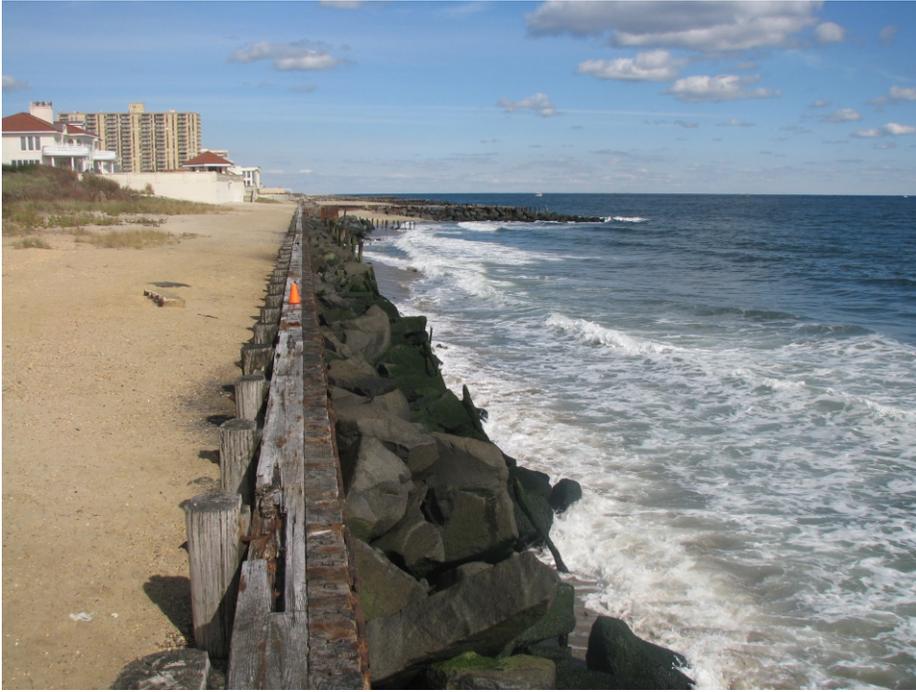
Photo taken October 14, 2009. View to the north.

Located on the highest elevation (+36 feet) along the Monmouth County bluff, this site lies about a mile south of the southern end of the beach fill in Long Branch. There was no dry beach in 2009, in fact none has existed since the May 2008 survey.

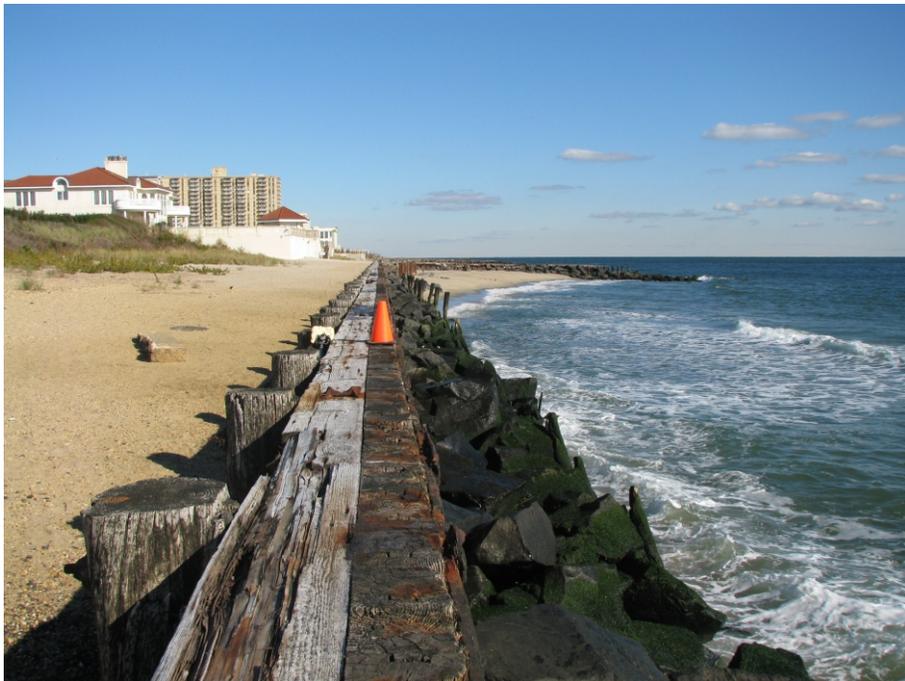
Photo taken November 1, 2010. View to the north (on the bulkhead/revetment).

Comparing the profiles over the year, the profile location gained volume (5.77 cu yd/ft) and the shoreline moved landward (-1.76 ft). Most of the volume loss occurred above the 0.0 ft NAVD88 datum.
