New Jersey Beach Profile Network 2010 Annual Report on Shoreline Changes in New Jersey Coastal Reaches One Through Fifteen Raritan Bay to Delaware Bay

New Jersey Department of Environmental Protection
Division of Construction and Engineering
1510 Hooper Avenue, Toms River, New Jersey 08753

The Richard Stockton Coastal Research Center
Richard Stockton College of New Jersey
30 Wilson Avenue, Port Republic, NJ 08241

June 30, 2011

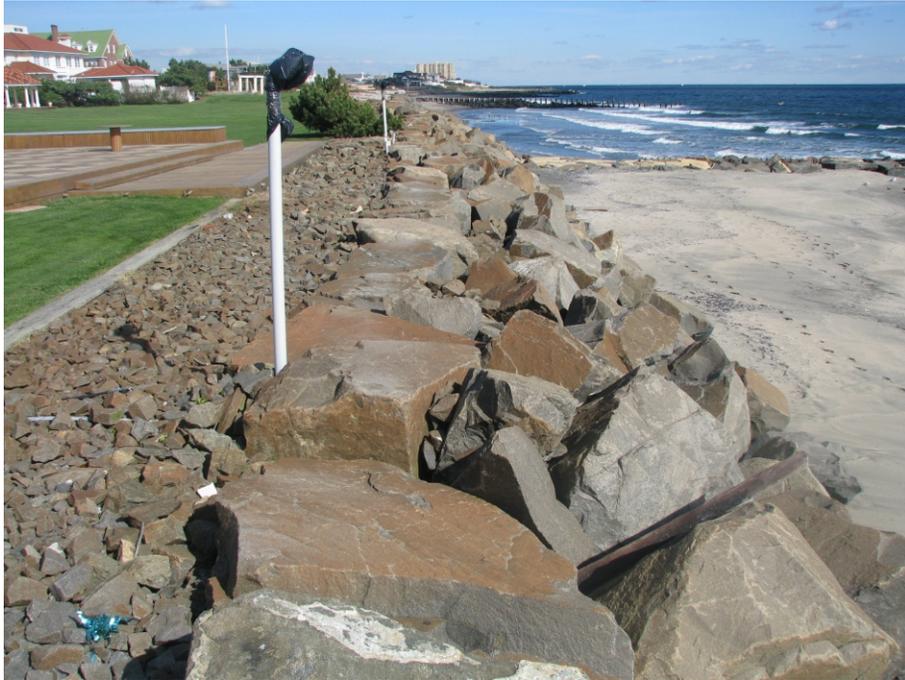
Photo taken October 14, 2009. View to the north.

This view to the north along the rock-armored shoreline of Deal shows a small sand pocket trapped against the northern groin in the cell. Sand shifts north to south within the cell, but little new material can move laterally along the shoreline. Groins every 700 to 1,000 feet make that impossible.

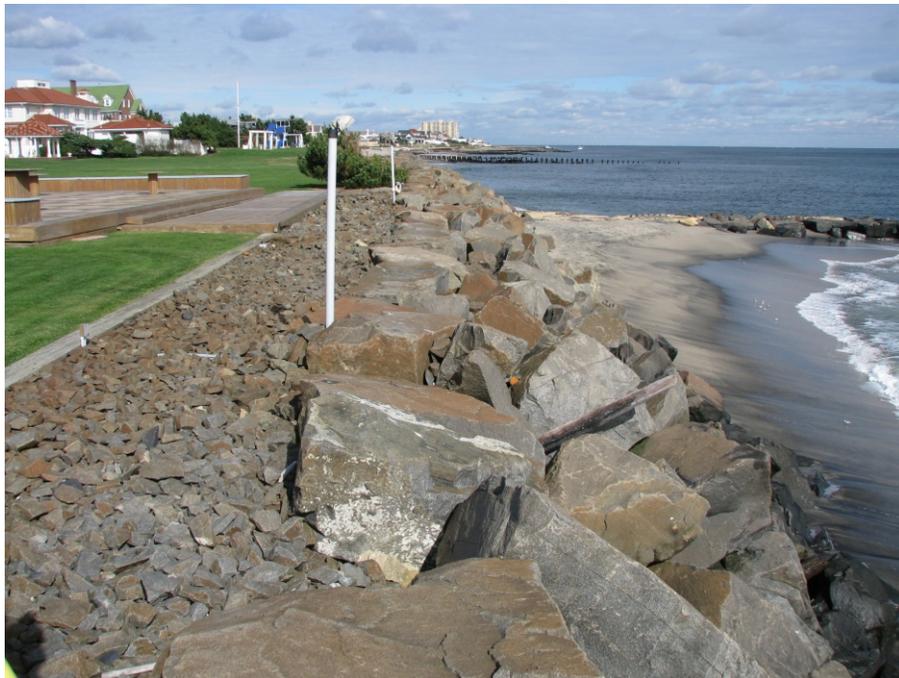
Photo taken October 29, 2010. View to the north.

Comparing the profiles over the year, the profile location gained volume (3.95 cu yd/ft) and the shoreline moved landward (-17.54 ft). The volume loss occurred above the 0.0 ft NAVD88 datum.

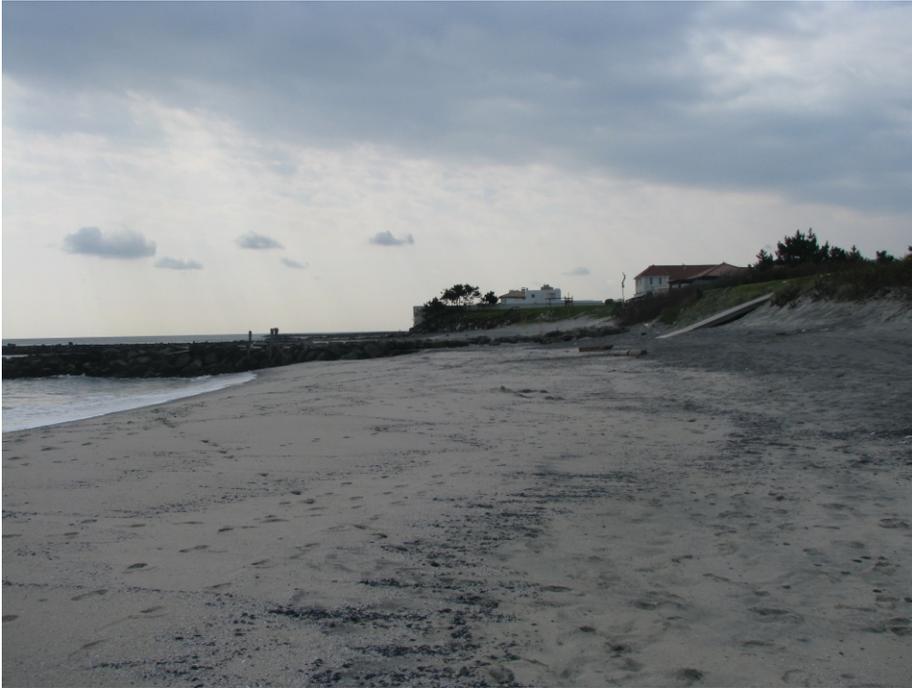
Photo taken October 13, 2009. View to the south.

Darlington Avenue in Deal has the best preserved bluff shoreline anywhere along the Monmouth County coast. The beach berm protects the toe of the bluff. The sand had ramped up the slope and was vegetated. Recently, owners have placed rock along the toe of the bluff to the south of the line at Darlington Avenue.

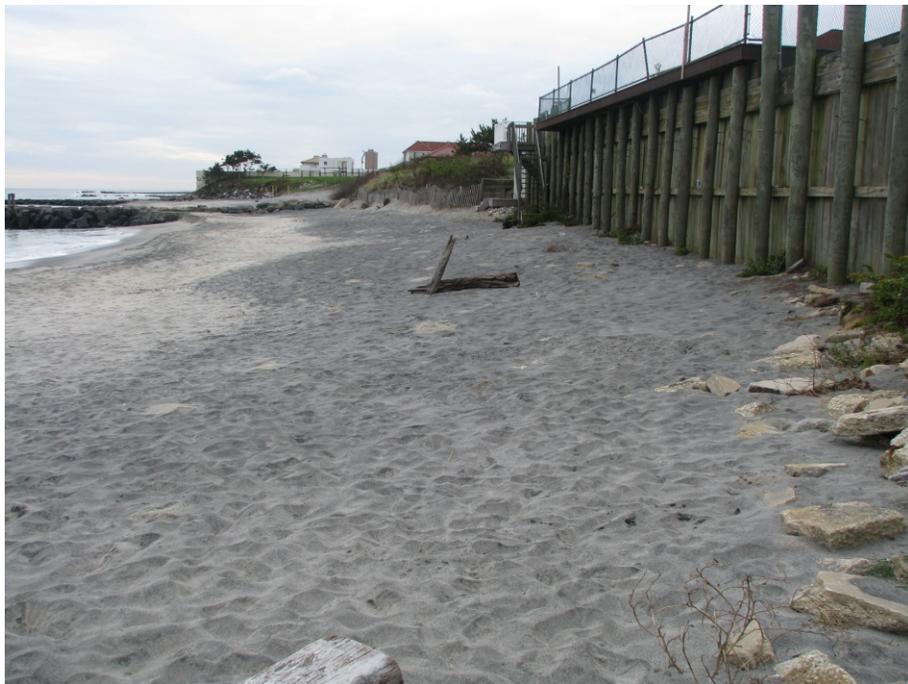
Photo taken October 29, 2010. View to the south.

Comparing the profiles over the year, the profile location lost volume (-8.14 cu yd/ft) and the shoreline moved landward (-14.6 ft).

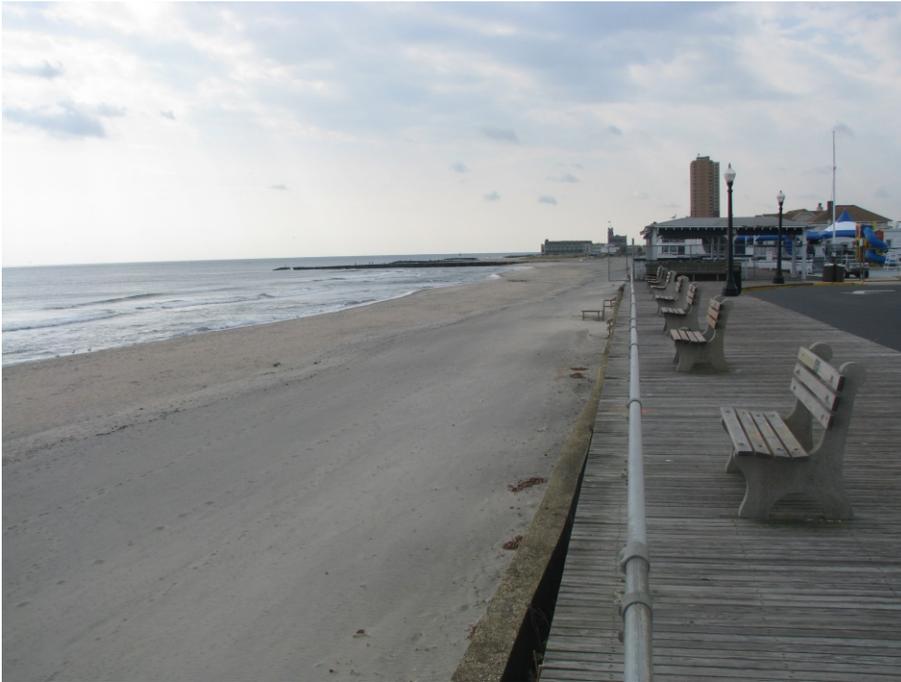
Photo taken October 13, 2009. View to the south.

The Allenhurst beach is located in front of an old concrete seawall built to protect the easily eroded bluff years ago. It has survived many storms. The beach was wider than it had been in decades due to sand escape from the groin seen to the south that retains the Asbury Park section of the Federal fill. For some reason neither Loch Arbor (a one-block wide oceanfront community) nor Allenhurst chose to participate in the US Army Corps Monmouth County project. However, the tendency for sand to move north along this part of the NJ coastline has provided a boost to both community beaches.

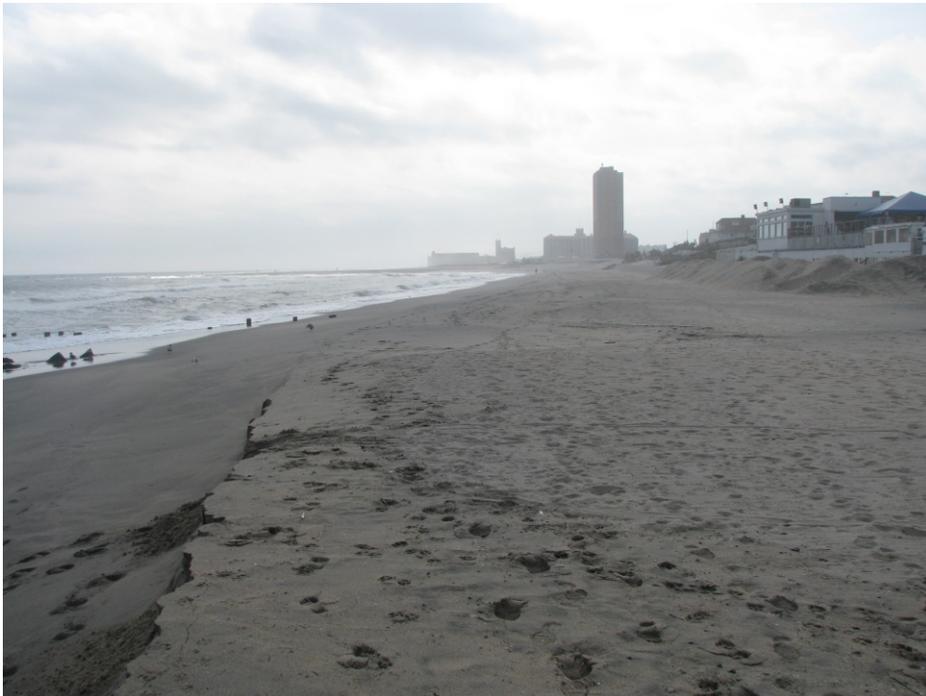
Photo taken October 26, 2010. View to the south.

Comparing the profiles over the year, the profile location lost volume (-12.88 cu yd/ft) and the shoreline moved landward (-42.48 ft).

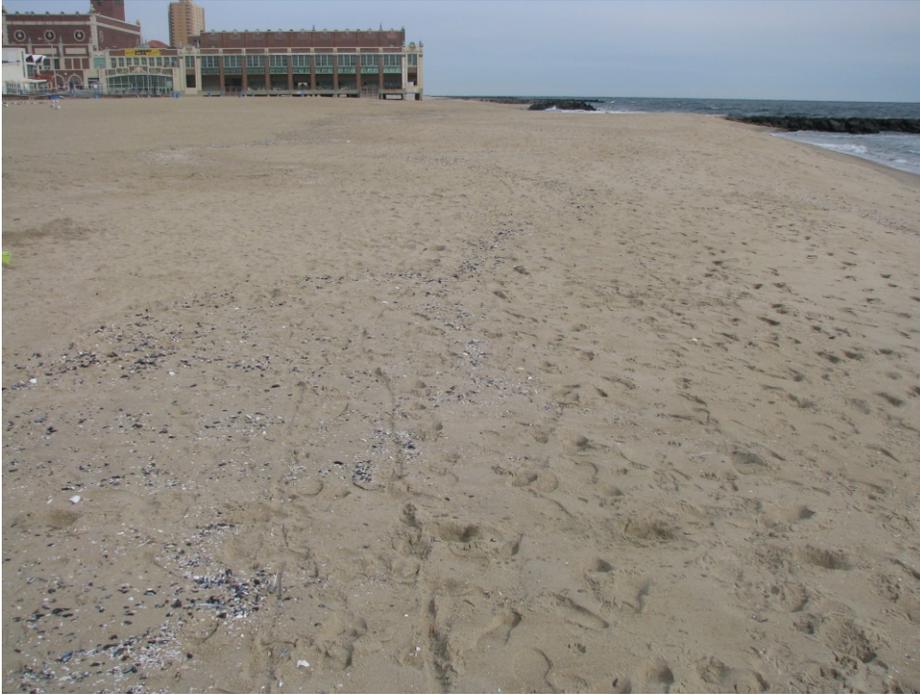
Photo taken October 12, 2009. View to the north.

The middle of the Asbury Park beach is wide and very flat with no dune. The recreational use precludes a natural dune from forming and no municipal work was done to force a dune to grow near the boardwalk.

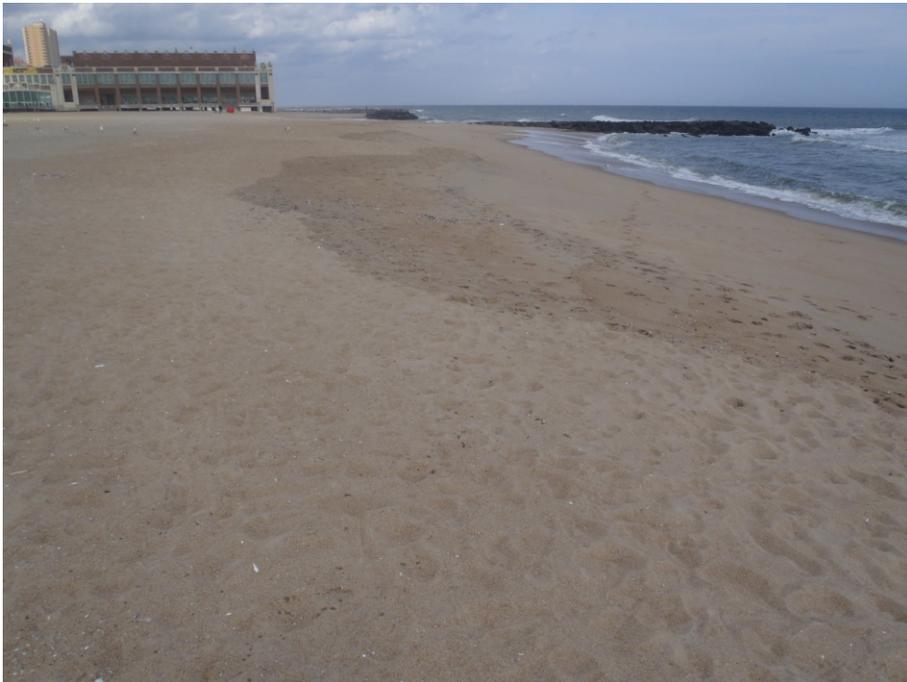
Photo taken October 25, 2010. View to the north.

Comparing the profiles over the year, the profile location lost volume (-21.77 cu yd/ft) and the shoreline moved landward (-23.92 ft).

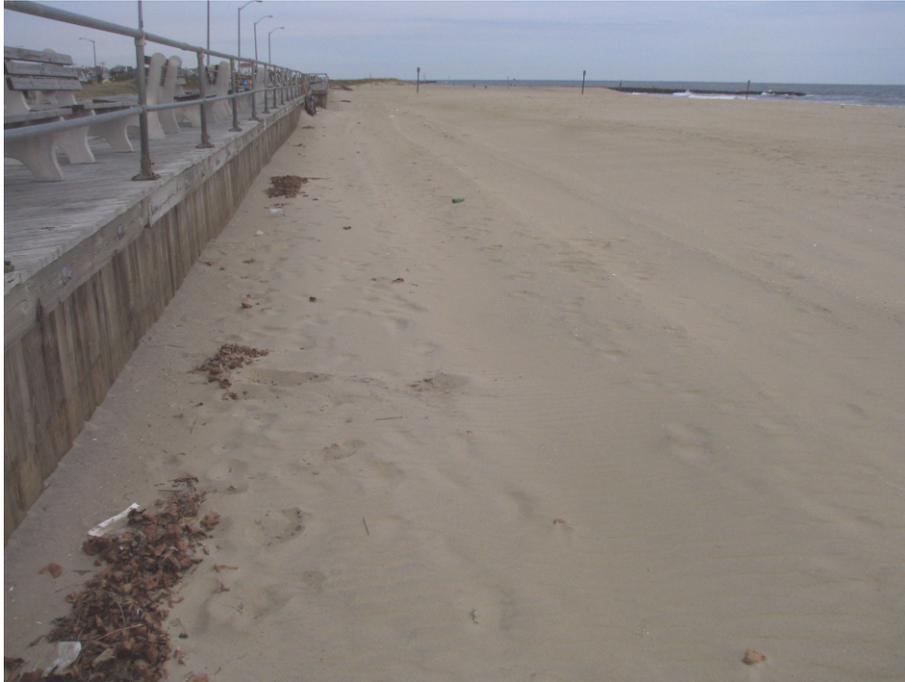
Photo taken October 12, 2009. View to the north.

Located at the northern end of the south segment of the Monmouth County project, this Asbury Park beach has retained most of the initial deposit of sand. No maintenance has been done since completion in 1999. There is a large terminal groin between Asbury Park and Loch Arbor that some sand has moved around in the last decade, but not enough to be any detriment to the Asbury Park beach.

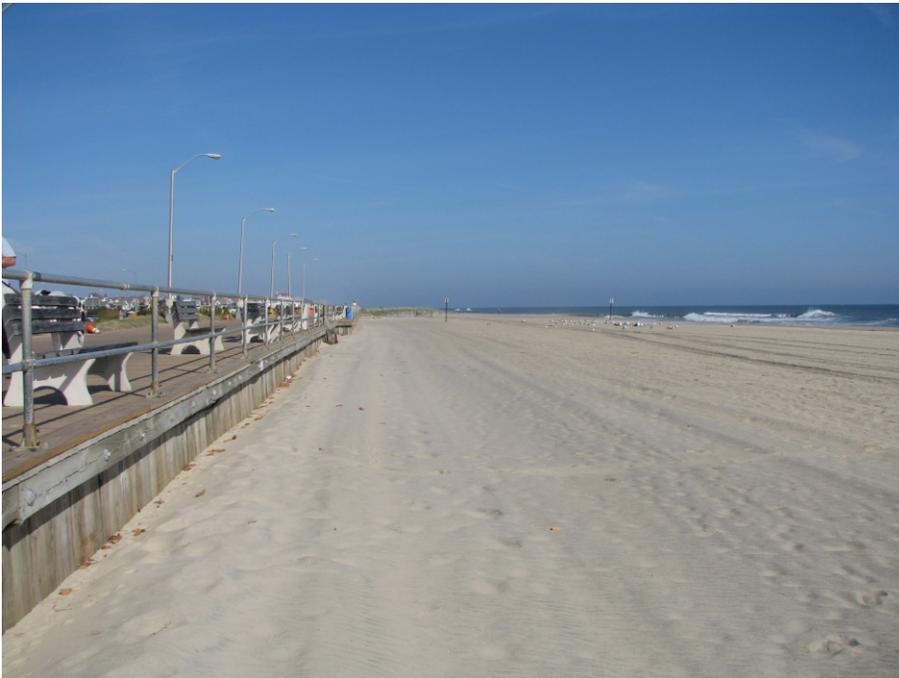
Photo taken October 26, 2010. View to the north.

Comparing the profiles over the year, the profile location lost volume (-22.96 cu yd/ft) and the shoreline moved landward (-28.21 ft).

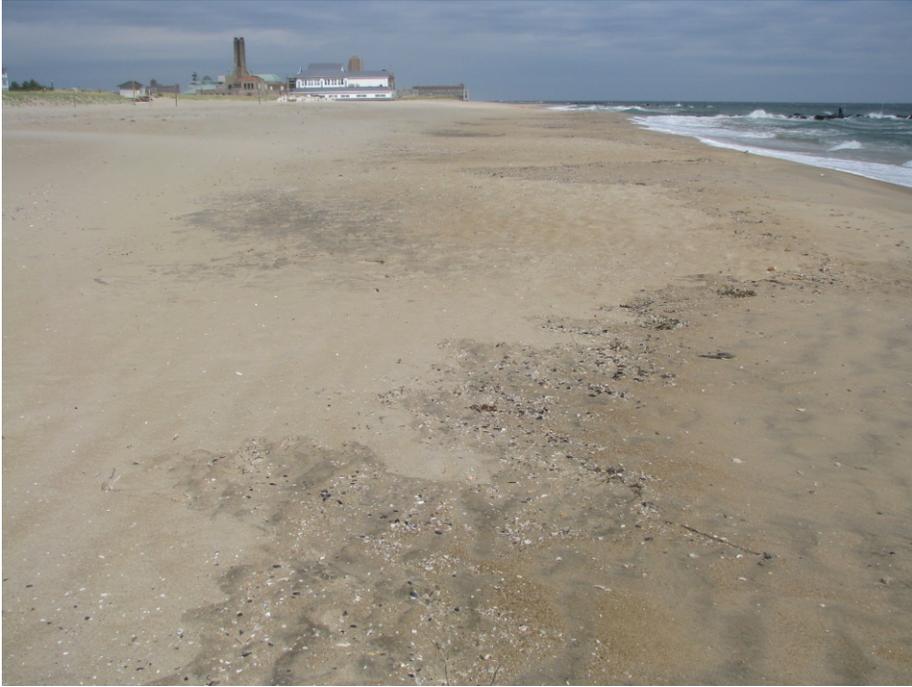
OCEAN PATHWAY, OCEAN GROVE - SITE 166

Photo taken October 9, 2009. View to the north.

Ocean Grove has an equally wide beach as Asbury Park, but took steps to create a dune between the beach and the boardwalk.

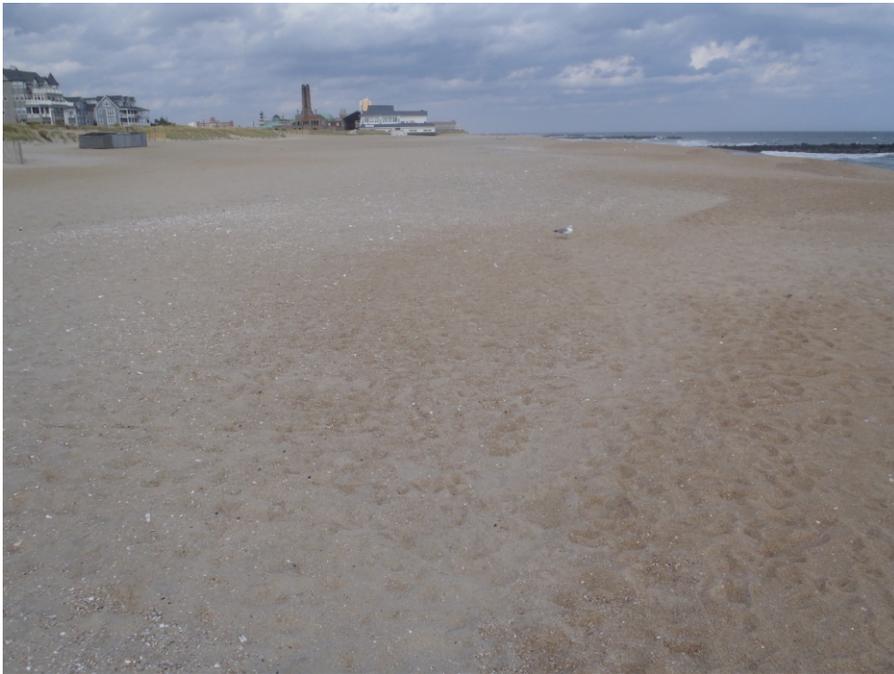
Photo taken October 25, 2010. View to the north.

Comparing the profiles over the year, the profile location lost volume (-6.17cu yd/ft) but the shoreline moved landward (-28.22 ft).

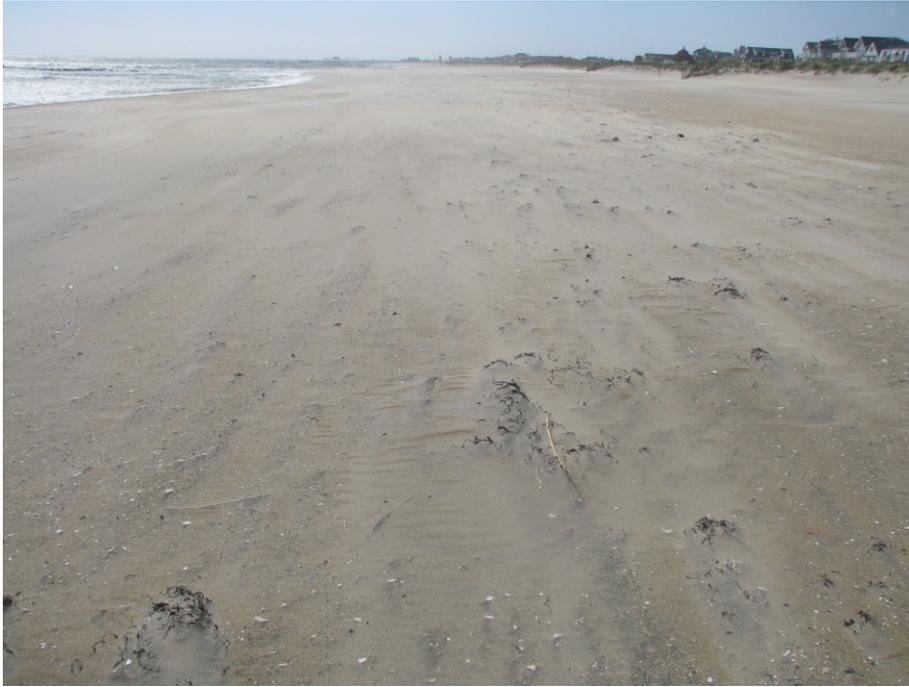
Photo taken October 9, 2009. View to the south.

This location is far different from what it was in 1996 before the beach fill. The first step the community made was to pull the boardwalk back off the beach and replace it with a paver promenade on the top of the bluff between Ocean Avenue and the boardwalk. This provided an additional 40 feet of badly needed beach width. By October 2008, the dune was well developed where the boardwalk once was and the filled beach extended 235 feet further seaward to the berm.

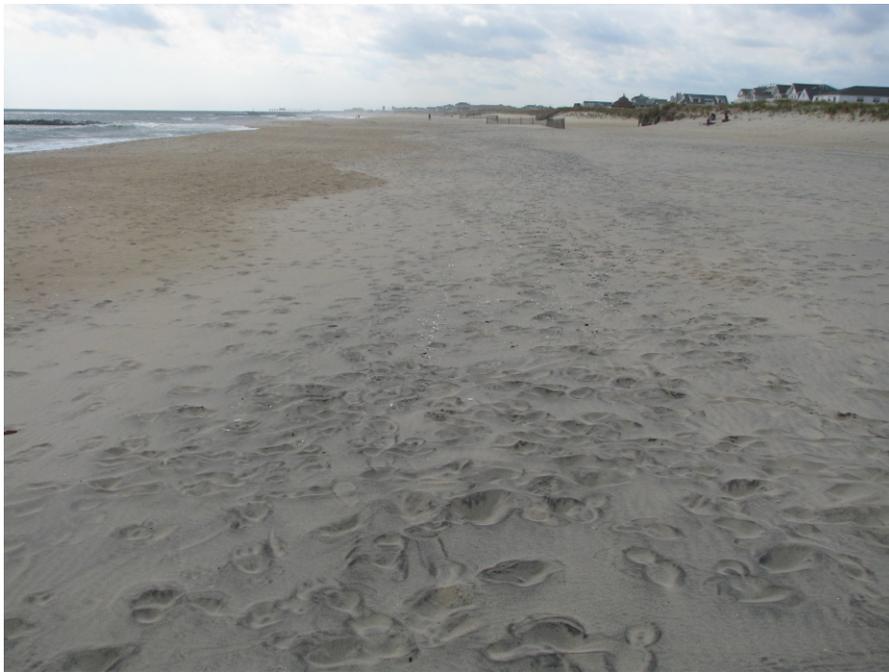
Photo taken October 25, 2010. View to the south.

Comparing the profiles over the year, the profile location lost volume (-23.25 cu yd/ft) and the shoreline moved landward (-25.96 ft).

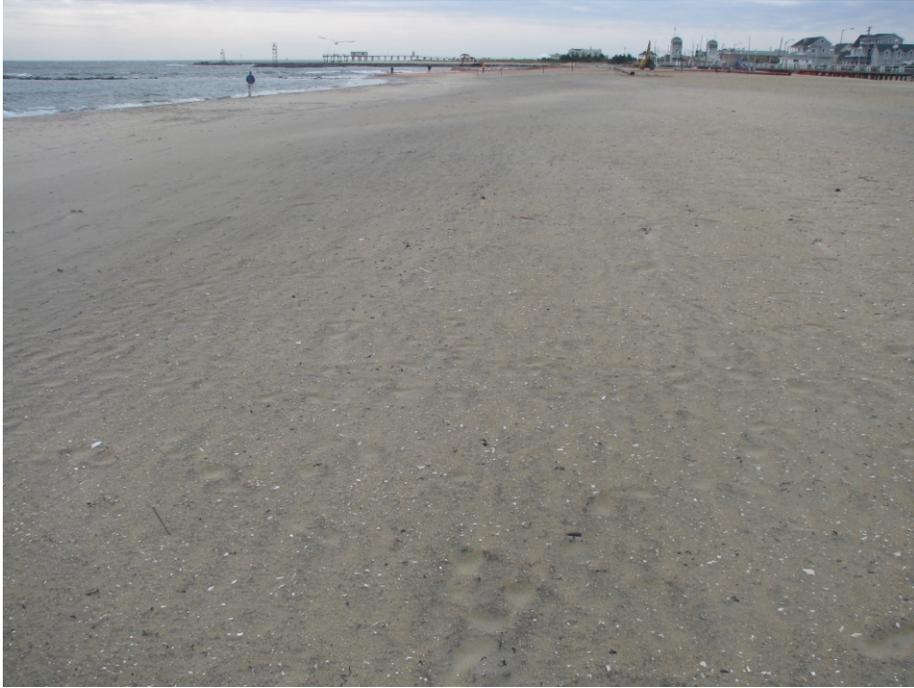
Photo taken October 9, 2009. View to the south.

This photo shows the beach just north of the Shark River Inlet. This is the most significant barrier to the free movement of sand along this southern Monmouth County fill segment. No dune was built along this community's shoreline so all the fill-widened beach is available for blankets in the summer.

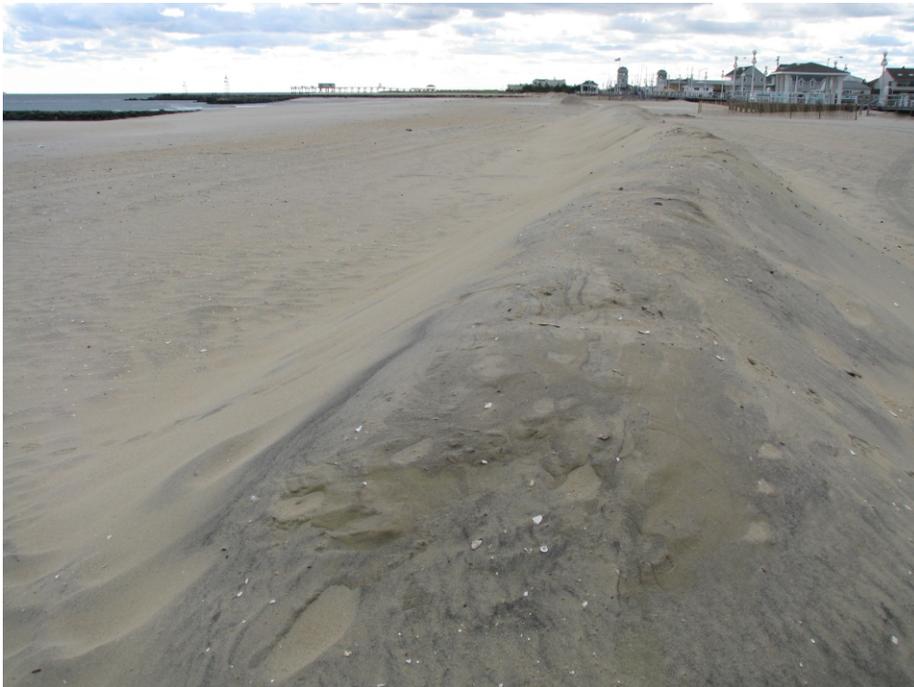
Photo taken October 22, 2010. View to the south.

In the fall/winter of 2009-2010, the town moved sand from the intertidal area to construct a dune and to prevent windblown sand from accumulating on the boardwalk. Comparing the profiles over the year, the profile location gained volume (18.24 cu yd/ft) and the shoreline moved landward (0.68 ft). Most of the volume gain was below the 0.0 ft NAVD88 datum.

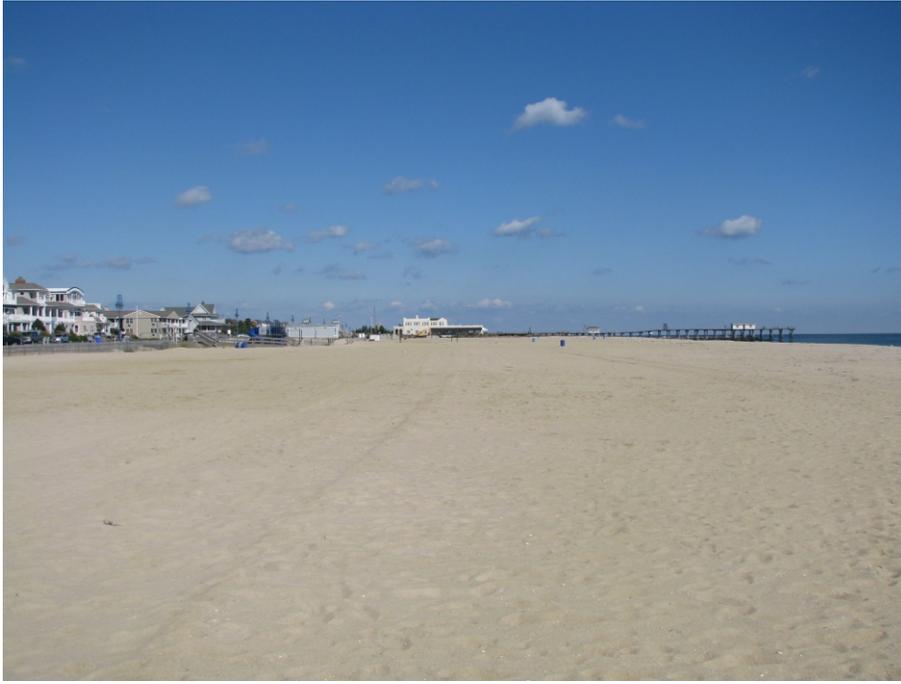
5th AVENUE, BELMAR - SITE 163

Photo taken October 5, 2009. View to the north.

The northern Belmar beach lies just south of the Shark River Inlet and has historically trapped sand moving north. This photograph illustrates the 350-foot wide, flat beach with a token dune just east of the boardwalk.

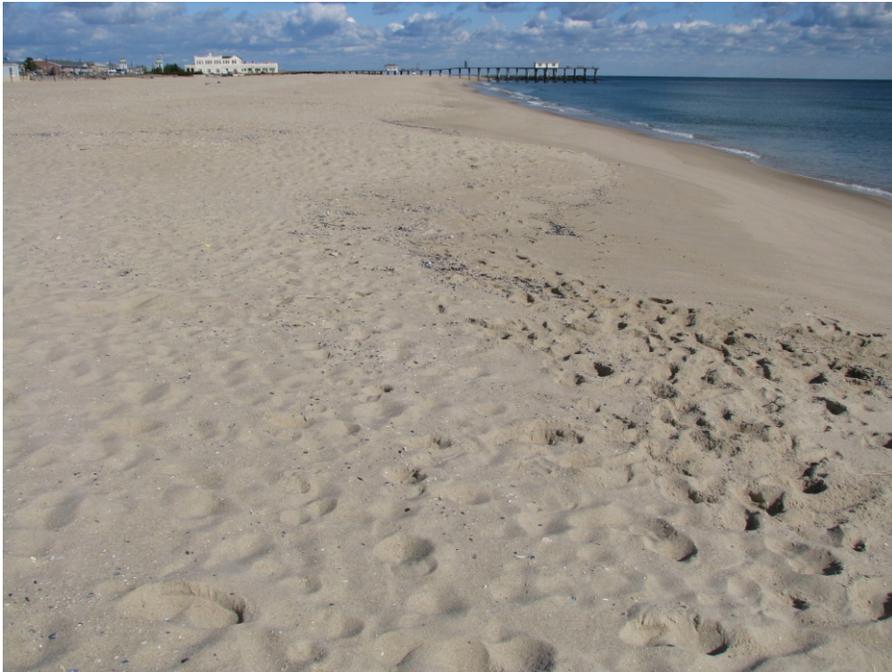
Photo taken October 22, 2010. View to the north.

Comparing the profiles over the year, the profile location lost volume (-4.05cu yd/ft) and the shoreline moved landward (-2.36 ft).

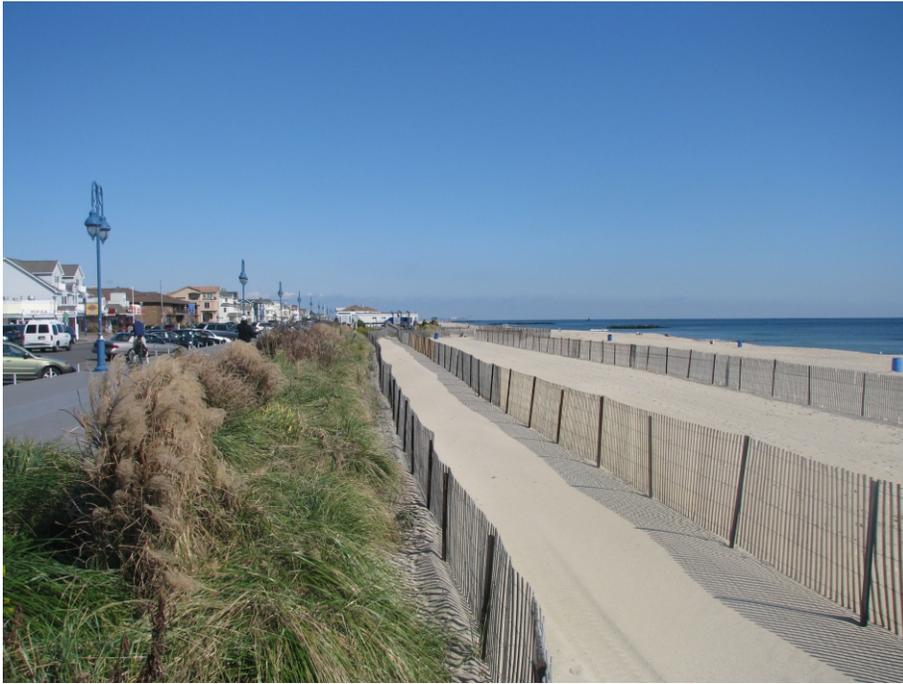
18th AVENUE, BELMAR - SITE 162

Photo taken October 5, 2009. View to the north.

In southern Belmar the beach is a little narrower, but the “dune” represents a landscaping endeavor. In 2008 the municipality erected three lines of sand fencing in an effort to reduce sand transport onto Ocean Avenue, the boardwalk and the decorative planting that constitutes the City’s dune system.

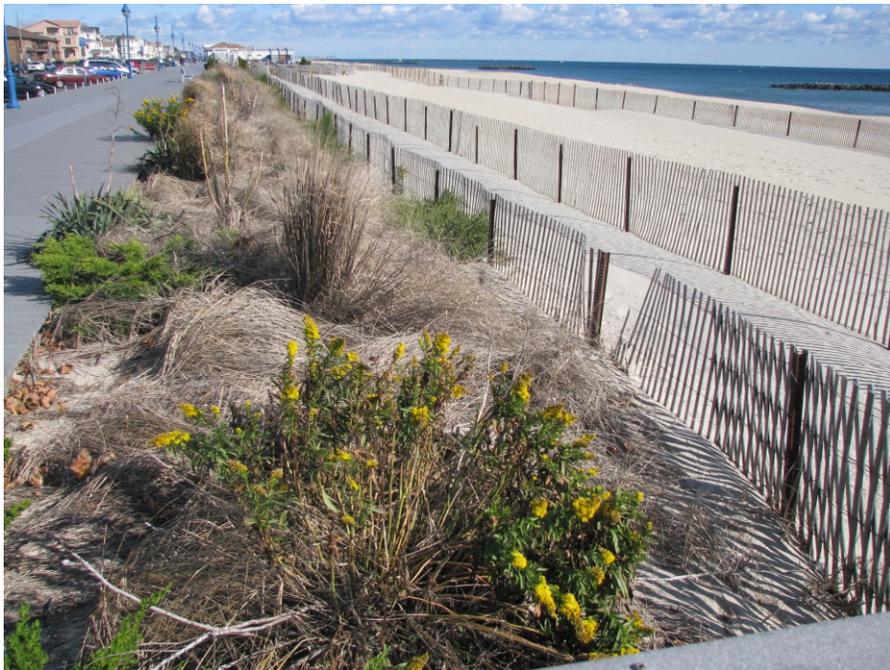
Photo taken October 22, 2010. View to the north.

Comparing the profiles over the year, the profile location lost volume (-16.38 cu yd/ft) and the shoreline moved landward (-13.02 ft). The City placed fencing for the winter season.

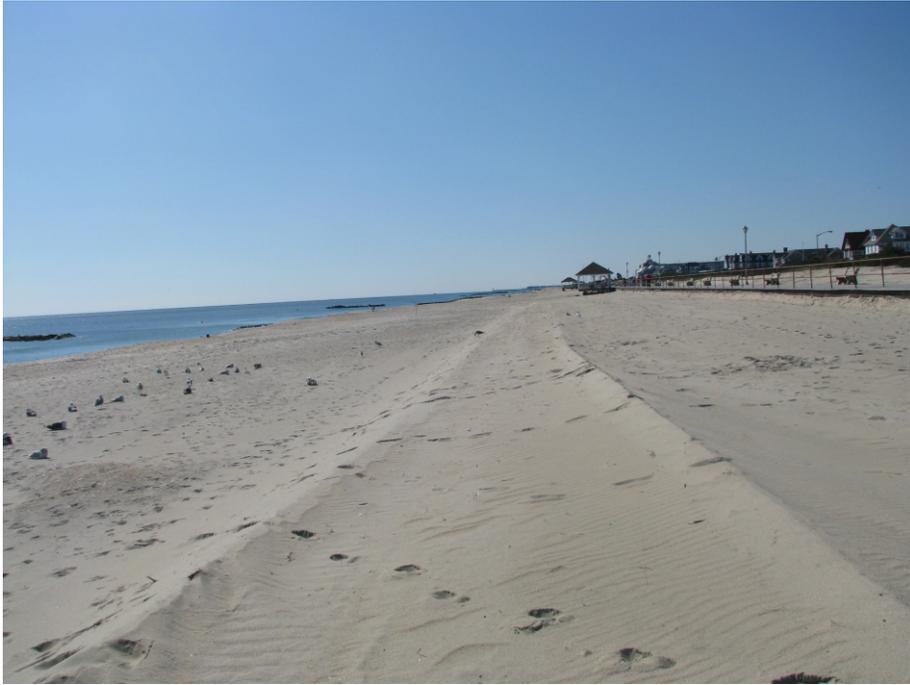
BRIGHTON AVENUE, SPRING LAKE - SITE 161

Photo taken October 5, 2009. View to the south.

The Spring Lake beach always had a dune located between the boardwalk and Ocean Avenue. This feature has grown larger since the Federal project was completed and a deep trough between the dune and the landward side of the boardwalk filled in with sand.

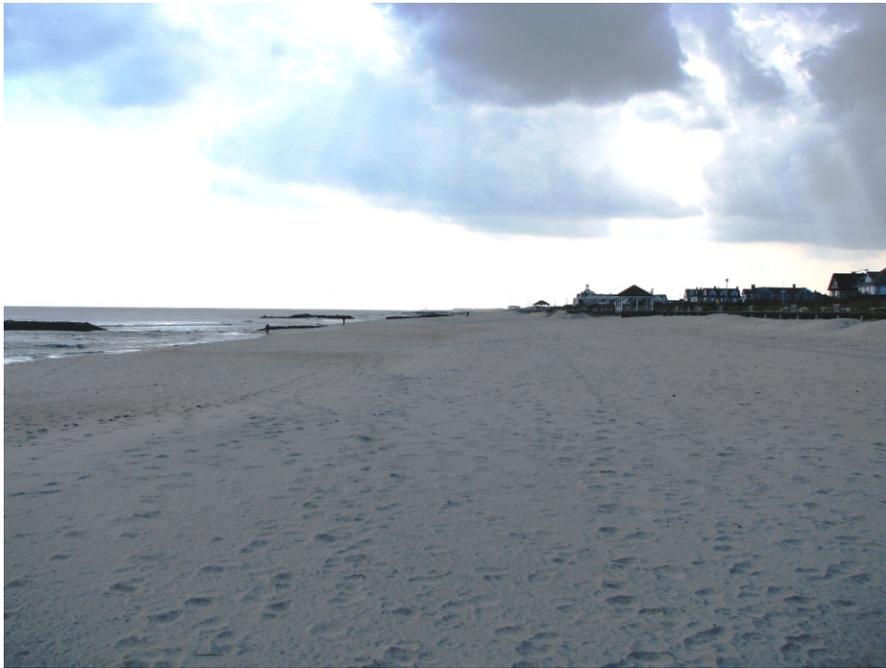
Photo taken October 21, 2010. View to the south.

Comparing the profiles over the year, the profile location lost volume (-16.59 cu yd/ft) and the shoreline moved landward (-40.37 ft).

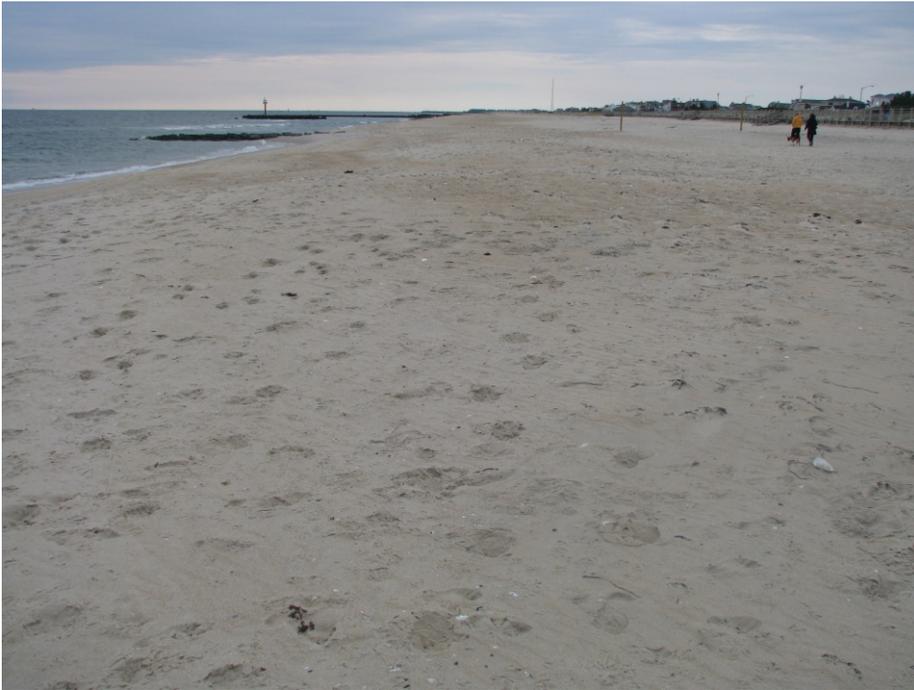
SALEM AVENUE, SPRING LAKE - SITE 160

Photo taken October 2, 2009. View to the south.

The beach restoration project dramatically changed the southern Monmouth County beaches by increasing the width by 200%.

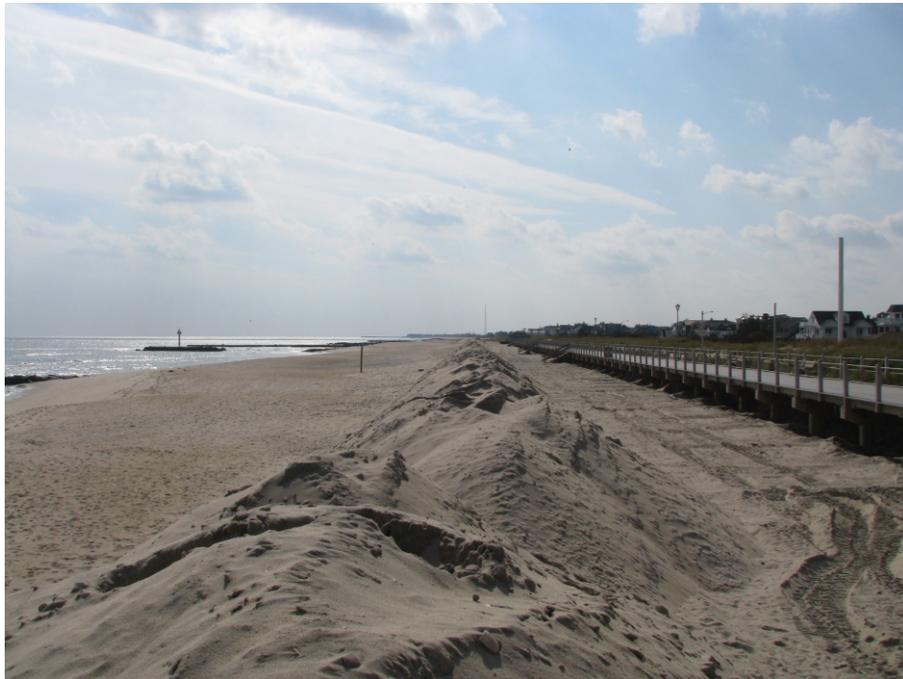
Photo taken October 21, 2010. View to the south.

The Town removed the sandy material from under the boardwalk and placed it on the beach as part of its routine sand management program. Comparing the profiles over the year, the profile location lost volume (-6.7 cu yd/ft) and the shoreline moved landward (-20.67 ft).

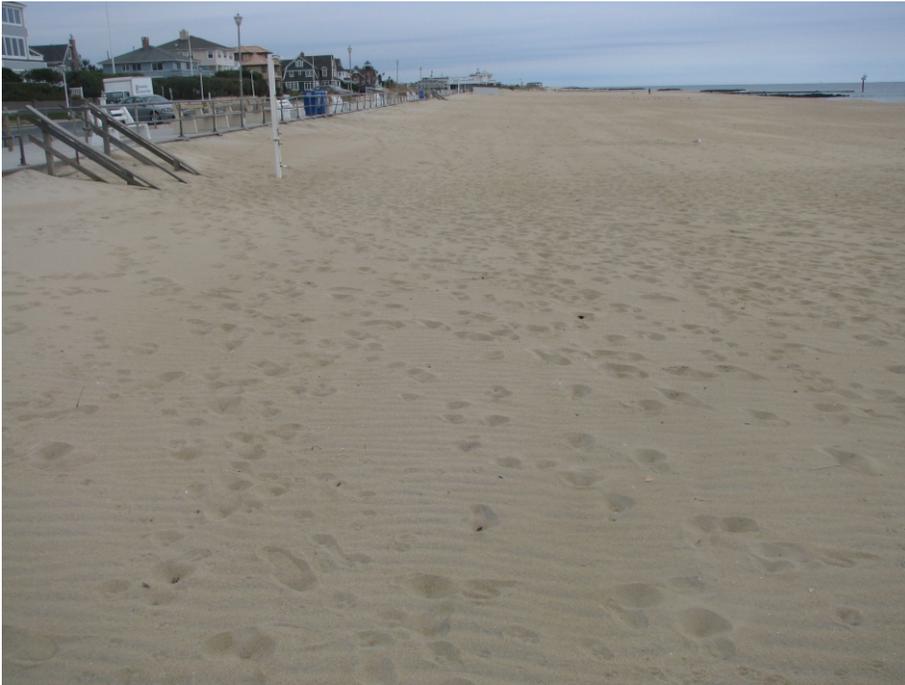
NEW YORK AVENUE, SEA GIRT - SITE 159

Photo taken October 2, 2009. View to the north.

New York Avenue is located in the public recreational section of the Sea Girt shoreline. This view shows the beach and boardwalk.

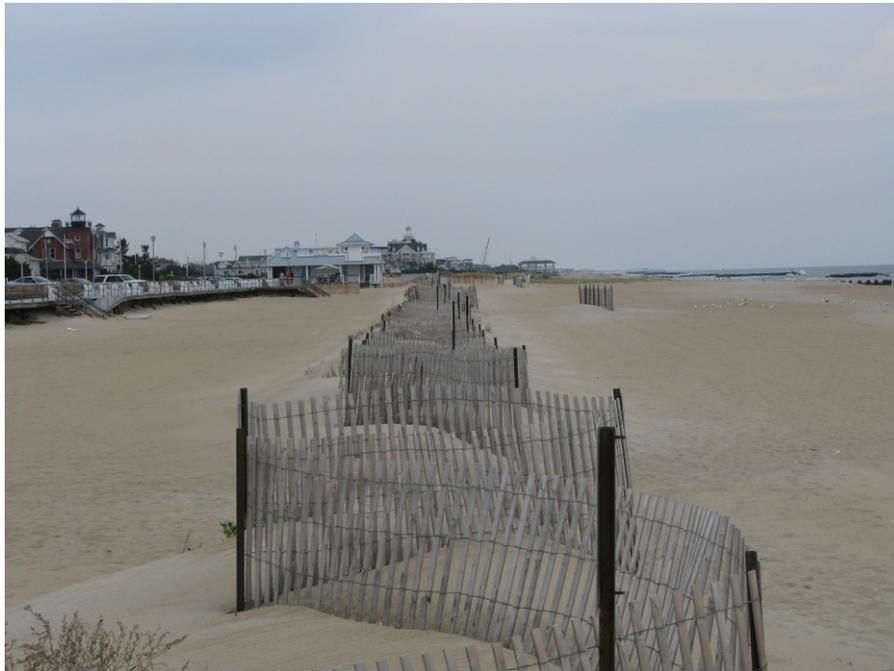
Photo taken October 21, 2010. View to the north.

The photo shows sand trapped by the sand fencing. Comparing the profiles over the year, the profile location lost volume (-11.62 cu yd/ft) and the shoreline moved landward (-20.52 ft).

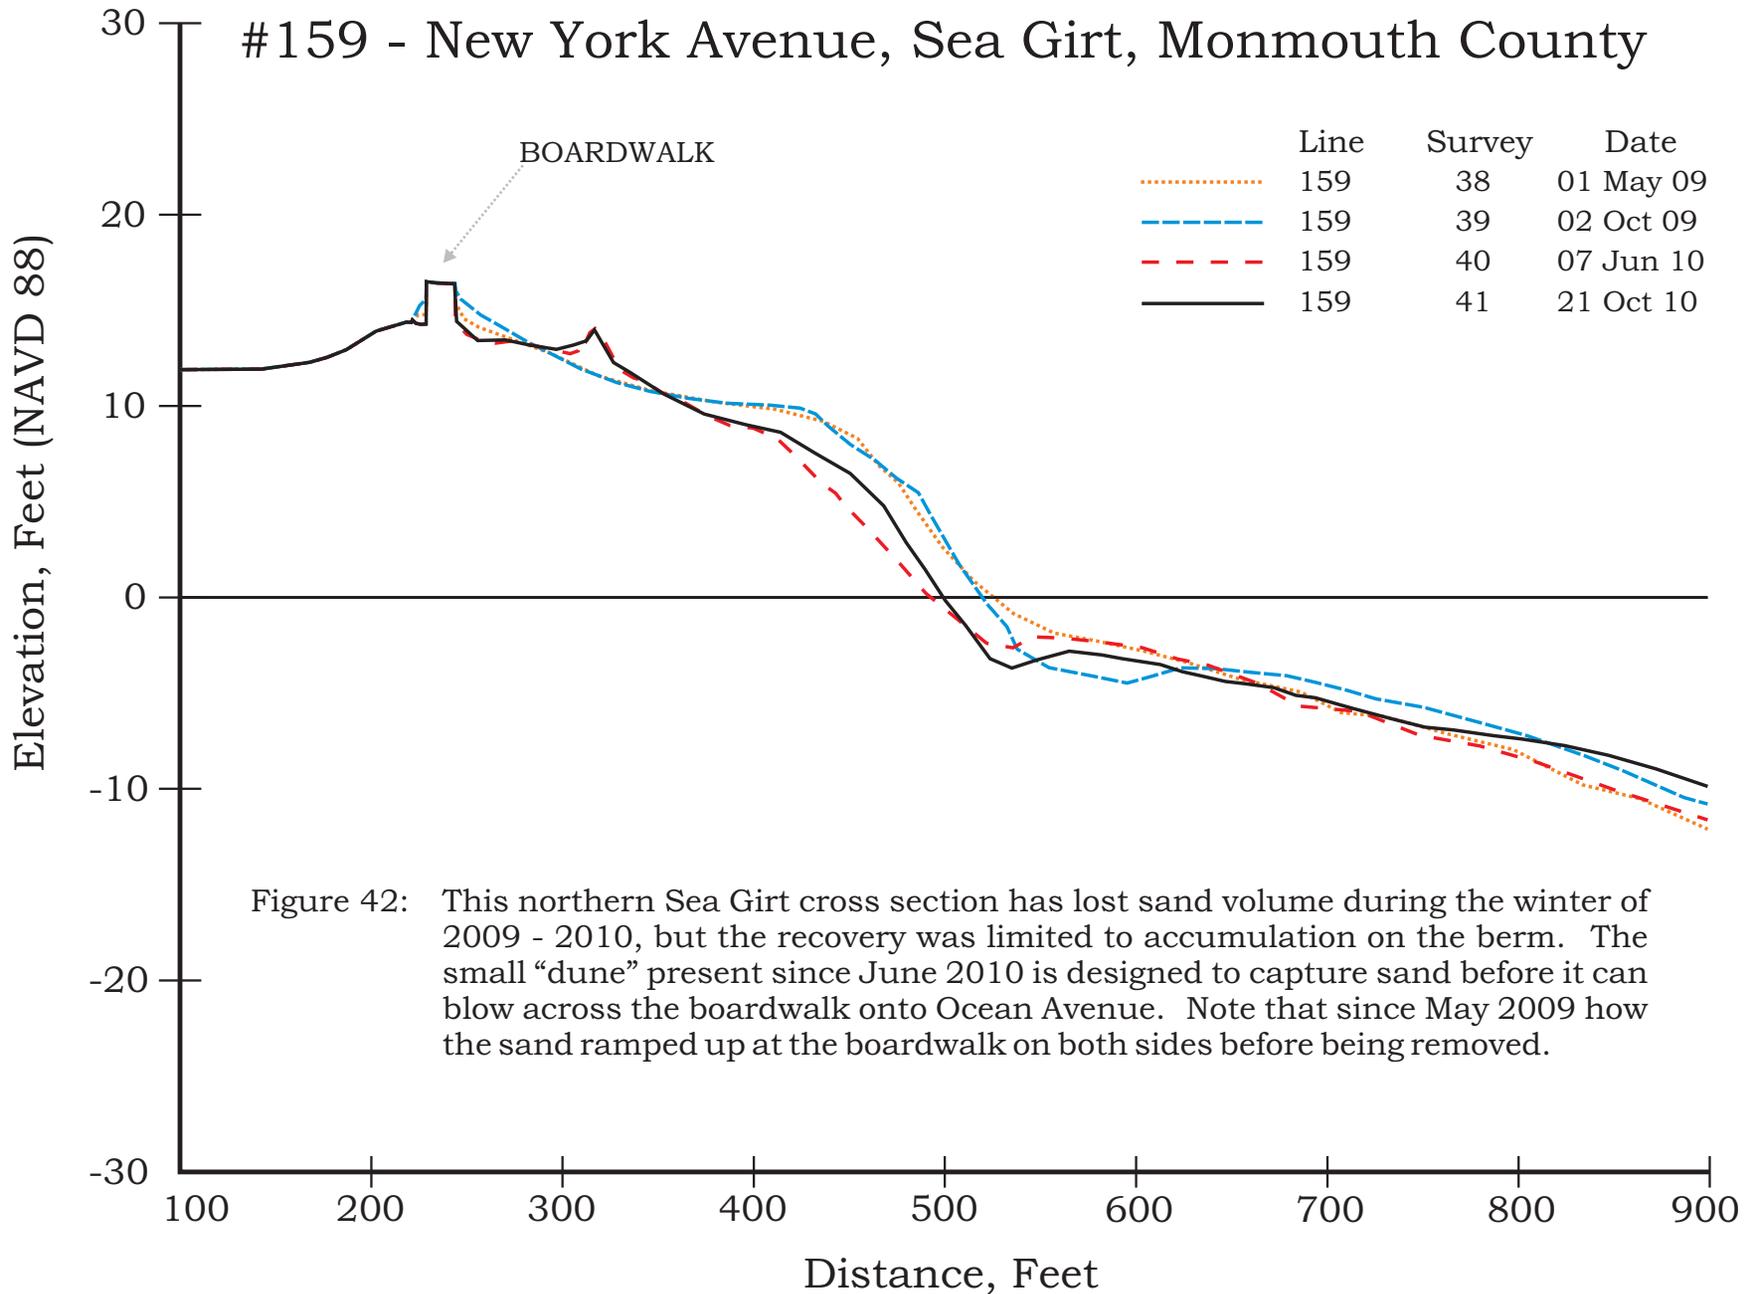
#159 - New York Avenue, Sea Girt, Monmouth County

Figure 42: This northern Sea Girt cross section has lost sand volume during the winter of 2009 - 2010, but the recovery was limited to accumulation on the berm. The small “dune” present since June 2010 is designed to capture sand before it can blow across the boardwalk onto Ocean Avenue. Note that since May 2009 how the sand ramped up at the boardwalk on both sides before being removed.

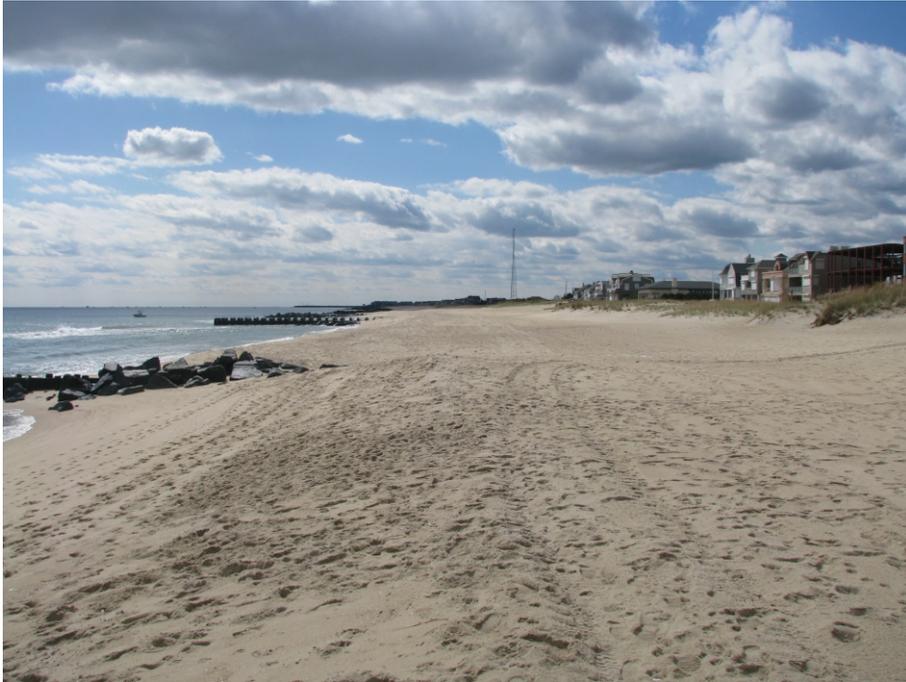
TRENTON AVENUE, SEA GIRT - SITE 158

Photo taken October 1, 2009. View to the south.

The Trenton Avenue site is near the southern boundary of Sea Girt and the NJ State Police training center between Sea Girt and Manasquan. The 1996 Federal beach restoration project has allowed accretion of dunes and the growth of grass seaward of the elevated boardwalk.

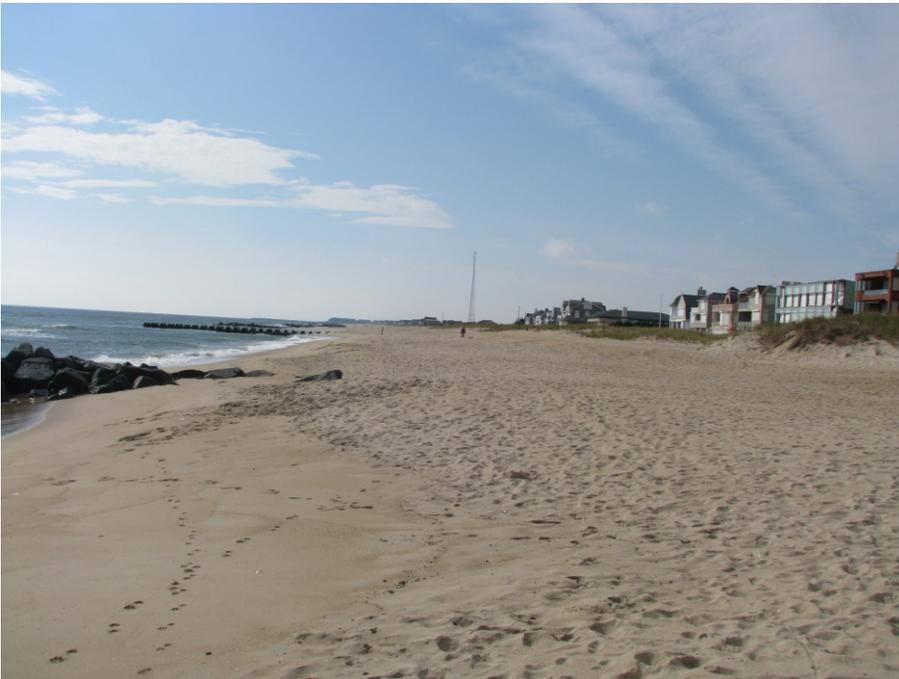
Photo taken October 21, 2010. View to the south.

Comparing the profiles over the year, the profile location lost volume (-30.22 cu yd/ft) and the shoreline moved landward (-18.69 ft).

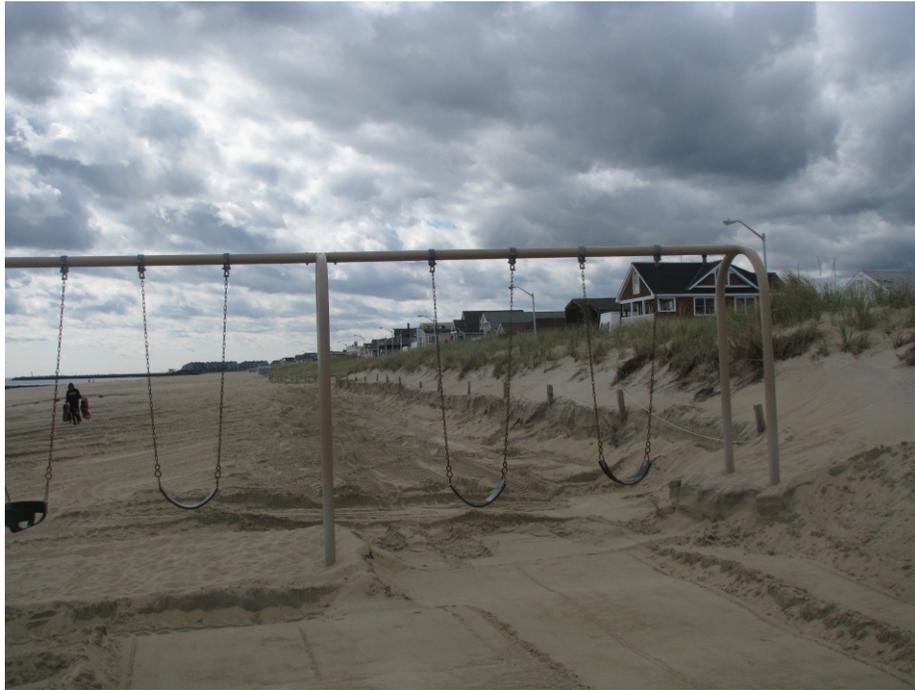
RIDDLE WAY, MANASQUAN - SITE 157

Photo taken October 1, 2009. View to the south.

Located in the middle of the Manasquan shoreline, Riddle Way has a dune that dates from after the December 1992 storm. The community erected straight line sand fence to capture winter sand transport on the beach rather than in the dunes.
