New Jersey Beach Profile Network 2010 Annual Report on Shoreline Changes in New Jersey Coastal Reaches One Through Fifteen Raritan Bay to Delaware Bay

New Jersey Department of Environmental Protection
Division of Construction and Engineering
1510 Hooper Avenue, Toms River, New Jersey 08753

The Richard Stockton Coastal Research Center
Richard Stockton College of New Jersey
30 Wilson Avenue, Port Republic, NJ 08241

June 30, 2011

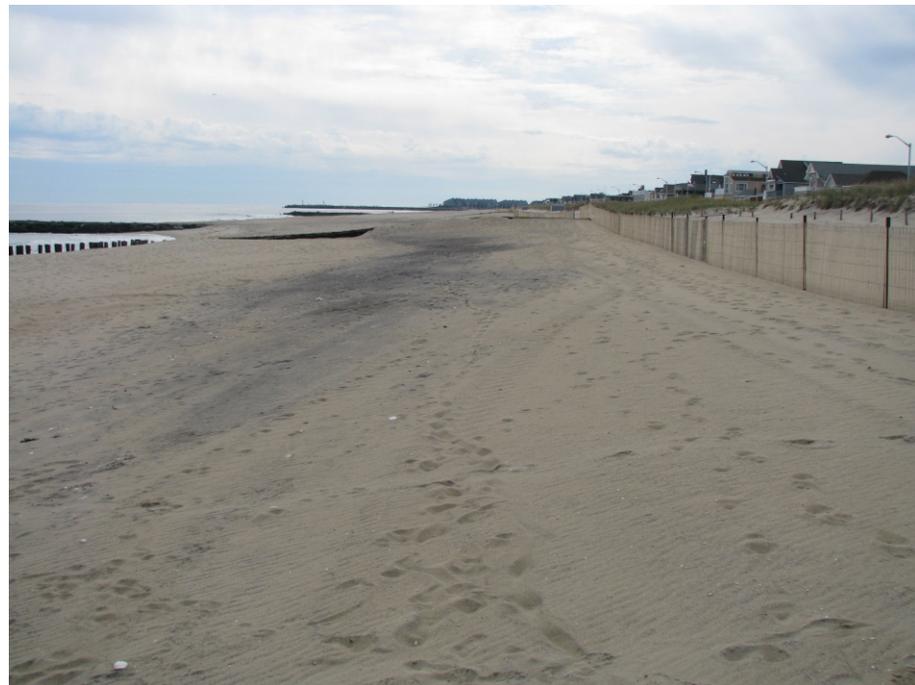
Photo taken October 20, 2010. View to the south.

Comparing the profiles over the year, the profile location lost volume (-47.07 cu yd/ft) and the shoreline moved landward (-34.0 ft).

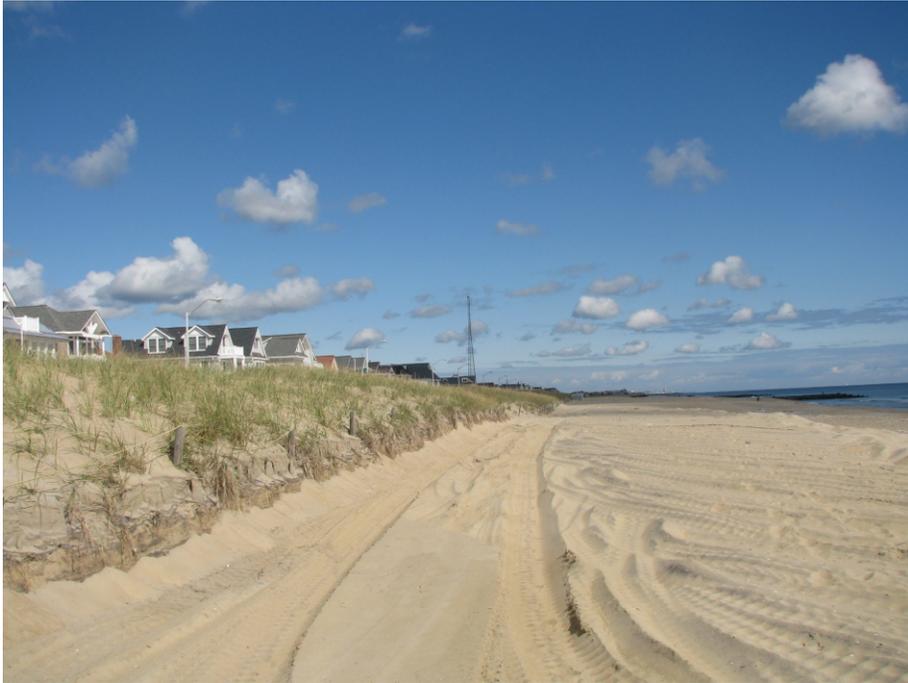
Photo taken October 1, 2009. View to the north.

This site was established following dramatic changes observed after the 1992 northeast storm. Pompano Avenue is two - three blocks from the north jetty to Manasquan Inlet.

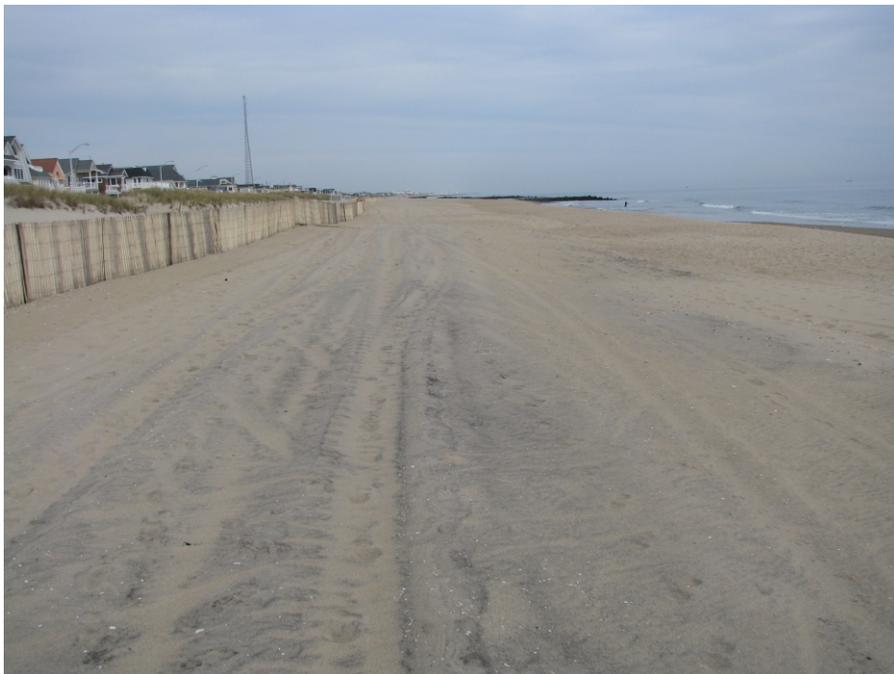
Photo taken October 20, 2010. View to the north.

Comparing the profiles over the year, the profile location gained volume (15.81 cu yd/ft) and the shoreline moved seaward (6.16 ft). The snow fence was designed to trap wind-transported sand.
