# New Jersey Beach Profile Network

## Ocean County

Manasquan Inlet  
to Little Egg Inlet

## OCEAN COUNTY SPRING 2008 to FALL 2009

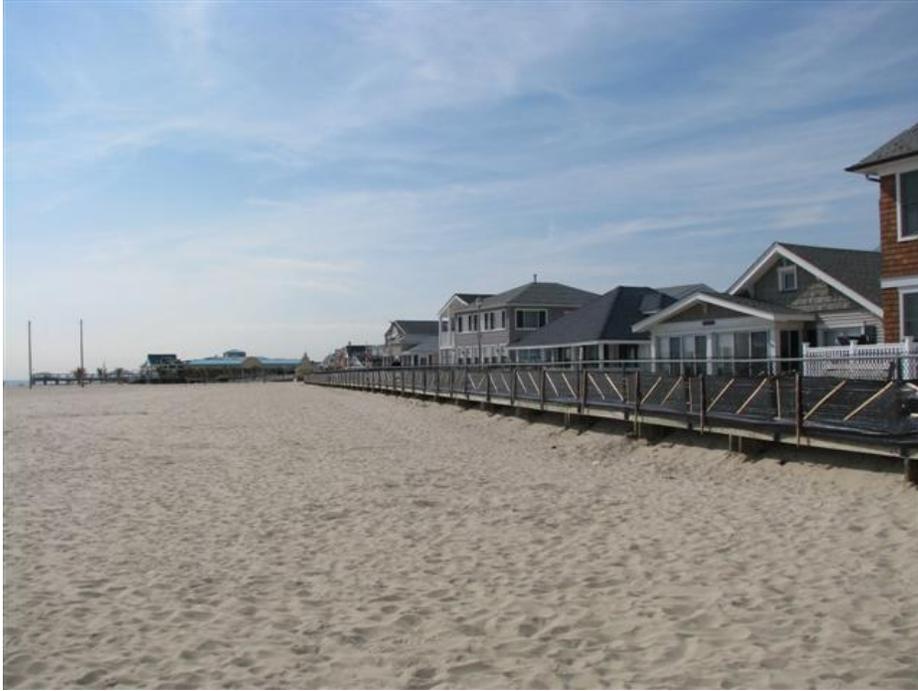
Photo taken October 15, 2008. View to the south.

The Manasquan Inlet is located a short distance to the north of this site, therefore often reflects dominant littoral transport toward or away from the inlet jetties. This view to the south shows the wide beach with no dune that lies in front of the Point Pleasant Beach boardwalk.

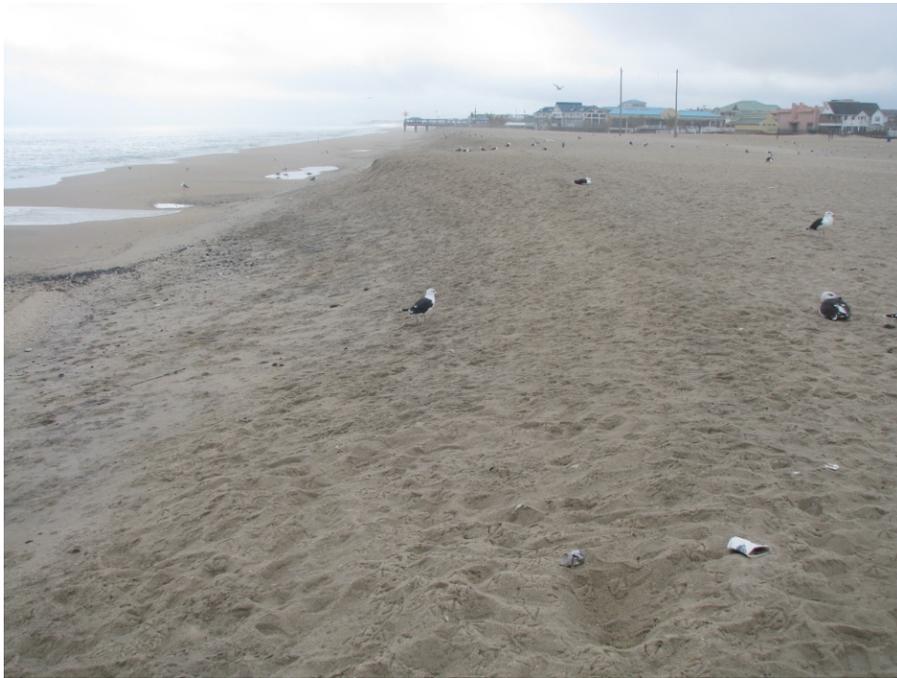
Photo taken September 23, 2009. View to the south.

Comparing the profiles over the eleven month time period, the profile location gained volume (4.12 cu yd/ft) and the shoreline moved landward (-15.09 ft) as much of the sand was contained on the berm.

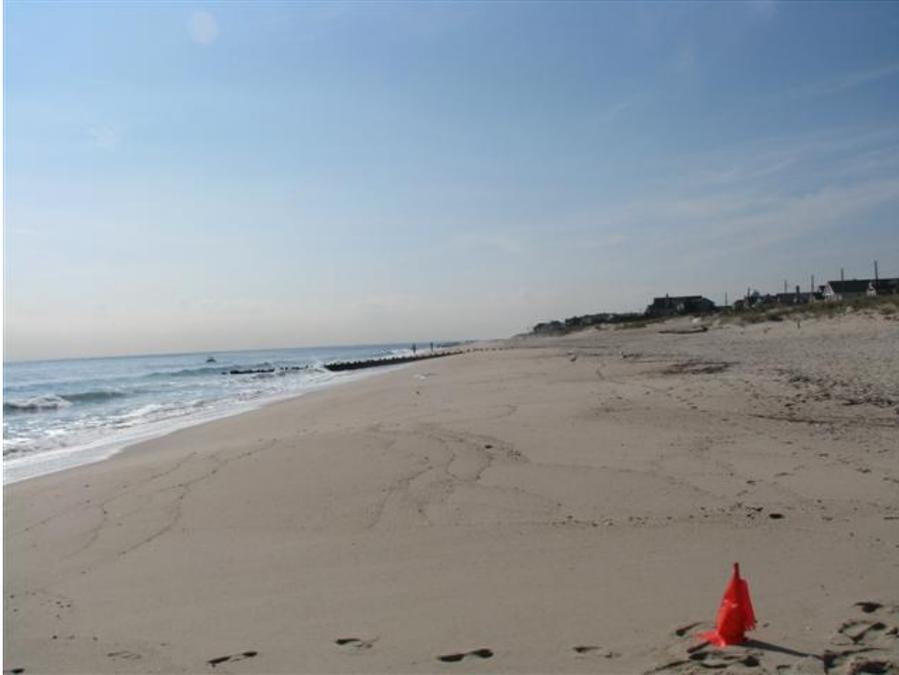
Photo taken October 15th 2008. View to the south.

This location has a substantial dune which has gained sand despite a relatively narrow beach.

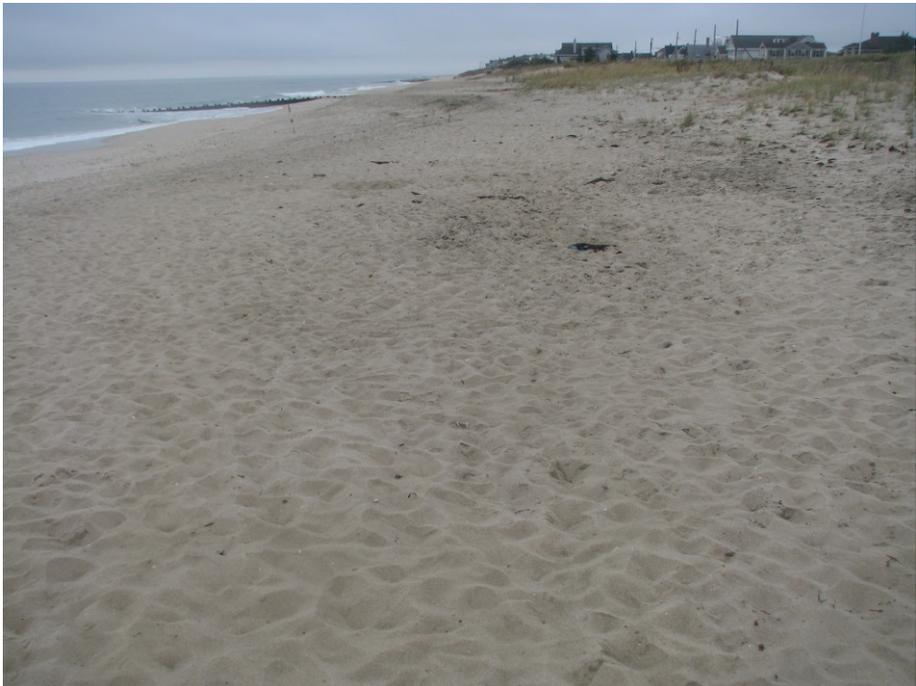
Photo taken September 23, 2009. View to the south.

This cyclic nature of the groin offsets is most common in the Northern Ocean County coast because there is a near equal incidence of littoral sand transport in either direction. Northeast storms move sand south, followed by the southeast winds acting to move sand back to the north. The groin offset simply shows which direction is dominant at any one time. Comparing the profiles over the eleven month time period, the profile location gained volume (17.89 cu yd/ft) and the shoreline moved seaward (14.12 ft).

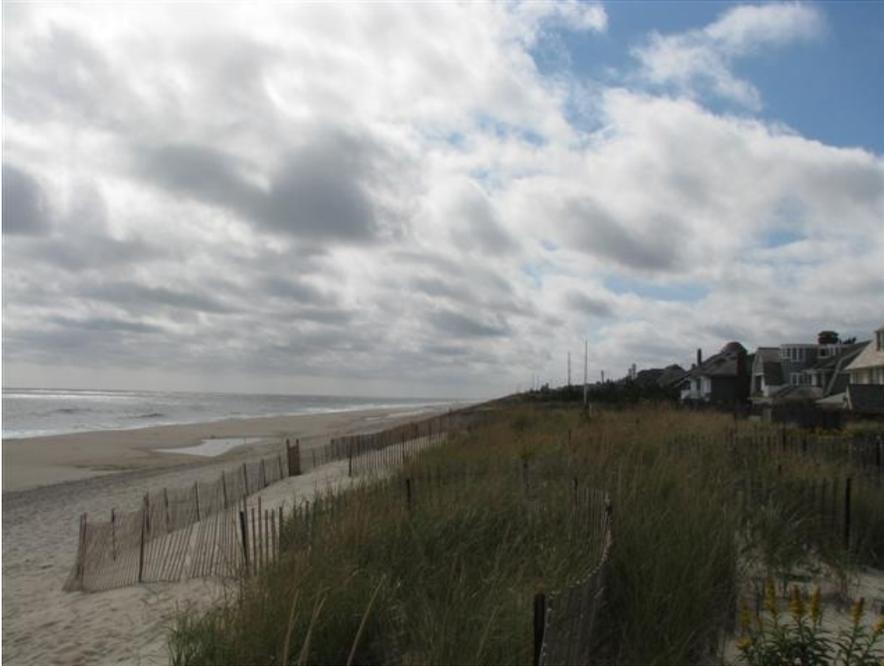
Photo taken October 14, 2008. View to the south.

The Bay Head beach contains a rock revetment below the dune crest that has not been exposed since December 1992.

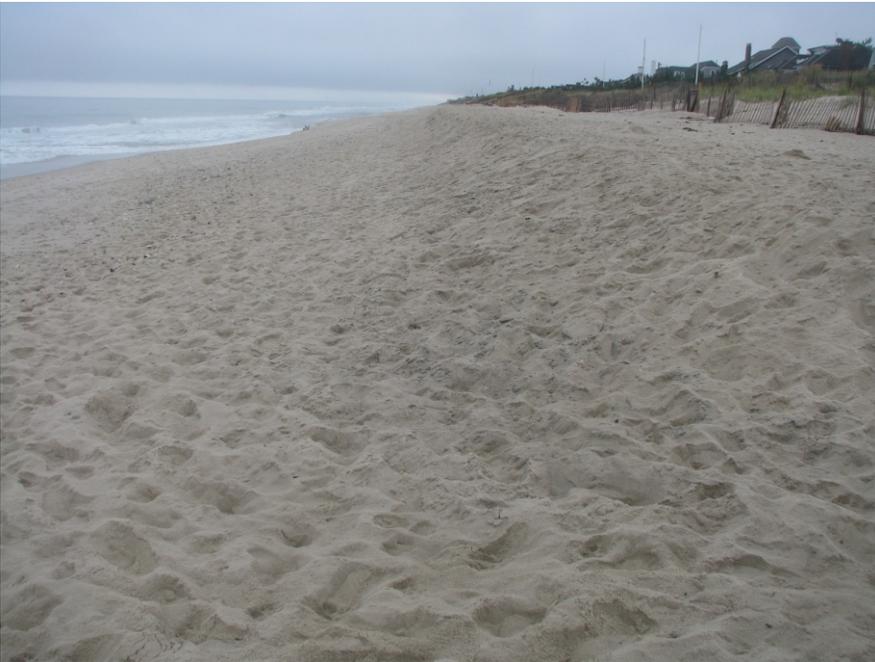
Photo taken September 23, 2009. View to the south.

Comparing the profiles over the eleven month time period, the profile location lost volume (-1.49 cu yd/ft) and the shoreline moved landward (-17.23 ft).

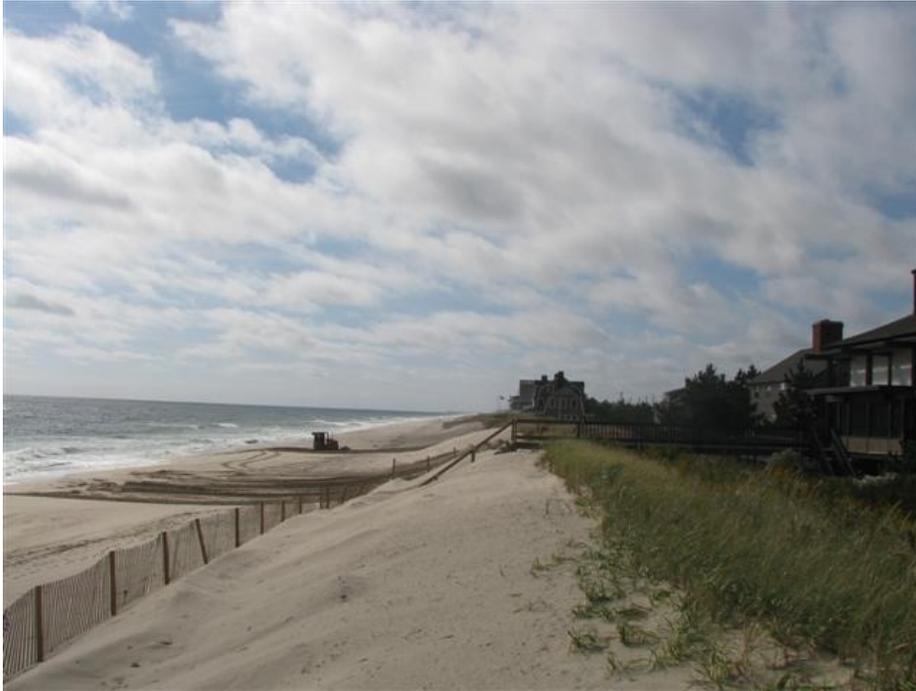
Photo taken October 14th 2008. View to the south.

The Mantoloking site is surveyed quarterly for the specific interests of the municipal officials along with four other sites along the Borough oceanfront. By October 14, 2008 this site was once again being restored by transferring sand from the berm up the seaward dune slope to restore winter erosion into the dune.

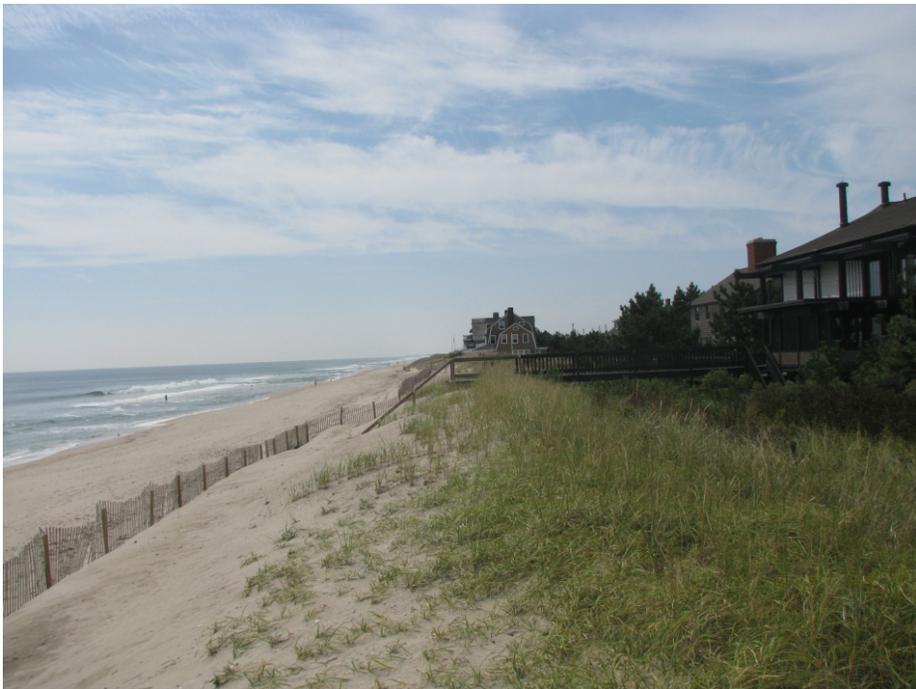
Photo taken September 15, 2009. View to the south.

Comparing the profiles over the eleven month time period, the profile location gained volume (2.48 cu yd/ft) and the shoreline moved landward (-17.09 ft). Winter events in 2009 produced significant dune retreat and prompted another restoration effort with the bulldozer. The fall 2009 required a community-wide bulldozing effort to move between 7 and 10 cubic yards of sand back to the dune.

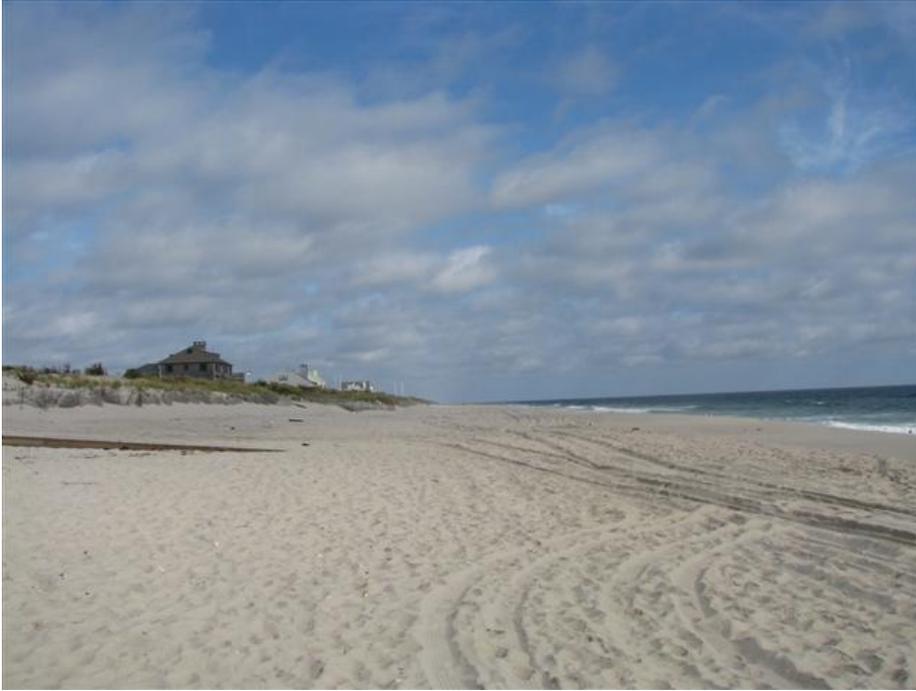
Photo taken October 14, 2008. View to the north.

The public beach in Brick Township has developed a sizable dune between the beach and the recreational area parking lot and service building.

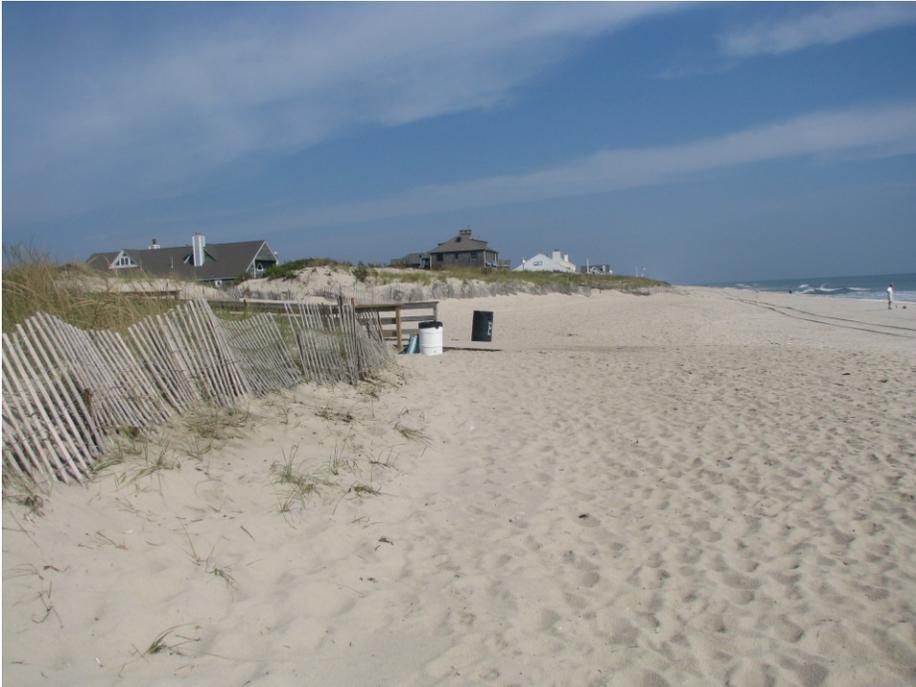
Photo taken September 24, 2009. View to the north.

Comparing the profiles over the eleven month time period, the profile location gained volume (10.66 cu yd/ft) and the shoreline moved landward (-9.81 ft). This site was surveyed prior to fall 2009 storms commencing.

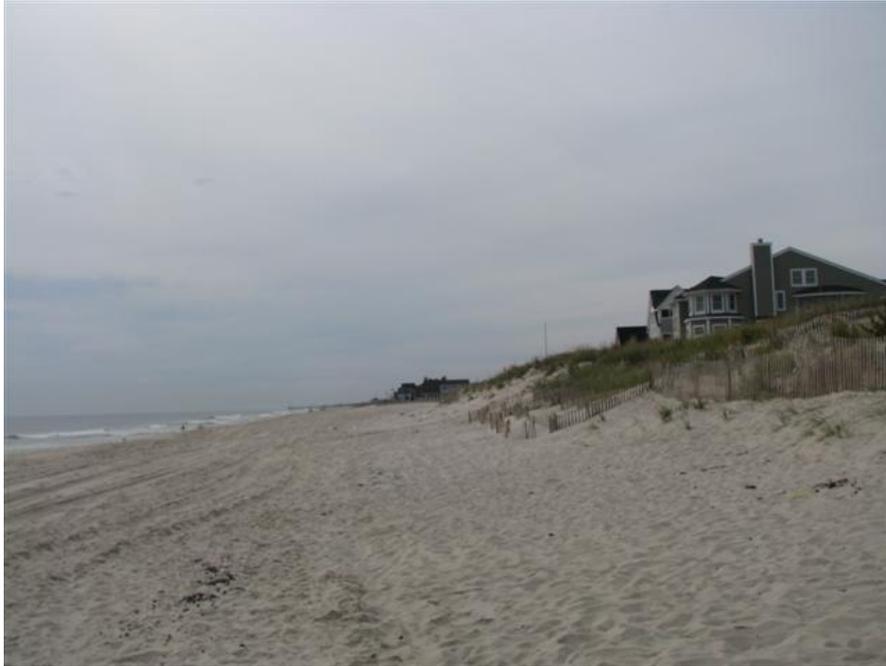
Photo taken October 13, 2008. View to the south.

The dune toe is vulnerable to storm wave activity. No large-scale beach fills have been carried out at this location.

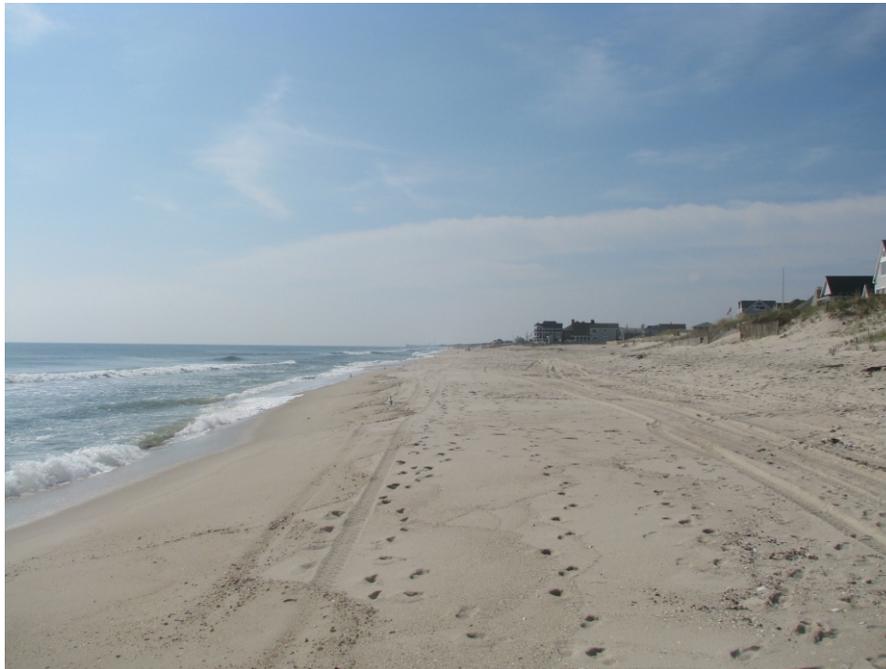
Photo taken September 24, 2009. View to the south.

Comparing the profiles over the eleven month time period, the profile location lost volume (-4.14 cu yd/ft) and the shoreline moved landward (-28.27 ft). The beach did manage a substantial expansion, followed by retreat to the May 2008 position prior to any storm activity.

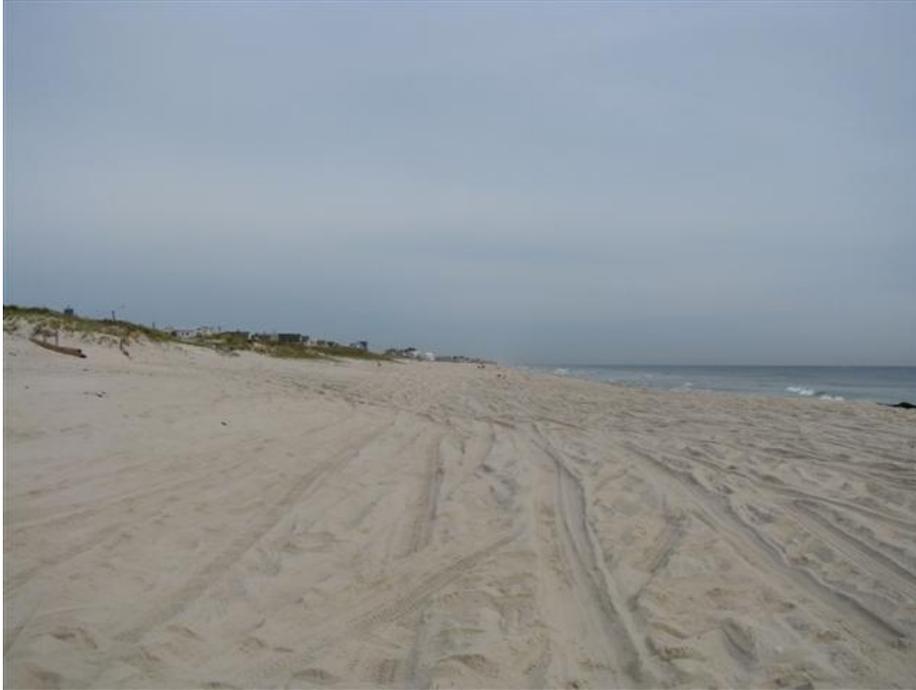
Photo taken October 13, 2008. View to the north.

The dry beach in Lavallette is relatively wide and stable.

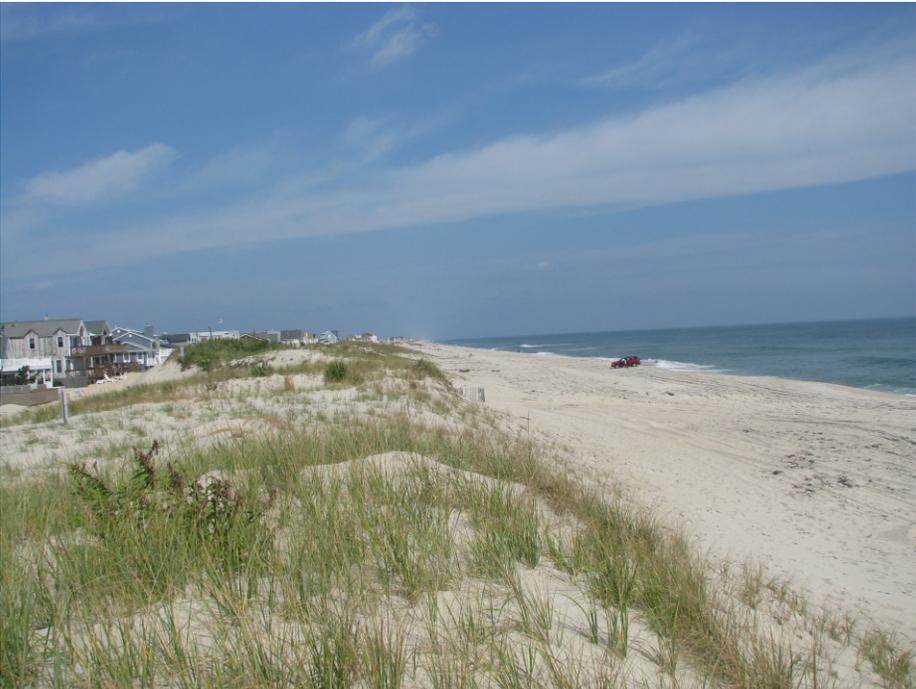
Photo taken September 24, 2009. View to the north.

Comparing the profiles over the eleven month time period, the profile location lost volume (-16.17 cu yd/ft) and the shoreline moved landward (-2.34 ft) due to a change in the nearshore bar. Again, the survey for the fall 2009 preceded the northeast activity.

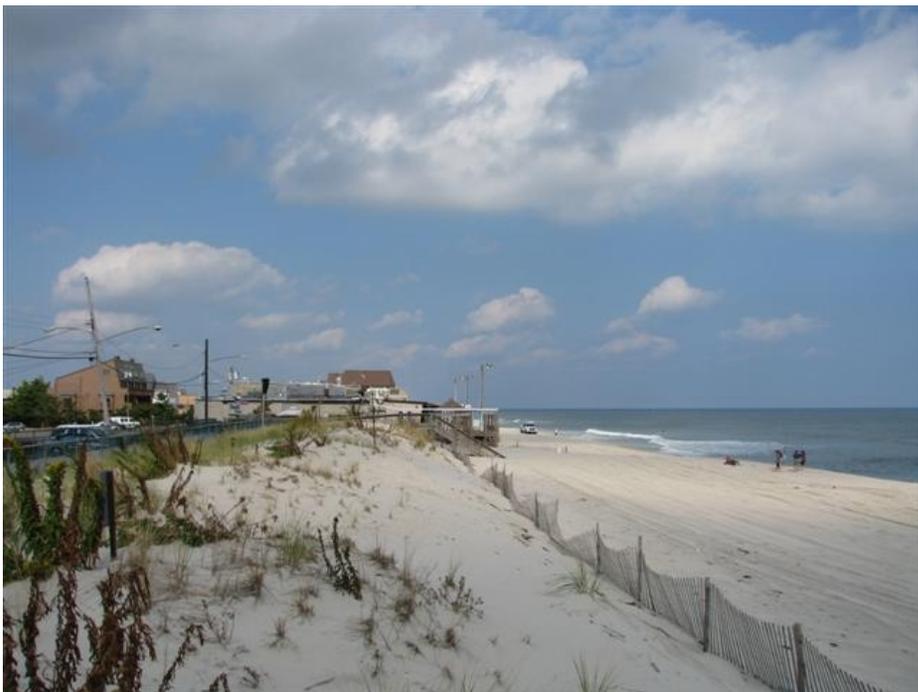
Photo taken October 9, 2008. View to the north.

The Ortley Beach location has a dune, but the close proximity of the beach road limits the landward extent. This view from the dune toe slope north shows the recreational services pavillion that occupies the dune's natural position.

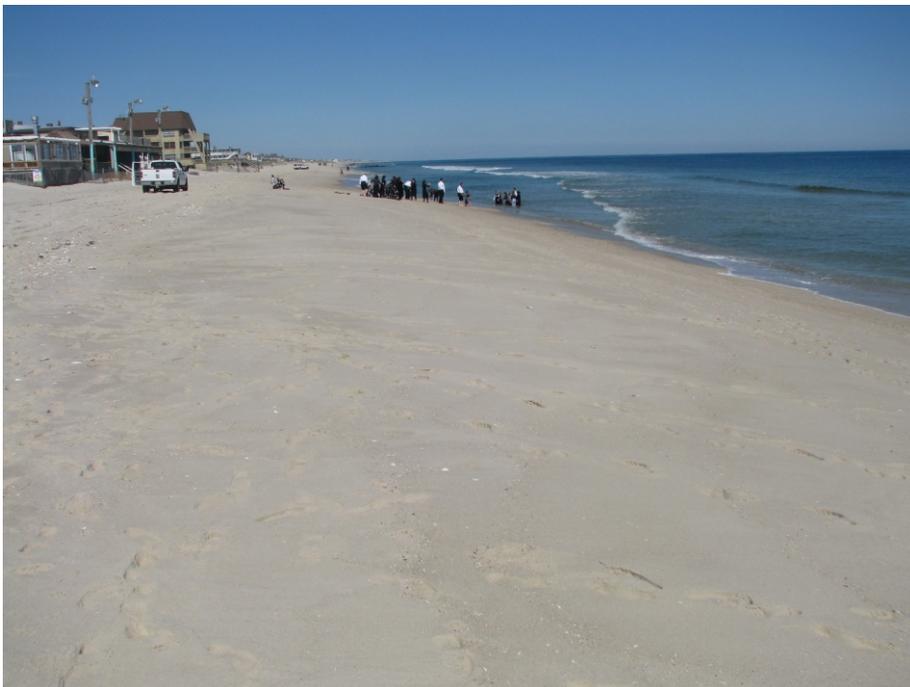
Photo taken October 6, 2009. View to the north.

Comparing the profiles over the one-year time period, the profile location gained volume (3.6 cu yd/ft) and the shoreline moved seaward (9.23 ft). This site was surveyed prior to the arrival of the northeast events during the fall of 2009.

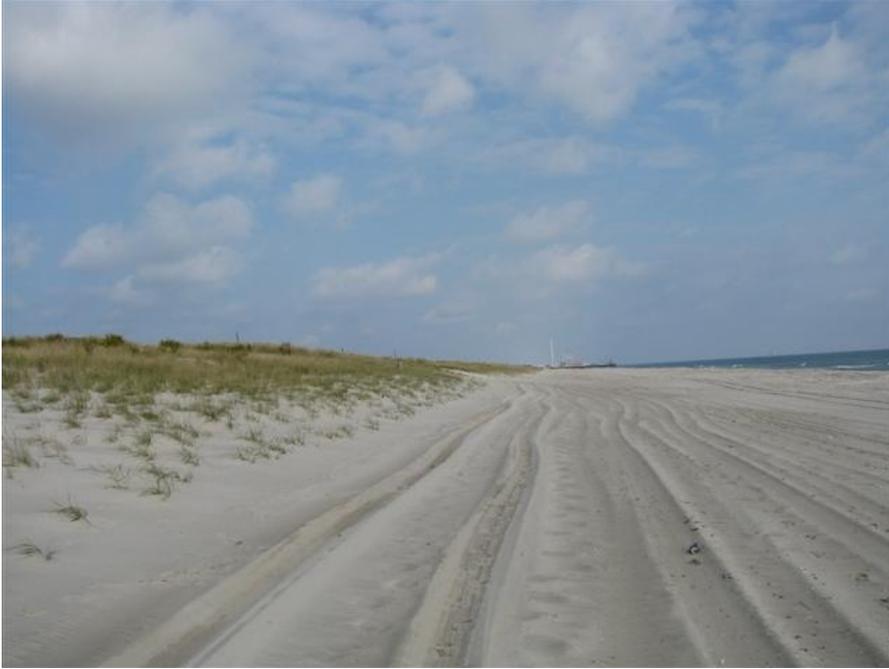
Photo taken October 9, 2008. View to the north.

The Fourth Avenue site in Seaside Park has a low relief, but wide dune protecting the property landward.

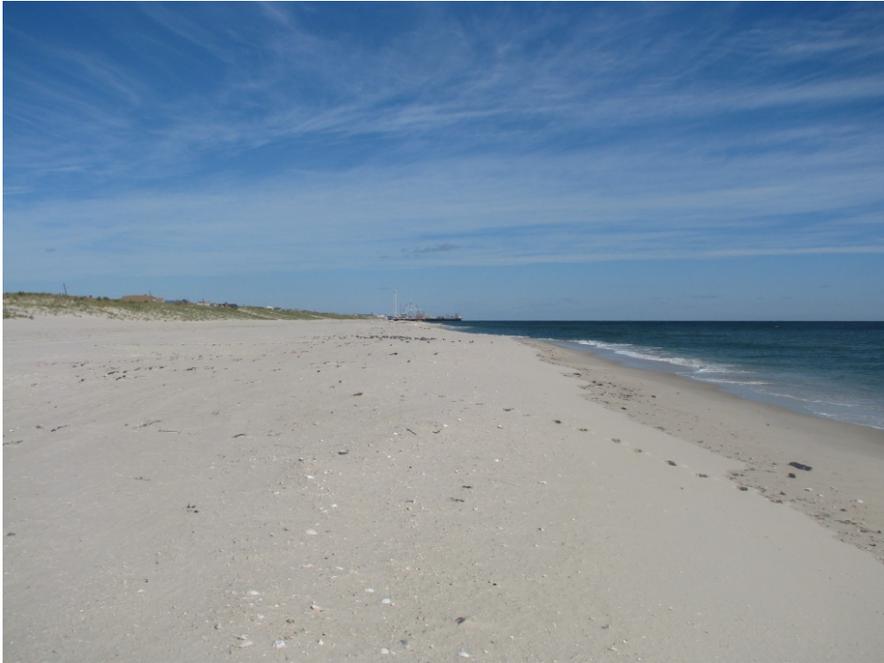
Photo taken October 8, 2009. View to the north.

Comparing the profiles over the one-year time period, the profile location lost volume (-16.73 cu yd/ft) and the shoreline moved landward (-18.65 ft).

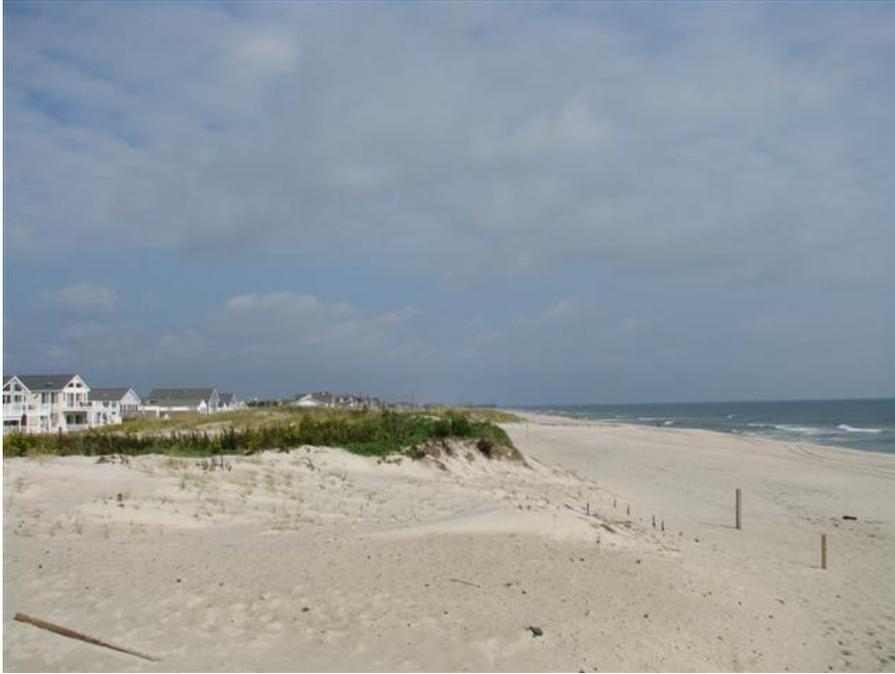
Photo taken October 9, 2008. View to the north.

This site was moved south off the pedestrian pathway in 2008 to monitor changes in the dune. When the site was established in 1986, there was no dune at all. However, the wind opened the pathway wider removing foredune seen on the earlier profile transects across the dune.

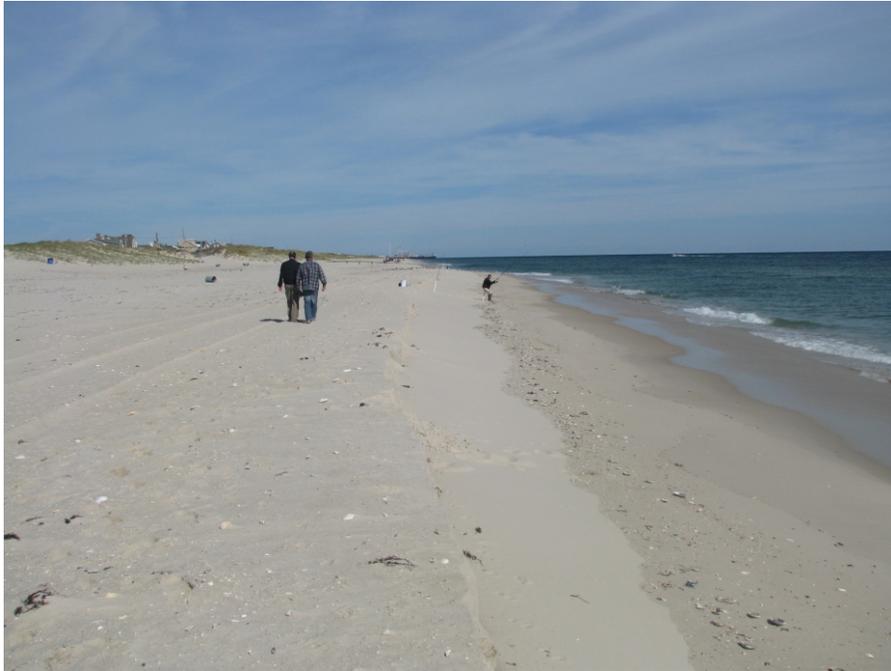
Photo taken October 8, 2009. View to the north.

Comparing the profiles over the one-year time period, the profile location lost volume (-2.38 cu yd/ft) and the shoreline moved landward (-20.29 ft).

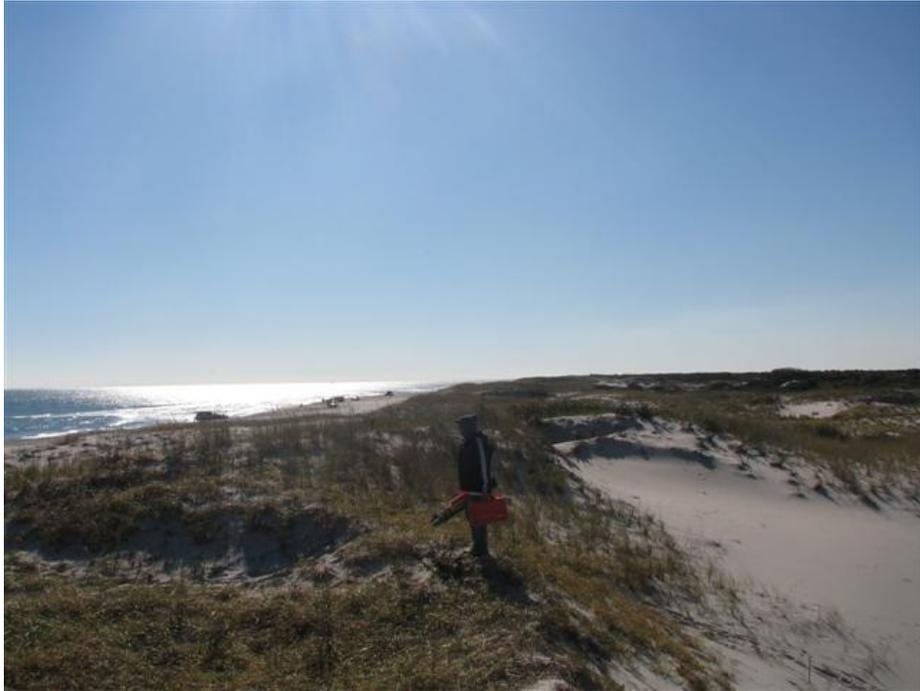
Photo taken November 11, 2008. View to the south.

The dunes at this location contain a series of ridges and swales and support a variety of vegetation. Further landward the maritime forest grows on older segments of this shoreline.

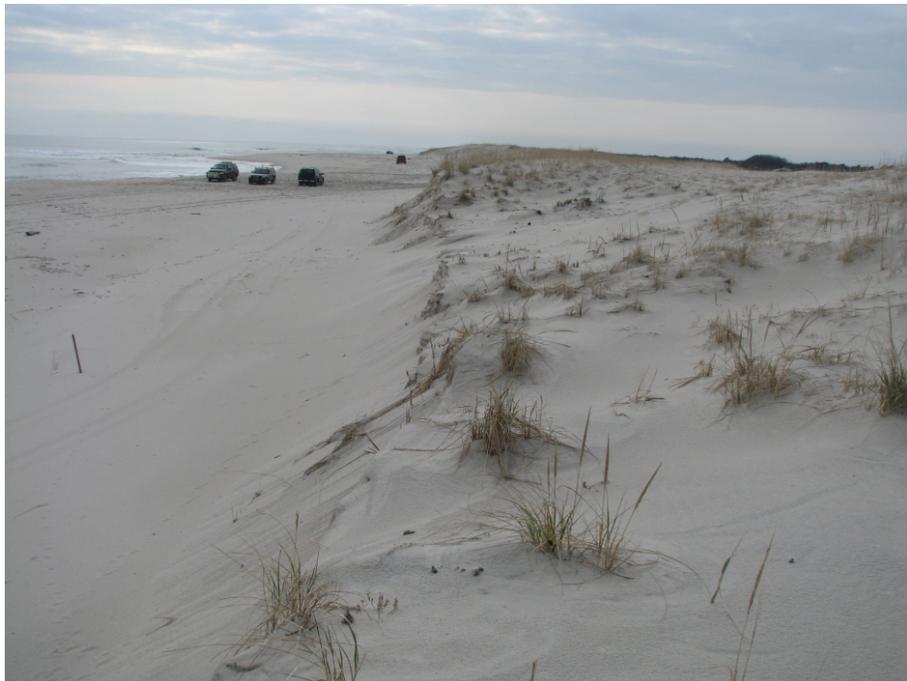
Photo taken December 15, 2009. View to the south.

Comparing the profiles over the thirteen month time period, the profile location gained volume (13.76 cu yd/ft) and the shoreline moved landward (-9.08 ft) as sediment was moved to the nearshore bar. The loss was not as dramatic as that seen at site 246 just to the south.

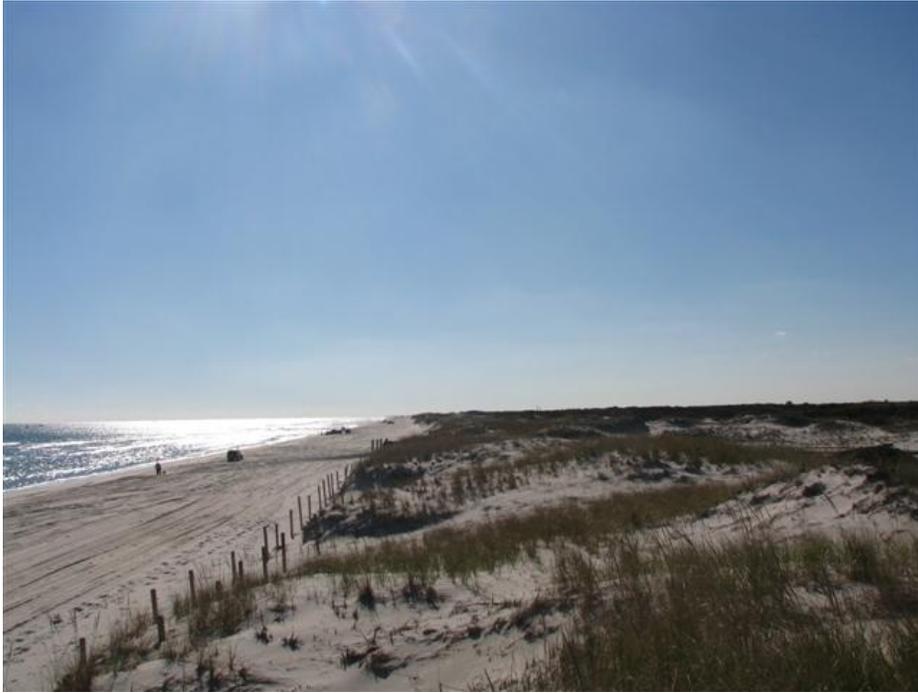
Photo taken November 11, 2008. View to the south.

The middle profile on Island Beach State Park also traverses a massive dune field to a wide beach. The gap just south is natural and typifies a “blow-out” gap in the dunes. This photograph shows an accretional beach that protects the dune toe from minor storm erosion.

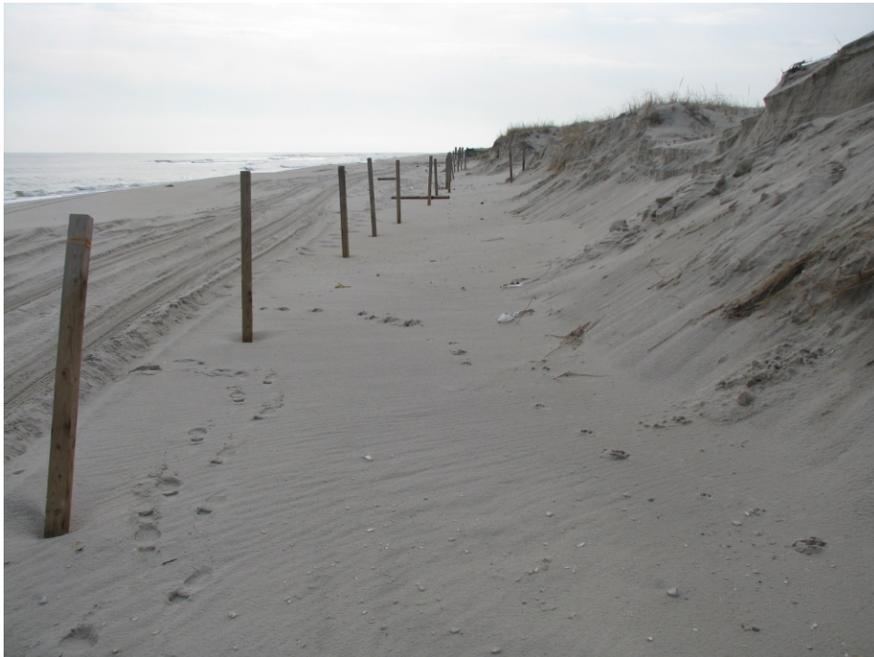
Photo taken December 15, 2009. View to the south.

Comparing the profiles over the thirteen month time period, the profile location lost volume (-24.6 cu yd/ft) and the shoreline moved landward (-43.91 ft). Storm impacts were severe to the dune and beach. The scarp retreat exposed the dune fence posts on the beach, not in the seaward dune toe. The beach followed this retreat landward.

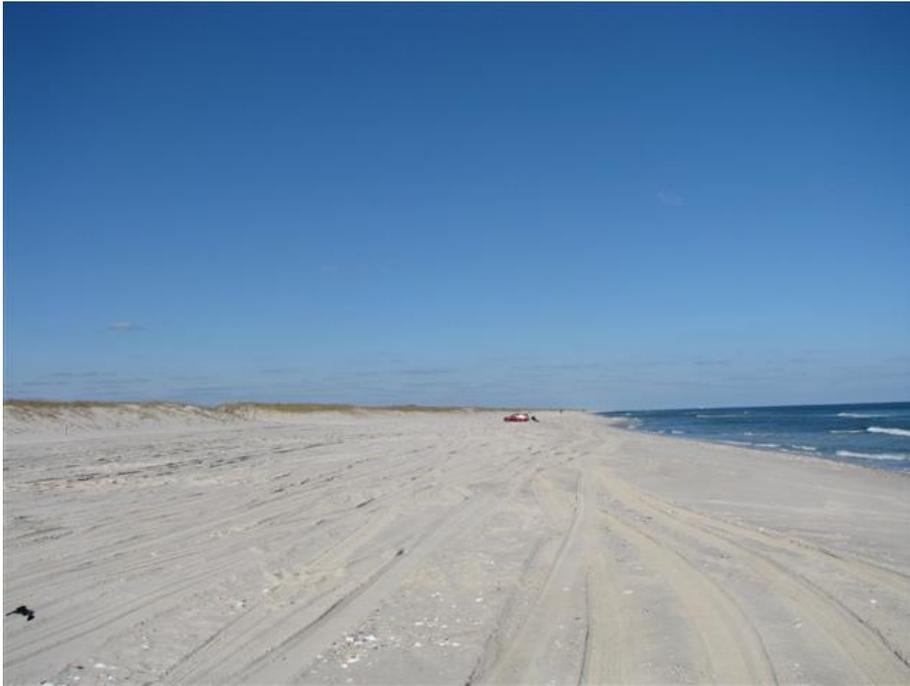
Photo taken November 11, 2008. View to the north.

The southern end of the Island Beach State Park has no human modification. The site can only be accessed from the beach.

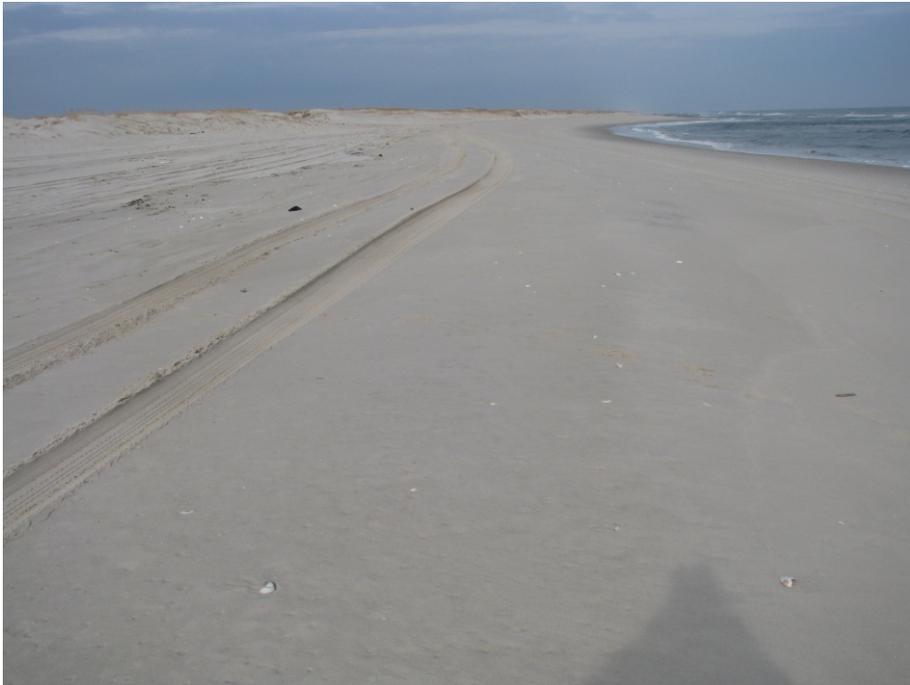
Photo taken December 15, 2009. View to the north.

The north jetty of Barnegat Inlet is located immediately to the south and traps sand moving south and produces this expanding beach that has grown wider almost every year since 1986. The jetties at Barnegat Inlet acted to trap sand producing the expansion seen. Comparing the profiles over the thirteen month time period, the profile location gained volume (15.05 cu yd/ft) and the shoreline moved seaward (25.32 ft).

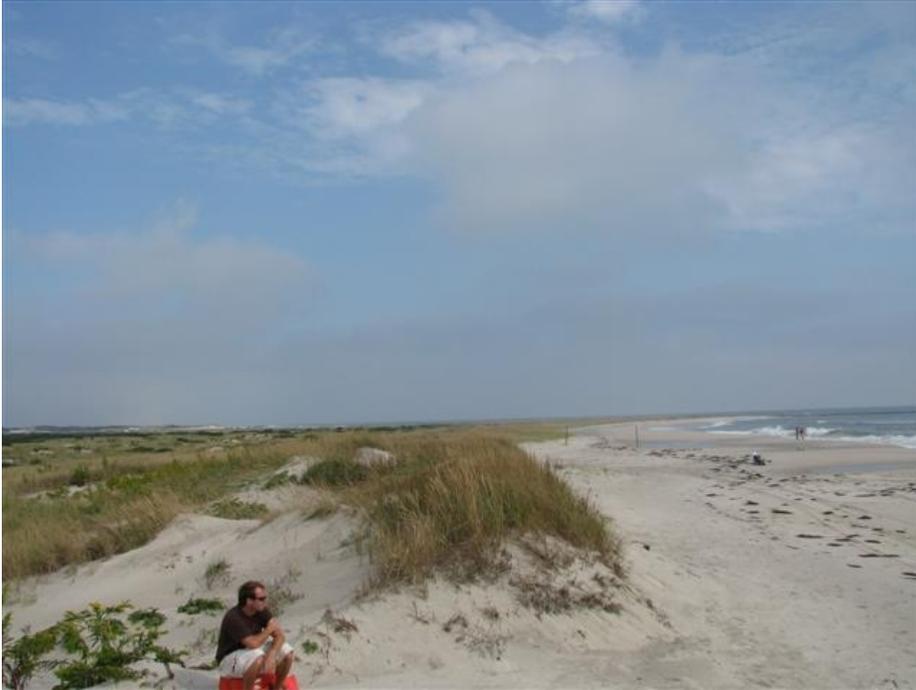
Photo taken October 1, 2008. View to the north.

In the northern segment of the Barnegat Light Borough shoreline lies in what will become a major maritime forest eventually. This site is positioned just south of the old “arrowhead jetty” configuration. There was a wide beach here previously due to the rock jetty making its attachment to the land nearby, but the new structure makes landfall at the Barnegat Light tower. The intervening distance was converted from tidal sand flats extending away from the main channel to a dry sand beach with a complex of dune ridges extending nearly to the seaward end of the new jetty.

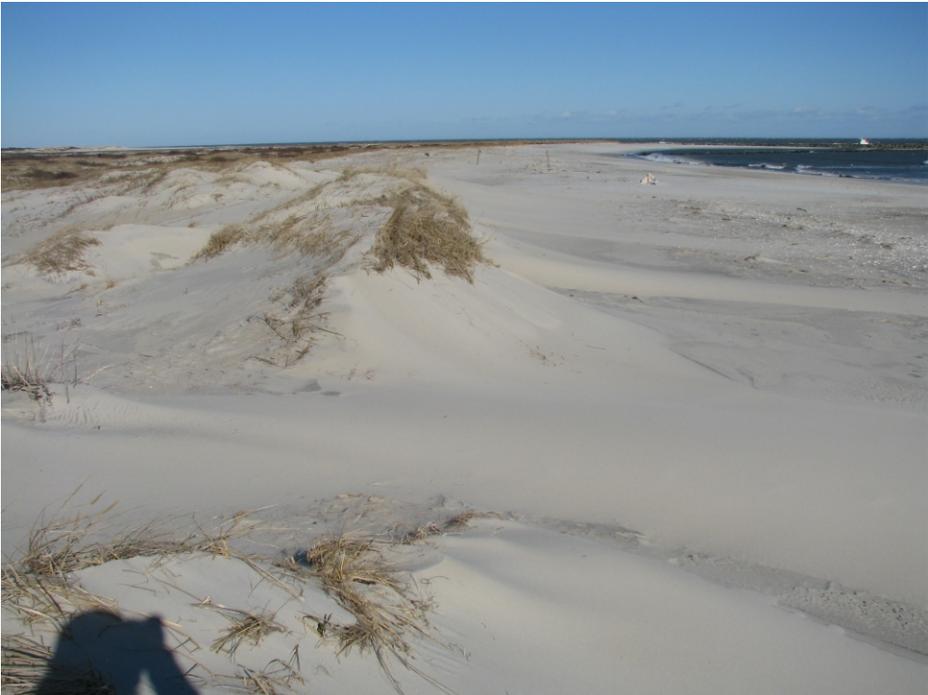
Photo taken December 29, 2009. View to the north.

To the southwest of this location a steel ship's mast extends out of the dune (about 300 feet landward of the beach) attached to a fishing vessel that sank in the inlet channel prior to the new jetty construction. This sunken vessel is now further landward of the dune crest than most of the homes built on Long Beach Island. This site was established in 1994 several years following the massive accumulation of sand that immediately followed the completion of the jetty. The northeast storm effects contributed sand to the site widening the beach at the expense of the offshore region. Comparing the profiles over the fourteen month time period, the profile location gained volume (8.56 cu yd/ft) and the shoreline moved seaward (70.22 ft).

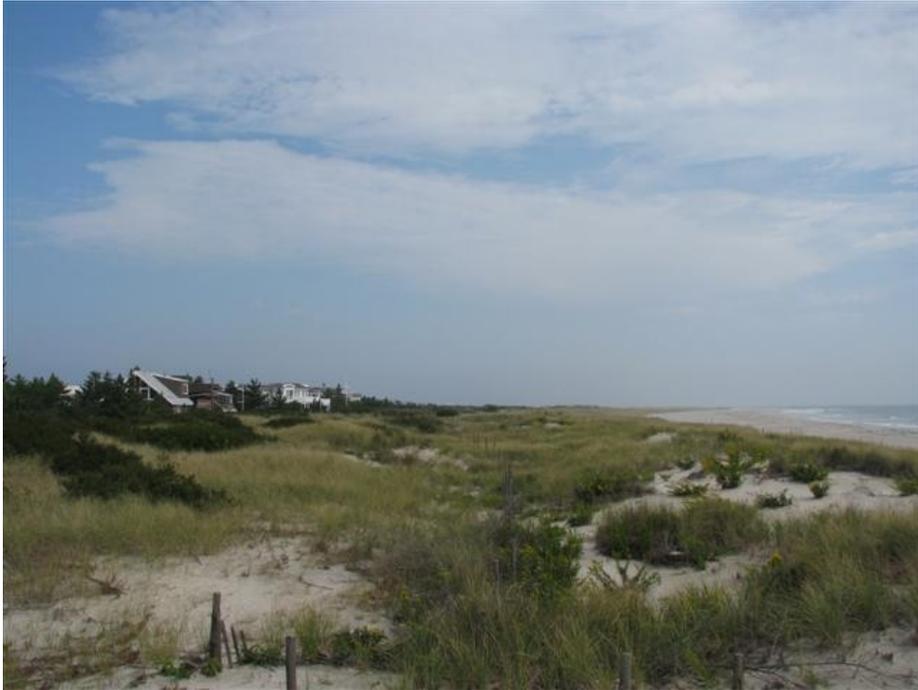
Photo taken October 1, 2008. View to the north.

This site in southern Barnegat Light lies within the accretional wedge of shoreline extending from nearly to the La Baia Street site to the Barnegat Inlet jetty that was re-constructed in a new location beginning in 1988.

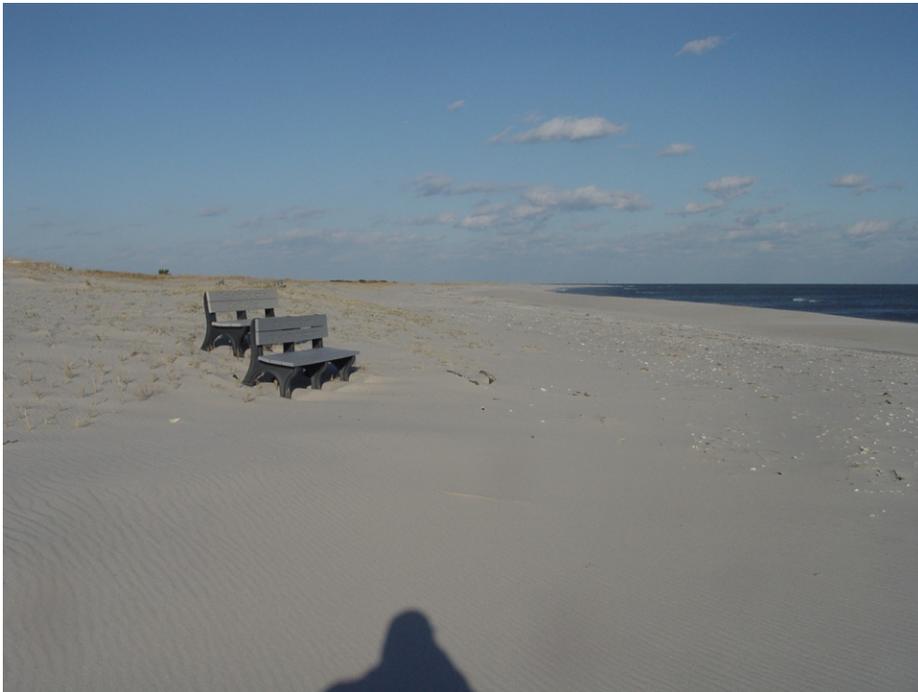
Photo taken December 11, 2009. View to the north.

Since the jetty was completed in 1990 the shoreline advanced as sand moved onto the beach from the old ebb-tidal delta position offshore. This expansion grows wider to the north, reaching a maximum at the jetty. During the fall of 2009 the trend reversed with the berm getting hit with erosion and a deep trough appearing just offshore. Comparing the profiles over the fourteen month time period, the profile location lost volume (-19.57 cu yd/ft) and the shoreline moved landward (-30.81 ft).

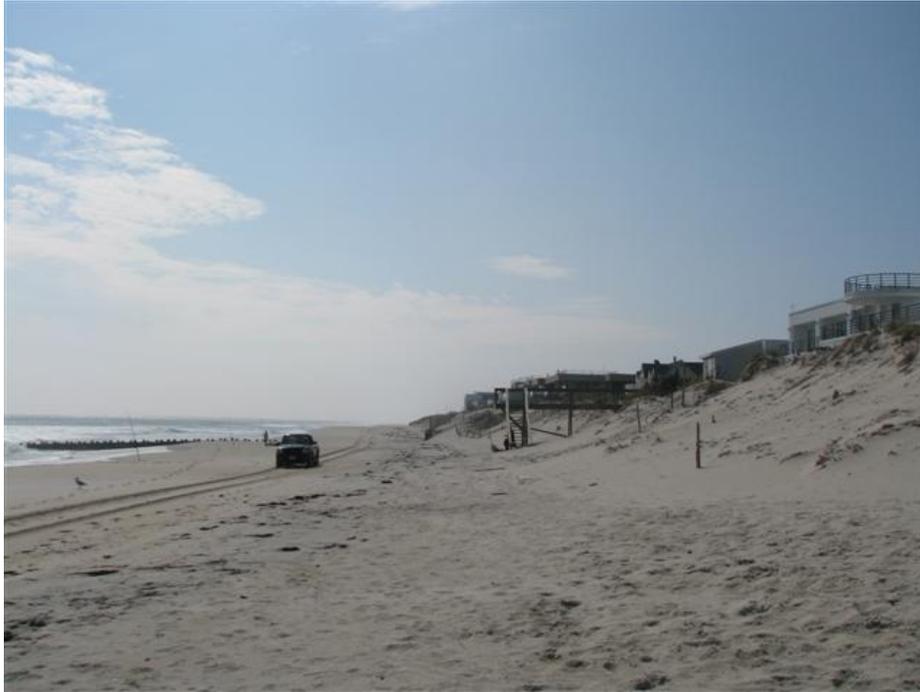
Photo taken October 1, 2008. View to the south.

The dune in Loveladies is much narrower with the homes built into the landward toe so that any breach means that wave energy will accelerate landward into the buildings. As it turned out the dune did not suffer damage, but sand moved offshore in quantity.

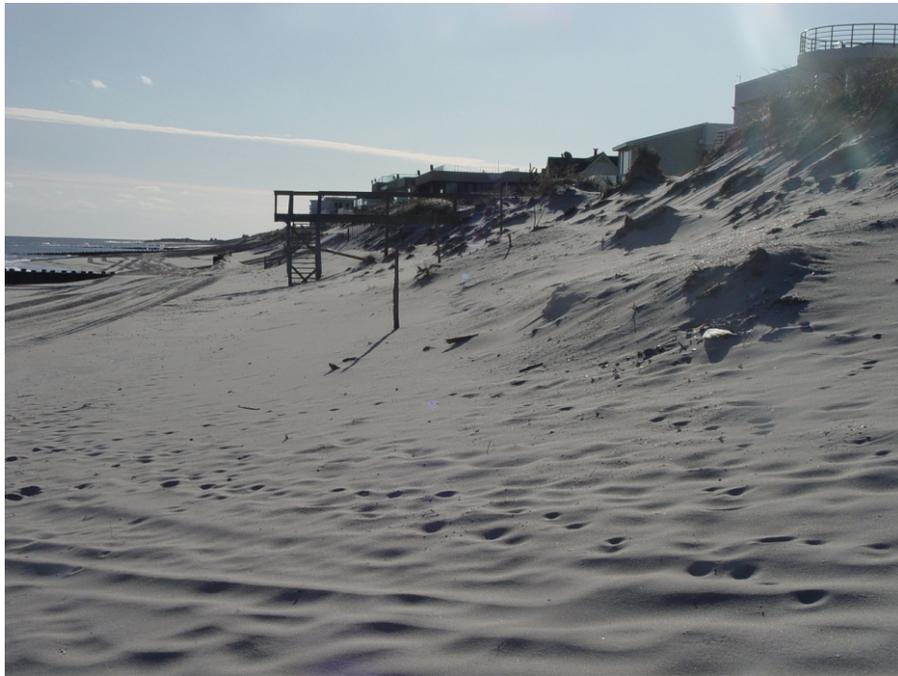
Photo taken December 11, 2009. View to the south.

Comparing the profiles over the fourteen month time period, the profile location gained volume (18.47 cu yd/ft) and the shoreline moved landward (-2.0 ft).
