# New Jersey Beach Profile Network

## Ocean County

Manasquan Inlet  
to Little Egg Inlet

## OCEAN COUNTY SPRING 2008 to FALL 2009

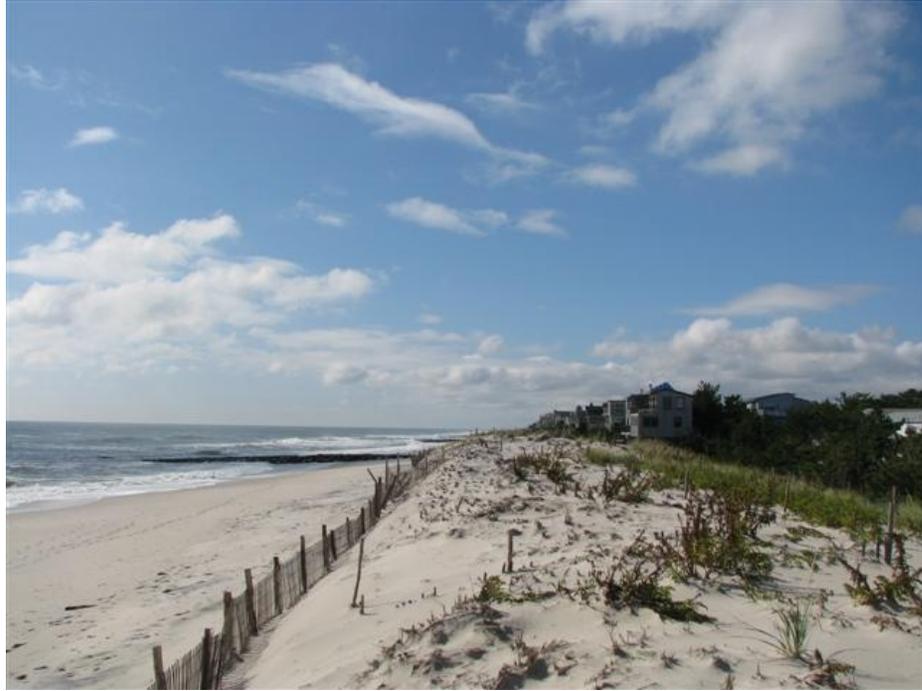
Photo taken September 29, 2008. View to the south.

The narrow beach exposes the dune to potential wave run up. A beach fill project planned for Spring 2010 will add considerable beach width and will protect the dune.

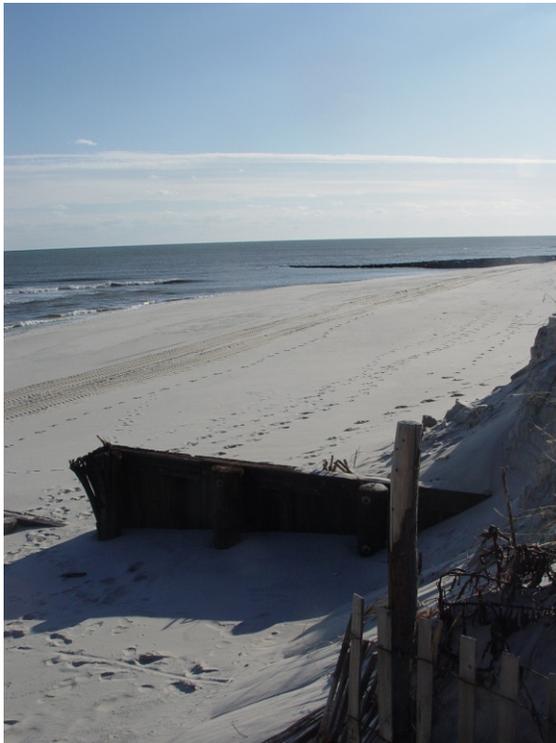
Photo taken December 11, 2009. View to the south.

Comparing the profiles over the fourteen month time period, the profile location lost volume (-27.98 cu yd/ft) and the shoreline moved landward (-27.41 ft). The loss here was significant with over half of the dune gone, the beach severely diminished and not much sand deposited offshore.

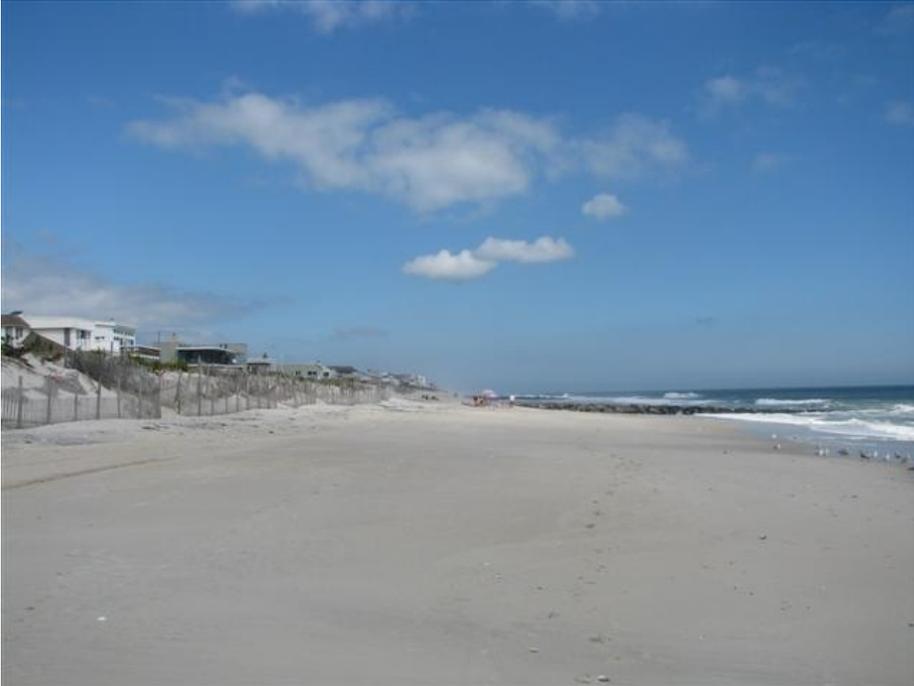
Photo taken September 29, 2008. View to the north. The dune was cut by a scarp to the crest and abundant sand appeared far offshore.

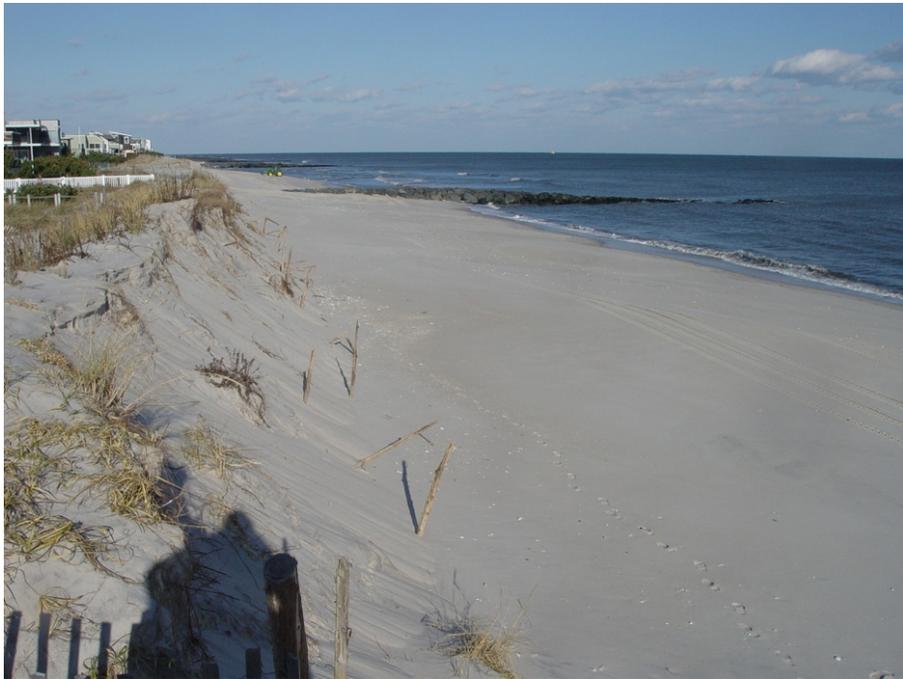
Photo taken December 11, 2009. View to the north.

Comparing the profiles over the fourteen month time period, the profile location gained volume (18.98 cu yd/ft) and the shoreline moved seaward (0.68 ft).

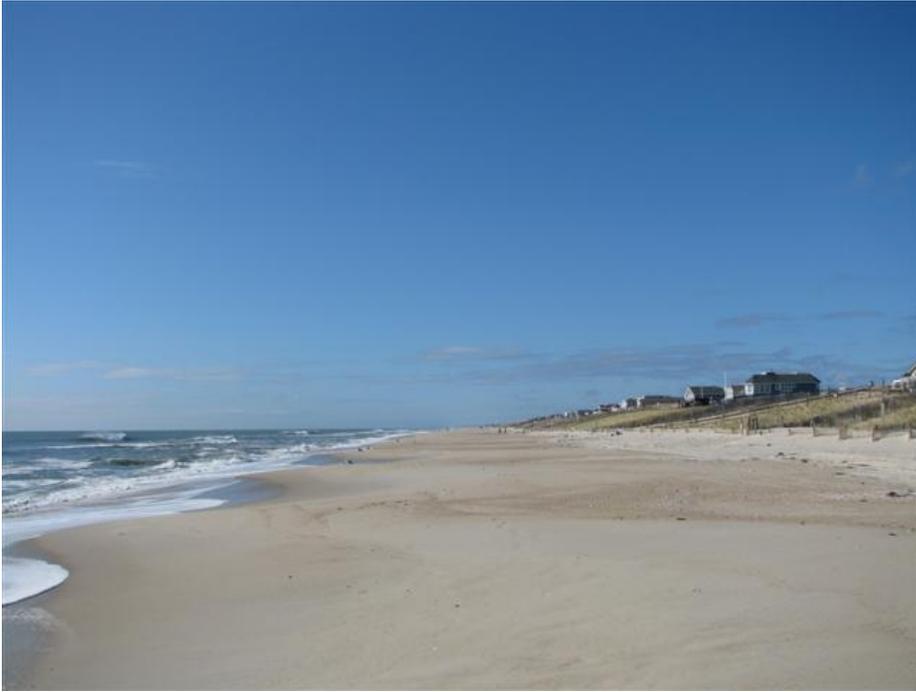
Photo taken September 29, 2008. View to the south.

Site of a beach fill in 2007 with erosion and shoreline retreat following the loss of the placed sand. The fall of 2009 had a profound effect on the berm width removing nearly all of it as opposed to minor losses seen between surveys 36 and 38. The sand volume remaining is still substantially more than what was present before the project.

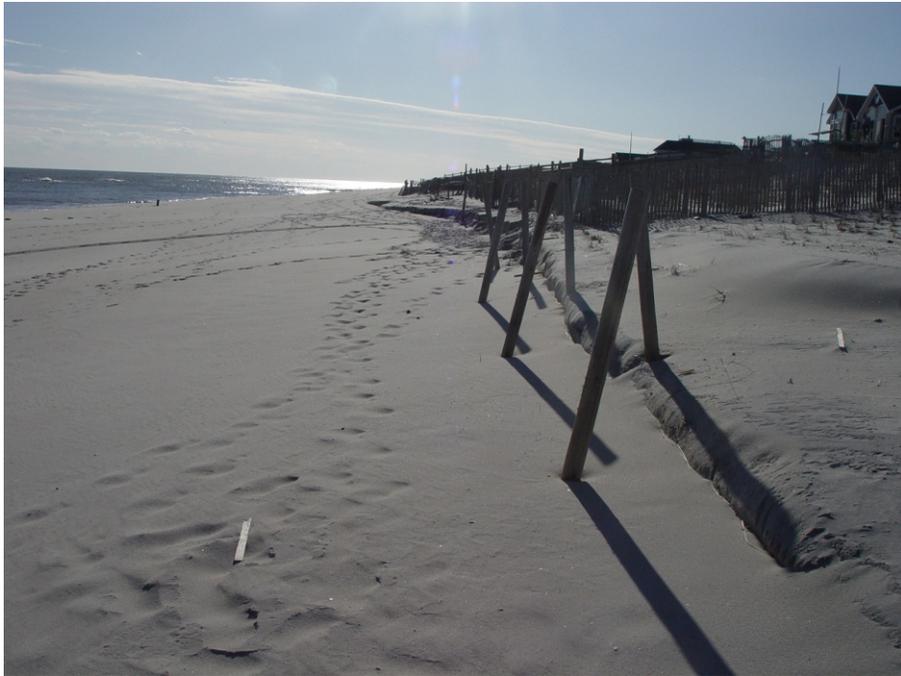
Photo taken December 11, 2009. View to the south.

Comparing the profiles over the fourteen month time period, the profile location lost volume (-41.98 cu yd/ft) and the shoreline moved landward (-87.47 ft).

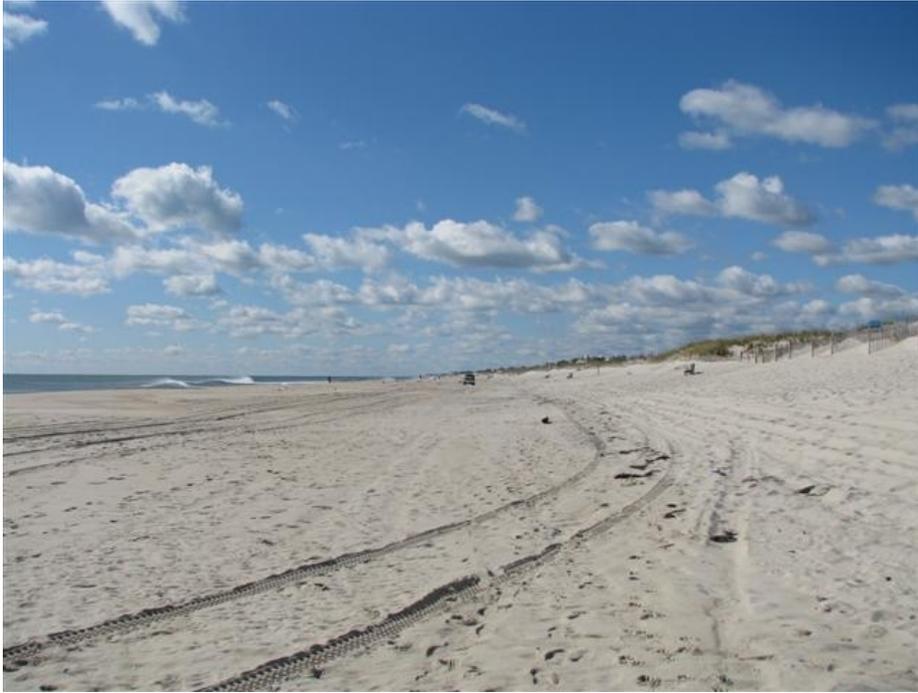
Photo taken October 2, 2008. View to the south.

This site has remained relatively stable over the past 20 years with dune volume increasing and minimal changes in the shoreline position.

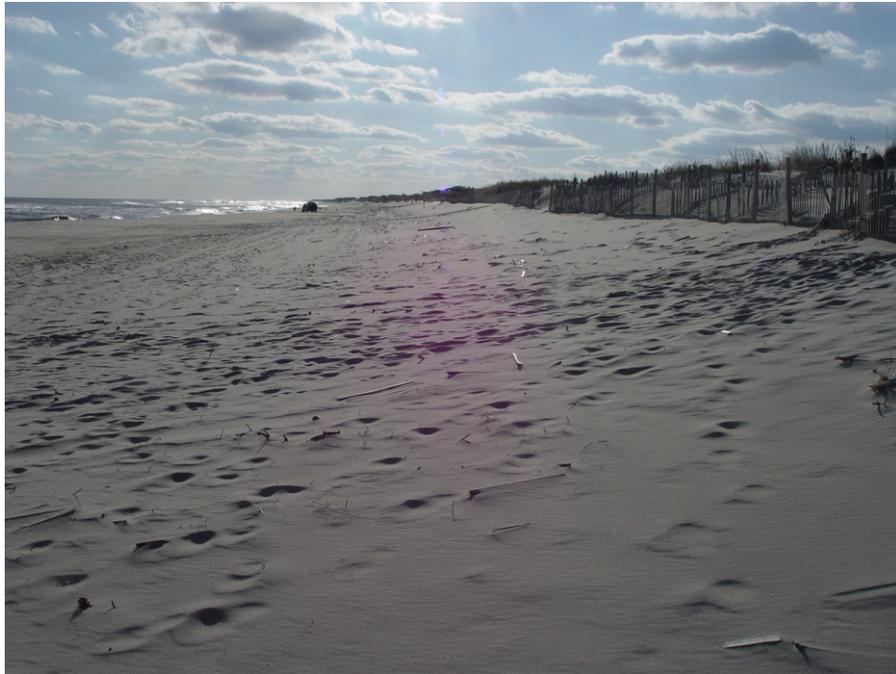
Photo taken December 10, 2009. View to the south.

Comparing the profiles over the fourteen month time period, the profile location gained volume (12.04 cu yd/ft) and the shoreline moved seaward (11.32 ft).

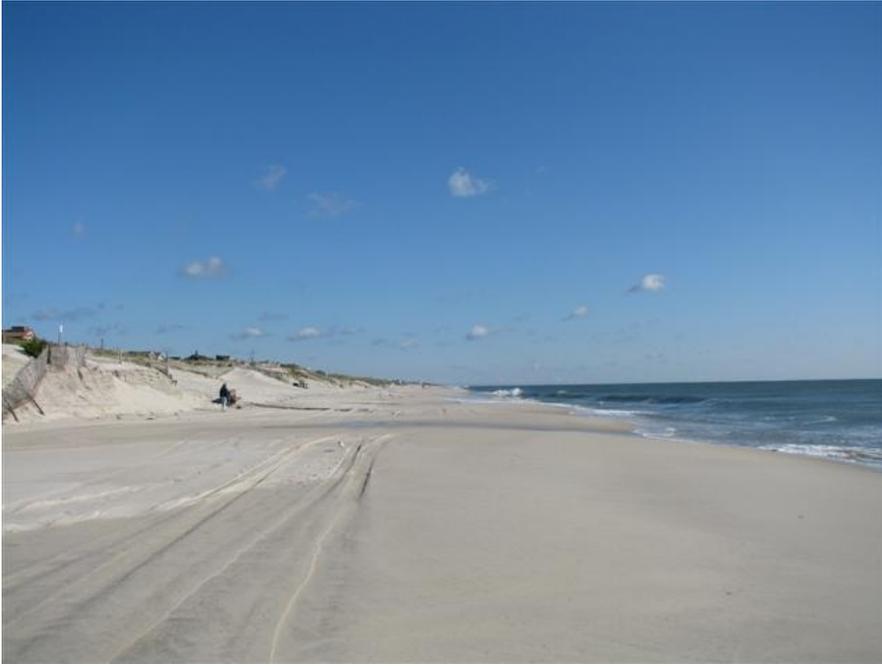
Photo taken October 2, 2008. View to the north. Sand was added to the beach and assembled into a bar far offshore.

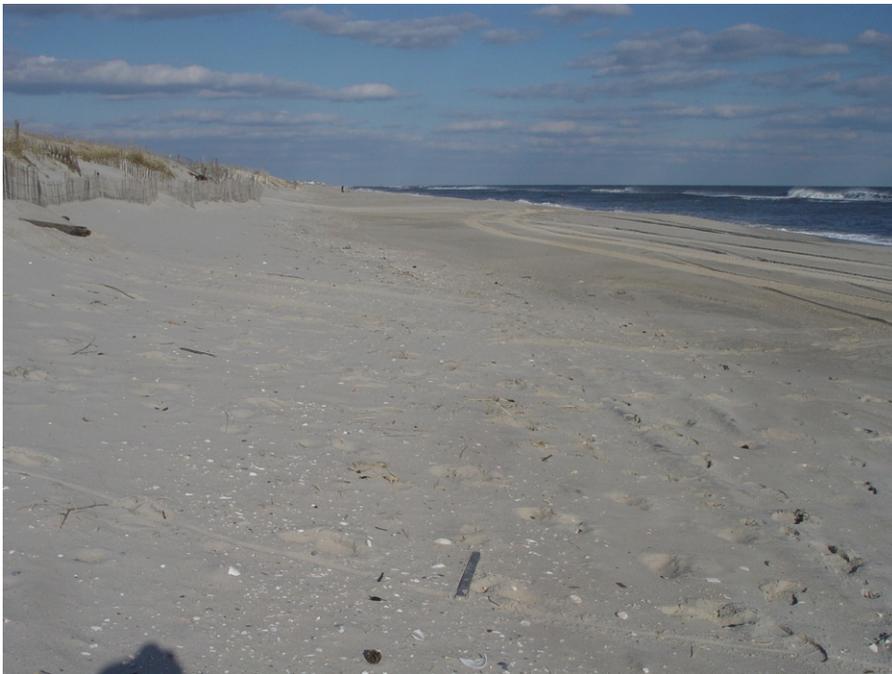
Photo taken December 10, 2009. View to the north.

Comparing the profiles over the fourteen month time period, the profile location lost volume (-7.05cu yd/ft) and the shoreline moved seaward (15.73 ft).

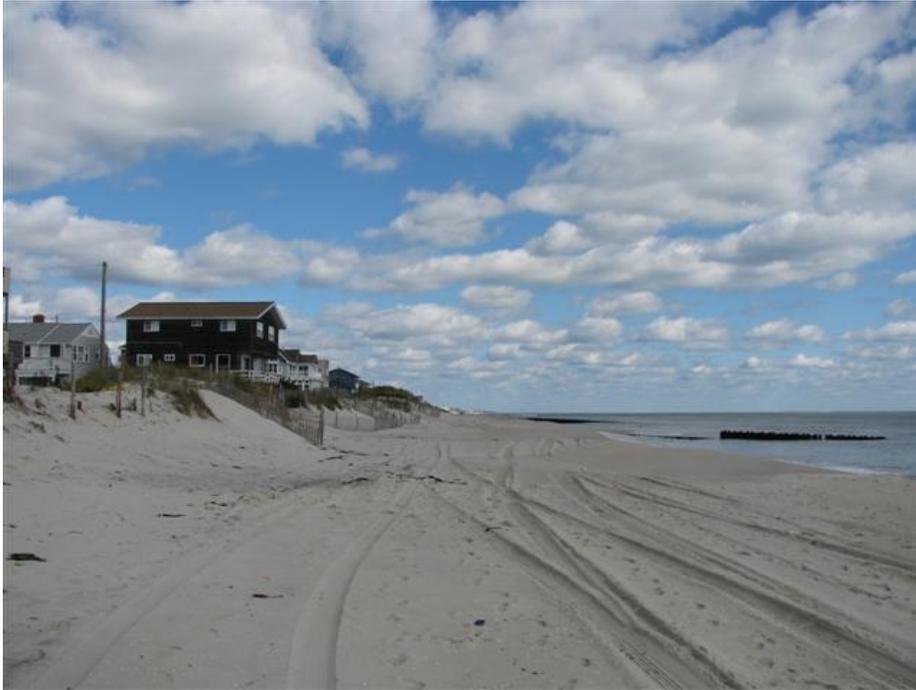
Photo taken October 2, 2008. View to the north.

The site has a minimal dune landward of a narrow beach. The beach was eroded back, but the dune was not damaged. Sand volume was added offshore.

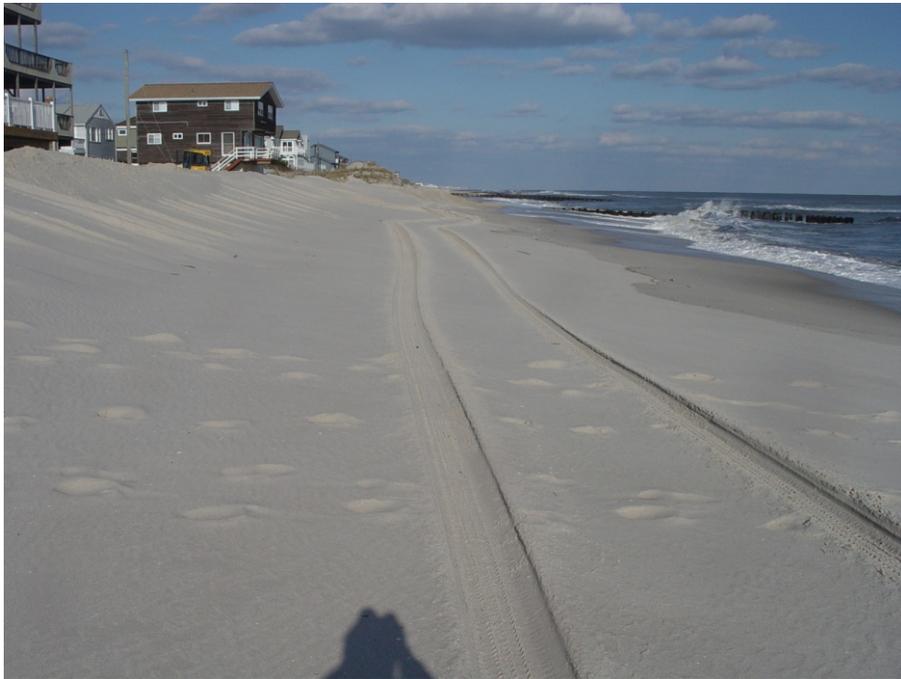
Photo taken December 10, 2009. View to the north.

Comparing the profiles over the fourteen month time period, the profile location lost volume (-4.58cu yd/ft) and the shoreline moved landward (-21.86 ft).

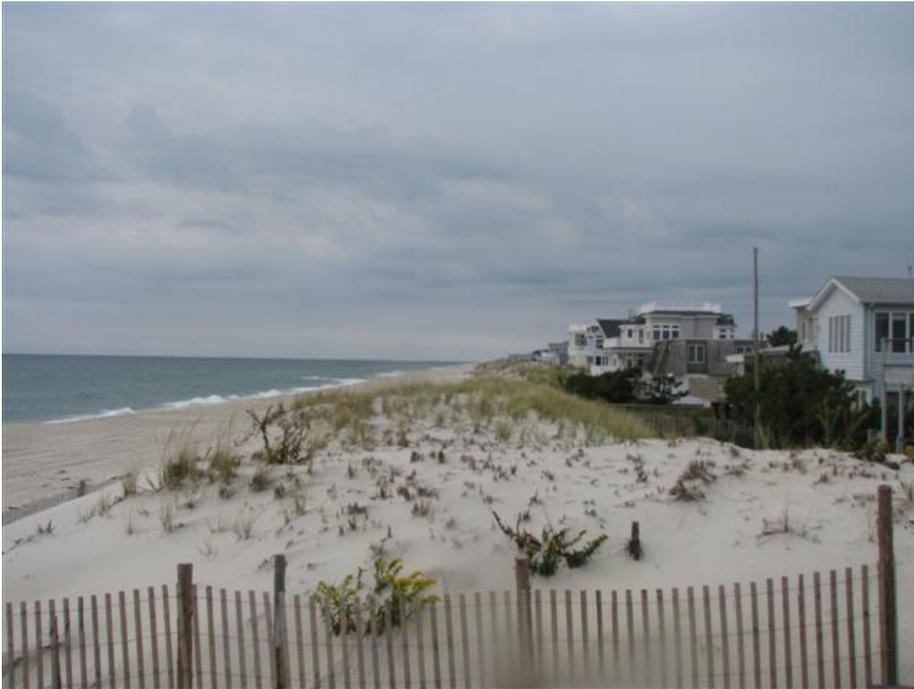
Photo taken October 6, 2008. View to the south. This location was another to receive sand due to storm activity rather than suffer erosion. Sand was added to the berm and offshore, the effect was quite impressive.

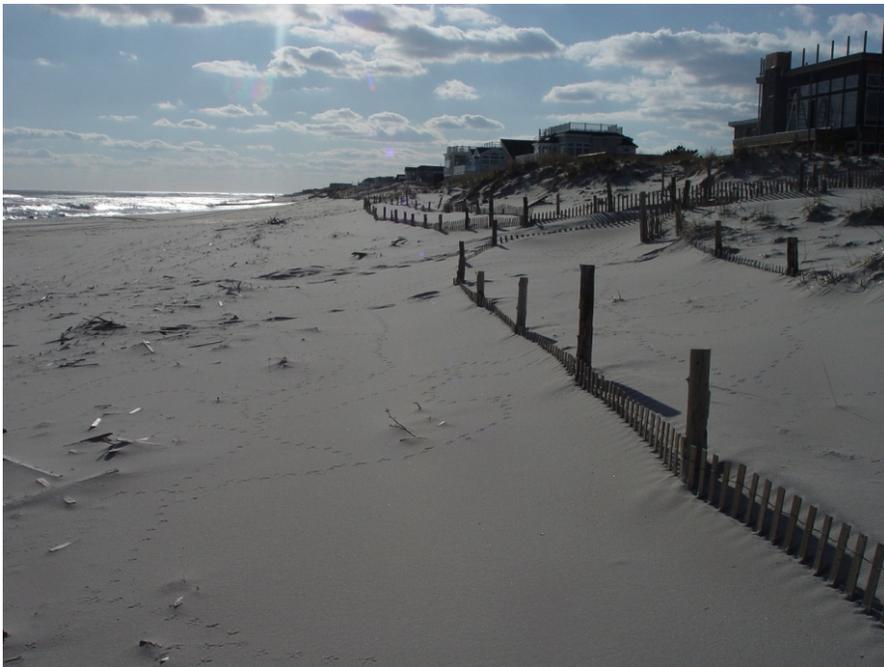
Photo taken December 10, 2009. View to the south.

Comparing the profiles over the fourteen month time period, the profile location gained volume (84.56 cu yd/ft) and the shoreline moved seaward (61.54 ft).

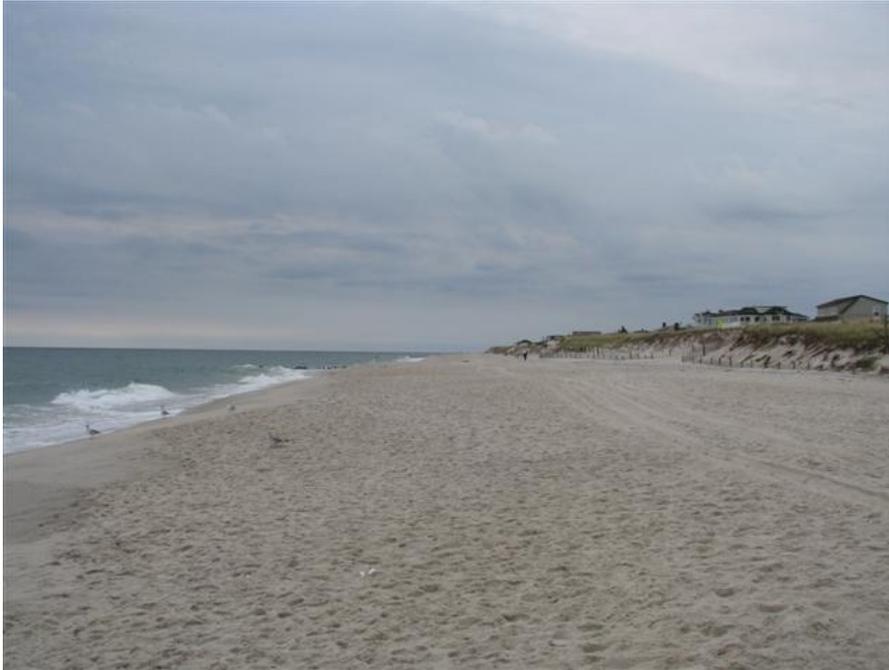
Photo taken October 5, 2008. View to the south.

The shoreline is relatively narrow at this site with a slightly wider dune between the dry beach and the residences. The 2008 “Mother’s Day” northeast storm cut a scarp in the dunes that was not repaired. The fall of 2009 did relatively little damage to the dunes or the beach. Sand was added offshore.

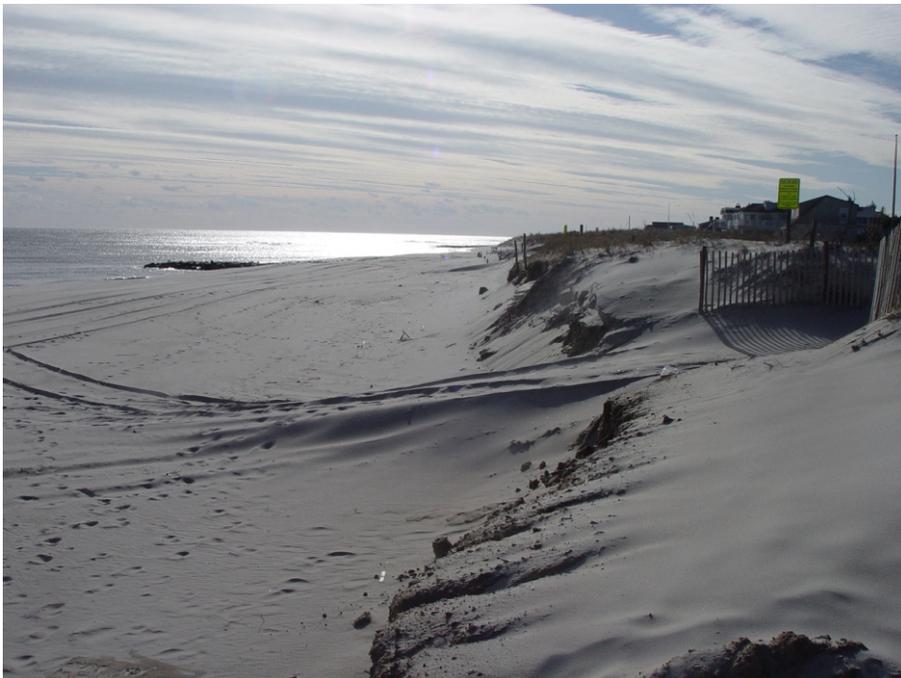
Photo taken December 11, 2009. View to the south.

Comparing the profiles over the fourteen month time period, the profile location gained volume (13.42 cu yd/ft) and the shoreline moved landward (-7.34 ft).

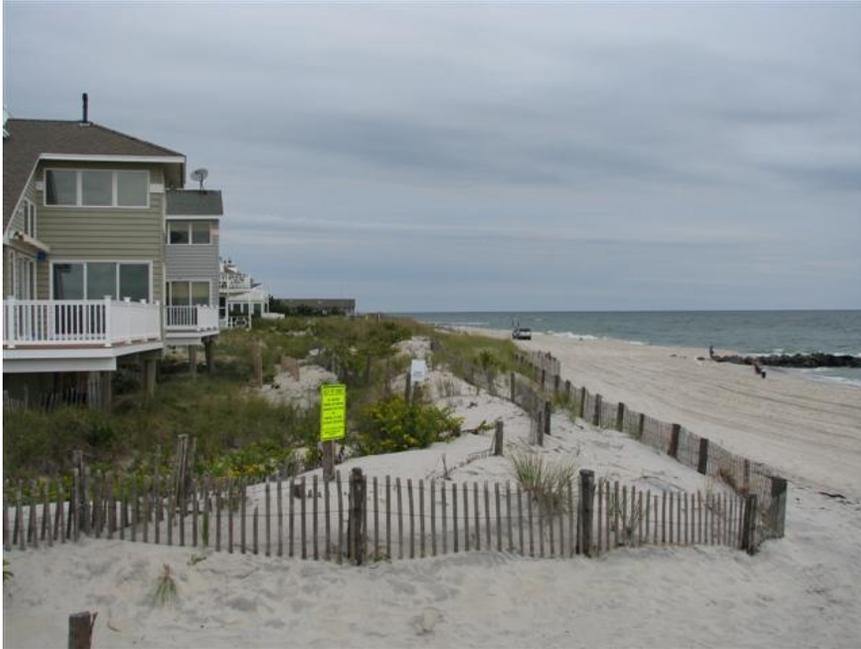
Photo taken October 6, 2008. View to the north. There was a deposit of sand on the beachface with more sand added offshore on the seaward slope of the offshore bar.

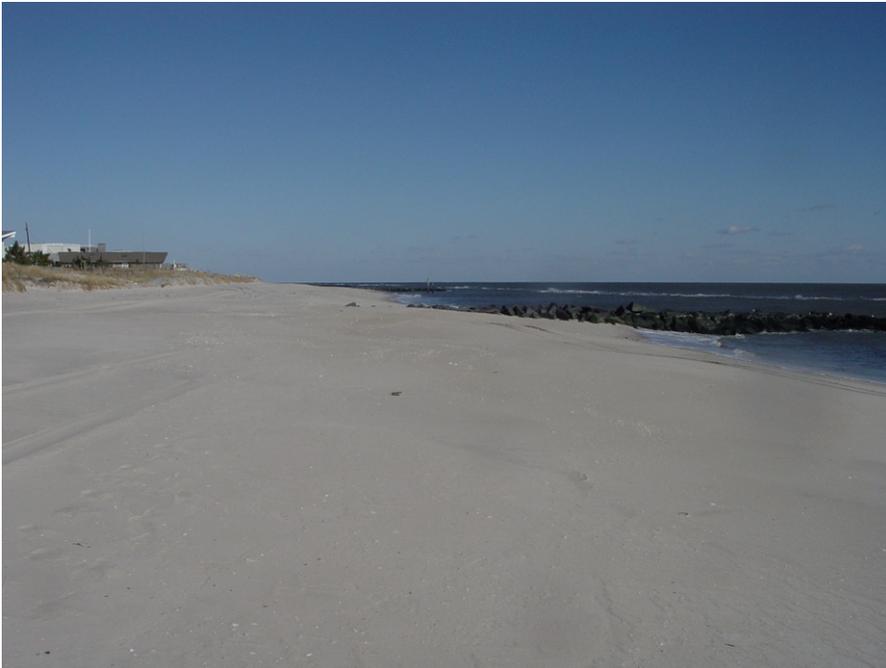
Photo taken December 11, 2009. View to the north.

Comparing the profiles over the fourteen month time period, the profile location gained volume (26.01 cu yd/ft) and the shoreline moved seaward (22.21 ft).

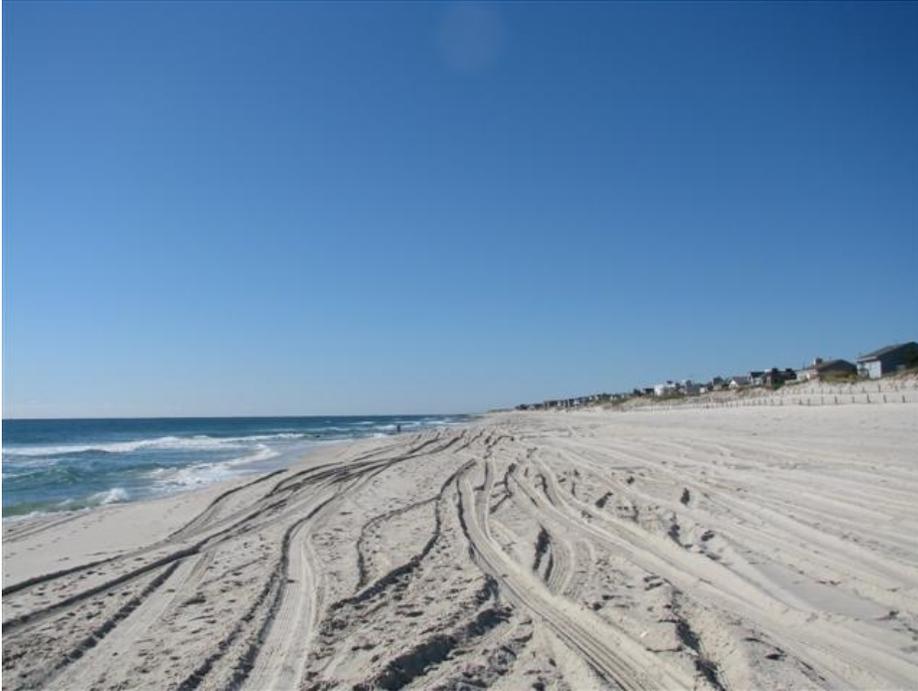
Photo taken October 7, 2008. View to the south.

The Webster Avenue site has a tall, but narrow dune with a beach that slopes seaward from the dune toe. Bar migration is important to building a summer berm.

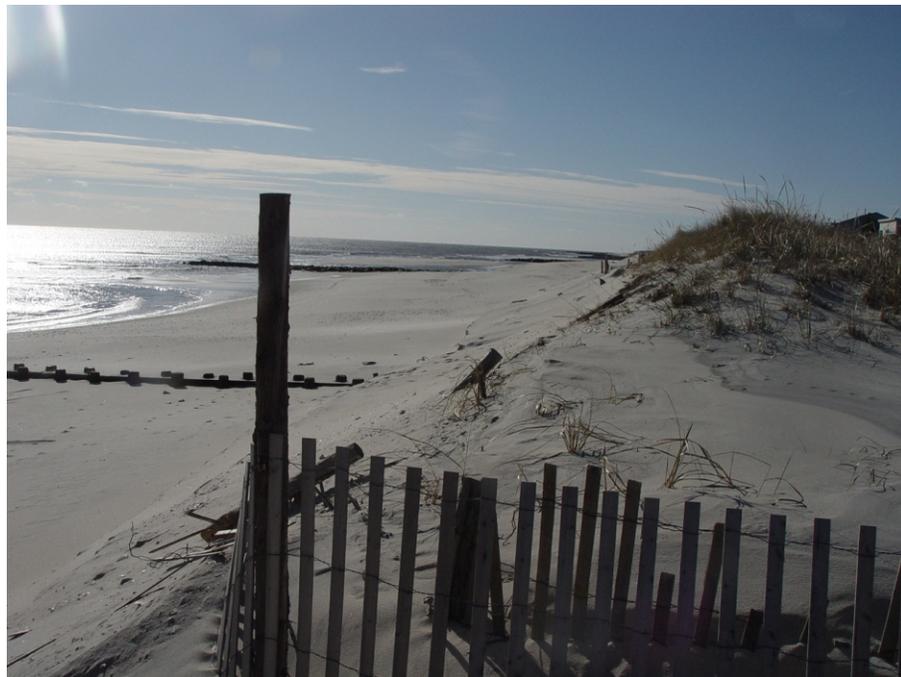
Photo taken December 11, 2009. View to the south.

Comparing the profiles over the fourteen month time period, the profile location lost volume (-63.70 cu yd/ft) and the shoreline moved landward (-93.95 ft). Particularly hard hit by the series of northeasters during the fall of 2009, this site lost much of the beach and the seaward toe of the dunes.

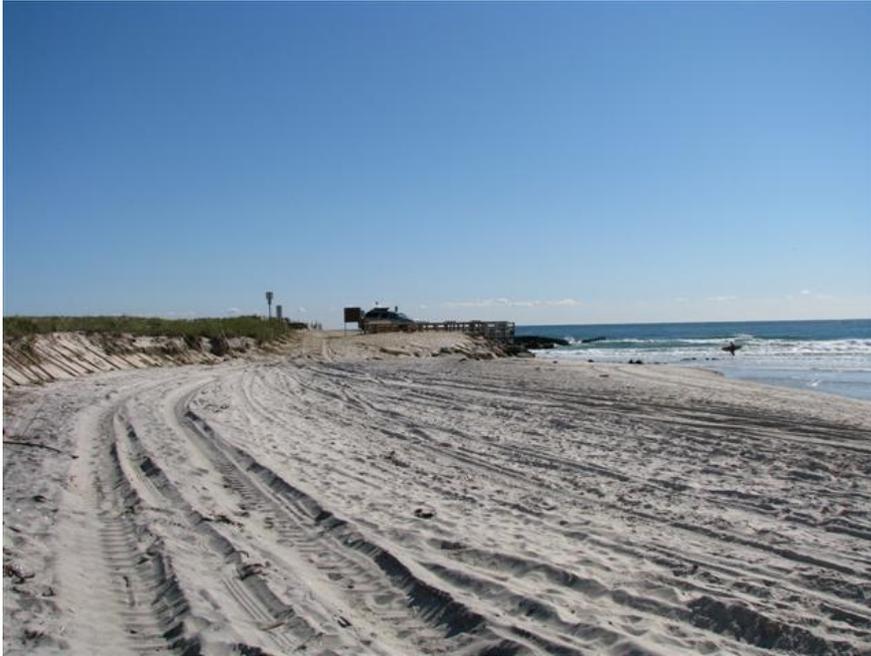
Photo taken October 7, 2008. View to the north.

This view toward the terminal groin shows a narrow beach with considerable exposure of the rocks. Northeast storms act to move sand around this groin where post-storm waves move it onto the beach after the storm. In the absence of northeasters sand will move up the beach from the south if southeast wave conditions prevail for extended periods of time.

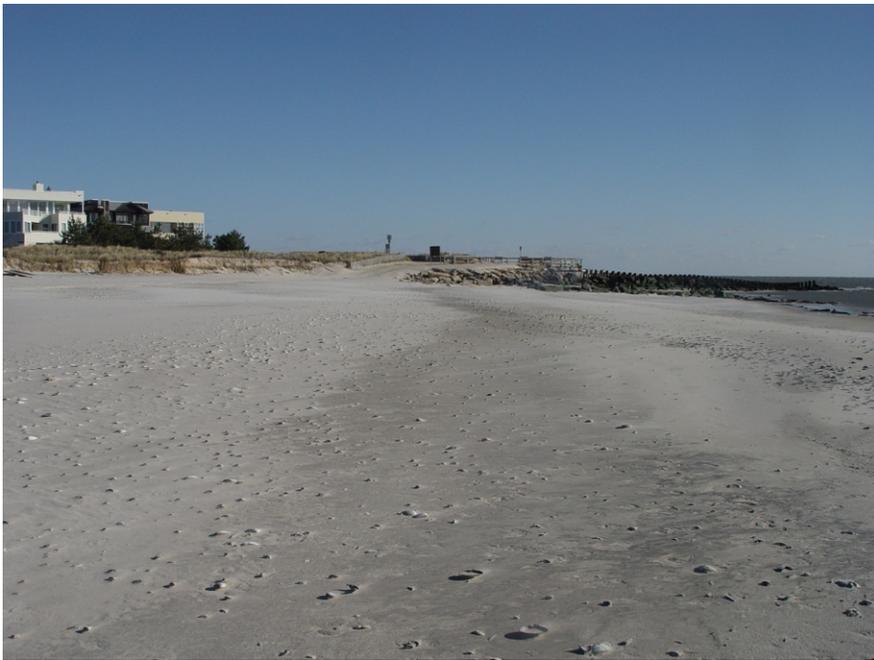
Photo taken December 11, 2009. View to the north.

Comparing the profiles over the fourteen month time period, the profile location gained volume (13.88 cu yd/ft) and the shoreline moved landward (-26.65 ft). The sand volume increase was dominantly found offshore.
