New Jersey Beach Profile Network

Ocean County

Manasquan Inlet
to Little Egg Inlet

NJBPN Profile #'s
156 - 234

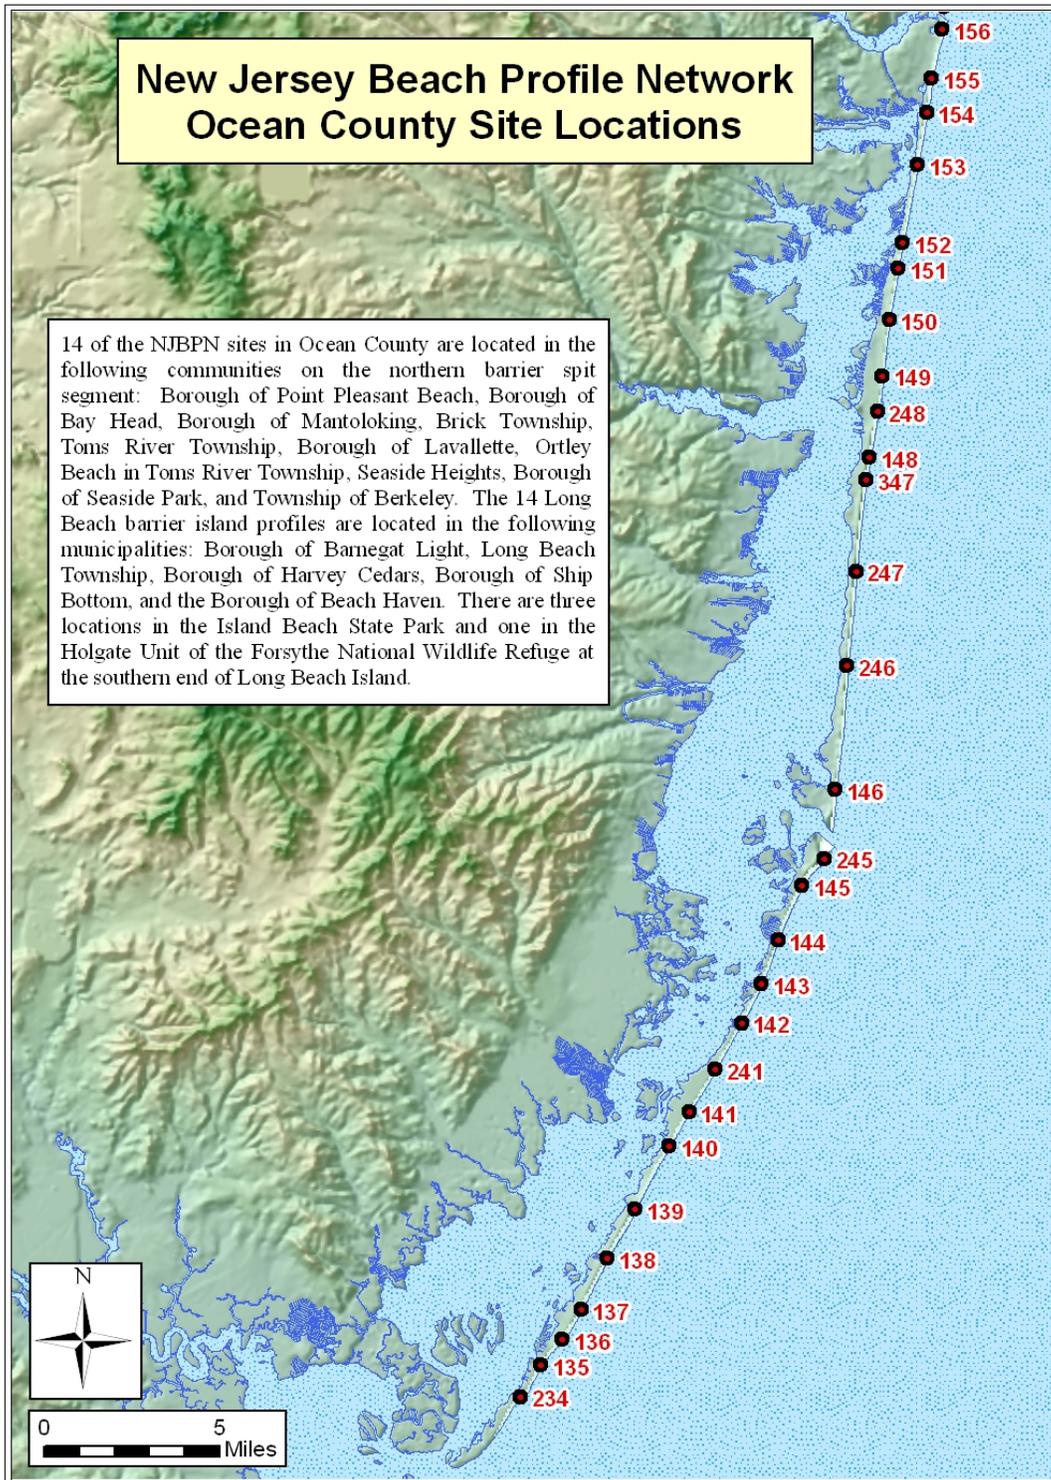
Figure 46. Locations of the 28 NJBPN profile stations in Ocean County, NJ. A new site was added in the Borough of Seaside Heights (#248).

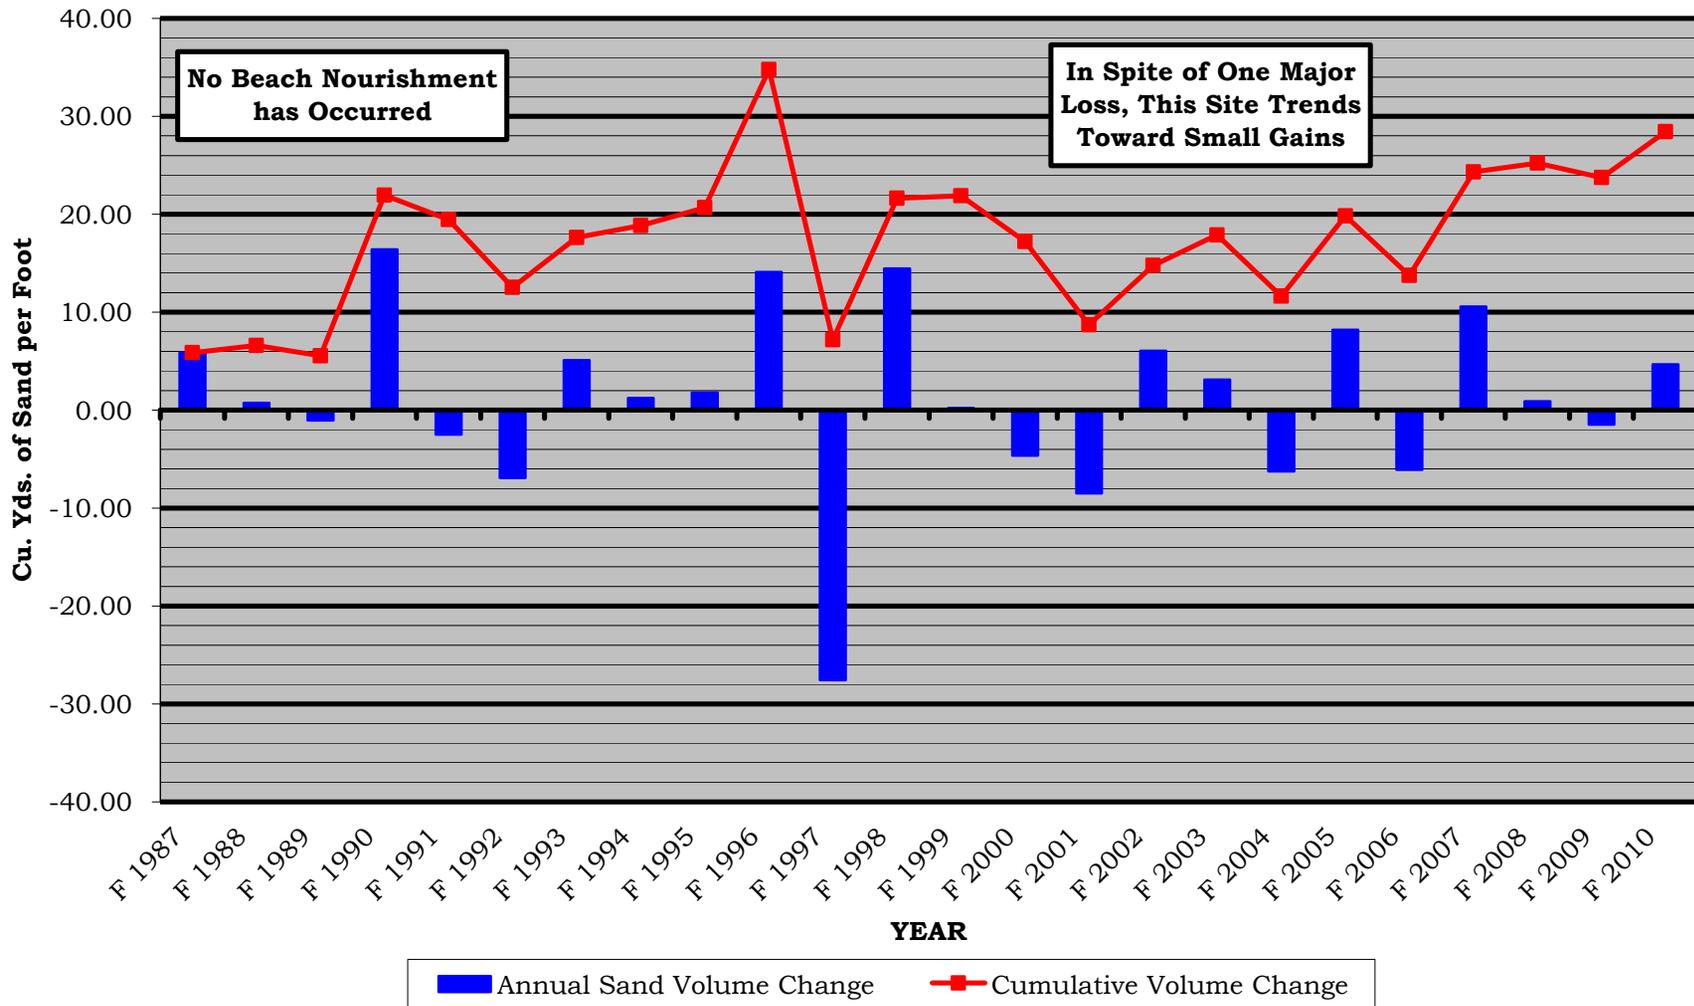
24- Year Sand Volume Changes at Site 154, 1117 Ocean Ave. Mantoloking

Figure 47. The Borough of Mantoloking has focused time and funding on maintaining the dunes along the 2 miles of shoreline with considerable success. Very little new sand has been introduced. Reliance has been placed on the harvesting of recovering berm sand to augment damaged dunes on an annual basis. The winter of 2010 – 2011 was the first in several years where no work was needed. The site varied in sand volume without much of a pattern in spite of two significant storms in 1991 and late 1992 (both negative above). The 1997 loss is unexplained by storm effects. In 24 years this site is about 29 yards of sand per foot of shoreline ahead of the 1986 situation.

Selected locations were chosen to review trends in shoreline changes for Ocean County. The trend analysis for Site 154 in Mantoloking shows small gains in the shoreline though no beach fills have been conducted over the past 23 years. Site 145 at Barnegat Light is located adjacent to the south jetty at Barnegat Inlet on Long Beach Island. Here, huge advances in the shoreline have been recorded due to the completion of the new jetty system. At Site 138, the gains that occurred in 2009 were reversed in 2010. The overall trend for the Ocean County shoreline shows gains that are due to the addition of sand through beach nourishment and results in better protection for structures adjacent to the open ocean.

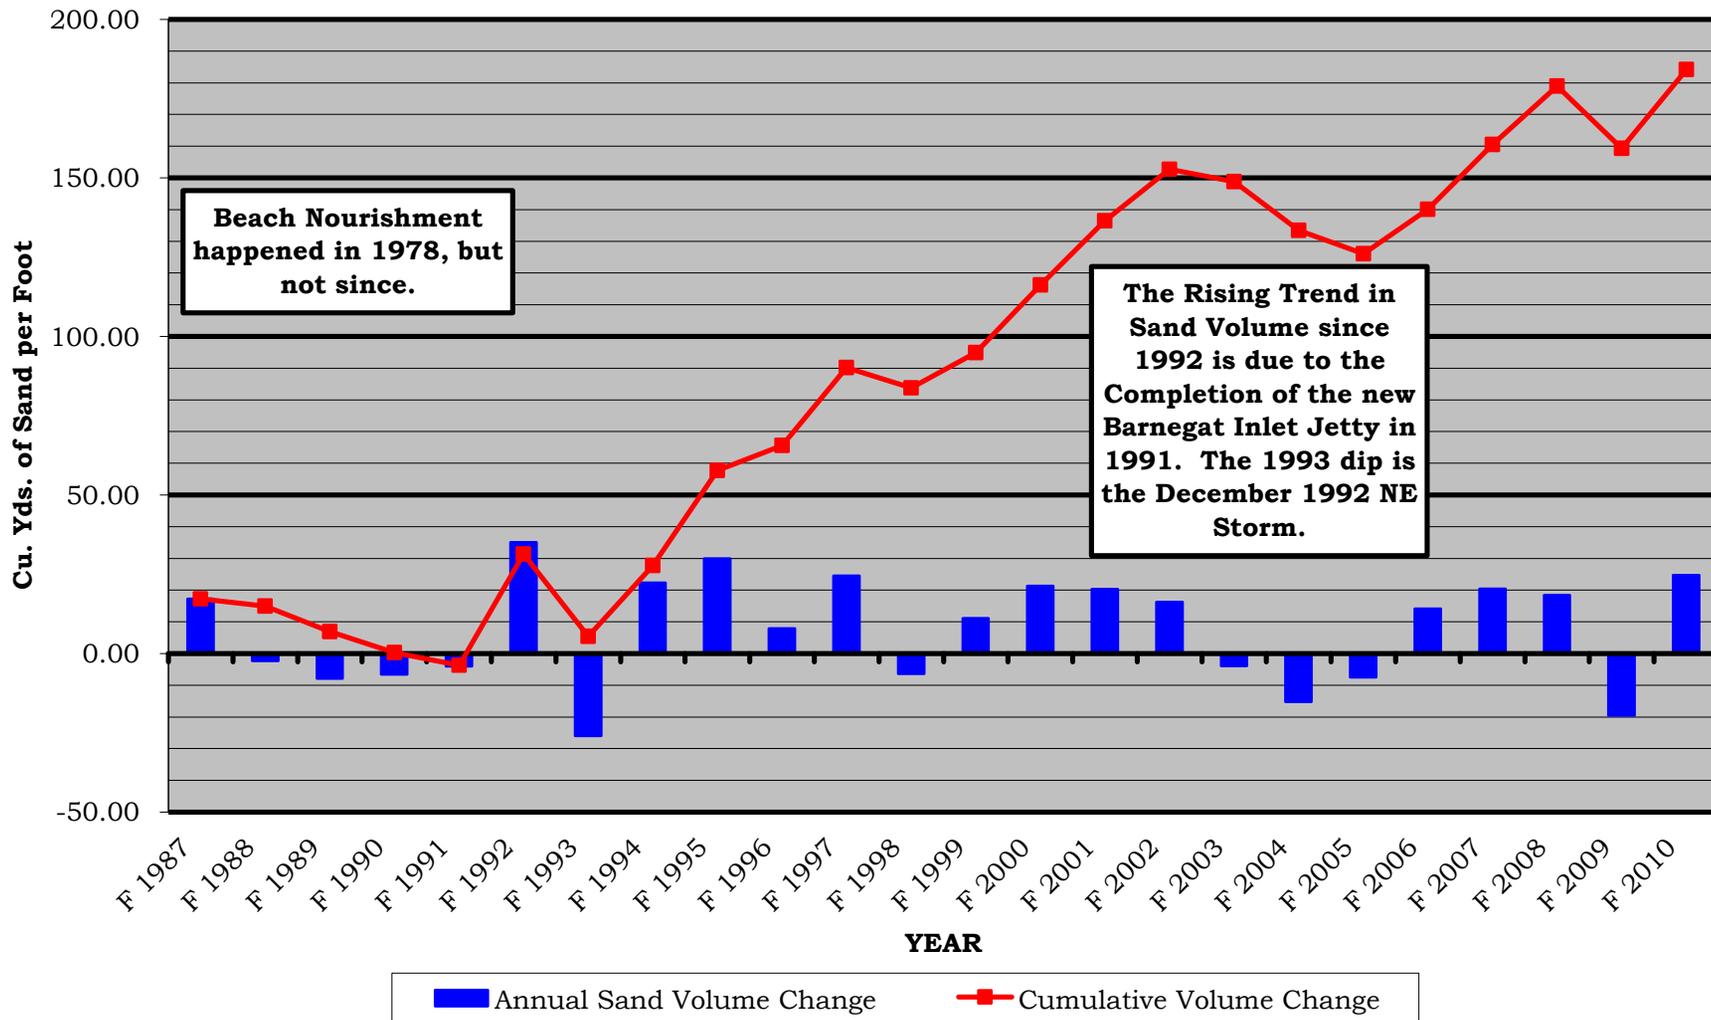
24- Year Sand Volume Changes at Site 145, 26th Street, Barnegat Light

Figure 48. The new jetty at Barnegat Inlet produced a huge advance in the entire Borough shoreline since 1992. The amount declines slowly from 2,400 feet of advance at the jetty to about 60 feet at 26th Street. That advance added 184 cy/ft to the site's sand volume. The blue bars show that for 24 years, only 5 were negative since the jetty was finished in the new alignment in 1991.

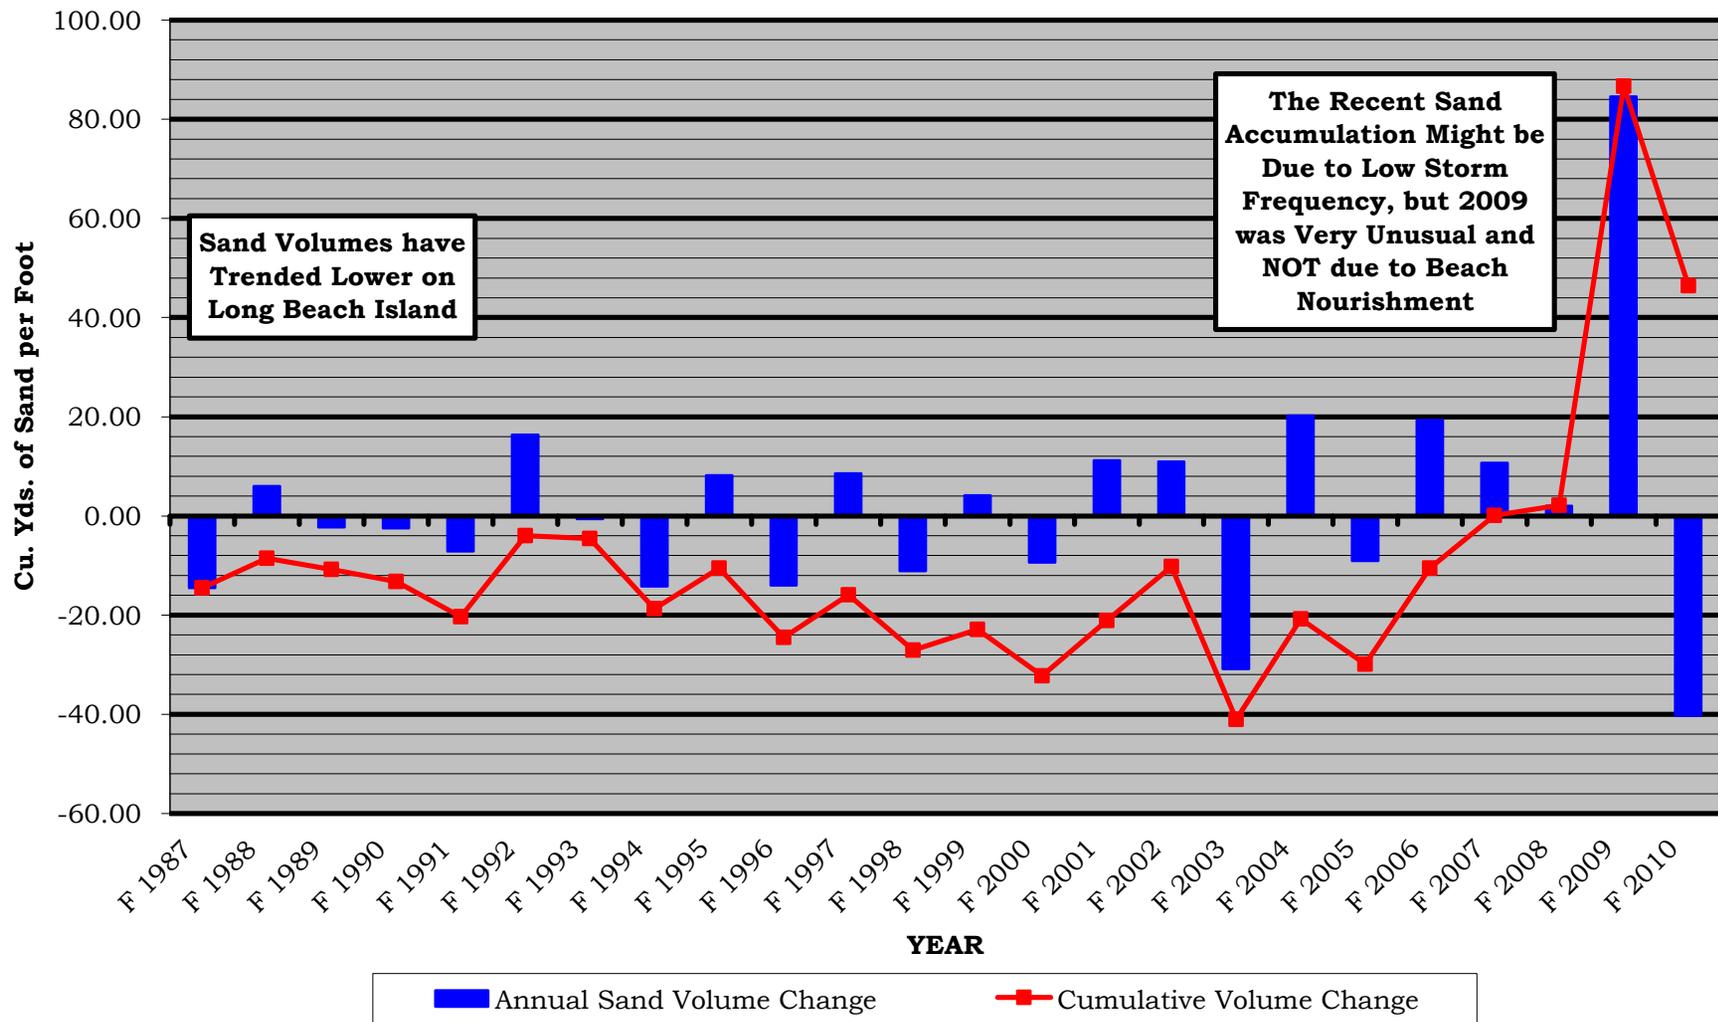
24 - Year Sand Volume Changes at Site 138, Old Whaling Road, Long Beach Island

Figure 49. The Old Whaling Road site was selected to illustrate a relative degree of instability present along the Long Beach Island shoreline. The 1991 completion of the realignment of the Barnegat Inlet south jetty produced massive accumulation at the two northern sites surveyed (145 and 245). The dramatic gain seen in 2009 was partially reversed in 2010. This site remains in positive sand volume territory based on the 2009 sand volume increase.

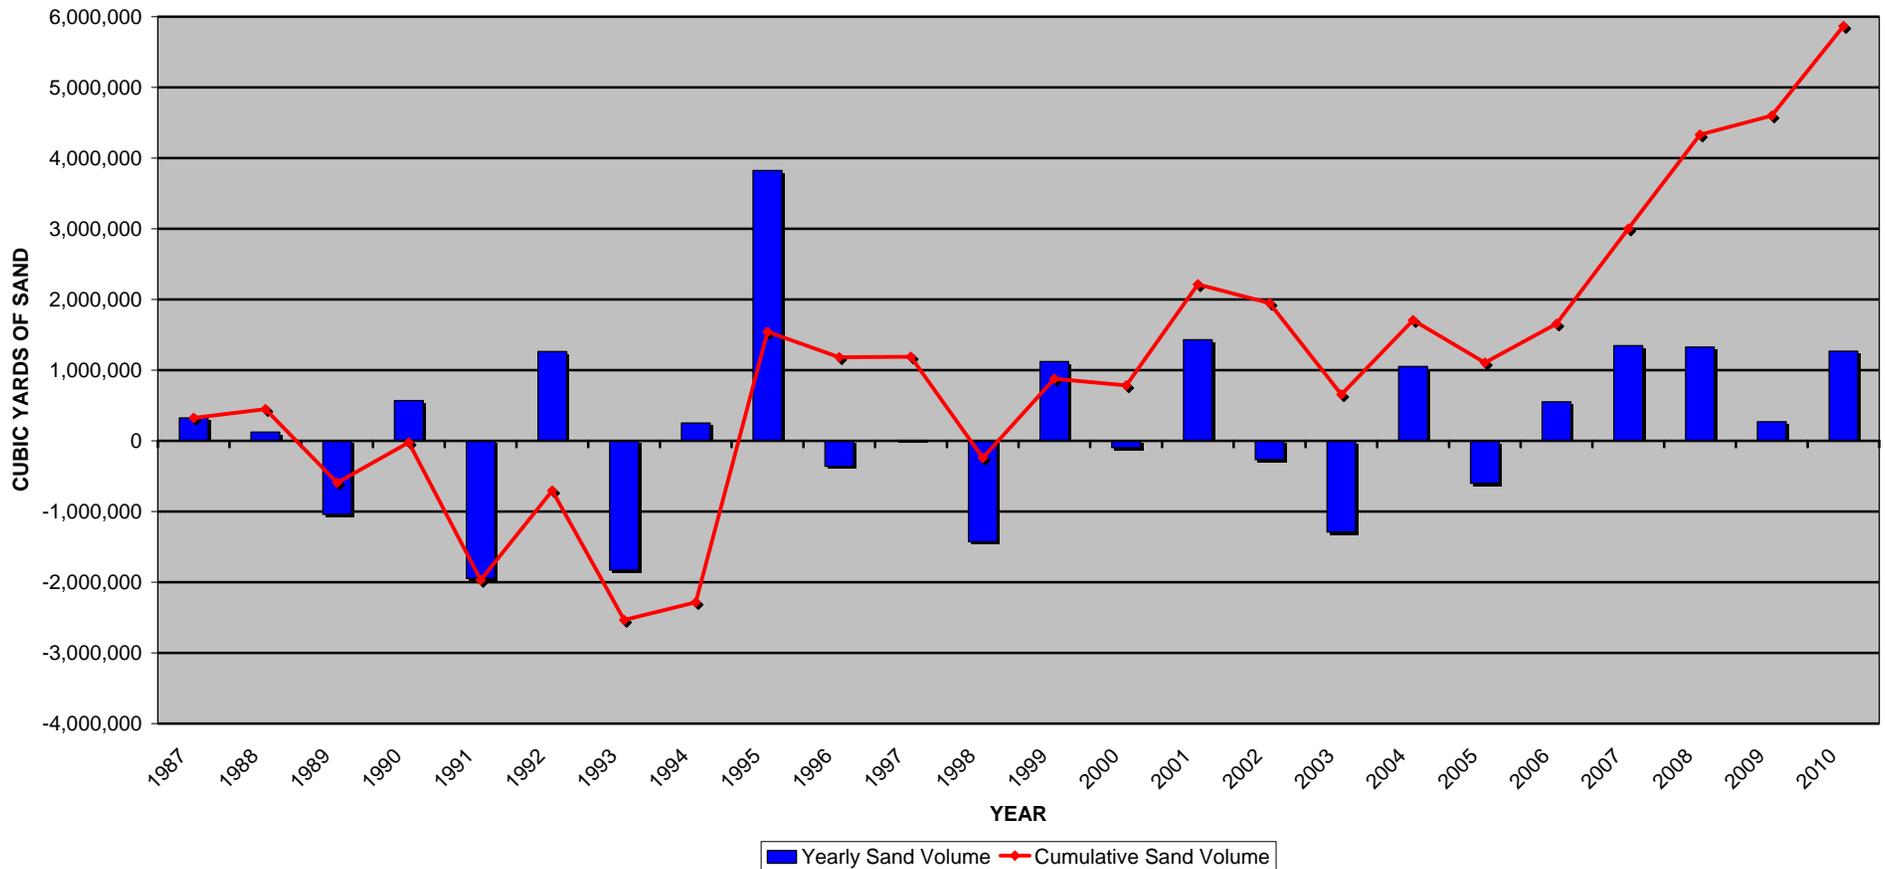
ANNUAL & CUMULATIVE OCEANFRONT SHORELINE SAND VOLUME CHANGES, OCEAN COUNTY 1987 to 2010

Figure 50. The 1995 Harvey Cedars beach fill project reversed the negative trend in Ocean County. Recently the trend has been upward driven in part by the impact of the ACOE Surf City project in 2007, continuing in 2010 and 2011. This was the first Federal project in Ocean County. 24 years of sand volume changes at the 28 sites in Ocean County shows the recent impact of beach restoration efforts on Long Beach Island. The cumulative trend line moved from about 1,000,000 cubic yards of sand gained between 1986 and 2005 (the last year of net loss) and 5,867,000 cubic yards gained by 2010. The advance in sand quantity by 4.8 million cubic yards is not due to natural accretion since there is no source for that much material derived from the natural environment. In spite of these gains being substantially smaller than those seen in Monmouth and Cape May Counties, this represents an advance in shoreline protection for some of this county’s communities.

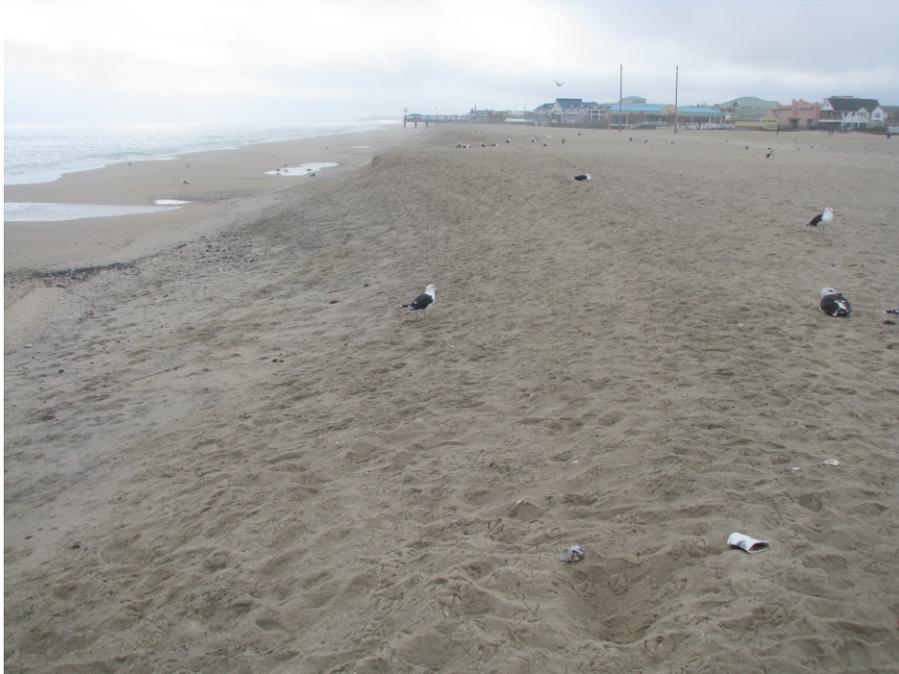
Photo taken September 23, 2009. View to the south.

The Manasquan Inlet is located a short distance to the north of this site, therefore often reflects dominant littoral transport toward or away from the inlet jetties. This view to the south shows the wide beach with no dune that lies in front of the Point Pleasant Beach boardwalk.

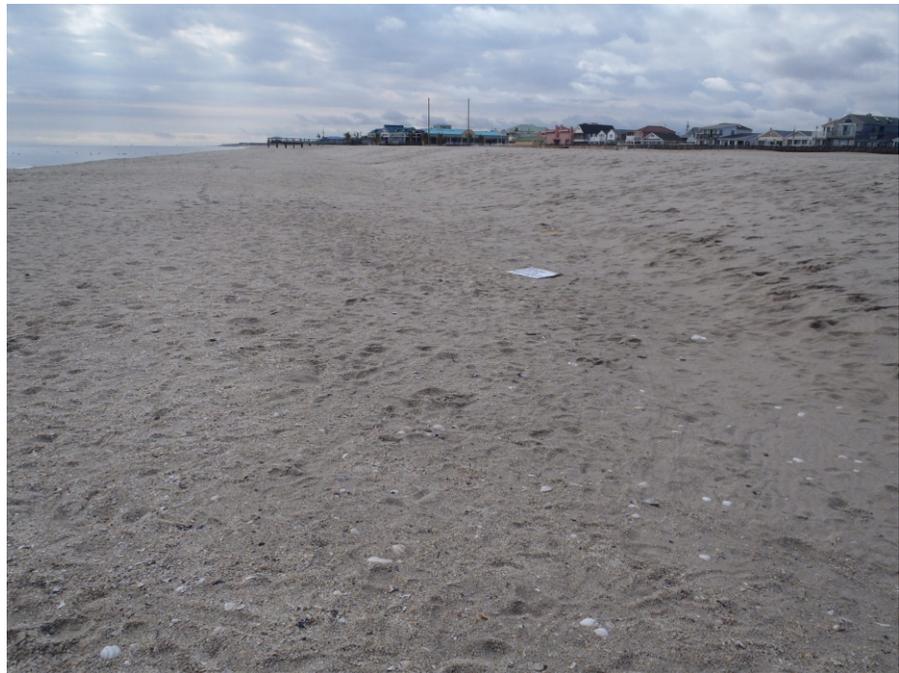
Photo taken October 19, 2010. View to the south.

Comparing the profiles over the year, the profile location lost volume (-40.14 cu yd/ft) and the shoreline moved landward (-30.08 ft).

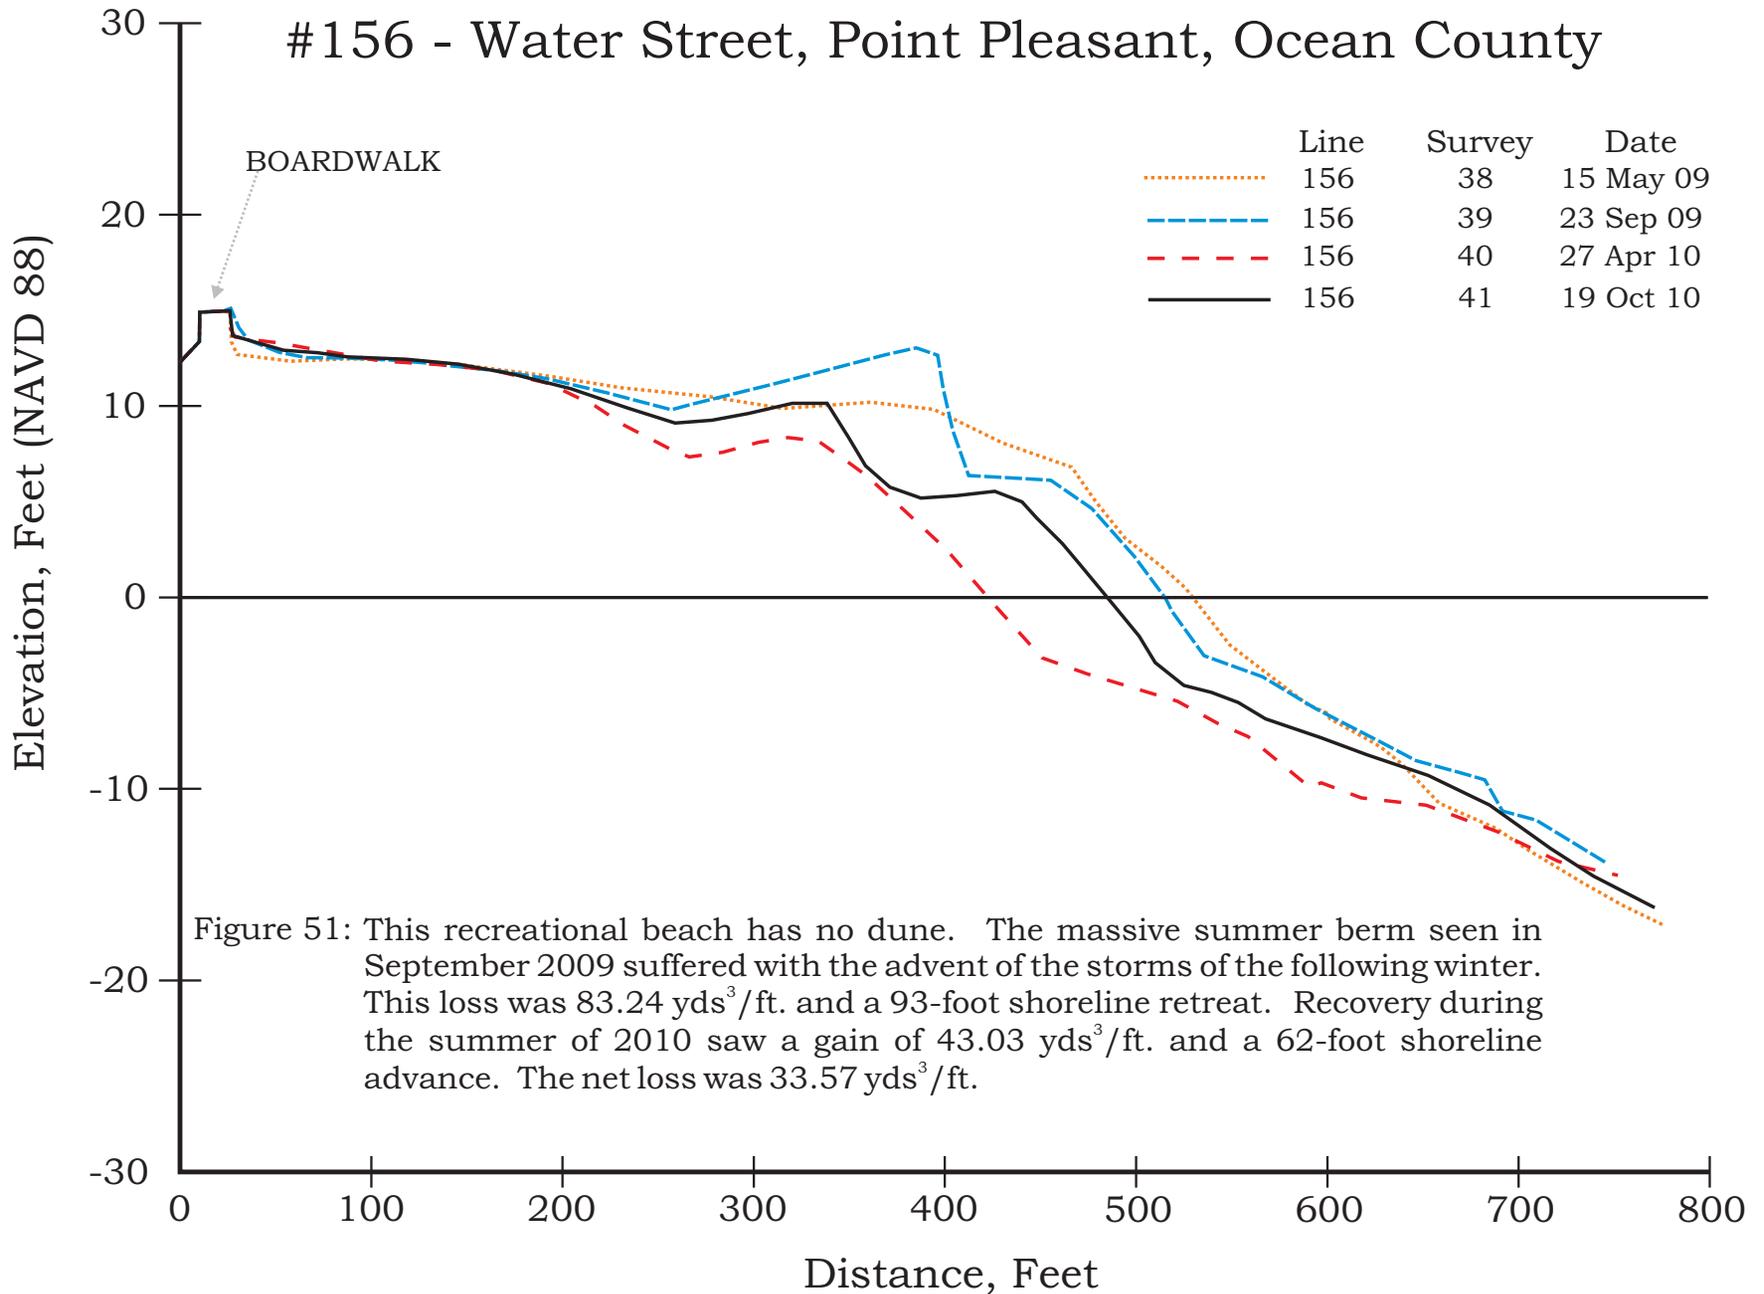
#156 - Water Street, Point Pleasant, Ocean County

Figure 51: This recreational beach has no dune. The massive summer berm seen in September 2009 suffered with the advent of the storms of the following winter. This loss was 83.24 yds³/ft. and a 93-foot shoreline retreat. Recovery during the summer of 2010 saw a gain of 43.03 yds³/ft. and a 62-foot shoreline advance. The net loss was 33.57 yds³/ft.

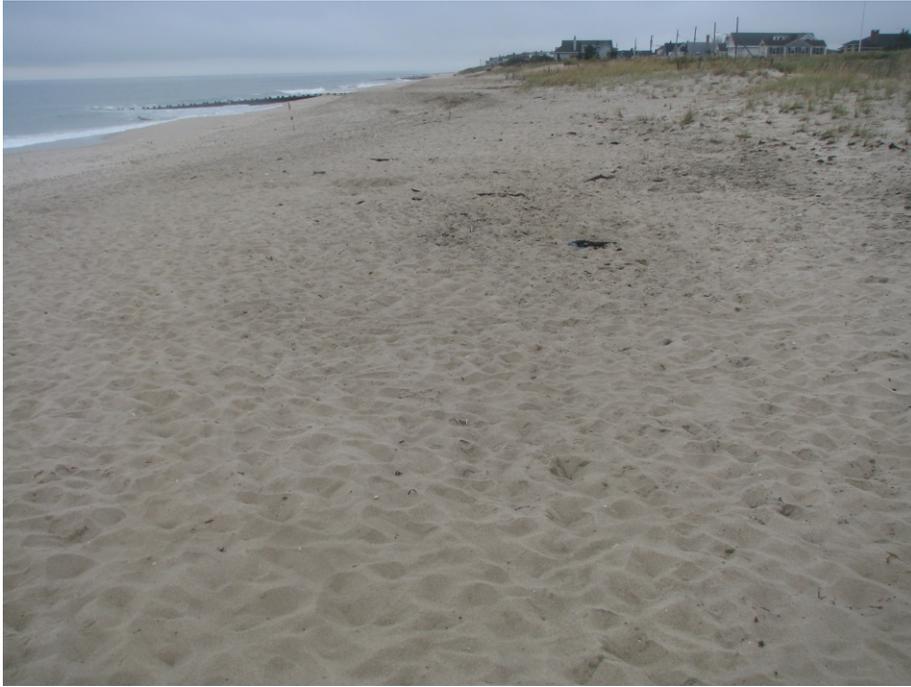
Photo taken September 23, 2009. View to the south.

This location has a substantial dune which has gained sand despite a relatively narrow beach. This cyclic nature of the groin offsets is most common in the Northern Ocean County coast because there is a near equal incidence of littoral sand transport in either direction. Northeast storms move sand south, followed by the southeast winds acting to move sand back to the north. The groin offset simply shows which direction is dominant at any one time.

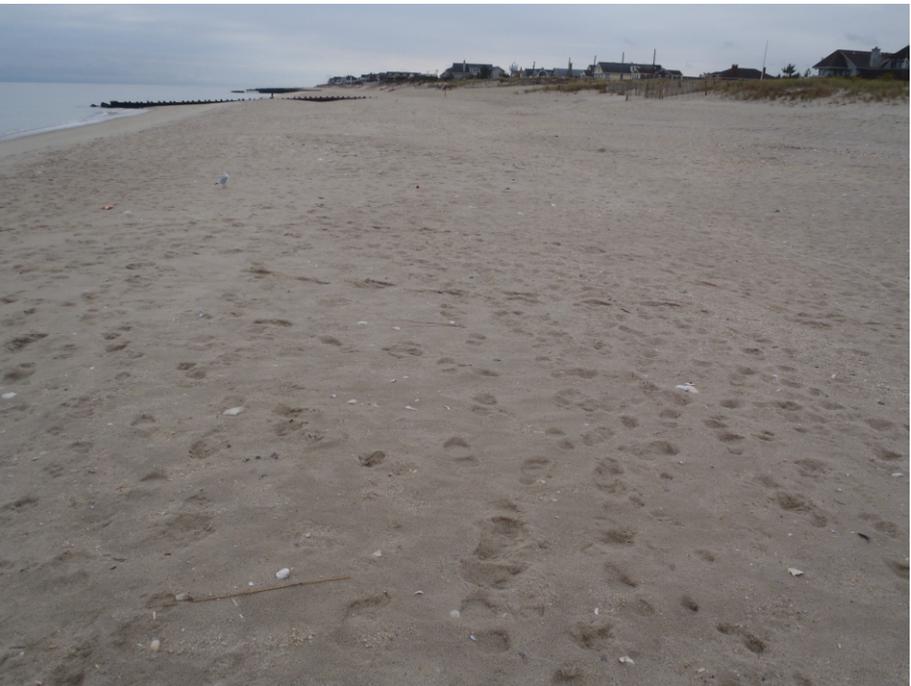
Photo taken October 19, 2010. View to the south.

Comparing the profiles over the year, the profile location gained volume (13.64 cu yd/ft) and the shoreline moved seaward (12.11 ft).

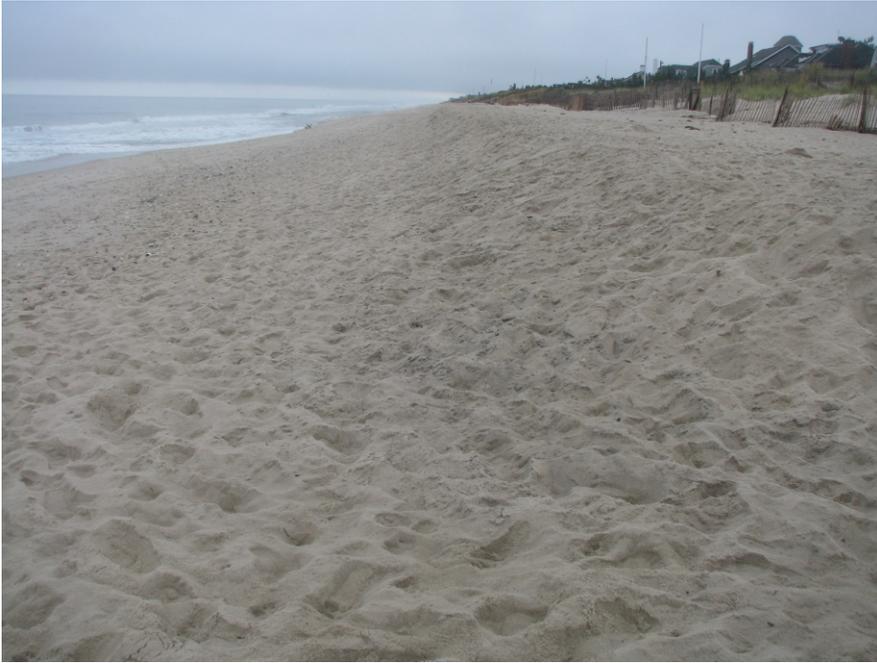
Photo taken September 23, 2009. View to the south.

The Bay Head beach contains a rock revetment below the dune crest that has not been exposed since December 1992.

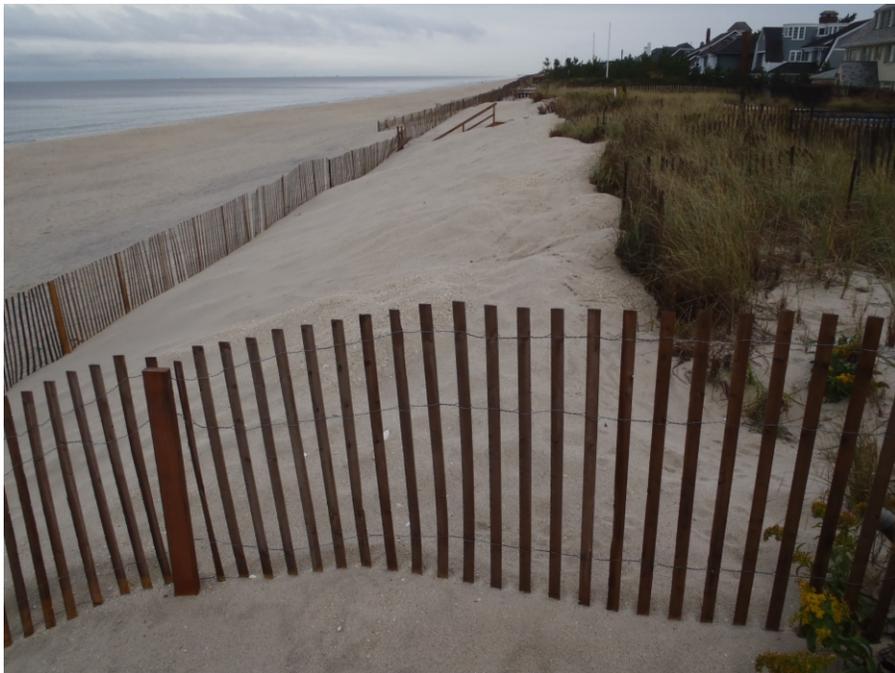
Photo taken October 19, 2020. View to the south.

Comparing the profiles over the year, the profile location gained volume (4.69 cu yd/ft) and the shoreline moved seaward (8.26 ft).

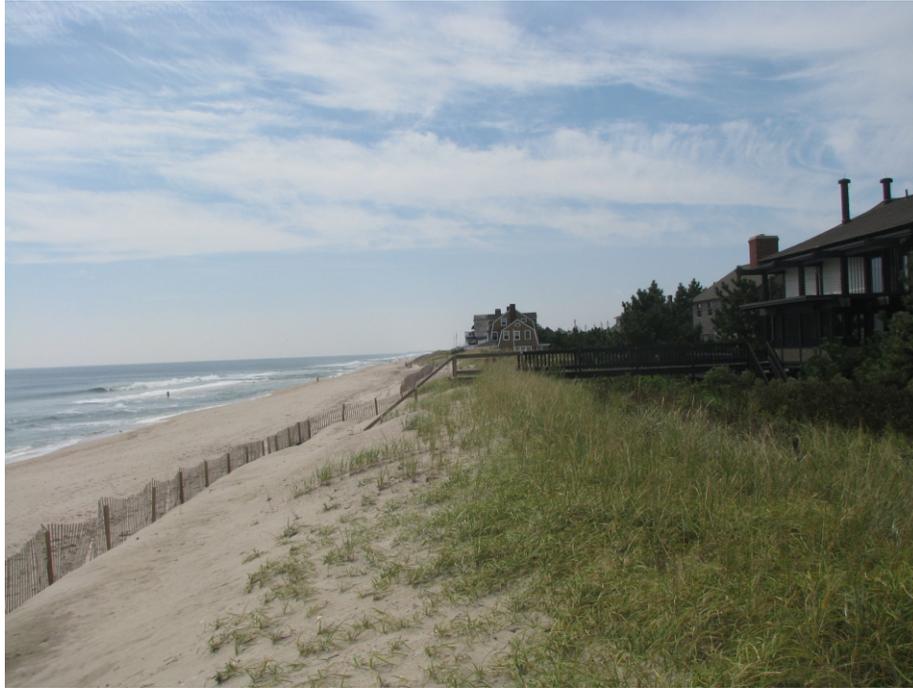
Photo taken September 15, 2009. View to the south.

The Mantoloking site is surveyed quarterly for the specific interests of the municipal officials along with four other sites along the Borough oceanfront. In October 2008, this site was restored by transferring sand from the berm up the seaward dune slope to restore winter erosion into the dune. Winter events in 2009 produced significant dune retreat and prompted another restoration effort with the bulldozer. The fall 2009 required a community-wide bulldozing effort to move between 7 and 10 cubic yards of sand back to the dune.

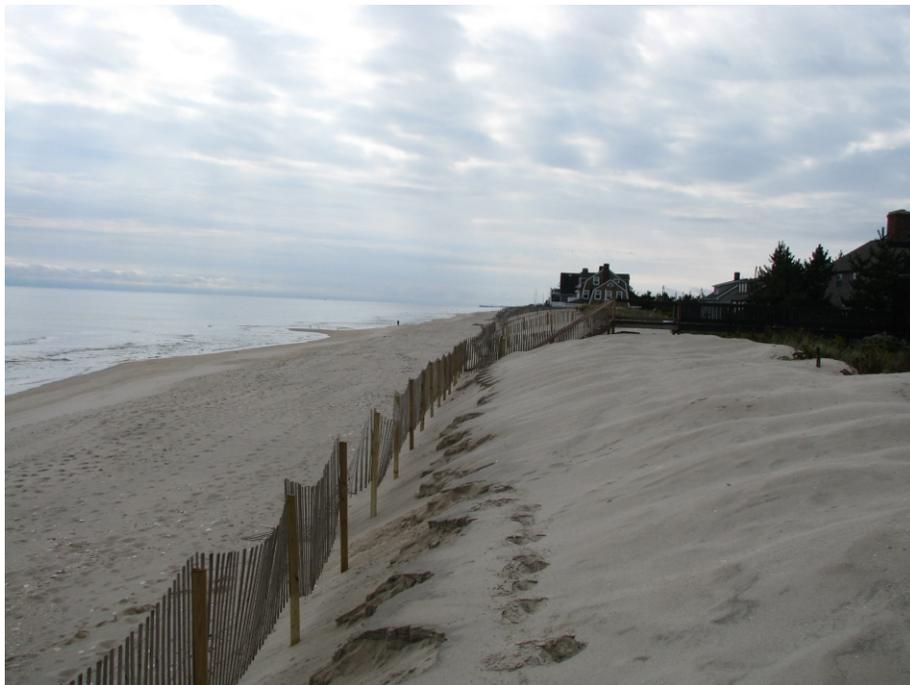
Photo taken October 19, 2010. View to the south.

Comparing the profiles over the year, the profile location gained volume (4.26 cu yd/ft) and the shoreline moved landward (-13.74 ft).

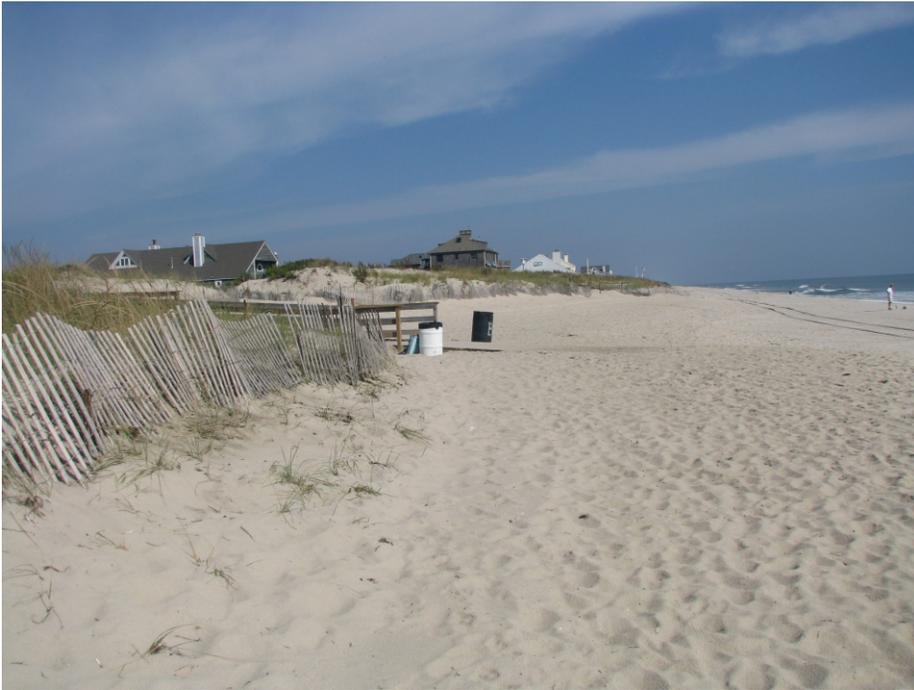
Photo taken September 24, 2009. View to the north.

The public beach in Brick Township has developed a sizable dune between the beach and the recreational area parking lot and service building. This site was surveyed prior to fall 2009 storms commencing.

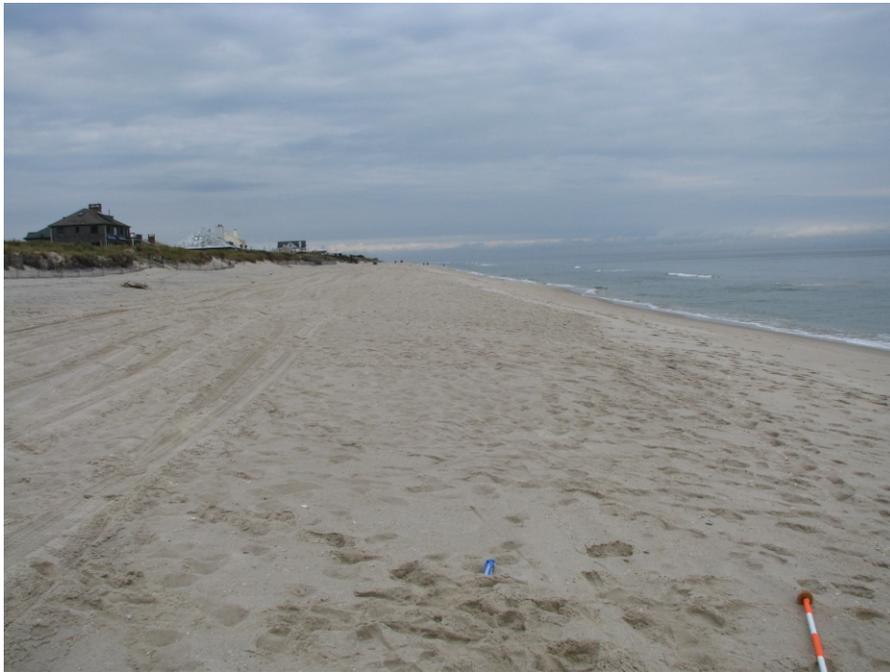
Photo taken October 19, 2010. View to the north.

Comparing the profiles over the year, the profile location lost volume (-16.9 cu yd/ft) and the shoreline moved landward (-0.5 ft).

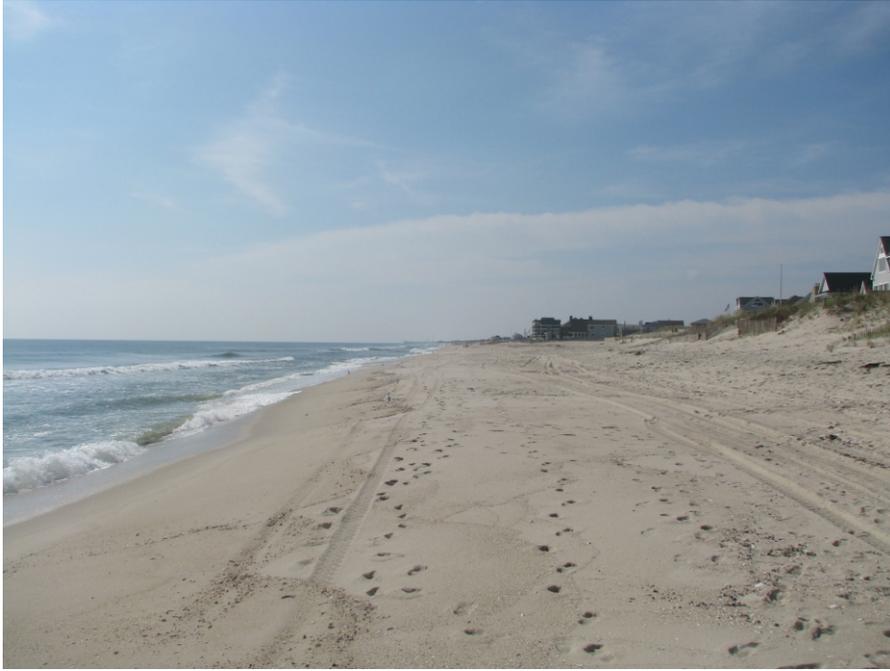
Photo taken September 24, 2009. View to the south.

The dune toe is vulnerable to storm wave activity. No large-scale beach fills have been carried out at this location.

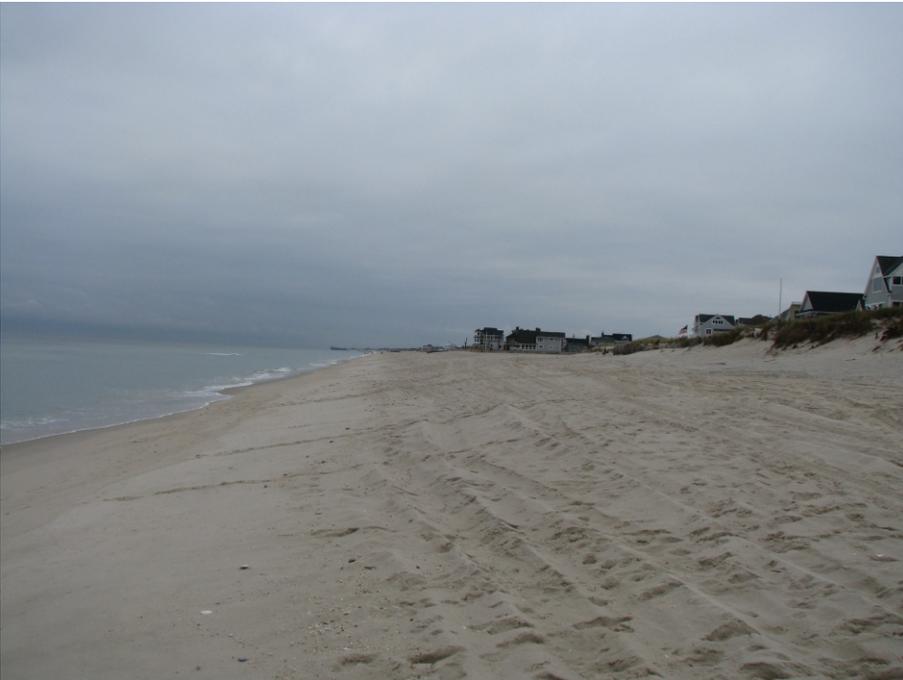
Photo taken October 19, 2010. View to the south.

Comparing the profiles over the year, the profile location lost volume (-6.16 cu yd/ft) and the shoreline moved seaward (3.95 ft).

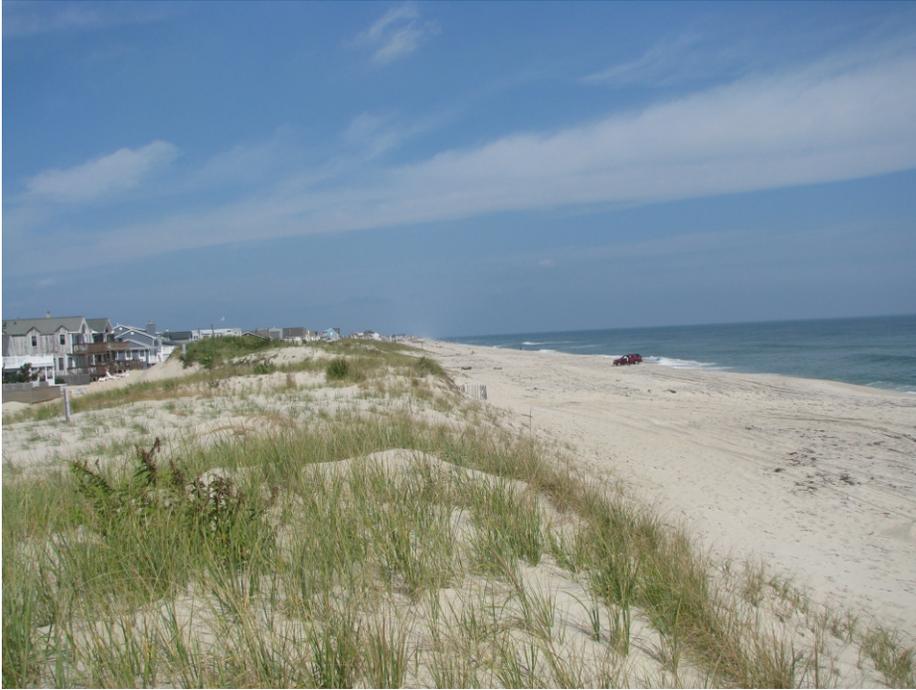
Photo taken September 24, 2009. View to the north.

The dry beach in Lavallette is relatively wide and stable.

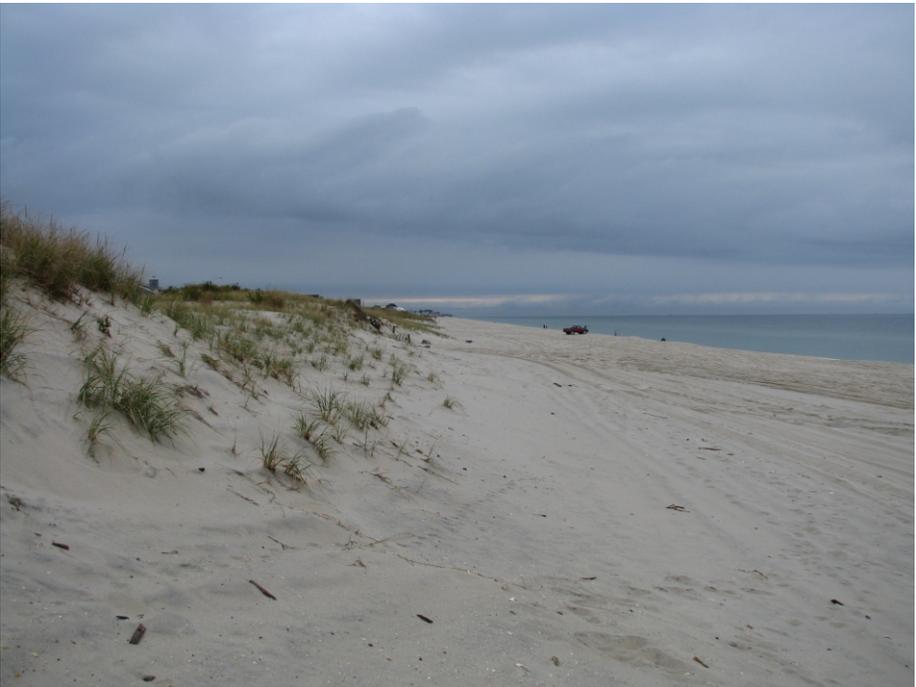
Photo taken October 19, 2010. View to the north.

Comparing the profiles over the year, the profile location lost volume (-4.25 cu yd/ft) and the shoreline moved landward (-19.35 ft). The survey for the fall 2009 preceded the northeast activity.

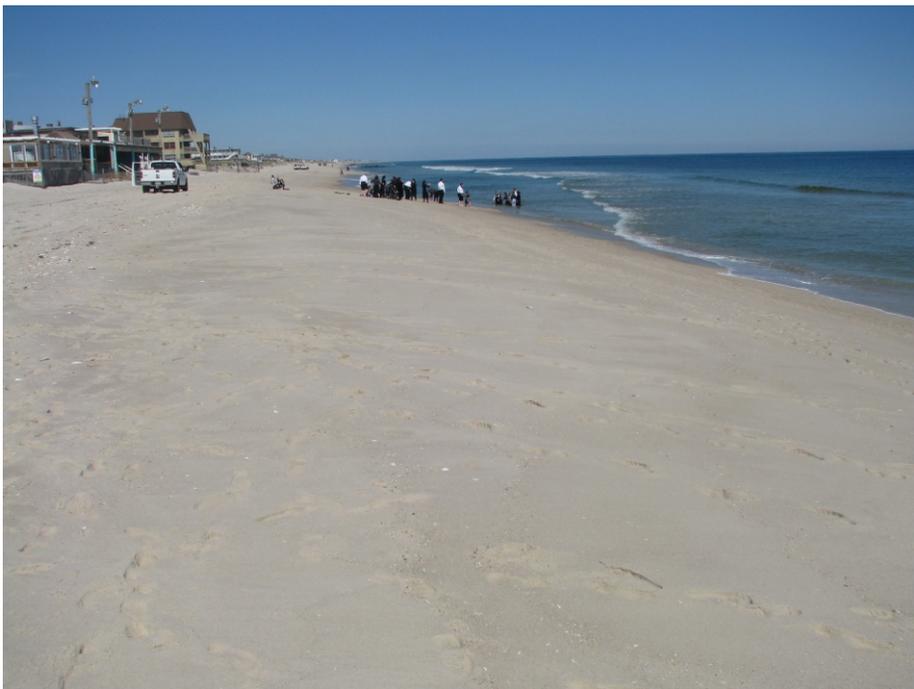
Photo taken October 6, 2009. View to the north.

The Ortley Beach location has a dune, but the close proximity of the beach road limits the landward extent. This view from the dune toe slope north shows the recreational services pavilion that occupies the dune's natural position.

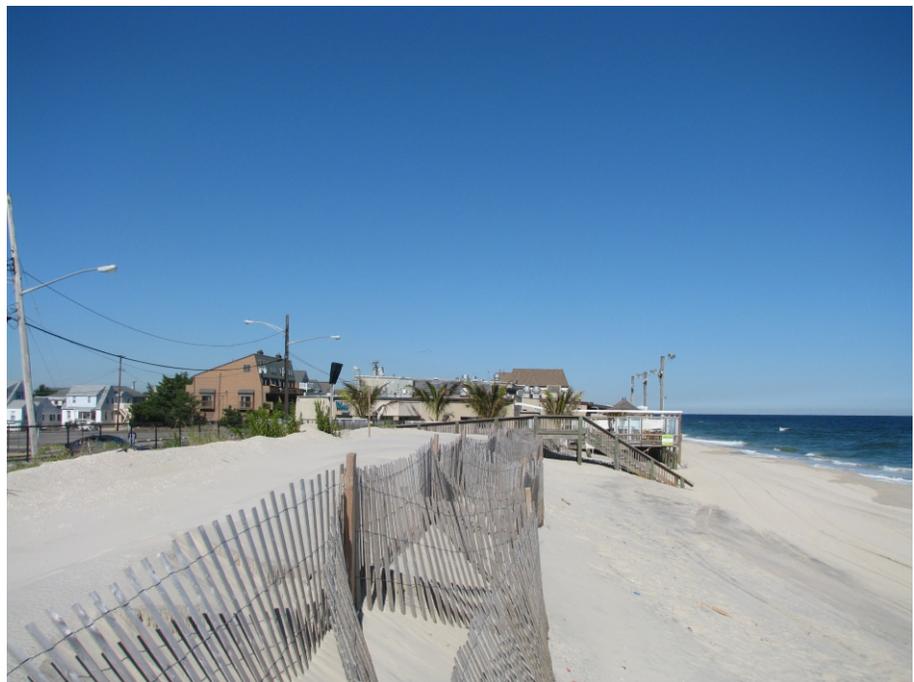
Photo taken October 13, 2010. View to the north.

Comparing the profiles over the one-year time period, the profile location lost volume (-0.77 cu yd/ft) and the shoreline moved landward (-22.04 ft). Most of the material lost was above the 0.0 ft NAVD88 datum.
