New Jersey Beach Profile Network

Ocean County

Manasquan Inlet
to Little Egg Inlet

NJBPN Profile #'s
156 - 234

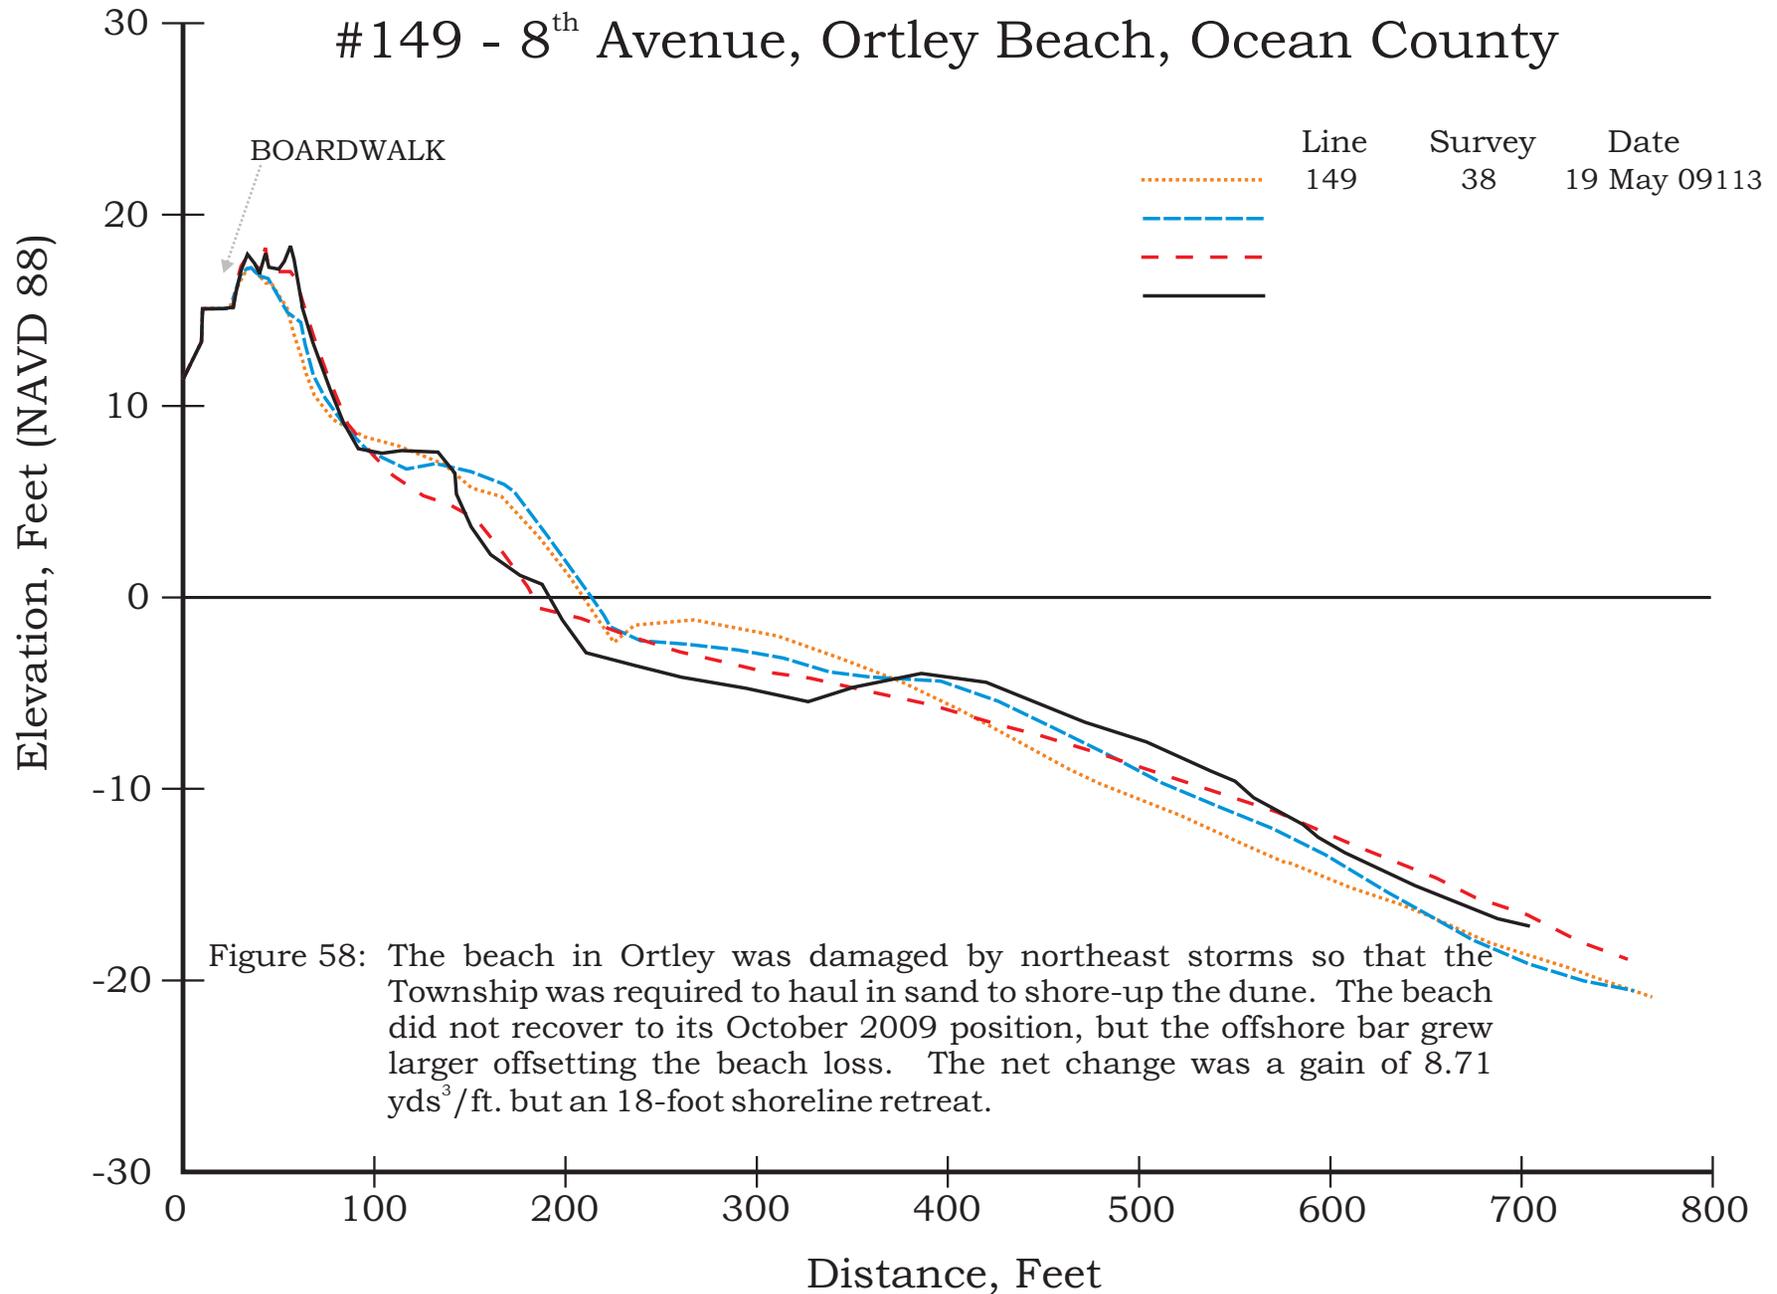
#149 - 8th Avenue, Ortley Beach, Ocean County

Figure 58: The beach in Ortley was damaged by northeast storms so that the Township was required to haul in sand to shore-up the dune. The beach did not recover to its October 2009 position, but the offshore bar grew larger offsetting the beach loss. The net change was a gain of 8.71 yds³/ft. but an 18-foot shoreline retreat.

Storm damage from the 2009-2010 winter season was addressed with dune augmentation (Ortley Beach), bulldozing of beach material up to restore the dune erosion (Mantoloking) and other management tools allowed under the NJ State Land Use Program's General Beach Maintenance Permits awarded to coastal communities.

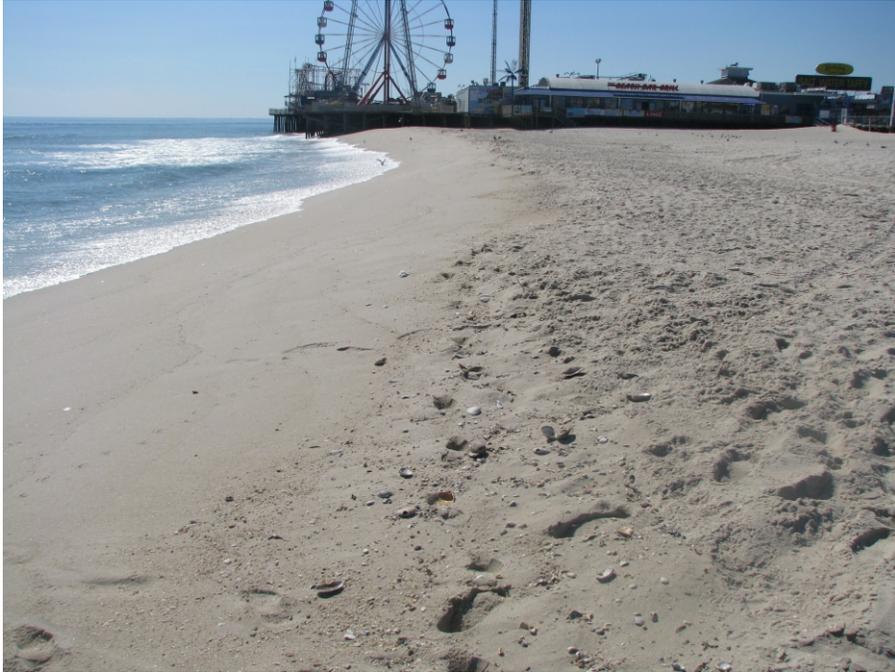
Photo taken October 6, 2009. View to the south.

The Borough of Seaside Heights required a site simply to include this municipal beach in the array of Ocean County communities being monitored. Located between major amusement piers, the beach is fairly wide with no dune at the boardwalk due to intense recreational use.

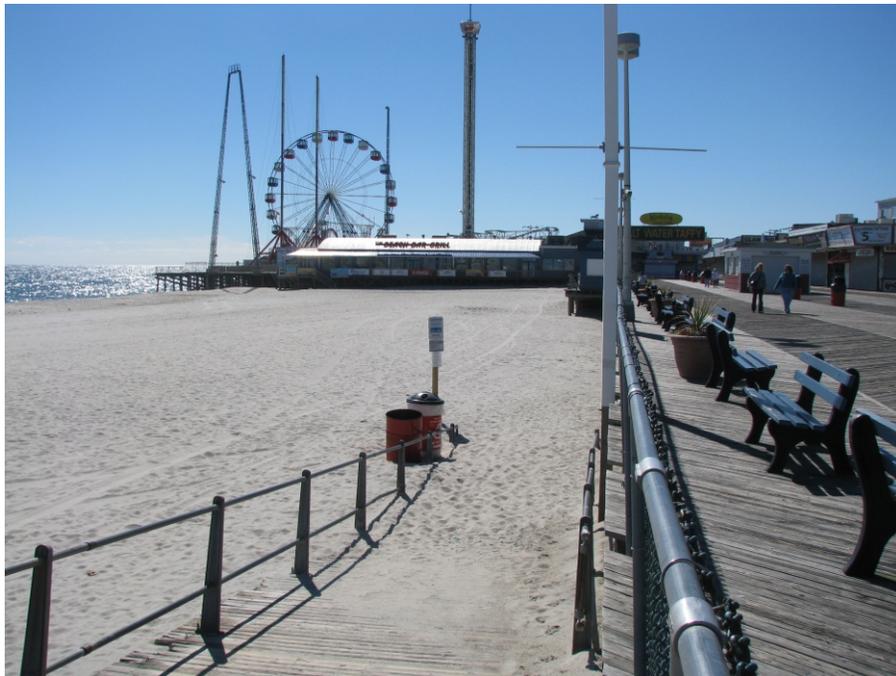
Photo taken October 13, 2010. View to the south.

This view is toward the southern pier from the boardwalk looking across the beach in the fall. The sand volume change was a seasonal loss for the first winter season followed by continued loss through the summer of 2010. The net was a loss of 31.26 cu yd/ft and the shoreline moved landward 6.0 feet. Only two of the three seasons are represented by surveys in this report.

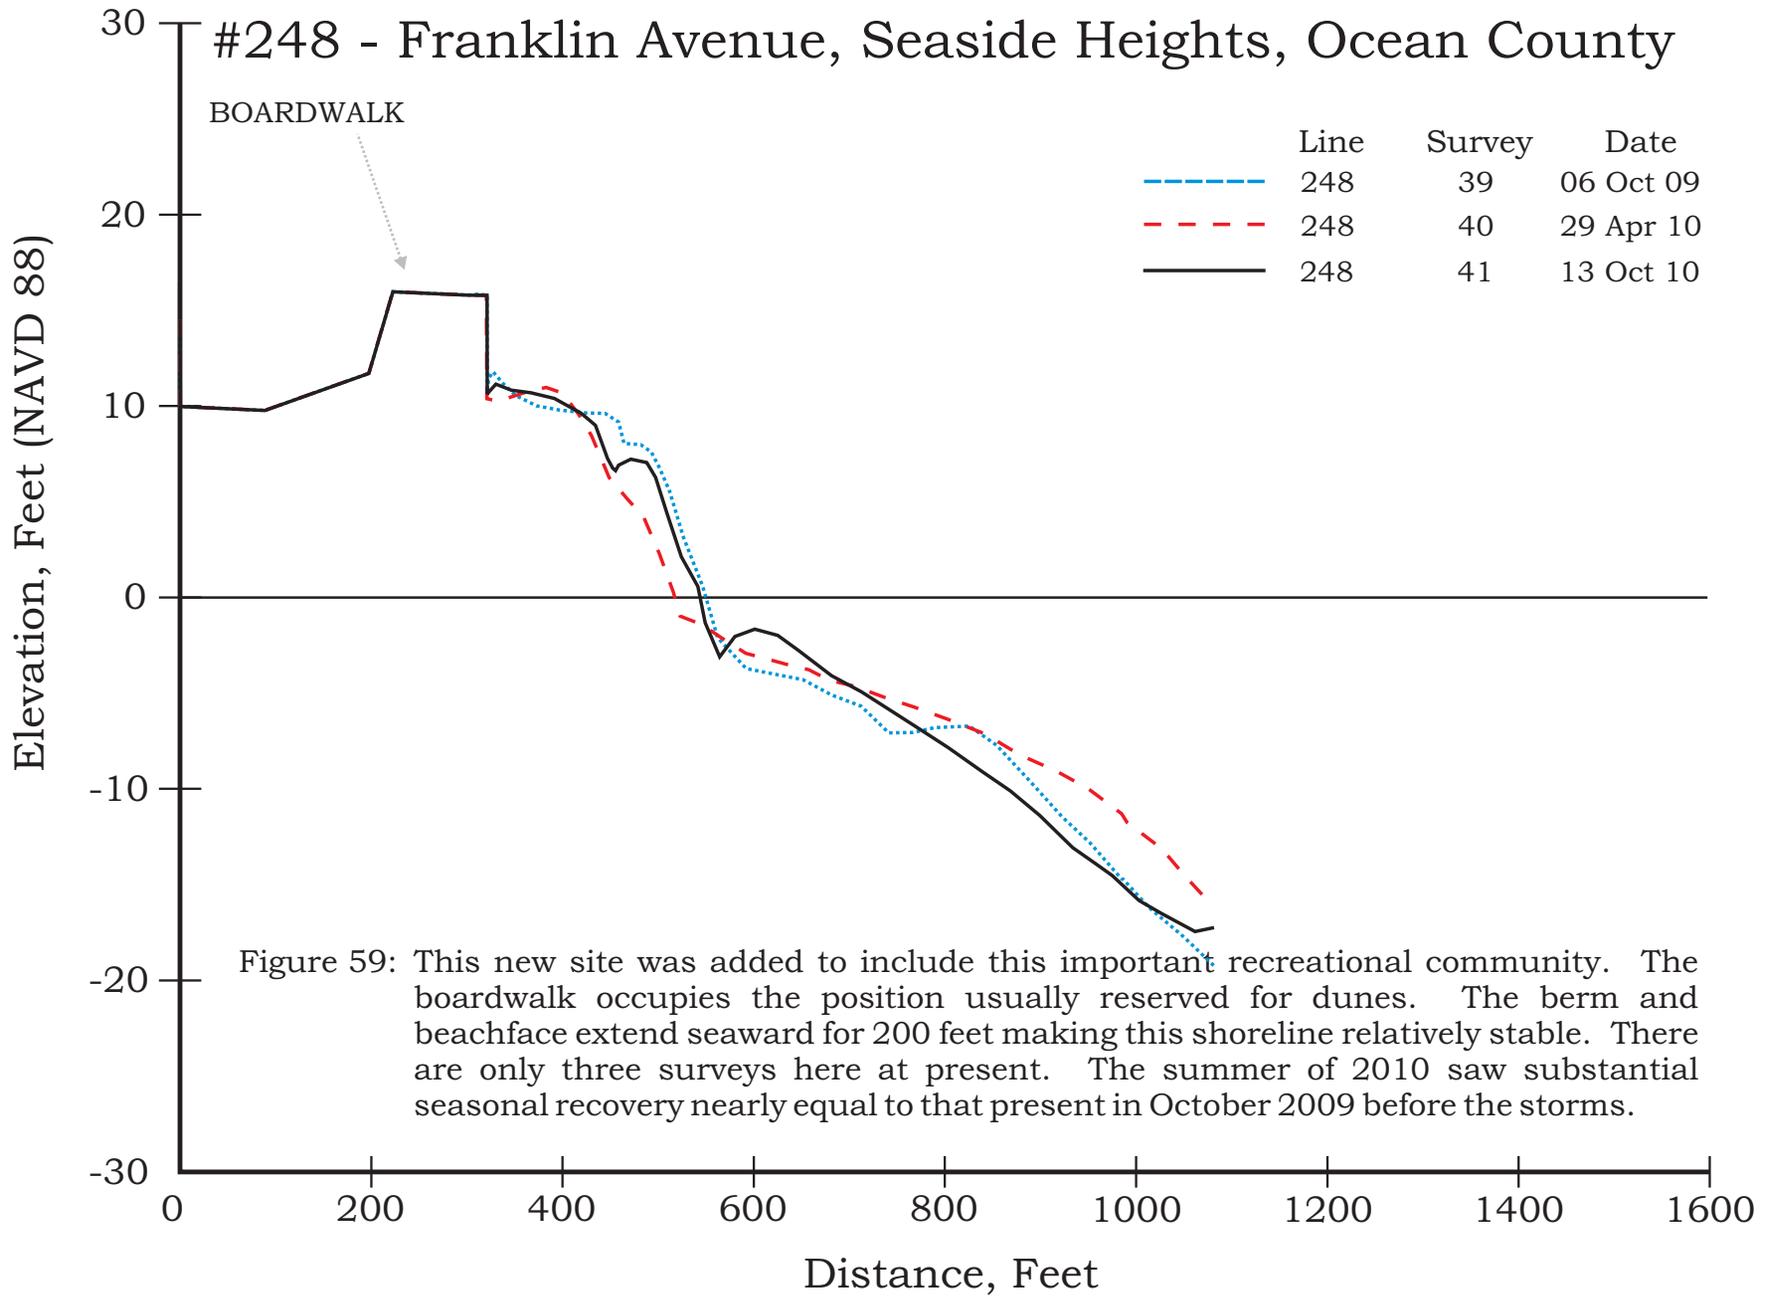
#248 - Franklin Avenue, Seaside Heights, Ocean County

Figure 59: This new site was added to include this important recreational community. The boardwalk occupies the position usually reserved for dunes. The berm and beachface extend seaward for 200 feet making this shoreline relatively stable. There are only three surveys here at present. The summer of 2010 saw substantial seasonal recovery nearly equal to that present in October 2009 before the storms.

A new site was established at Franklin Avenue in Seaside Heights (Site 248) along the boardwalk of this tourist-friendly municipality because of the heavy recreational use of the beach. The beach is the dominant feature with no dune system seaward of the bulkhead and boardwalk. Seasonal and summer losses were recorded during the short monitoring time period.

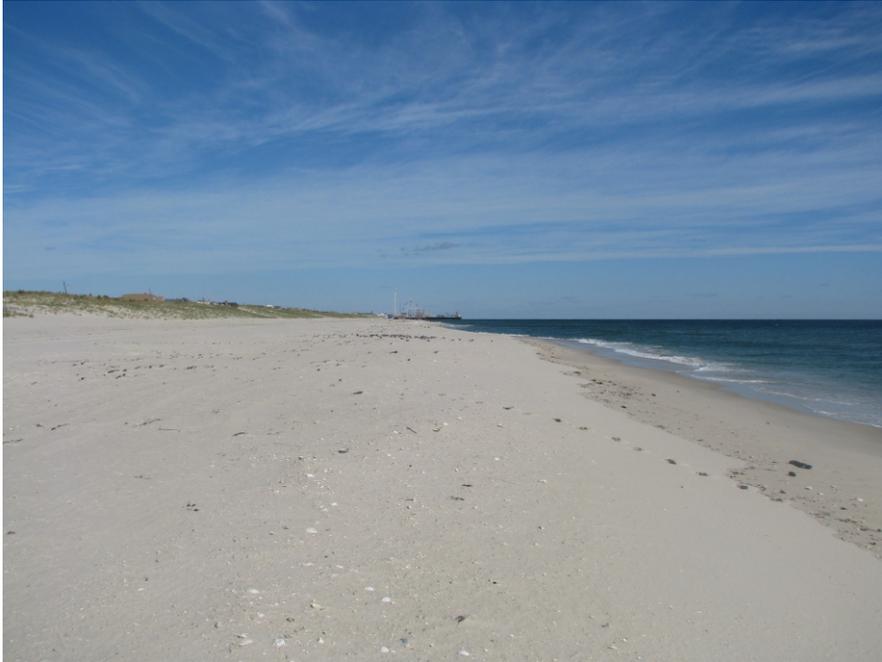
Photo taken October 8, 2009. View to the north.

The Fourth Avenue site in Seaside Park has a low relief, but wide dune protecting the property landward.

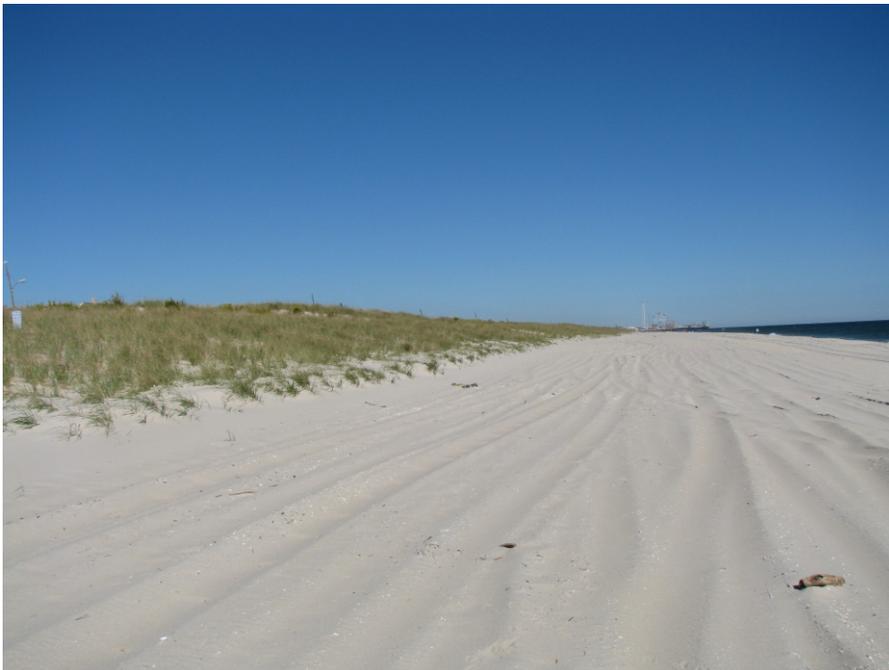
Photo taken October 13, 2010. View to the north.

Comparing the profiles over the one-year time period, the profile location remained stable in volume (0.05 cu yd/ft) and the shoreline moved landward (-18.69 ft).

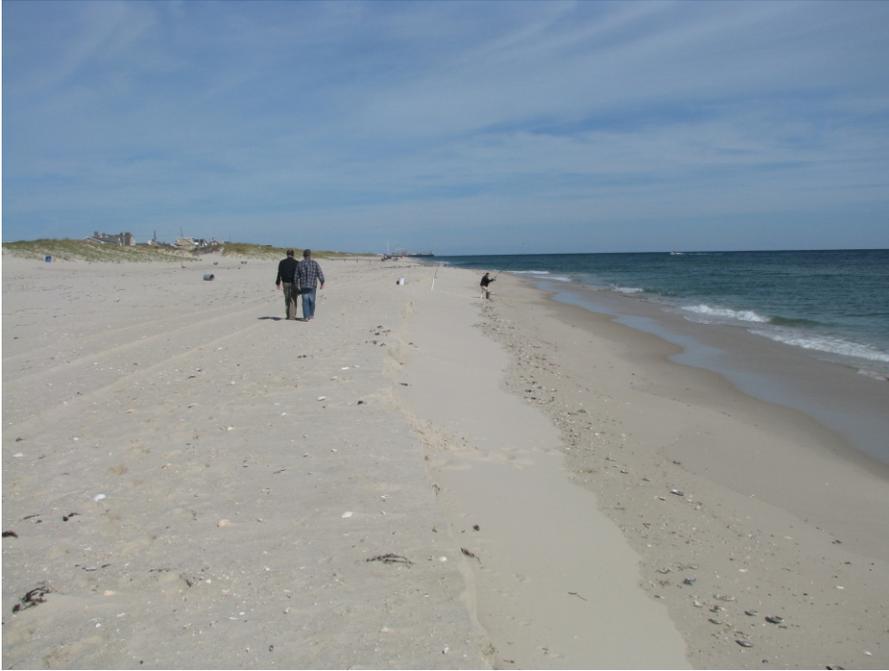
Photo taken October 8, 2009. View to the north.

This site was moved south off the pedestrian pathway in 2008 to monitor changes in the dune. When the site was established in 1986, there was no dune at all. However, the wind opened the pathway wider removing foredune seen on the earlier profile transects across the dune.

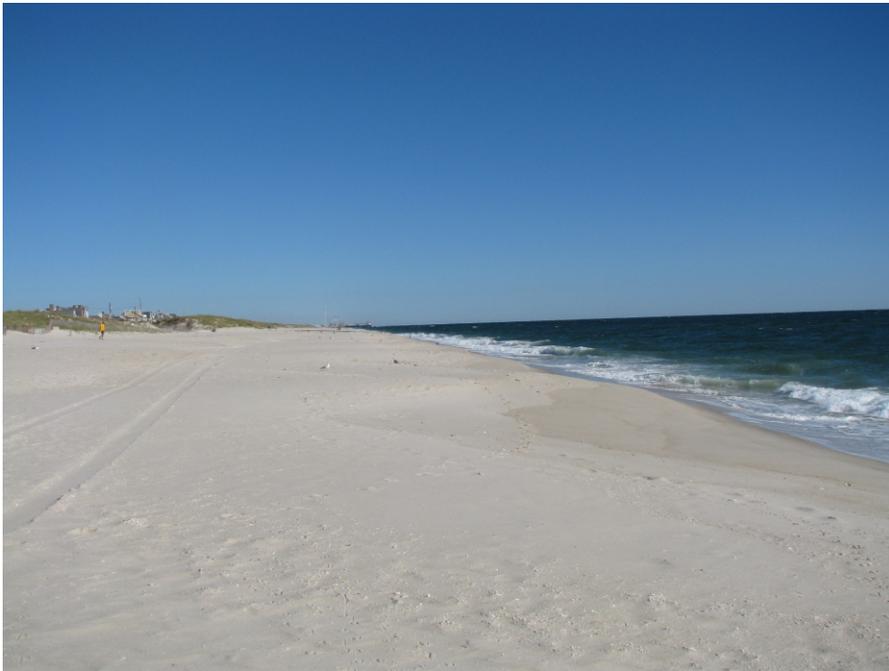
Photo taken October 13, 2010. View to the north.

Comparing the profiles over the year, the profile location lost volume (-11.27 cu yd/ft) and the shoreline moved landward (-5.14 ft).

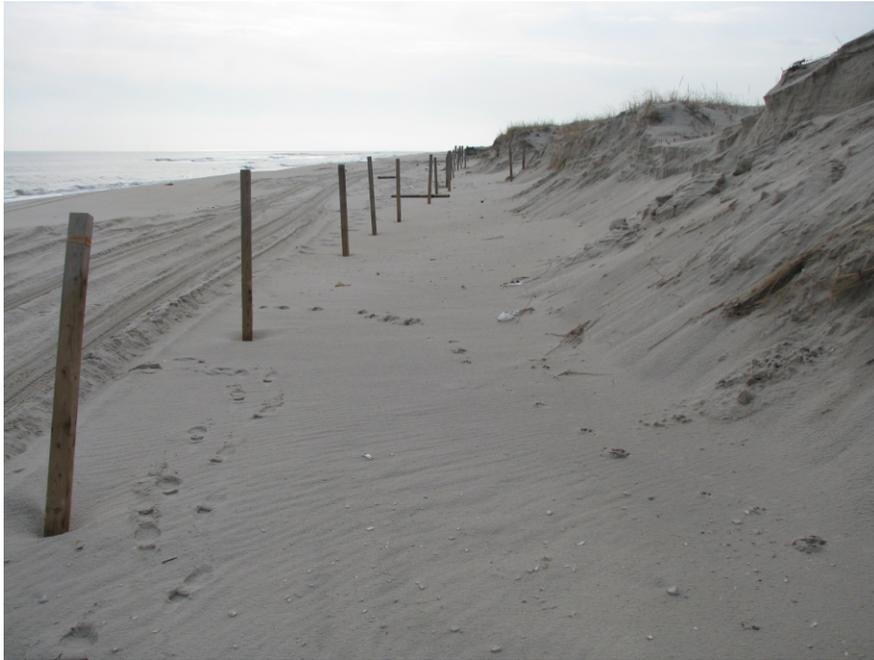
Photo taken December 15, 2009. View to the south.

The middle profile on Island Beach State Park also traverses a massive dune field to a wide beach. The gap just south is natural and typifies a “blow-out” gap in the dunes. Storm impacts were severe to the dune and beach. The scarp retreat exposed the dune fence posts on the beach, not in the seaward dune toe. The beach followed this retreat landward.

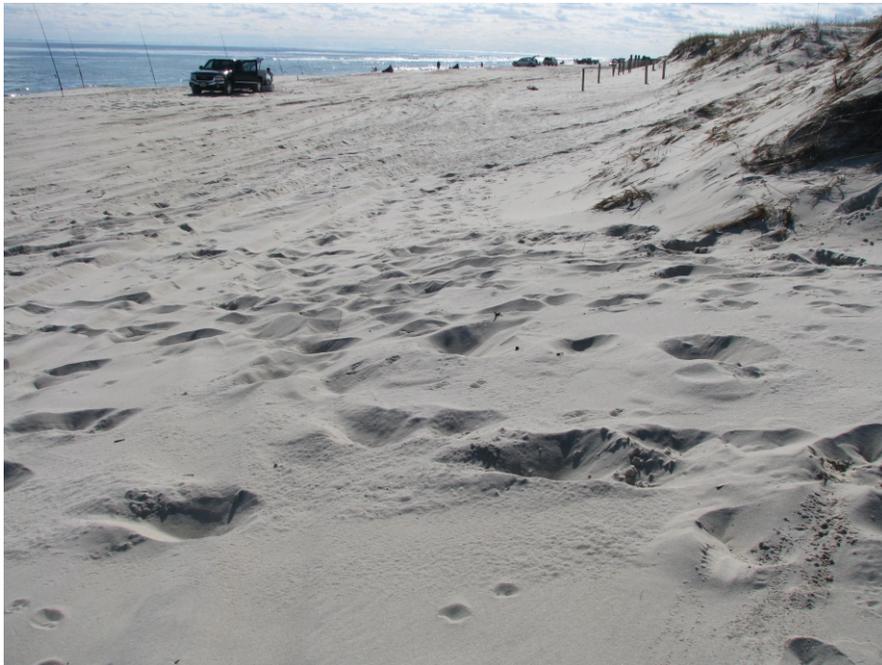
Photo taken November 3, 2010. View to the south.

Comparing the profiles over the year, the profile location gained volume (3.63 cu yd/ft) and the shoreline moved seaward (32.56 ft). Most of the sand gain was above the 0.0 ft NAVD88 datum.

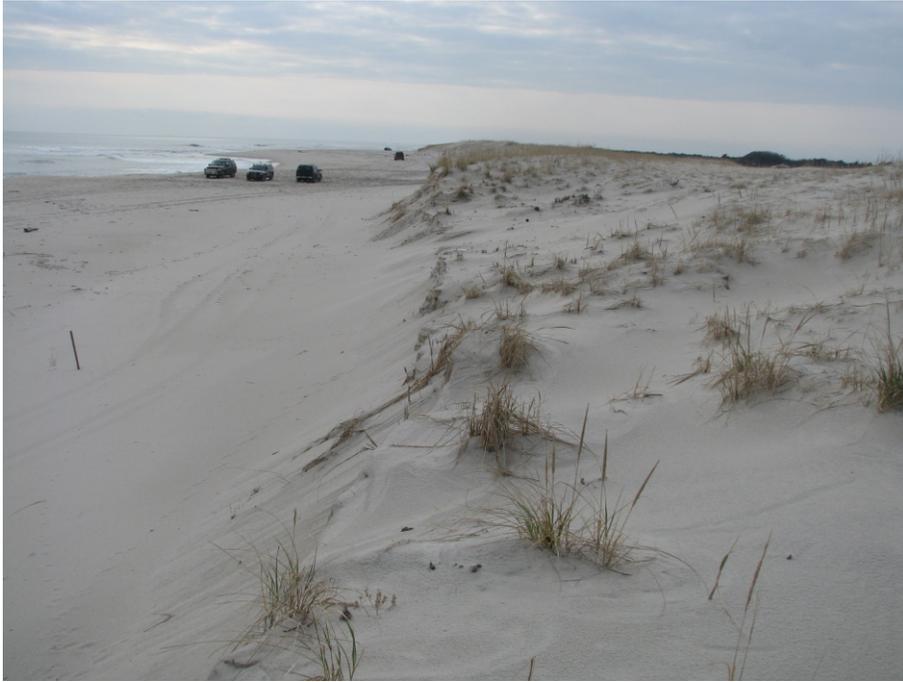
Photo taken December 15, 2009. View to the south.

The dunes at this location contain a series of ridges and swales and support a variety of vegetation. Further landward the maritime forest grows on older segments of this shoreline.

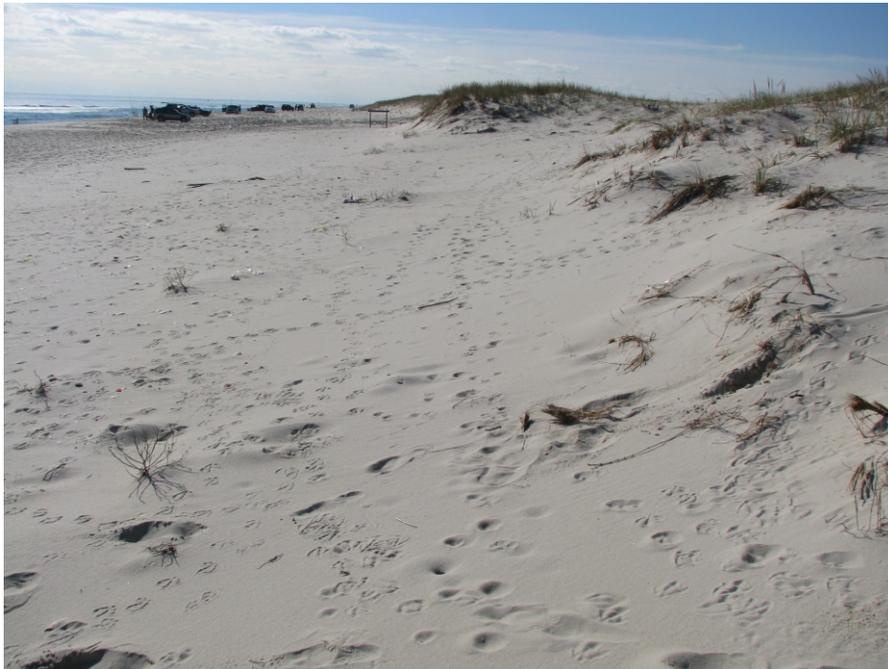
Photo taken November 3, 2010. View to the south.

Comparing the profiles over the year, the profile location lost volume (-36.98 cu yd/ft) and the shoreline moved seaward (7.57 ft). Most of the sediment loss was below the 0.0 ft NAVD88 datum.

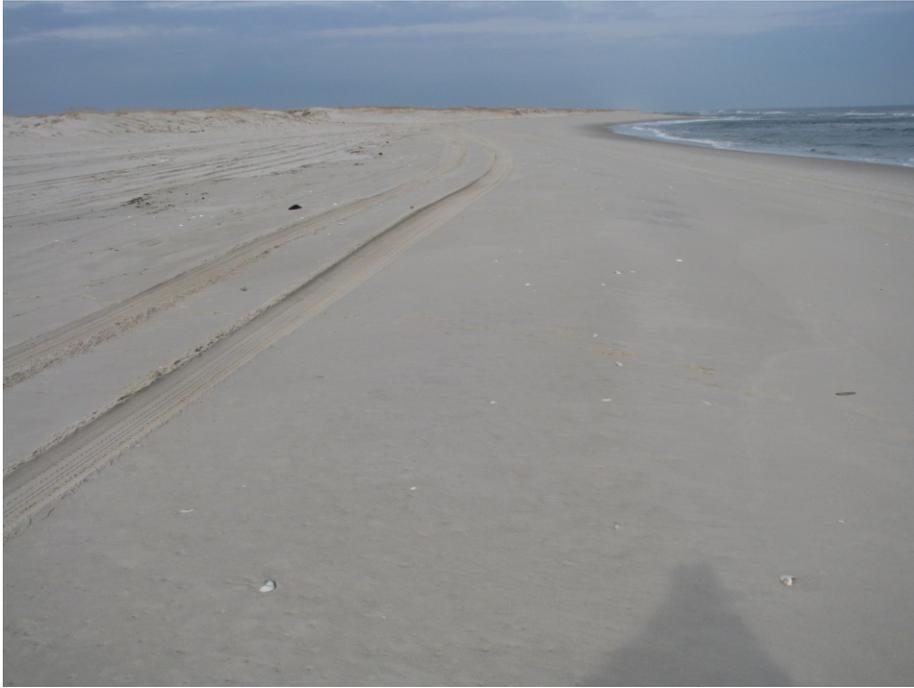
Photo taken December 15, 2009. View to the north.

The southern end of the Island Beach State Park has no human modification. The site can only be accessed from the beach. The north jetty of Barnegat Inlet is located immediately to the south and traps sand moving south and produces this expanding beach that has grown wider almost every year since 1986. The jetties at Barnegat Inlet acted to trap sand producing the expansion seen.

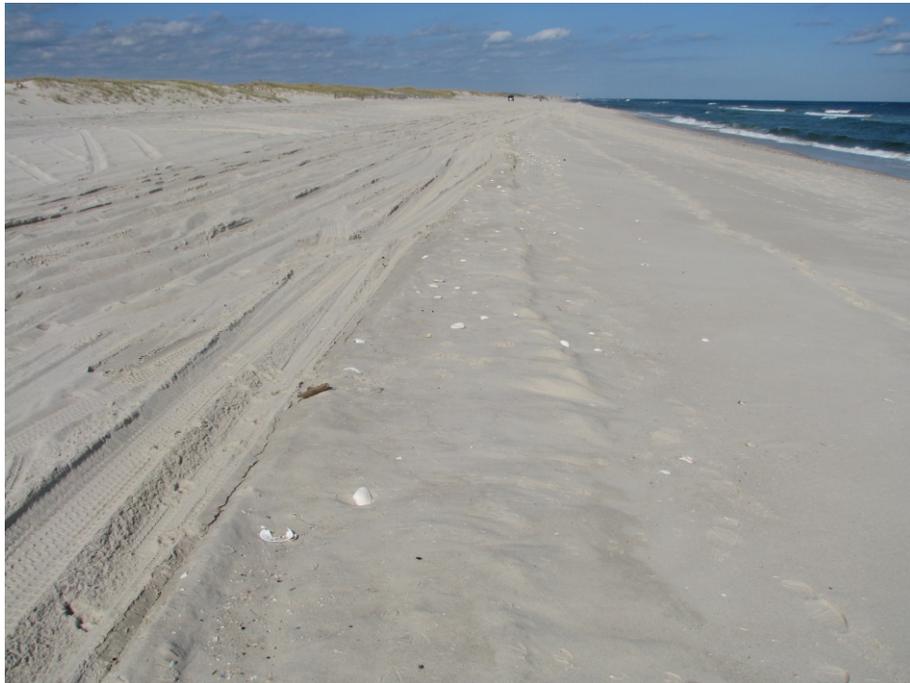
Photo taken November 3, 2010. View to the north.

Comparing the profiles over the year, the profile location lost volume (-34.74 cu yd/ft) and the shoreline moved landward (-40.63 ft). Most of the sand lost was below the 0.0 ft NAVD88 datum.

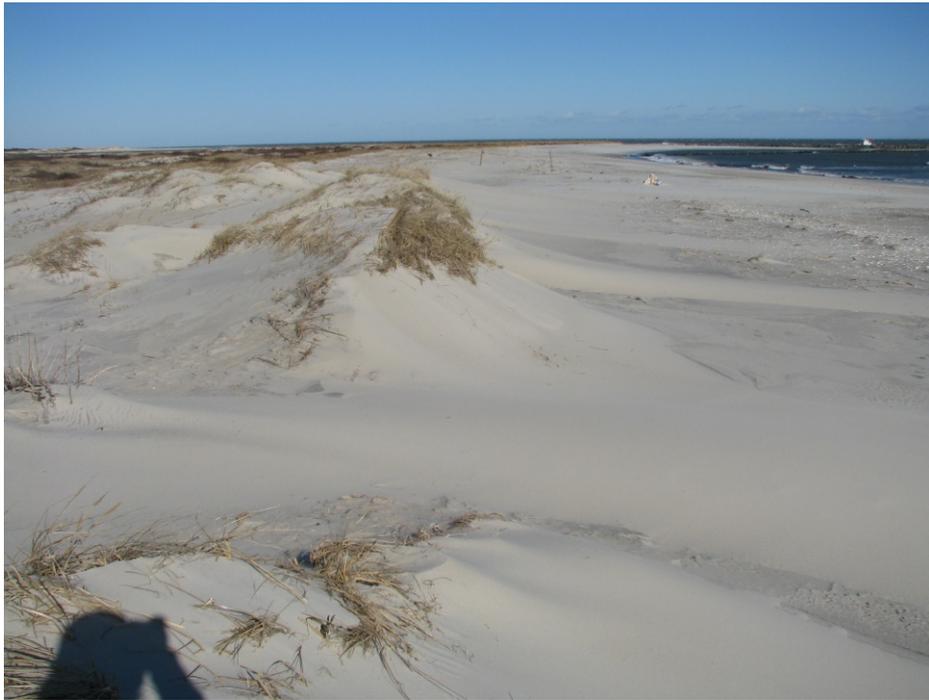
Photo taken December 29, 2009. View to the north.

In the northern segment of the Barnegat Light Borough shoreline lies in what will become a major maritime forest eventually. This site is positioned just south of the old “arrowhead jetty” configuration. There was a wide beach here previously due to the rock jetty making its attachment to the land nearby, but the new structure makes landfall at the Barnegat Light tower. The intervening distance was converted from tidal sand flats extending away from the main channel to a dry sand beach with a complex of dune ridges extending nearly to the seaward end of the new jetty.

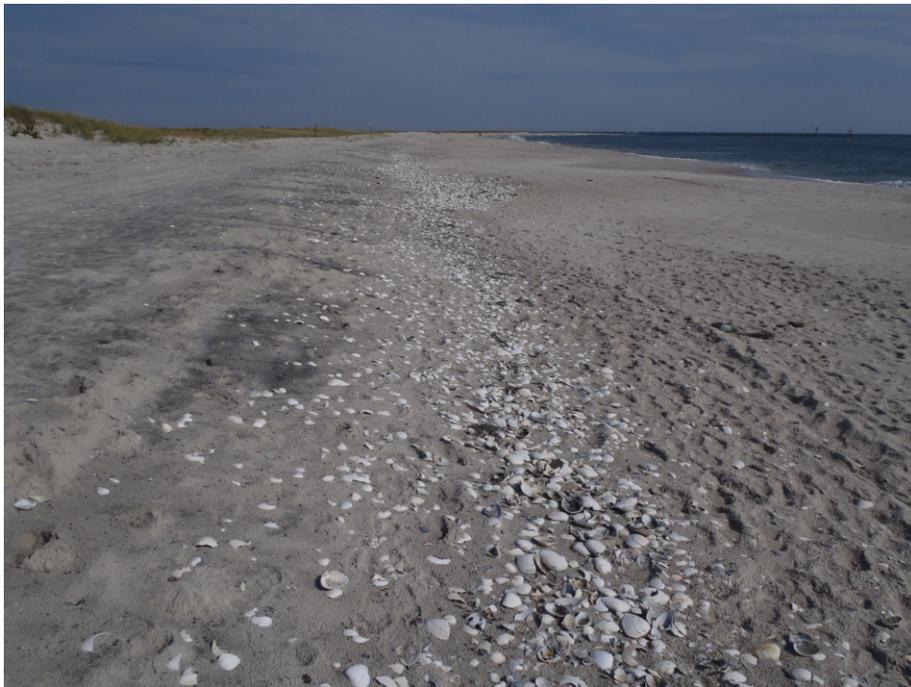
Photo taken October 12, 2010. View to the north.

The offshore portion of the profile was already stressed prior to the fall 2009-winter 2010 storms. Comparing the profiles over the year, the profile location lost volume (-76.26 cu yd/ft) and the shoreline moved landward (-76.12 ft).

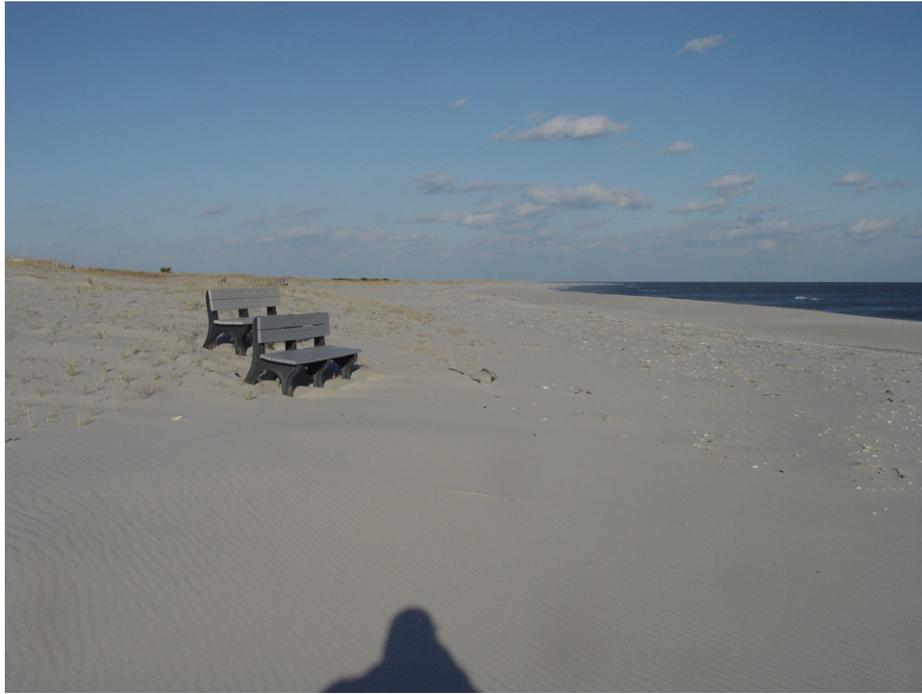
Photo taken December 11, 2009. View to the north.

This site in southern Barnegat Light lies within the accretional wedge of shoreline extending from nearly to the La Baia Street site to the Barnegat Inlet jetty that was re-constructed in a new location beginning in 1988.

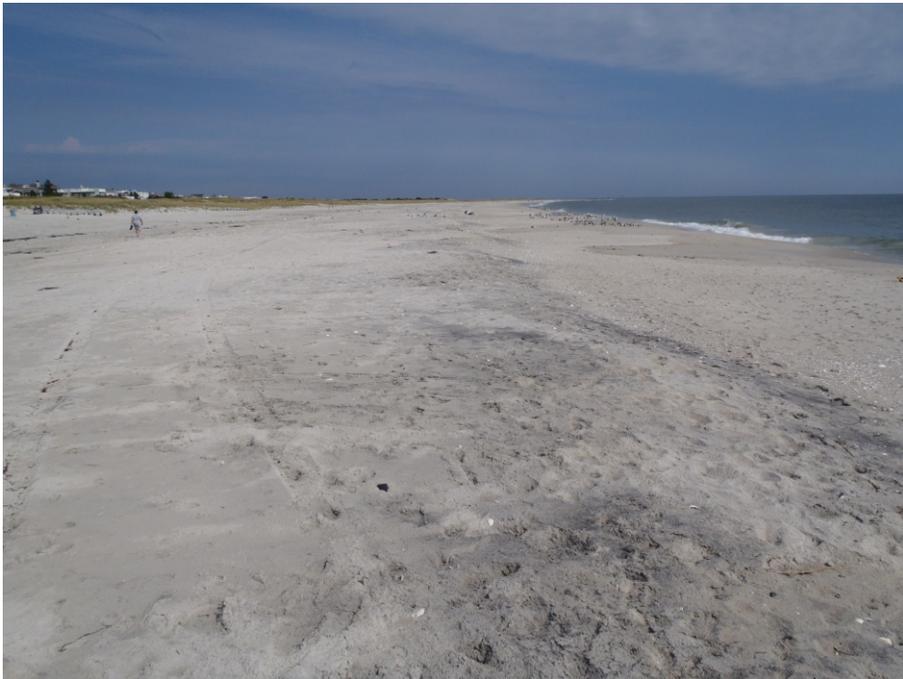
Photo taken October 12, 2010. View to the north.

Since the jetty was completed in 1990 the shoreline advanced as sand moved onto the beach from the old ebb-tidal delta position offshore. This expansion grows wider to the north, reaching a maximum at the jetty. During the fall of 2009 the trend reversed with the berm getting hit with erosion and a deep trough appearing just offshore. Comparing the profiles over the year, the profile location gained volume (24.78 cu yd/ft) and the shoreline moved seaward (49.14 ft).

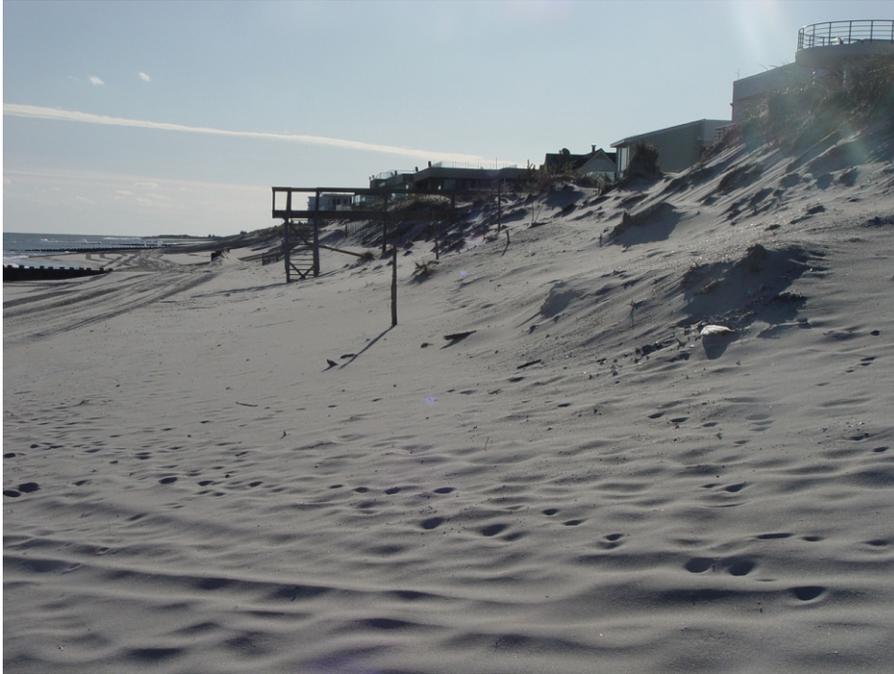
Photo taken December 11, 2009. View to the south.

The dune in Loveladies is much narrower with the homes built into the landward toe so that any breach means that wave energy will accelerate landward into the buildings.

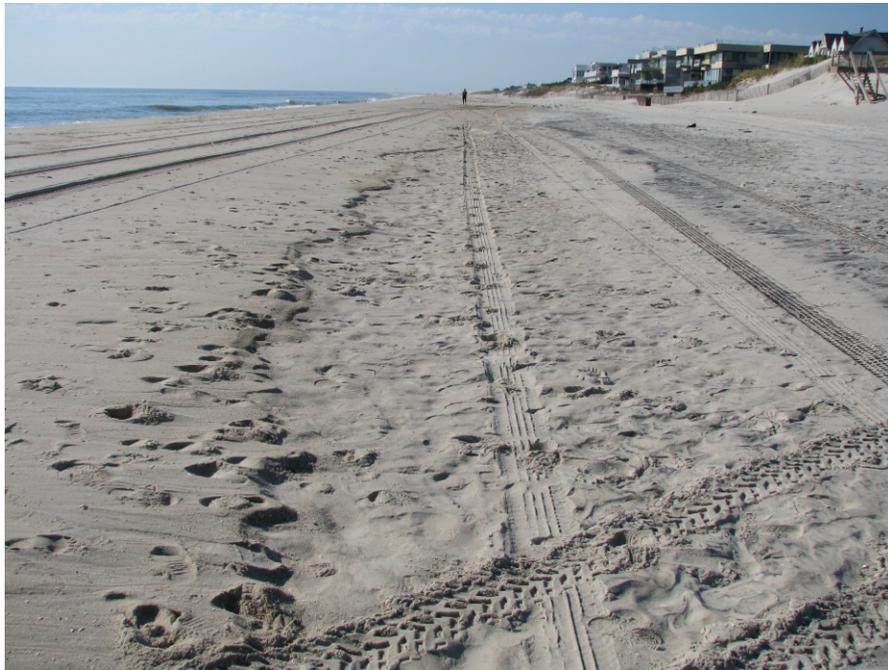
Photo taken October 11, 2010. View to the south.

This site received some of the end material from the USACE beach fill. Comparing the profiles over the year, the profile location gained volume (28.59 cu yd/ft) and the shoreline moved seaward (43.04 ft).

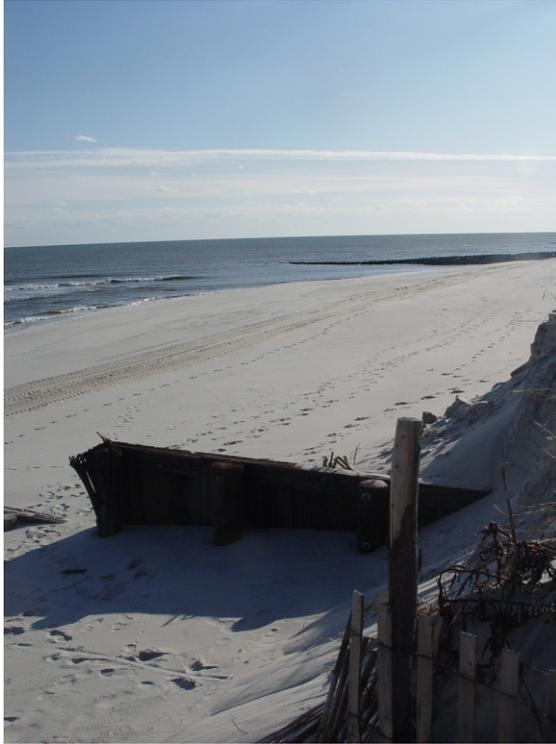
Photo taken December 11, 2009. View to the south.

The narrow beach exposes the dune to potential wave run up.

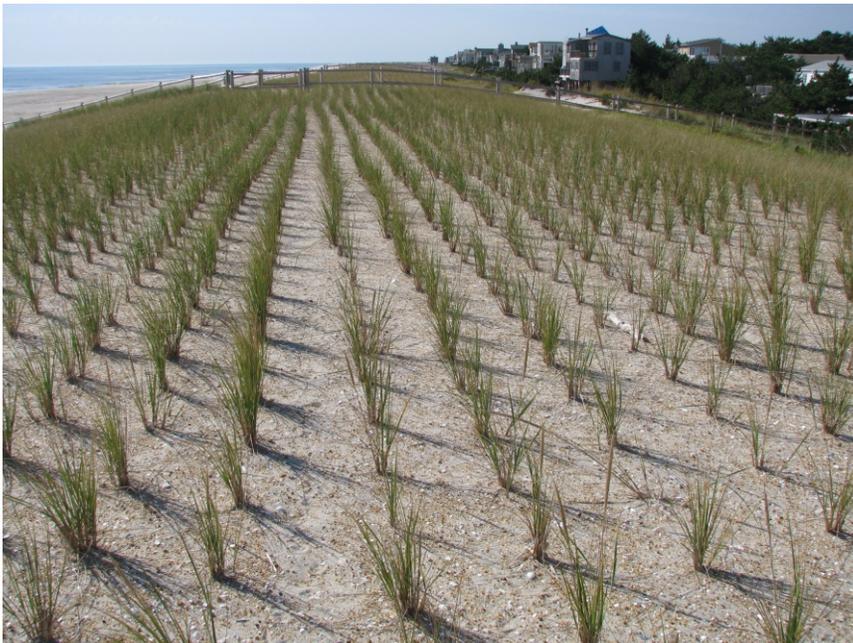
Photo taken October 11, 2010. View to the south.

The USACE placed beach fill at this site in the Spring of 2010. Comparing the profiles over the year the profile location gained volume (250.71 cu yd/ft) and the shoreline moved seaward (292.23 ft).

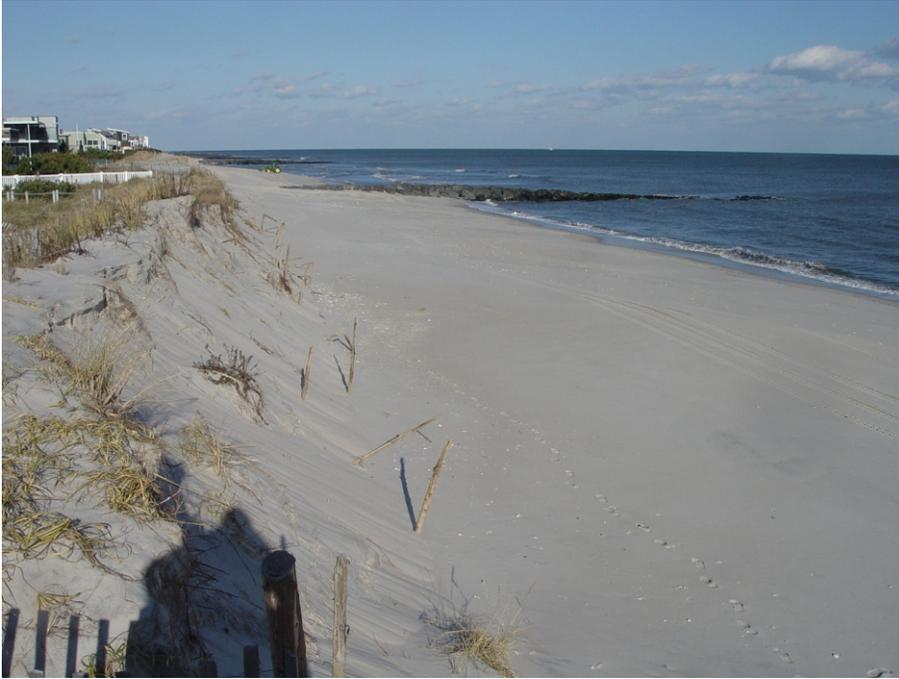
Photo taken December 11, 2009. View to the north. The dune was cut by a scarp to the crest and abundant sand appeared far offshore.

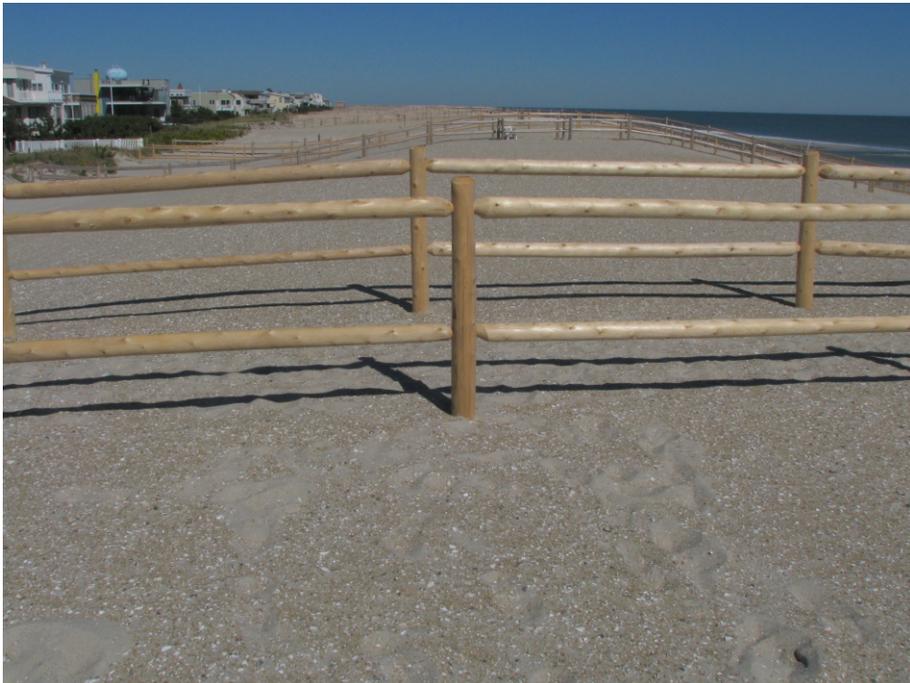
Photo taken October 8, 2010. View to the north.

The USACE placed beach fill at this site in the Spring of 2010. Comparing the profiles over the year, the profile location gained volume (160.19 cu yd/ft) and the shoreline moved seaward (157.34 ft).

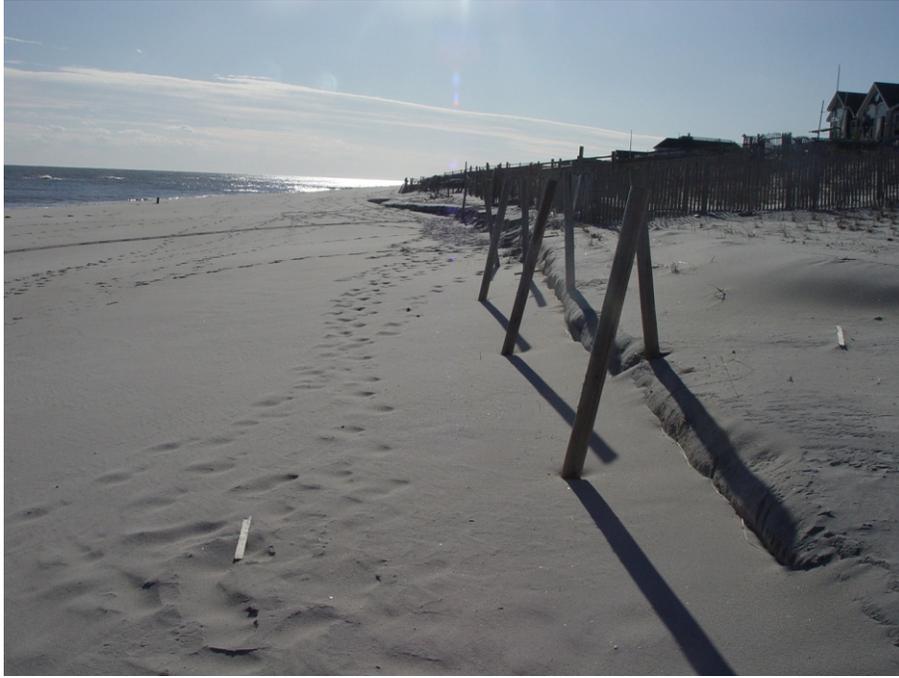
Photo taken December 11, 2009. View to the south.

Site of a beach fill in 2007 with erosion and shoreline retreat following the loss of the placed sand. The fall of 2009 had a profound effect on the berm width removing nearly all of it as opposed to minor losses seen between surveys 36 and 38. The sand volume remaining is still substantially more than what was present before the project.

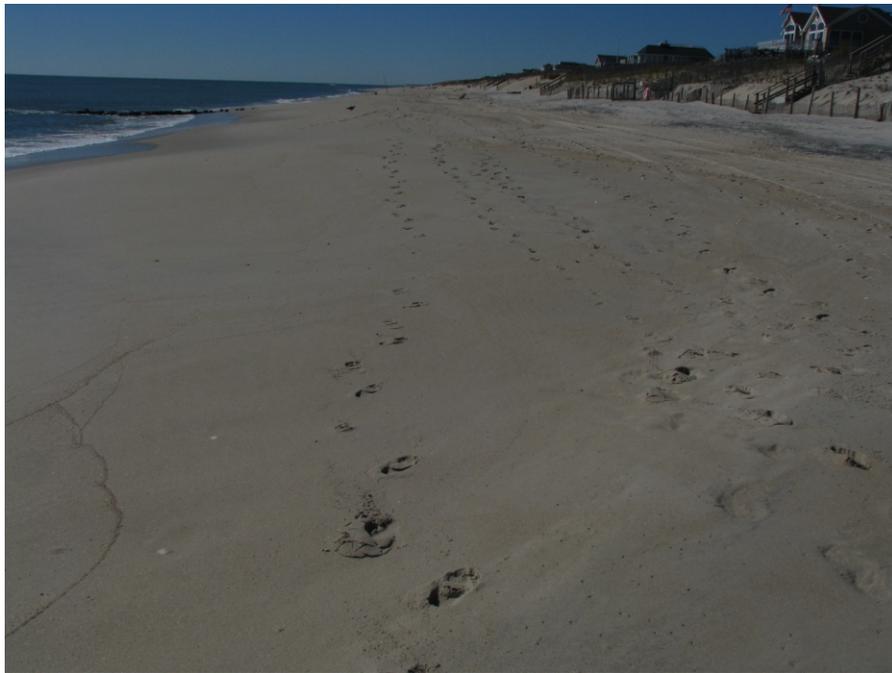
Photo taken October 8, 2010. View to the south.

Comparing the profiles over the year, the profile location lost volume (-3.38 cu yd/ft) and the shoreline moved seaward (24.12 ft).

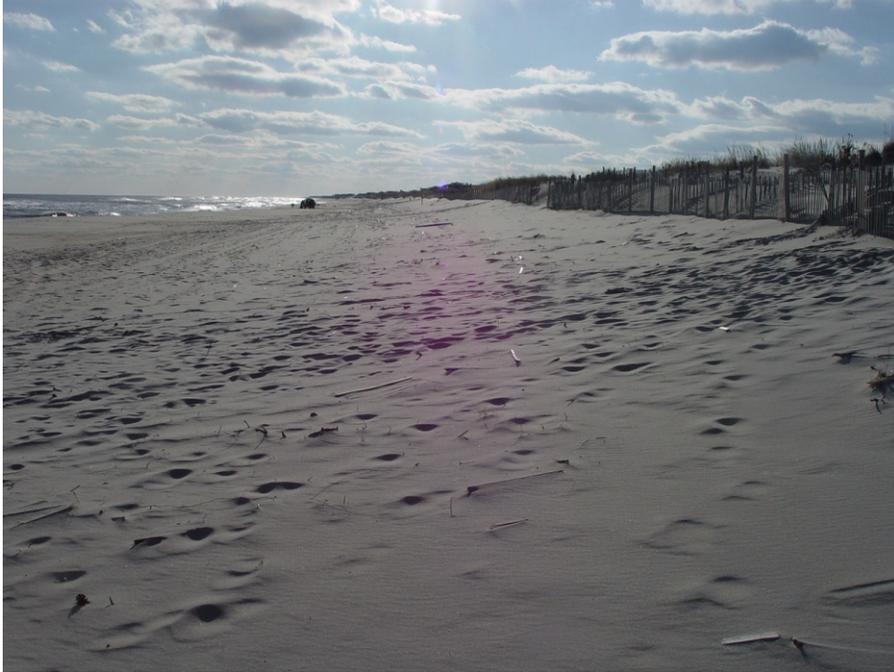
Photo taken December 10, 2009. View to the south.

This site has remained relatively stable over the past 20 years with dune volume increasing and minimal changes in the shoreline position.

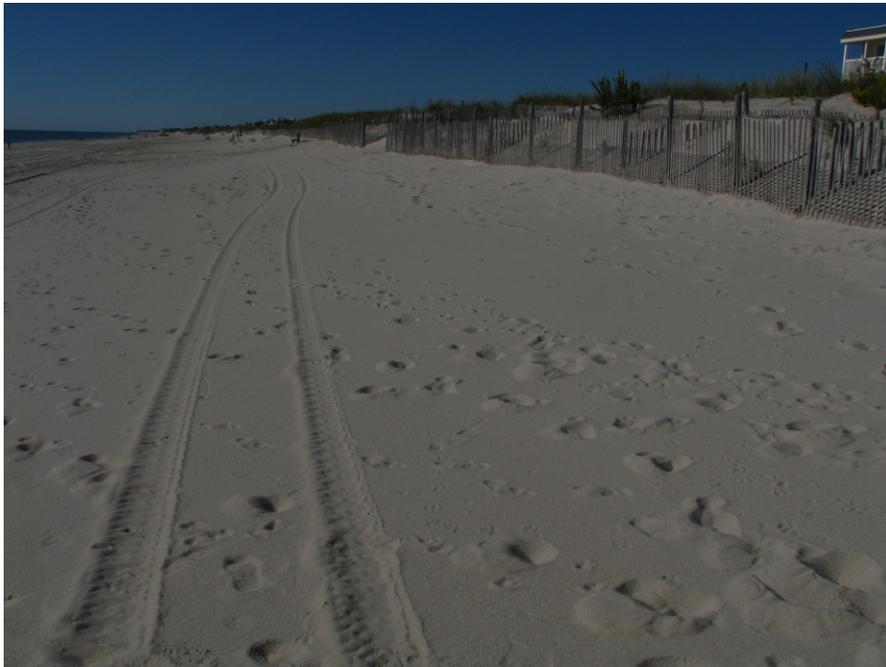
Photo taken October 8, 2010. View to the south.

Comparing the profiles over the year, the profile location lost volume (-16.43 cu yd/ft) and the shoreline moved landward (-14.7 ft).
