New Jersey Beach Profile Network

Ocean County

Manasquan Inlet
to Little Egg Inlet

NJBPN Profile #'s
156 - 234

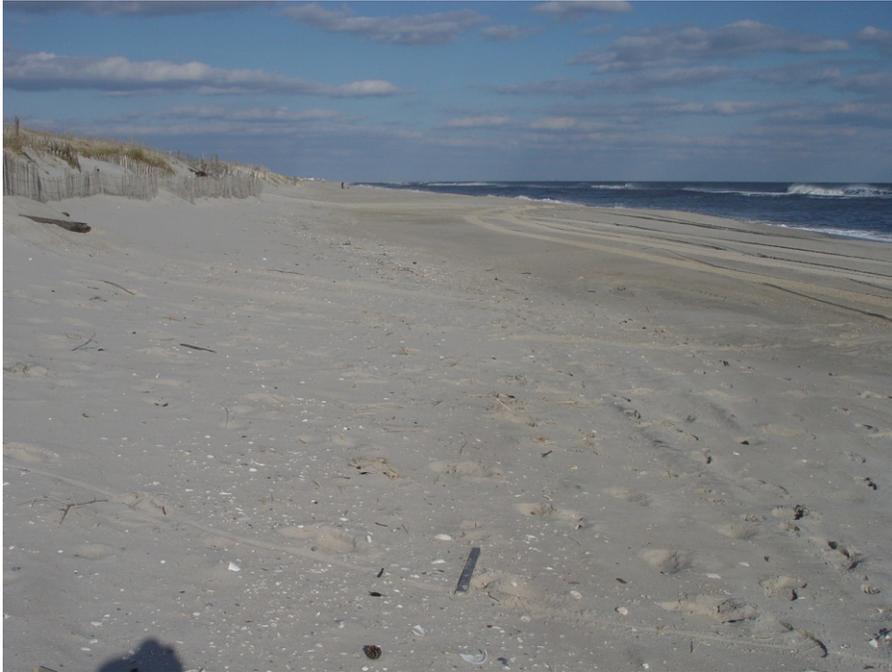
Photo taken December 10, 2009. View to the north. In 2008-2009, sand was added to the beach and assembled into a bar far offshore.

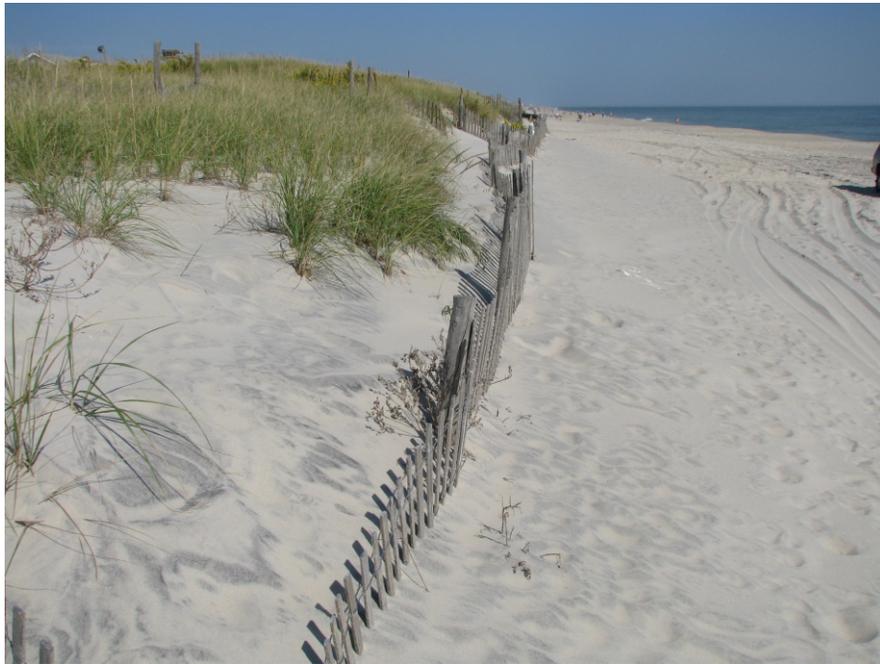
Photo taken October 11, 2010. View to the north.

Comparing the profiles over the year, the profile location gained volume (17.78cu yd/ft) and the shoreline moved landward (-0.57 ft). The sediment gain was predominantly below the 0.0 ft NAVD88 datum.

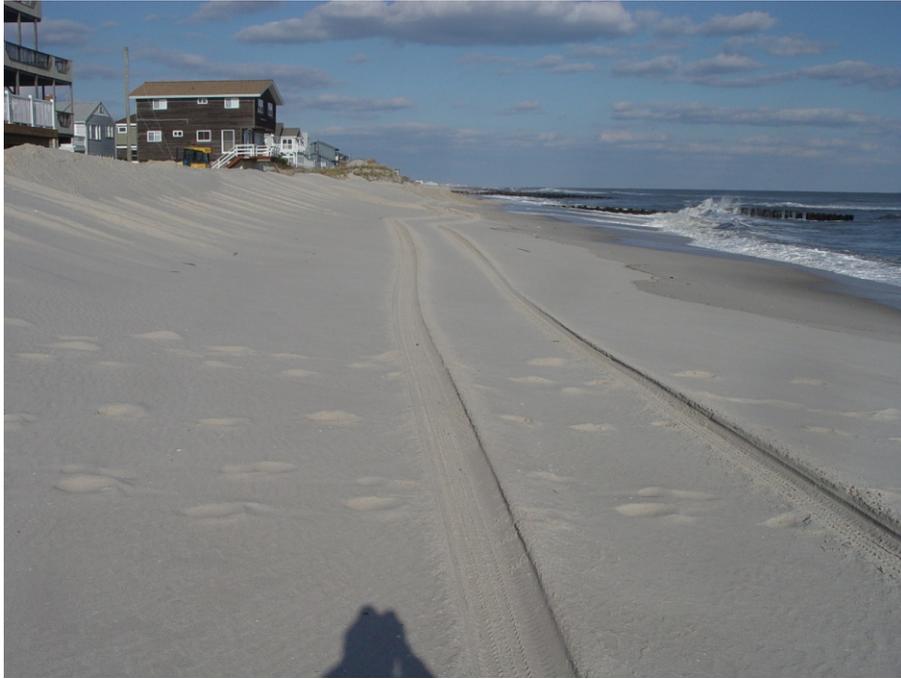
Photo taken December 10, 2009. View to the north.

Fall storms prompted the Township to move sediment within the profile to the dune.

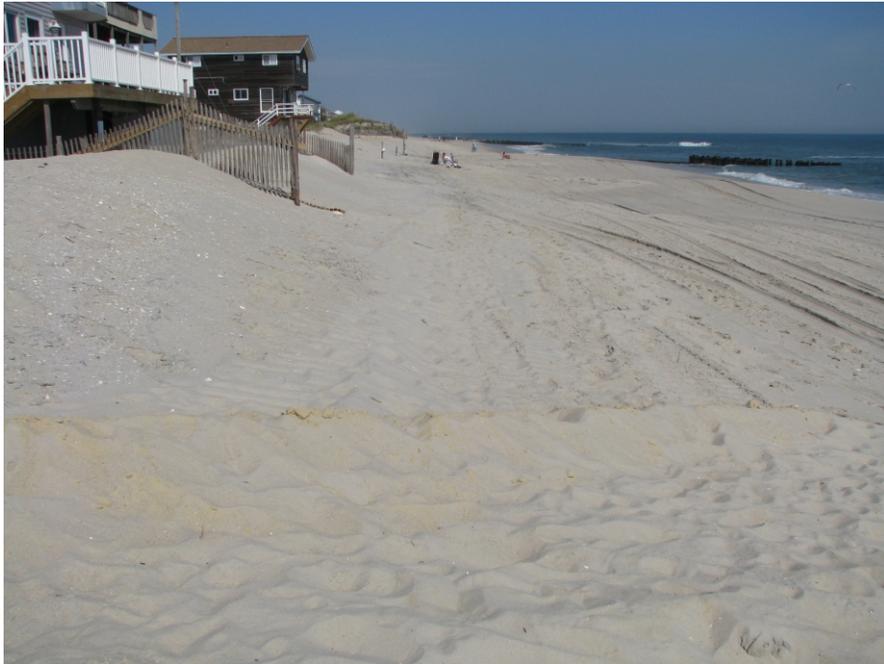
Photo taken October 11, 2010. View to the north.

Comparing the profiles over the year, the profile location lost volume (-8.86 cu yd/ft) and the shoreline moved seaward (7.21 ft). Most of the sand loss was below the 0.0 ft NAVD88 datum.

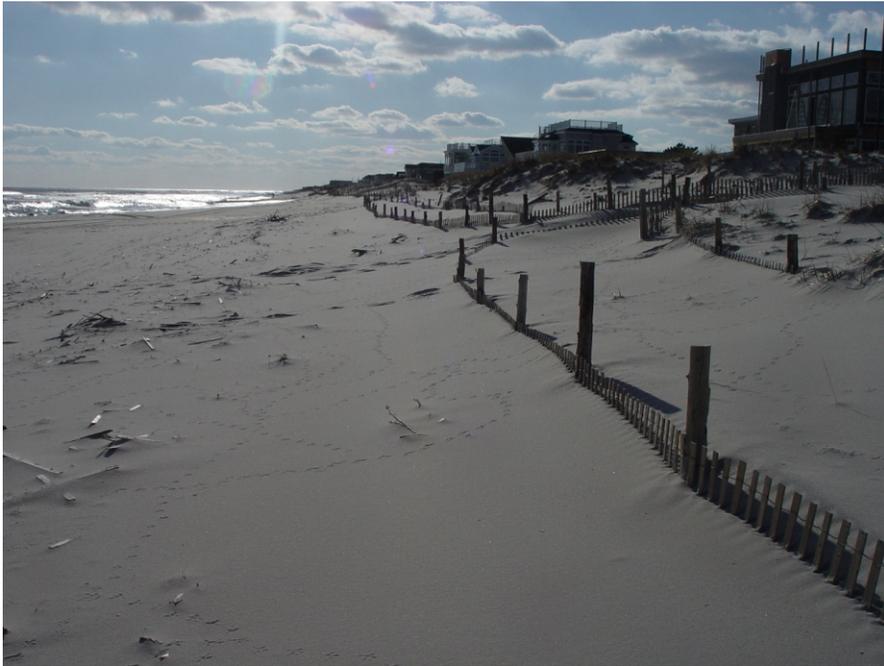
Photo taken December 10, 2009. View to the south. This location was another to receive sand due to storm activity rather than suffer erosion. Sand was added to the berm and offshore, the effect was quite impressive.

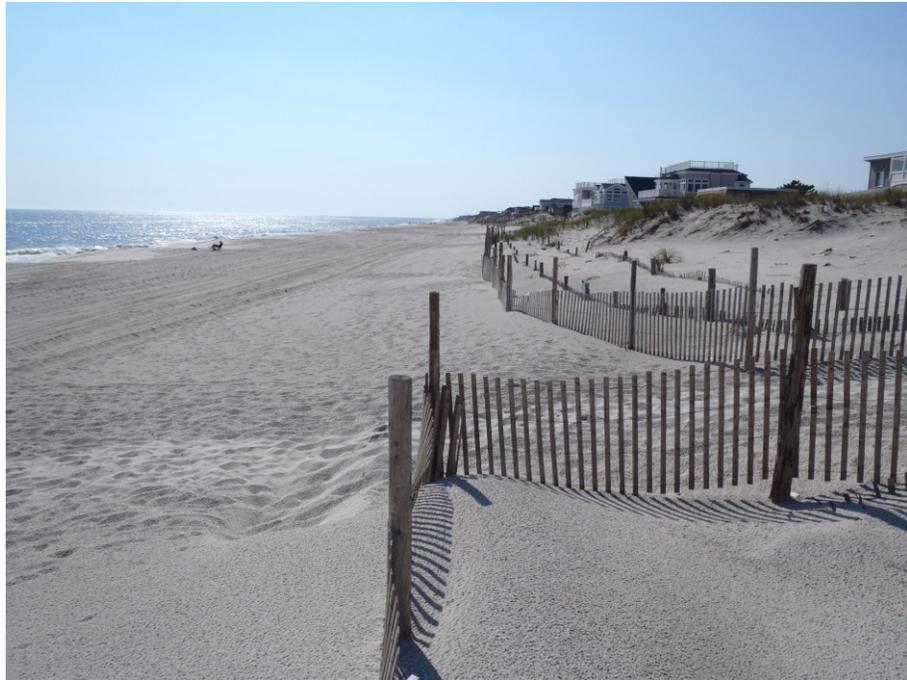
Photo taken October 12, 2010. View to the south.

Comparing the profiles over the year, the profile location lost volume (-40.27 cu yd/ft) and the shoreline moved landward (-24.49 ft). Sand was lost across the entire profile.

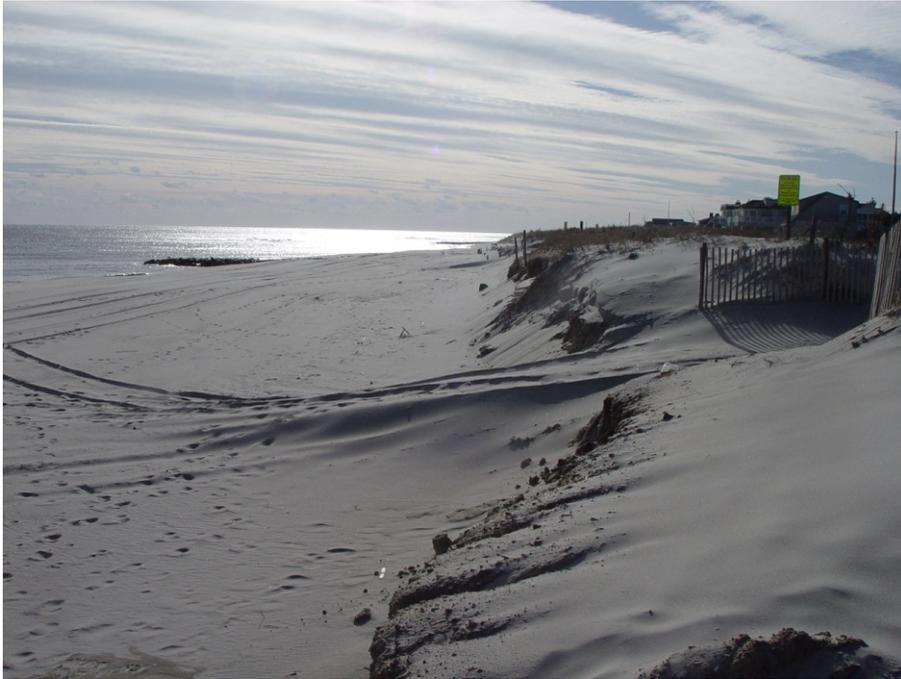
Photo taken December 11, 2009. View to the south.

The shoreline is relatively narrow at this site with a slightly wider dune between the dry beach and the residences. The 2008 “Mother’s Day” northeast storm cut a scarp in the dunes that was not repaired. The fall of 2009 did relatively little damage to the dunes or the beach. Sand was added offshore.

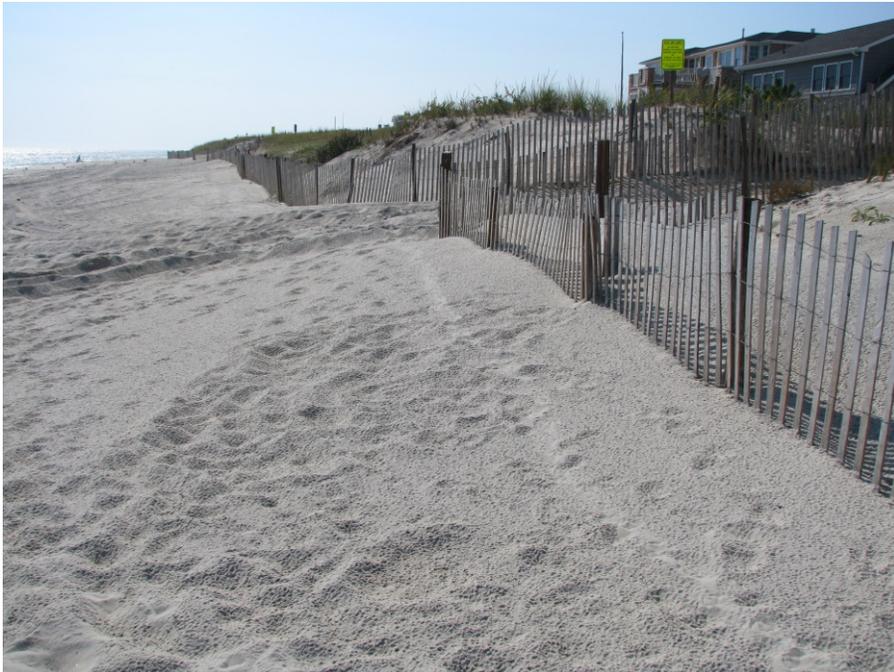
Photo taken October 12, 2010. View to the south.

Comparing the profiles over the year, the profile location gained volume (6.89 cu yd/ft) and the shoreline moved seaward (21.1 ft).

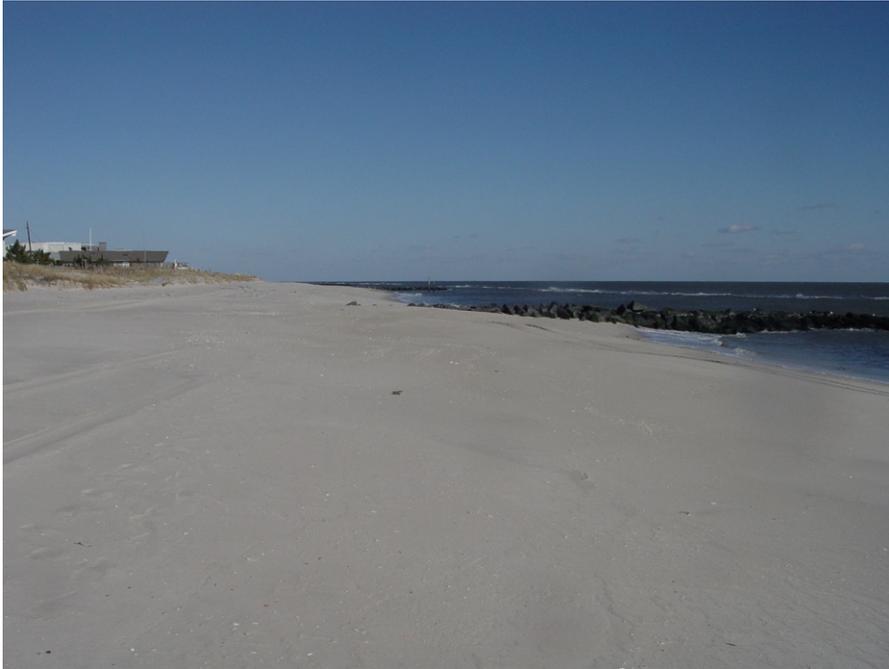
Photo taken December 11, 2009. View to the north.

Conditions of the beach following the storms in September to November.

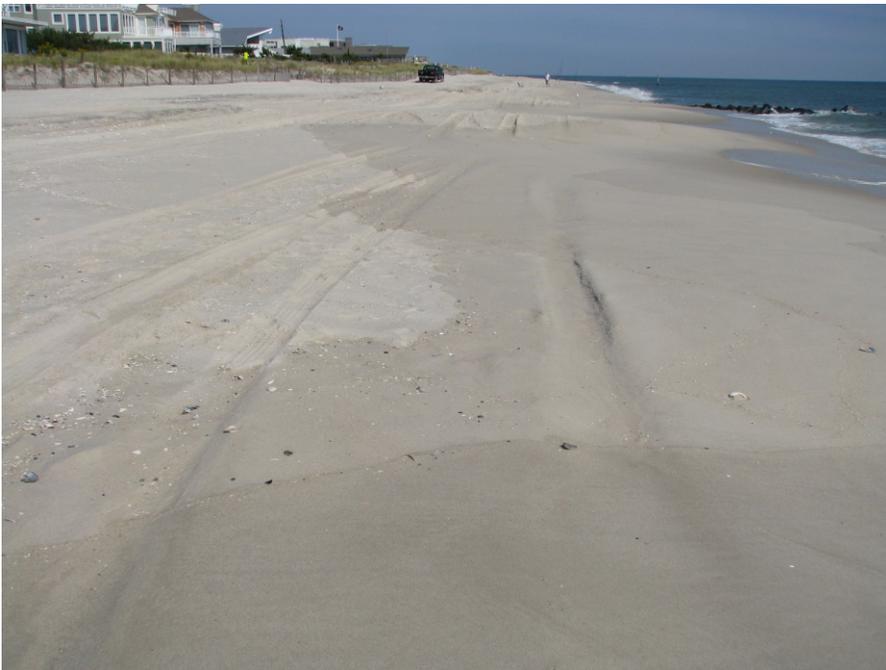
Photo taken October 12, 2010. View to the north.

Comparing the profiles over the year, the profile location lost volume (-15.83 cu yd/ft) and the shoreline moved seaward (1.36 ft). Most of the volume lost was below the 0.0 NAVD88 datum.

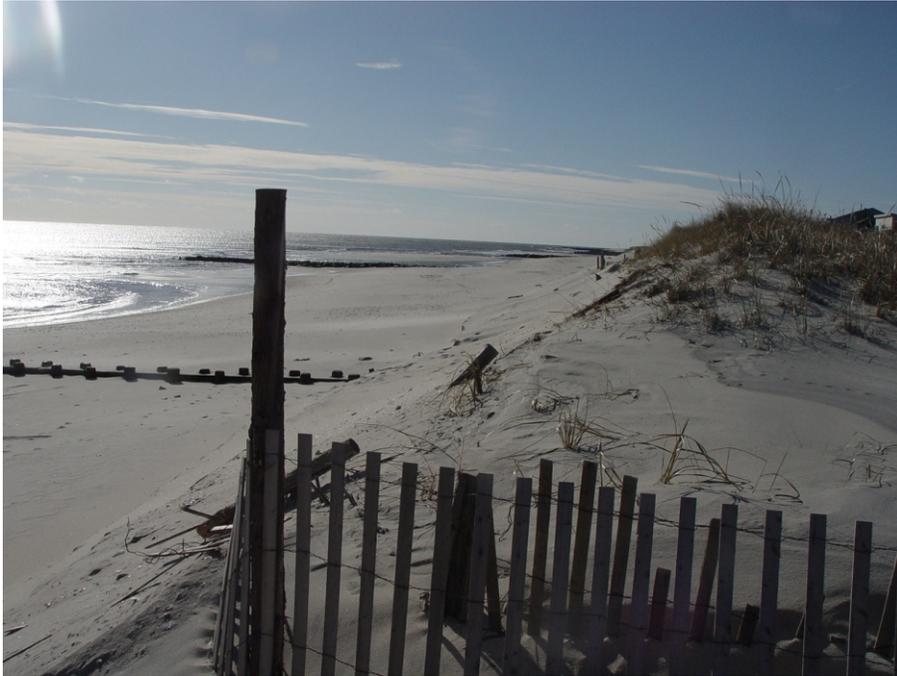
Photo taken December 11, 2009. View to the south.

The Webster Avenue site has a tall, but narrow dune with a beach that slopes seaward from the dune toe. Bar migration is important to building a summer berm.

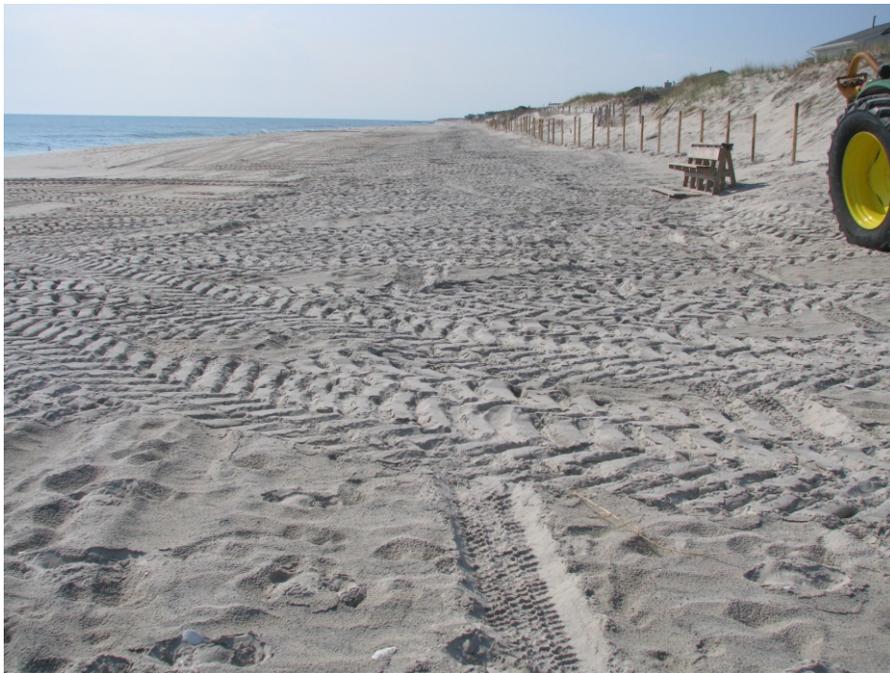
Photo taken October 12, 2010. View to the south.

Comparing the profiles over the year, the profile location gained volume (45.81 cu yd/ft) and the shoreline moved seaward (87.75 ft). This site was particularly hard hit by the series of northeasters during the fall/winter of 2009-2010, but begins to show some recovery in the summer of 2010.

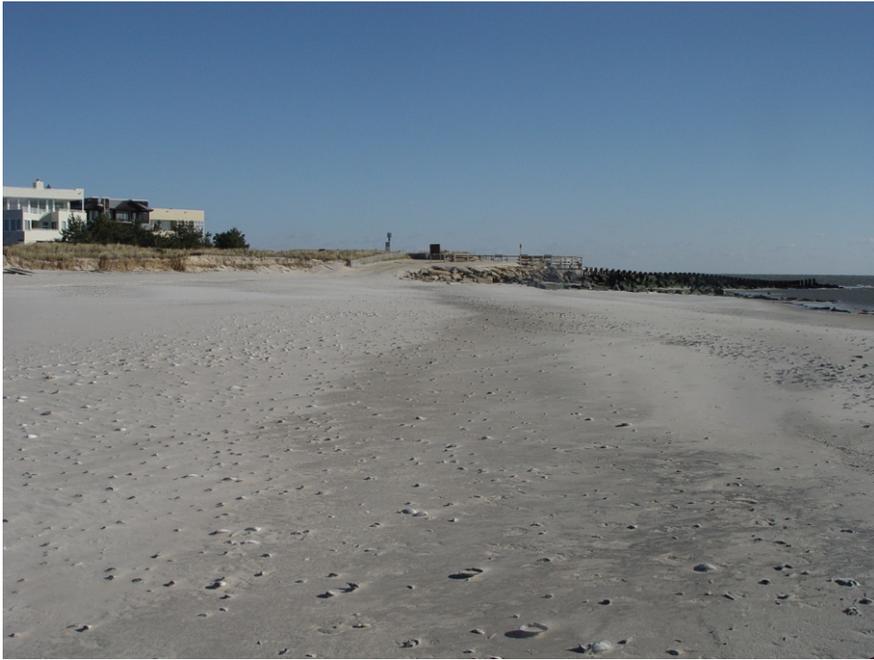
Photo taken December 11, 2009. View to the north.

This view toward the terminal groin shows a narrow beach with considerable exposure of the rocks. Northeast storms act to move sand around this groin where post-storm waves move it onto the beach after the storm. In the absence of northeasters sand will move up the beach from the south if southeast wave conditions prevail for extended periods of time.

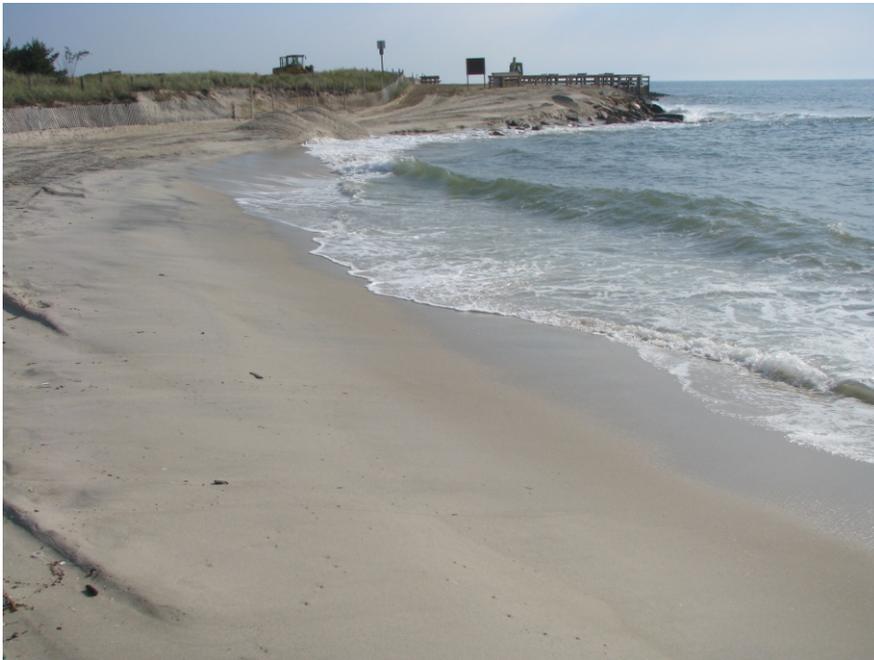
Photo taken October 12, 2010. View to the north.

Comparing the profiles over the year, the profile location lost volume (-54.94 cu yd/ft) and the shoreline moved landward (-93.81 ft). The sand loss was across the entire profile.
