**Beach-Dune Performance Assessment of  
New Jersey Beach Profile Network (NJBPN) Sites at  
Atlantic County, New Jersey**

**After Hurricane Sandy Related to FEMA Disaster DR-NJ 4086**

December 21, 2012

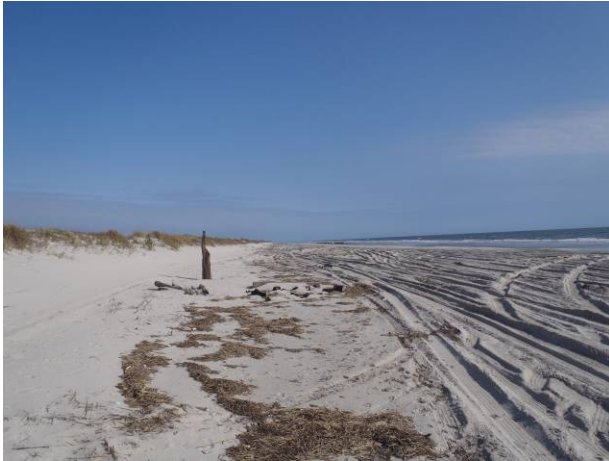
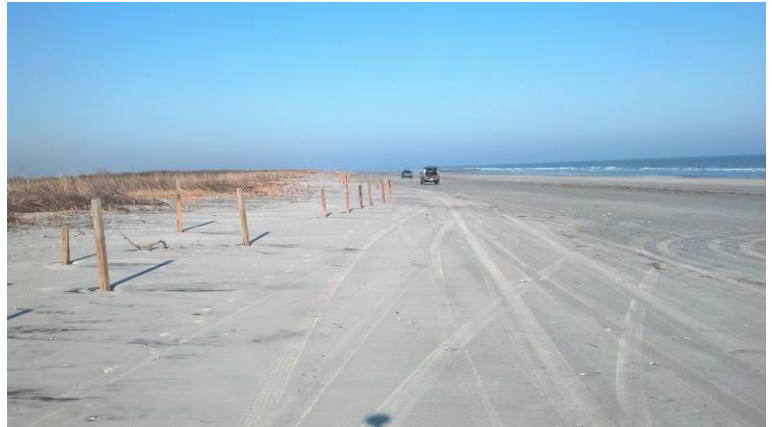
**NJBPN 134 – Green Acres Area, Brigantine**

The photographs above were taken on October 26, 2012 (left) and November 11, 2012 (right). The dune on the left started from nothing in January 1993, and was washed flat by Sandy (right). It is likely that the posts in the right picture date from the original post-storm effort to re-create the dune along this open-space beach.

The northern-most profile site on the Island of Brigantine is located on the undeveloped northern end of the island now in the possession of the State of New Jersey. This location was overwashed by waves from the ocean to the bay marshes by Sandy. The vegetation survived behind the dune ridge, so re-growth is assured, but at a more landward location. The northeast storm of 1992 was the last time this occurred.

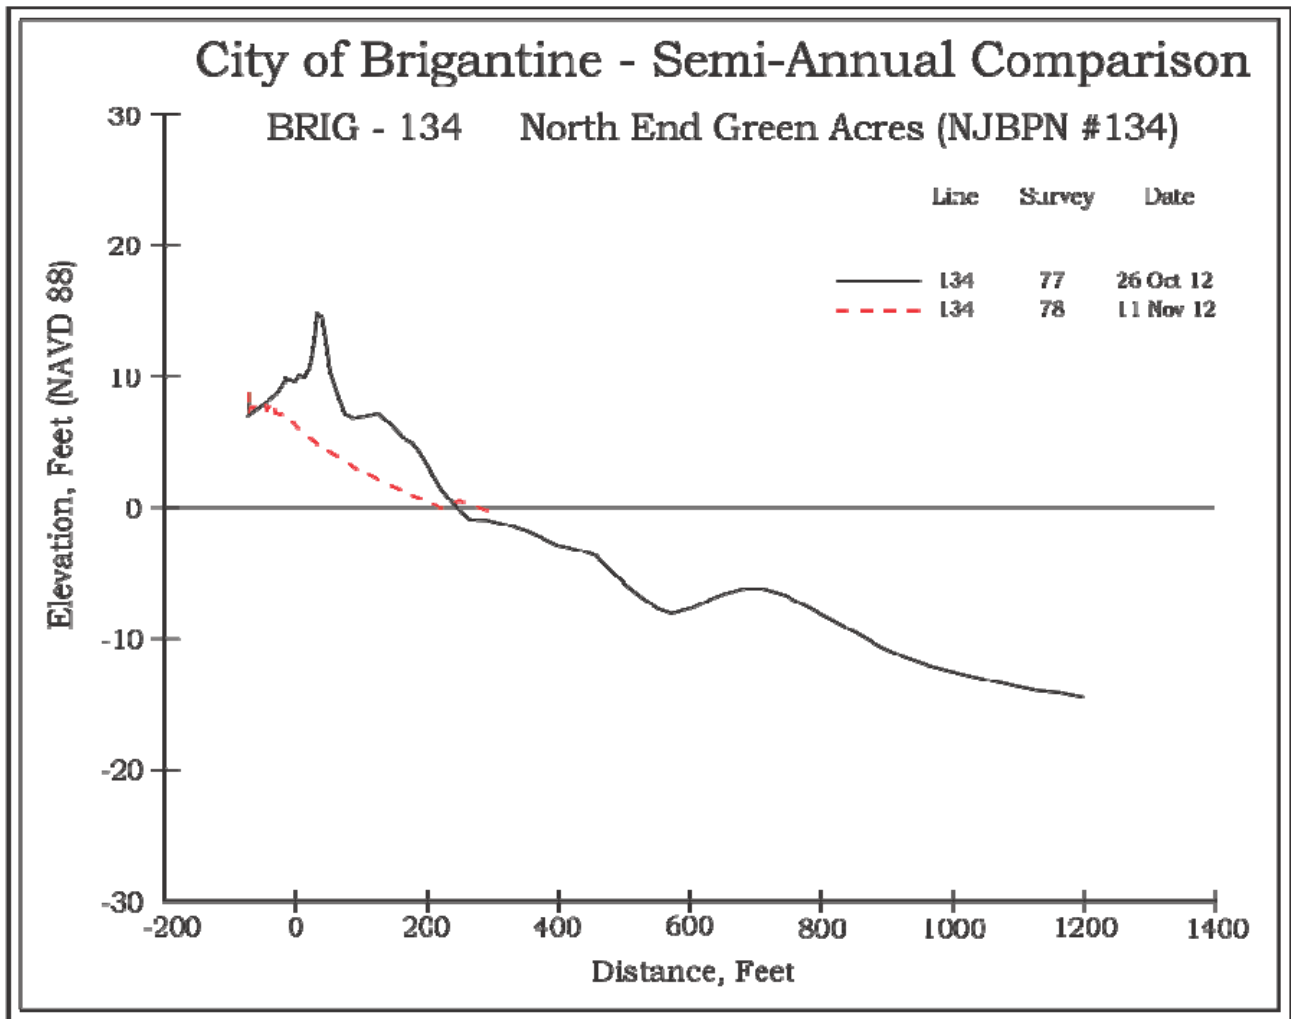
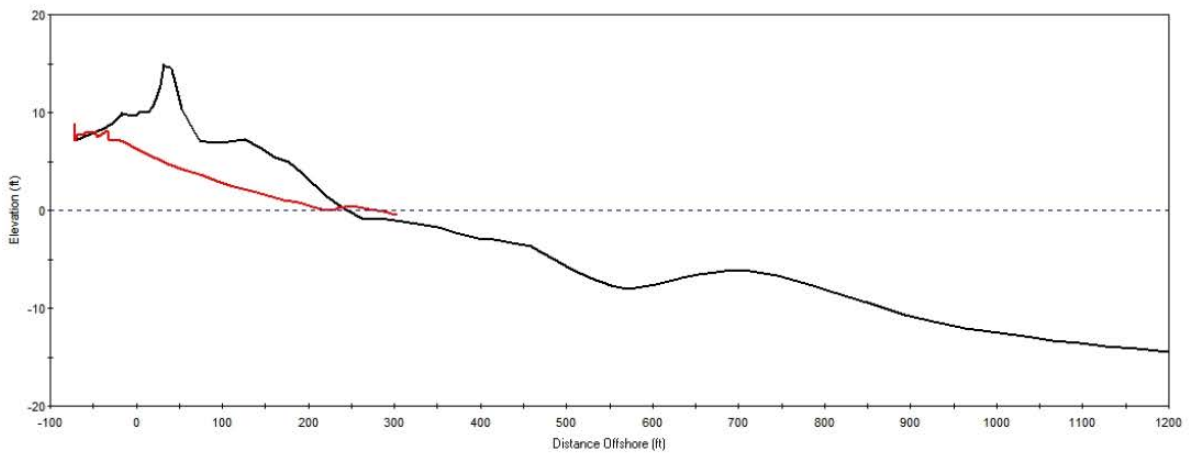
Pre vs. Post Sandy  
 Site 134 (Brig-134)  
 North End Green Acres, Brigantine

Figure 2. This site is located in the natural area on the northern segment of Brigantine Island, preserved as public open space. The dune (built since 1992) was washed landward onto the salt marshes. The photo above and cross-section below show the low and flat berm that was created by the large waves of Hurricane Sandy.

Volume Change = -41.182 cu. yd/ft

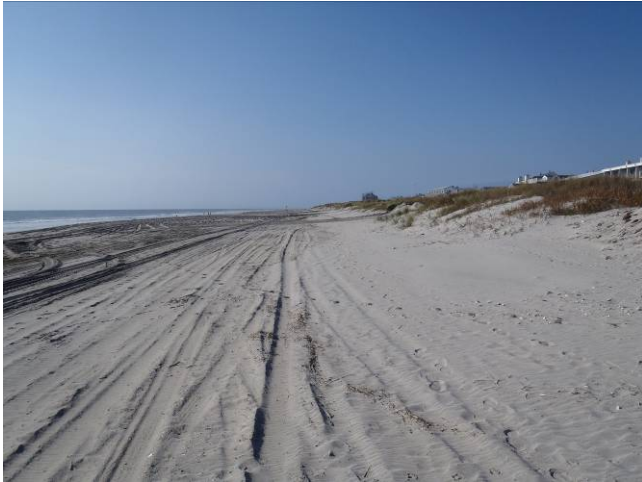
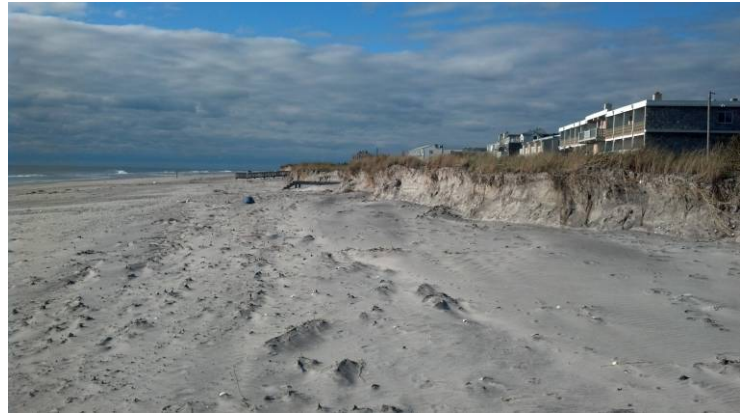
**NJBPN 133 – 4<sup>th</sup> Street North, Brigantine**

The photographs above were taken on October 26, 2012 (left) and November 3, 2012 (right). The seaward slope of the dunes was truncated by Sandy with sand moved seaward. Minor overwash at street ends occurred in places, but wholesale damage was absent.

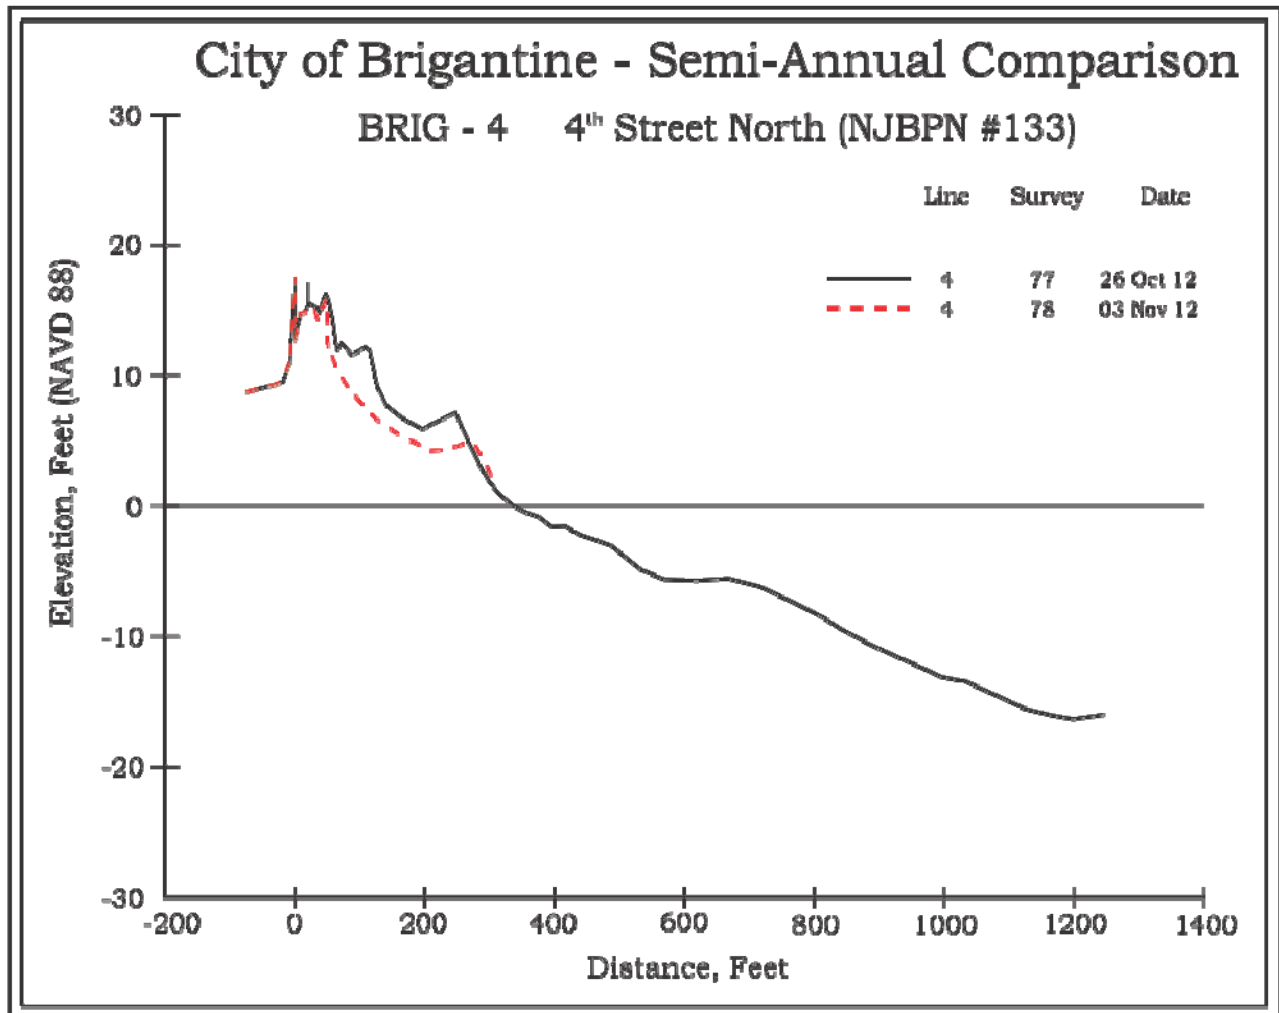
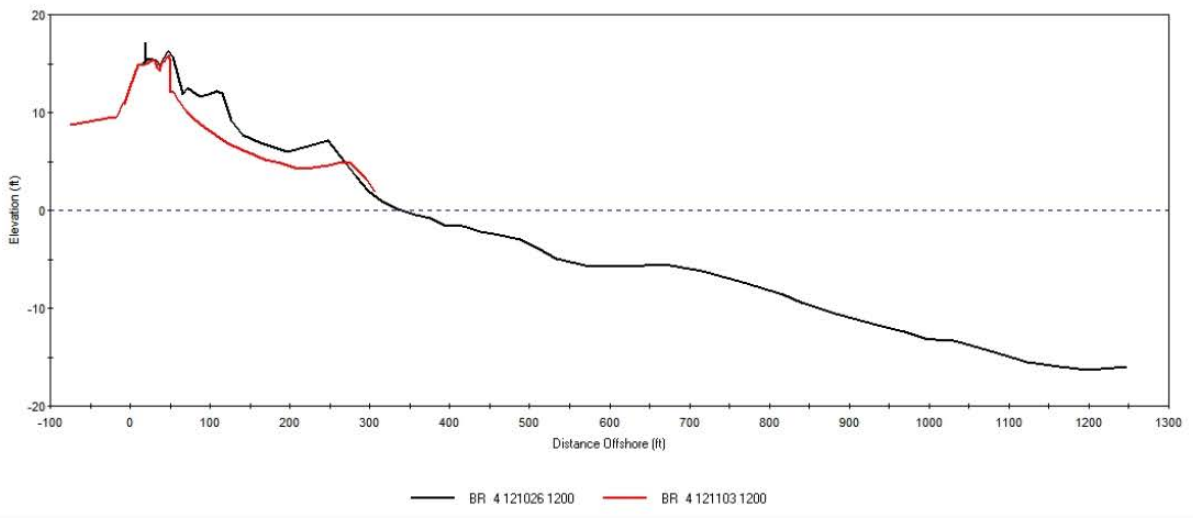
Pre vs. Post Sandy  
 Site 133 (Brig-4)  
 4th Street North, Brigantine

Figure 3. This site is located in the developed section of the island at the south end of the 1997 State beach nourishment project and the subsequent Federal project in 2006. Maintenance or emergency fills did not extend to this location in 2012. Though the berm and dune lost sand from the impact of Sandy, the primary dune remains.

Volume Change = -17.707 cu. yd/ft

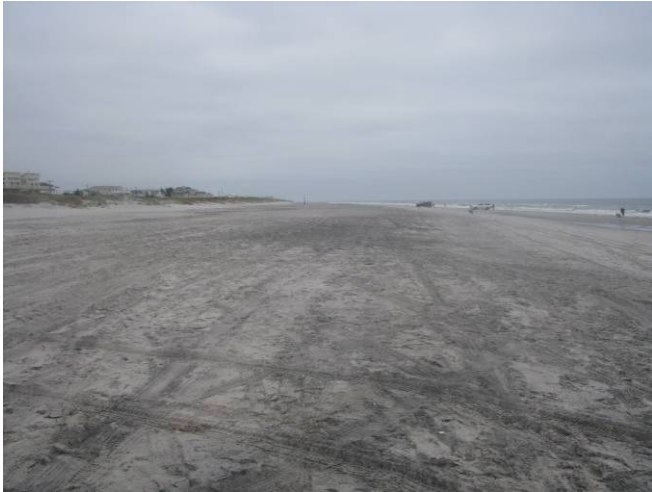
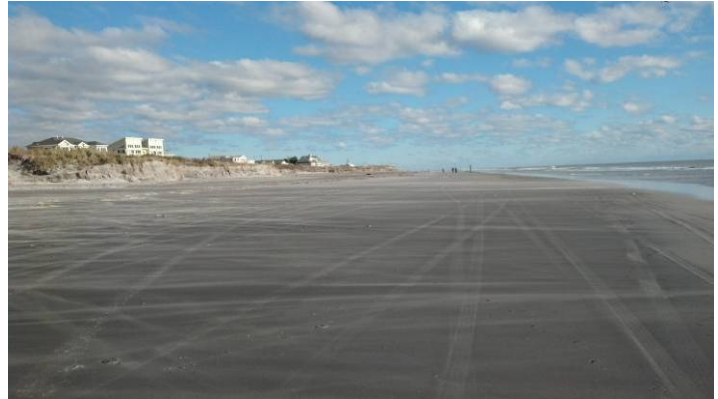
NJBPN 132 – 15<sup>th</sup> Street South, Brigantine

The photographs above were taken on October 25, 2012 (left) and November 3, 2012 (right). This part of the beach lies in a zone where little erosion or accretion has occurred until beach nourishment started in 1997. Since then the shoreline has moved seaward by 200 feet. But the damage was caused by a lack of dunes in front of the parking lot and the building at 15<sup>th</sup> Street South.

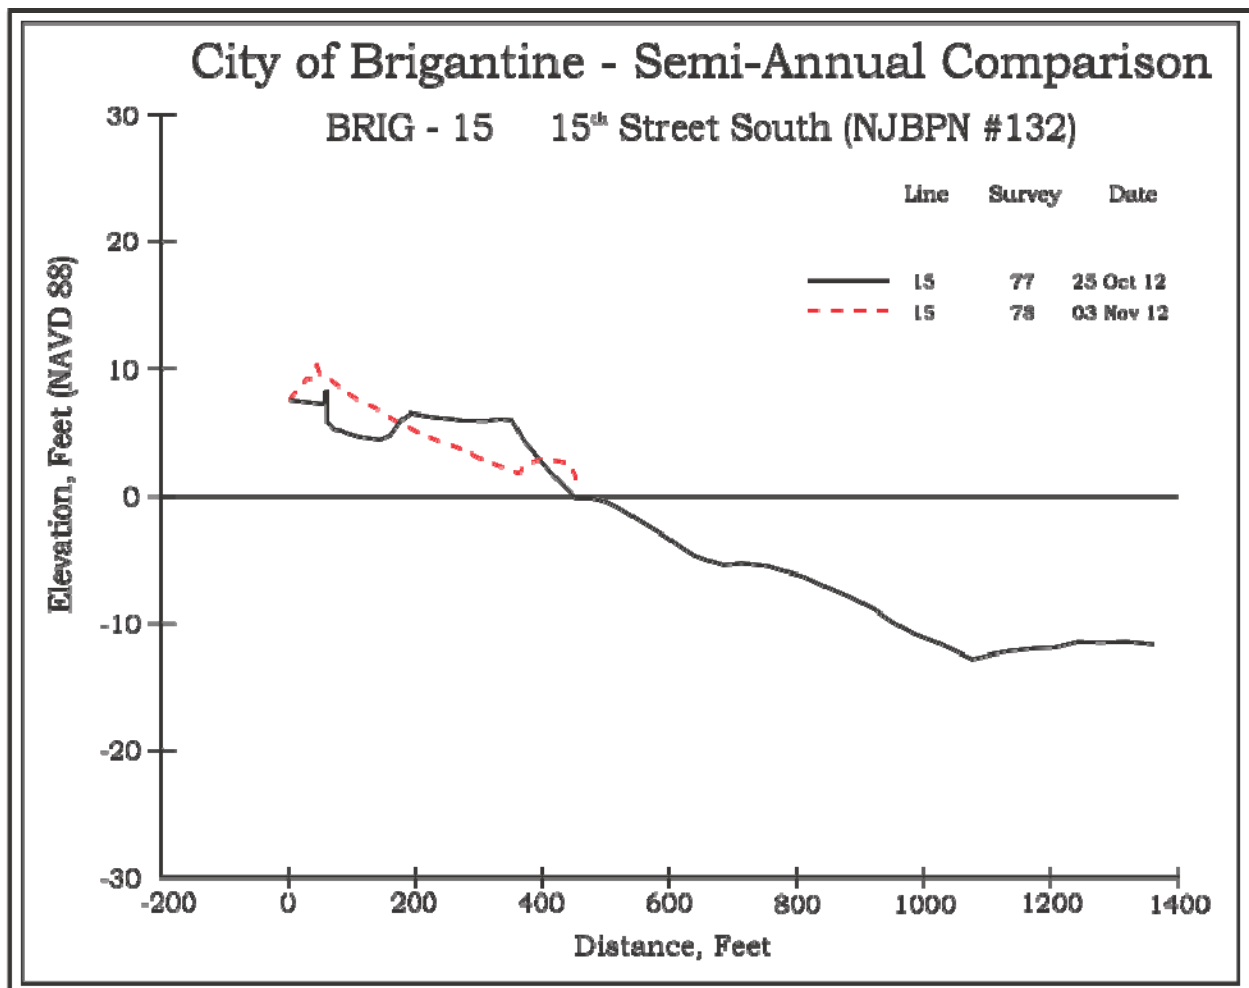
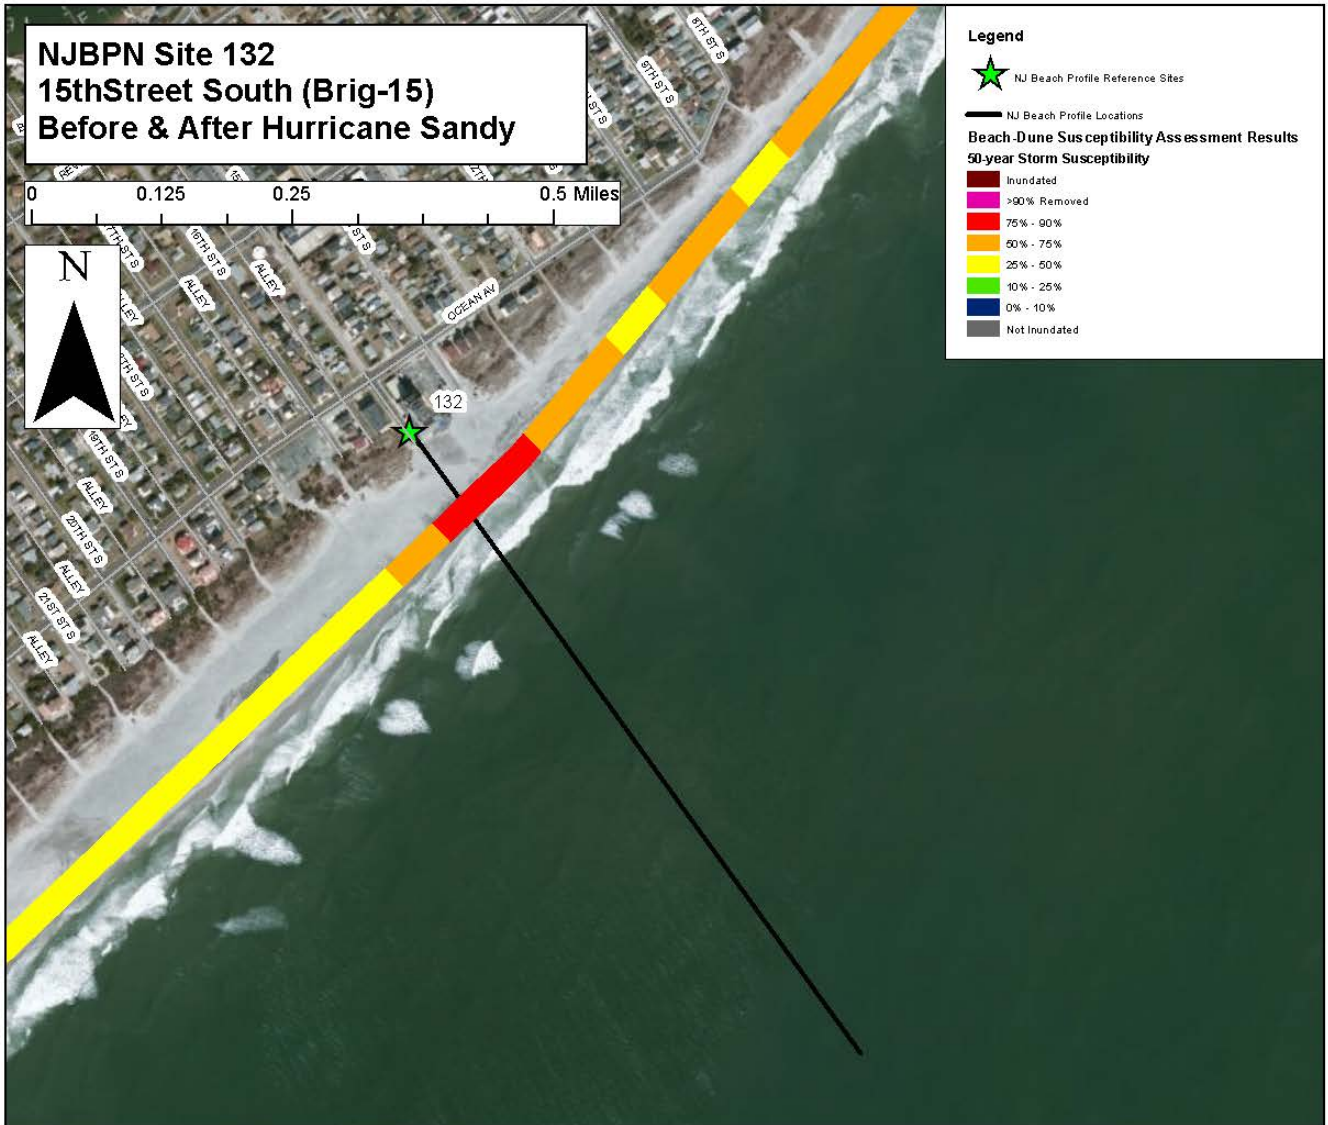
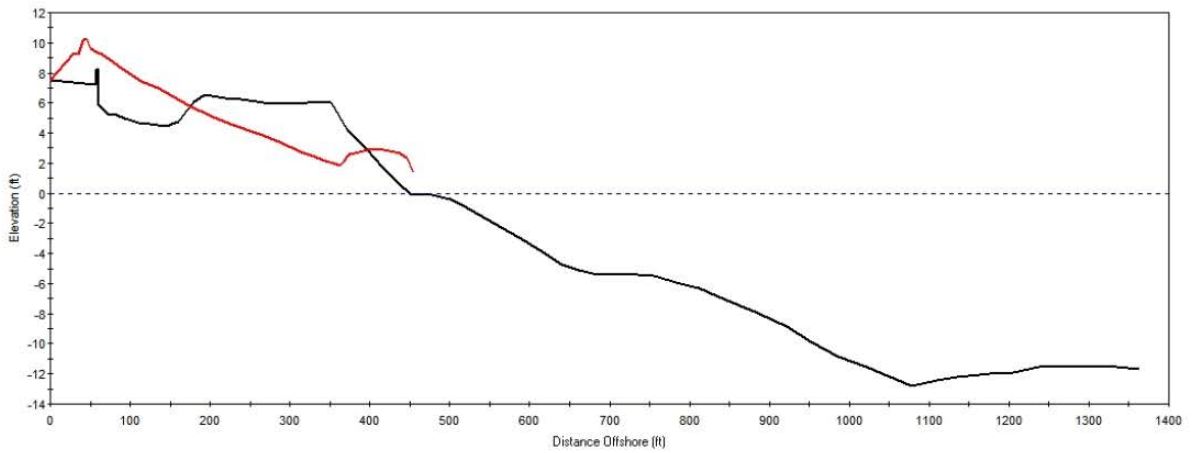
Pre vs. Post Sandy  
Site 132 (Brig-15)  
15th Street South, Brigantine

Figure 4. This site has never been included in the beach replenishment projects but is the recipient of sand due to the littoral transport of that material to the south. The result is a wide berm and some dune growth. Hurricane Sandy's waves relocated the berm sand landward and buried the bulkhead. The deposit covered the immediate street end at 15<sup>th</sup> Street South.

Volume Change = -0.737 cu. yd/ft

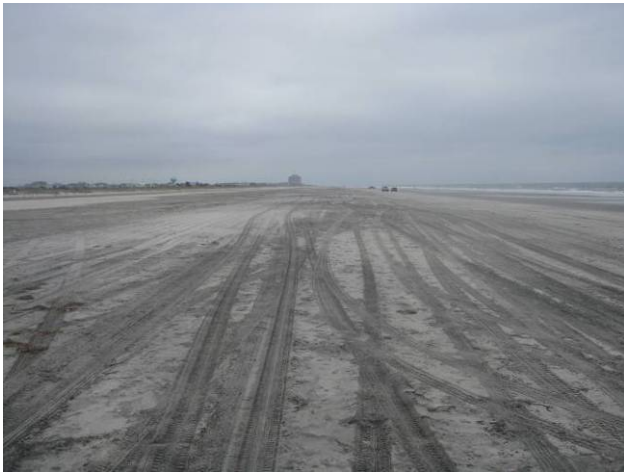
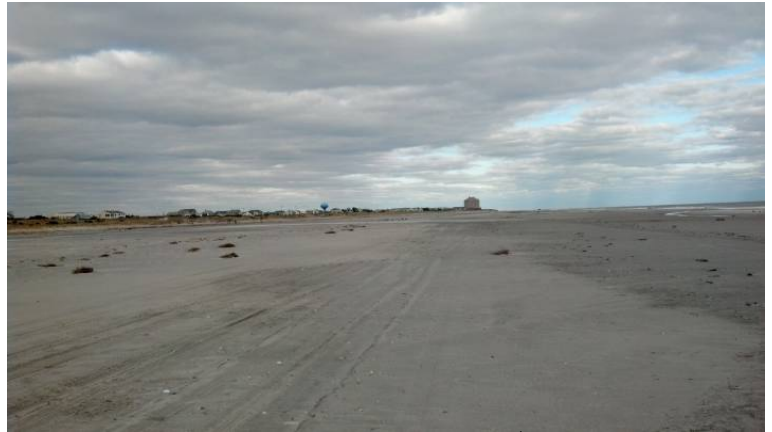
**NJBPN 131 – 43<sup>rd</sup> Street South, Brigantine**

The photographs above were taken on October 25, 2012 (left) and November 3, 2012 (right). The large building at 15<sup>th</sup> Street South shows in both pictures in the distance. From there to a mile south of this site, the beach width is huge with multiple rows of vegetated dune ridges to the landward site. The storm surge and wave energy expended itself in the dunes closest to the back beach margin with no ill effect on the development.

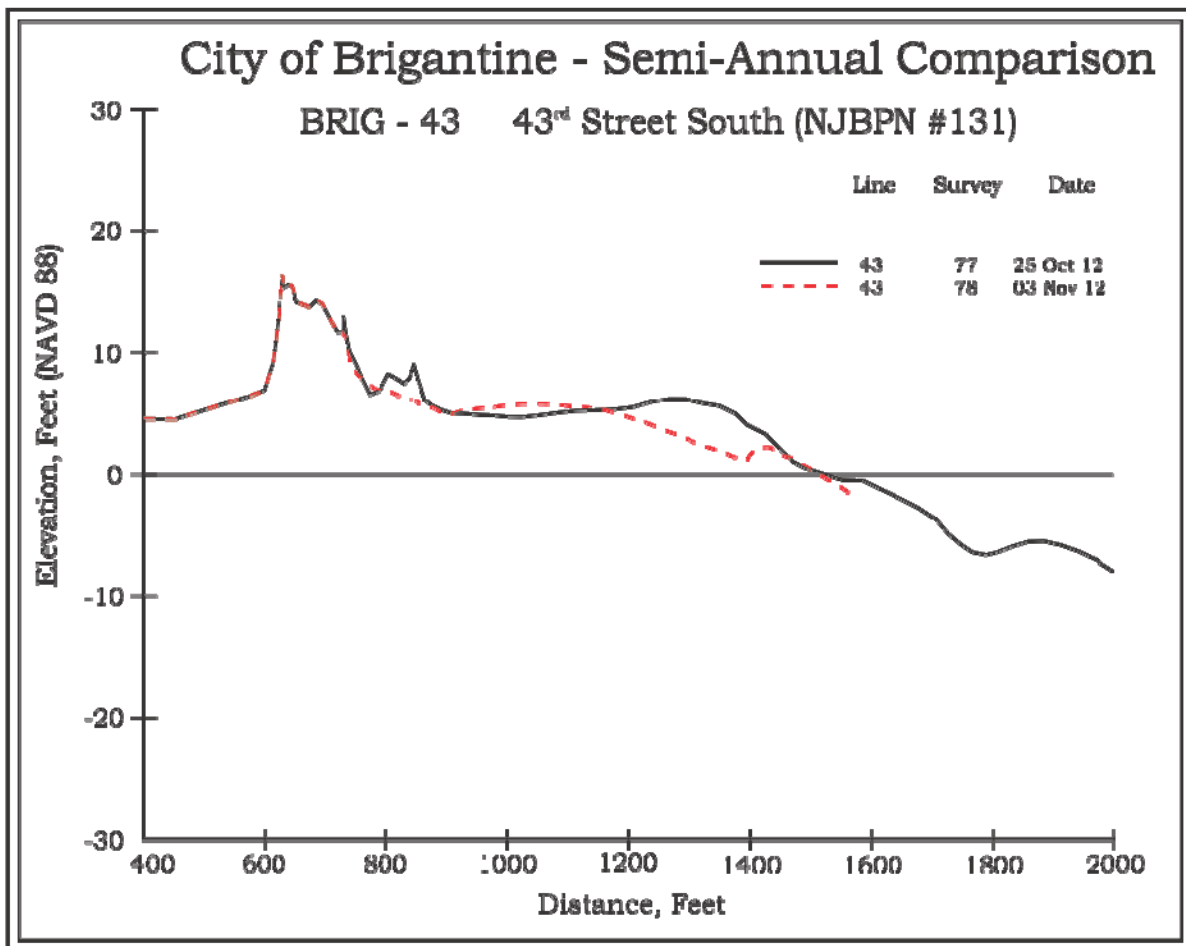
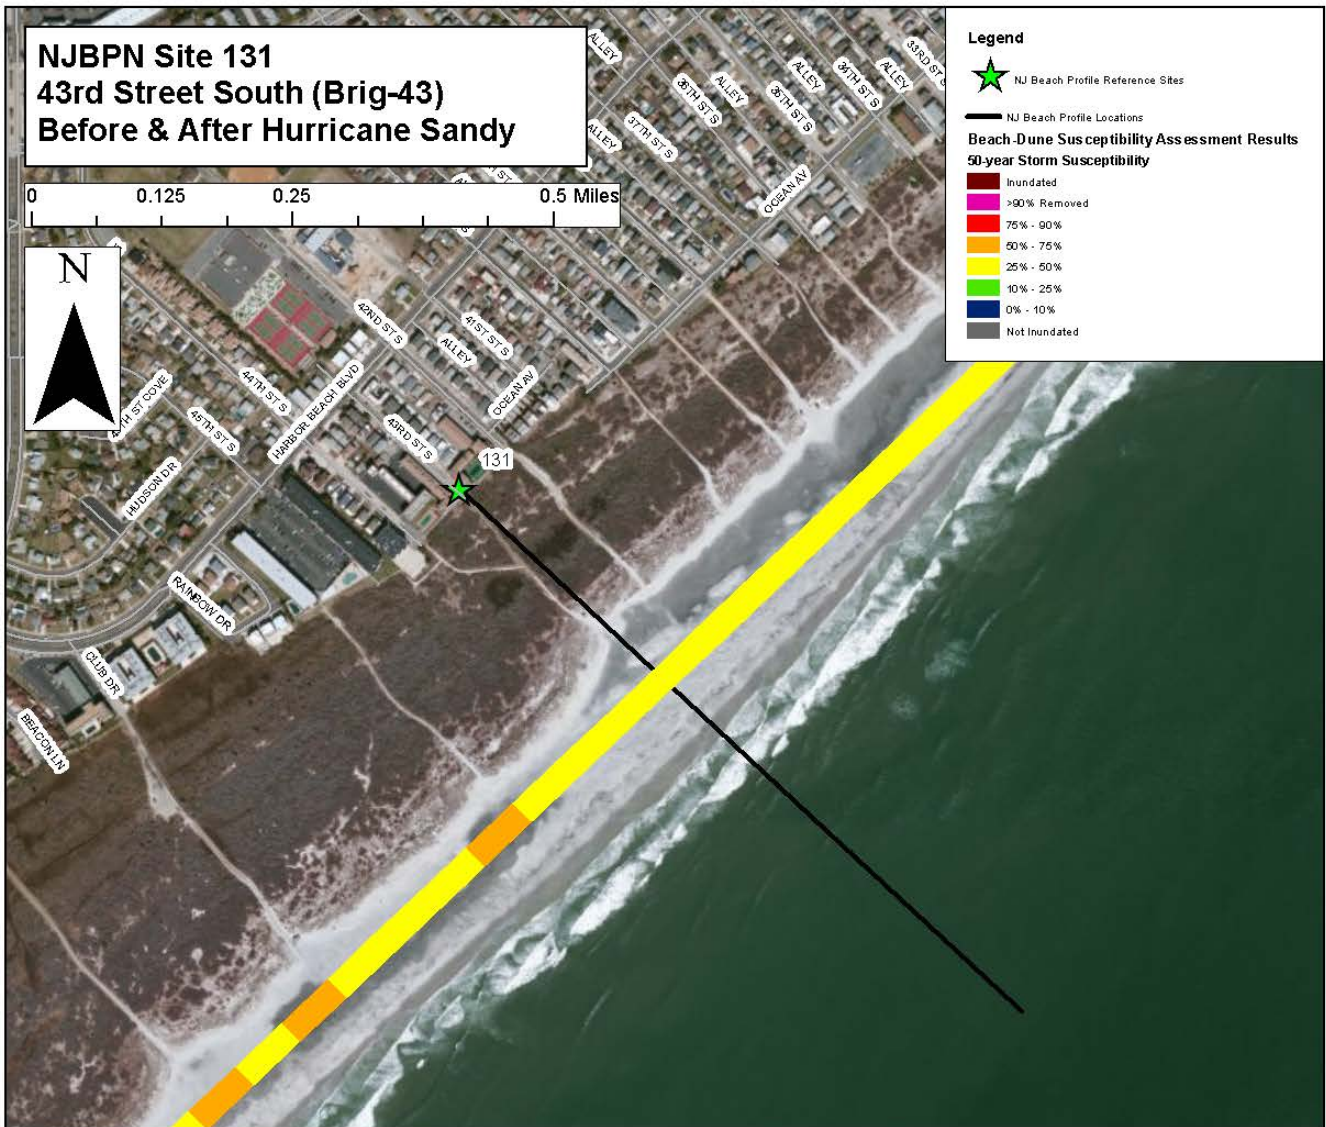
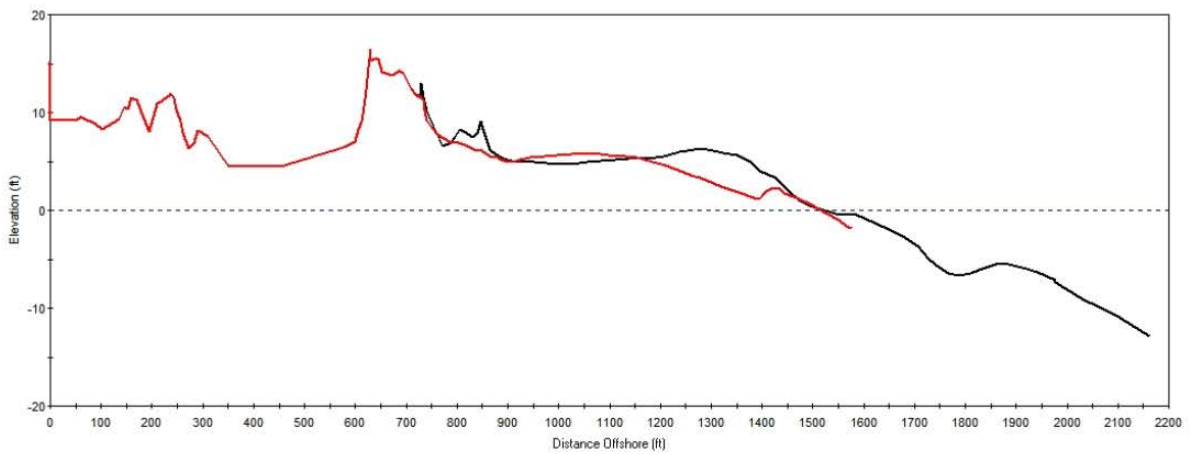
Pre vs. Post Sandy  
Site 131 (Brig-43)  
43rd Street South, Brigantine

Figure 5. Sand has been accumulating at this profile location since the NJBPN’s initial 1986 survey. The healthy dune system and wide berm protected landward properties and infrastructure from Hurricane Sandy’s waves and storm surge. Sand was moved landward into the dunes from the berm. The large, primary dune diverted all flow to the sides with water and sediment moving landward along pedestrian paths leading back to the development 400 feet further landward than the graph displays. The zero distance starts at the 43<sup>rd</sup> Street South street end.

Volume Change = -22.748 cu. yd/ft

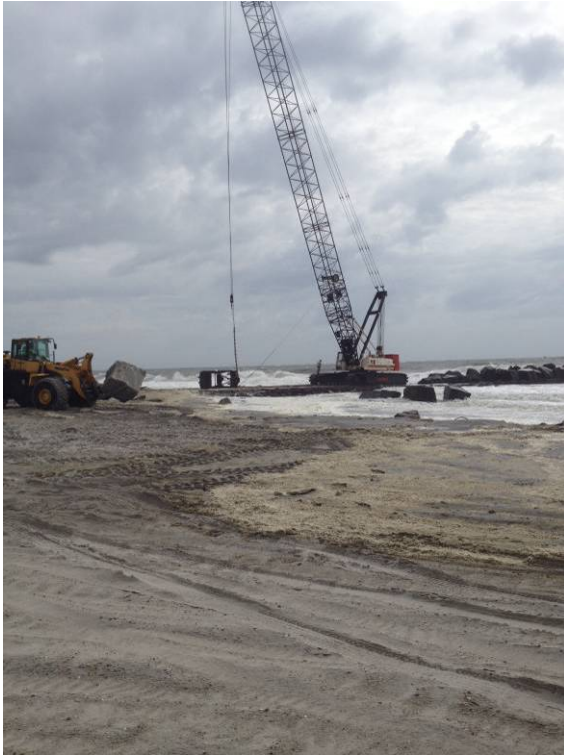
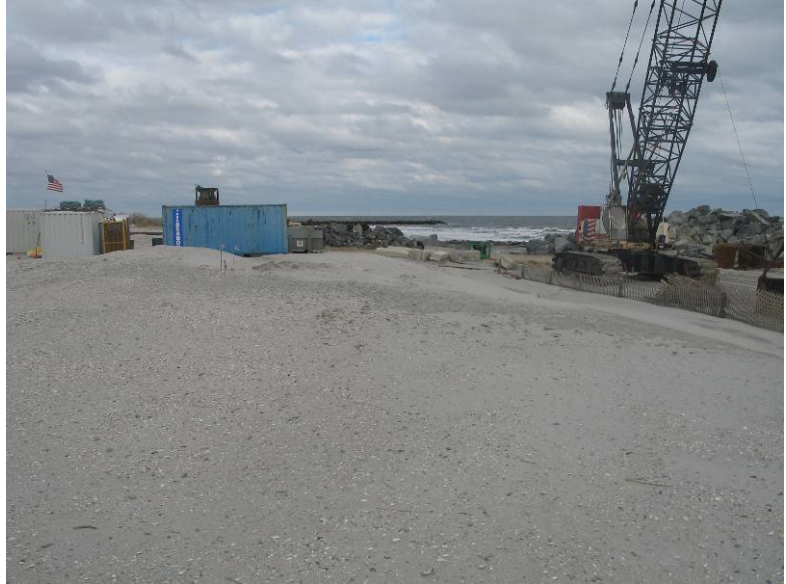
**NJBPN 230 – Rhode Island Avenue, Atlantic City**

The photographs above were taken on September 18, 2012 (left) and November 6, 2012 (right). Work was continuing on the rock sill being placed between the Massachusetts and Vermont Avenue groins in northern Atlantic City. The new Revel Entertainment casino was built here and the owner’s desire to have a usable beach with amenities resulted in an attempt to construct a submerged, shore-parallel rock sill between the two groins to trap sand as a “perched” beach for a longer time period between the maintenance interval for the Federal beach project. Since the maintenance was just completed following hurricane Irene in 2011, the dune/beach system resisted the storm damage from Sandy with about three quarters of the dune surviving.

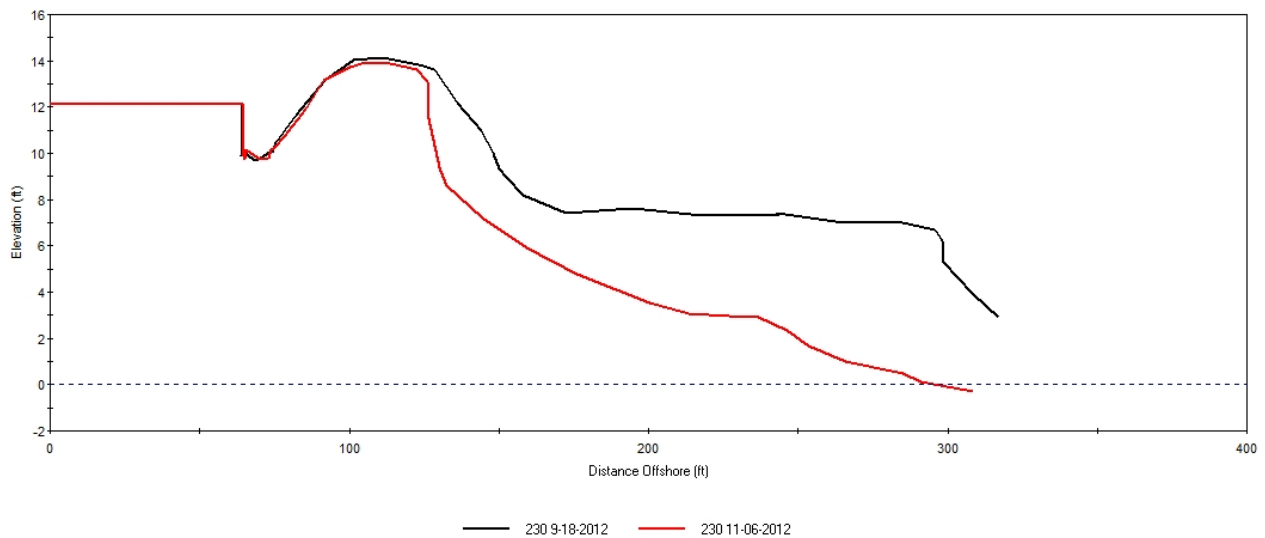
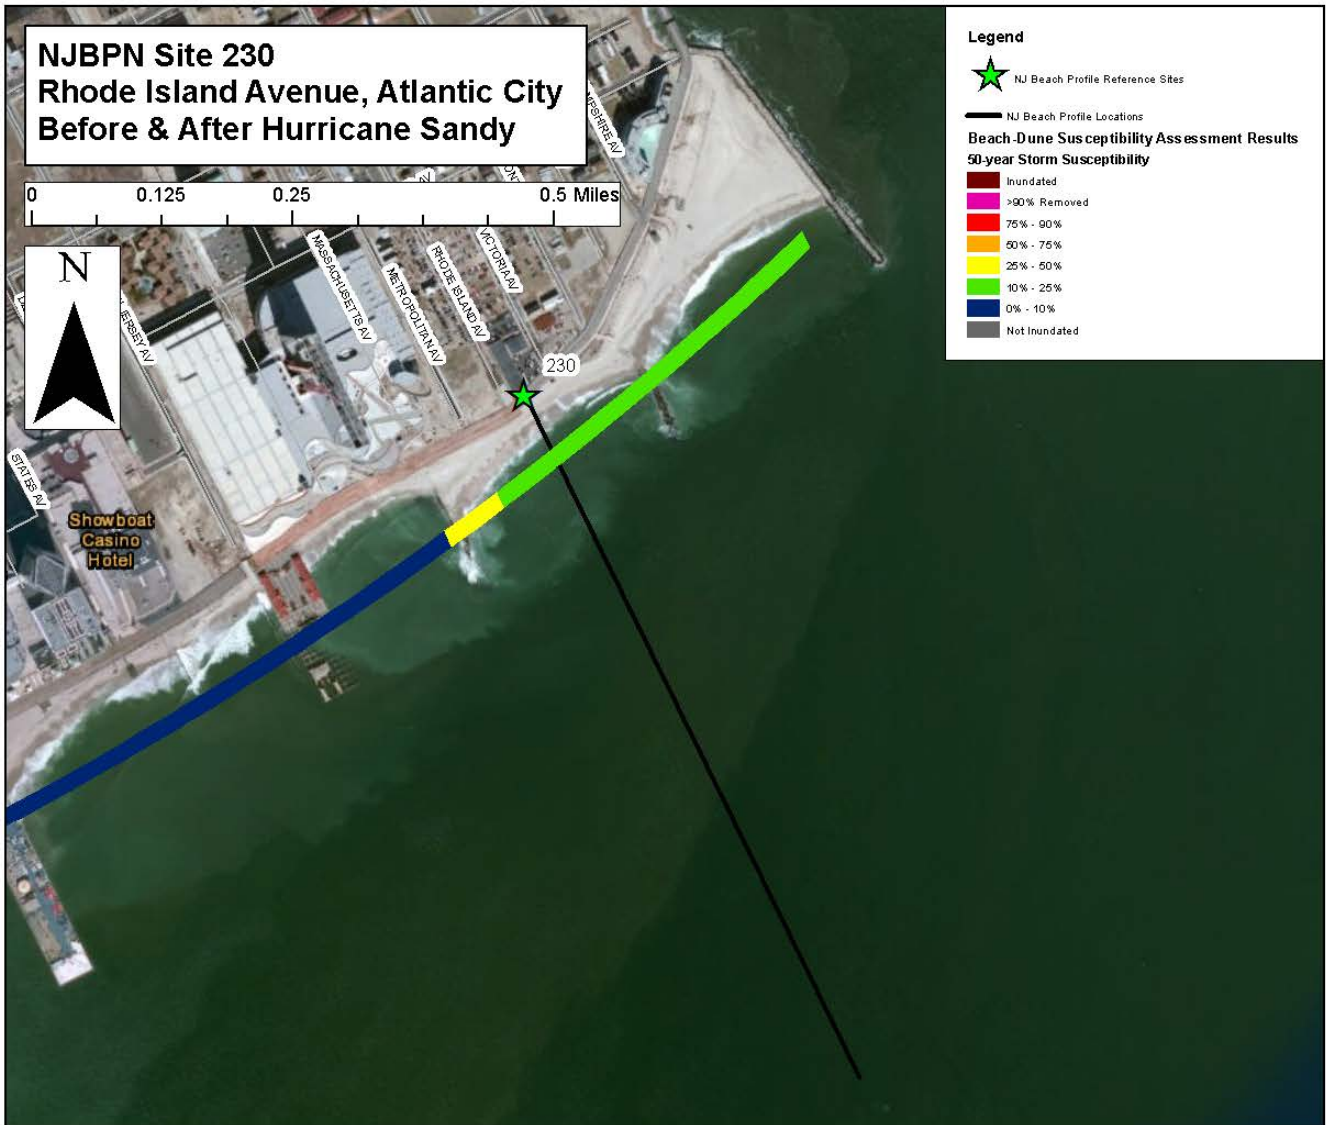
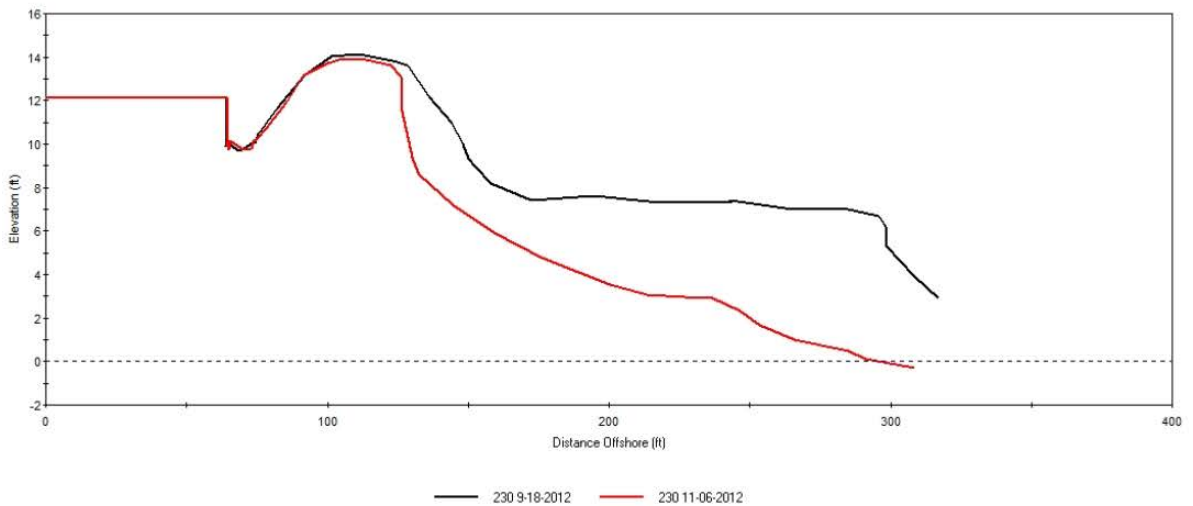
Pre vs. Post Sandy  
Site 230  
Rhode Island Ave., Atlantic City

**Figure 6. This profile site is located near the Absecon Inlet jetty. The berm was wide following a Federal maintenance in 2012, which helped the un-vegetated dune survive the storm. Construction of a perched beach began in the summer of 2012 and was underway during the passage of Hurricane Sandy. The volume of sand in the berm was drastically reduced by Sandy.**

Volume Change = -29.836 cu.yd/ft

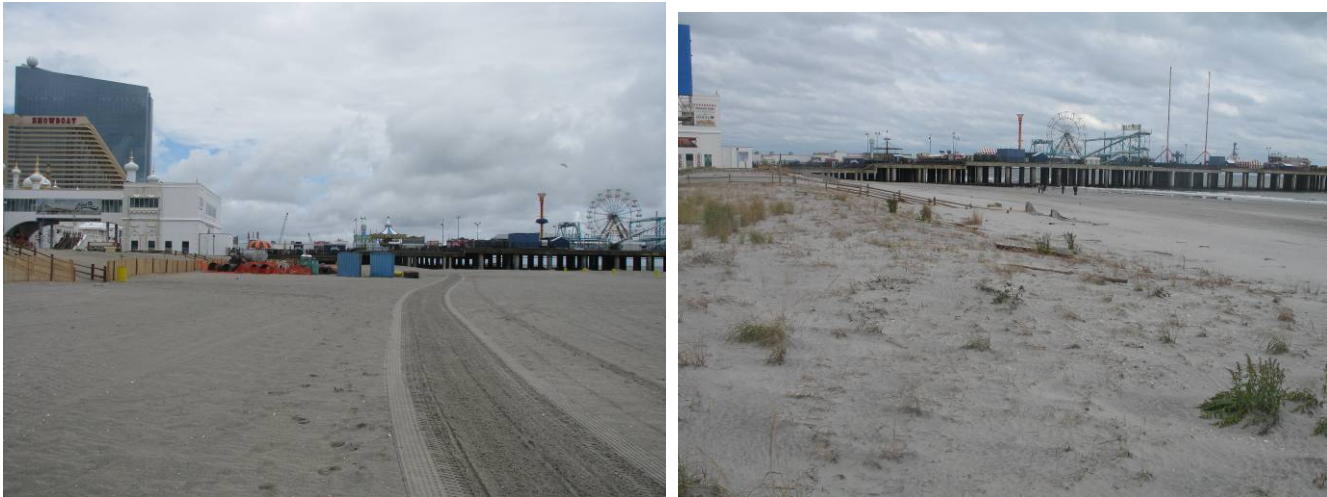
**NJBPN 130 – North Carolina Avenue, Atlantic City**

The photographs above were taken on June 4, 2012 (left) and November 6, 2012 (right). The beach lost much of the berm sand volume, but the dune survived by being just high enough. Note that there is abundant debris deposited near the crest of the dune and stream gullying was in evidence on the landward side of the dune indicating that sea water had crossed it in significant volume at the height of the storm.

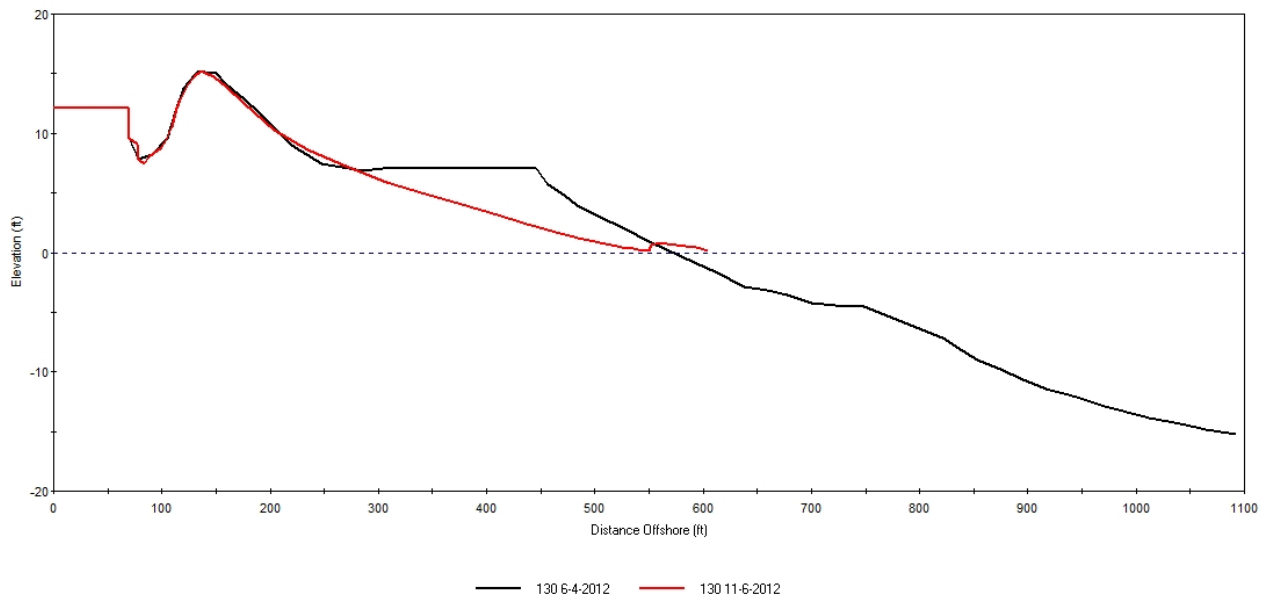
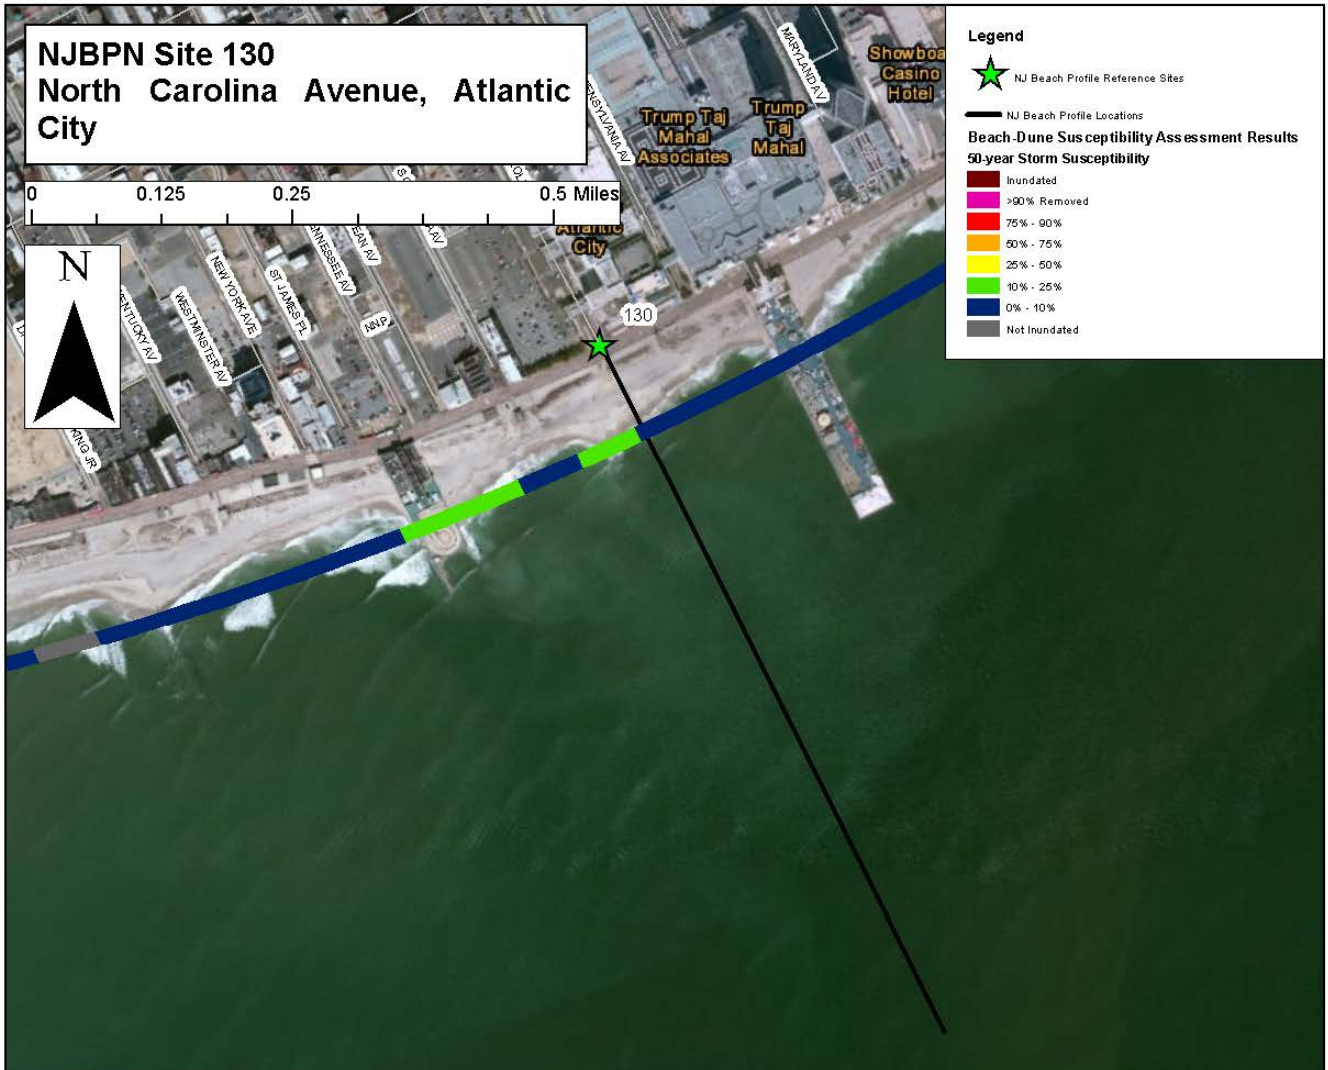
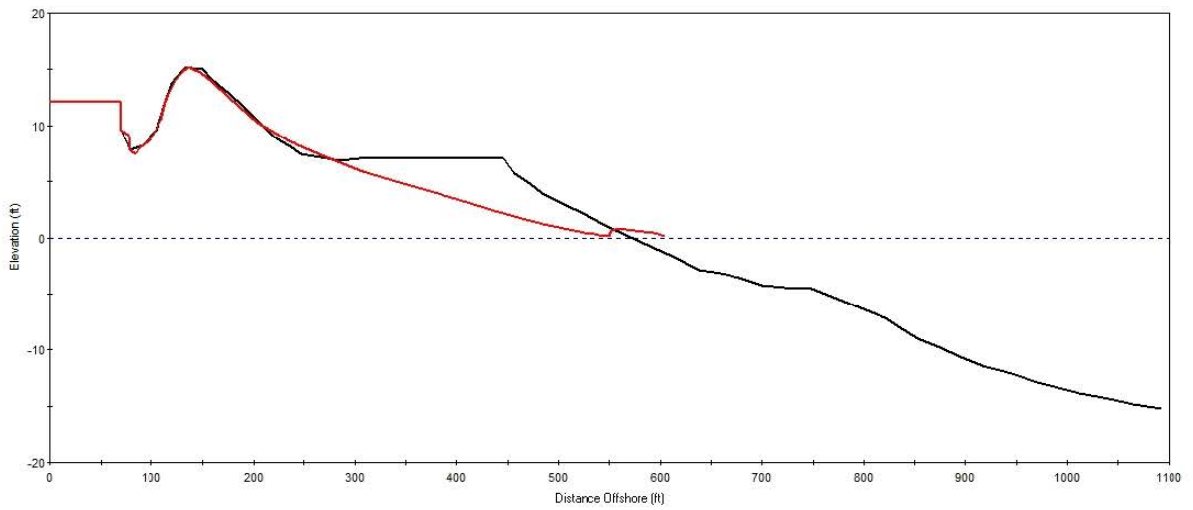
Pre vs. Post Sandy  
Site 130  
North Carolina Ave., Atlantic City

**Figure 7. The 2003 Federal beach nourishment project established a protective dune at this site. A 2011 Federal beach maintenance fill added to the dune, berm and nearshore. The dune remained intact during Hurricane Sandy while the berm was lowered in elevation. The wave run-up elevation here was 14.0 feet NAVD88, about 10 feet less than measured in Long Branch, NJ.**

Volume Change = -25.133 cu. yd/ft

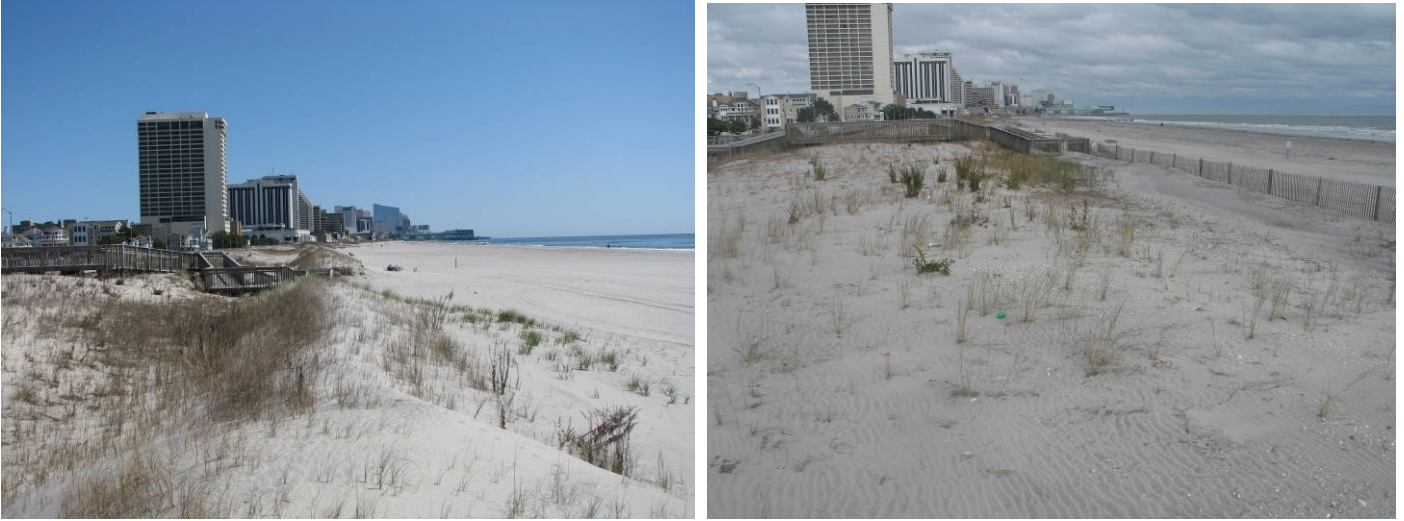
## NJBPN 129 – Raleigh Avenue, Atlantic City

The photographs above were taken on April 13, 2012 (left) and November 6, 2012 (right). Raleigh Avenue lies in the middle of the Federal beach project and this meant that little damage was done. The dunes were invaded on the seaward slope depositing sand in the grass and knocking down an incipient foredune.
