**Beach-Dune Performance Assessment of  
New Jersey Beach Profile Network (NJBPN) Sites at  
Atlantic County, New Jersey**

**After Hurricane Sandy Related to FEMA Disaster DR-NJ 4086**

December 21, 2012

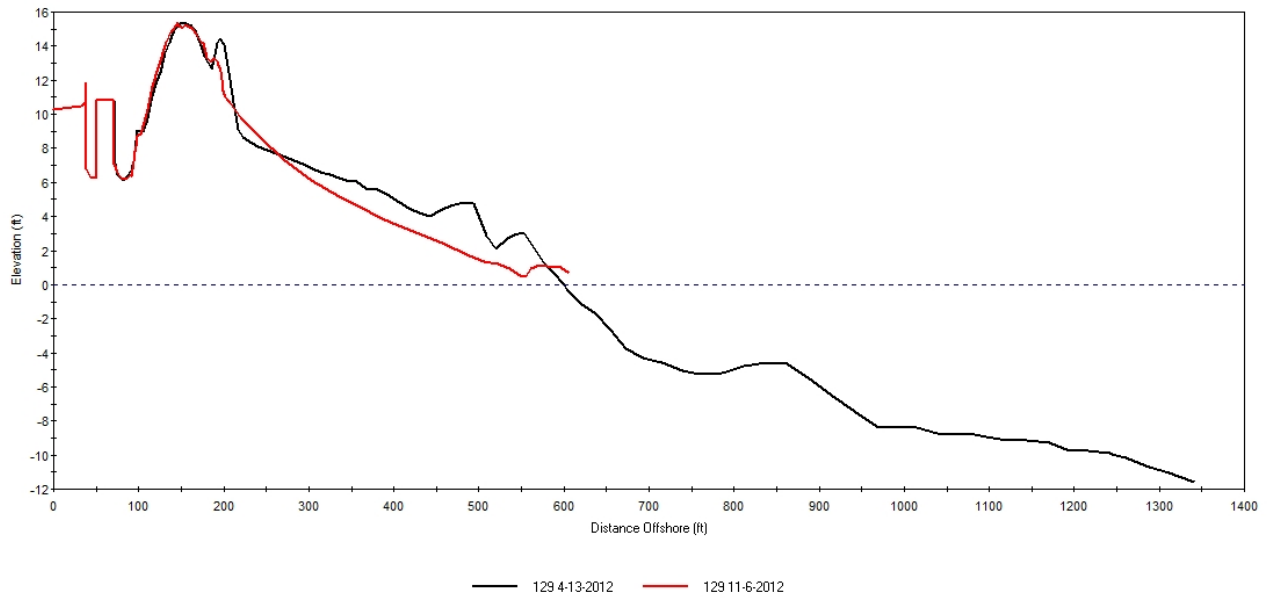
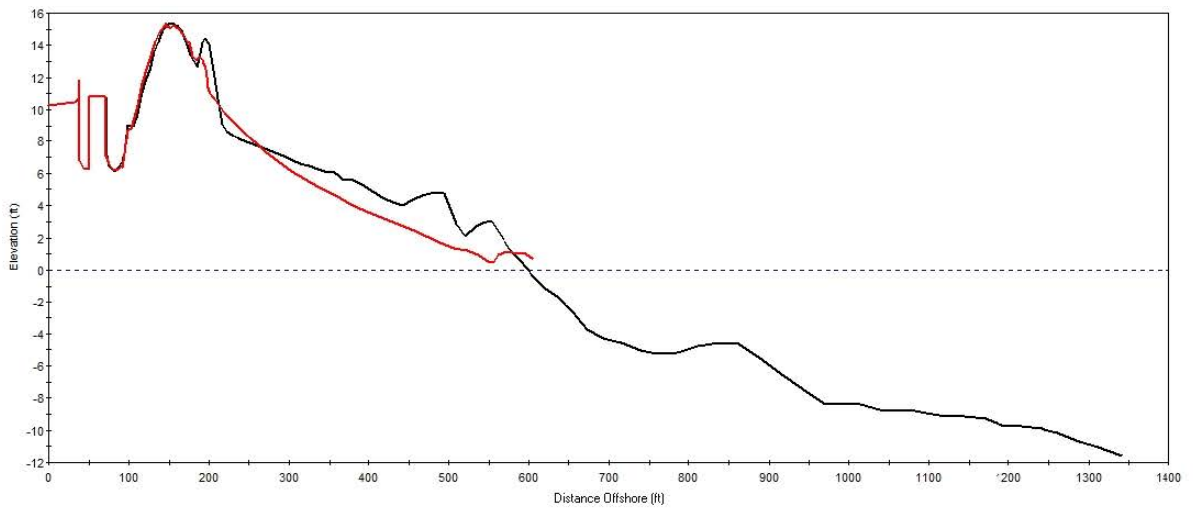
**Pre vs. Post Sandy**  
**Site 129**  
**Raleigh Ave., Atlantic City**

Figure 8. This profile has been relatively stable over the past 25 years due to its mid-island location and the past beach nourishment projects up-drift of the site. The comparison plot between the pre- and post-storm survey shows little loss of the foredune but lowering of the berm.

Volume Change = -15.355 cu.yd/ft

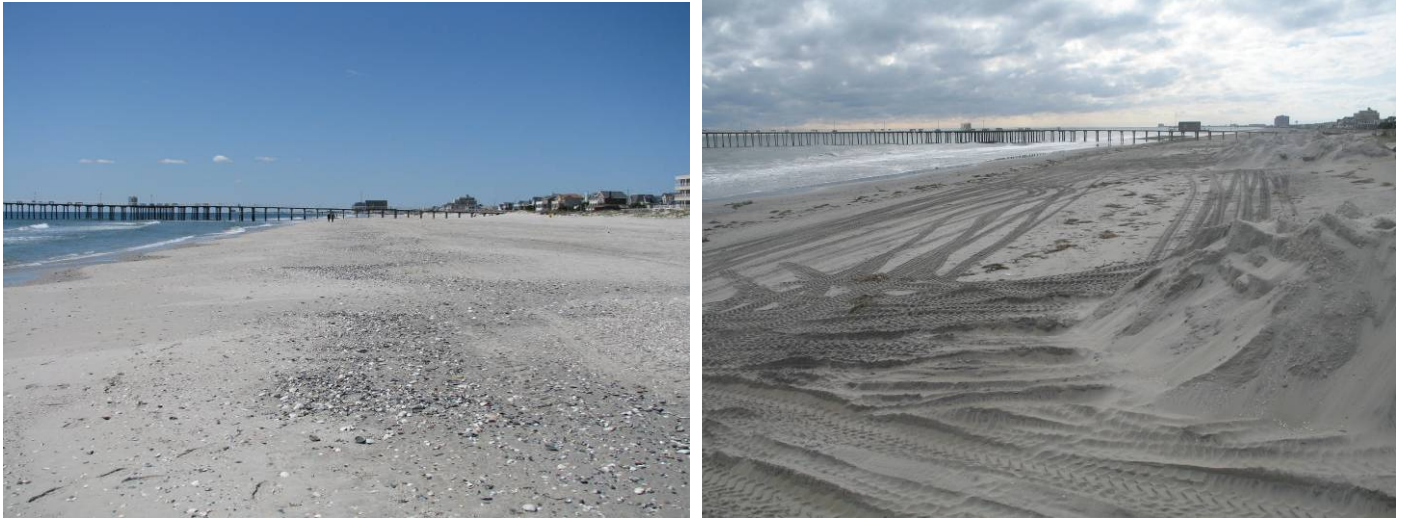
**NJBPN 128 – Dorset Avenue, Ventnor City**

The photographs above were taken on April 13, 2012 (left) and November 6, 2012 (right). Dorset Avenue in Ventnor City also is located in the middle of the Federal project with excellent retention of the sand placed in 2004.

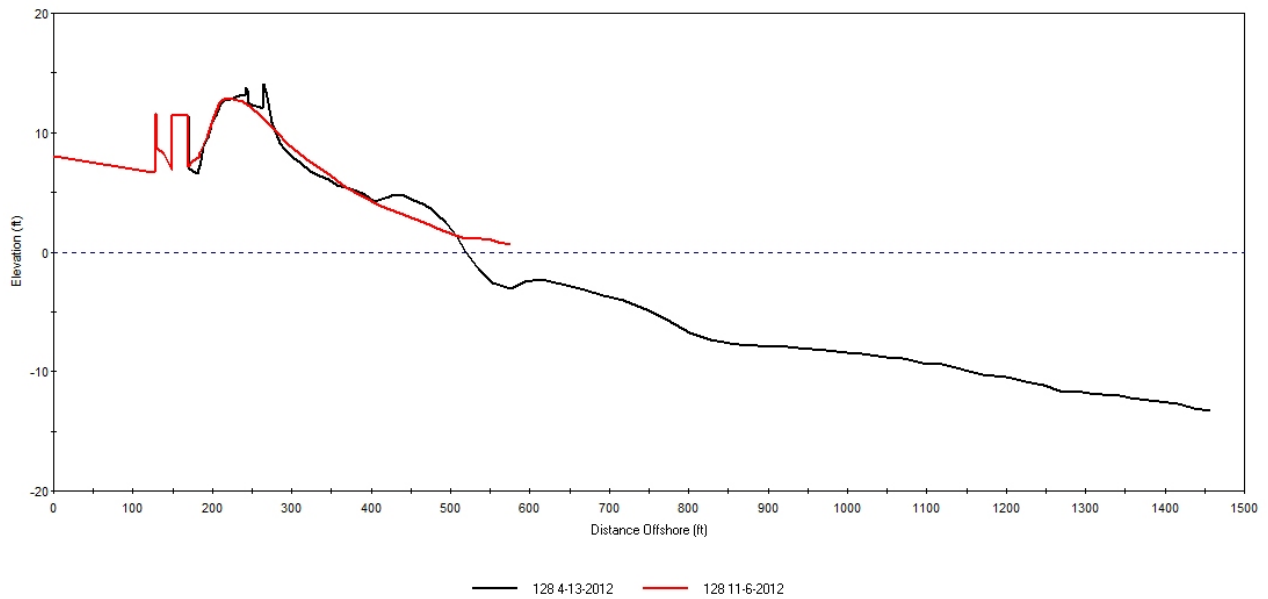
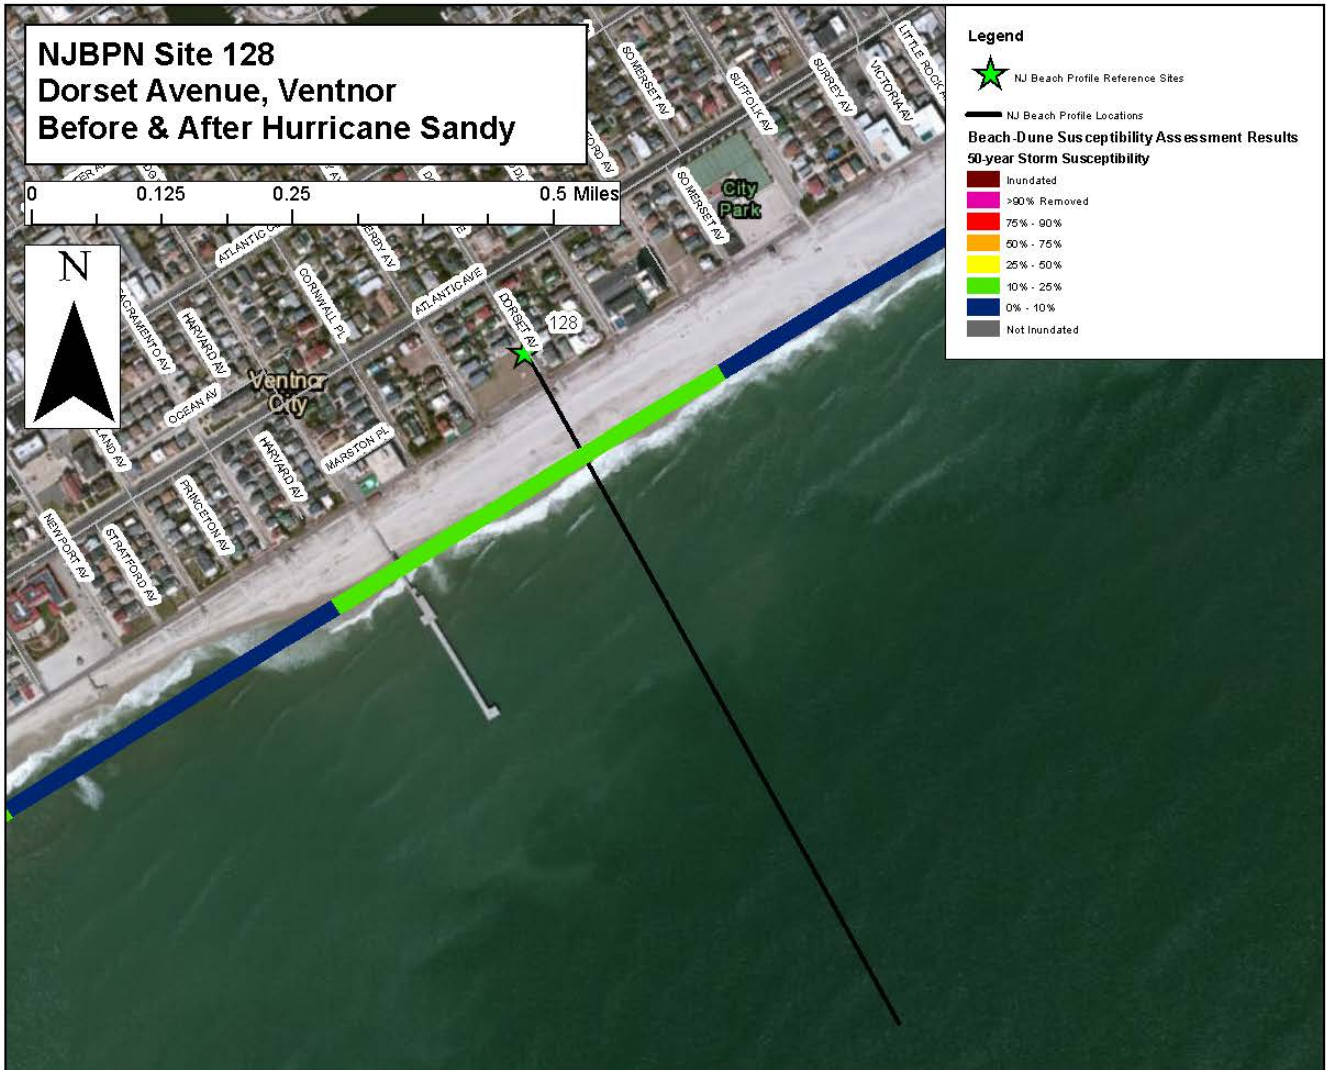
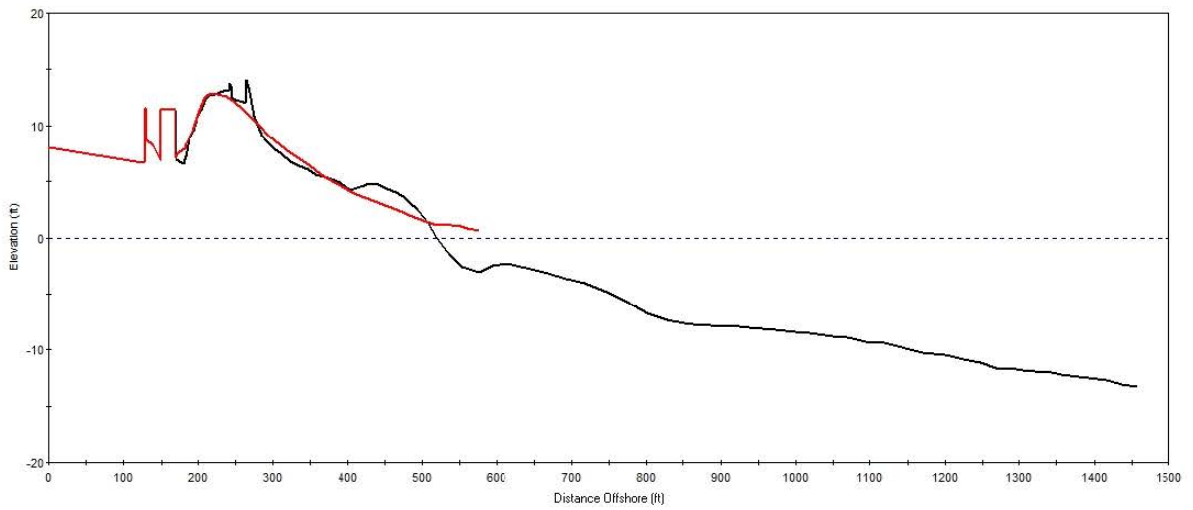
Pre vs. Post Sandy  
Site 128  
Dorset Ave., Ventnor

**Figure 9. The 2004 Federal beach nourishment project created a wide berm and dune which has remained relatively stable since that time. Minor amounts of sand were relocated seaward of the berm during Hurricane Sandy.**

Volume Change = 2.947 cu.yd/ft

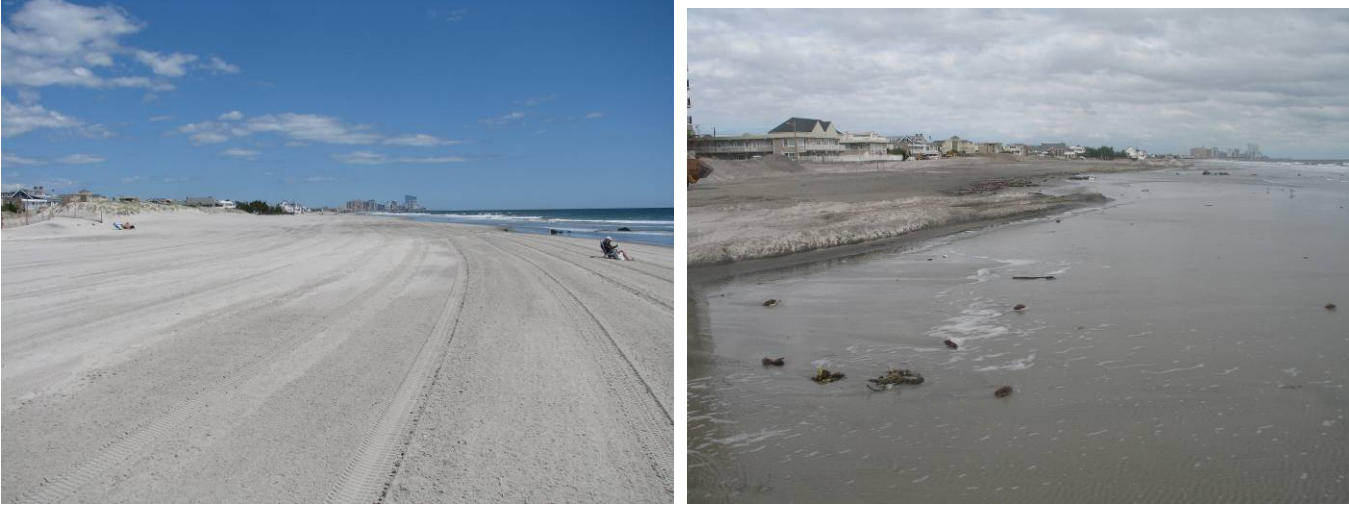
## NJBPN 127 – Benson Avenue, Margate City

The photographs above were taken on April 13, 2012 (left) and November 6, 2012 (right). The relatively robust berm was cut down and pushed landward as a substantial deposit that included Benson Avenue and environs. The work was underway to excavate the sand at the sea-side of the bulkhead to keep water from simply running over it.

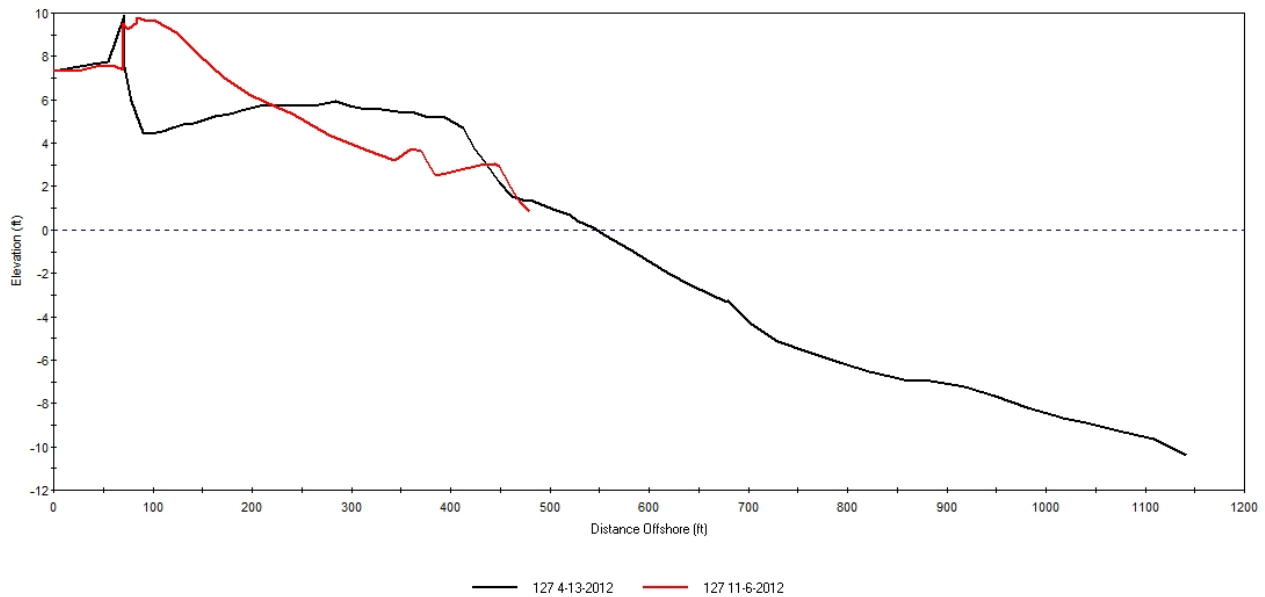
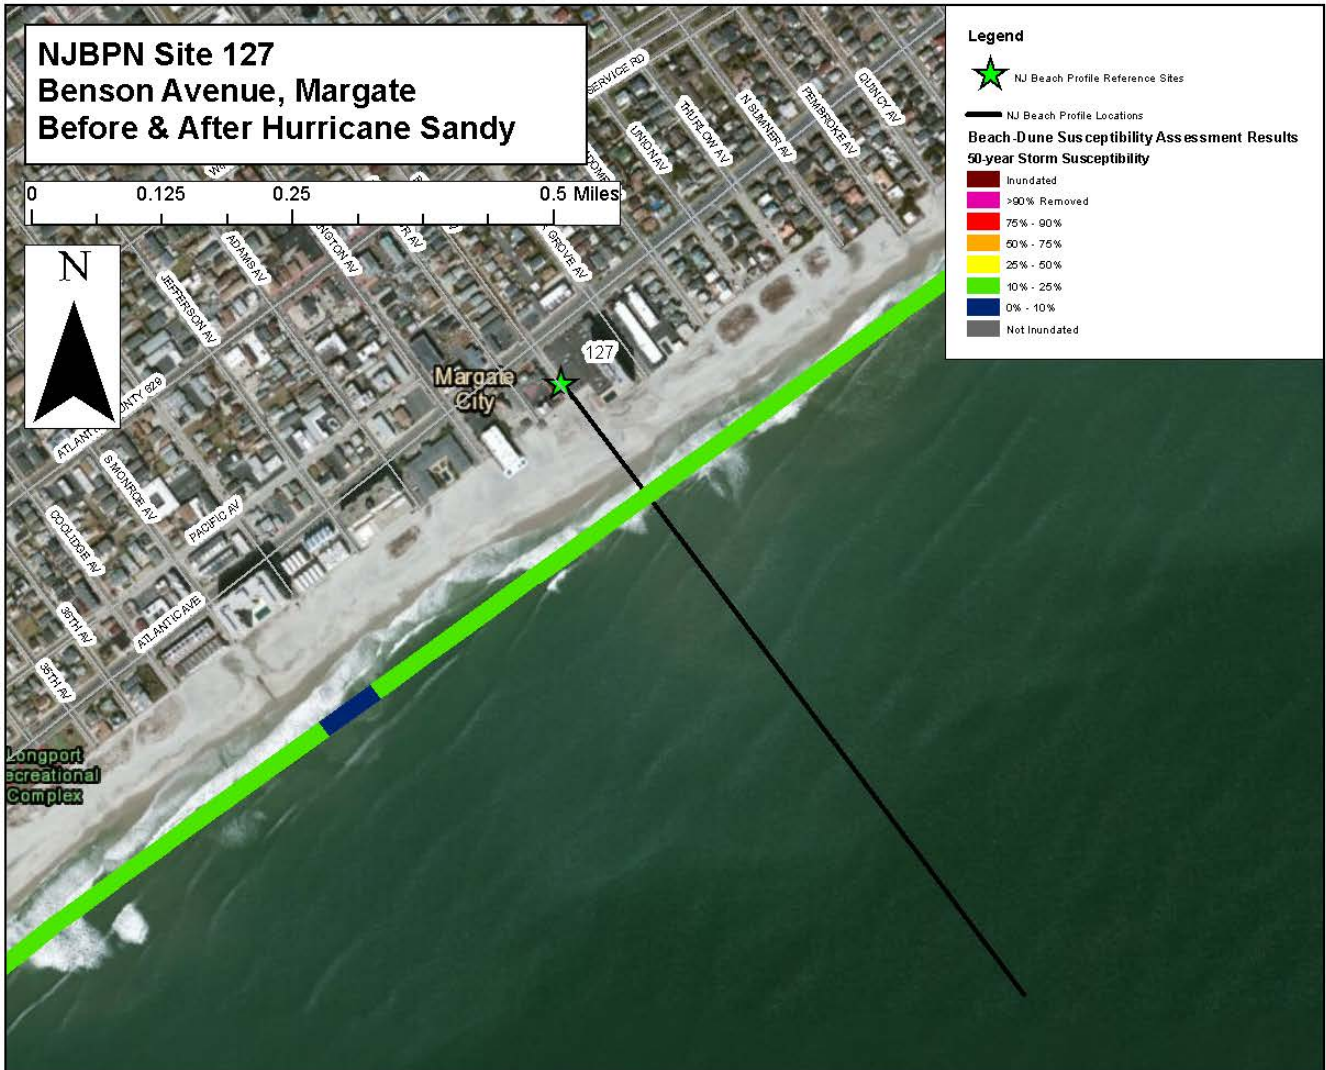
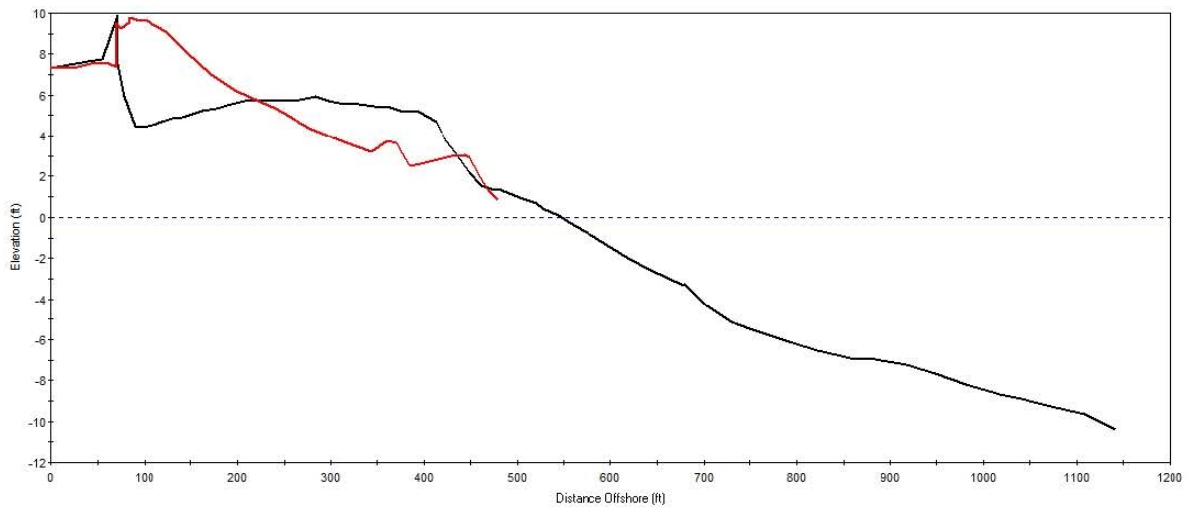
Pre vs. Post Sandy  
Site 127  
Benson Ave., Margate

**Figure 10.** This beach has benefited from the nourishment projects that were constructed to the north. No dunes exist, but there is a wide berm that has remained relatively stable. Following Hurricane Sandy, sand was transported to the bulkhead filling the swale immediately seaward and continuing landward to Ocean Avenue. The ridge at the bulkhead was sand from the streets deposited back on the beach to be spread back toward the ocean.

Volume Change = 2.647 cu.yd/ft

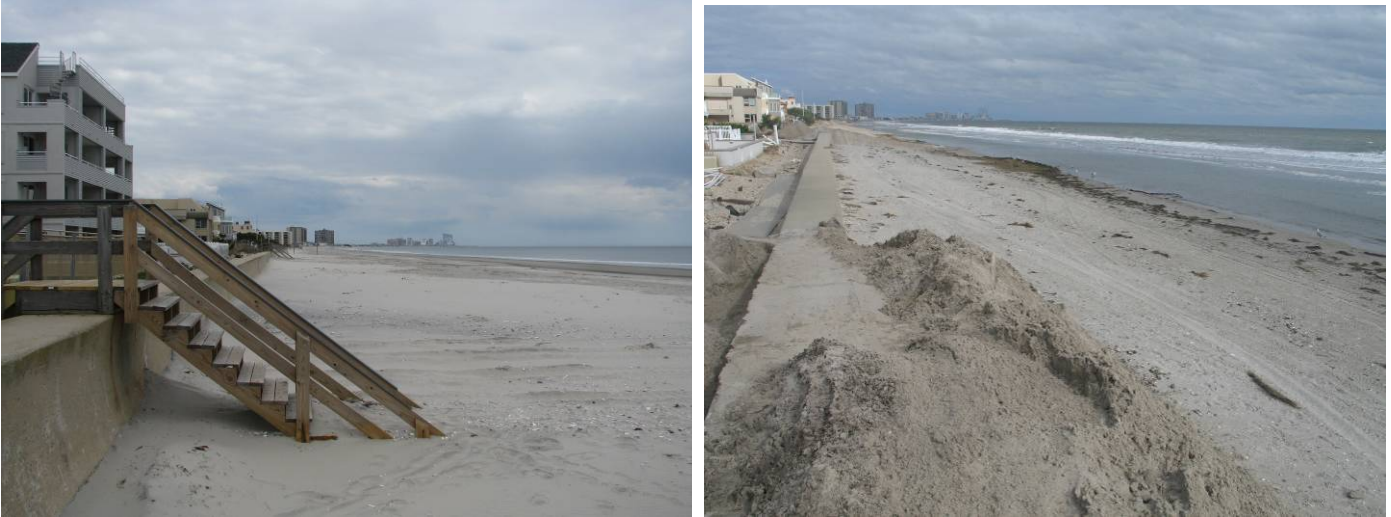
## NJBPN 126 – 17<sup>th</sup> Street, Longport

The photographs above were taken on April 11, 2012 (left) and November 6, 2012 (right). The narrow beach allowed wave energy to explode on the seawall. The water bounced over it and crashed into the homes built at the base of the wall. Street end flooding, sand deposition to Atlantic Avenue and structural damage was spread along the shoreline.

The southern community has an old concrete seawall protecting the development with a narrow, low elevation beach to the seaward. Waves crashed into the wall and poured over it down most of the Borough streets into Atlantic Avenue. Since the homes are very close to the wall, house damage was evident as well. Flooding was apparent and structural damage was wide spread. Many oceanfront properties had expensive landscaping with outside structures in abundance. These were destroyed. Longport also has a southern tip with no beach and a rock revetment seaward of a timber bulkhead with homes pressed right up to the top of the timber structure. Each of these expensive properties had the first floor of each residence ripped open and flooded with enough force to transport the electric distribution substation into the street. The homes can be restored, but the price will be high.

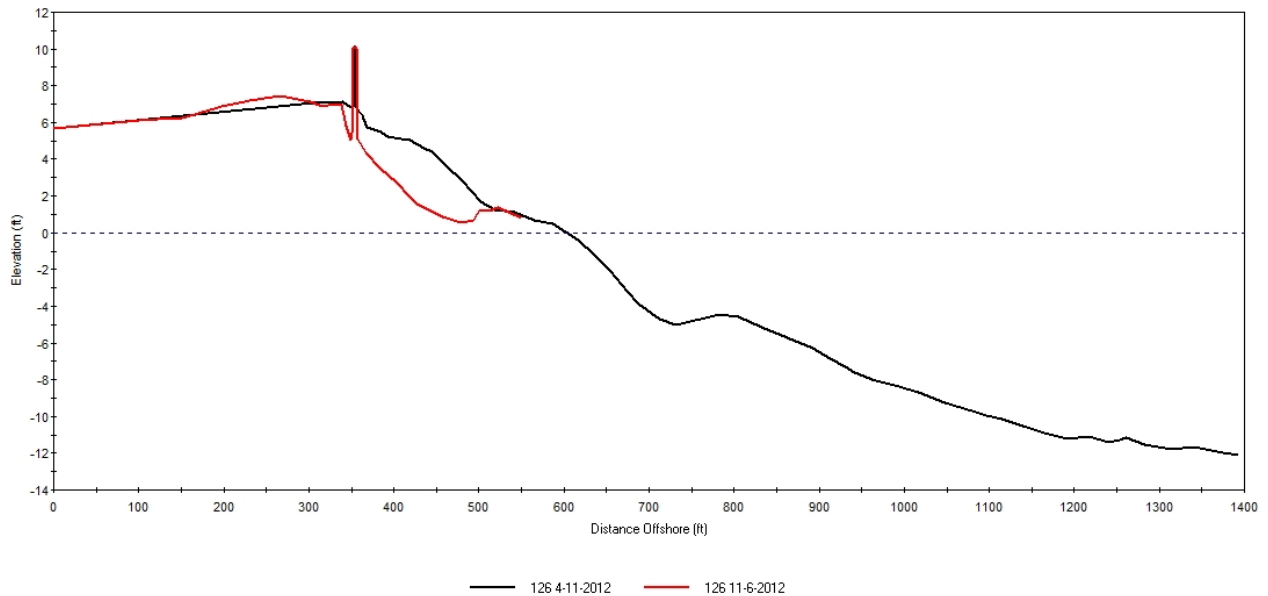
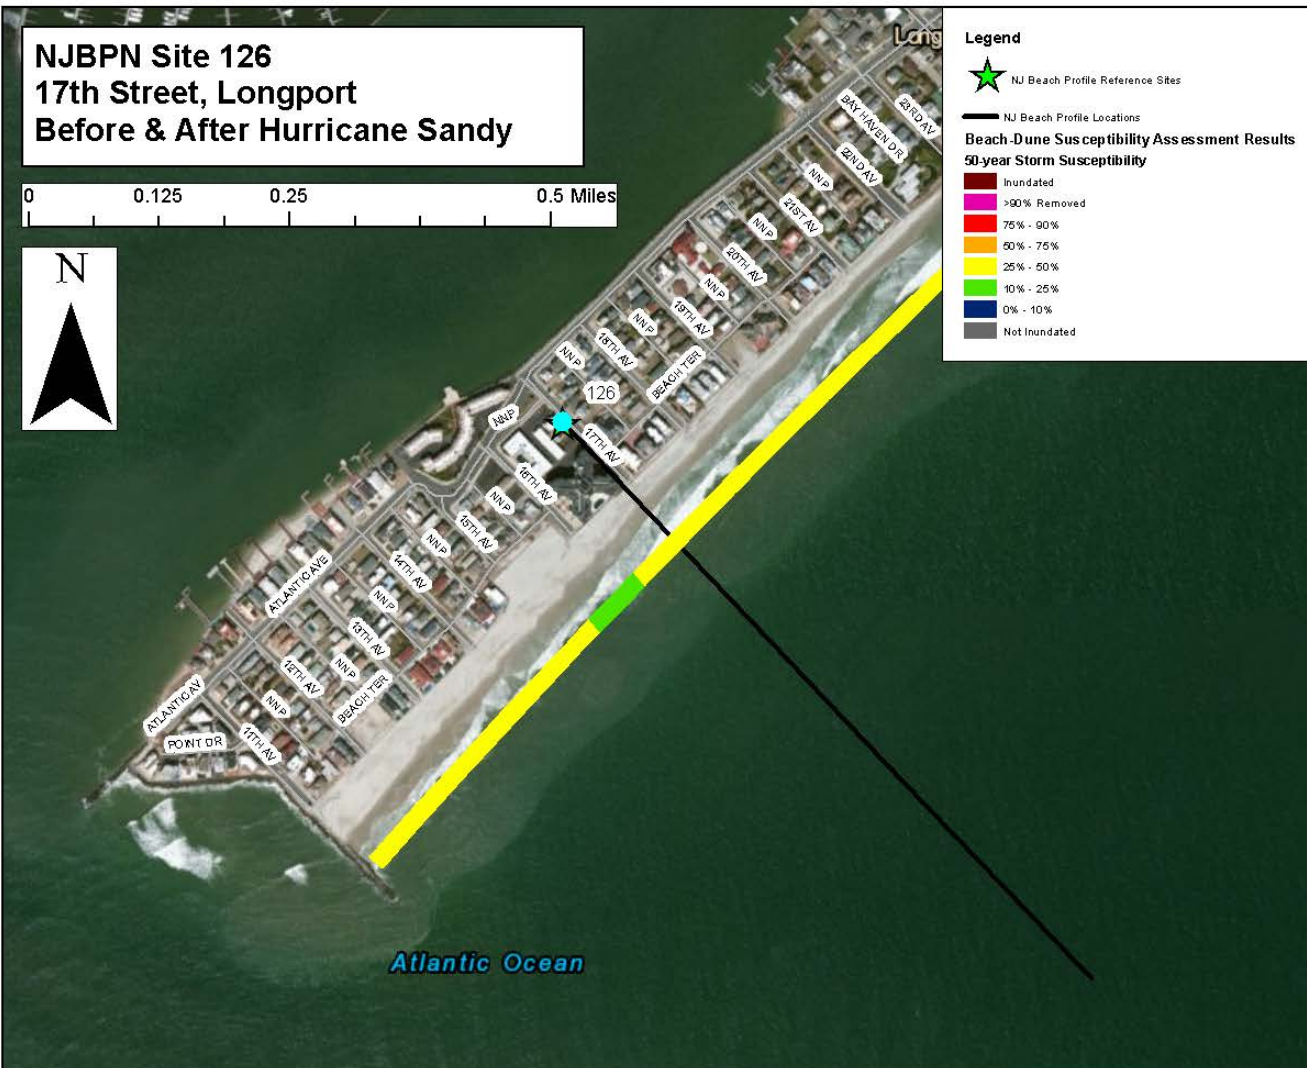
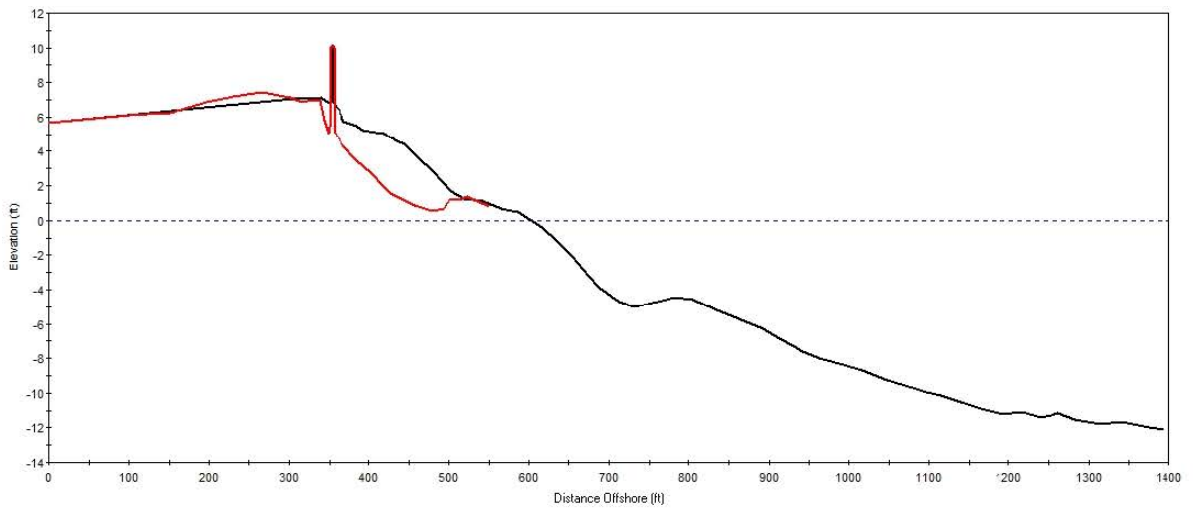
**Pre vs. Post Sandy**  
**Site 126**  
**17th St., Longport**

Figure 11. The concrete seawall stands in place of a dune system along this section of Longport. Hurricane Sandy's waves relocated the berm sand landward of the seawall and steepened the berm slope. Trucks were unloading material in piles over the wall back to the beach on November 6<sup>th</sup>.

Volume Change = -12.169 cu.yd/ft

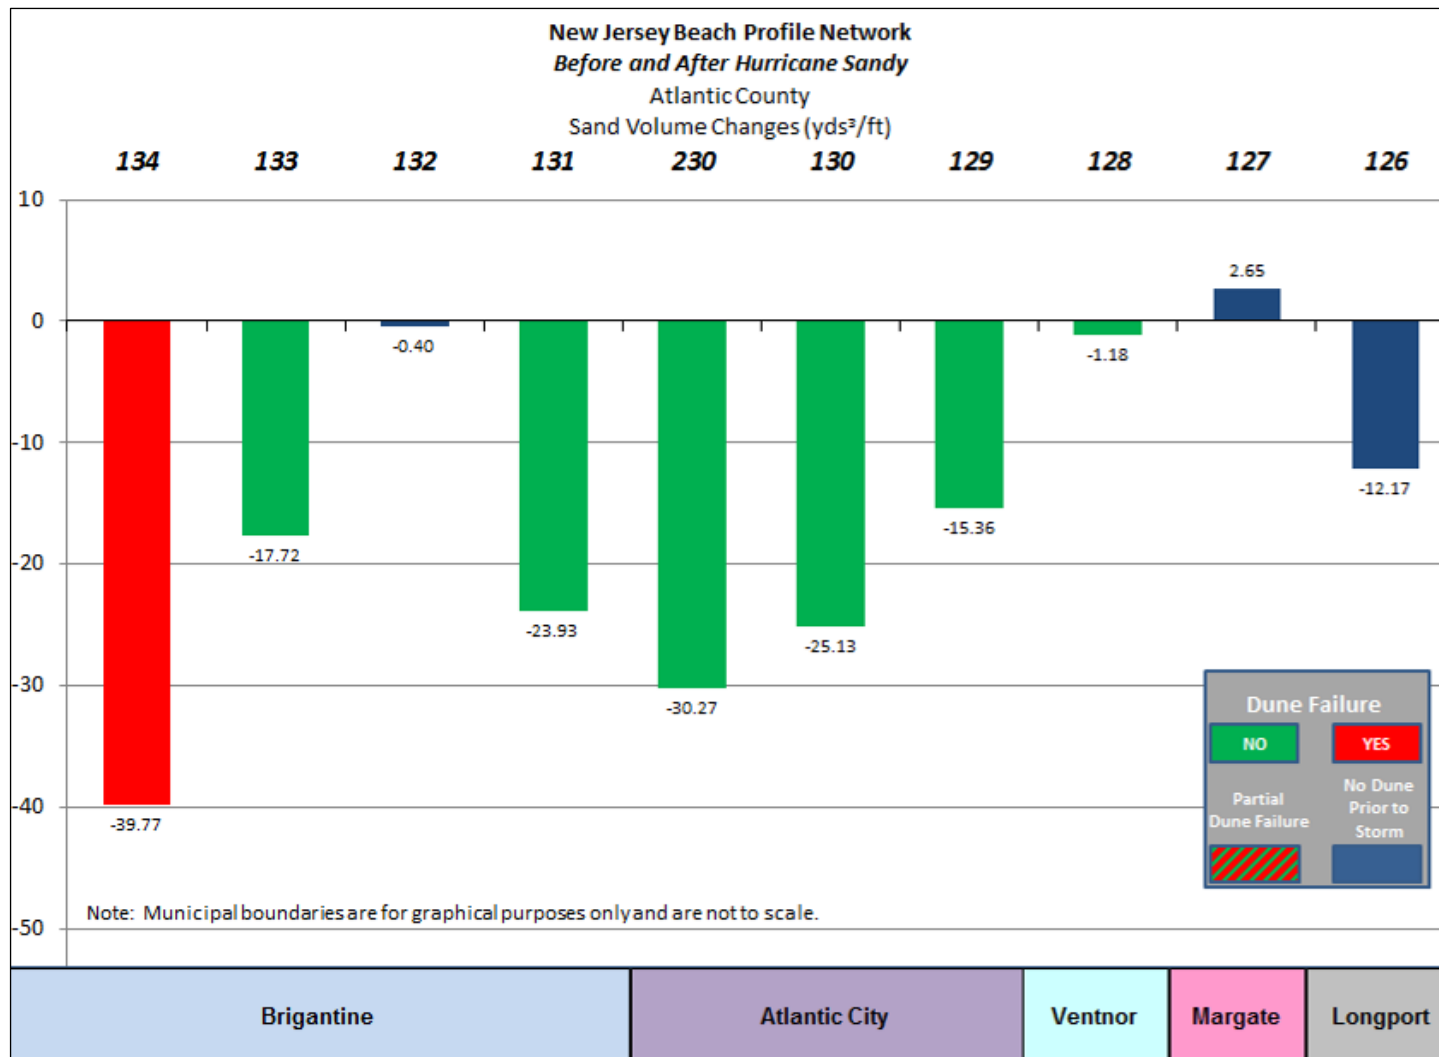
Figure 13. This graphic shows the sand volume loss figures for each of the communities within the developed sections of the Atlantic County shoreline. Federal shore protection projects have occurred along this portion of the New Jersey shoreline in Brigantine (northern portion), Atlantic City, and Ventnor. In Brigantine, prior to the storm the engineered beach had been eroded away. Atlantic City and Ventnor’s engineered beach and dune systems have been maintained by the USACE recently and withheld the storm generated waves from breaching the dunes. All sites experienced berm erosion and dune losses except for site 127 in Margate, where sand had accumulated in front of the bulkhead adjacent to the street end (No dune at this location). The only true dune failure occurred in the national area on the north end of Brigantine (site 134), however sites 132 (Brigantine), 127 (Margate) and 126 (Longport) did not have dune systems in place prior to the storm and all experienced overwash of waves with sand being transported landward of the beach.
